## Comments on CDN/24/0005 and 0011

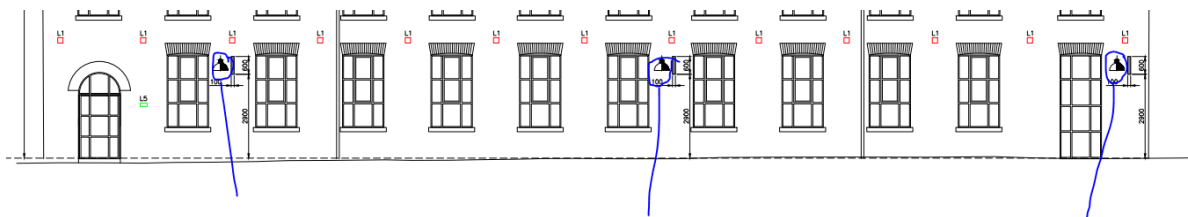
Also the drawings show fuse connection units which add further external clutter - can these be located internally. The elevation also seems to show what appears be three external projecting signs does this align with the proposed / approved signage that has been discussed with Michael?

The drawings show electrical feeds to **former** signage proposals that are now superseded by the submission of updated proposals via the separate applications. For clarity, drawing H\_O - J369-LEXA & LEX2A should be omitted and for external building mounted lighting proposals refer to previously submitted JDA drawings 353 PD 1007 - 1010 (all rev P2)

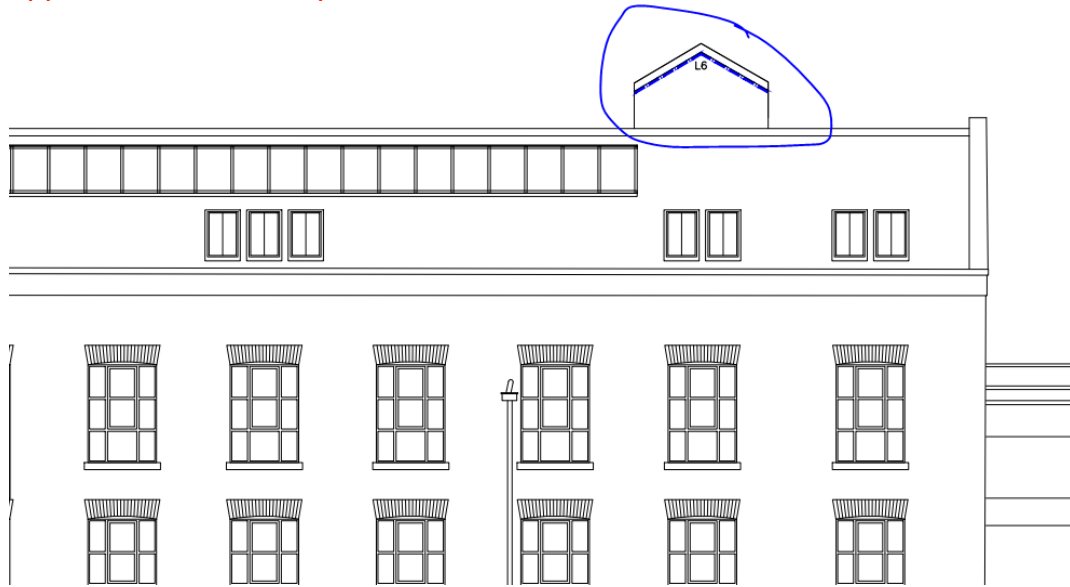
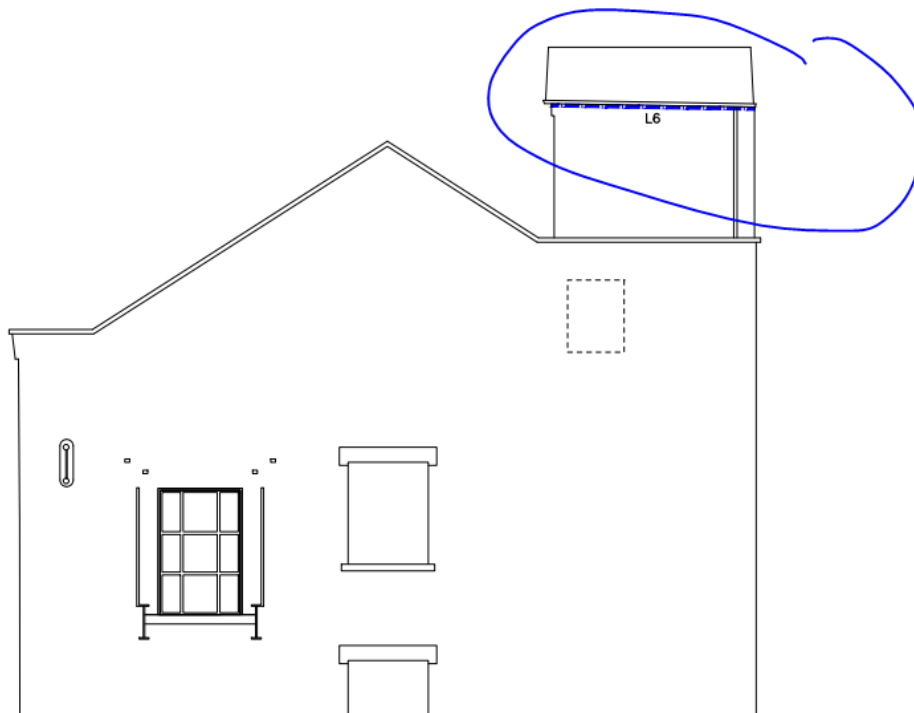
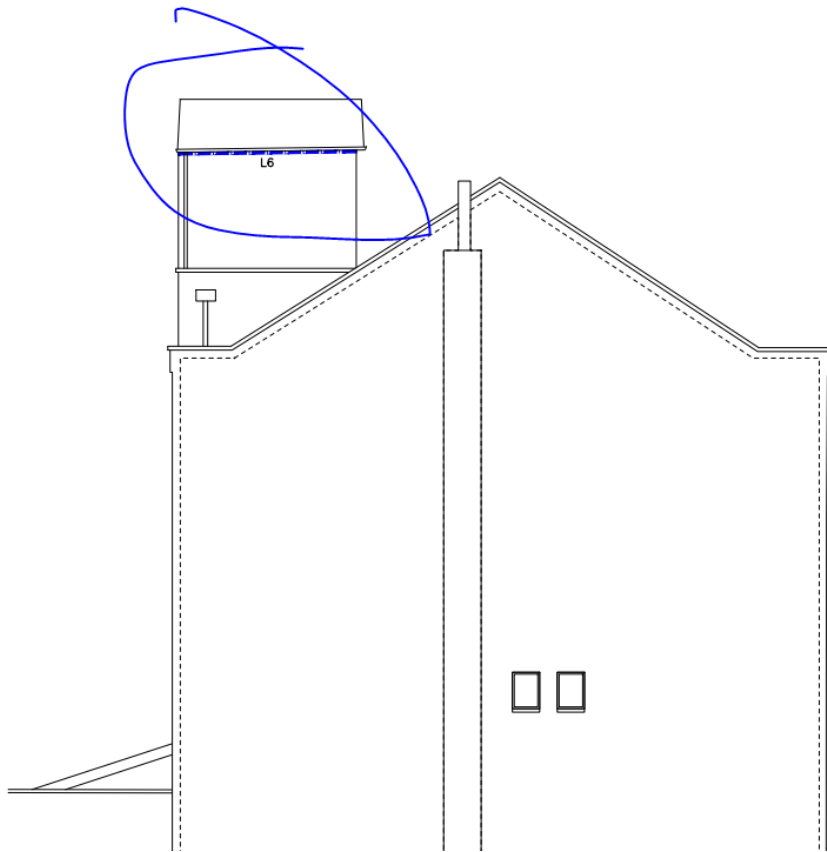
There is reference to high level LED lighting around the lift shaft again can this be removed from the condition discharge dwgs. Has this been agreed as part of the signage application?

As above, this was shown on JDA drawings submitted and approved as part of NMA application. This is to provide illumination to mural zone on lift overrun.

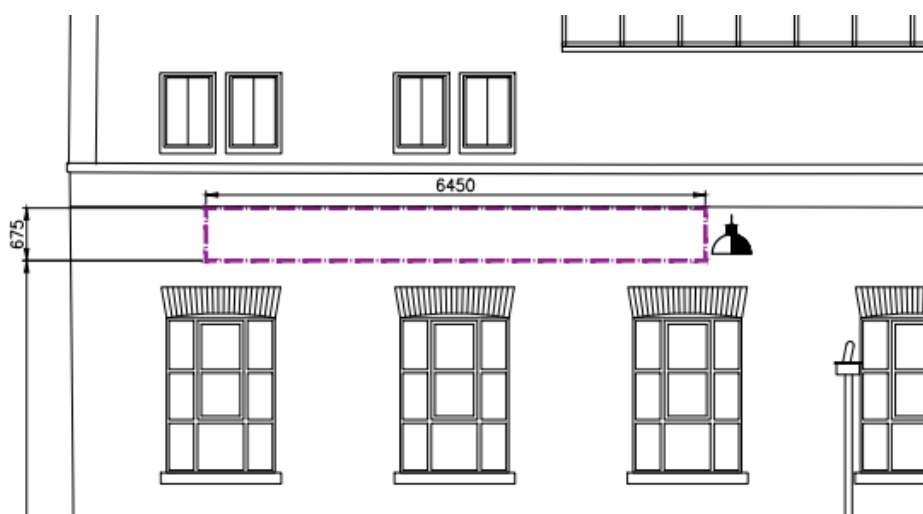
There is also lighting shown to this area where we have been discussing the signage – again it would be useful to understand what has been agreed.

Updated signage application drawings have been issued and strategy for facade signs agreed in principle by MCC. We are currently awaiting technical input and data sheets from Astra signs in response to MCC request. See drawings 353 PD 1003 (P9), /1004 (P8), /1011 (P1) & /1012 (P1) for current proposals agreed as part of separate signage application.

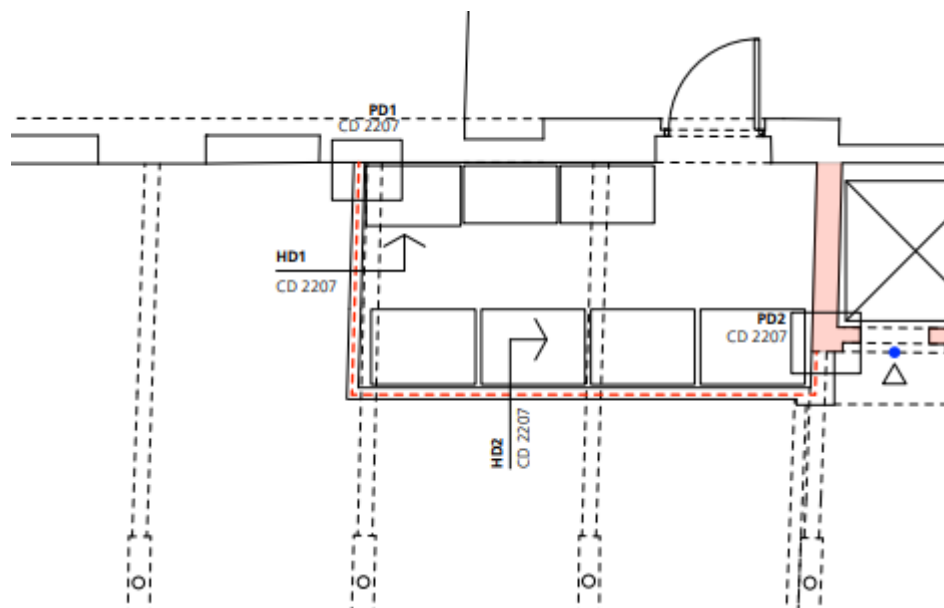
The Partition Type HD1 below is to the bin store. The beam is shown in the detail as boxed in which is not ideal as it should be exposed. The preference would be to relocate the partition to the right hand side of the beam to allow it to be fully exposed on the office side. This will involve some reconfiguration of the bin store if this is feasible.

This will not be exposed as the WCs are located next to the refuse store and these have a suspended ceiling (updated layouts submitted as part of NMA app). Refuse store also requires 60 mins fire protection so bulkhead introduced to avoid blockwork having to be cut around joists and gaps filled to retain fire protection. This is the only location in the building where the detail is different
