# Photographic Method Statement

## Former Stables to the North-West of Heaton Hall

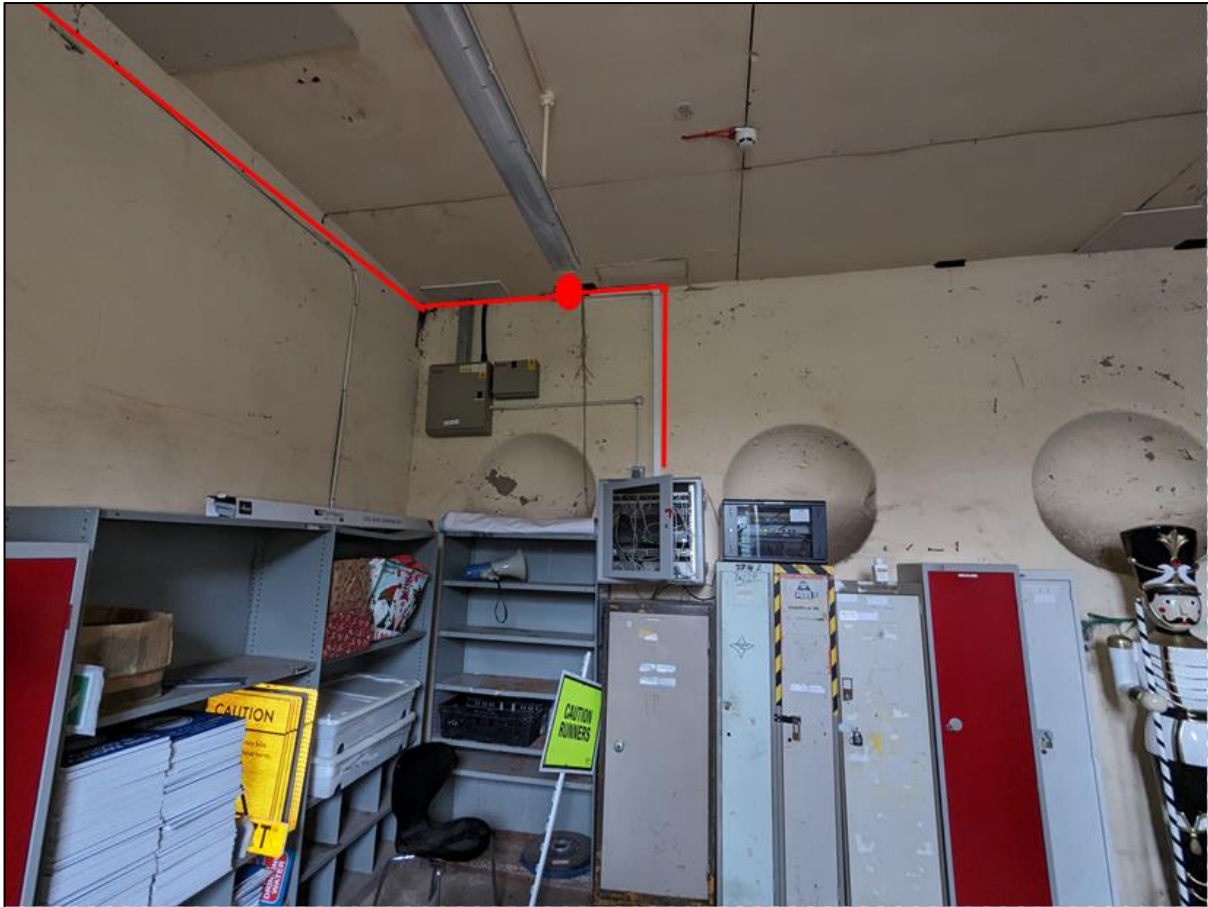
**Appendix 1:** The photograph above illustrates GF021 Store. The comms cabinet, the containment unit from which a red line protrudes, will provide the basis for connecting access points throughout the complex with a WAN connection. From the comms cabinet, a Cat6a cable will replace existing network cabling using the same trunking clad route. As it approaches the ceiling the cable branches, one arm will provide network connection to AP3 and AP6 whilst the second branch utilizes an existing hole in the ceiling (marked by a red dot) to access the loft cavity which will be used to route the remaining 4 AP's.

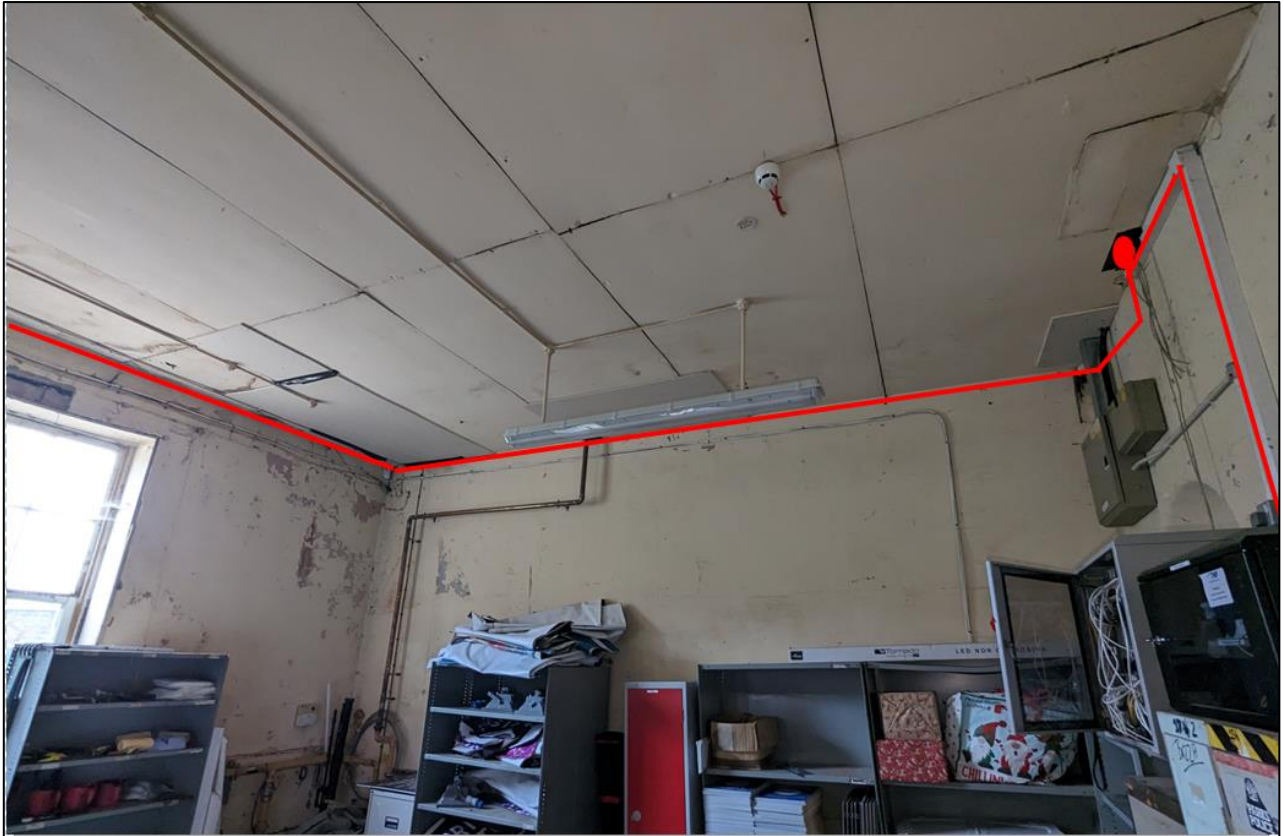
**Appendix 2:** Pictured above is GF021 Store. From the comms cabinet, located on the far right of the photograph, a Cat6a cable follows an existing trunked cable run to the point at which the cable branches. One branch continues to wrap around the room following the route of existing cabling towards AP3 and AP6. A second branch enters the loft cavity via an existing penetration marked by a red dot. The presence of a cable run tracing the outskirts of GF021 Store should not significantly impact the heritage value of the stables due to its present dilapidated state. Care will be taken to install cables using methods which allow for their removal without causing structural harm to the building's fabric.

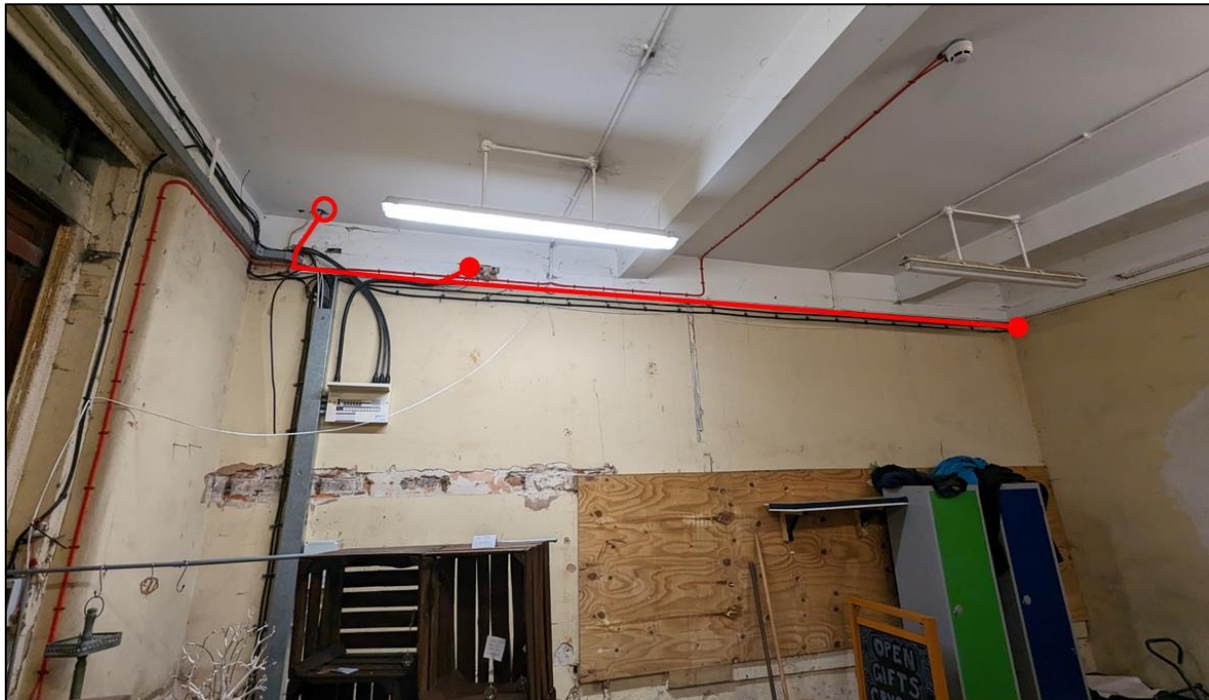
**Appendix 4:** Pictured above is GF027 Store. The central red dot indicates the point at which the cable run enters from GF021 using an existing penetration. As the Cat6a cable enters GF027 the route branches with the left branch utilizing a penetration in the ceiling to access 014 Office. As the route branches towards the right it uses an existing penetration to access 024 Staff Room.

**Appendix 6:** The photograph adjacent, taken in 014 Office, indicates the point at which the cable run pictured in Appendix 4 passes from GF021 into 024 Staff Room. This is done utilizing an existing penetration indicated by the red circle. The cable then utilizes the existing trunking encircling 024 Staff Room to provide network connection to AP6.

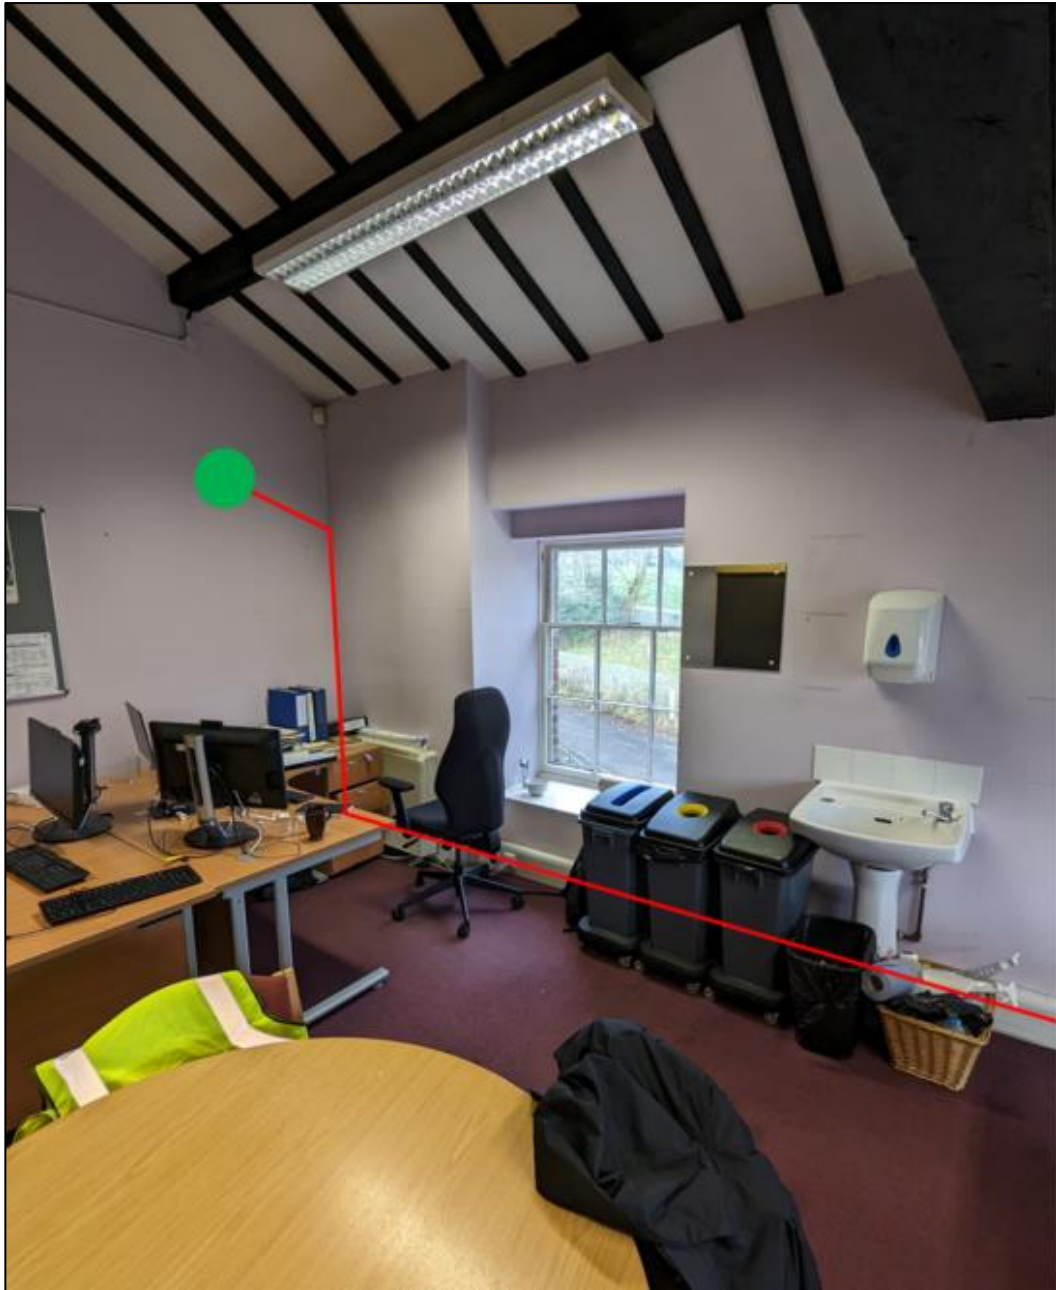
**Appendix 7:** The photograph above, taken in 014 Office, illustrates the continuation of the cable run detailed in Appendix 6 with its termination at the point marked by a green circle indicating the point at which an access point is to be installed. The cable run primarily utilizes an existing stretch of trunking and will then use a steel conduit to run up the wall and provide network connection to the access point.

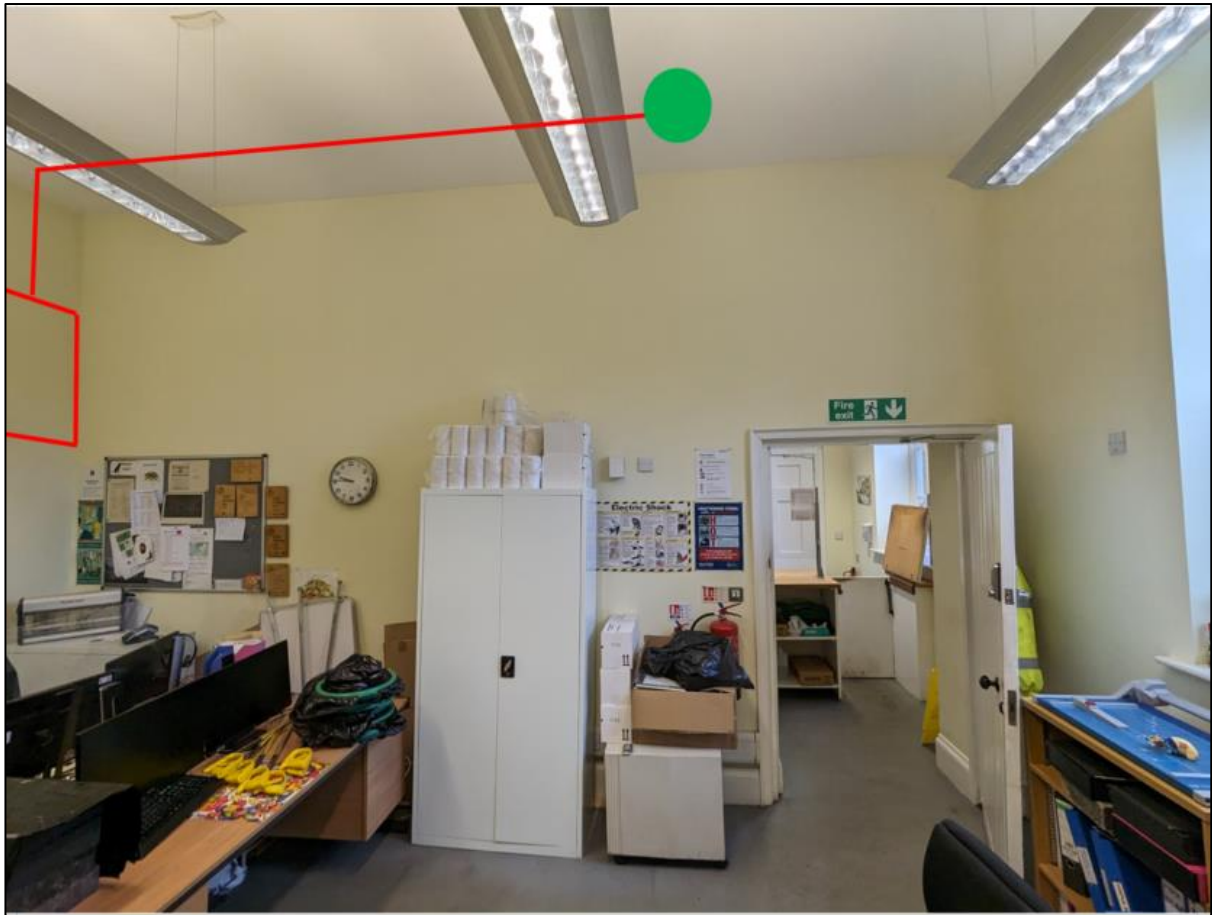
**Appendix 8:** GF018 Office, pictured above, is to see the installation of a single access point (AP4) in its ceiling. AP4 will be wired from the comms cabinet via the ceiling void mentioned in Appendix 1.

**Appendix 9:** GF030 Office, pictured above, shows a second cable running from the point at which the run enters the loft void, as opposed to the first which terminates with AP5, pictured in Appendix 8. Within the loft void, the cable run branches, with the branching arm terminating in Appendix 11 with AP5 in 031Office and the continuing cable run bridging 001 Circ.

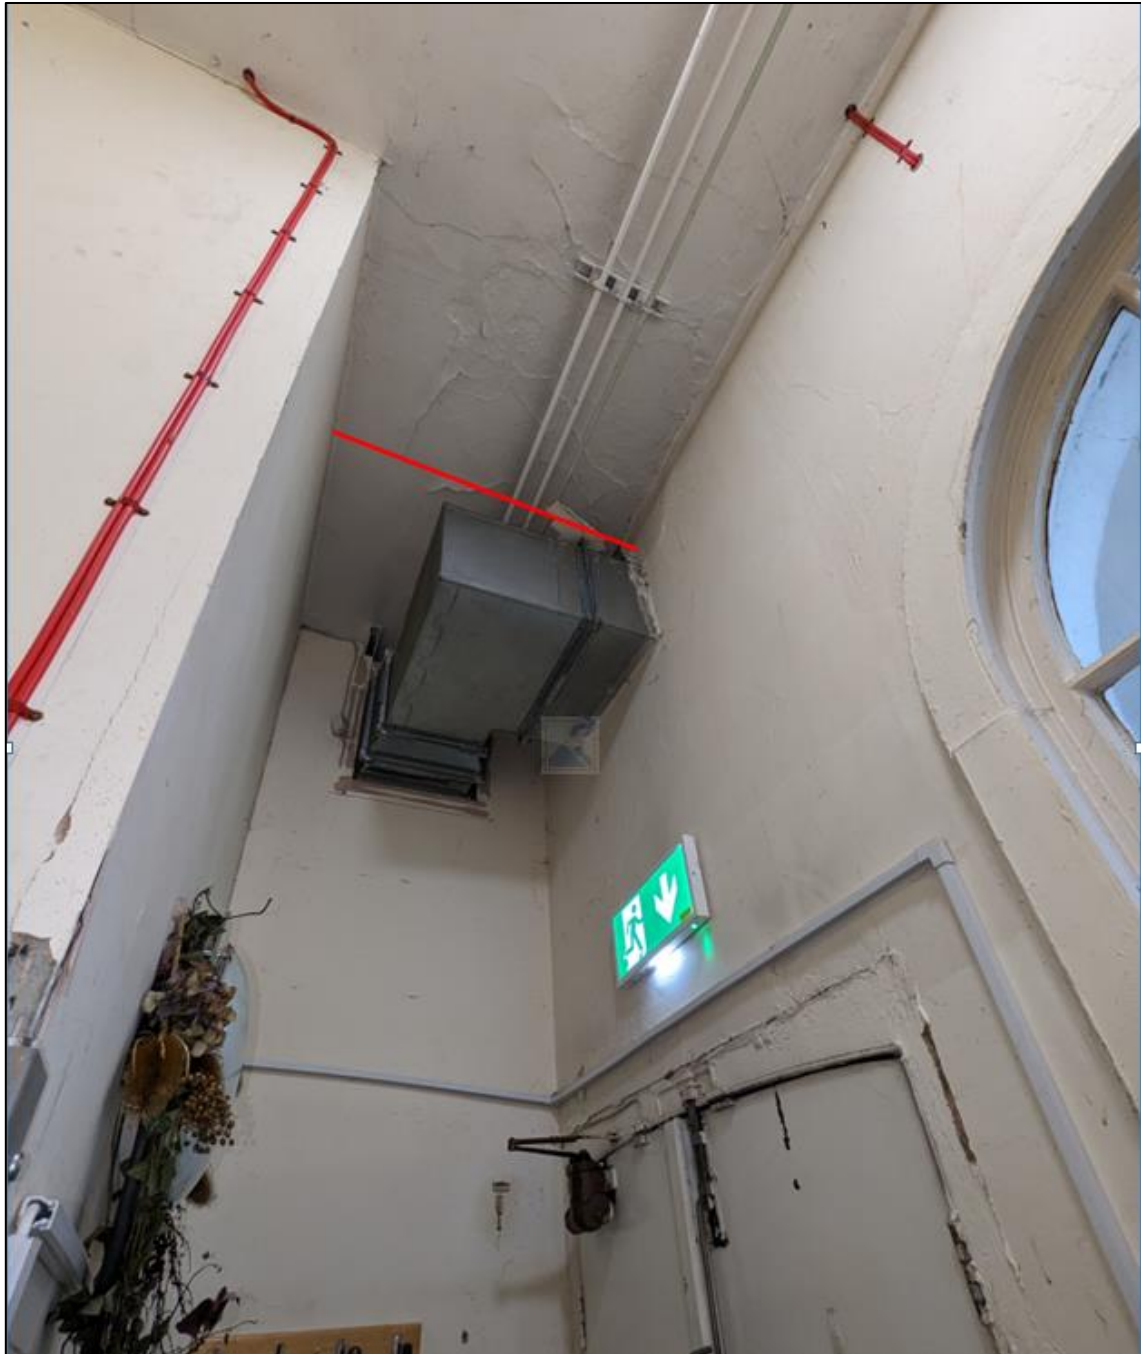
**Appendix 13:** As mentioned in Appendix 12, the cable run passes from 001 Circ. into 002 Circ. via the loft space. The red line illustrated above indicates the cables continued use of the loft space to pass from 002 Circ. into 016 Kitchen (as can be seen in Appendix 14).

**Appendix 14:** As mentioned in Appendix 13, the cable run passes via the loft space between 002 Circ. and 016 Kitchen. Photographed above, the cable enters 016 Kitchen via 002 Circ. and using the ceiling void is routed through the wall facing the Café area (as seen in Appendix 15).

**Appendix 15:** Pictured above is the cable run mentioned in Appendices 13 and 14. Utilizing the ceiling void, the cable run enters the 005/015 Café area by drilling a single 20mm hole (Drill 3). As can be seen above, the buildings fabric is currently perforated by several such holes and in keeping with the existent style of service elements, any visible stretches of cabling will be affixed using a steel or copper trunking.

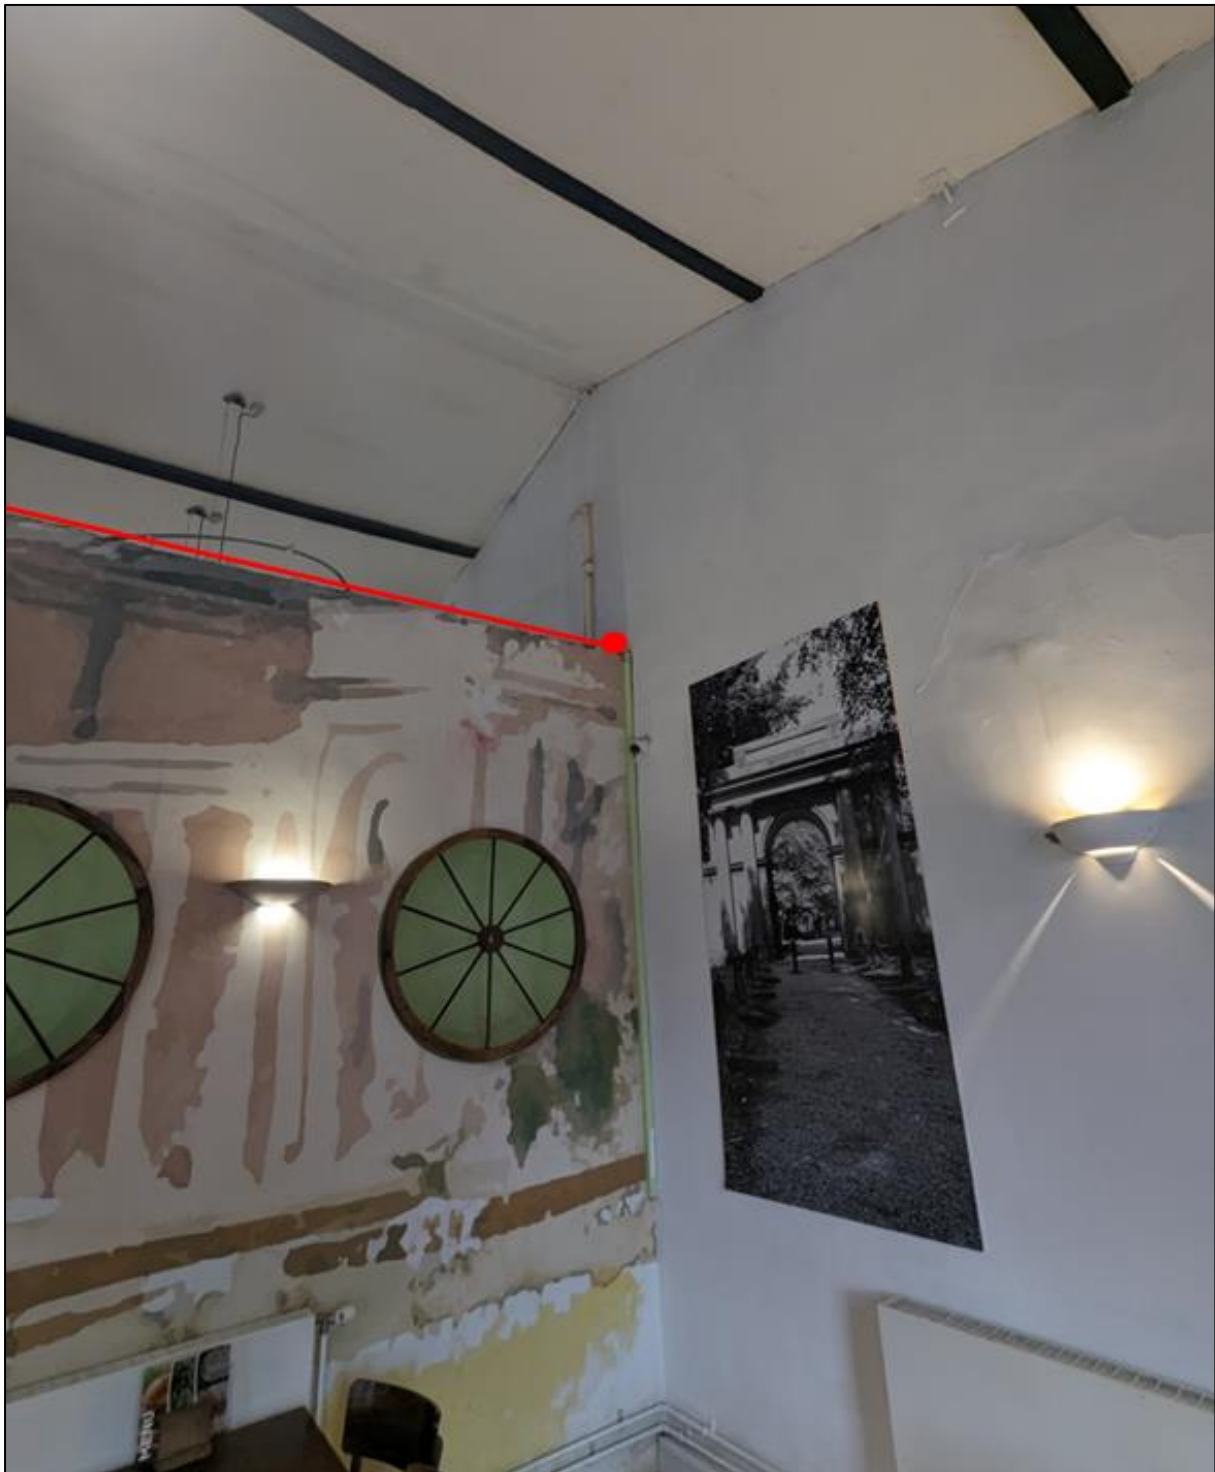
**Appendix 16:** Pictured above is the wall partitioning 005 Café from 015 Café, which bisects the large room. Drill 3, mentioned in Appendix 15, will penetrate the wall separating 016 Kitchen from the Café area level with the top of the partitioning wall. In doing so, the visual impact of alterations made through the installation of Wi-Fi are minimised as a Cat6a cable will be run along the top of the wall, meaning that the cable is completely invisible from eye level.

**Appendix 17:** Following from Appendix 16, the cable continues to run along the top of the partitioning wall with AP1 to be affixed to a wooden beam using industrial Velcro. More detail on its location can be found detailed in Appendix 18.

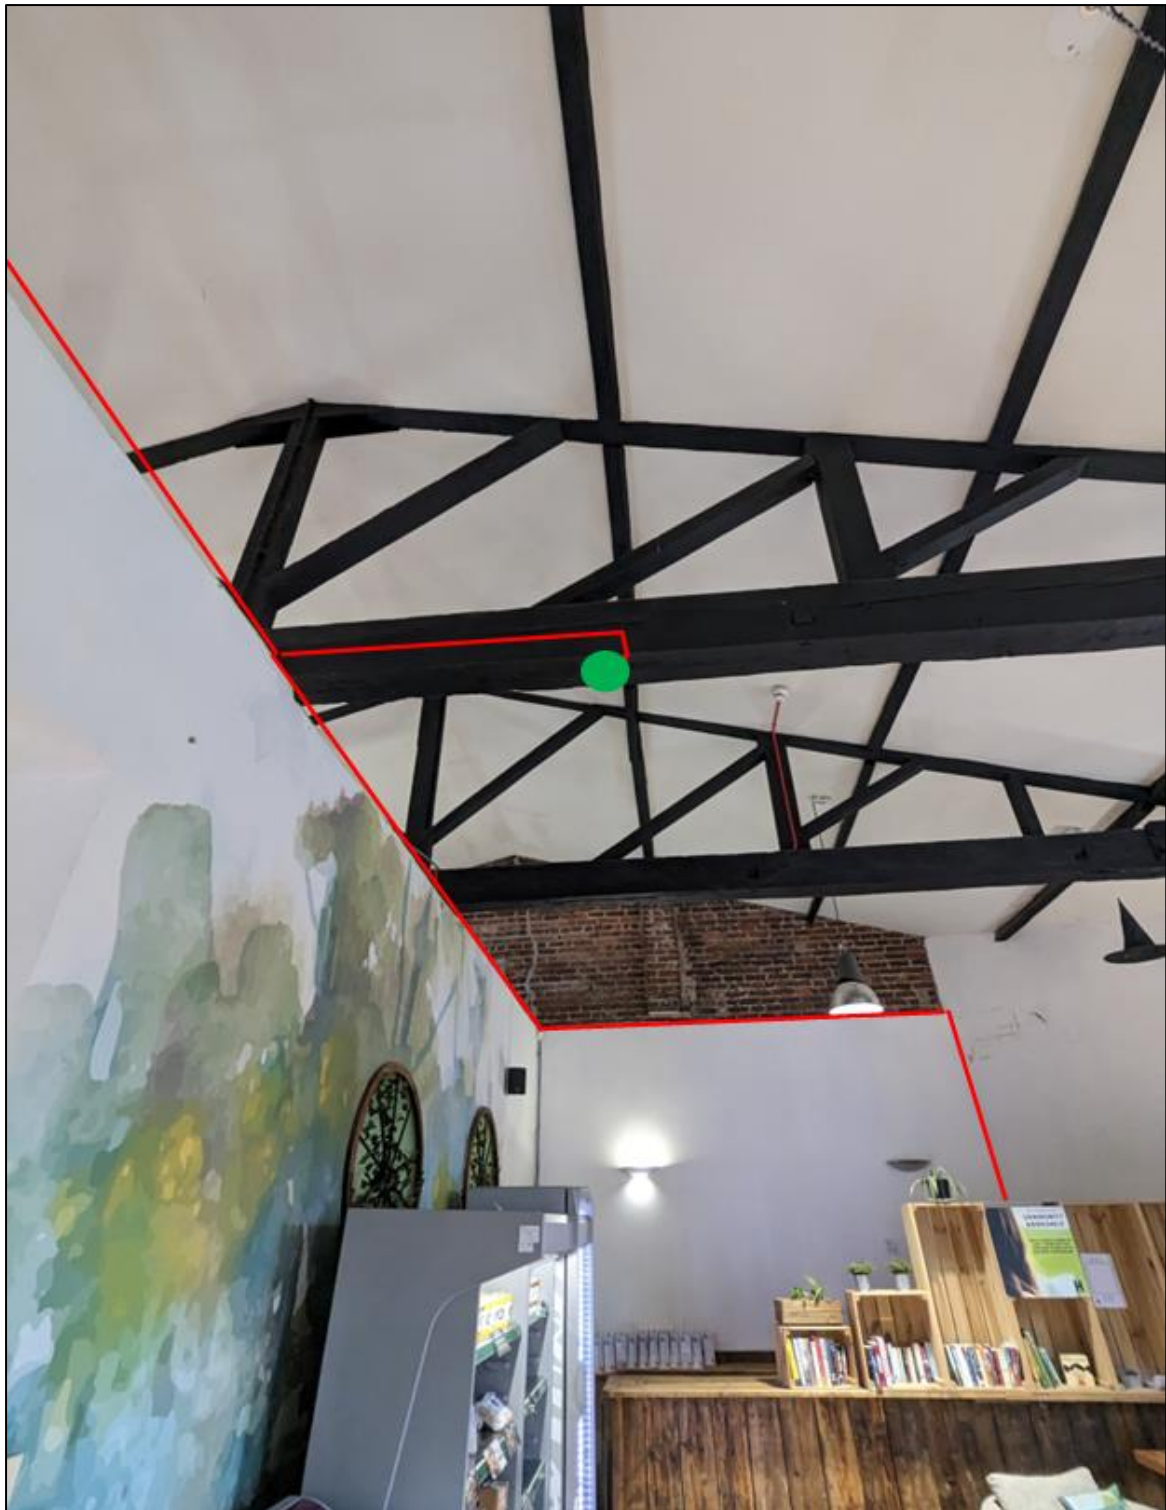
**Appendix 18:** Pictured above, Appendix 18 illustrates the location of AP1, affixed to the beam running perpendicular to the partitioning wall using industrial Velcro, chosen to minimize damage should the device be removed in the future. The device itself should not significantly impact the historic character of the space due to the presence of existent devices installed using the wooden beams. A second branch of the Cat6a cable run will continue to run along the partitioning wall, then using the lip of the false wall to remain hidden and finally dropping towards the door to 013 Circ. using steel or copper trunking to minimize the visual impact of the cable.

**Appendix 19:** Pictured above is the door separating 015 Café from 013 Circ., the proposed cable run, highlighted in red, continues from the Cat6a cable run mentioned in Appendix 18. As can be seen above, the cable will be affixed to the wall adjacent to the door and a single penetration will be made in the doors frame to route the cable from 015 Café into 013 Circ (Drill 2). Due to a lack of existing penetrations between these two areas, this method has been agreed upon as the only viable means of providing internet access to 044 Activity Classroom. Wherever possible the cable route will be installed in such a way as to minimize its impact upon the buildings fabric and historic character. As such, the cable will be clad using steel trunking to minimize the visual impact upon its surroundings.

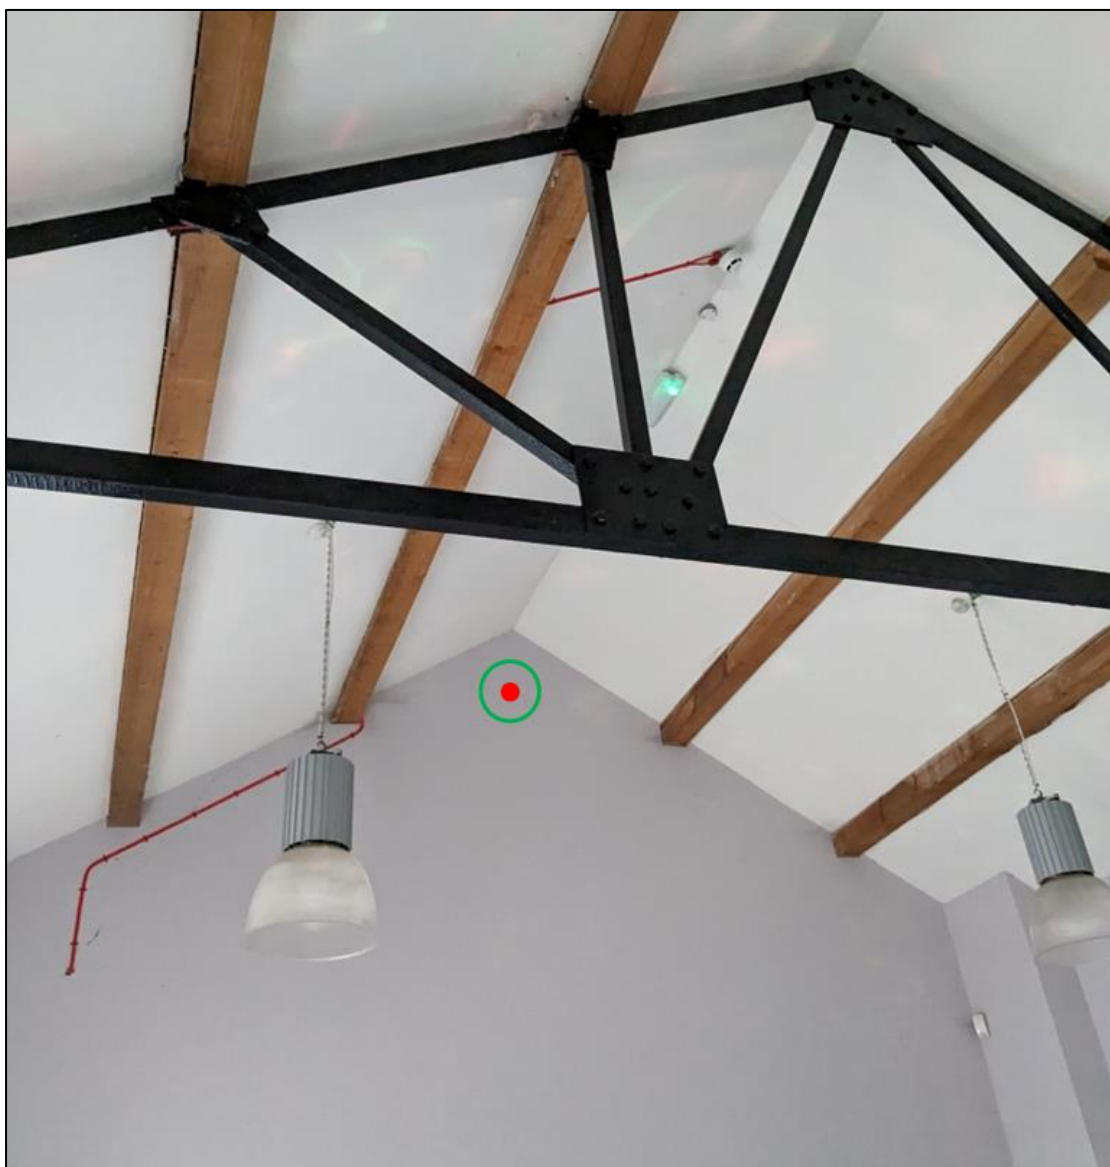
**Appendix 21:** Pictured above, Drill 3 enters 044 Activity Classroom via 013 Circ. AP2 is to be affixed using a steel wall bracket directly over this point, terminating the route. As the SDA access point mirrors existing equipment in the space, its impact on the character of the building is minimal.

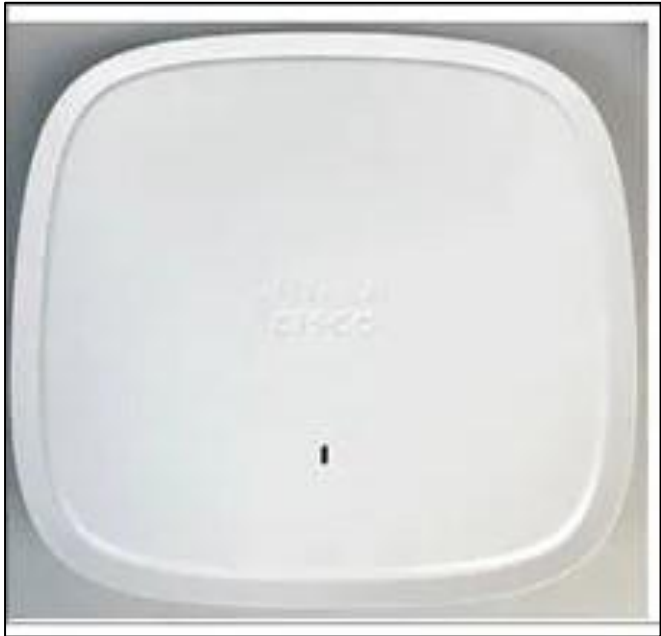
**Appendix 22:** Sample of an SDA access point, of the same type to be installed in Blackley Crematorium.
