Old Bank, Manchester

Method Statement / Risk Assessment / Technical Submission

Stone Removal / Restoration / Reinstallation

Stone Demolition / Deconstruction Sequence

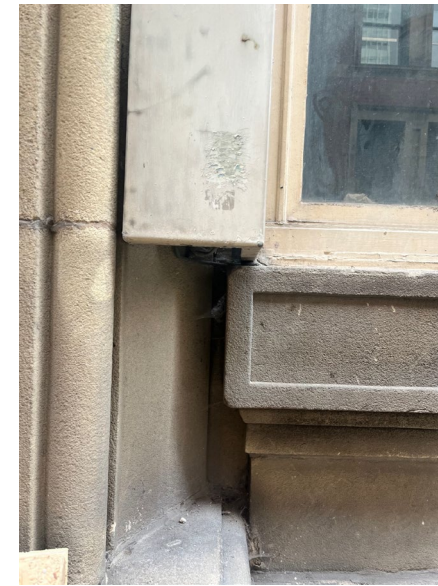
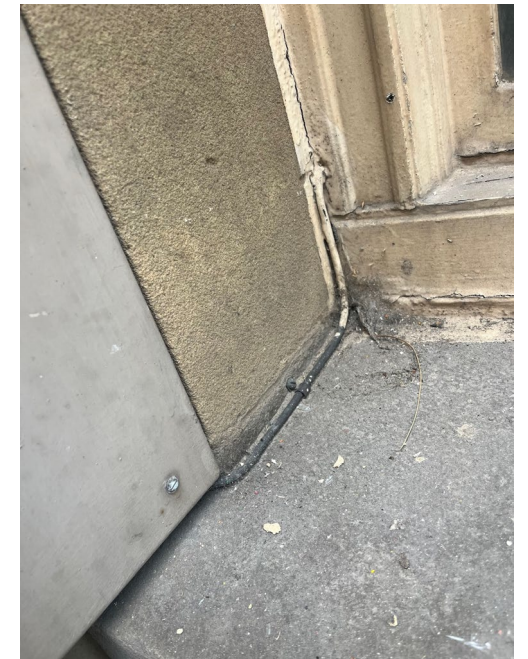
Cill stone will potentially need to be cut centrally to facilitate removal due to interface with reveal / jamb stone

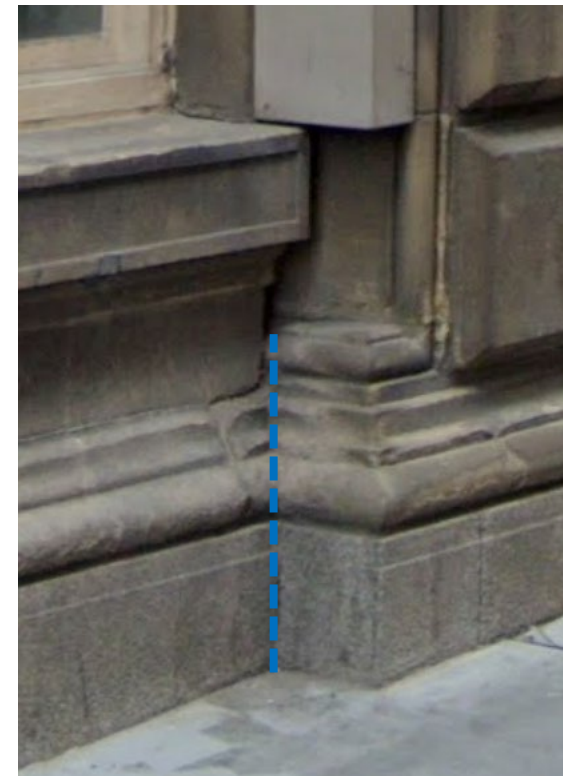
Straight cut required  
at dashed line  
location to facilitate  
continuation of  
moulded stone back  
to window frame
