# **Photographic Method Statement**

## **Manchester Art Gallery First Floor**

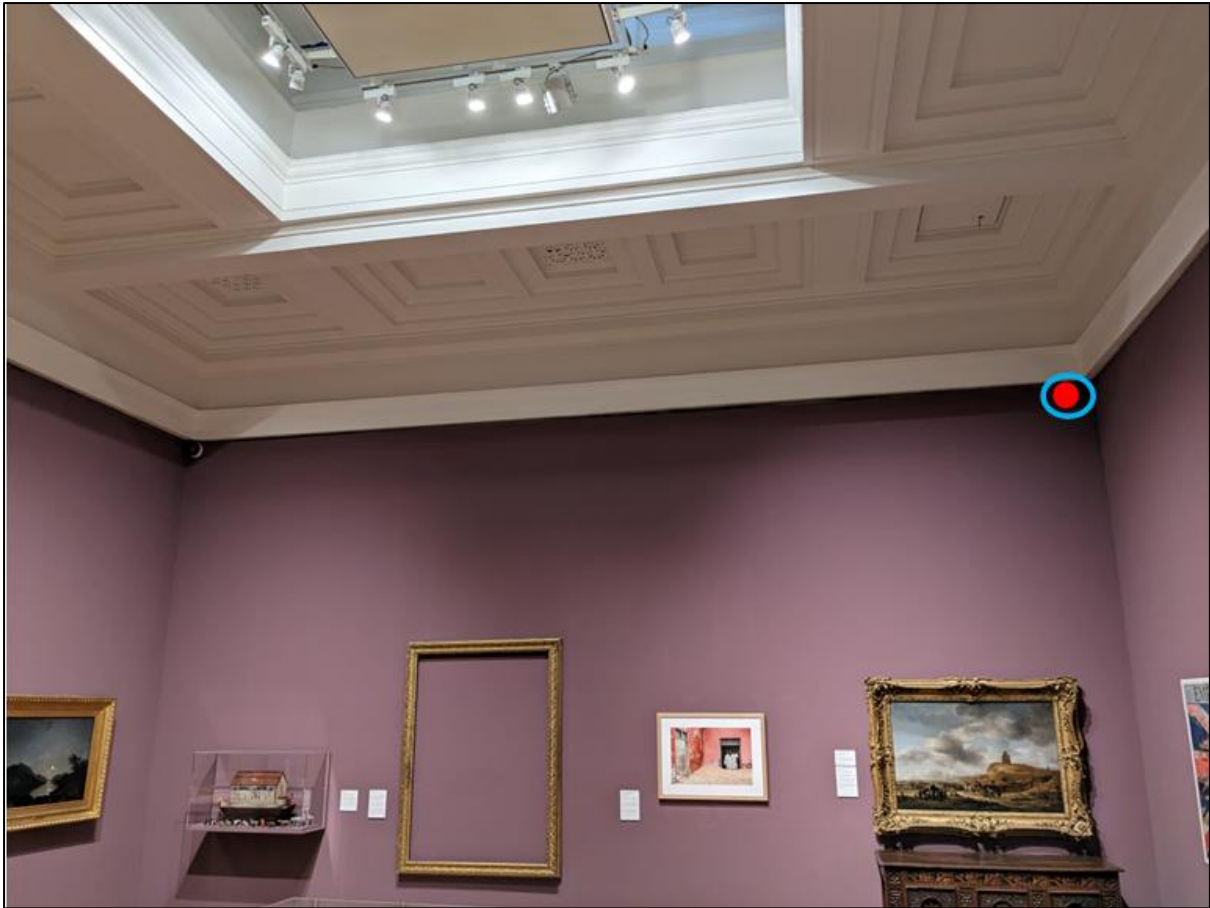
**Appendix 30:** The photograph above indicates the exit point of Drill6 (10mm) in 013 Art Gallery using a red dot. The hole is to be used for cabling L1AP3, the position of which is demarcated by the blue circle pictured above, which will be mounted to the wall using industrial Velcro so as to minimize potential damage should L1AP3 be removed in the future. The position of the access point is such that the hole and wiring will be invisible to the public when in the gallery. L1AP3, whilst not matching the furnishings of the room is essential to its viability as a functioning gallery space. As with the wall mounted security cameras present in the space, access points are an essential feature of any modern public space.

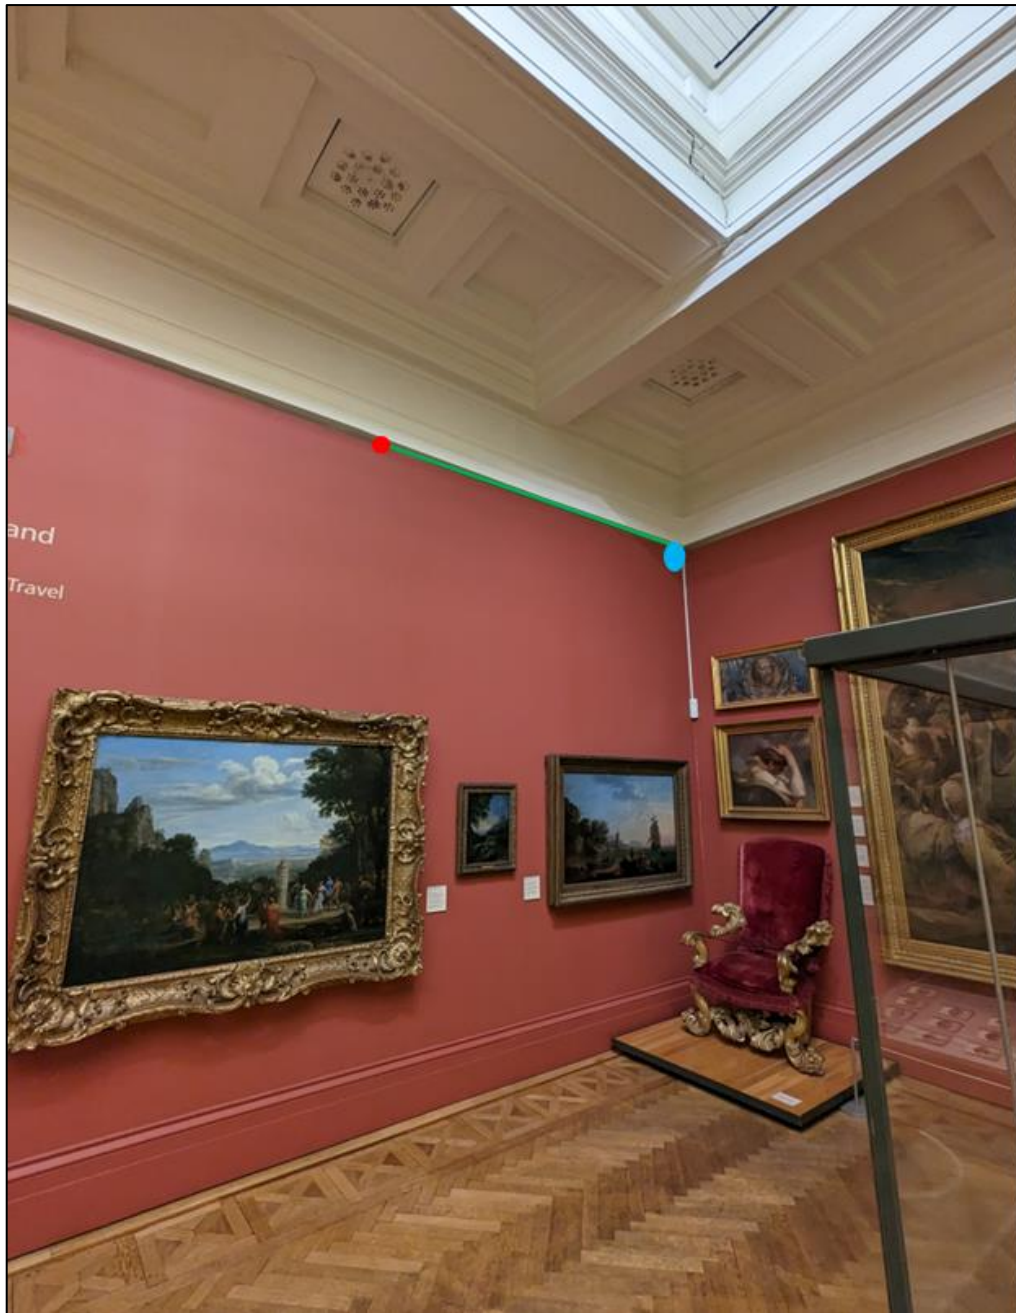
**Appendix 31:** The photograph above indicates the exit point of Drill5 (10mm) in 012 Art Gallery using a red dot. The hole is to be used for cabling L1AP1, the position of which is demarcated by the blue circle pictured above, which will be mounted to the wall using industrial Velcro as to minimize potential damage should L1AP1 be removed in the future. The green line running between Drill5 (10mm) and L1AP1 indicates the route of a prospective Cat6a cable which will use the lip of the false wall to remain completely concealed as it connects the cable run entering 012 Art Gallery to L1AP1. L1AP1, whilst not matching the furnishings of the room is essential to its viability as a functioning gallery space. As with the wall mounted security cameras present in the space, access points are an essential feature of any modern public space.

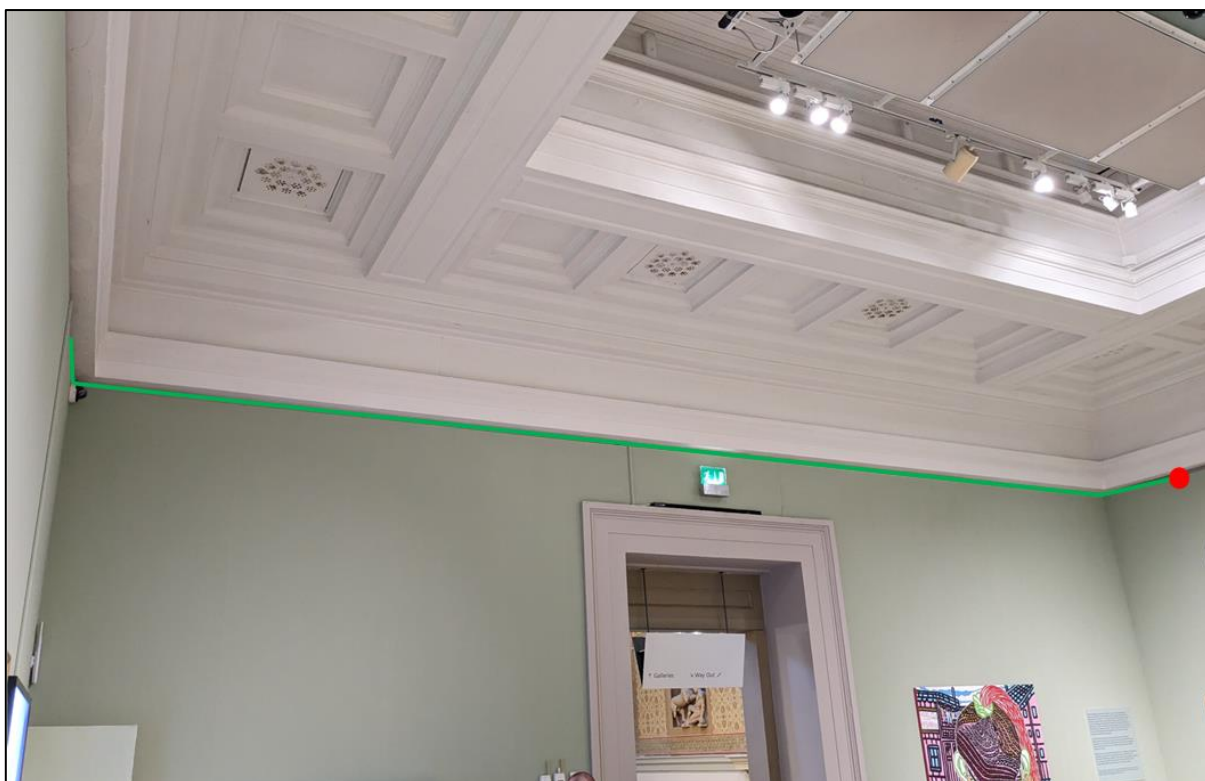
**Appendix 33:** Pictured above is 004 Art Gallery, facing towards the door to 007 Art Gallery. Above the door is a proposed cable run marked in green. The cable run terminates at the point marked with a red dot indicating the point at which Drill8 (10mm) is planned to penetrate the wall. The penetration will allow L1AP5 to be installed on the walls obverse, providing network connection to 002 Art Gallery. As mentioned in Appendix 35, the cable will utilize the lip of the skirting which surrounds the room, ensuring that wiring is not visible from eye-level and thus mitigating potential damage to the rooms historic character.

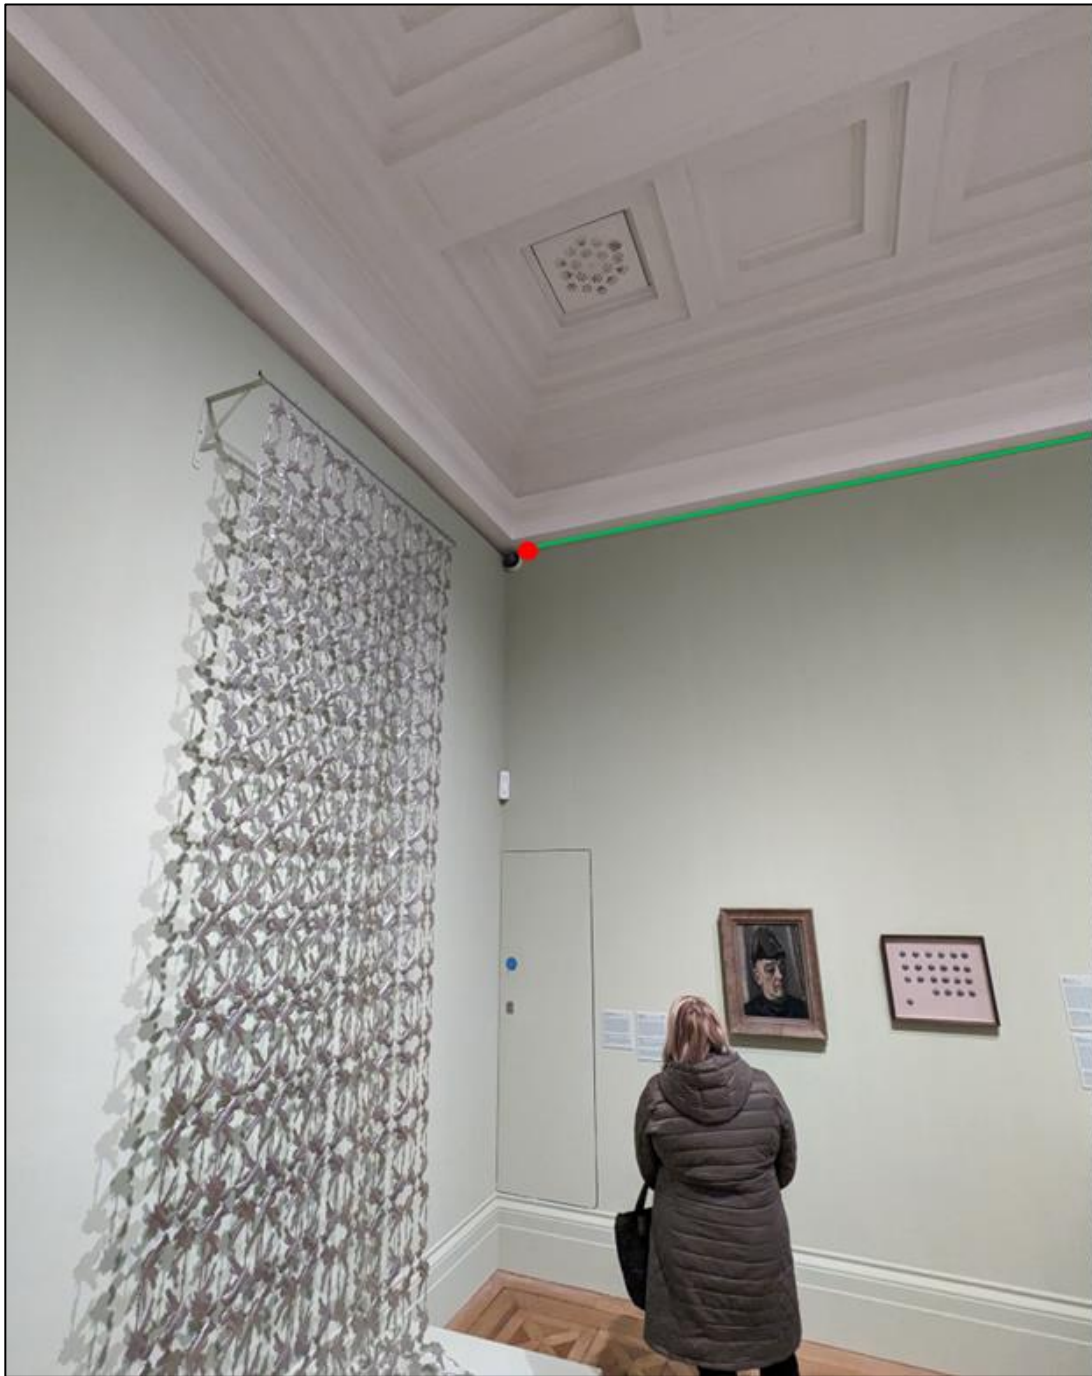
**Appendix 35:** In the above photograph, taken in 004 Art Gallery, the cable running from 006 Switch Room uses the lip of the gallery's false wall to run its length unseen (as mentioned in Appendix 36). Drill 10 (10mm) penetrates 005 Switch room, illustrated by a red dot in the above photograph. Using this penetration, the Cat6a cable will pass into 005 Switch Room from which it will utilize Drill9 (10mm) to provide L1AP6 with network access.

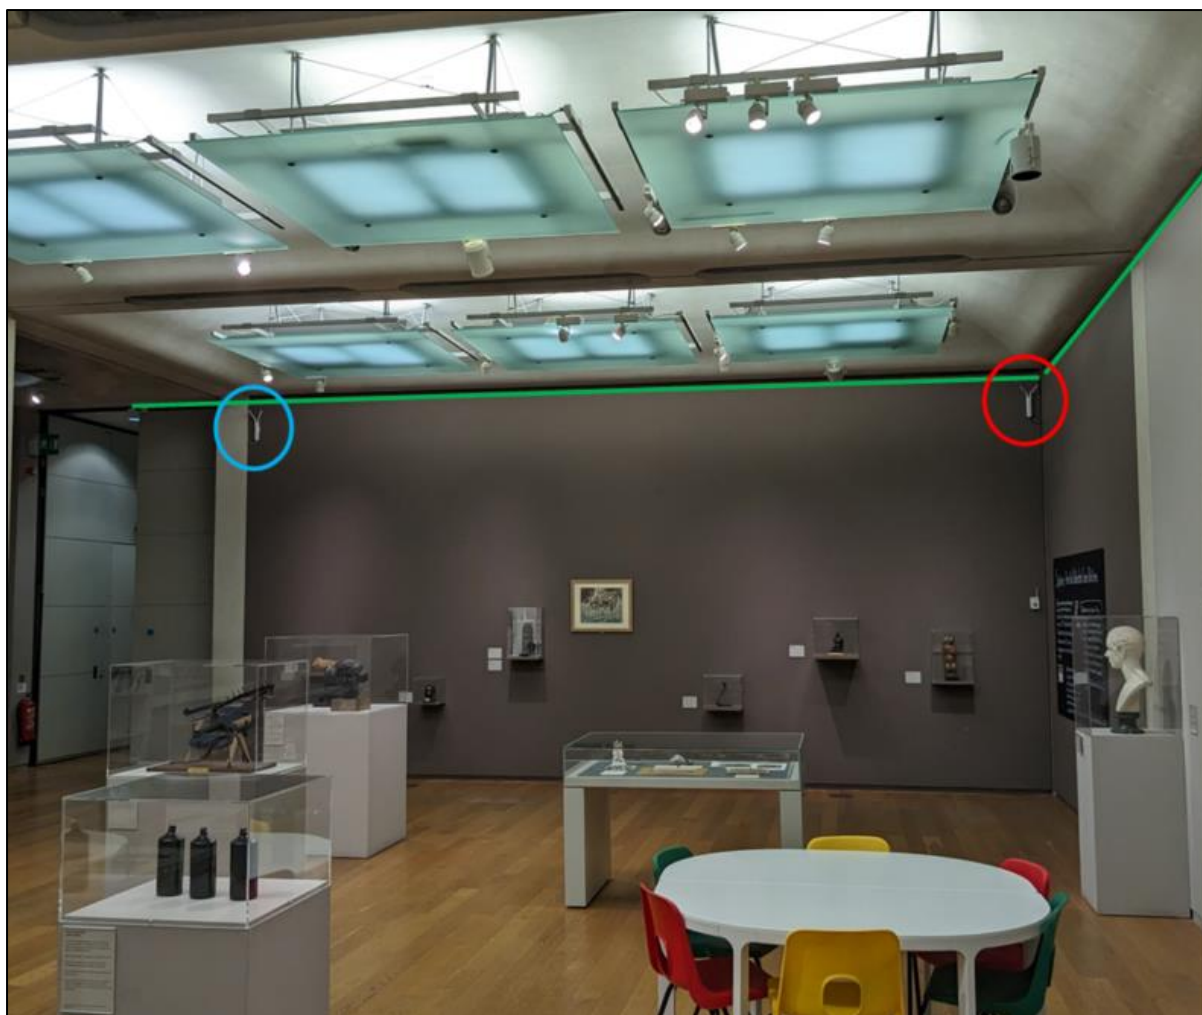
**Appendix 39:** L1AP8, located in 005 Exhibition Space, will replace the existing access point (highlighted by a blue circle) like for like. L1AP8 is to be fixed to the wall using a steel bracket. The existing Cat5a cabling (highlighted in green) will be replaced using its existing route. Highlighted in a red circle is an existing access point which is not to be replaced, as the coverage from L1AP7 and L1AP8 have been deemed sufficient. From L1AP8 the cable will continue its demarcated route (as can be seen in the building plan) towards L1AP9.

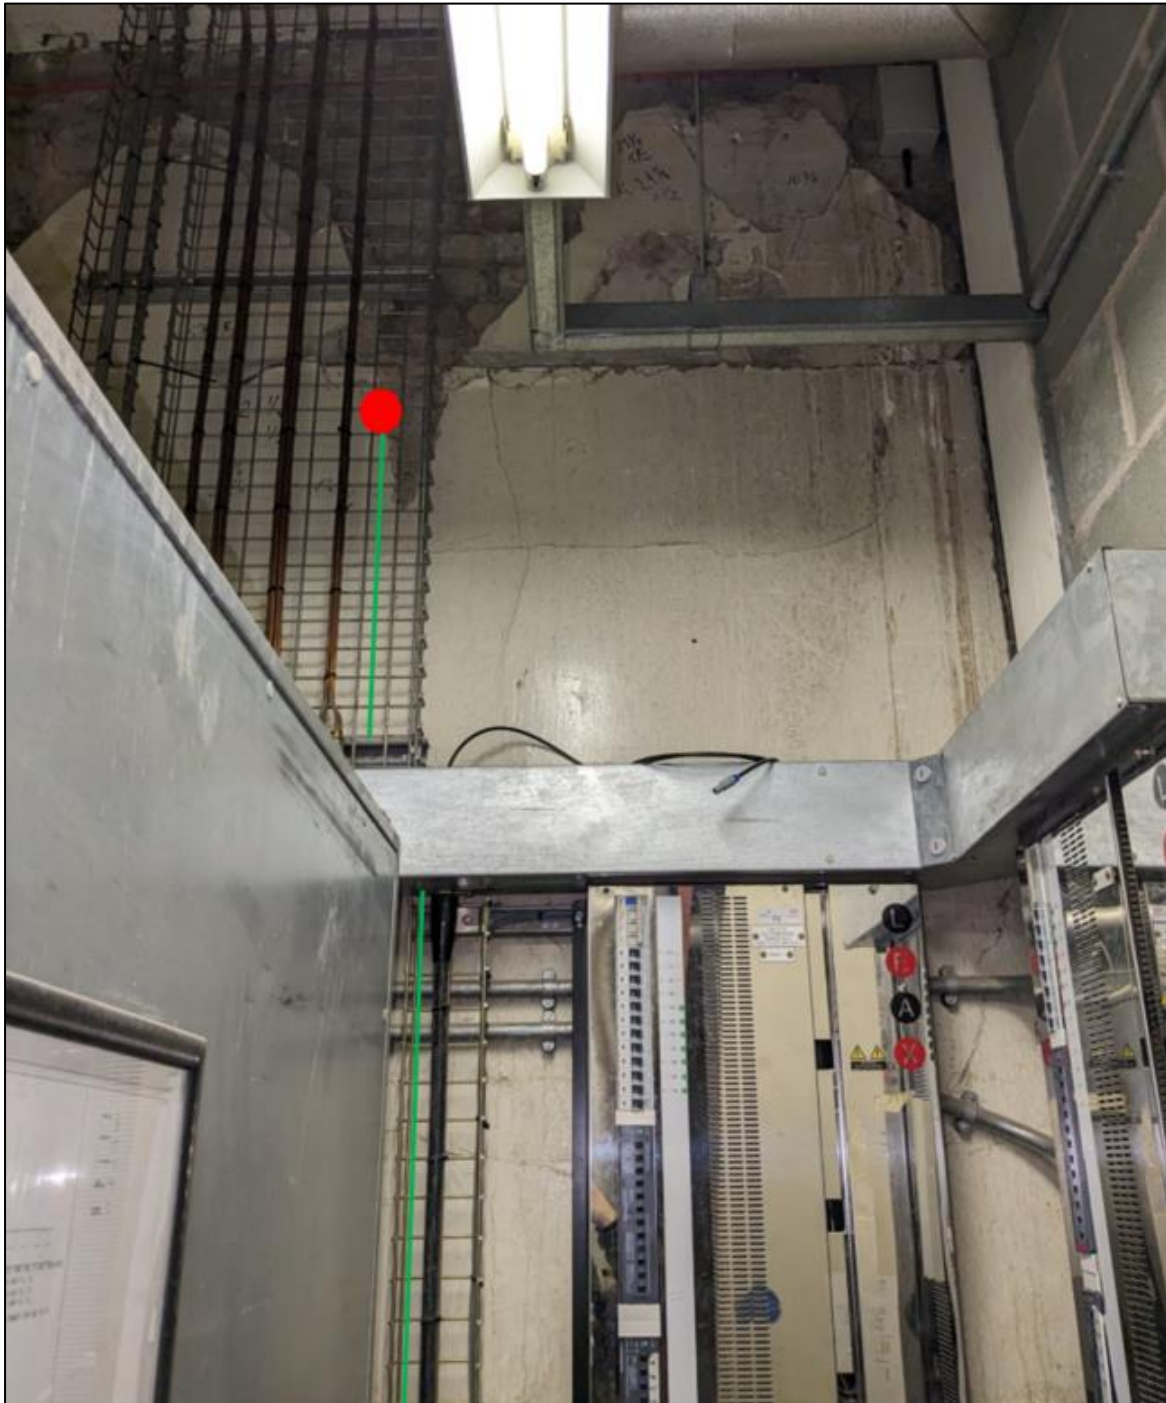
**Appendix 42:** Pictured above is 016 Plant Room, facing towards 004 Art Gallery. Above is a proposed cable run marked in green following on from Appendix 44, the cable will rise from the underfloor run and up the steel bracket. The cable run terminates at the point marked with a red dot indicating the point at which Drill18 (20mm) is planned to penetrate the wall. The penetration will allow the cable run to continue into the false ceiling of 004 Art Gallery. From this cable run, L1AP10, L1AP11 and L1AP12 are to be wired.

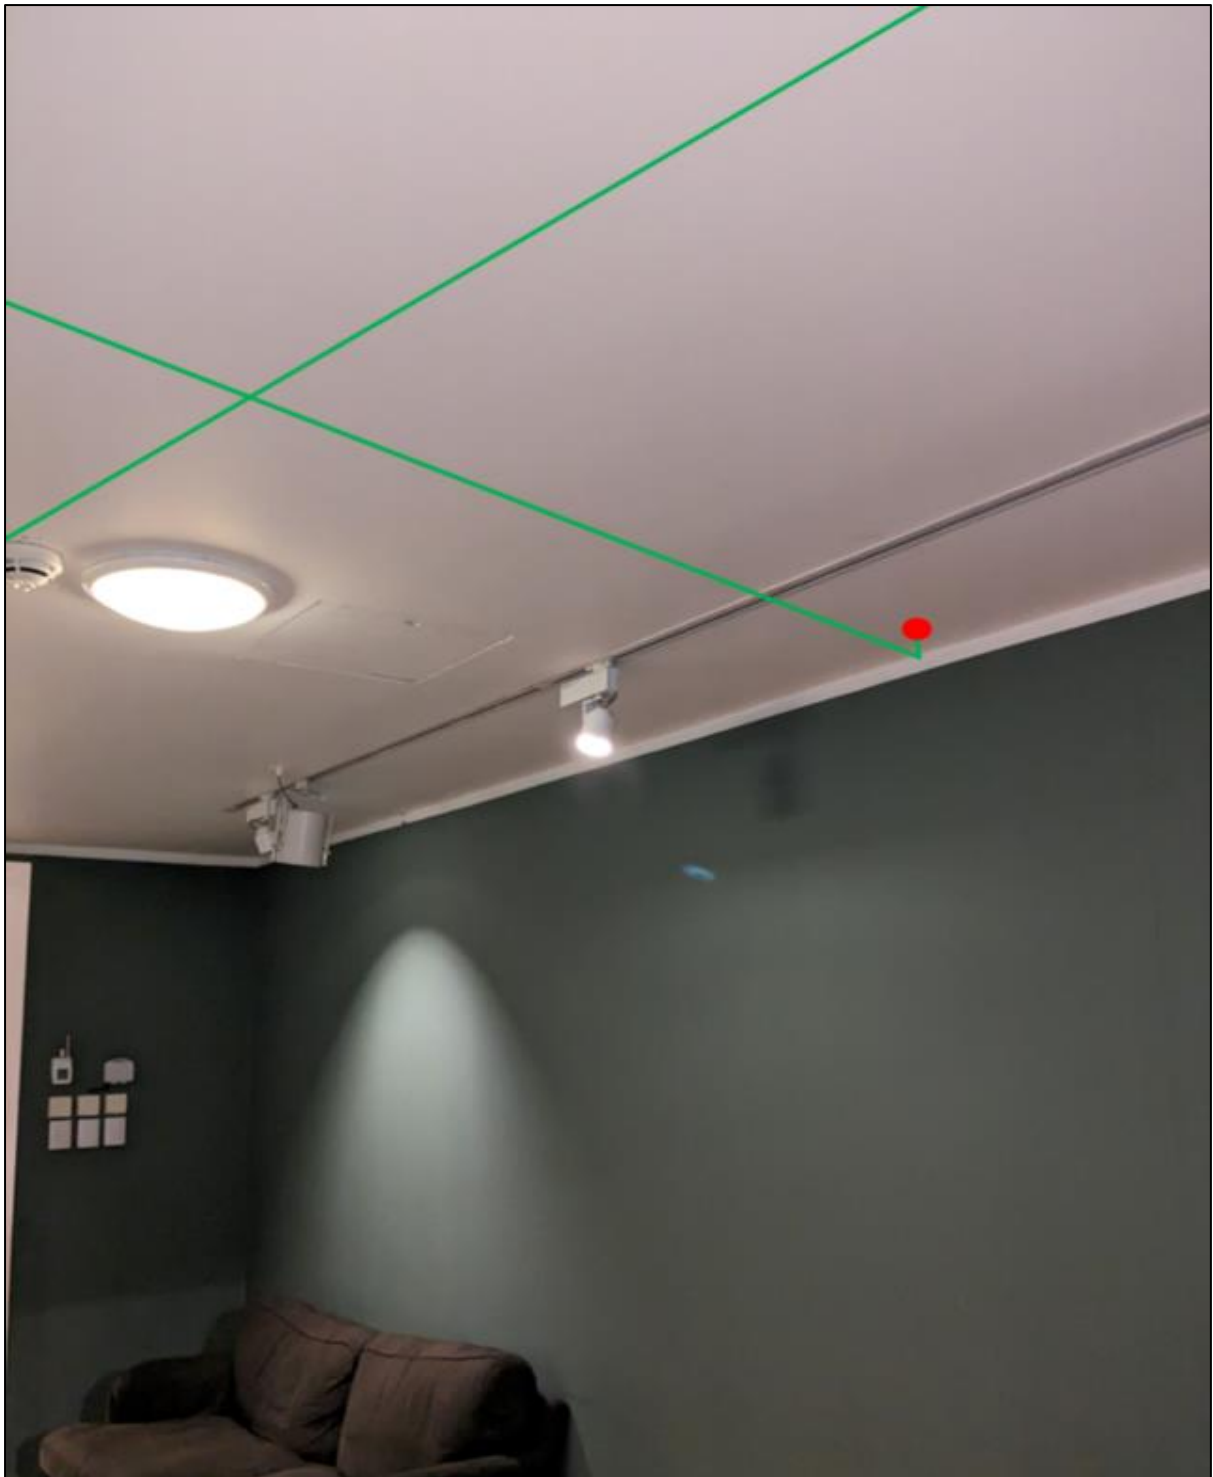
**Appendix 43:** In the above photograph, taken in 004 Art Gallery, Drill18 (20mm) (highlighted by a red dot), enters the space within the false ceiling. Within the false ceiling a cable run illustrated in green branches to provide network connection to L1AP10, L1AP11 and L1AP12. As these cables utilize the false ceiling, they will not be visible and as such should have no impact on the buildings form and character.

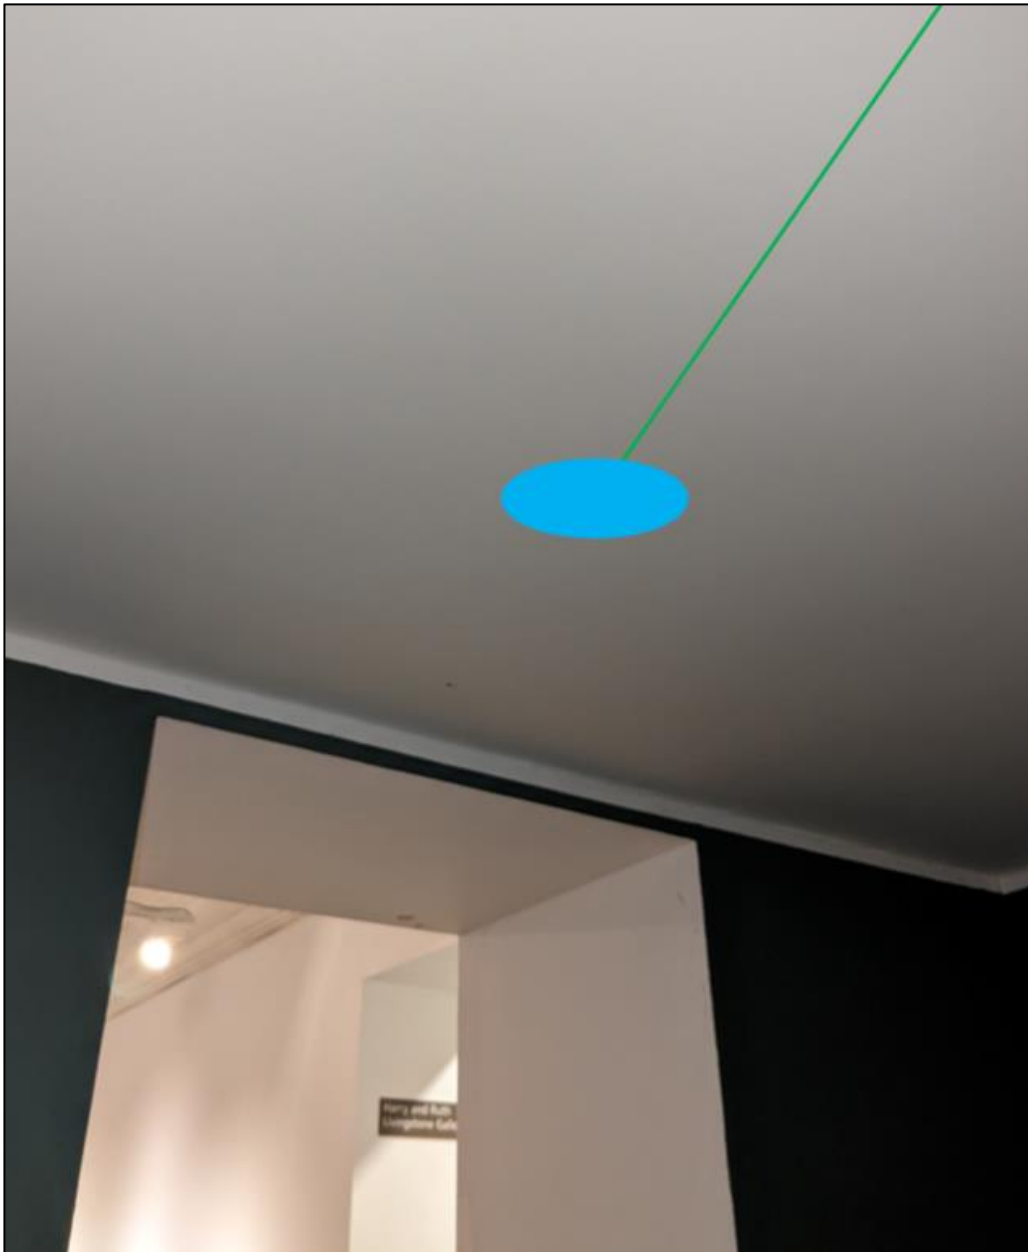
**Appendix 44:** Pictured above is the prospective location of L1AP10. Wired from the branching connection pictured in Appendix 47, the Cat6a cable will provide network access to L1AP10. The access point will be installed by making a penetration through the false ceiling through which a cable will pass. This penetration should not affect the form or fabric of the building as the changes will be both invisible and avoid alterations to the buildings original fabric. L1AP10 will then be affixed to the false ceiling using a steel bracket.

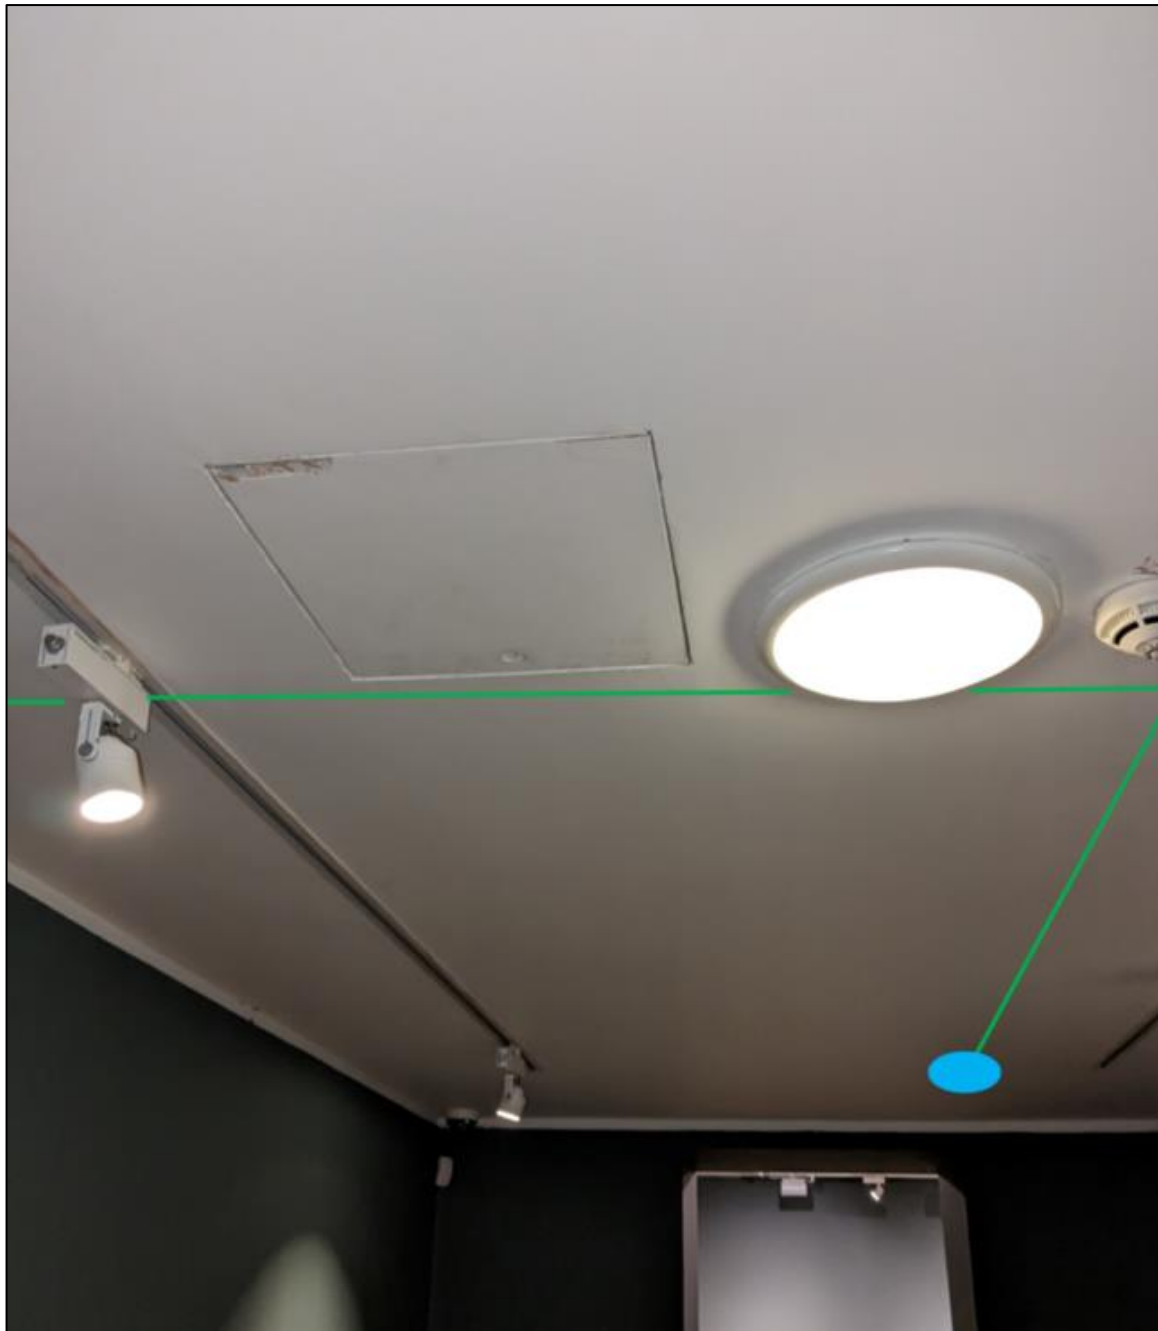
**Appendix 45:** Pictured above is the prospective location of L1AP11. Wired from the branching connection pictured in Appendix 47, the Cat6a cable will provide network access to L1AP11. The access point will be installed by making a penetration through the false ceiling through which a cable will pass. This penetration should not affect the form or fabric of the building as the changes will be both invisible and avoid alterations to the buildings original fabric. L1AP11 will then be affixed to the false ceiling using a steel bracket.

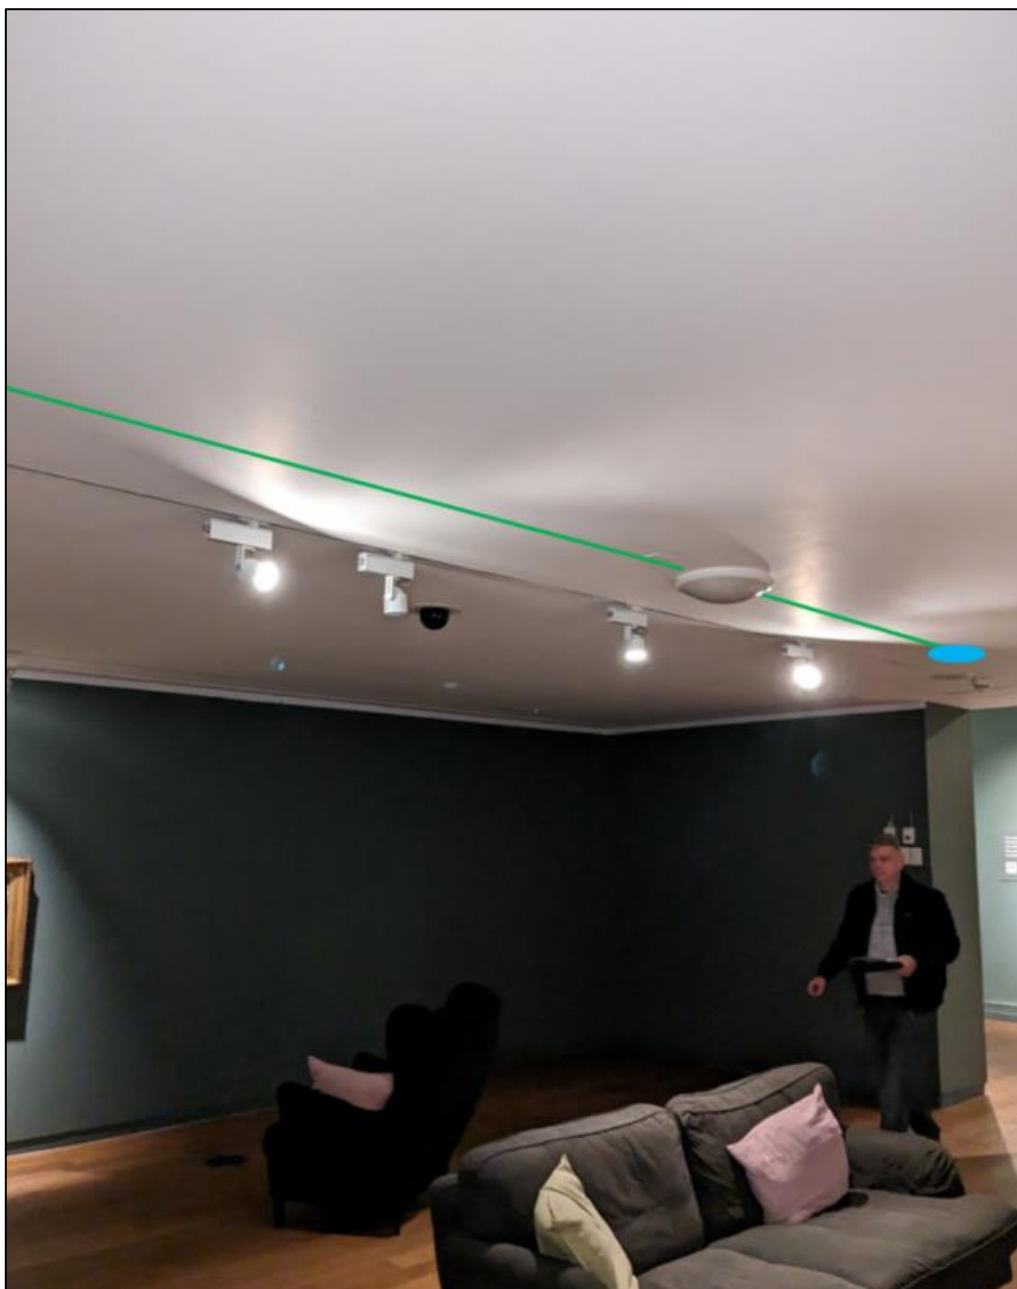
**Appendix 46:** Pictured above is the prospective location of L1AP12. Wired from the branching connection pictured in Appendix 47, the Cat6a cable will provide network access to L1AP12. The access point will be installed by making a penetration through the false ceiling through which a cable will pass. This penetration should not affect the form or fabric of the building as the changes will be both invisible and avoid alterations to the buildings original fabric. L1AP12 will then be affixed to the false ceiling using a steel bracket.
