## Method Statement

St Joseph Group

24 Lever Street – Basement Level

### 1.0 Proposed Works and detail for the Listed Building

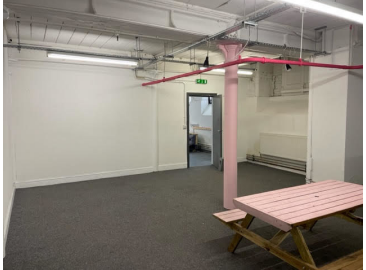
| | Item | Proposed Method | Image |
|---|---|---|---|
| 1 | Removal of existing plasterboard wall | Modern plasterboard wall to be removed in full. Fixings to ceiling and floor to be removed and surrounding surfaces made good. | |

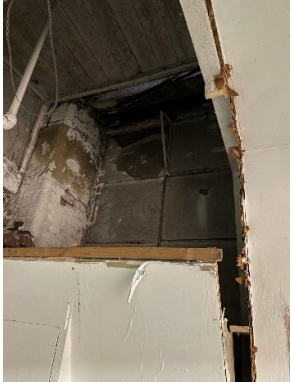
| 3 | <b>Reveal existing window aperture.<br/>Removal of glass and replacement with louvre.</b> | <p>Existing window opening partly uncovered at present to be revealed in full by removing existing modern plasterboard partition and timber stud. Glass within existing metal frame to be removed and new louvre installed to allow for ventilation and cooling.</p> | |

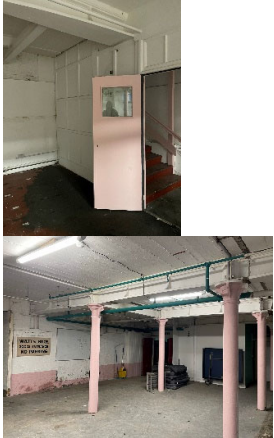
| 9 | <b>Skirting Boards</b> | <p>There are limited areas of skirting boards within the unit. Where skirting boards are in place these will be retained and made good. Where visible they will be decorated to match the proposed scheme. If positioned behind fixed furniture they will be left in situ and protected.</p> | |

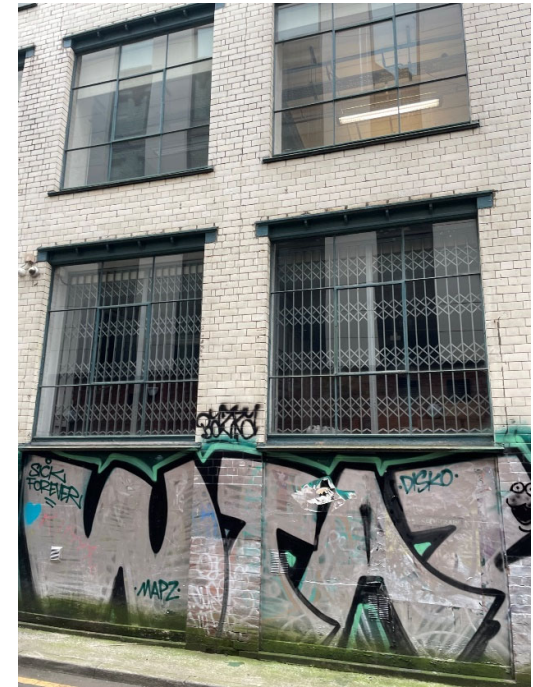
**Image 3:** Bunsen Street view - End Panel used replaced with new louvre.

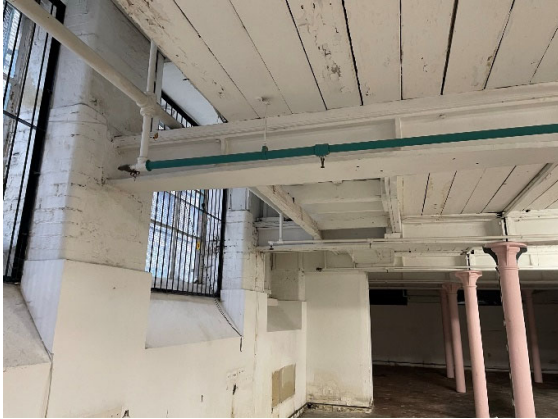
Image 4: Existing ceiling to be overclad.

| 4 | <b>Overboarding existing ceiling to provide Fire protection and division with upper floors</b> | <p>New plasterboard ceiling to be installed beneath existing timber boarded ceiling to provide fire separation. Existing steels to remain exposed.<br/>Plasterboard to be installed on MF hanging system.</p> | |

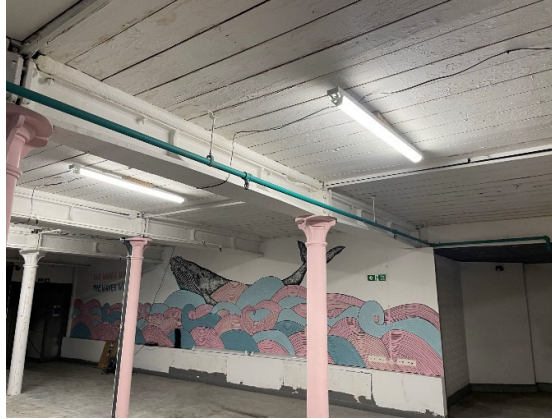
Image 5:  
Existing photo of existing columns and walls.

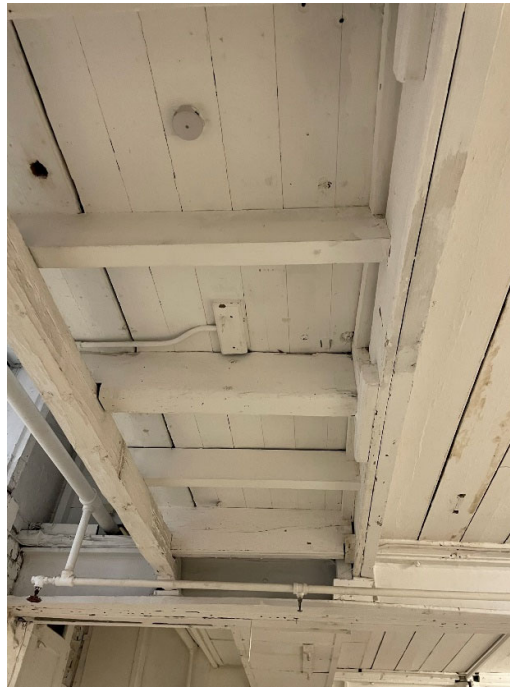
Image 8: Existing ceiling detail to be over clad.

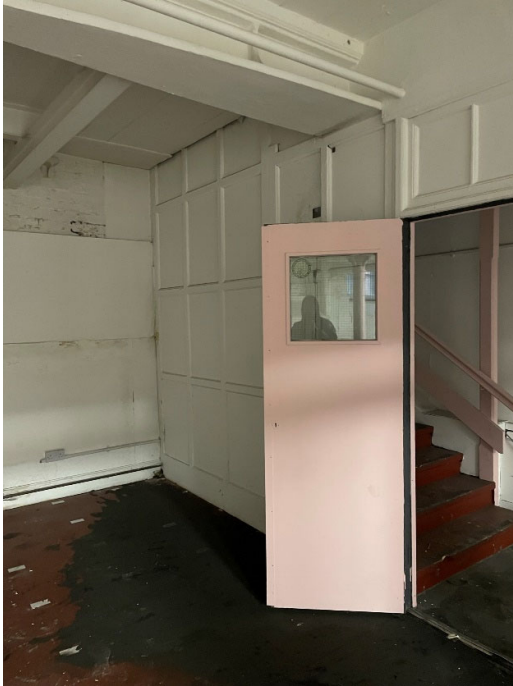
Image 10: Existing entrance to be over boarded.

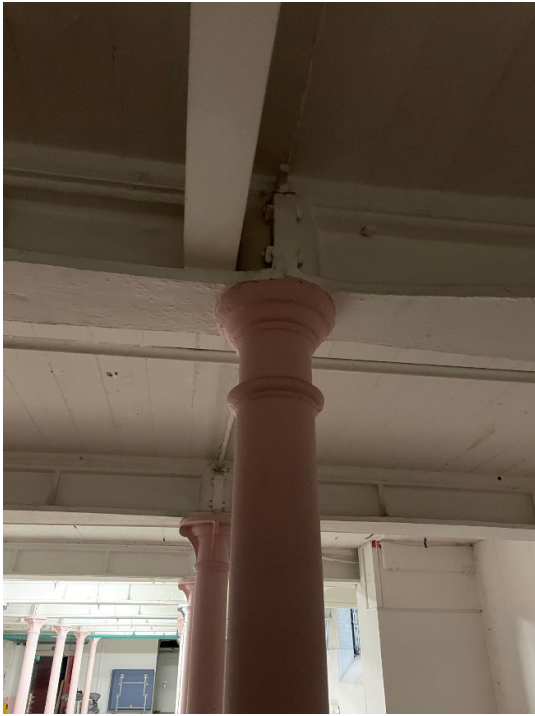
Image 13: Existing Columns redecorated
