# Pre-Remediation Ground Model

**VertaseFLI** for  
*Nuvu Investments Ltd*  
November 2023

**REPORT TITLE:** Pre-Remediation Ground Model

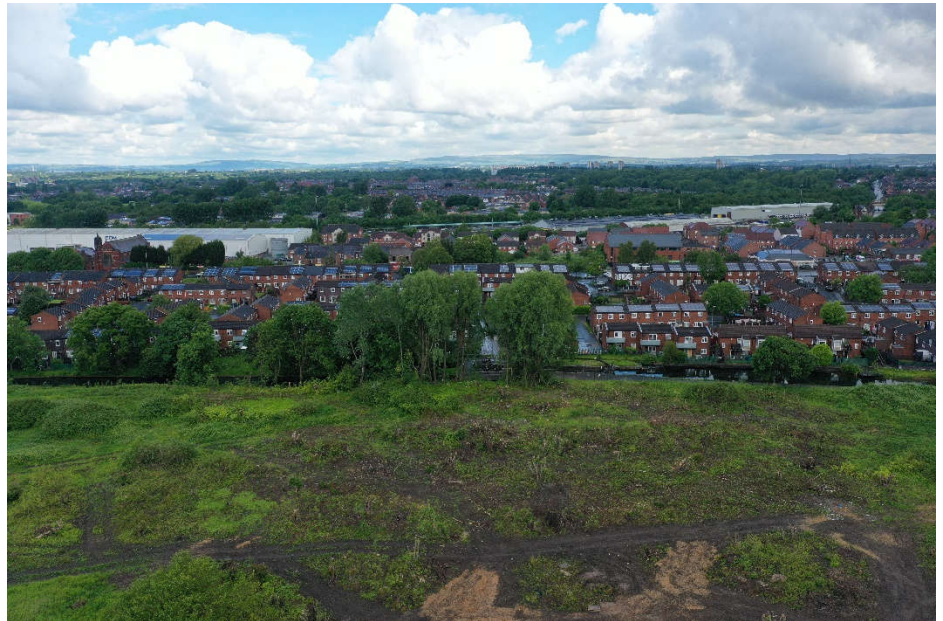
**Figure 7-View north – Rochdale Canal and housing dense housing and well as industrial and commercial buildings**

- 2.2.3 The site has been left to become overgrown scrub land with former self set trees now removed. The aerial photos (figures 7-10) below show the site following the vegetation clearance in 2022.

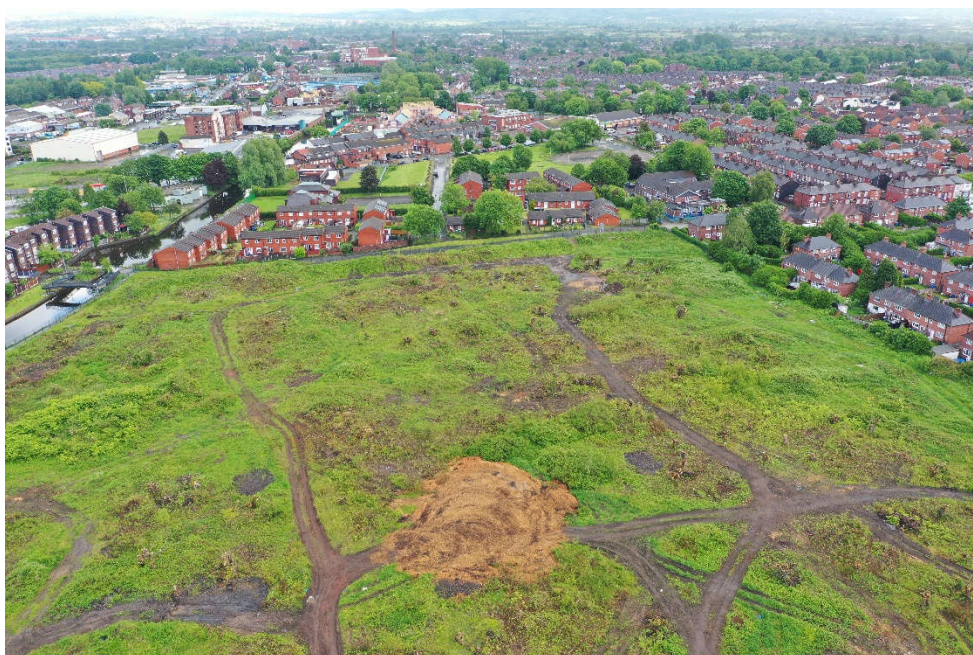
**Figure 9-View east – mainly housing in close proximity to site with some commercial use and the canal to the north of the site.**

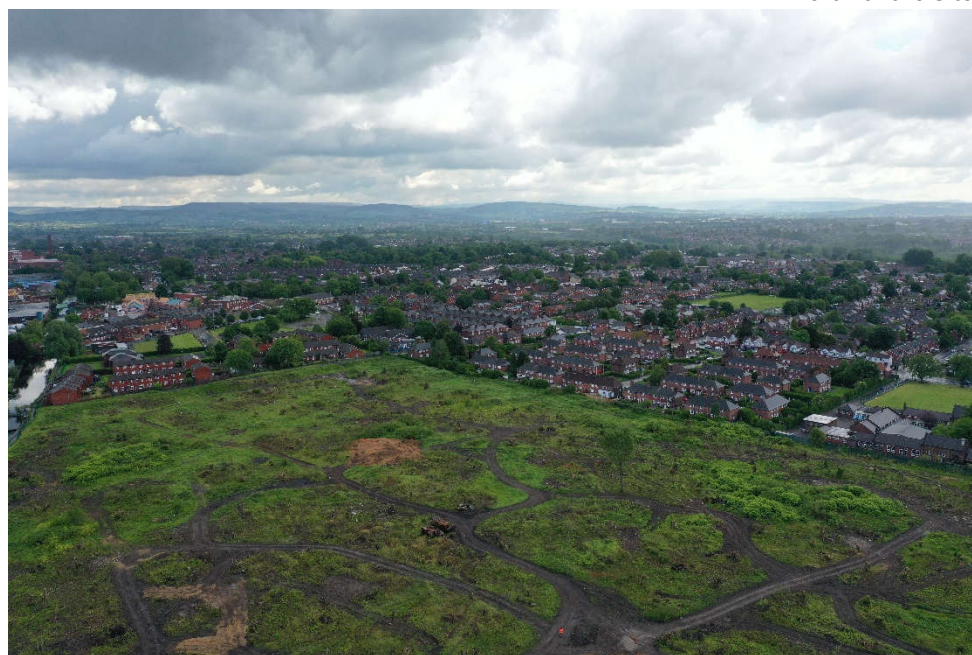
**Figure 10-View southeast – views of housing in the immediate area with the primary school to the south of the site to the right of this photo**

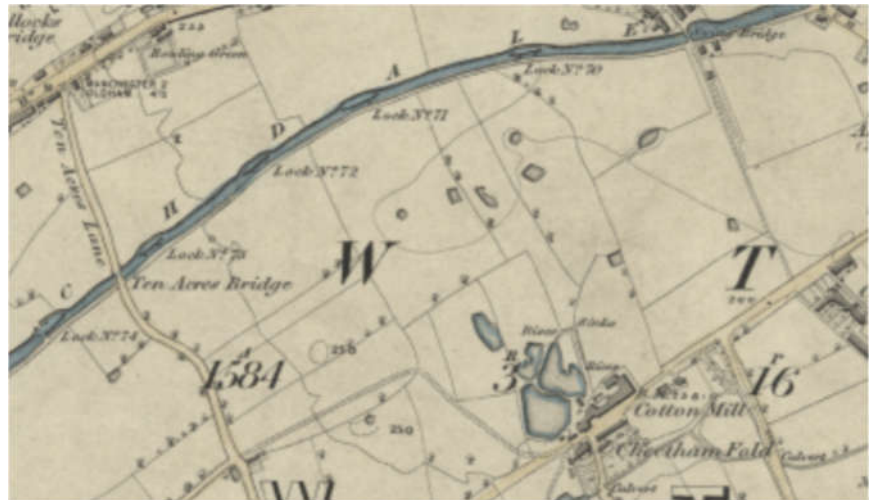
Figure 11 – 1848 OS Map – Shows Open Fields

2.3.2 The below figures (Figures 11-19) below give an overview as to how the site was excavated and filled and aids in the preparation of a final ground model and the interpretation of the site investigation data.

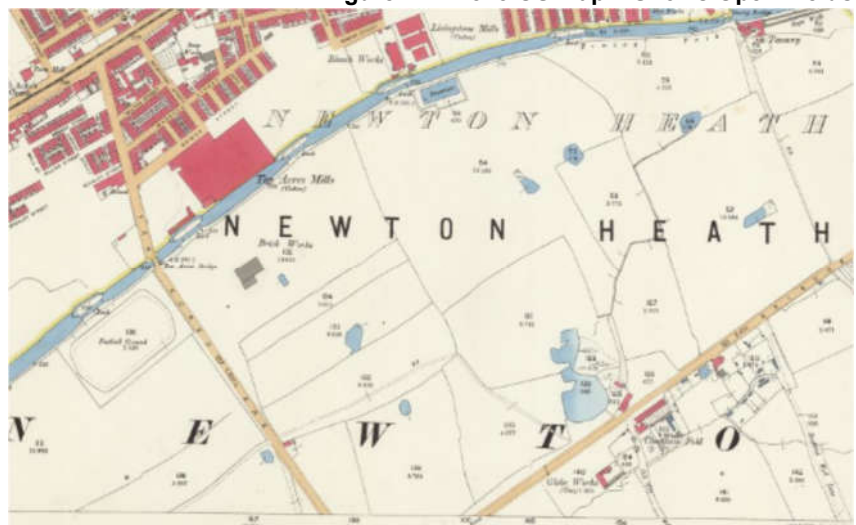
Figure 12 – 1889 – Shows the introduction of reservoir in the north and Brickworks to the west and various waterbodies across the site.

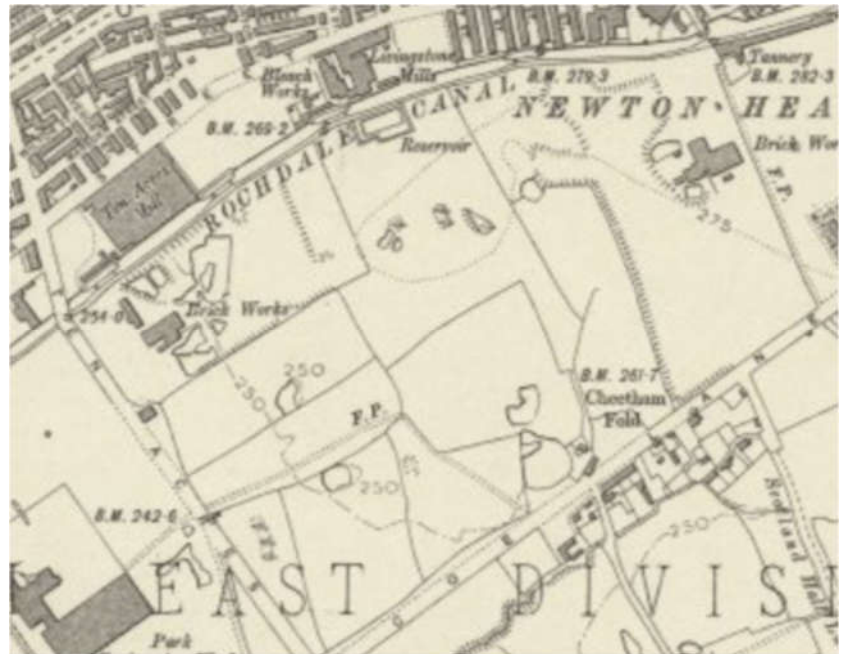
**Figure 13 – 1905 – Brickworks constructed to the east and the introduction of outlines of excavations.**

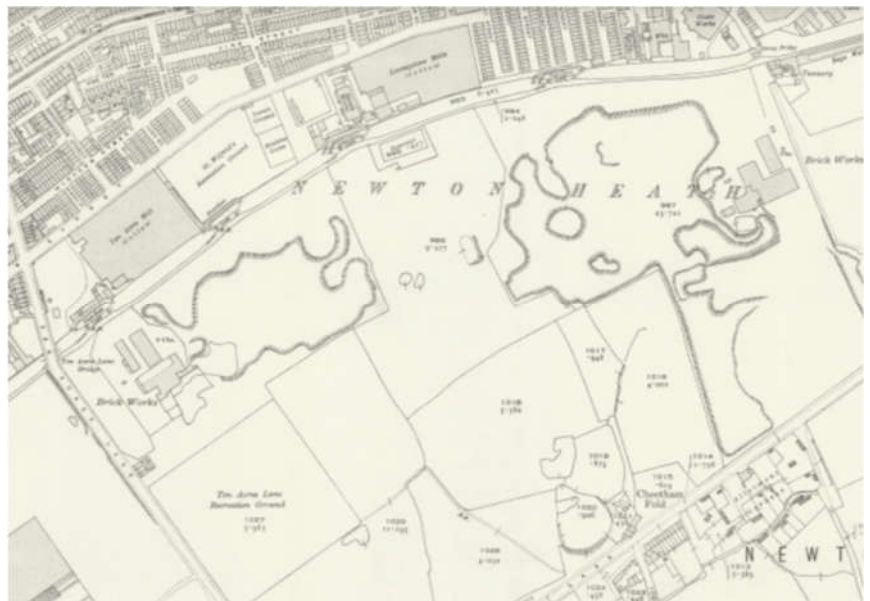
**Figure 14 – 1915 – Increased excavations shown.**

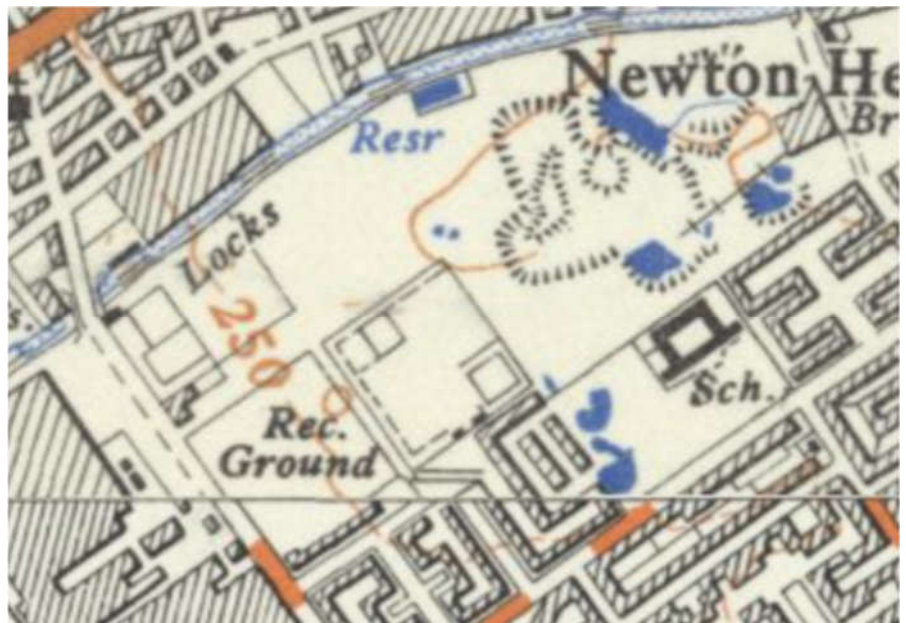
Figure 16 – 1947 – Site largely unchanged.

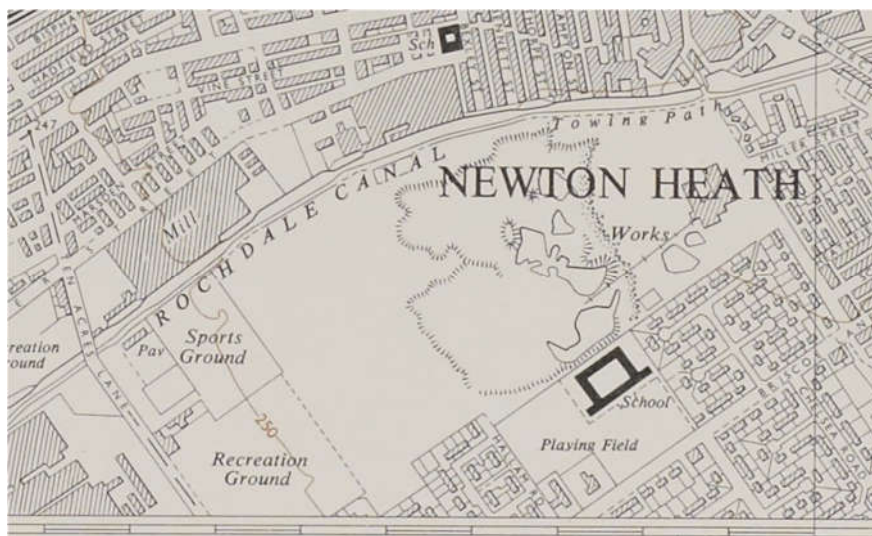
Figure 17 – 1956 – Removal of sports ground in the southwest.

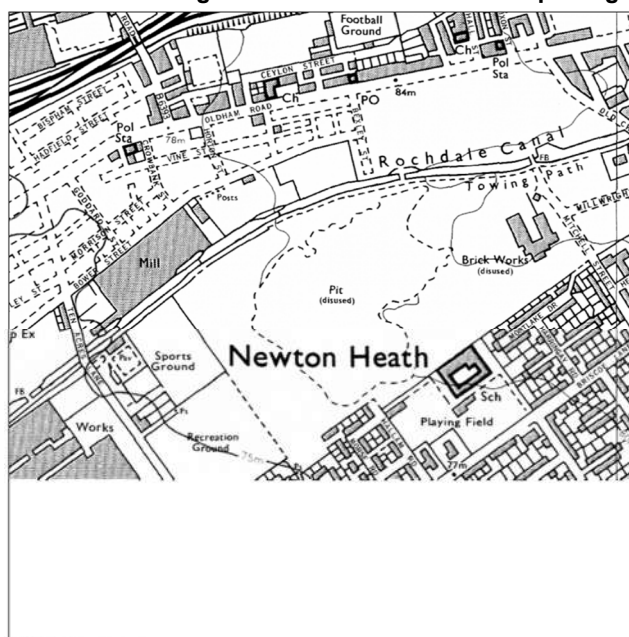
Figure 18 – 1978 - Shows brickworks and pit to the east as disused.

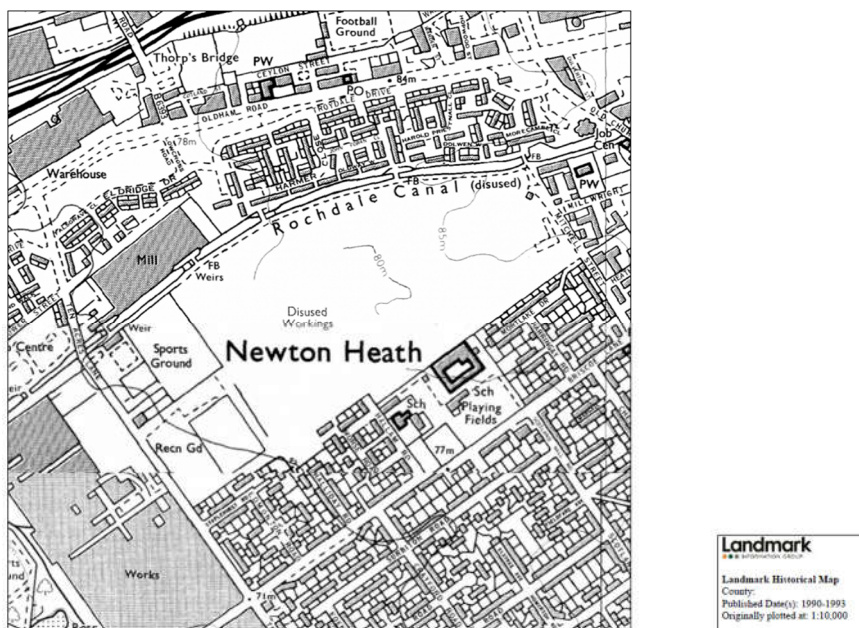
Figure 19 – 1993 – Shows the entire eastern part of the site as disused with the sports ground still present in the west.

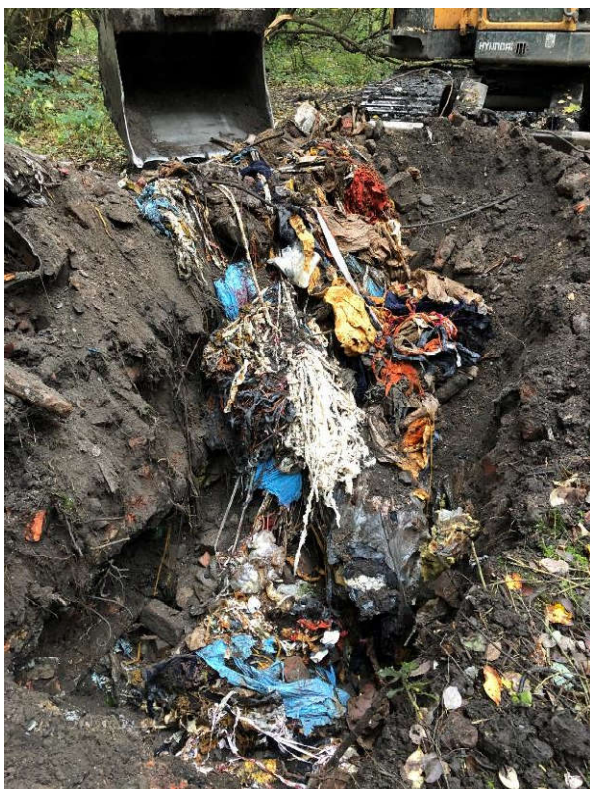
Typical Photos of HRM from the site investigation are below:

2.7.5 High Risk Materials are the materials we might reasonably and quickly identify traditionally as “waste”. The sort of material we would expect not to be readily reuseable or contain significant proportions of concrete and other materials that could and are regularly recycled for re-use as aggregates within construction. HRM could comprise the following components or a mixture of the following components. We have also added a “type” code to each of these to aid in clarity and referencing.

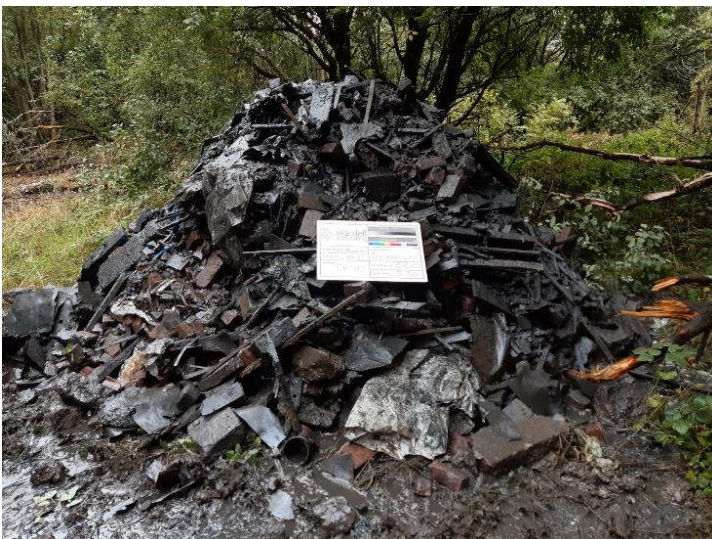
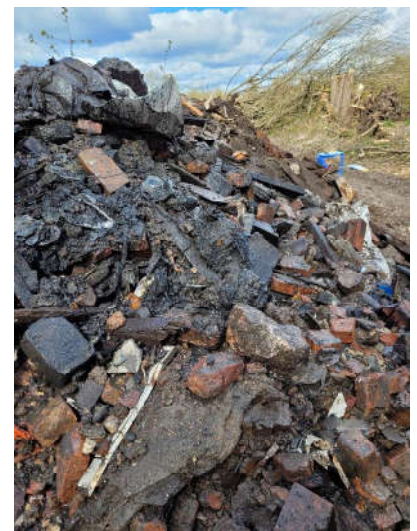
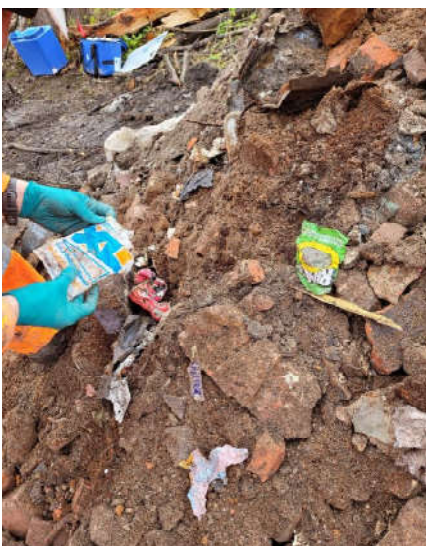
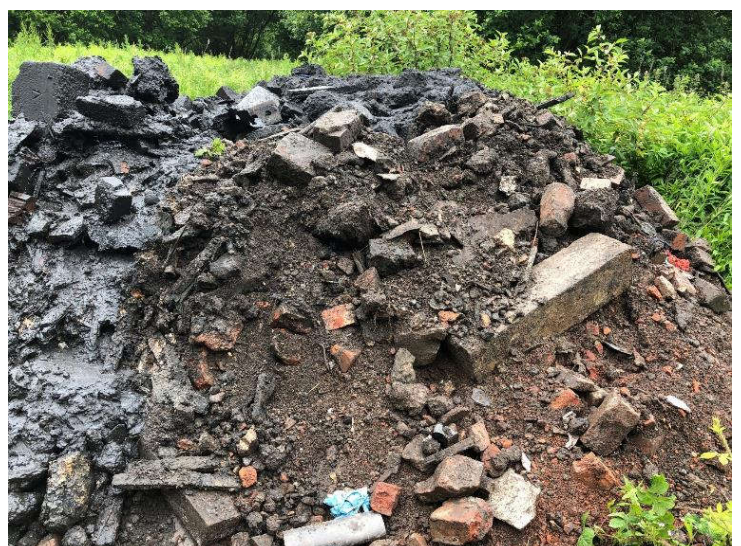
2.7.8 Typical Photos of LRM C&D from the site investigation are below:

2.7.7 From a review of the data, it is also evident that there is a significant proportion of the waste, which is predominantly recoverable hard materials such as concrete, brick tile etc that can be segregated and crushed to reuse as engineered fill or aggregate. Whilst this material does contain some "waste" elements, the matrix is that which would be referred to as construction and demolition waste which is regularly recycled in the industry currently. This classification therefore could comprise the following components or a mixture of the following

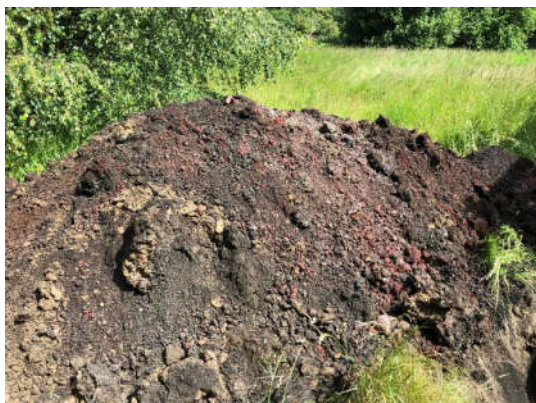
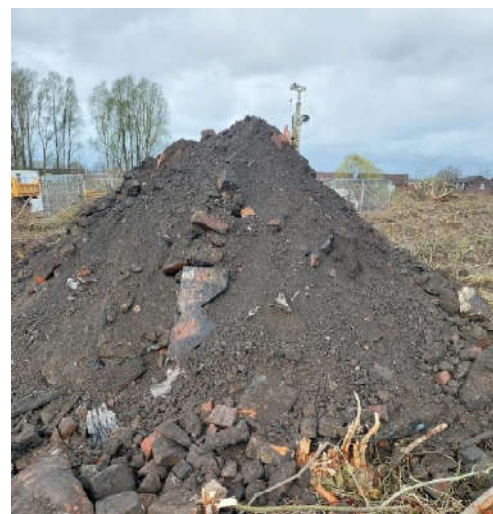
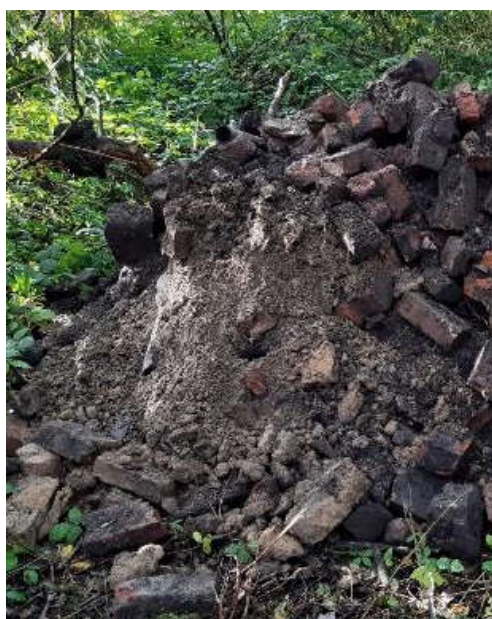
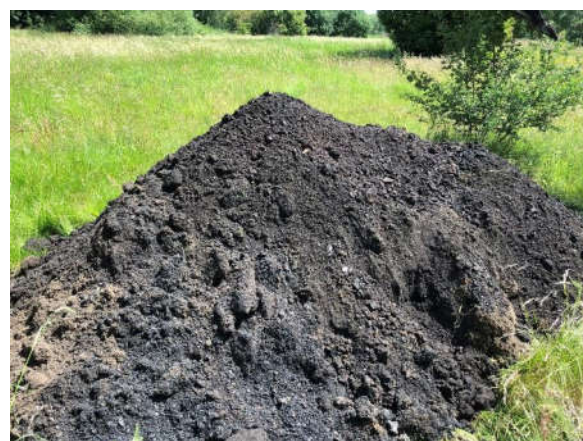
2.7.11 Typical Photos of LRM from the site investigation are below:

2.7.10 Remaining materials that are not naturally occurring are what would often be referred to as "Made Ground" on Brownfield sites. This material is varied in nature but importantly contains only small proportions of waste or deleterious materials.

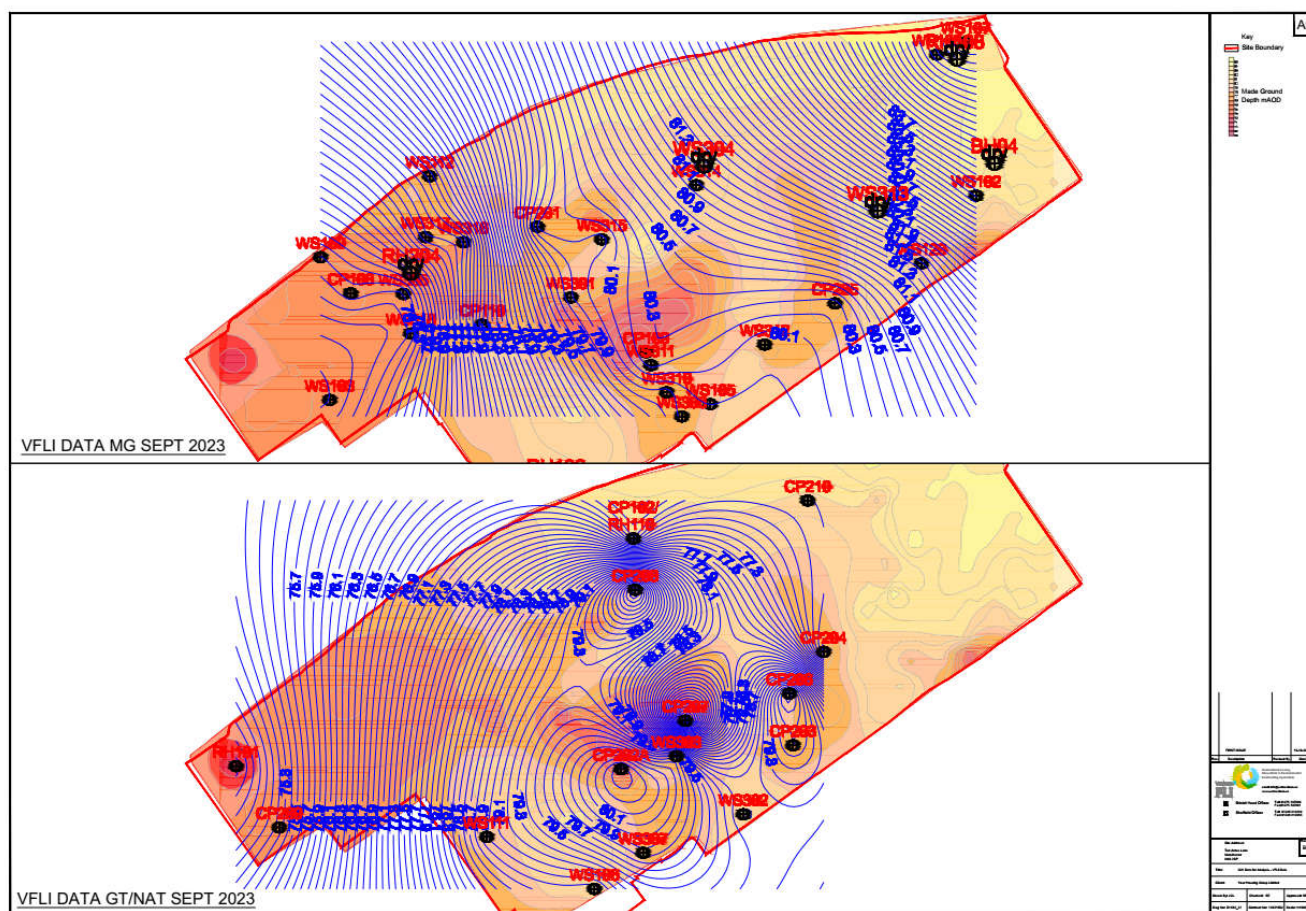
Figure 26: GW Data (VertaseFLI)

- 2.8.6 This data has also been added to the ground model as Figure 24 to 26 below and also in Appendix B and Drawings D1932\_07, D1932\_21B and D1932\_21, to enable the assessment of the interaction between excavations, remediation and the management/remediation or groundwater/leachate. Remediation requirements will be set out in the Remediation Strategy.

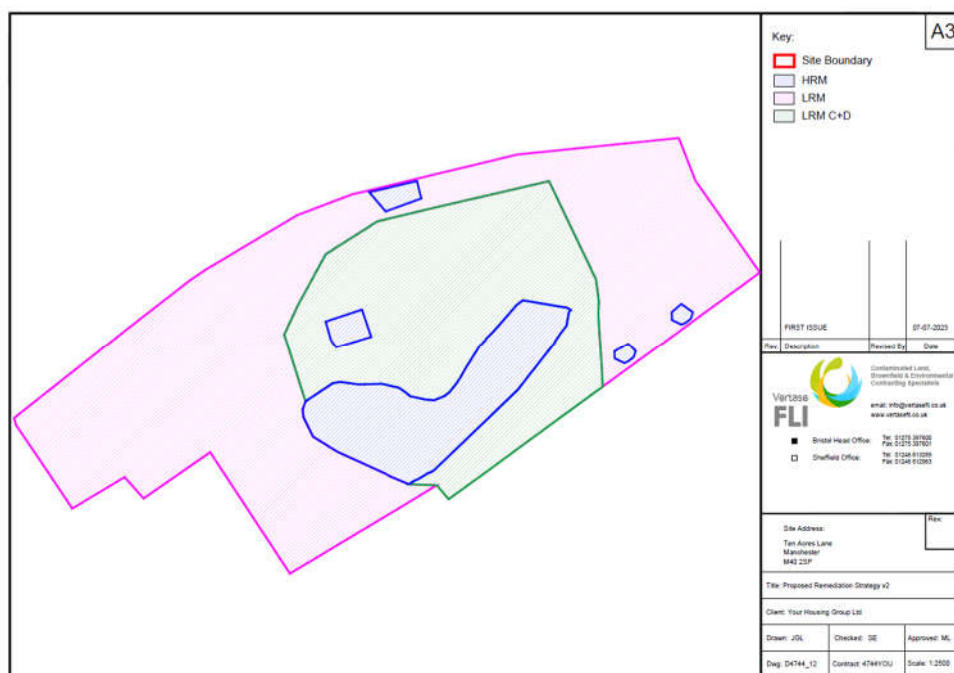
**Figure 28 – Material Locations (beneath topsoil).**

been done on the basis of the 3 main material types as set out above. LRM, LRM C+D and HRM. The Figure 28 below and in Appendix B as Drawing D4744\_12 shows these areas in a simple diagrammatic output from the ground model.

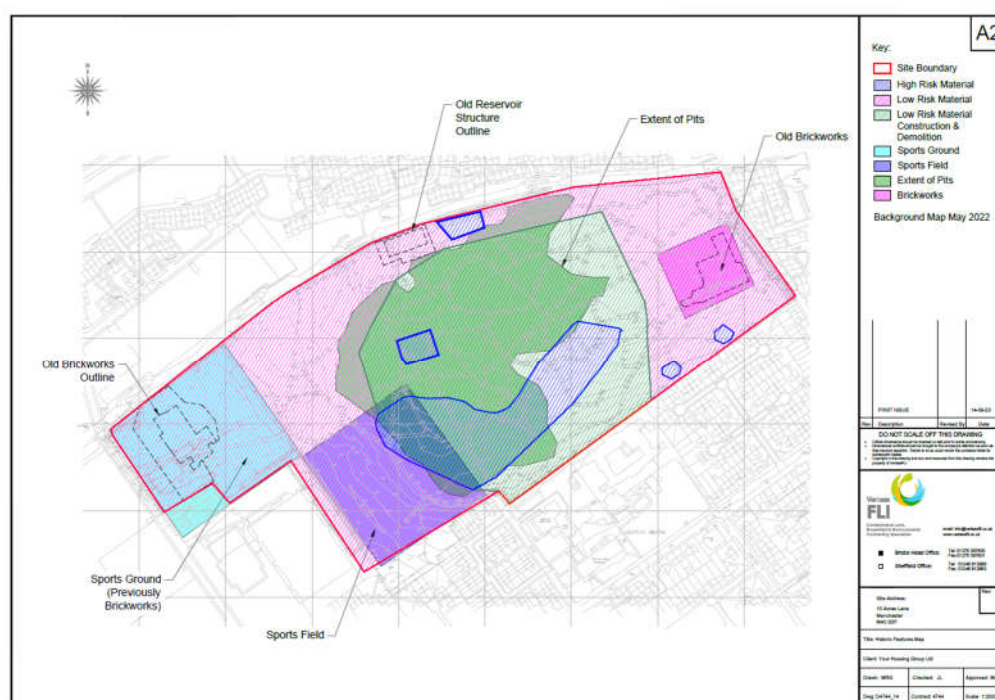
Figure 30 – Historic Structures

2.12.1 There is the potential for historic structures and foundations in the footprints of the historic brickwork boundaries as well as features associated with both historic sports pitch areas. Figure 30 below in in Appendix B as *Drawing D4744\_14* gives an overview of areas where significant historic structures have been identified and again excavation depths have been set to ensure that these structures will be identified and removed during the remediation works.

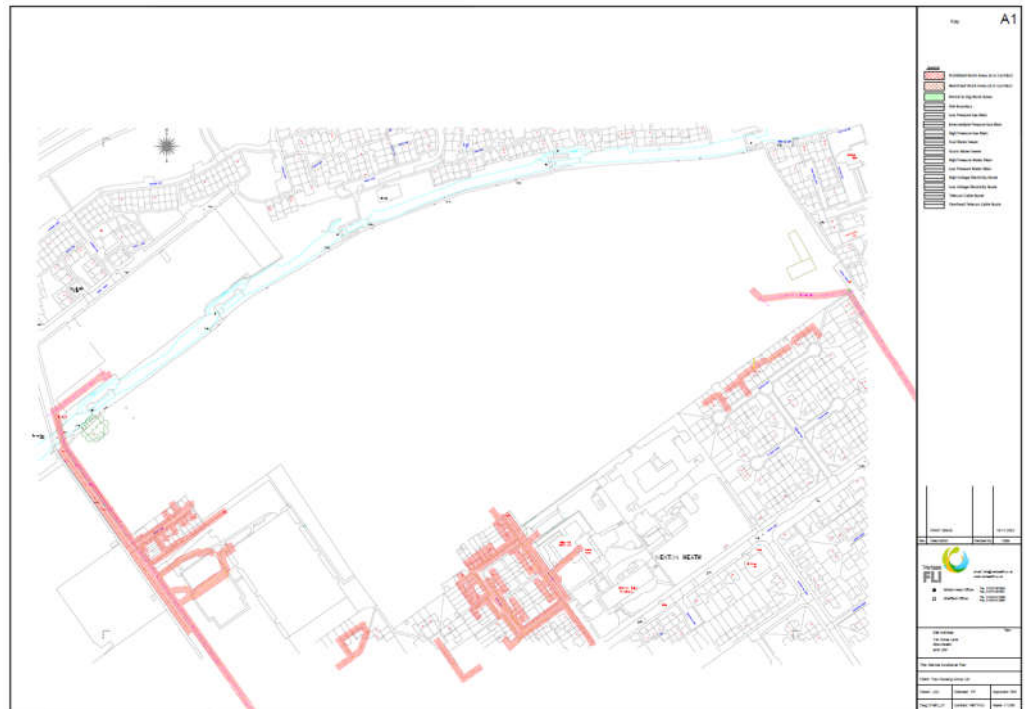
**Figure 31 – Services and utilities**

2.13.1 There are several historical services connections to the site which may pose risk to both the future development and may also provide preferential pathways for contamination, vapours, and gas. These pathways are discussed in more detail in the historical reports references for which can be found at Appendix A. For the purposes of the ground model these have been incorporated to ensure that they are managed as part of the remediation works with the recording of work undertaken to these pathways added to the VertaVerse database of the site and ultimately the Post Remediation Ground Model. Figure

31 below and in Appendix B as Drawing D1967\_01 shows the services and utilities currently identified on site.
