# **Photographic Method Statement**

## **Manchester Art Gallery Second Floor and Access Point Specifications**

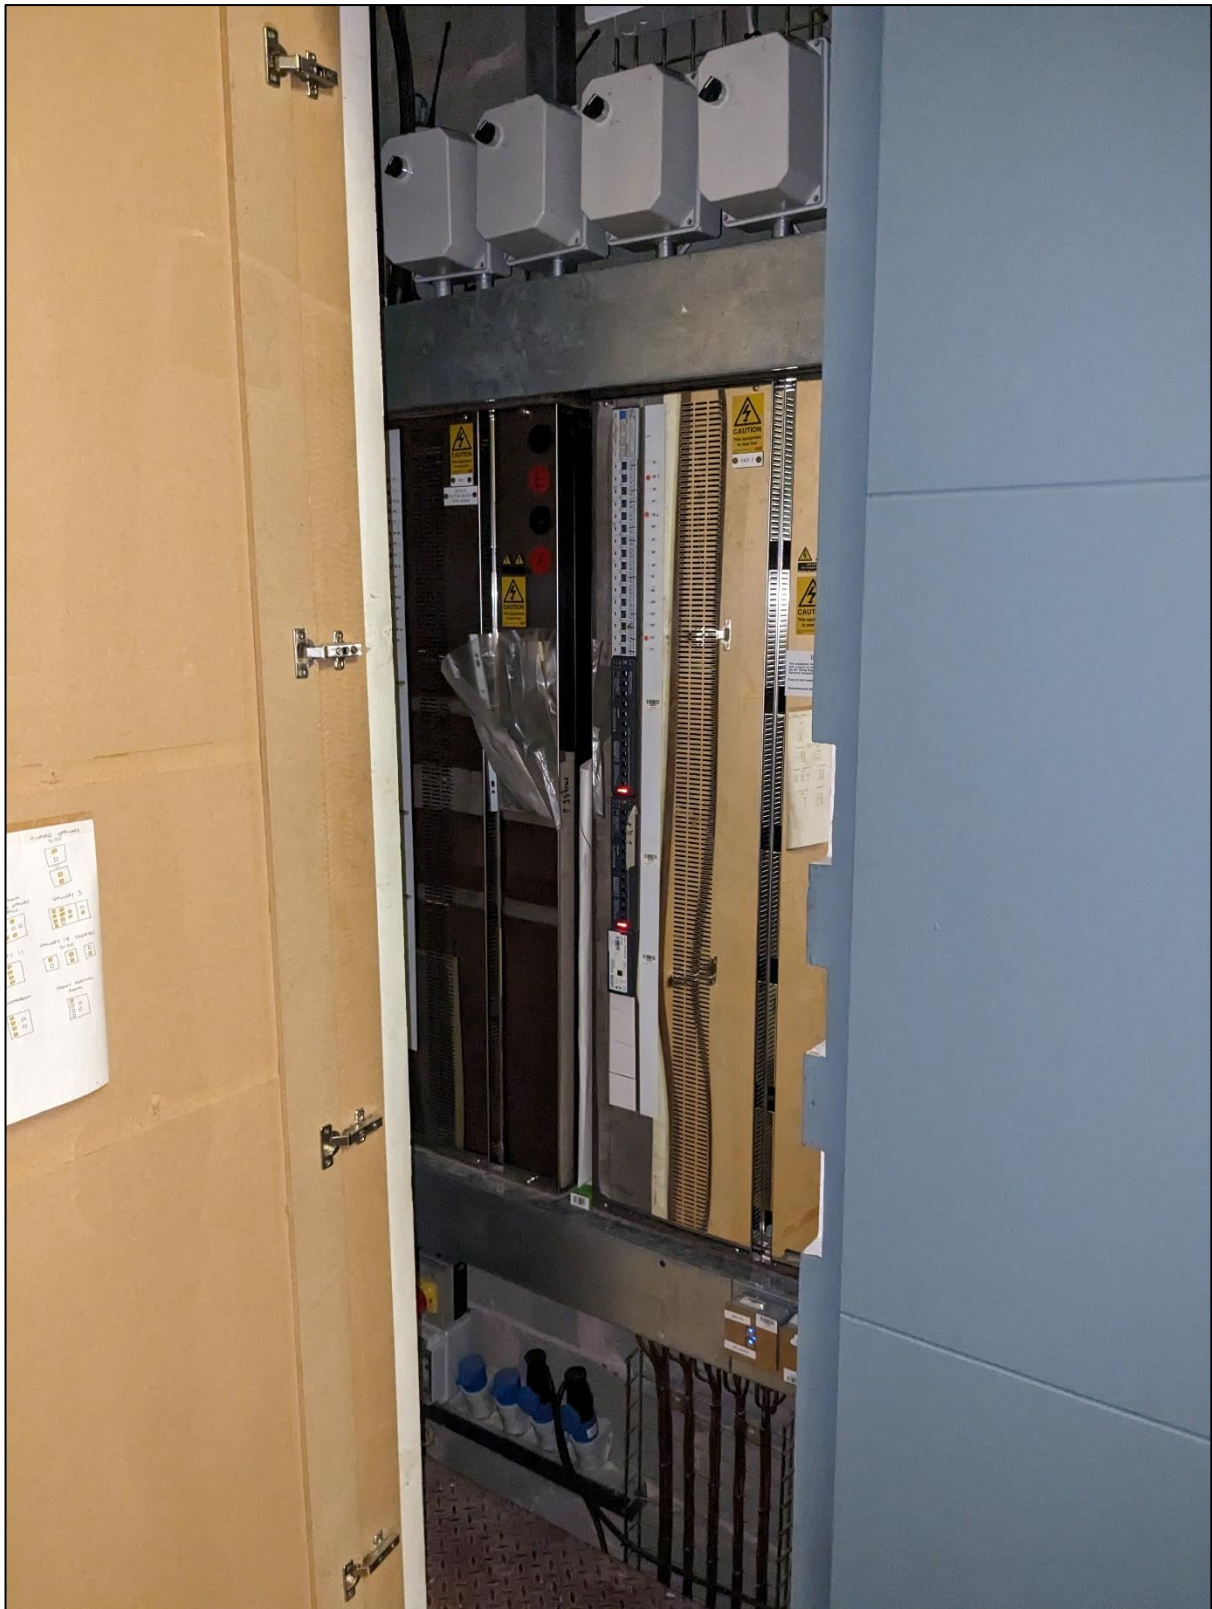
**Appendix 51:** The above photograph pictures Service Riser 6 on Level 2 of the Gallery. As mentioned in Appendix 44, network cables run up the riser from the ground floor. As the service riser continues upwards the cables utilize the existing steel conduit tray to pass into 003 Plant Room.

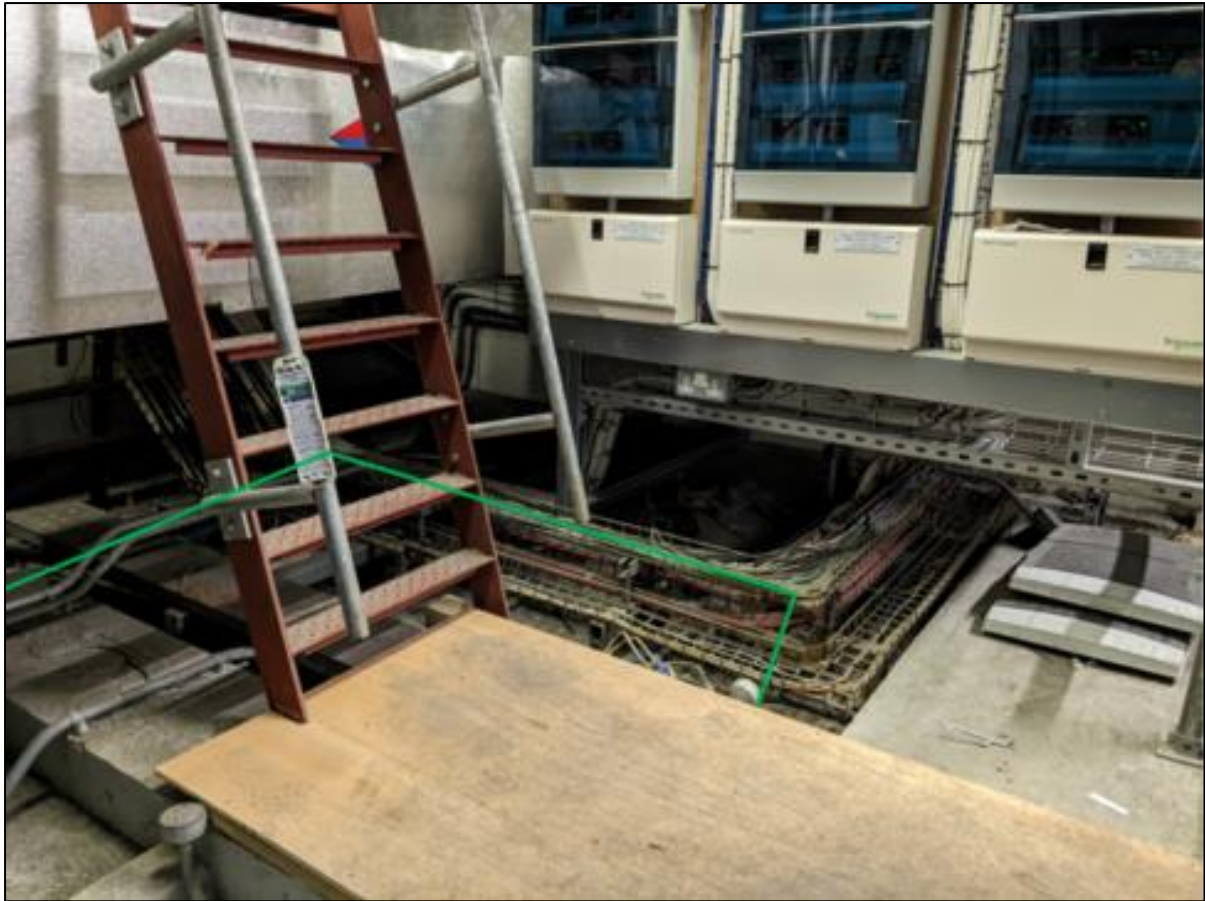
**Appendix 52:** The cable run above, pictured in green, enters 003 Plant Room via 006 Service Riser pictured in Appendix 55. From the riser the cable follows the steel conduit tray pictured above to an existing drill used to wire a lightbulb (pictured in Appendix 58) and to a cavity which provides access to 021A Services.

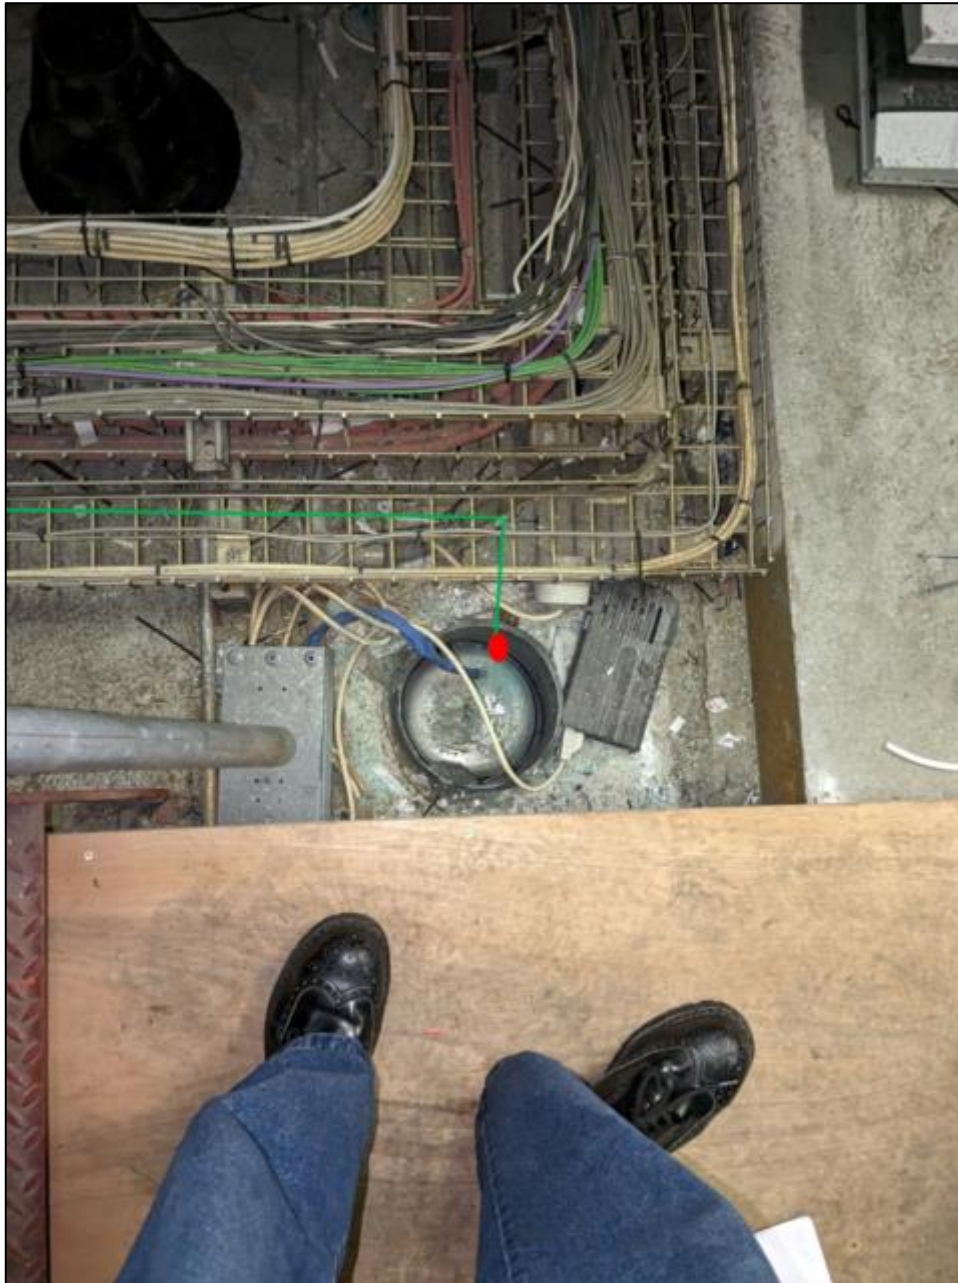
**Appendix 53:** The photograph above, taken in 003 Plant Room pictures the steel conduit tray (also pictured in Appendix 56) with the prospective cable run marked in green. The cable utilizes an existing penetration to run a network cable partway through the concrete ceiling of 020 Display Room. From the penetration, Drill17 (20mm) will puncture the walls of the existing penetration at an angle to provide access to the false ceiling of 020 Display Room whilst minimizing damage to the building's fabric.

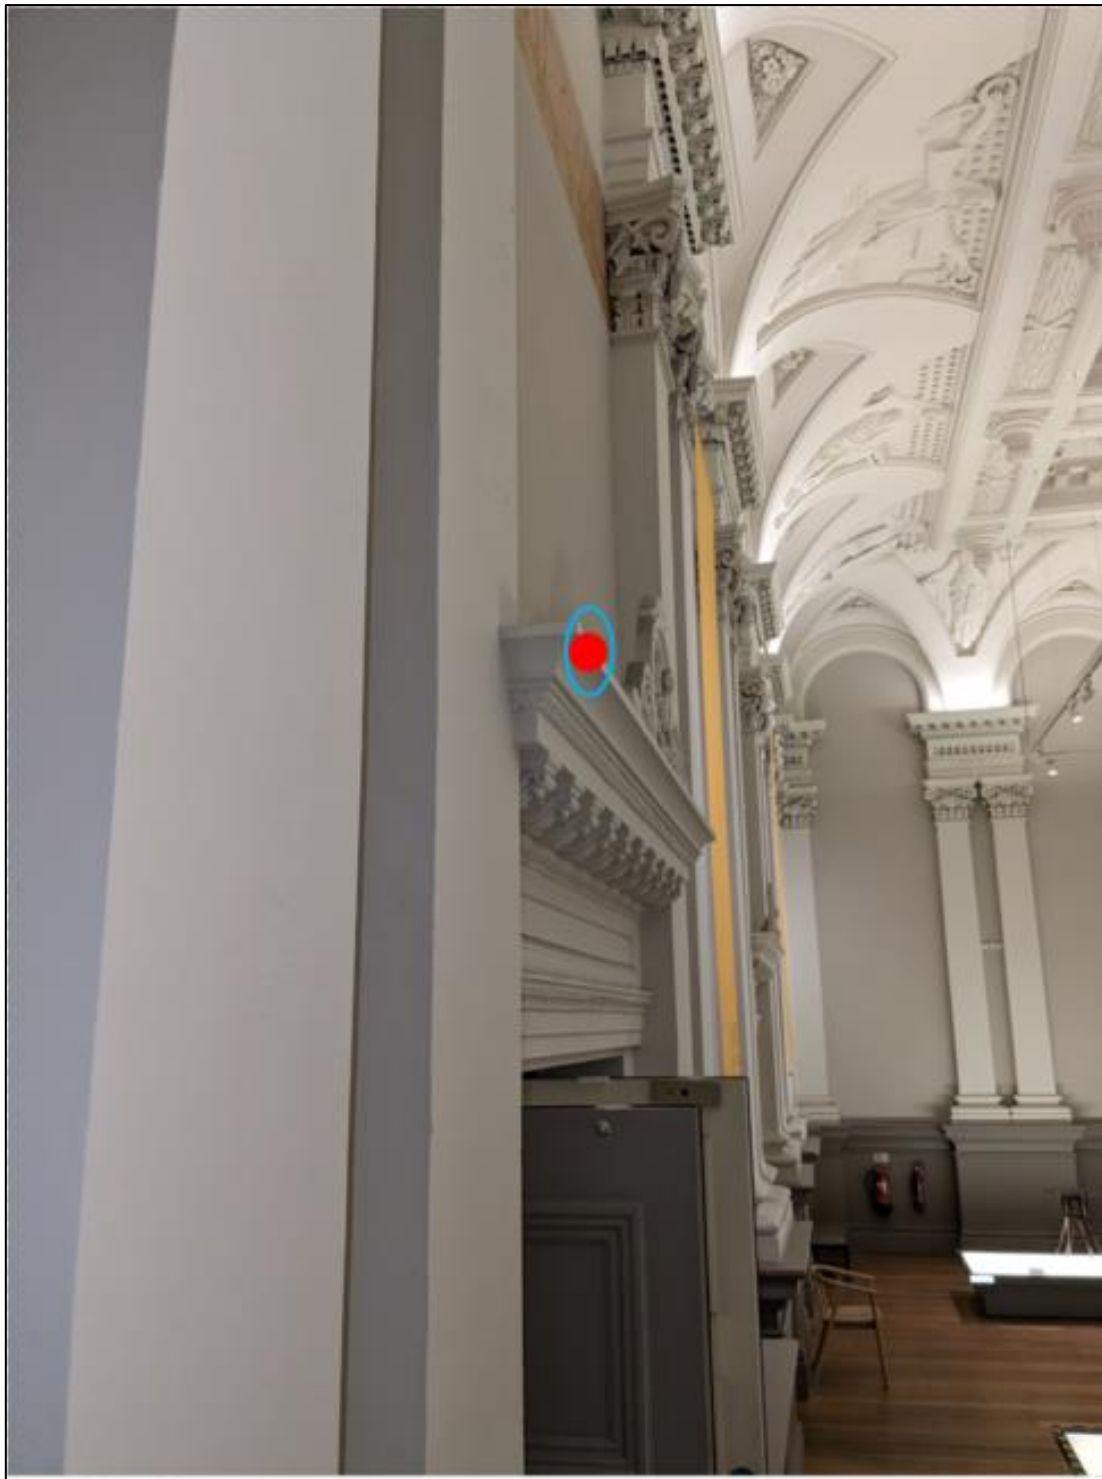
**Appendix 57:** The photograph above indicates the exit point of Drill19 (10mm) in 001 Exhibition Room using a red dot. The hole is to be used for cabling L2AP6, the position of which is demarcated by the blue circle pictured above, which will be mounted to the wall using industrial Velcro to minimize potential damage should L2AP6 be removed in the future. The position of the access point is such that the hole, wiring and SDA access point will be invisible from ground level. L2AP6, whilst not matching the furnishings of the room is essential to its viability as a functioning gallery space.

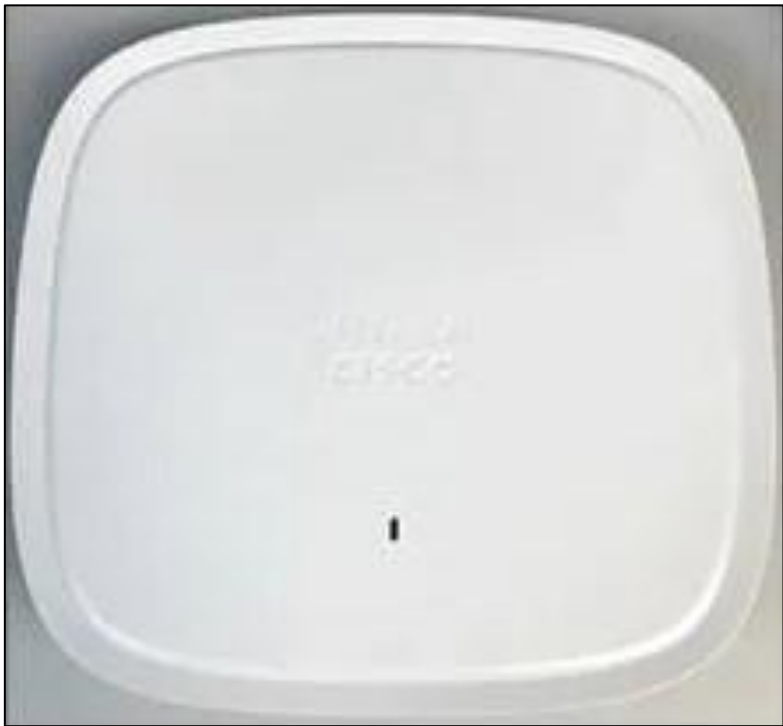
**Appendix 58:** Sample of an SDA access point, of the same type to be installed in the Manchester Art Gallery.

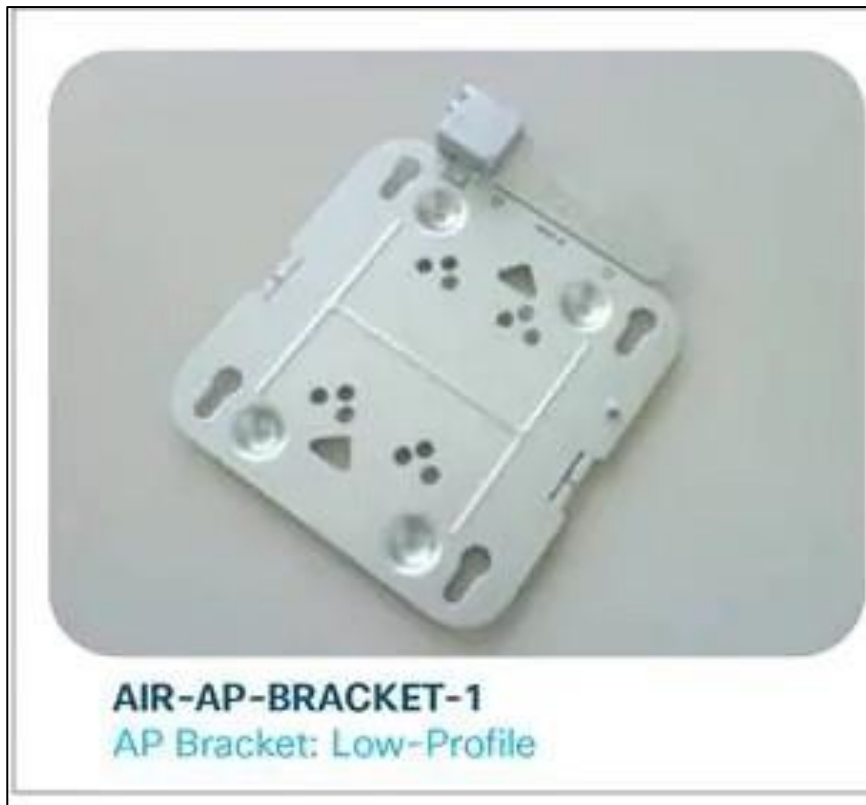
**Appendix 60:** Bracket used to affix SDA access points to wall surfaces.
