# Proposed Alterations at The Brunswick, 97 Piccadilly, Manchester M1 2DB

## Heritage Statement

January 2024

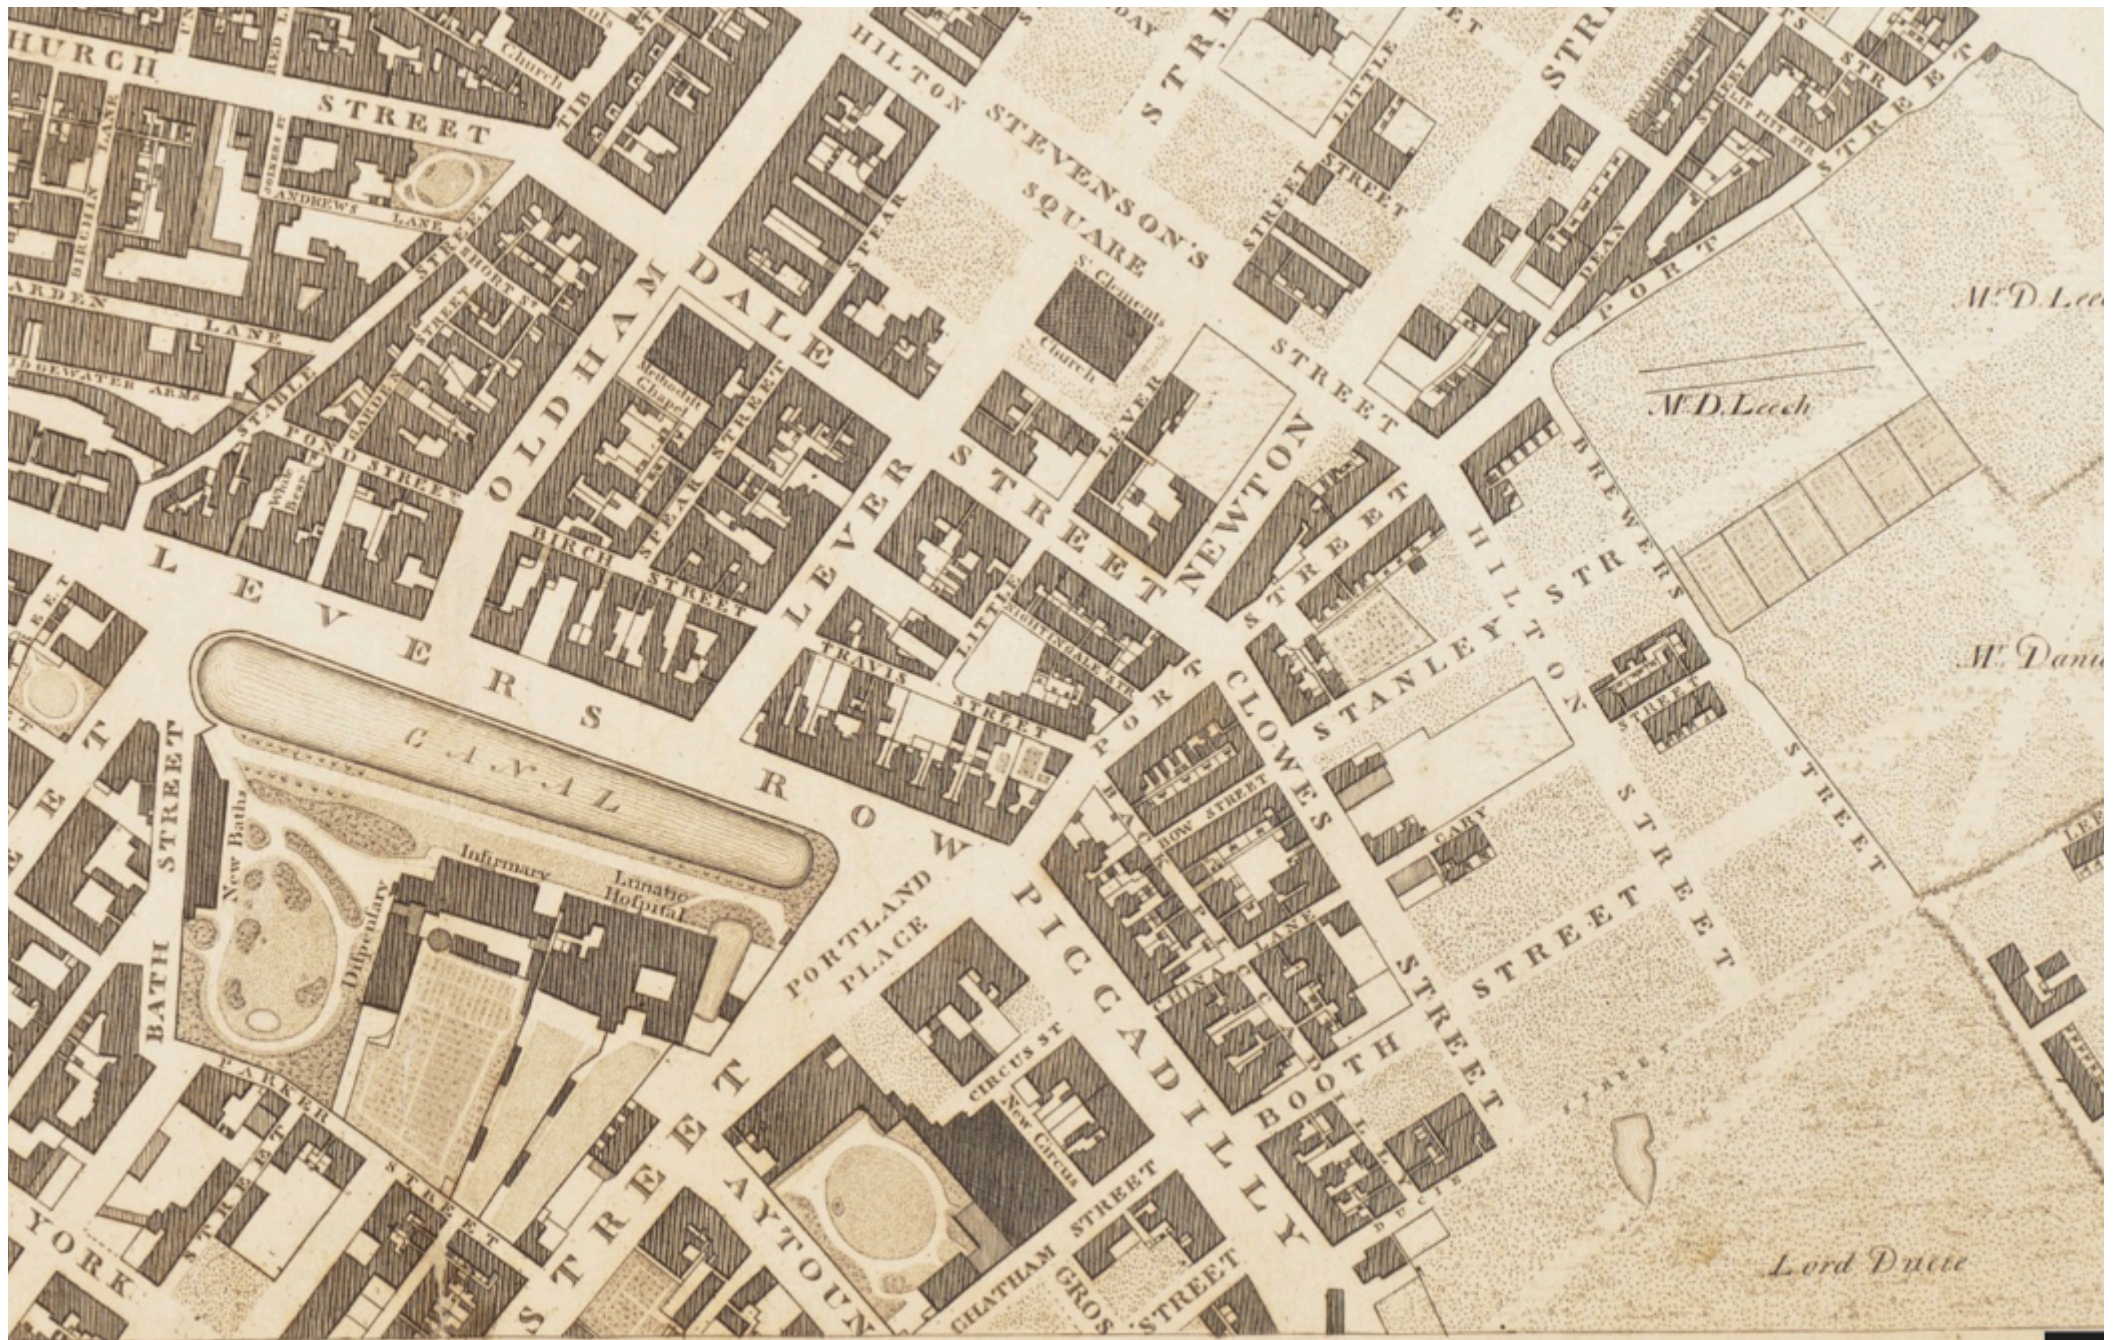
**Figure 3.** William Green's map of 1794. Paton Street was then known as Booth Street, and the building now known as the Brunswick is shown. This is evidence that it is a late 18<sup>th</sup> rather than an early 19<sup>th</sup> century building.

The building (The Brunswick Hotel and 2 & 4 Paton Street) was Listed Grade II in 1974. The List description states that it is early nineteenth century, but it is shown on William Green's map of 1794 (Figures 3 & 7) but not on a plan of Manchester dated 1772, and so must date from the late eighteenth century and probably from shortly before 1794. The description simply states 'Interior altered'.

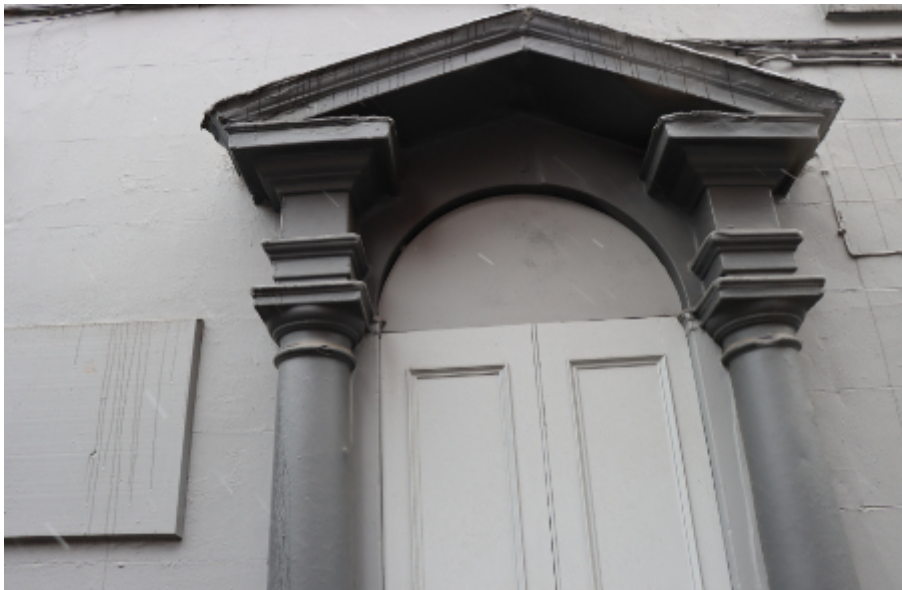
**Photograph 11.** The left-hand doorcase on the Paton Street elevation.

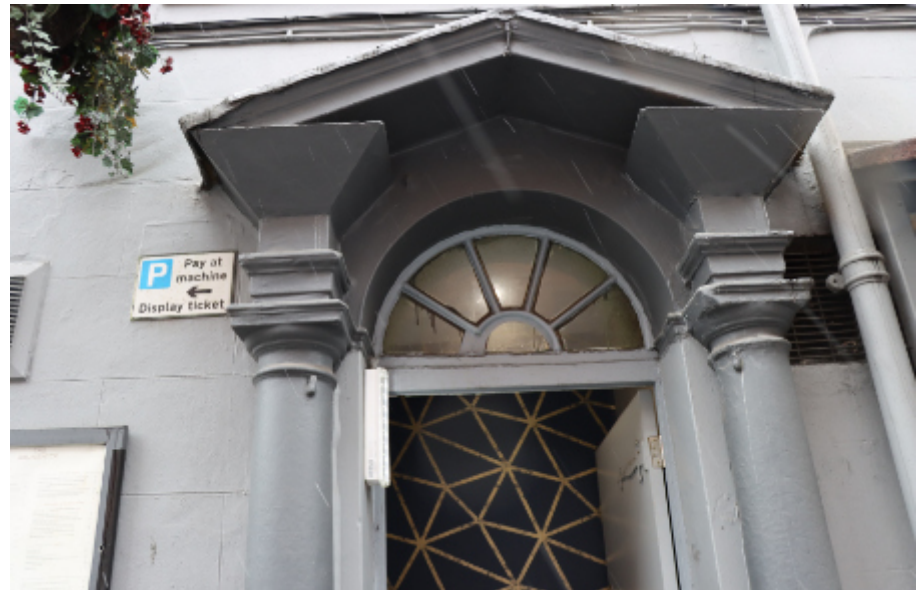
**Photograph 12.** The middle doorcase on the Paton Street elevation.

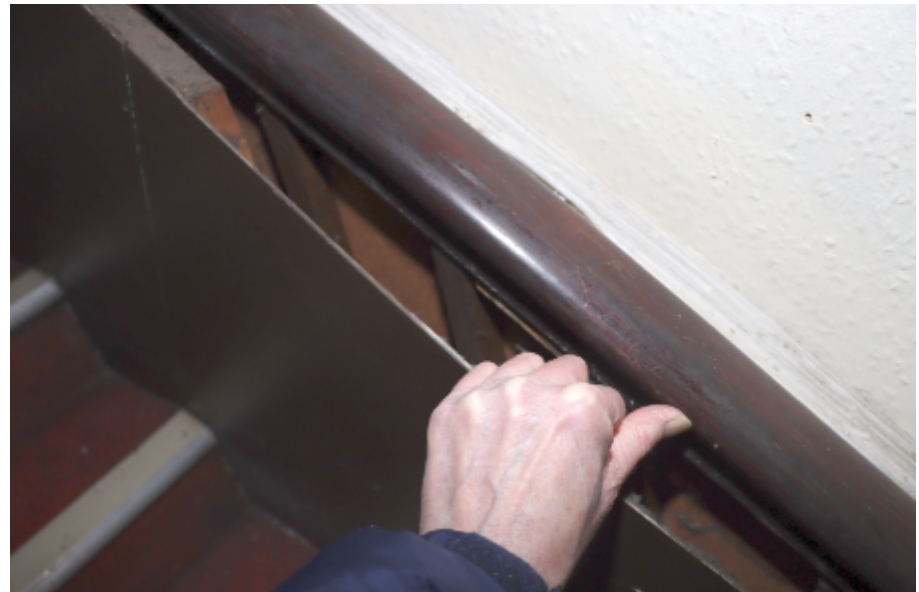
**Photograph 22.** The balustrade to the staircase that leads from behind the bar in the pub to the first floor.

The only internal evidence of a late eighteenth century origin for the building visible on the ground floor is a balustrade to the staircase that is now accessed from behind the bar area. This leads up to the first floor and has a stick balustrade that is now covered with plywood (Photographs 22 & 23) and has a newel treated as a modified version of a Tuscan column. The lobby at the bottom of the staircase is much altered, but has part of a moulded plaster cornice remaining.

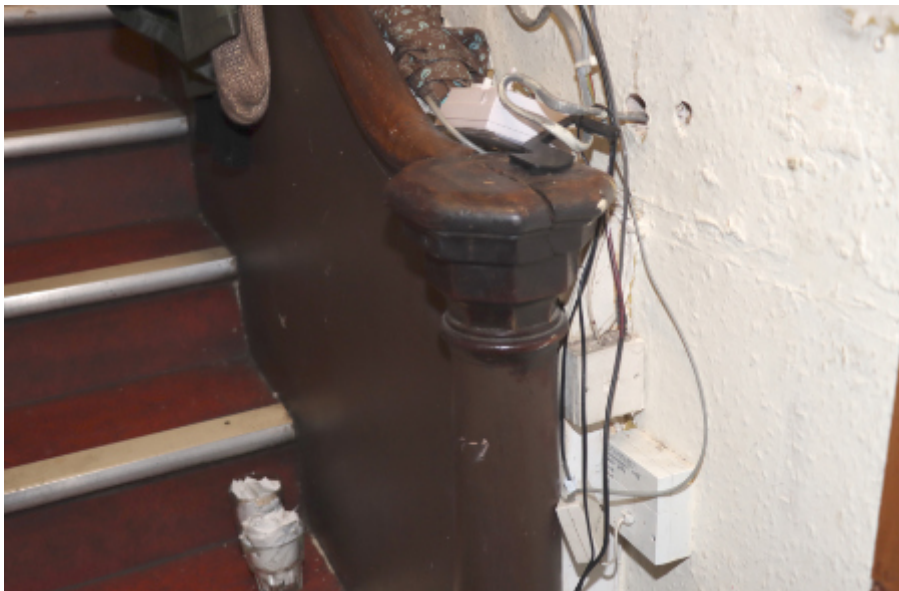
**Photograph 23.** The newel post to the staircase that leads from behind the bar in the pub to the first floor.

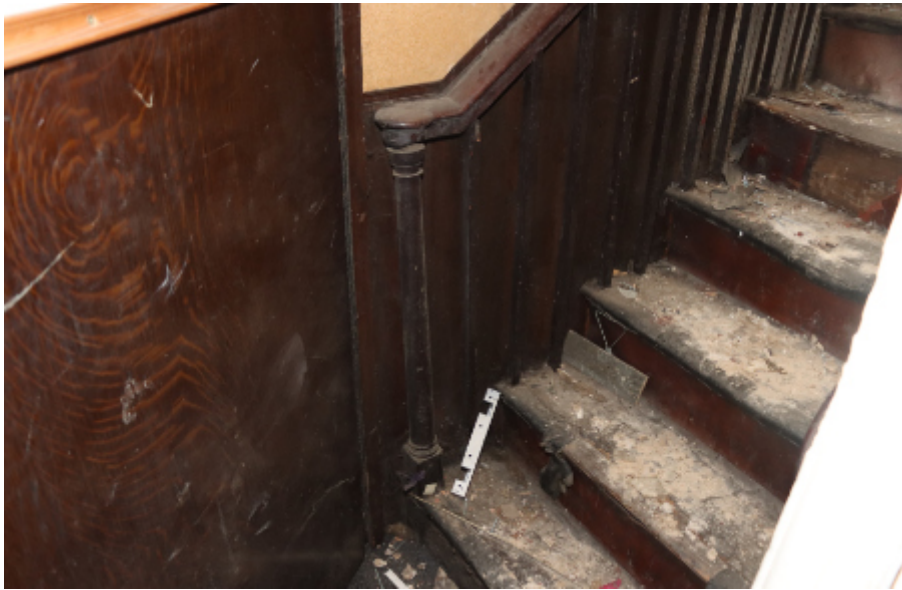
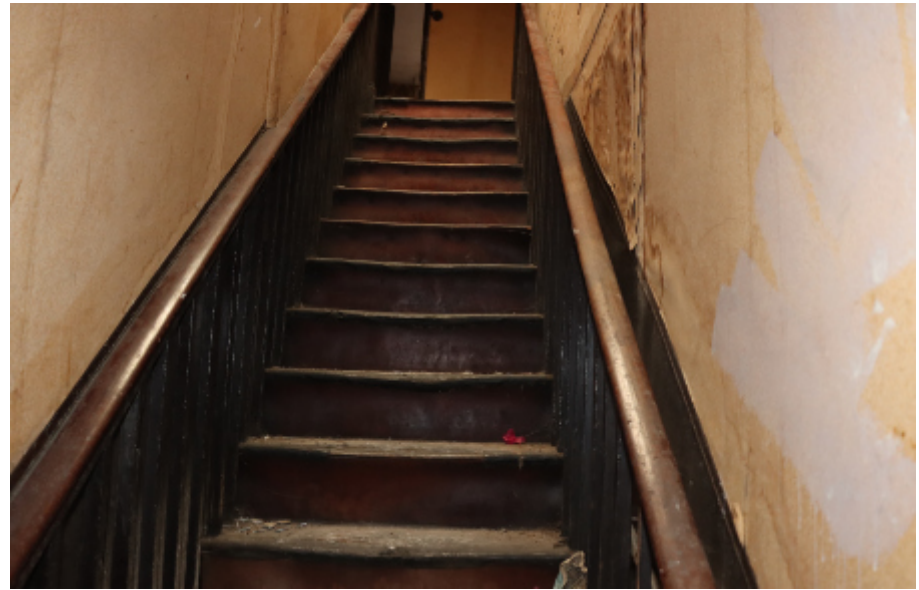
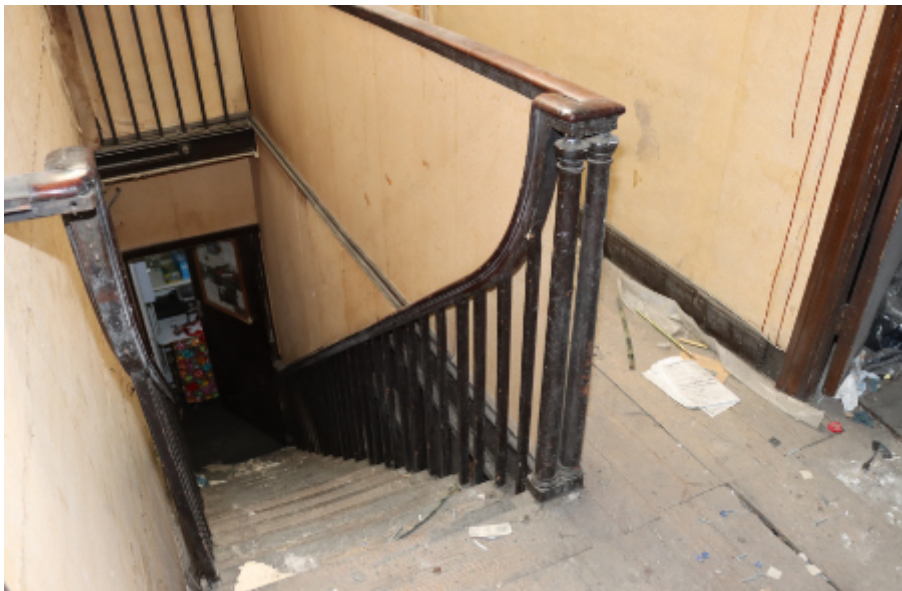
**Photograph 25.** The staircase from the first to the second floor in the front part of the building.

**Photograph 26.** The staircase from the first to the second floor in the front part of the building.

**Photograph 27.** The staircase from the first to the second floor in the front part of the building.

The staircase from the first to the second floor is of more interest (Photographs 25, 26 & 27), as it has stick balusters, ramped mahogany handrails, Tuscan columns as newels, and a second floor landing balustrade.

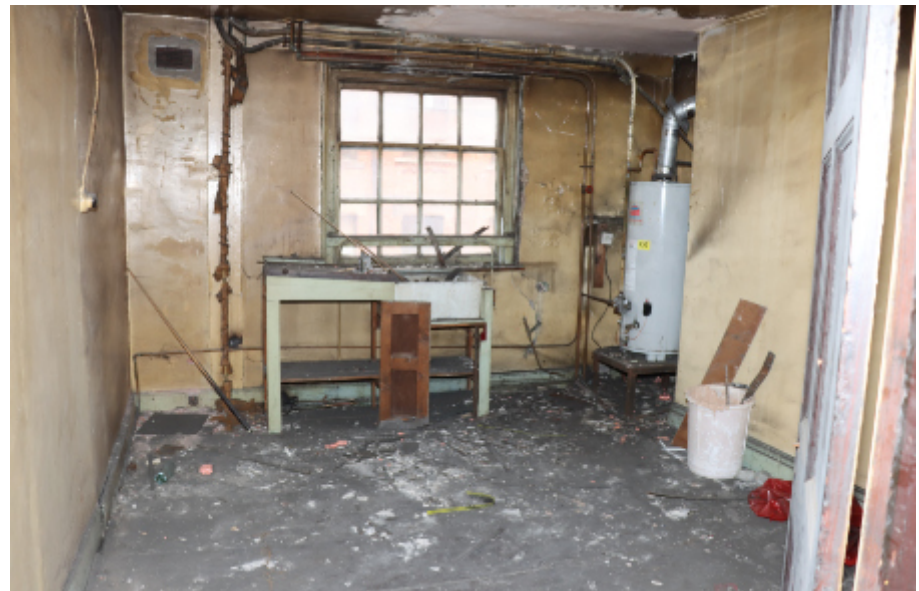
**Photograph 28.** A second floor room, with a 4 over 8 sash window on the Paton Street elevation.

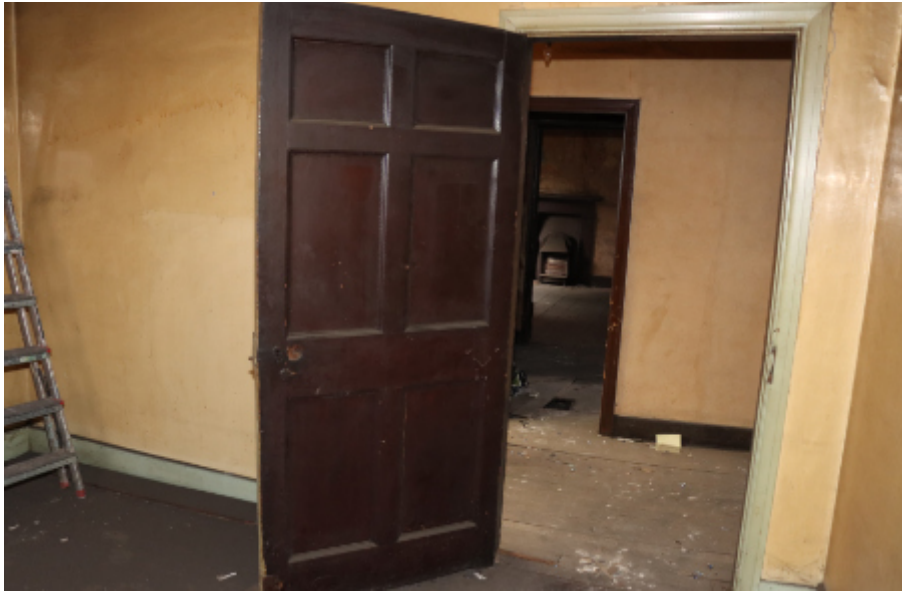
**Photograph 29.** A 6-panel door on the second floor.

The second floor has also been altered greatly and is now partly semi-derelict. It does retain two fireplaces in the front part of the building that probably date from the 1790s, and these will be retained and repaired. Two six-panelled doors also remain. These are unremarkable but are evidence of the pre-Victorian origins of the building and will be retained with their fire resistance upgraded by covering their plain sides.

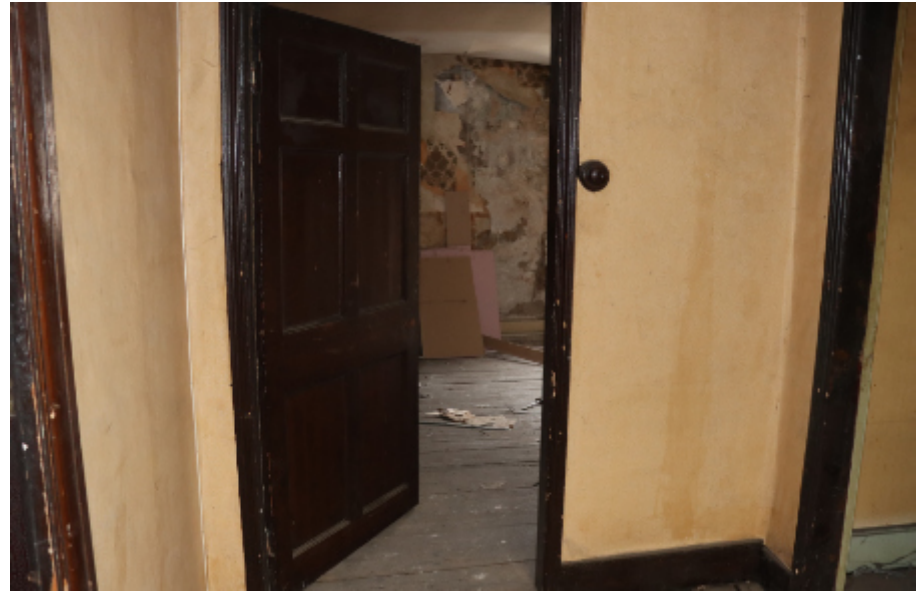
**Photograph 30.** A 6-panel door on the second floor.

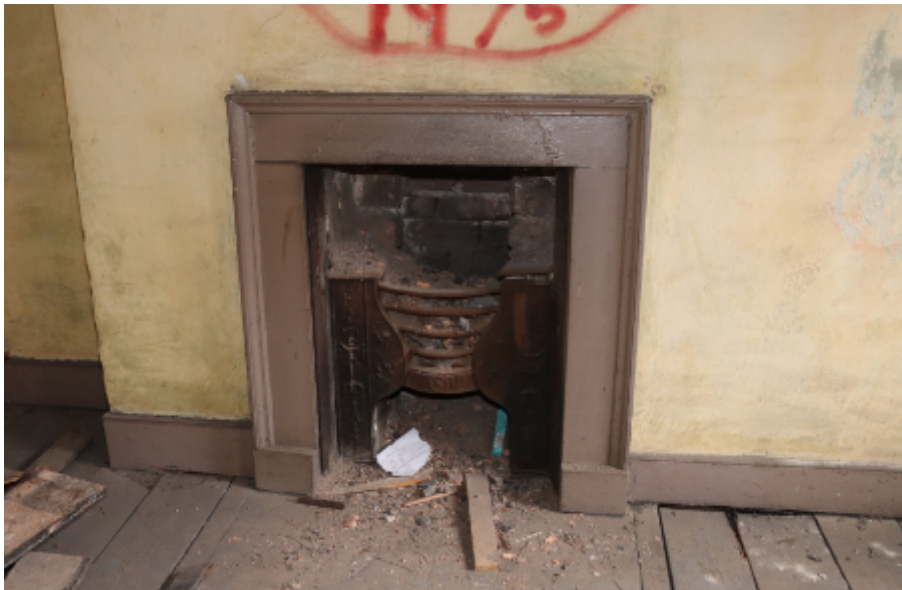
**Photograph 31.** A fireplace with a hob grate, in the southern second-floor room on the Piccadilly elevation.

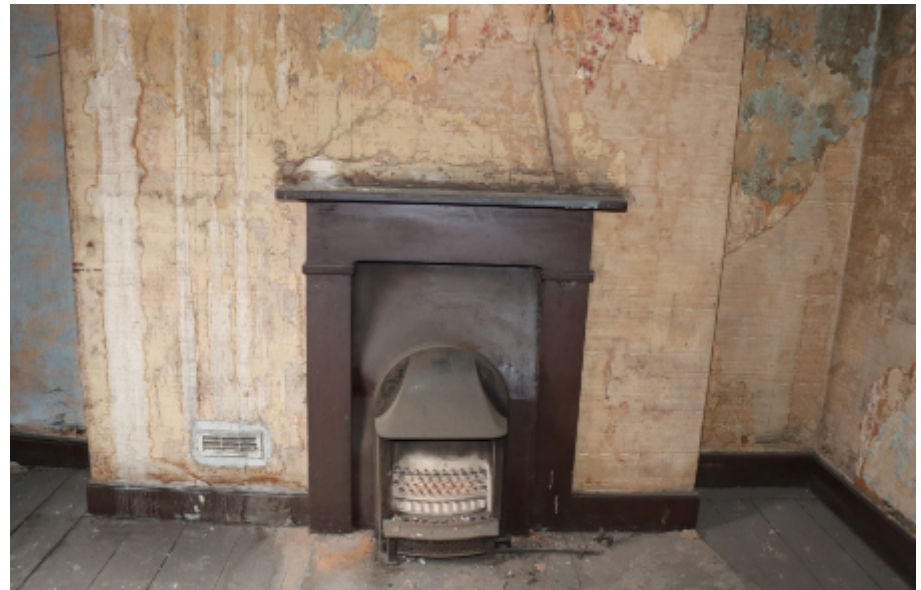
**Photograph 32.** A fireplace in the southern second-floor rear room.
