## LAND AT BENMORE ROAD, BLACKLEY

### Remediation Method Statement

Report Ref: BEK-23104-2 (Rev A)

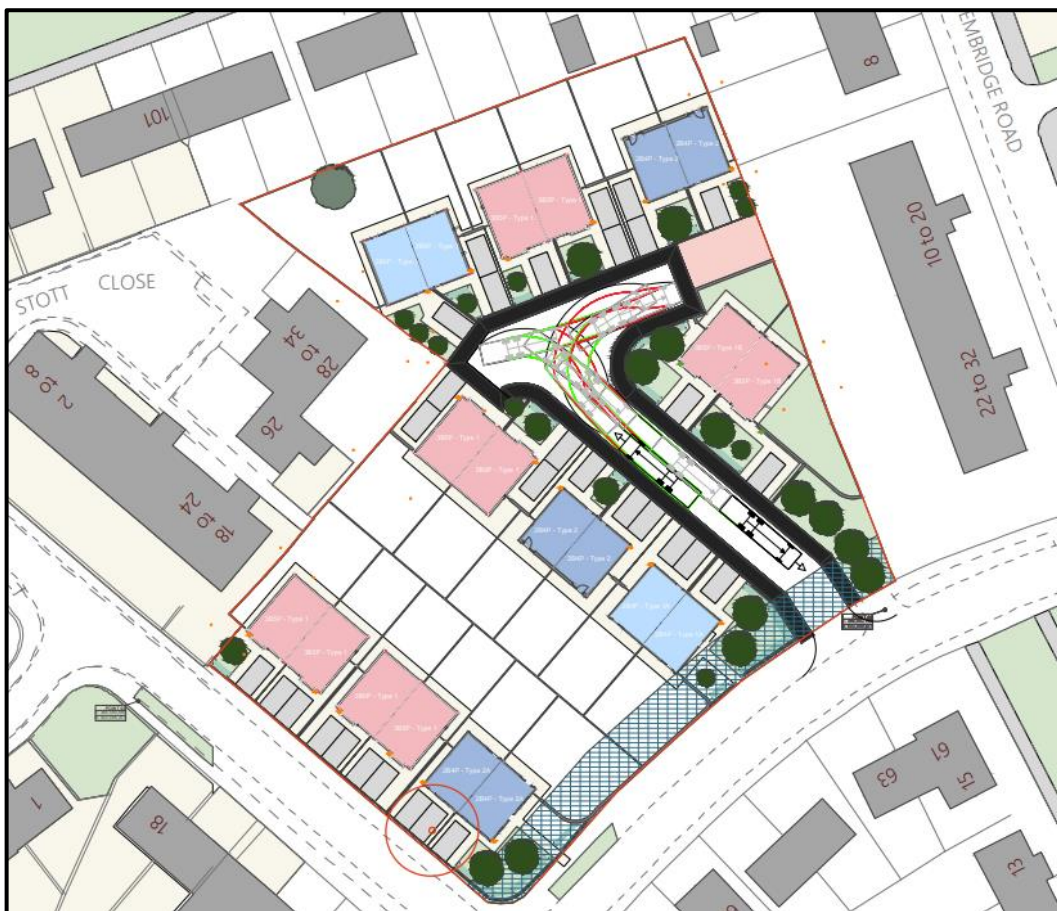
Figure 1: Proposed Development Plan

- 1.1 The site is located to the east of Benmore Road approximately 5.7 km north-east of Manchester city centre and 6 km west of Oldham town centre. The site is currently comprised of a vacant grassed area.
- 1.2 Development proposals for the site are for the construction of 20 residential dwellings with associated private garden areas, access and parking. An extract of the proposed development is shown below:
