**CONTRACTORS SITE SETUP**  
(all compass references are based on liturgical directional notation i.e. Sanctuary at the east)

Work Areas / Repair Issues / Site Setup

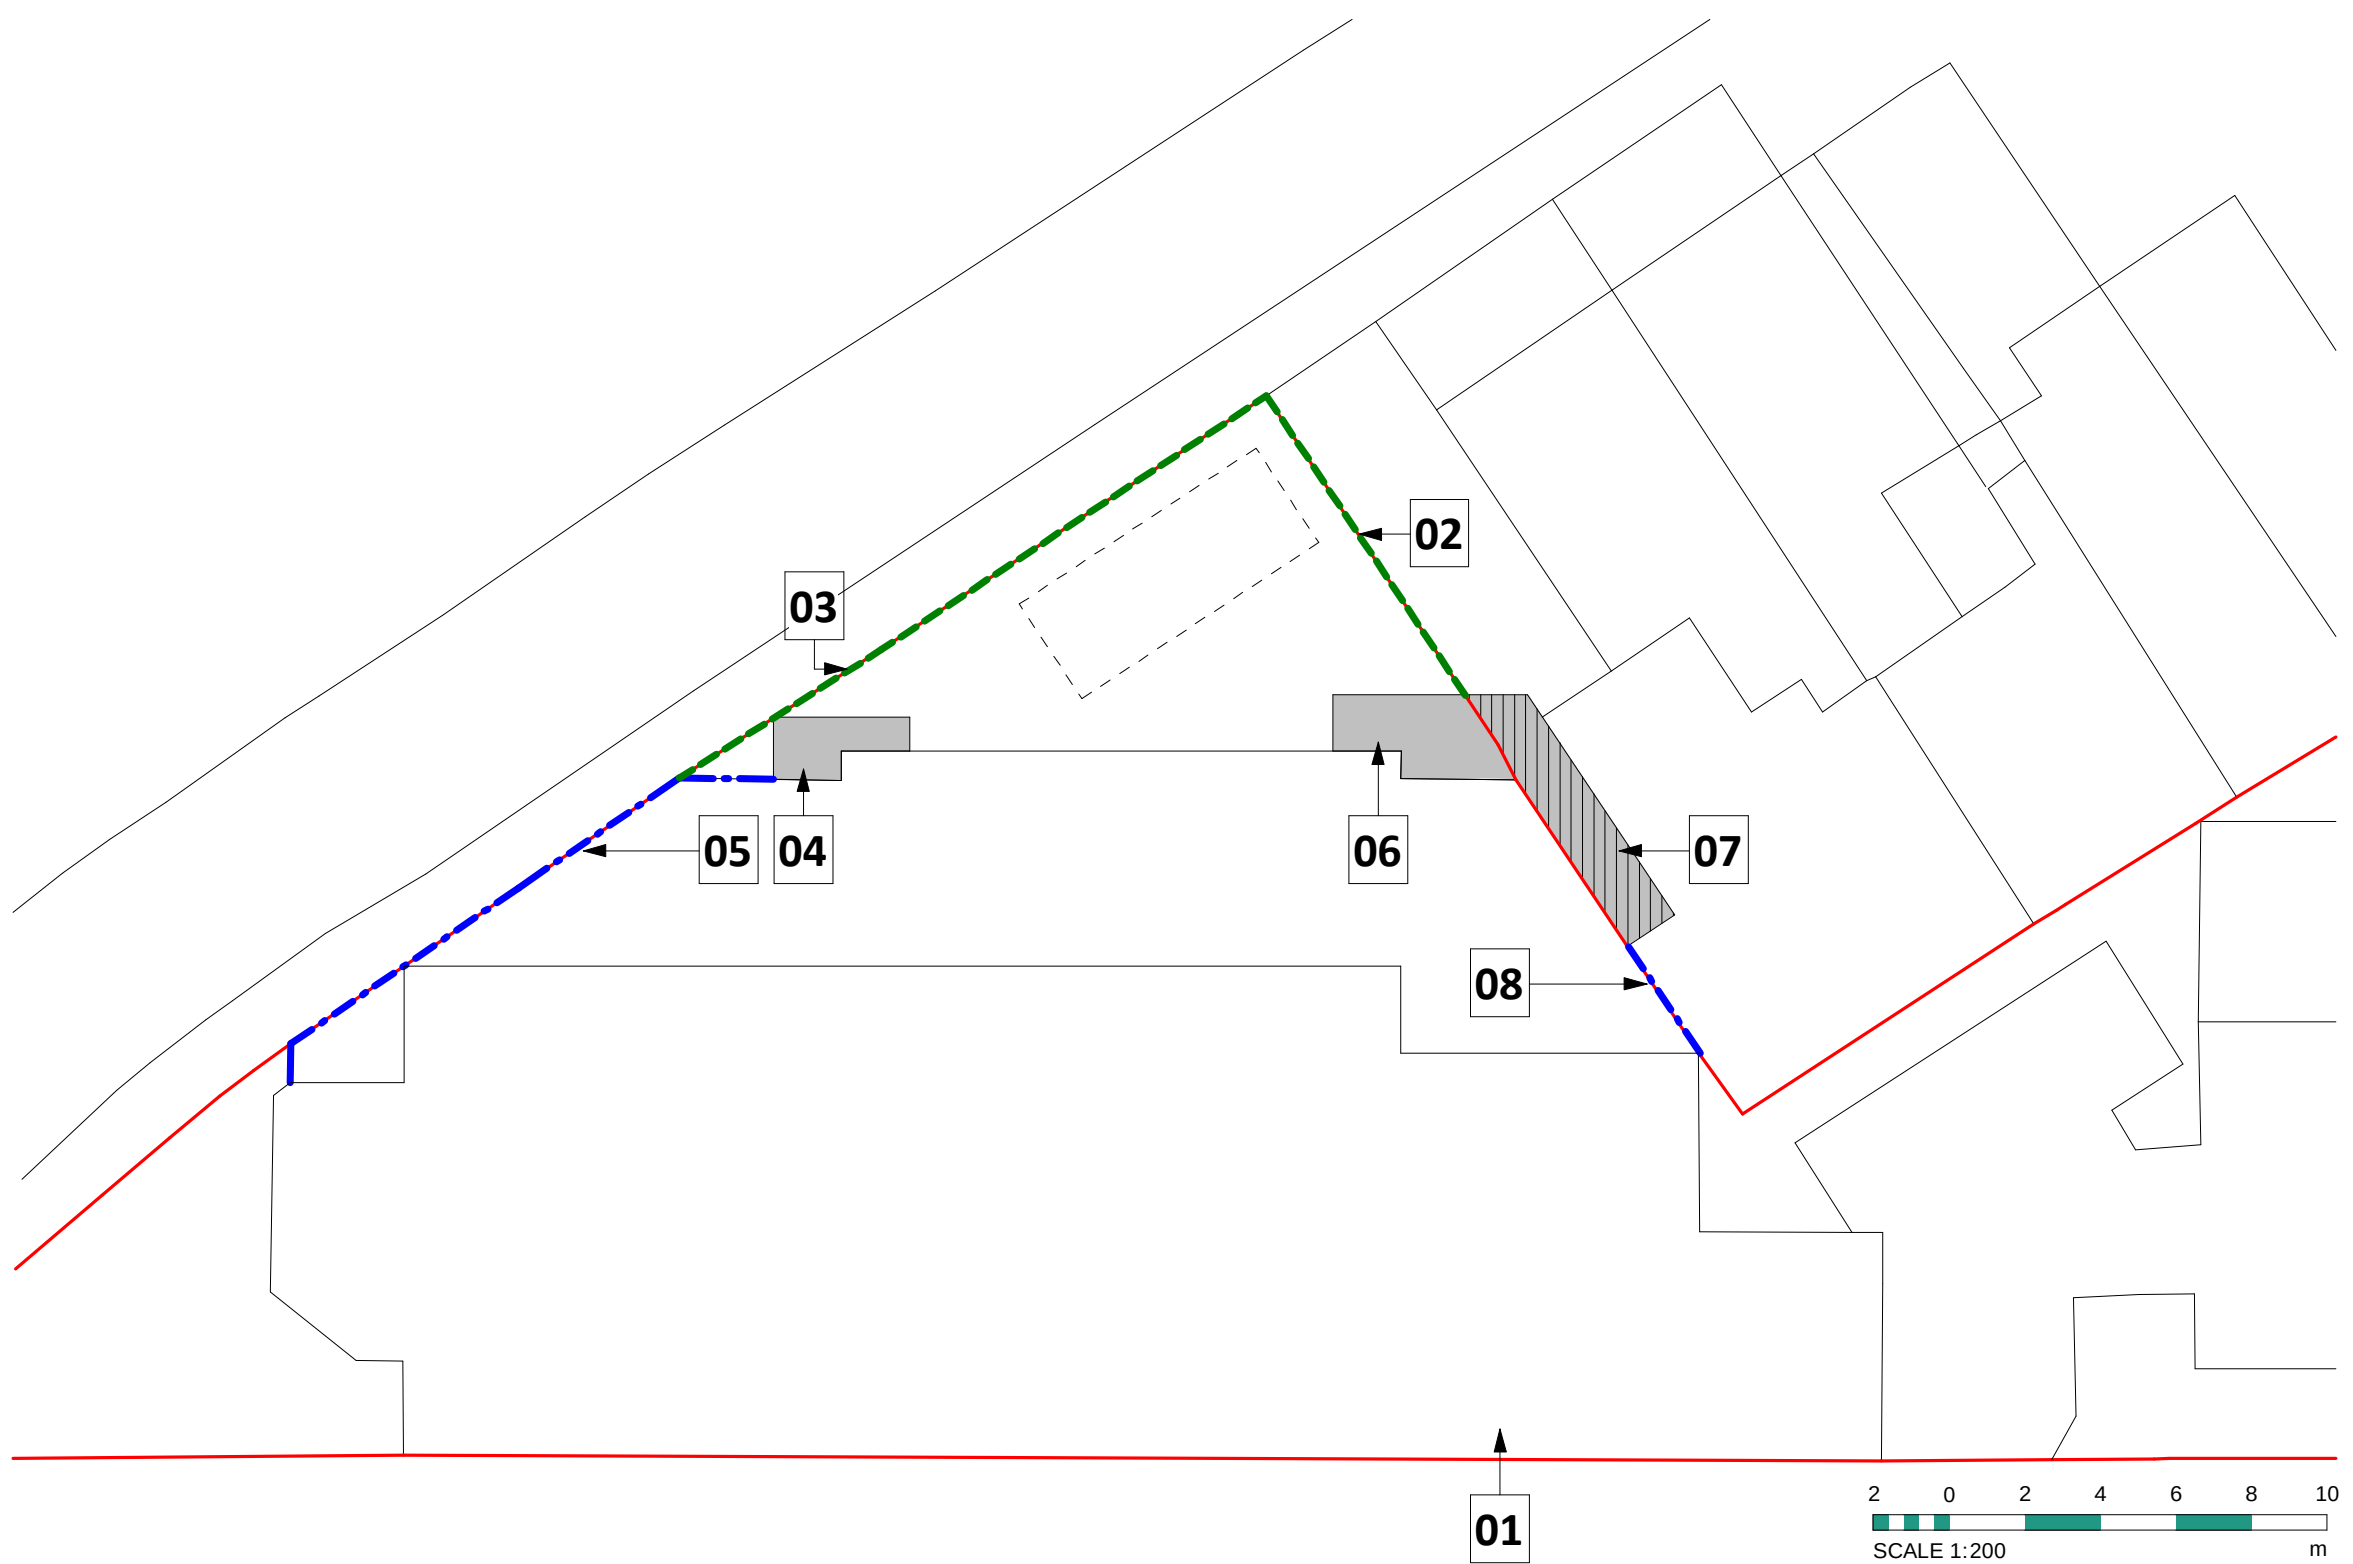
The site area is limited through the close proximity of the legal ownership boundaries which surround the North Aisle. At the east end the walls upon which the apsidal Lady Chapel roof is built site immediately on the boundary. Any scaffold access/protection from this side will depend on negotiating this with the adjacent owner and agreeing any commercial terms in recognition of any disruption caused.

On the north side a small garden area may provide a location for access via a scaffold which starts at the east end of the elevation and is then built off the adjacent neighbours land for works to the apsidal end roof subject to the above.

At the west end of the elevation and just before the garden runs out, it maybe possible to provide access inside the boundaries up and onto the flat roof area at this location.

- 01** ~~Max 7.5m x 3m combined site office / welfare / toilet cabin located in garden in location to minimise damage to existing planting –~~  
Welfare facilities will be located in the presbytery (REV A)

**3. Copper Roof to Lady Chapel**  
Part of the copper roof covering was removed during a recent theft. Roof covering is to be replaced with TCSS (Terne coated stainless steel) roof coverings to minimise threat of future attack

**4. Copper apaisal roof box gutter and spitter/outlet**  
Copper box gutter was partially removed during a recent theft. The box gutter is to be replaced with new TCSS box gutter to match original.
