# ADDENDUM HERITAGE STATEMENT

**Former Offices at 3 York Street, Manchester  
Above Browns Bar & Brasserie  
1-3 York Street, Manchester, M2 2AW**

December 2023

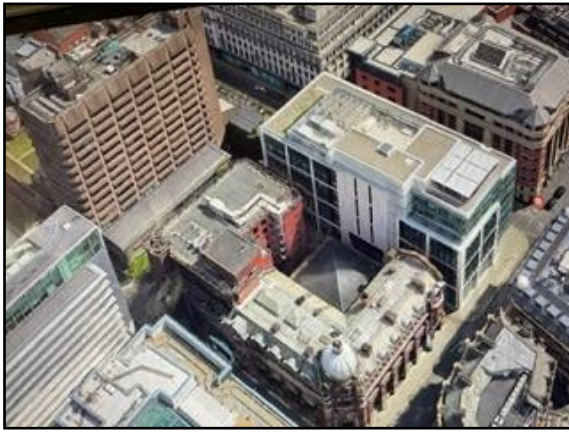
*Figure 3: Aerial photo of pyramid roof over service area behind 1-3 York Street. The picture is looking north-west. The street block is bounded by York Street (bottom right), Milk Street (top) Marble Street (left) and Spring Gardens (bottom centre).*

- 6.1 The three aerial photos (**Figures 3, 4 & 5**) below illustrate the general setting of 1-3 York Street. **Figure 6** is an extract from the Upper King Street Conservation Area Map showing Listed Buildings (edged **Blue**) and viewpoints in **Photographs 2 - 7** below.

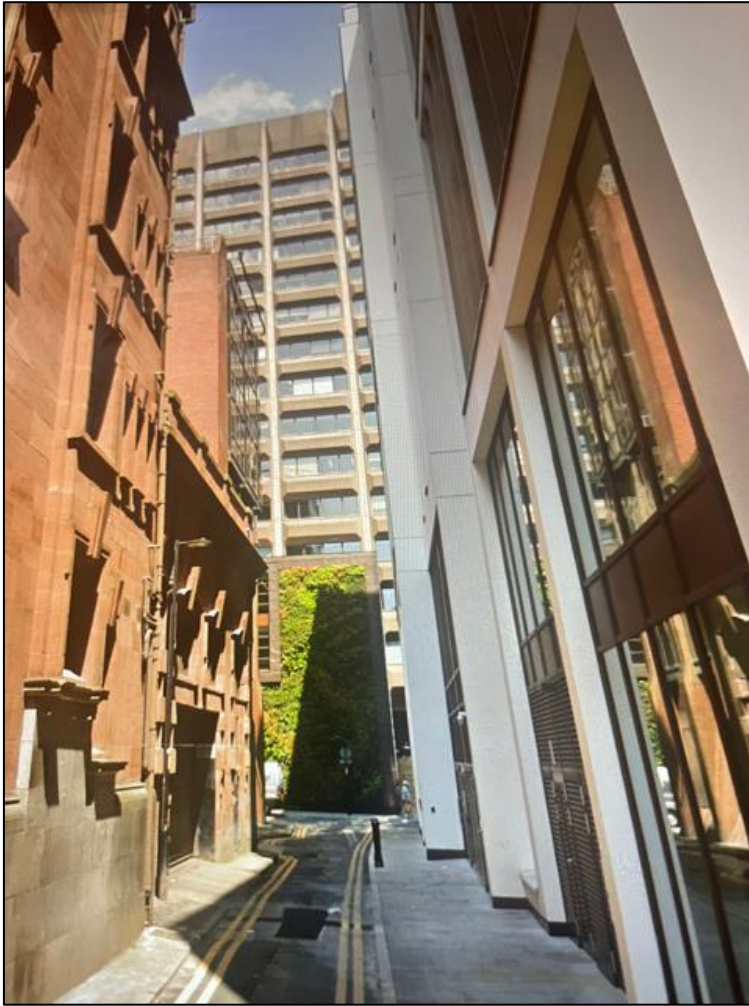
*Photo 3: Viewpoint 2. Milk Street looking north from York St. with service area /car park entrance on left and newly built offices at 11 York Street opposite*

- 8.2 The lift shaft terminates below the ridge line of the building. From the principal setting viewpoints (**illustrated in Photos 4 and 6 above**), the shaft cannot be seen. Within this part of the conservation area, the rich mixture of 19<sup>th</sup>, 20<sup>th</sup> and 21<sup>st</sup> century buildings mostly have total site coverage (**Photos 2 and 7**), so that in the narrower thoroughfares, such as Milk Street, views are channeled along the street rather than up (**Photo 3**).

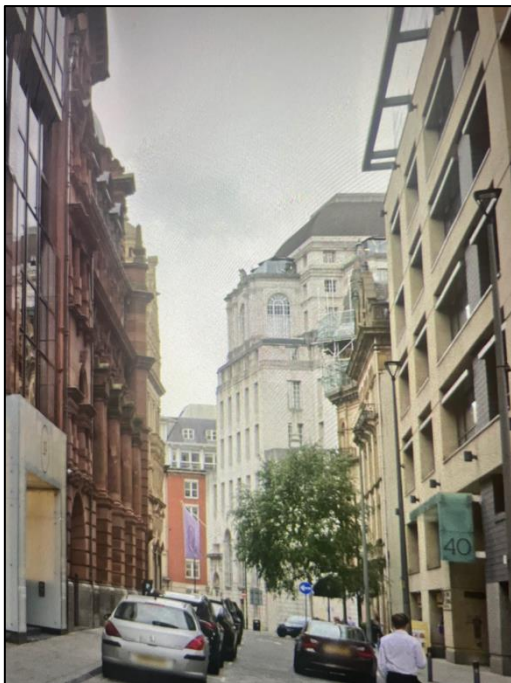
*Photo 6: Viewpoint 5. Spring Gardens looking south. 1-3 York Street is on the left. Modern offices right foreground, then former Reform Club, then no.100 King Street in Portland Stone, centre.*

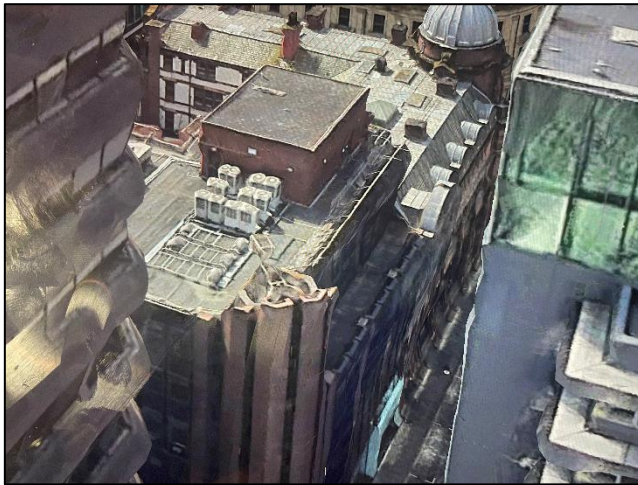
Figure 7: Aerial photo of north east rear elevation, showing proposed lift shaft location to right of rainwater downpipe (top left)

- 8.1 The proposal is to construct an external lift enclosure to the height of the 4<sup>th</sup> floor to the right of the rainwater downpipe shown on the aerial photograph at **Figure 7** below and in the location shown on drawings **AP14revD** and **AP15revE**. Externally, the shaft will be finished in a slate grey metal cladding sympathetic to the modern slated roof, the apex of which is level with the third floor.
