## CRIME IMPACT STATEMENT

Bromley Street, Manchester  
Co-working space (4,326sqm)

FOR: Meanwhile Creative

REFERENCE: 2023/0240/CIS/01

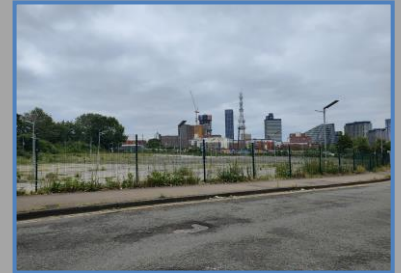
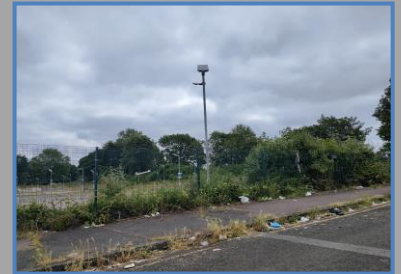
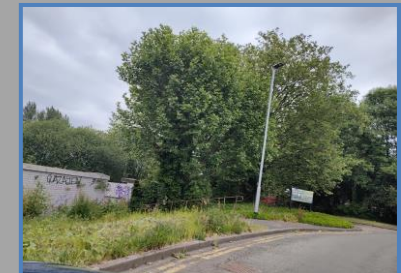
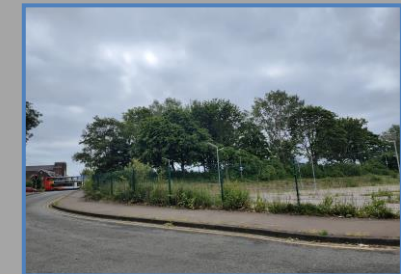
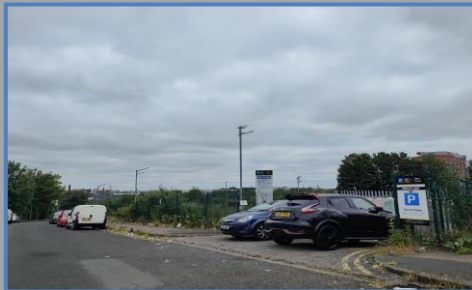
The site is currently vacant and was last previously developed as a surface car park, which has not been in use for over 2 months. The site boundary remains intact and there are a large number of solar powered lighting columns which cover the site. There is a considerable amount of litter surrounding the site and the vegetation is overgrown.

- 3.3.5 The existing site boundary should be inspected for any damage and repaired where necessary to ensure the integrity of the perimeter. Any new secure boundary treatments should be a minimum of 2400mm high and of robust construction, to prevent climbing or using tools to damage it to gain entry. Secure boundaries should generally use a secure paladin 358 panel (or similar system) or be certified to LPS 1175 SR 2. There should be minimal ground clearance to prevent an offender from crawling underneath. Any gates should be of the same height and construction and should feature no climbing aids such as exposed midrails, hinges, or locking points.
