DESIGN & ACCESS STATEMENT

Change of Use to Upper Floors and Alterations  
to create 46 Bedroom Hotel

1-3 York Street, Manchester

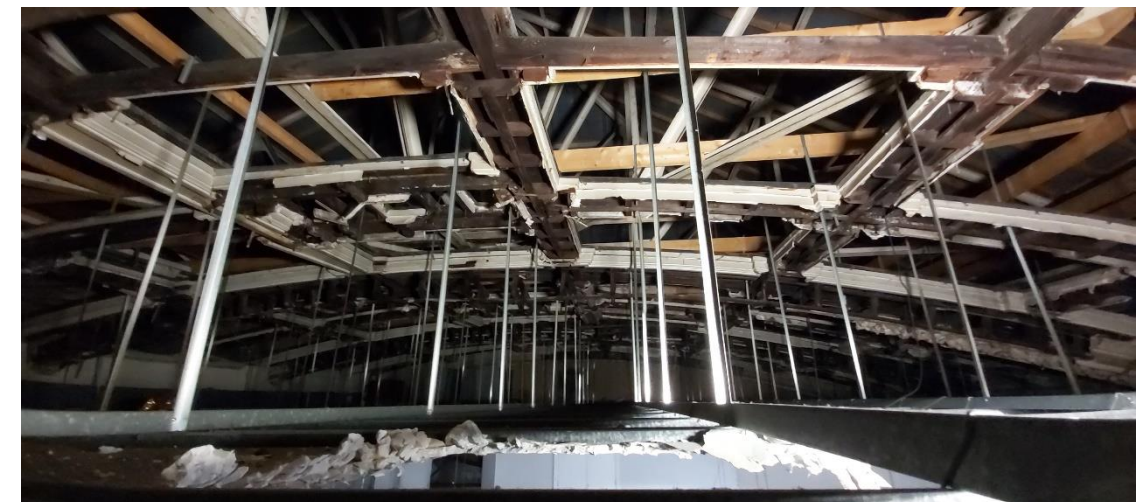
Fig 8: Photographs taken above courtyard ceiling level

It is highly unlikely that the curved glazed timber and glass ceiling structure was a weatherproof construction. We have opened-up an area of modern plasterboard ceiling to the courtyard ceiling as can be seen in the photographs below. Above the remains of the timber ceiling structure, there are a series of white painted metal trusses forming a pyramidal roof structure, which supports timber purlins and roof joists with a slated roof finish. From the condition of the timbers and the membrane used, this looks like a more recent roof covering – possibly from the mid-70s or more recent. The metal truss structure looks original, although this is not conclusive. It is quite possible that the pyramid roof structure is original but may have incorporated roof lights in the original covering to bring daylight illumination through the decorative glass ceiling.

It is not known when the glazing and timber (or plaster) detailing was removed – this could have been in the 1970s or pre-listing - any deterioration would have presented a significant safety risk of glass falling from height. A plasterboard ceiling has been installed on a metal frame system hung from the upper-level timber roof joists. Multiple strap hangers support the primary ceiling channels. Two small panes of leaded glazing are all that remain of the original finish (as can be seen on the lower photograph), however these have been punctured by metal ceiling strap hangers.

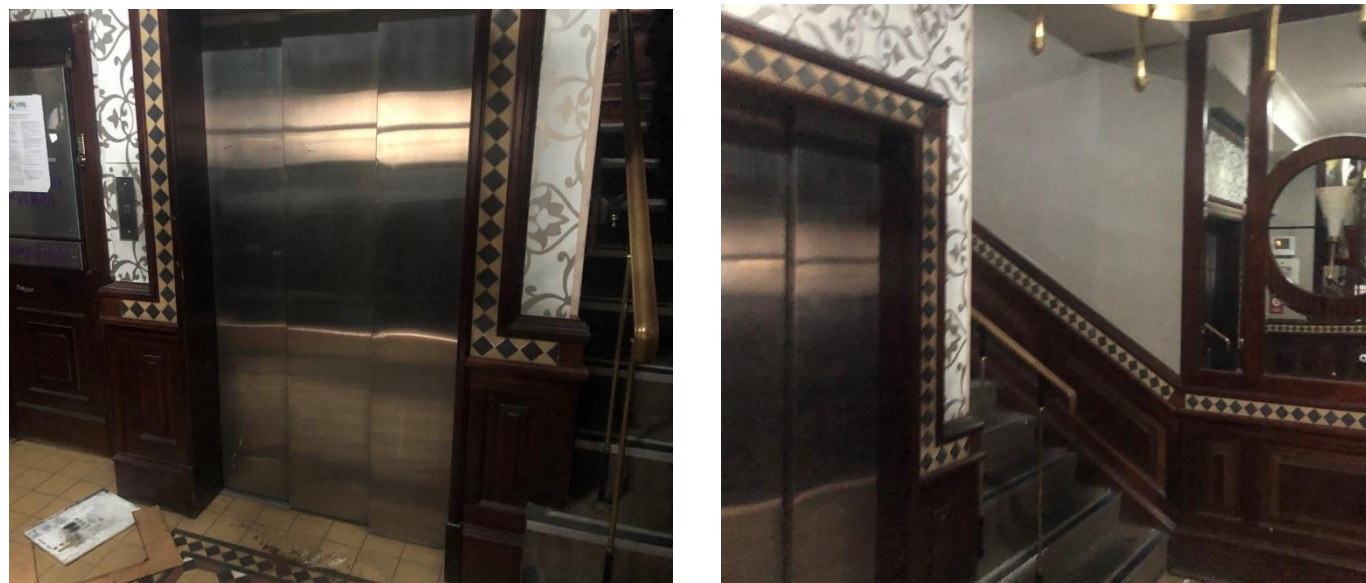
Fig 10: Lift shaft and stair well at ground floor level

Access to the upper floor office space is gained via a stepped entrance to a stair lobby with an original lift serving all storeys above, the staircase wraps around the lift shaft. The lift can be seen (highlighted) on the architectural ground floor plan of 1907 (opposite). The joinery detailing around the lift and to the entrance lobby and main stairwell appears to be original and in very good condition.

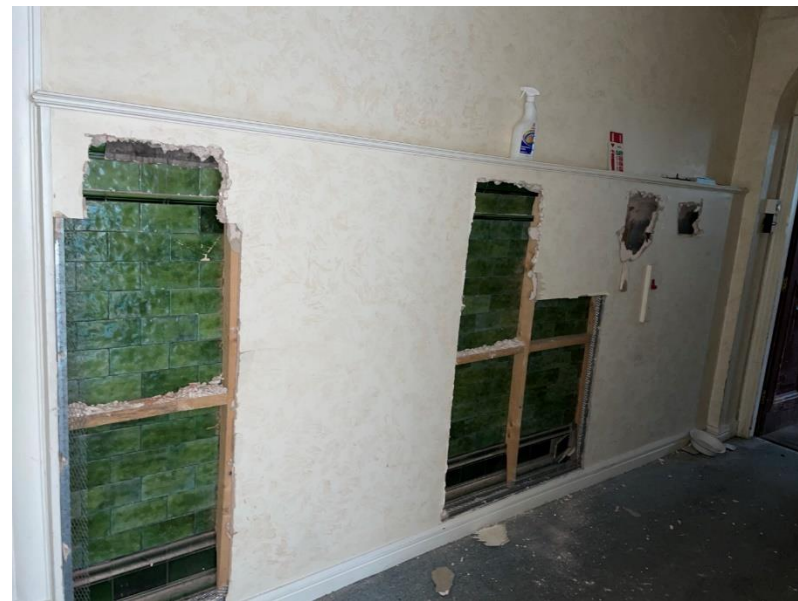
Fig. 13: plasterboard boxing removal – intrusive investigation at 4<sup>th</sup> floor level

At fourth floor (the topmost level) there is green glazed tiling behind boxing below dado level to most of the corridor. As we were able to remove large sections of plasterboard boxing at fourth floor, we have been able to make an assessment of the condition of the tiling. The tiling, together with a tiled skirting and dado, is largely in good condition, however there are some areas (approximately 10%) where tiles are missing or damaged, and there are numerous holes through tiles where the timber studs that frame the boxing-out are fixed.

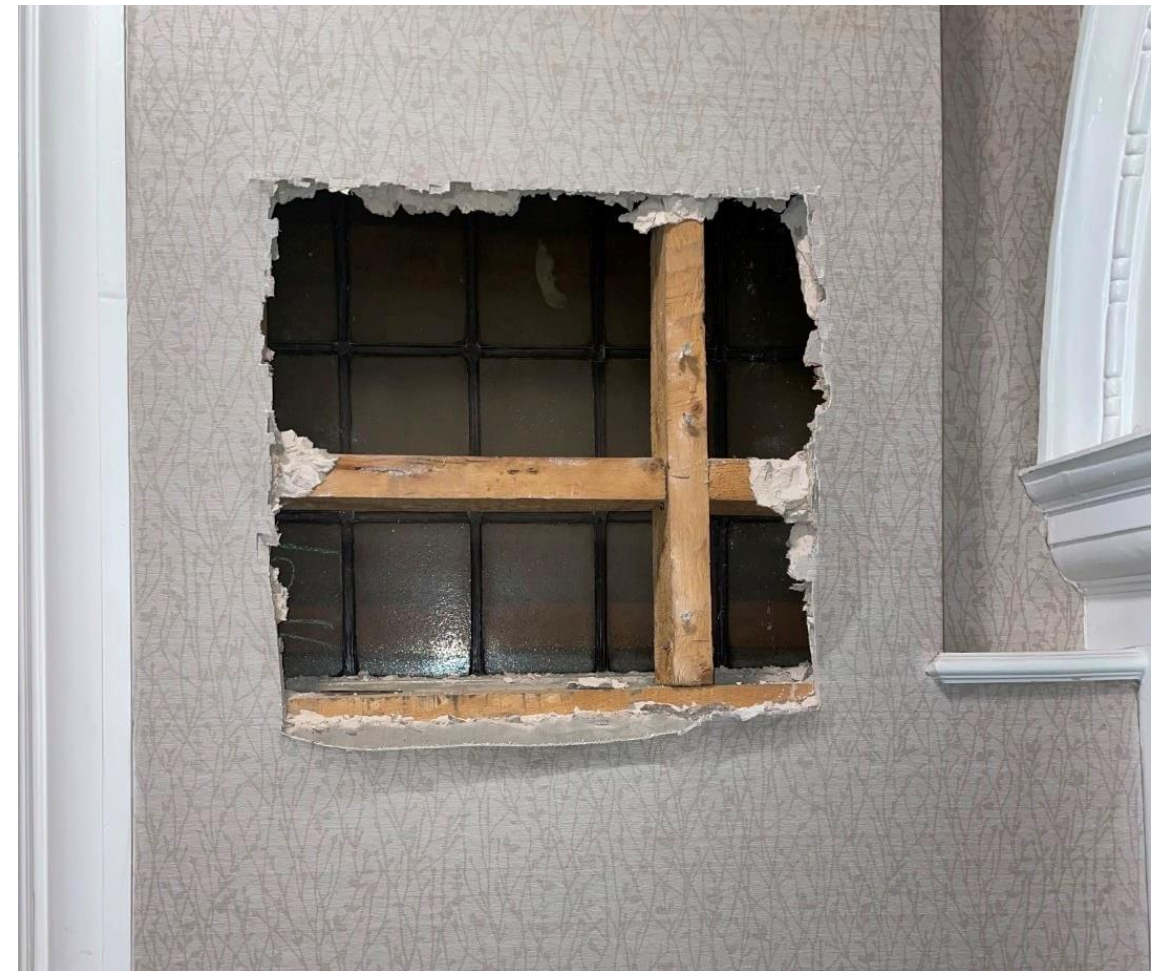
Fig. 15: Exposed internal leaded window at 3<sup>rd</sup> floor level

Due to the presence of live-in property guardians at second and third floor levels, we have not been able to remove such extensive areas of boxing, however smaller exploratory holes were made and have subsequently been patched-over. We have photographic records of all these openings. The tiling on these levels appears to be of similar quantity and quality as found at fourth floor. Where boxings on these two lower floor levels extend up to high level, it has been revealed they obscure internal leaded windows that previously brought daylight from the office spaces into the corridors – see record photographs on the following page.

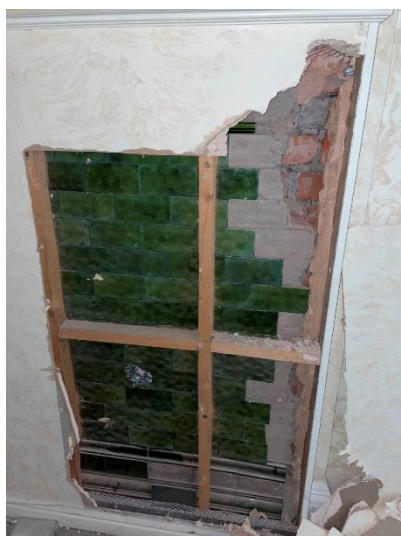
Fig. 14: typical details at 4<sup>th</sup> floor showing missing tiling

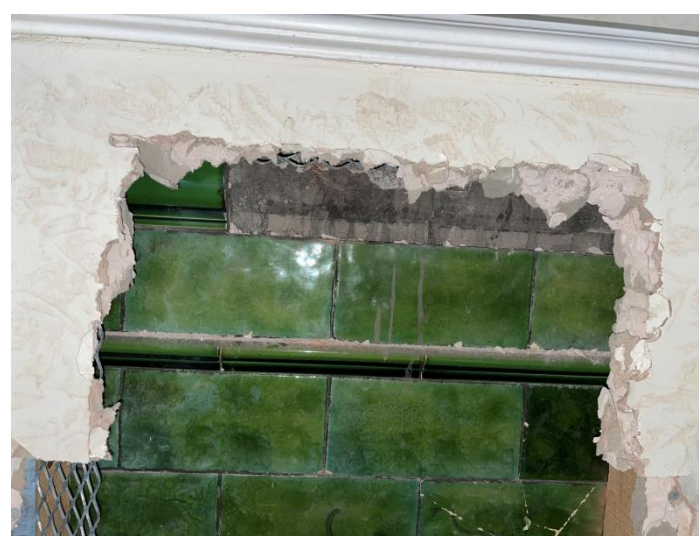
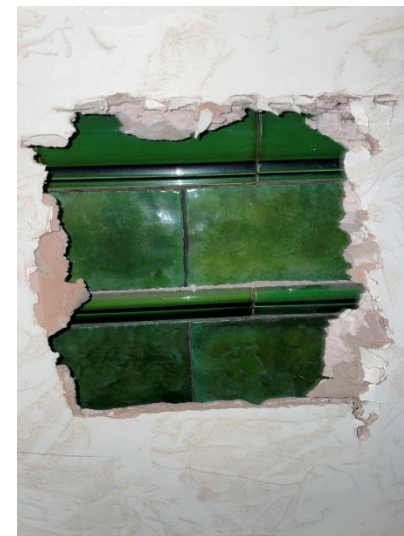
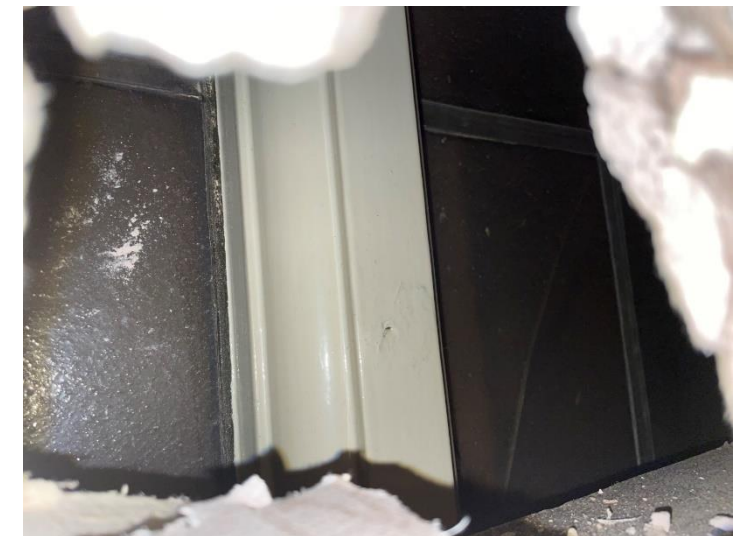
Fig. 16: typical investigative holes at 3<sup>rd</sup> floor level showing similar tiling below dado level and internal windows above dado level

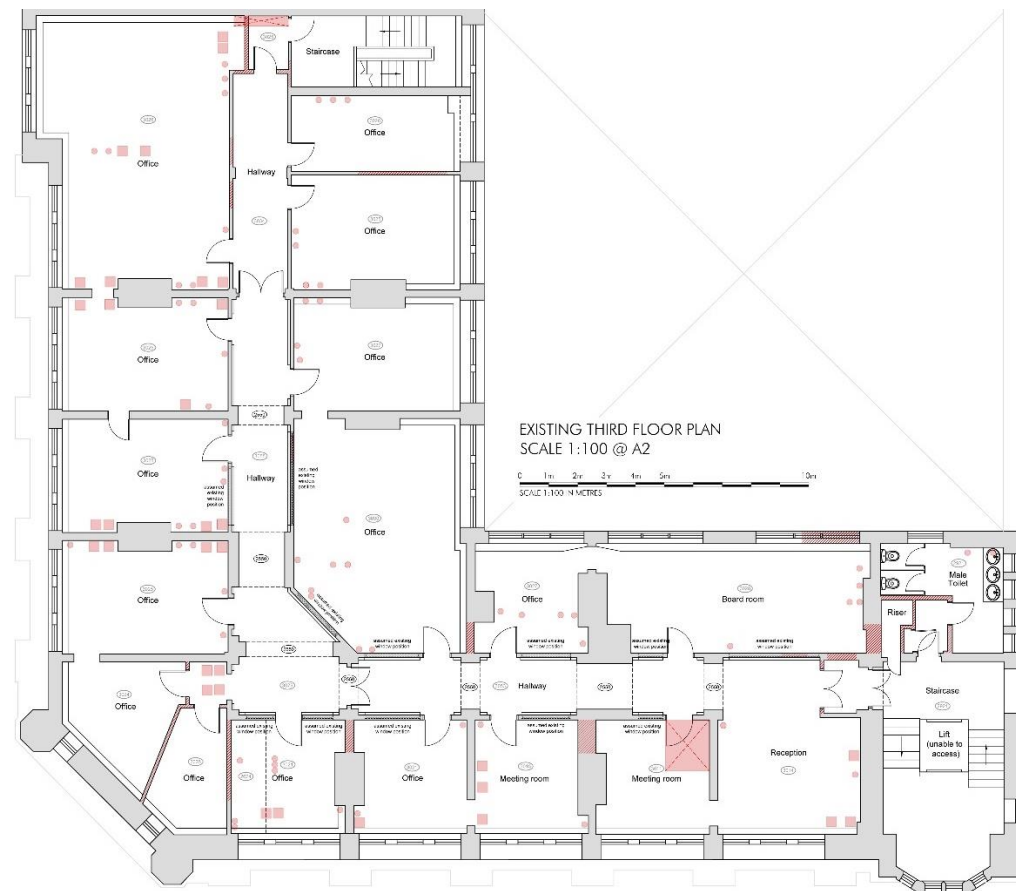
Fig. 17: Existing third floor plan (showing alterations)

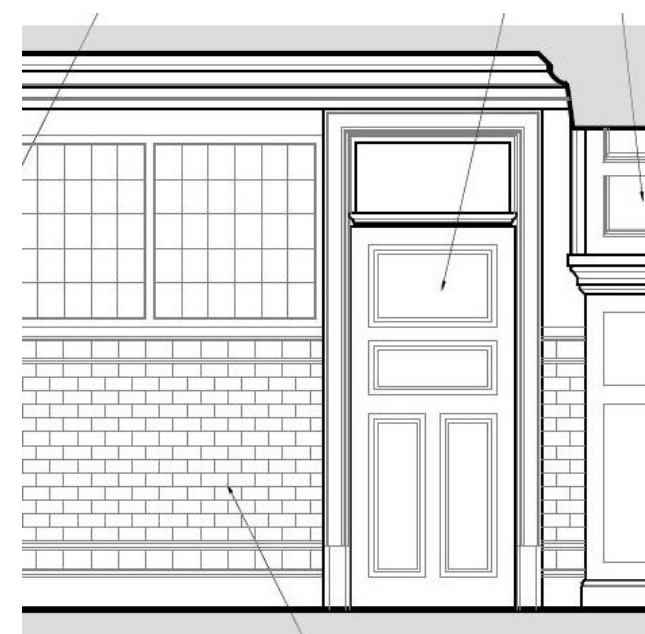
Fig. 24: Section showing servicing strategy.  
Inset below: Browns ground floor decorative high ceilings.  
Inset above: typical restored corridor appearance.

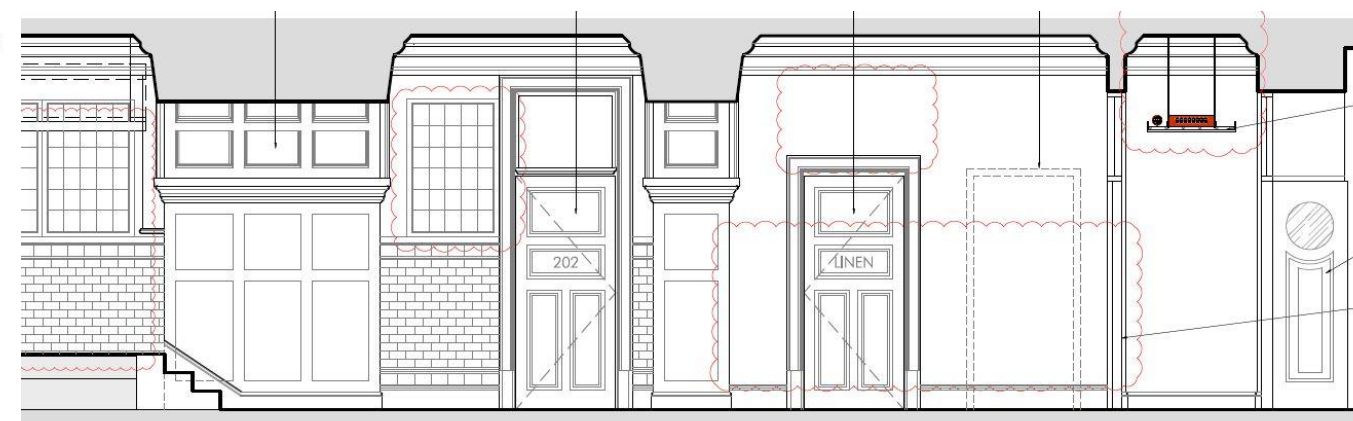
Fig. 25: Extract from drawing AP.35 showing the restoration of a section of corridor immediately off reception at second floor level

Since the submission of the pre-app, we have carried out further work to establish if we can minimise the extent of encapsulation at second floor level. The M&E design has been interrogated and we have managed to divert corridor services locally through bedrooms in order to expose the corridor wall finishes and first two decorative archways immediately off the reception at second floor – this is the area where a raised drainage floor is not necessary as there are first floor rooms below. This has maximised the potential for restoration in the more publicly accessible corridor areas.

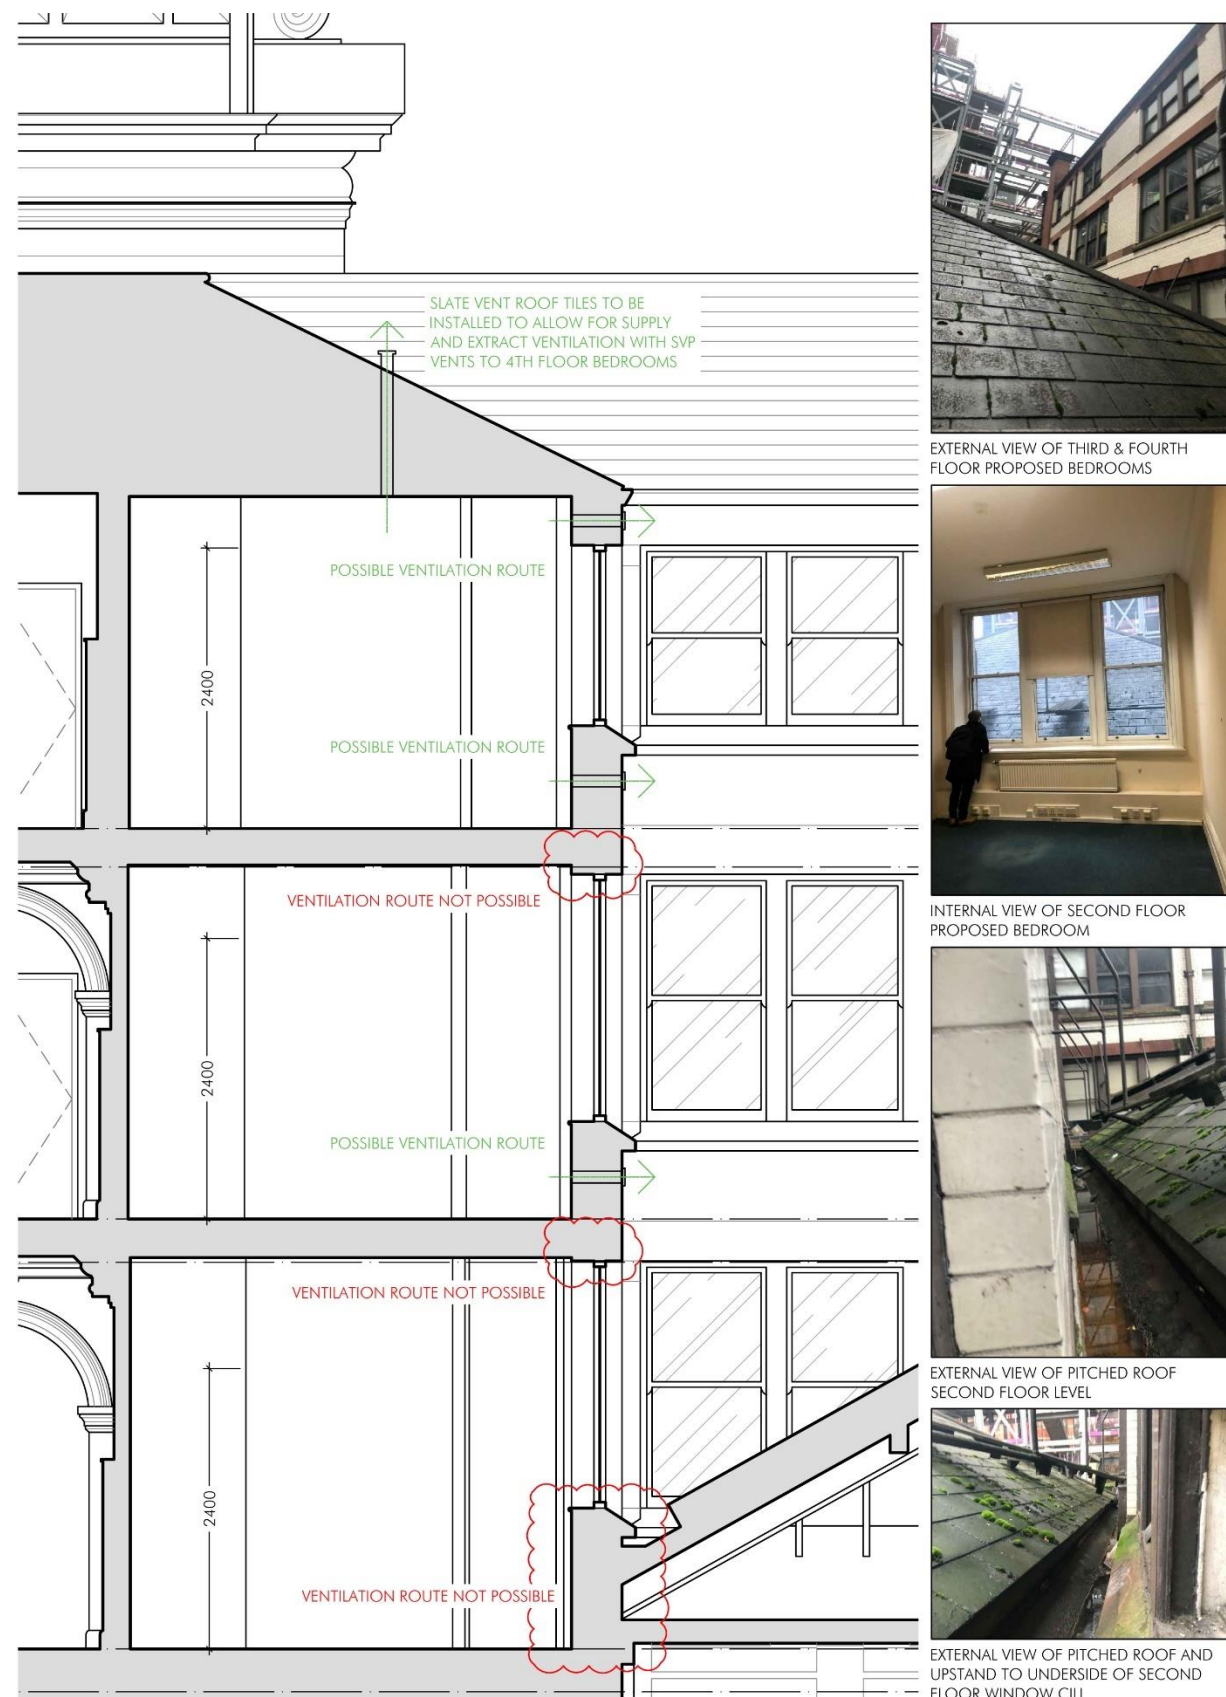
Fig. 26: Marked-up sectional drawing illustrating the difficulty in taking ventilation pipework through the masonry building fabric

We have investigated the Conservation Officer's requests to either provide central extraction or to take the vents through brickwork walls. As can be seen from the marked-up drawing and photographs opposite, we have investigated this and at second and third floor level there is not sufficient areas of masonry to cut out holes for ventilation pipework. Nor is central extraction possible due to the restricted roof void space – this is already filled with central extraction ductwork (and is also the reason why water pipework needs to run in the corridor ceiling void, due to lack of space). These lower two levels of window, however, will be entirely obscured at street level by the courtyard roof and they will not be required to the top floor windows where input and extract air for all top floor bedrooms can run to the rear roof slope.

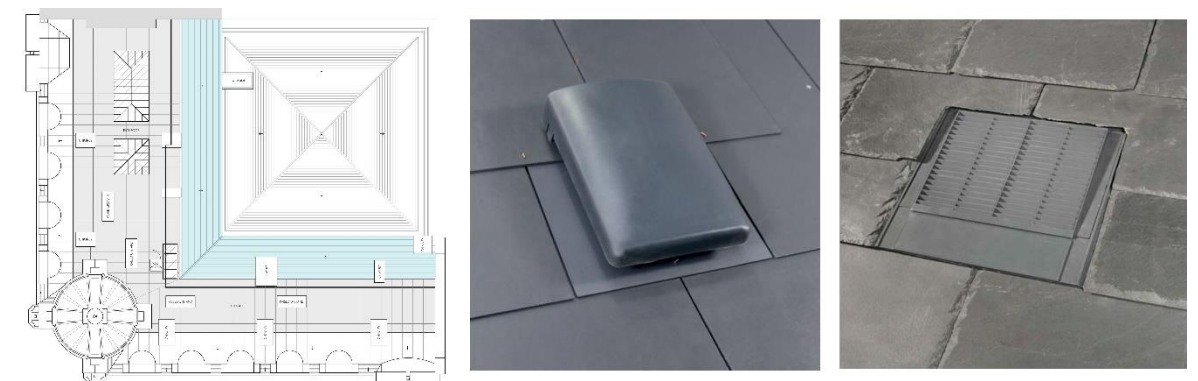
Fig. 27: Typical roof vent types

The top floor windows will remain untouched as we can use the roof void above to route ventilation, terminating in mushroom 'slate vents' on the rear roof slope. We also propose to take venting soil pipes to this unobserved rear roof slope, terminating in a more discreet 'slate vent' (both types are illustrated below).

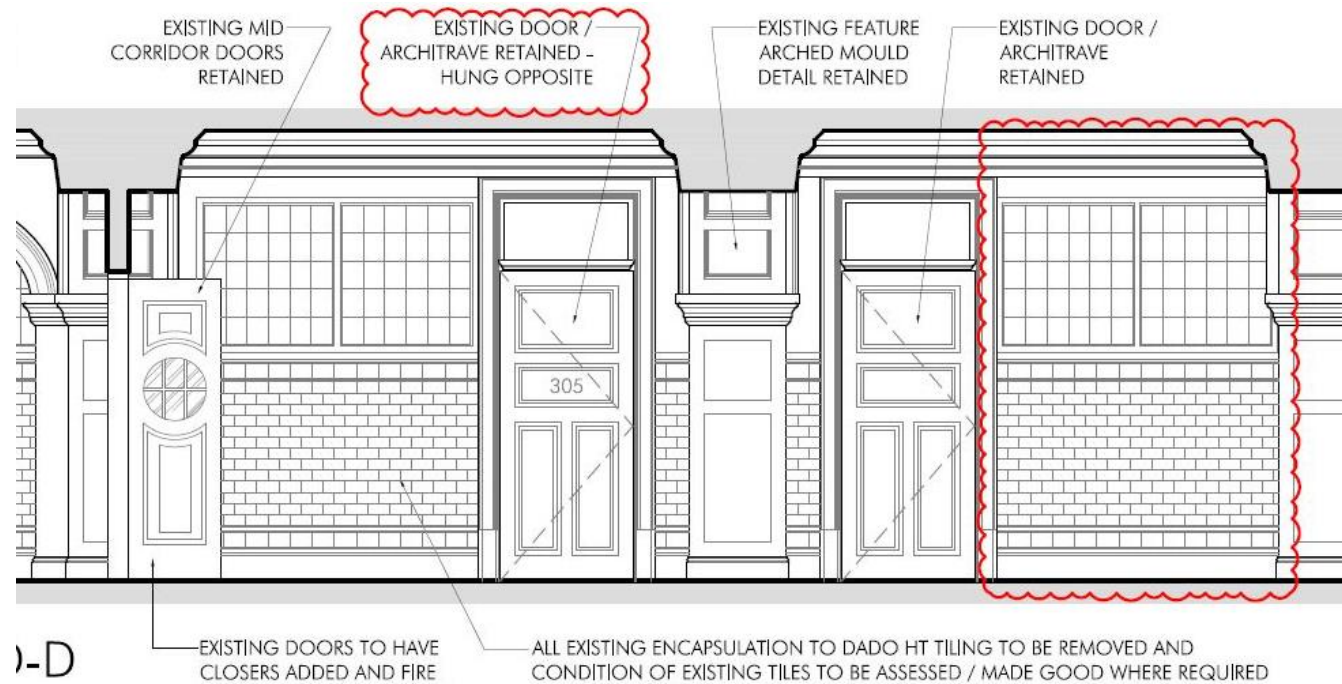
Fig. 26: Drawing illustrating the likely final appearance of a restored section of third floor corridor.

The existing wall tiling to second, third and fourth floor corridors can be fully restored and left on show in the final scheme. The tiles date from 1902 and it is unlikely to be economically feasible to manufacture replacement tiles to match these exactly, particularly where skirting and dado moulded tiles are missing. The tiling to fourth floor is missing approximately 10% of tiles (a mix of moulded and standard wall tiles), and it is likely that a similar proportion may be missing at third and second floor levels. Therefore, replacement tiles will be provided to either contrast or match as closely as possible to the existing glazed tiles. Where vertical battens have been drilled/screwed through tiles leaving a hole, in-situ localised repairs to the tile finish by a specialist contractor is proposed.
