## **Re: Dean Trust Academy, Ardwick – Proposed Fitness Suite**

This letter report has been produced to satisfy the 'site investigation report' element of condition 4a and looks to reassess existing information relevant to the new application.

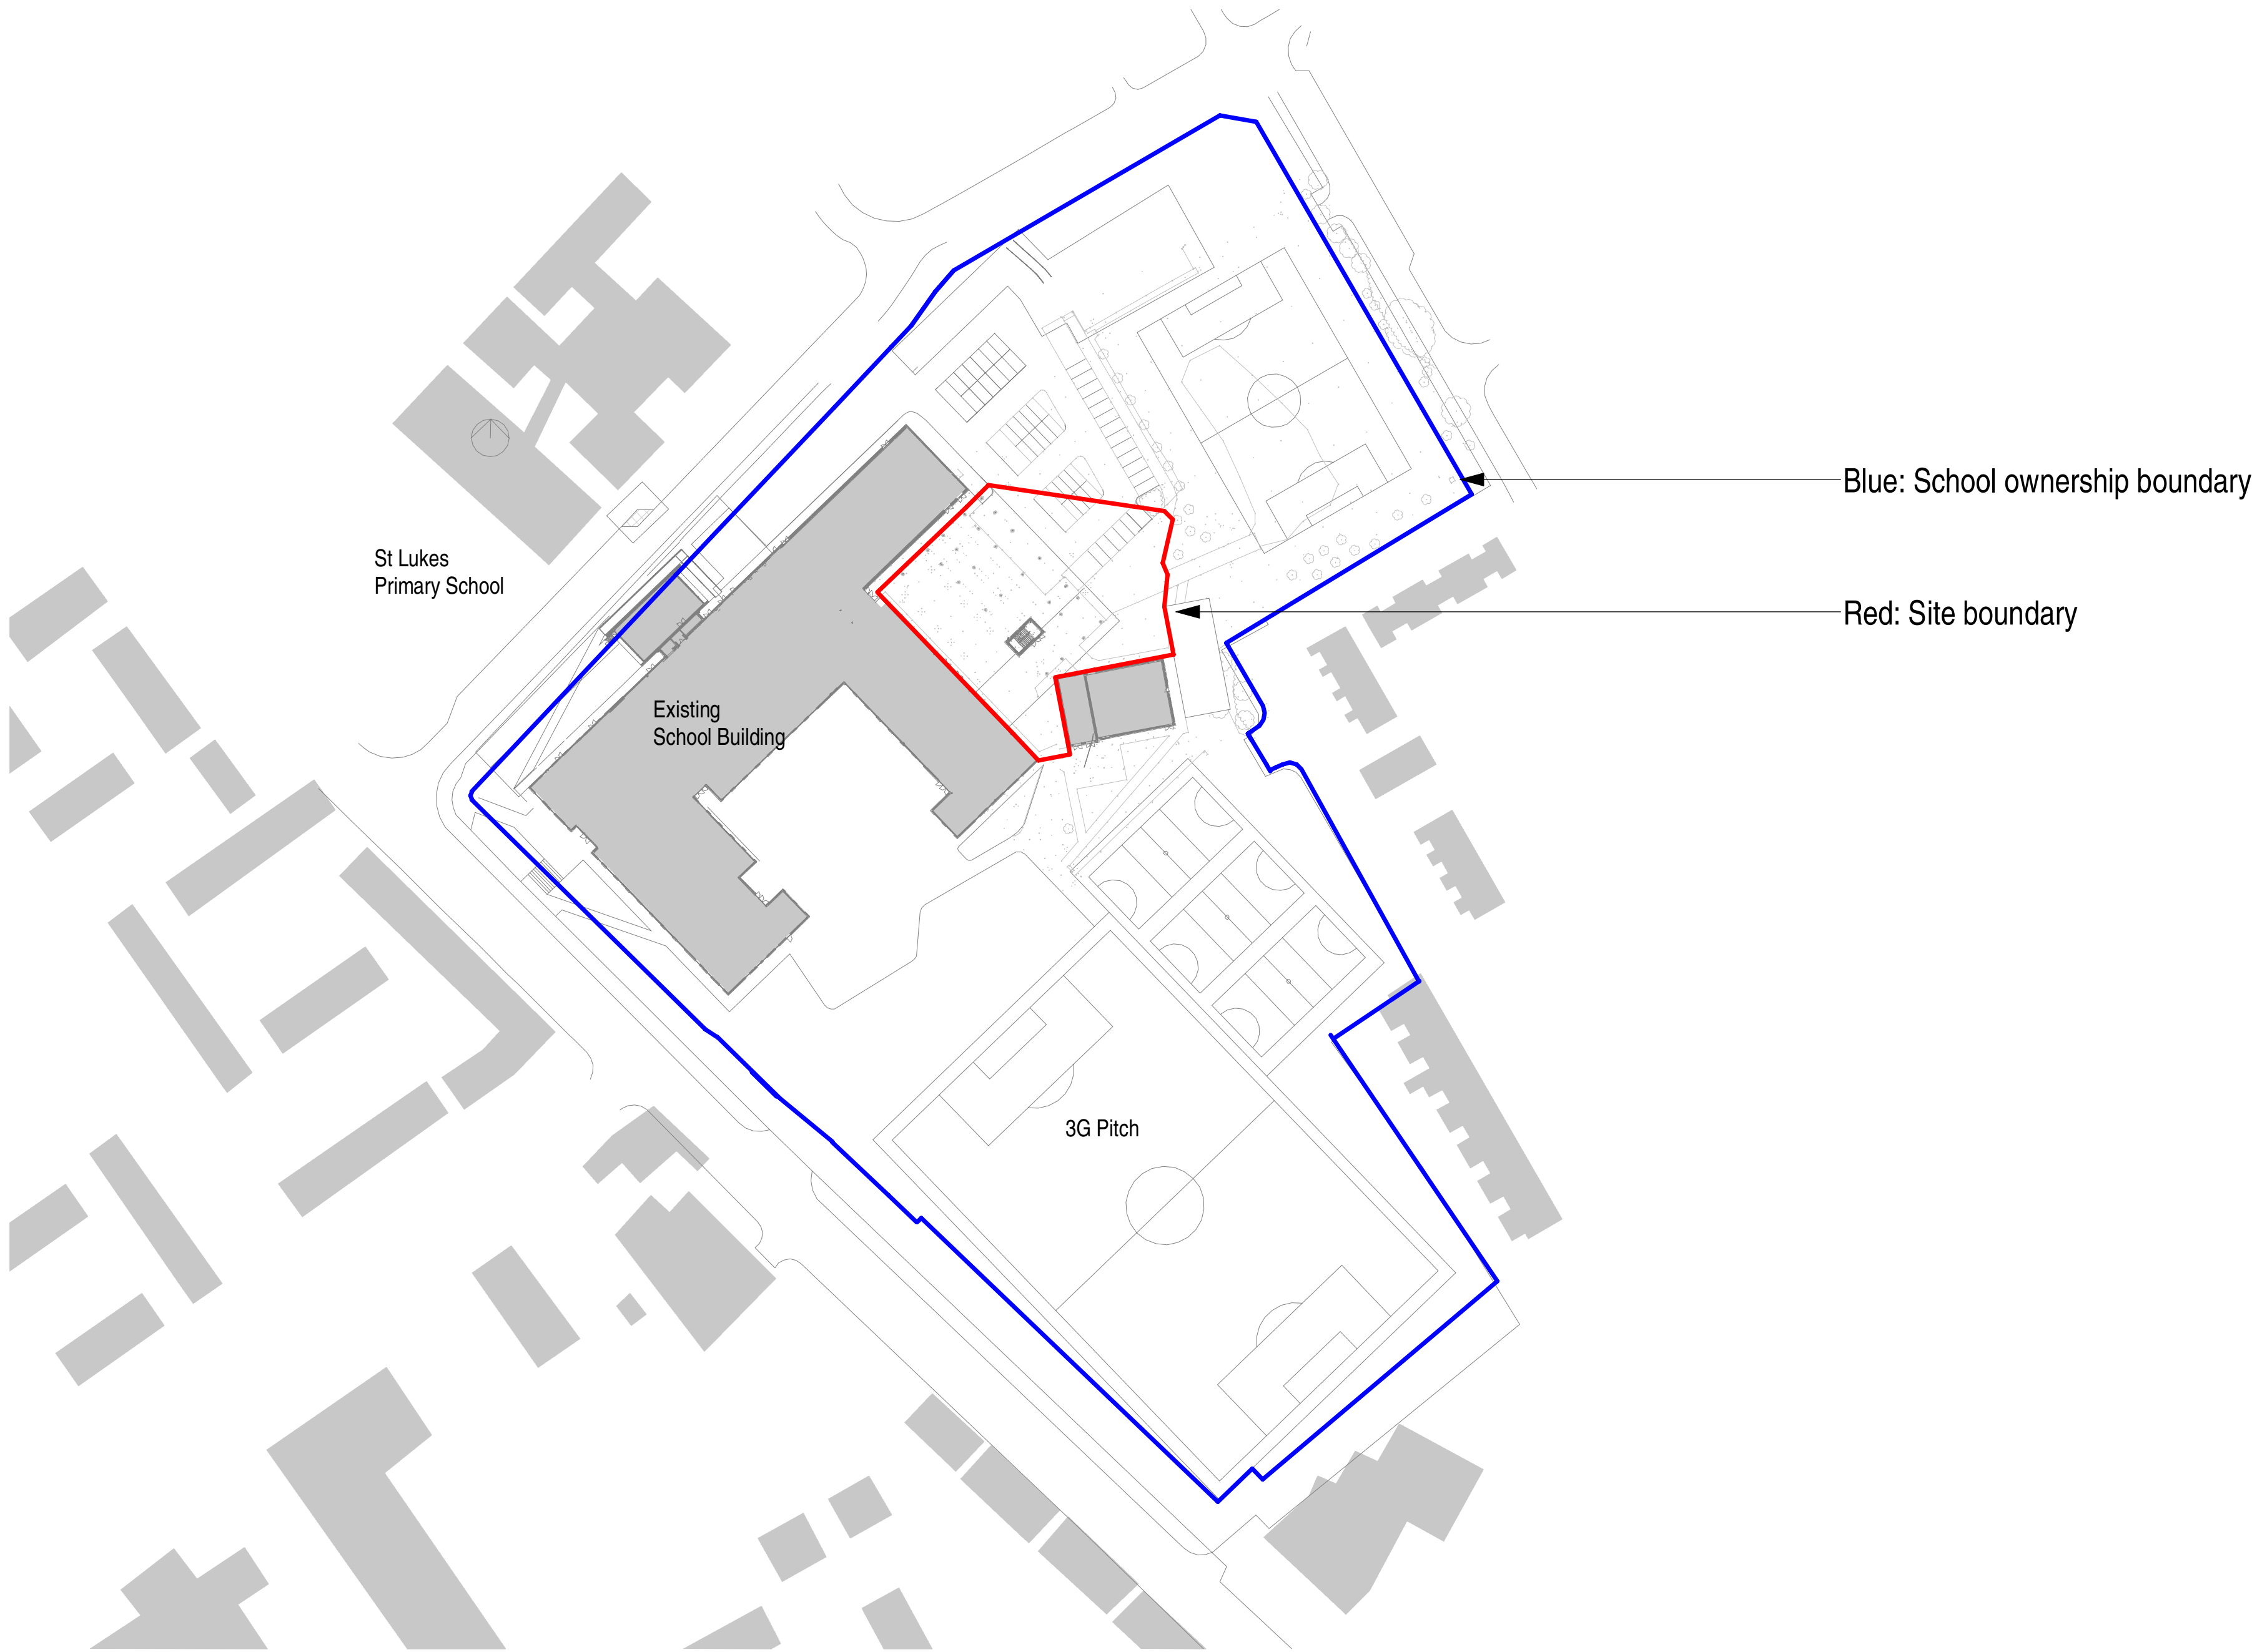
Location Plan

| P02 | Red line boundary | 12.07.23 | SD | PH |

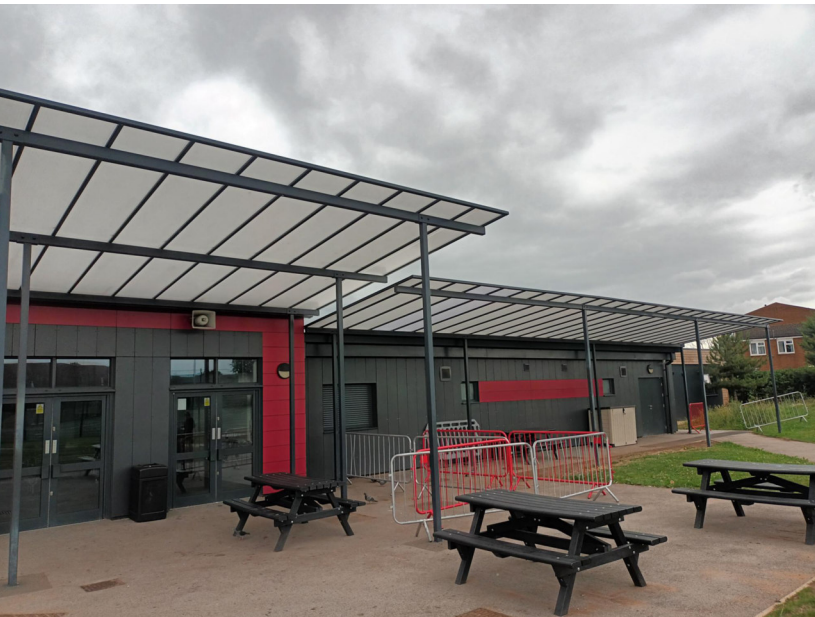
Image 1: Lean-to shelter supported off the building, as with existing canopies

Proposed 5 covered relocated cycle parking bays which total 40 bikes.Image 1 shelter (Lean-to)NBS B91/331

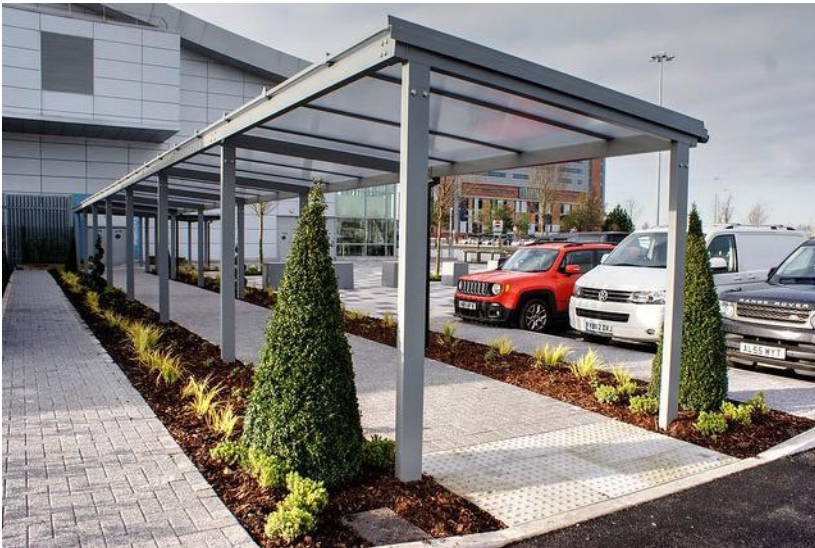
Image 2: Covered cycle parking structure adjacent to the car parking

- Allow for burning off existing road marking and applying new Q25/115
- Fencing line to be removed
- Proposed 5 covered cycle parking bays relocated which total 40 bikes. Image 2 shelter. NBS B91/332
