Drawing Status: PLANNING

CLIENT  
Centurion Student Services (UK) Ltd trading as Dwell Student Living

PROJECT  
MSV Central Block B, Dwell Student Living  
Lower Chatham St, Manchester M1 5SX

DRAWING  
Proposed Internal Wall Elevations & Drylining Details

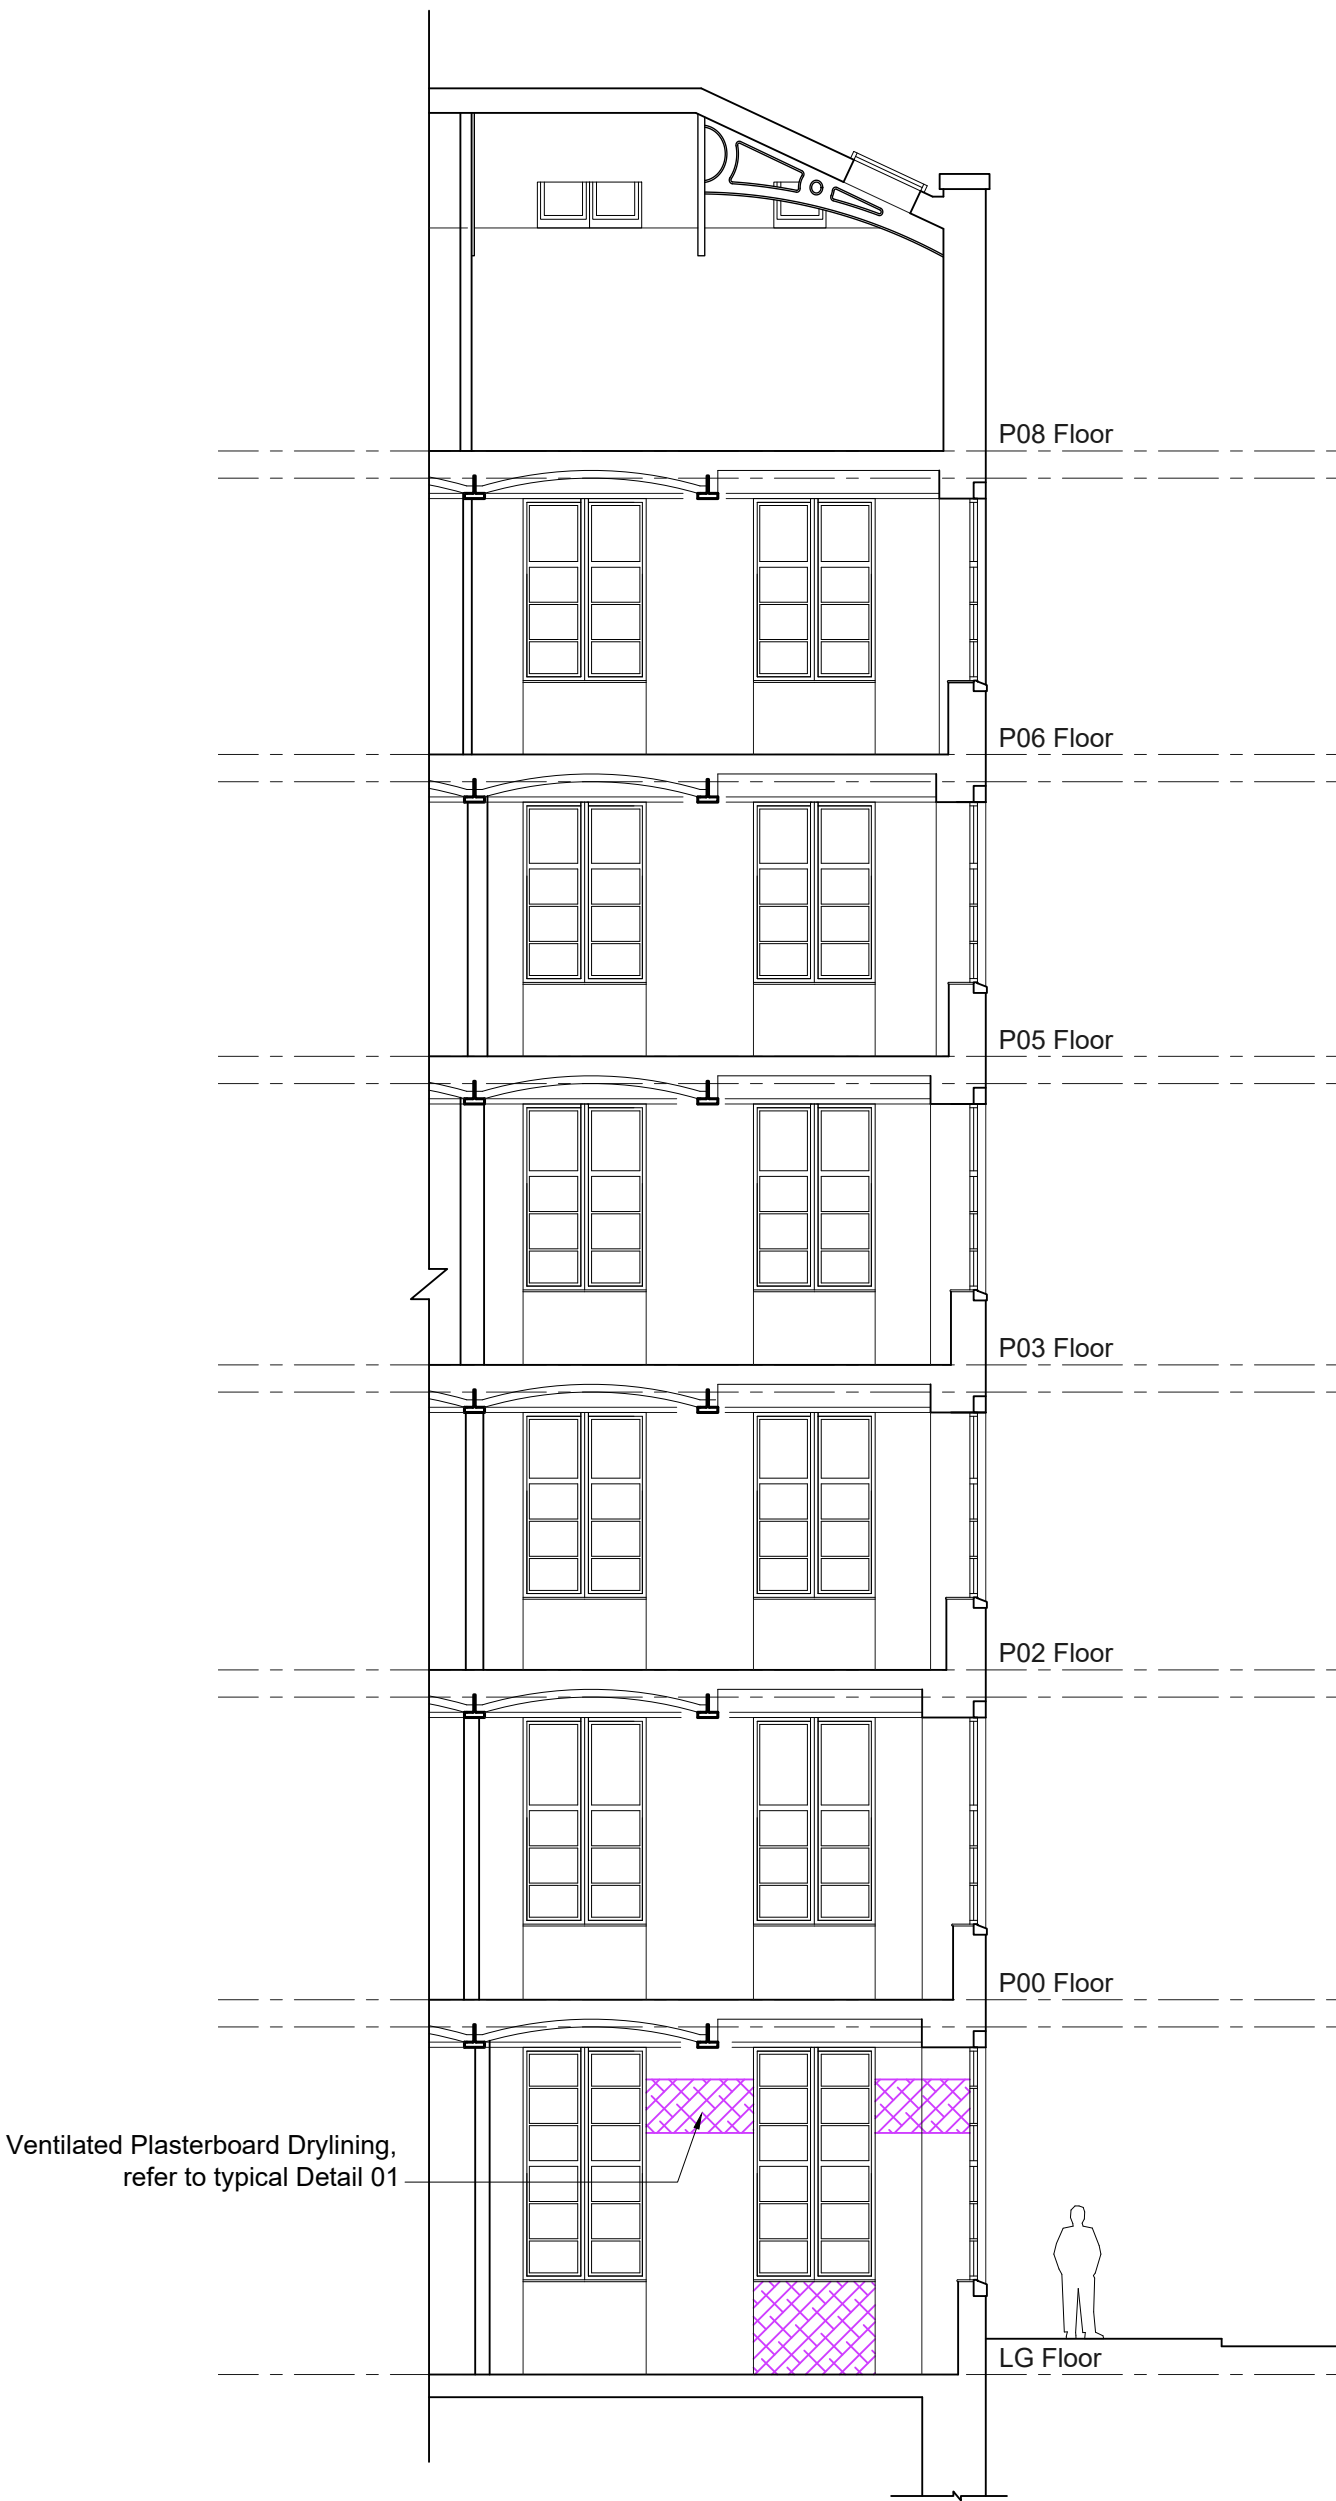
Internal elevation B  
Scale 1:100

50x50mm treated timber batten fixed to wall or equivalent approved metal profile to specialist drylining contractor details

The crosshatch on the drawing represents indicatively the original brickwork wall, which has suffered significant damage and now appears unsightly. In the past, this brickwork was repaired using blockwork as a historical remedy

Original brickwork wall

50mm gap to ensure airflow so that the brick walls retain its breathability, preserving its original design and construction intent. Additionally ventilation will prevent long-term deterioration of the bricks caused by moisture ingress.

12.5mm plasterboard with white metal angle to edge + skimming & painting

Airflow through 50mm gap

Lower Ground Floor, there are concerns as here the brickwork is really damaged, it looks unsightly. This hatch on the drawing indicates the locations where new ventilated plasterboard drylining will be applied to cover the historical blockwork repairs on the original wall. The introduction of ventilation is essential to meet the requirements of Planning Condition 4. This measure ensures that the brick walls retain their breathability, preserving their original design and construction intent. Additionally, proper ventilation will prevent long-term deterioration of the bricks caused by moisture ingress.

Note: All other areas of internal elevations A and B of external walls to be sandblasted, cleaned and made good as necessary in order to expose the original brickwork fabric of the Listed Building. Concrete repairs of brickwork to both walls and ceilings are not acceptable by Planning Conservation Department. Damage to brickwork should be repaired in suitable materials - i.e. NHL 2 mortar, lime-based plaster and brickwork to match existing.

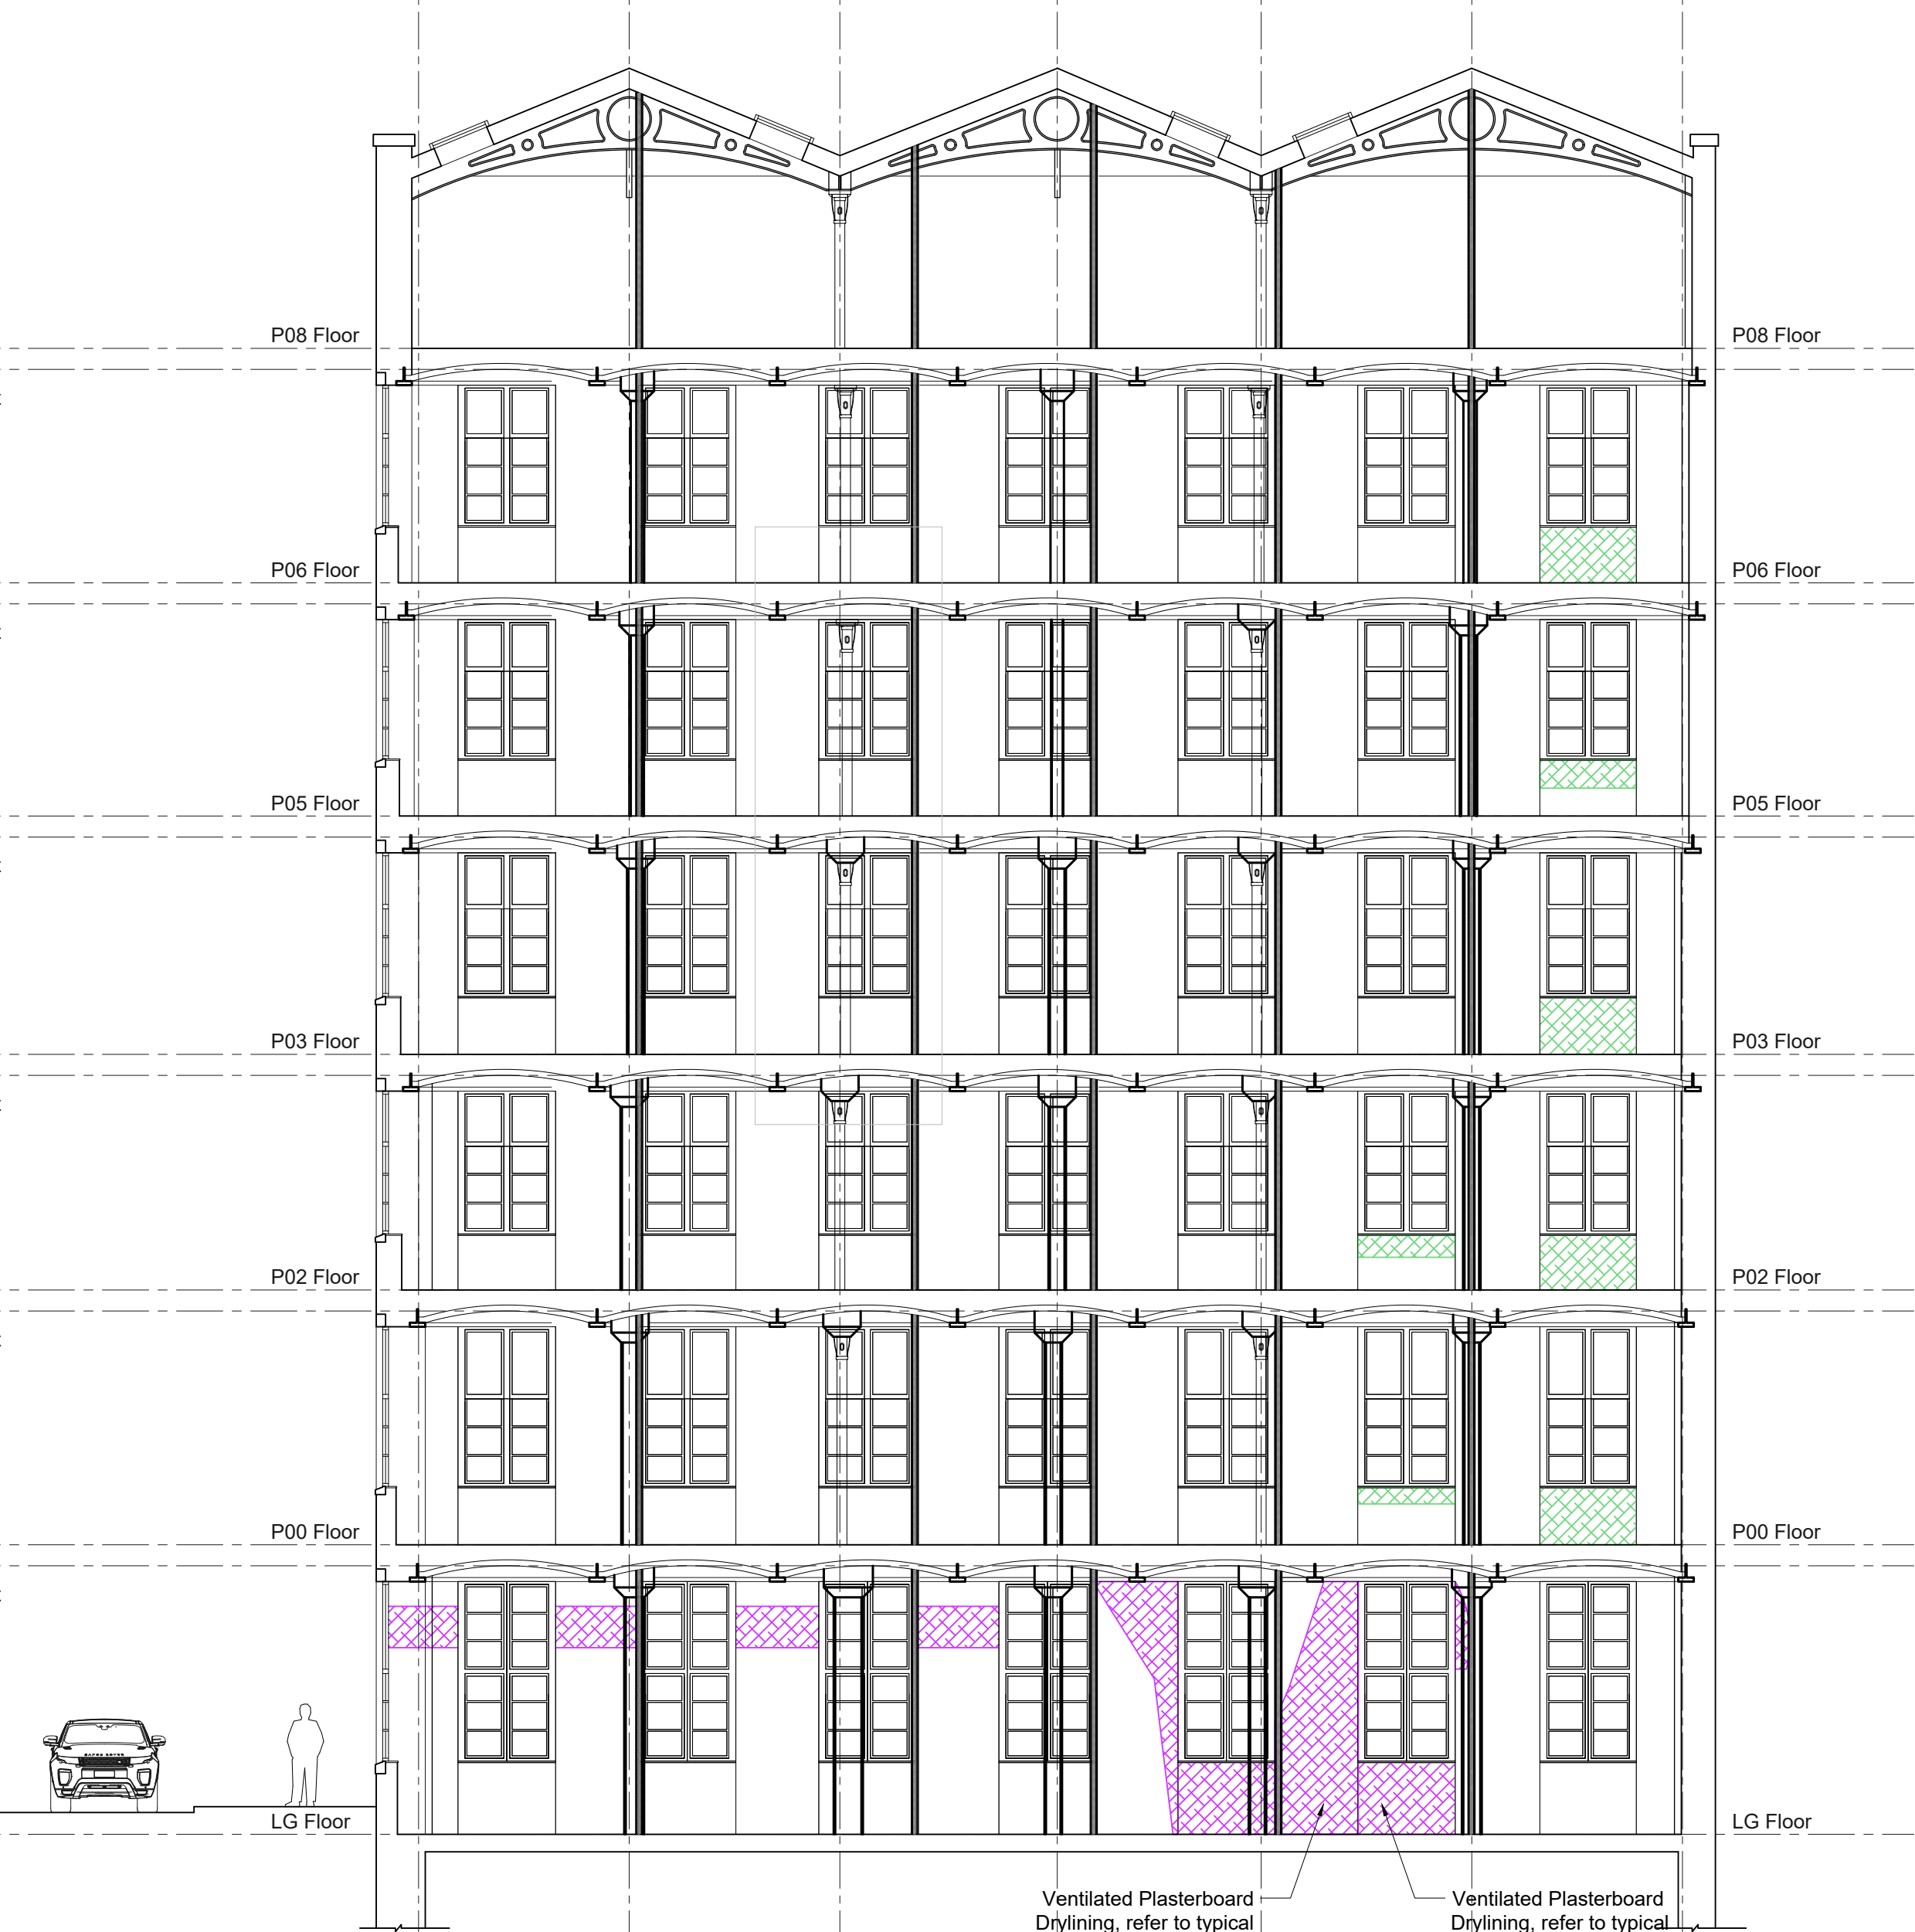
Internal elevation A  
Scale 1:100

Airflow through 50mm gap

50mm gap to ensure airflow so that the brick walls retain its breathability, preserving its original design and construction intent. Additionally ventilation will prevent long-term deterioration of the bricks caused by moisture ingress.

The crosshatch on the drawing represents indicatively the original brickwork wall, which has suffered significant damage and now appears unsightly. In the past, this brickwork was repaired using blockwork as a historical remedy

Floors above Lower Ground Floor. This hatch on the drawing indicates the locations where new white permeable paint will be applied to the historical blockwork repairs on the original wall. This measure ensures that the walls retain their breathability, preserving their original design and construction intent.
