# 1073 LIVERPOOL ROAD, MANCHESTER DESIGN AND ACCESS REPORT

TO PLANNING PERMISSION 117897/FO/2017

TIM GROOM ARCHITECTS

This report has been prepared by Tim Groom Architects to describe proposed non-material amendments to the Planning Application Number 117897/FO/2017 and support the Listed Building Consent Application for the revised scheme.

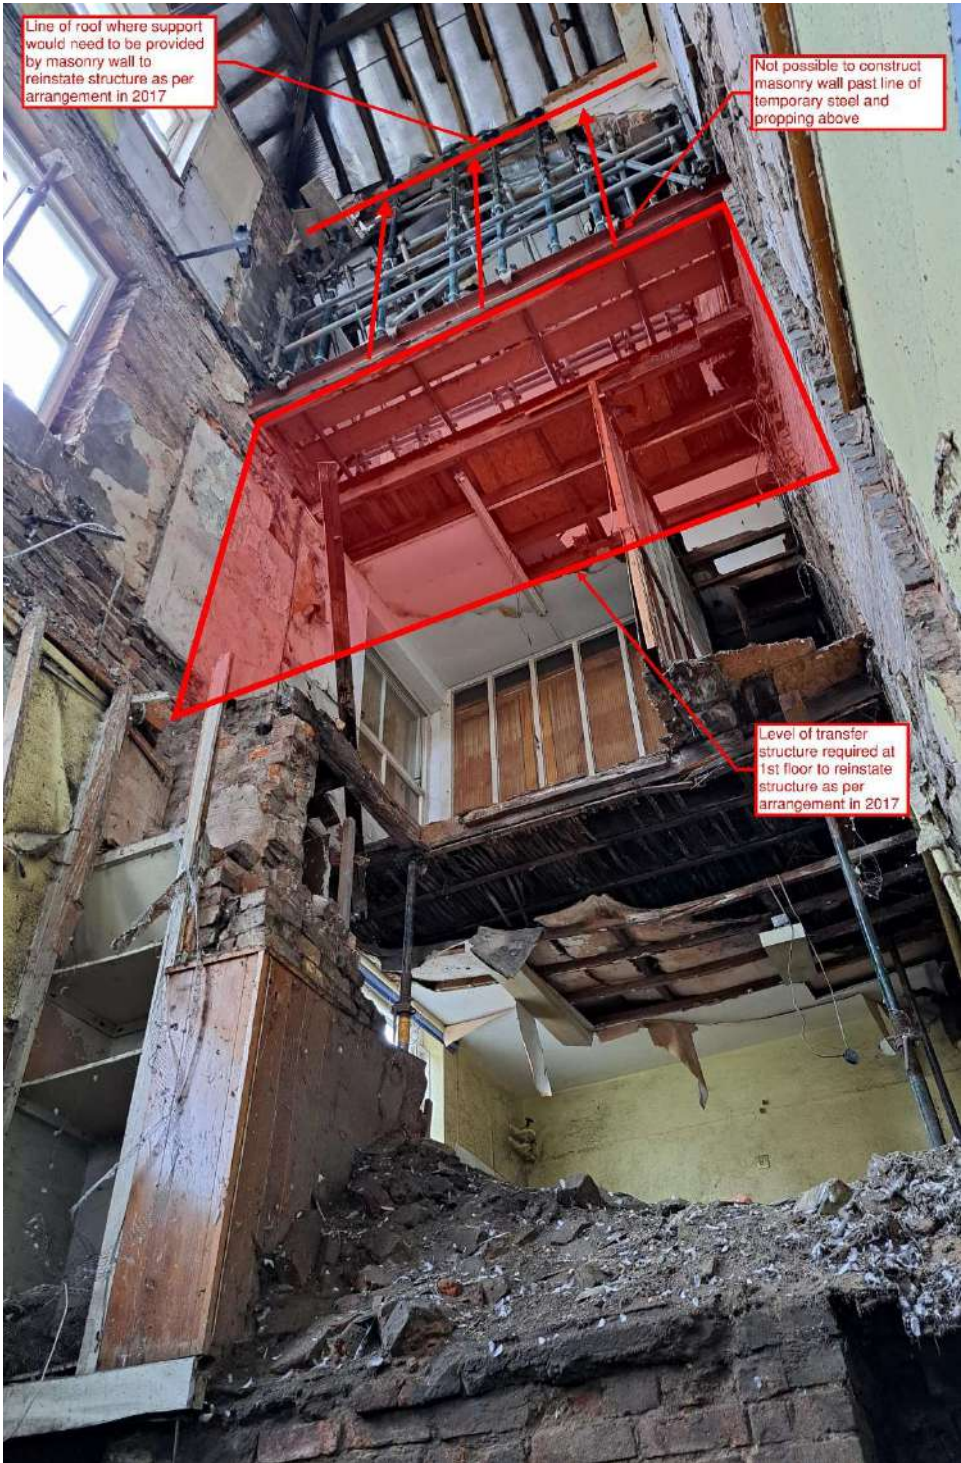
Renaissance collapse annotation

Renaissance have prepared a design and supporting statement for proposed emergency making safe works in response to the internal structural collapse that has occurred. These emergency making safe works were completed to ensure the building is safe for access to further survey the building.

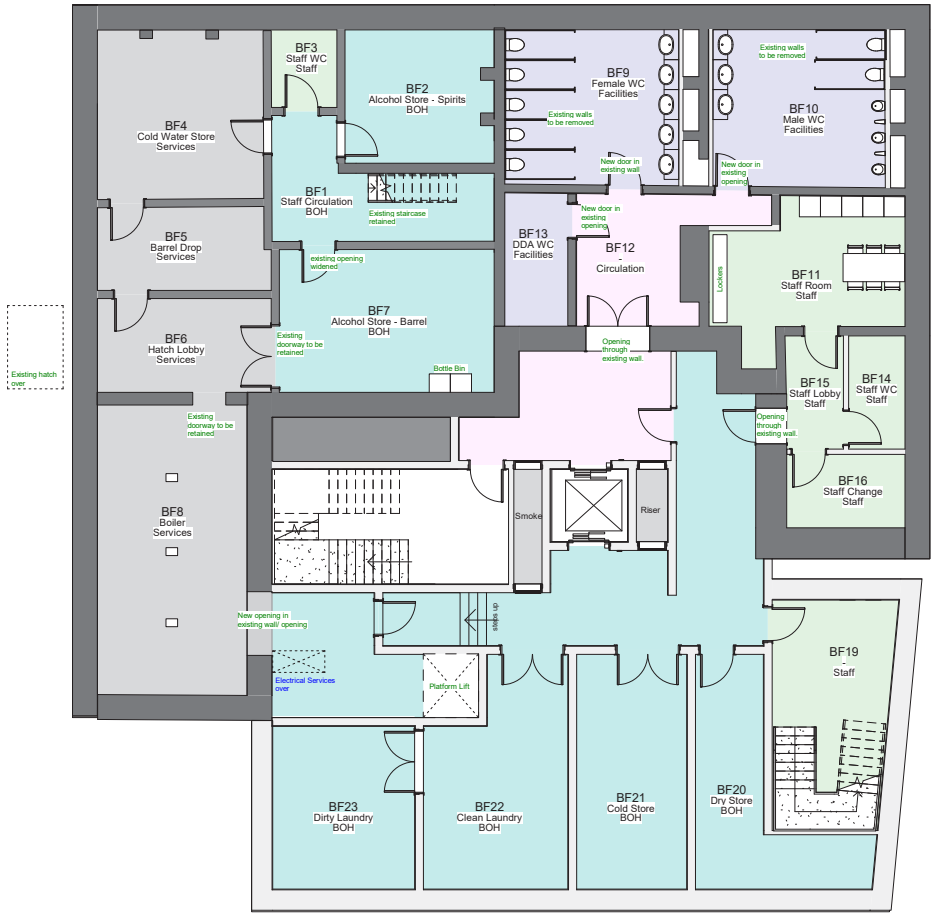
CONSENTED DRAWING

5.0 BASEMENT FLOOR PLAN

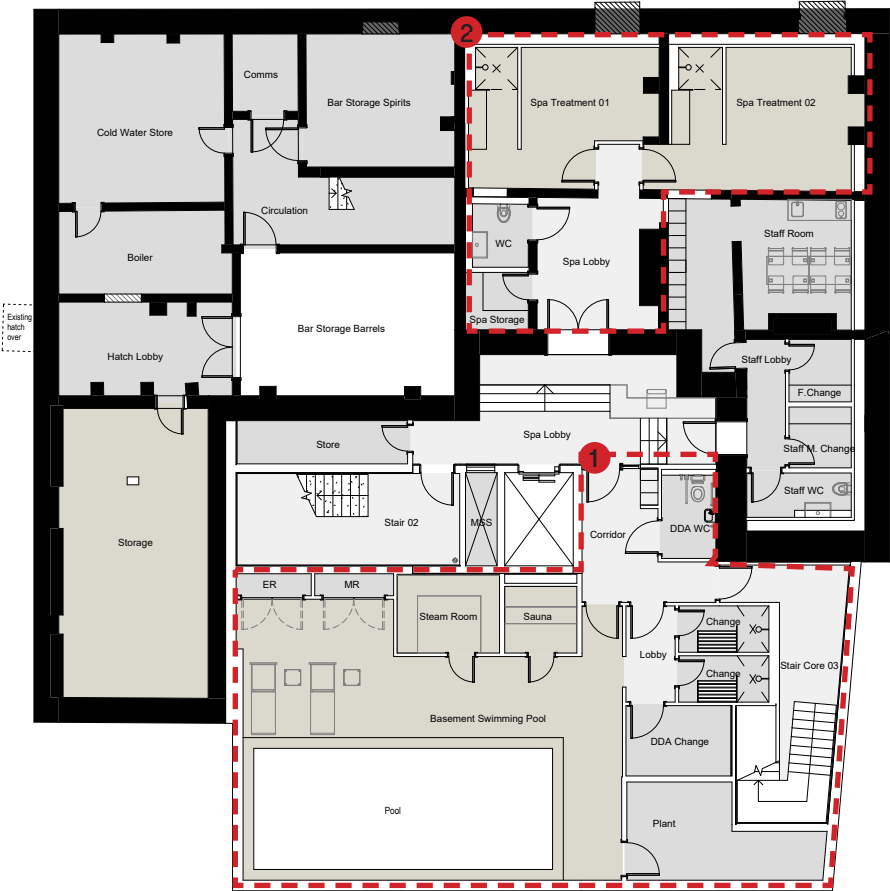
CURRENT PROPOSAL

- 1. Spa area and changing facilities introduced to new-build basement to achieve 5\* rated hotel amenities.
- 2. WC facilities and spa treatment rooms added to no.123 basement to achieve 5\* rated hotel amenities.

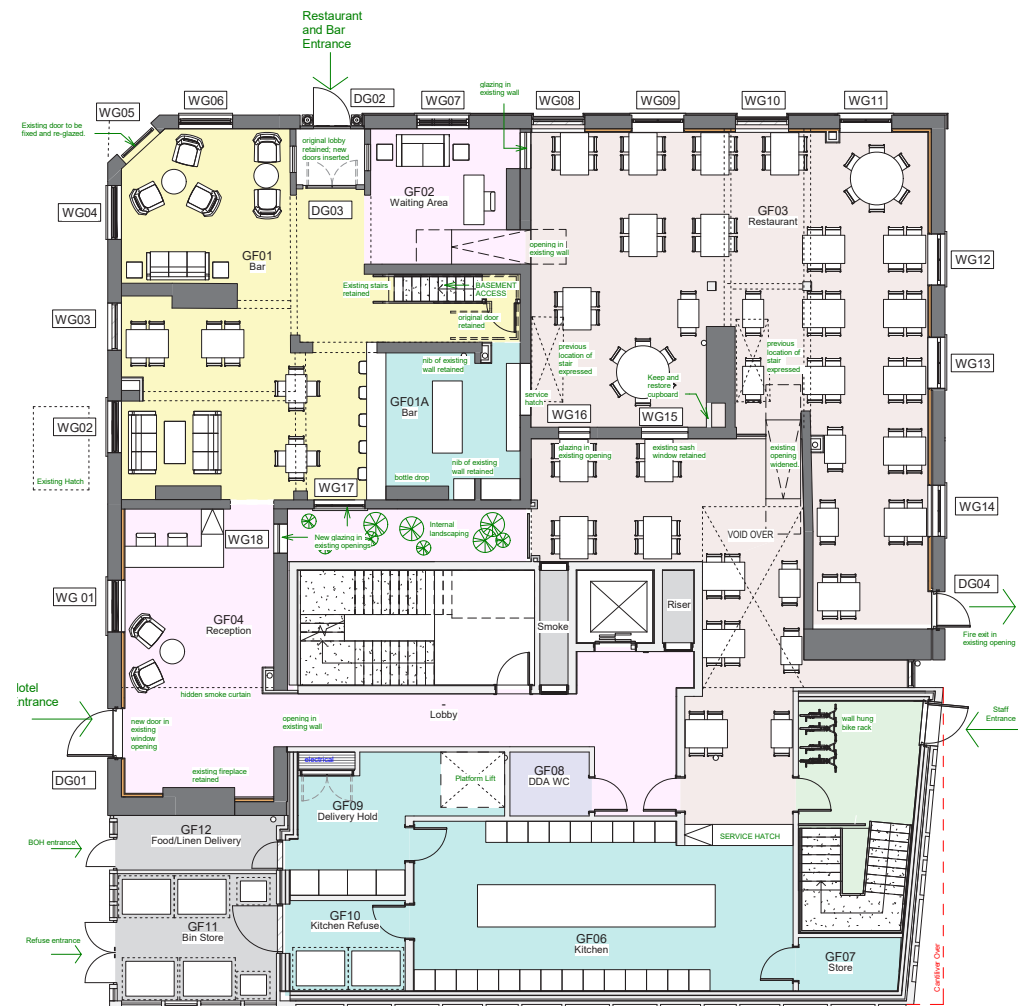
## CONSENTED DRAWING

## 5.1 GROUND FLOOR PLAN

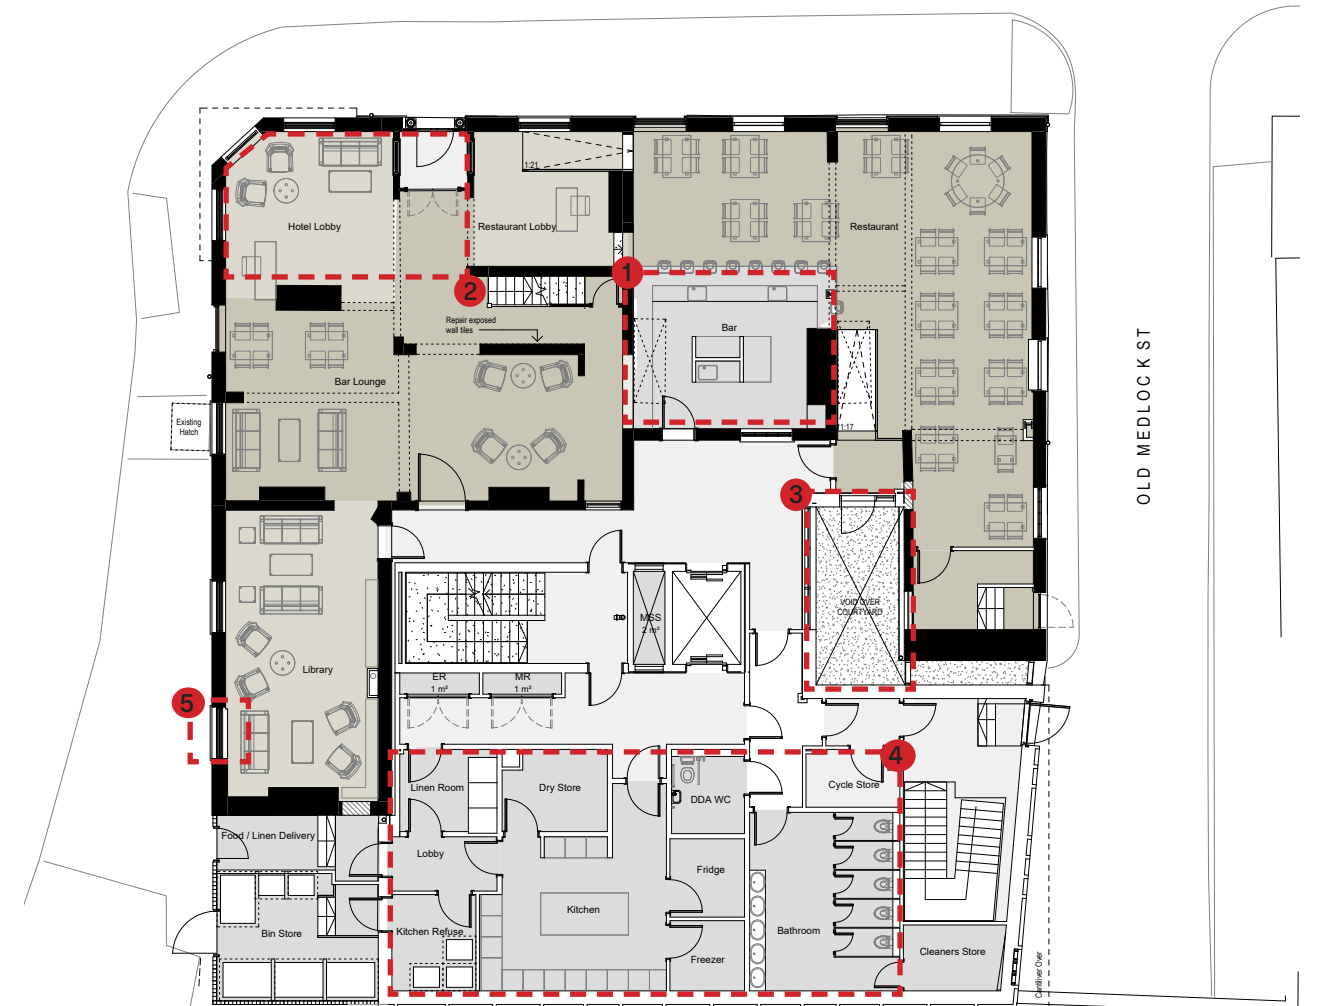
## CURRENT PROPOSAL

1. Placement and general arrangement of bar area amended to serve bar & restaurant and create larger bar seating area.
2. Hotel entrance location changed and waiting area amended to retain importance of original building entrance.
3. Inclusion of internal courtyard with access from the restaurant to bring light and a focal point into the centre of the plan.
4. General arrangement changes of kitchen, WC's and service spaces for improved circulation.
5. Proposed previous hotel entrance omitted and existing window retained.

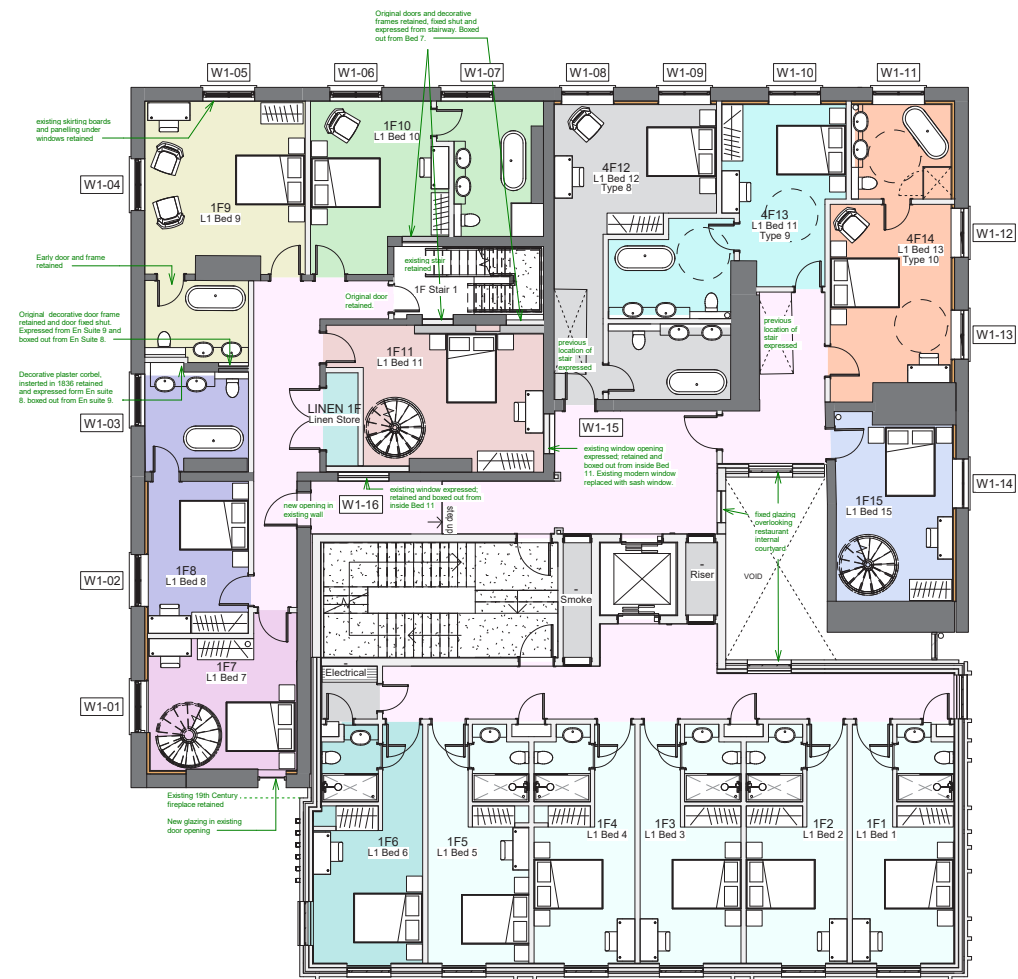
## CONSENTED DRAWING

## 5.2 FIRST FLOOR PLAN

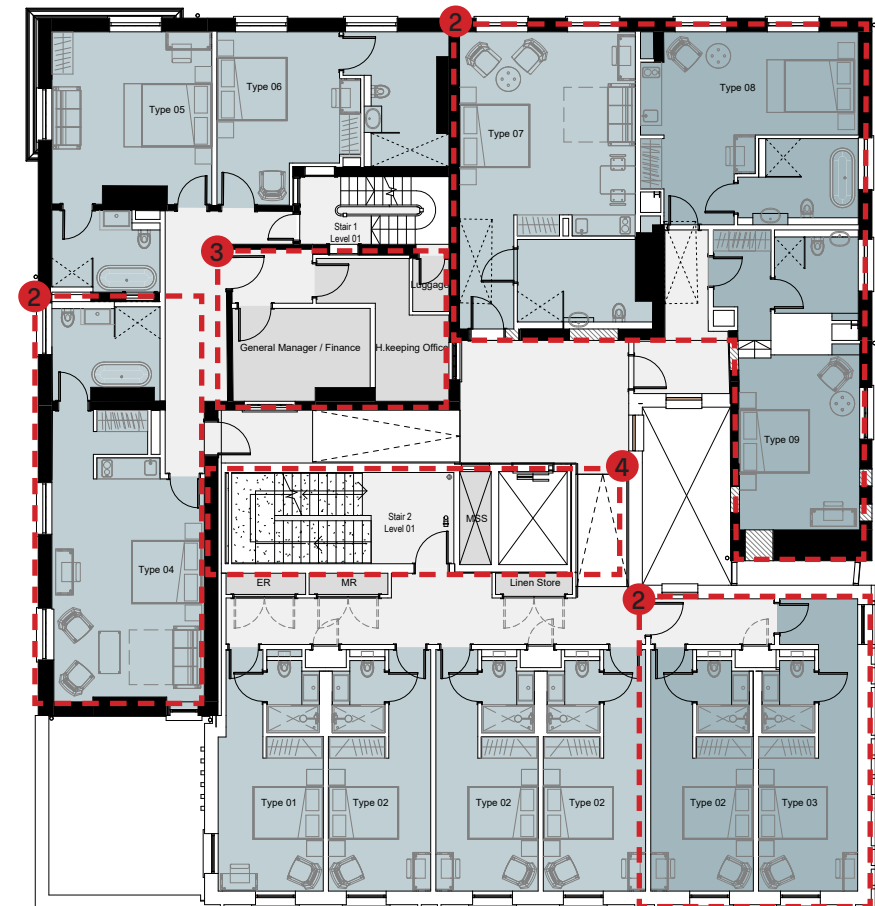
## CURRENT PROPOSAL

1. Removal of duplex hotel rooms for improved room layouts and a wider appeal through diverse room features such as kitchenettes, lounge areas, lock off rooms etc. This design also improves on the legibility of the historic plan form.
2. General amendments to room layouts of existing building resulting in larger room types that are more sympathetic to the buildings historic use.
3. Inclusion of staff BoH areas to provide additional offices.
4. Alterations to main circulation core for improved circulation.

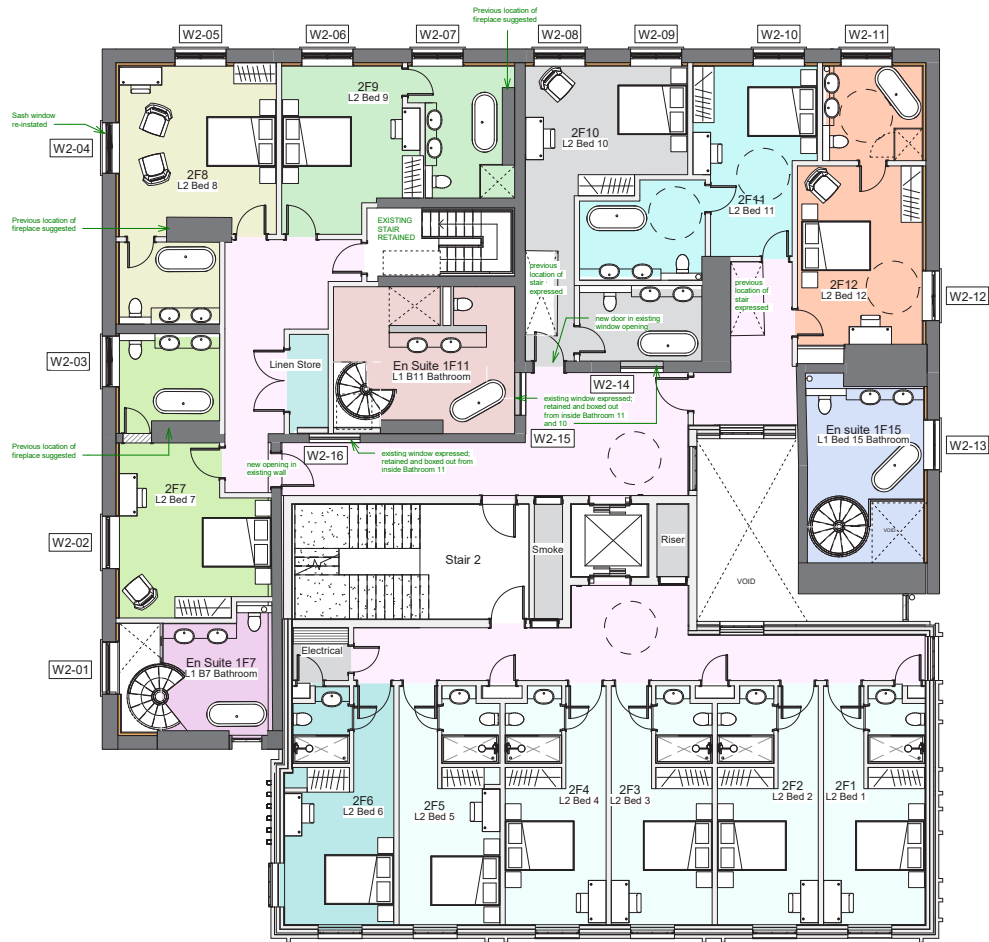
CONSENTED DRAWING

5.3 SECOND FLOOR PLAN

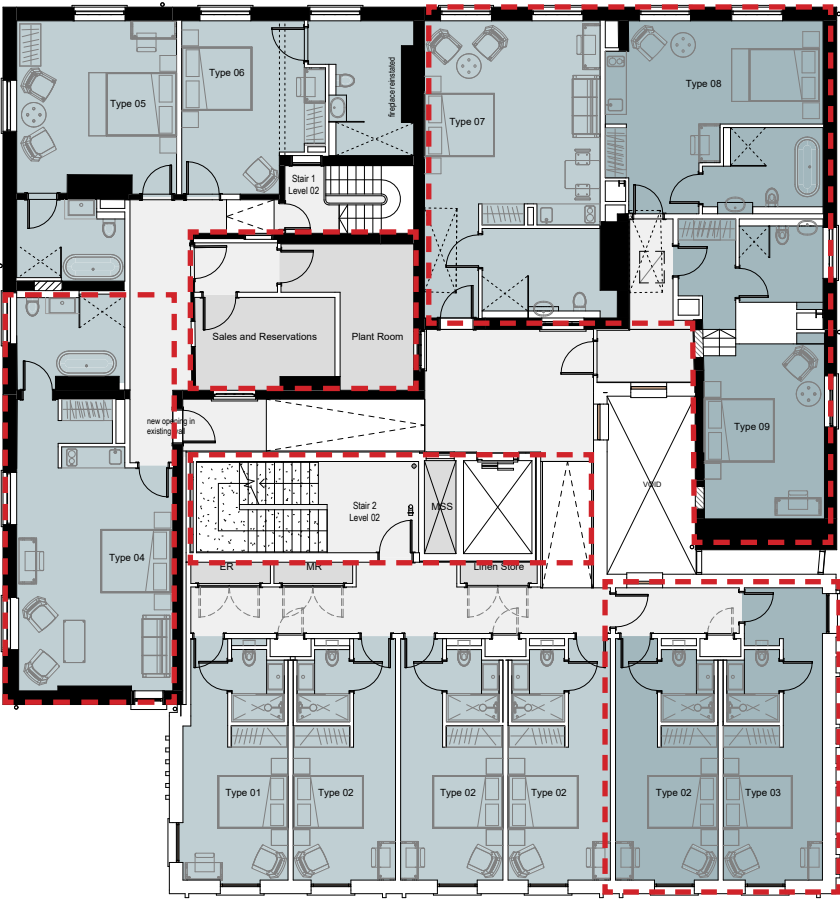
CURRENT PROPOSAL

As level one plan.

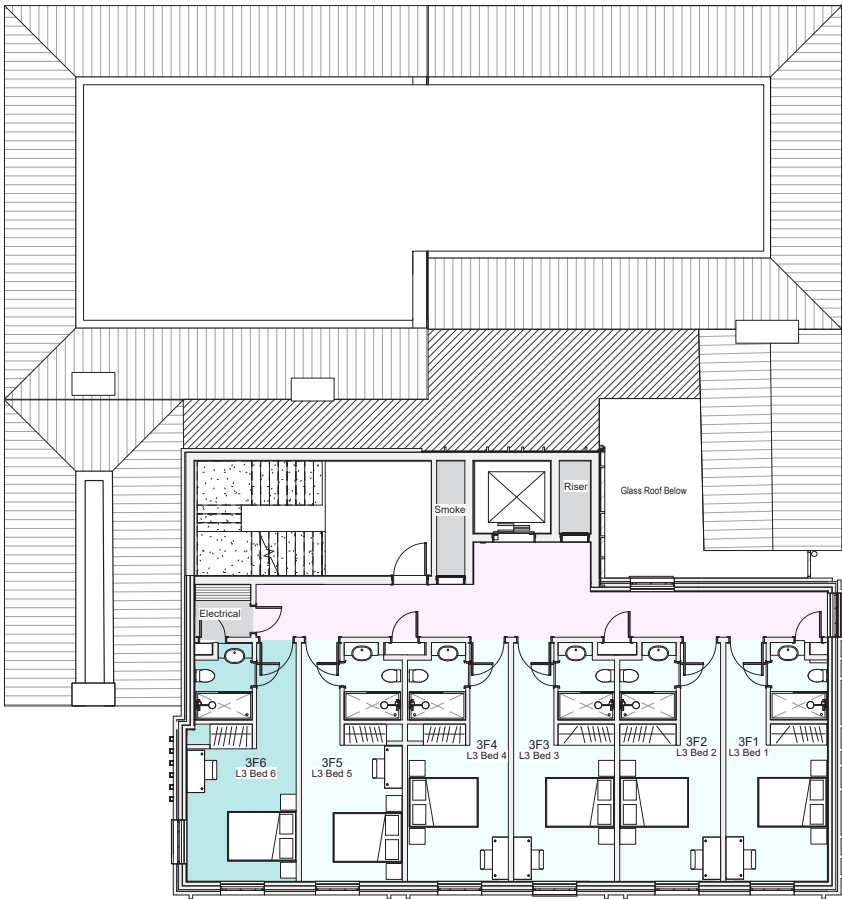
CONSENTED DRAWING

5.4 THIRD FLOOR PLAN

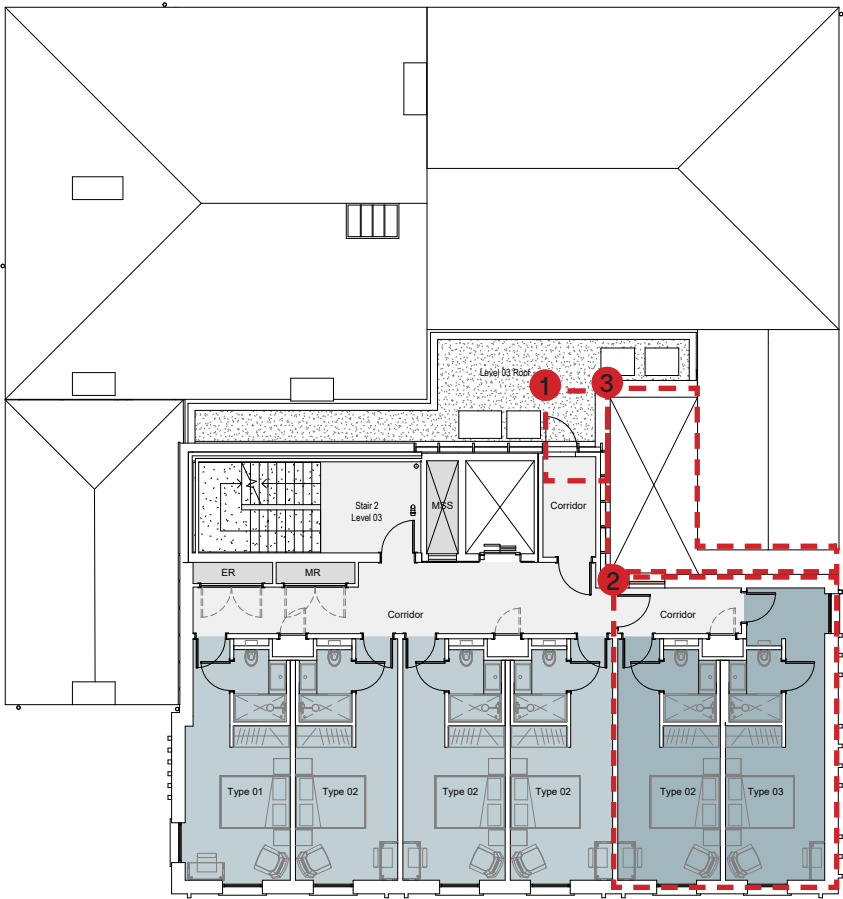
CURRENT PROPOSAL

- 1. Additional roof access provided for maintenance and discrete locating of plant.
- 2. Minor alterations to internal layout that include lock-off rooms to expand hotel offering.
- 3. Glass roof omitted to remove maintenance risk.

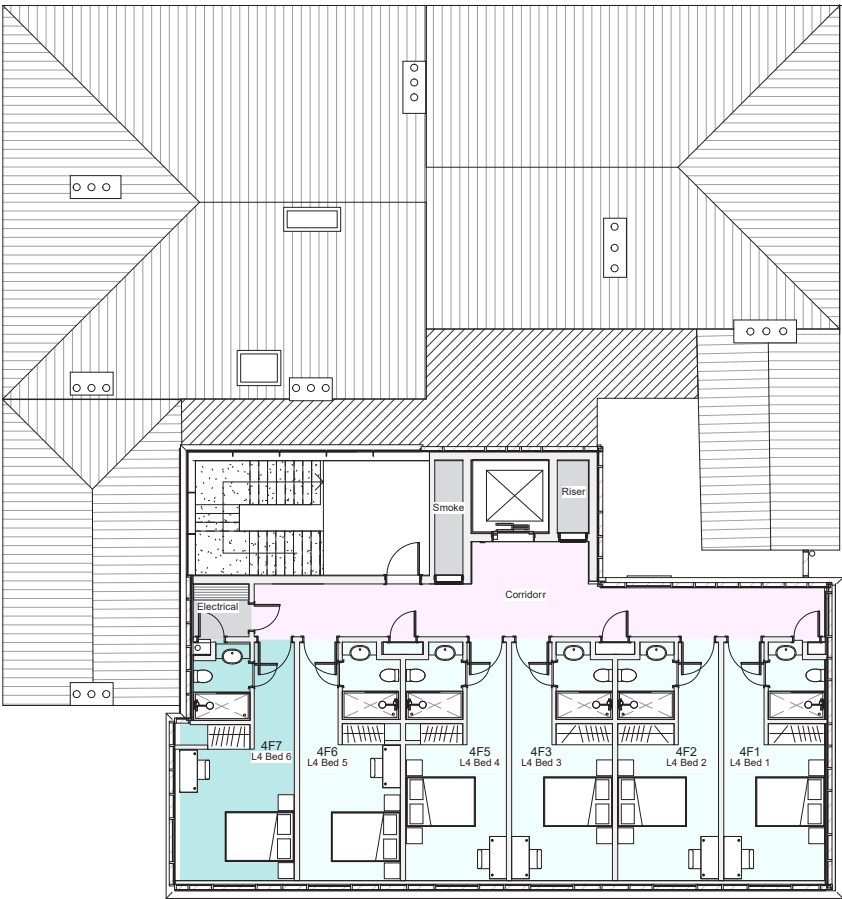
CONSENTED DRAWING

5.5 FOURTH FLOOR PLAN

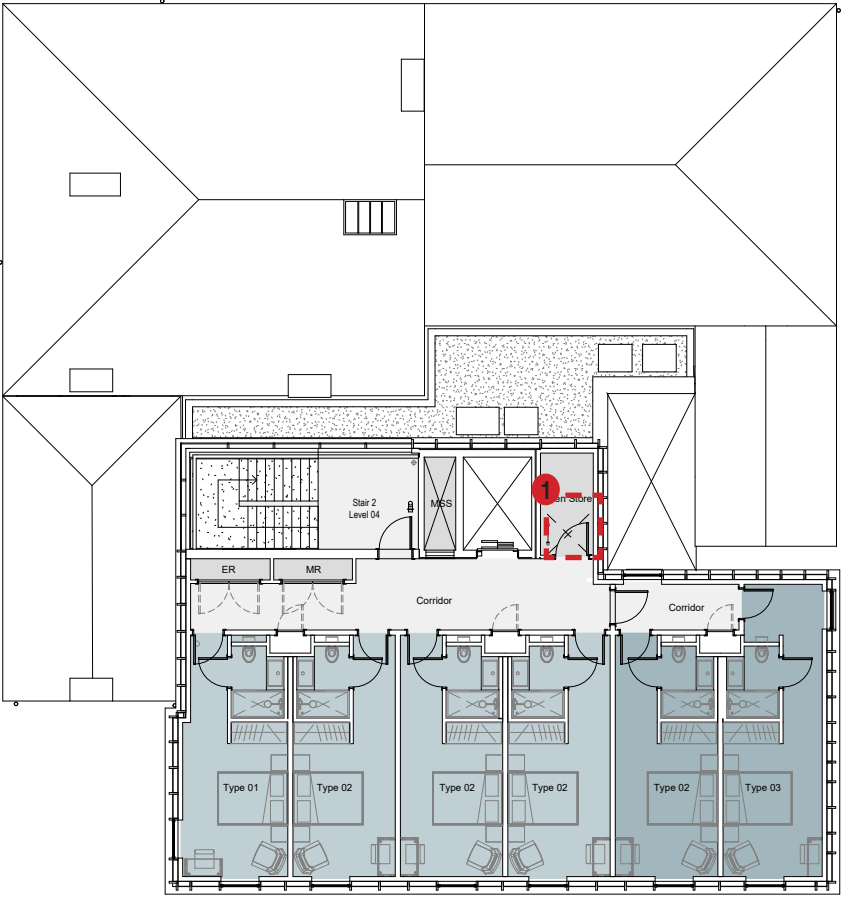
CURRENT PROPOSAL

- 1. Roof access hatch with ladder amended to inside linen store for private access for maintenance.

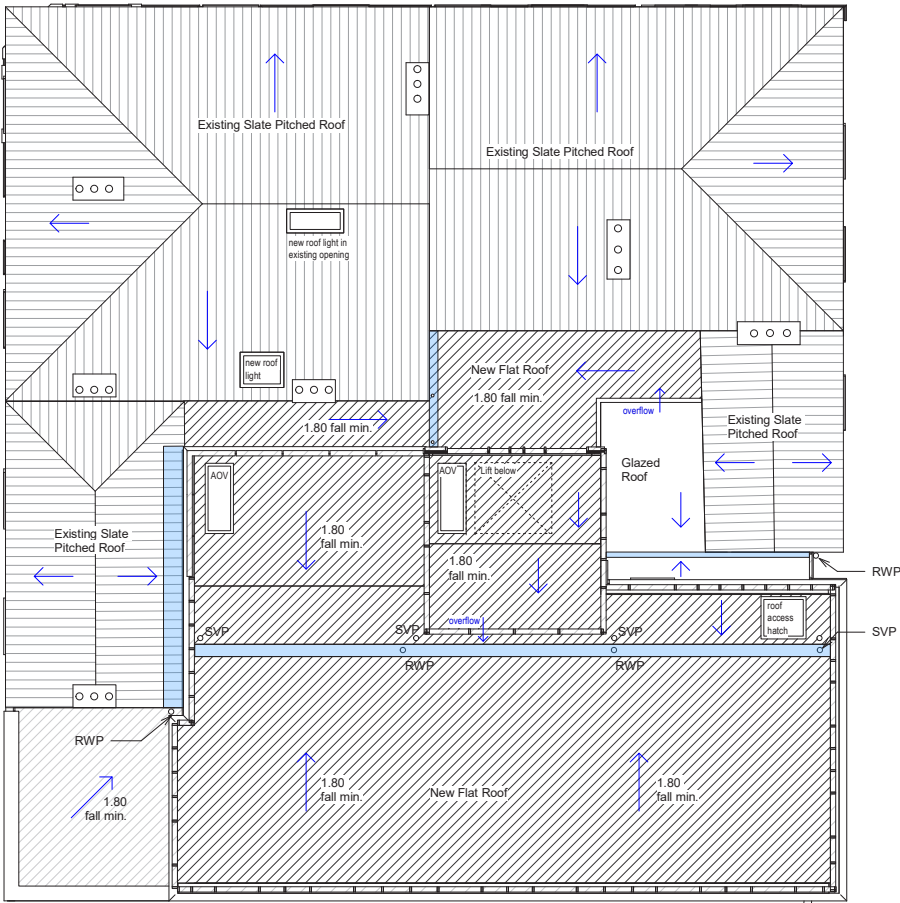
CONSENTED DRAWING

5.6 ROOF PLAN

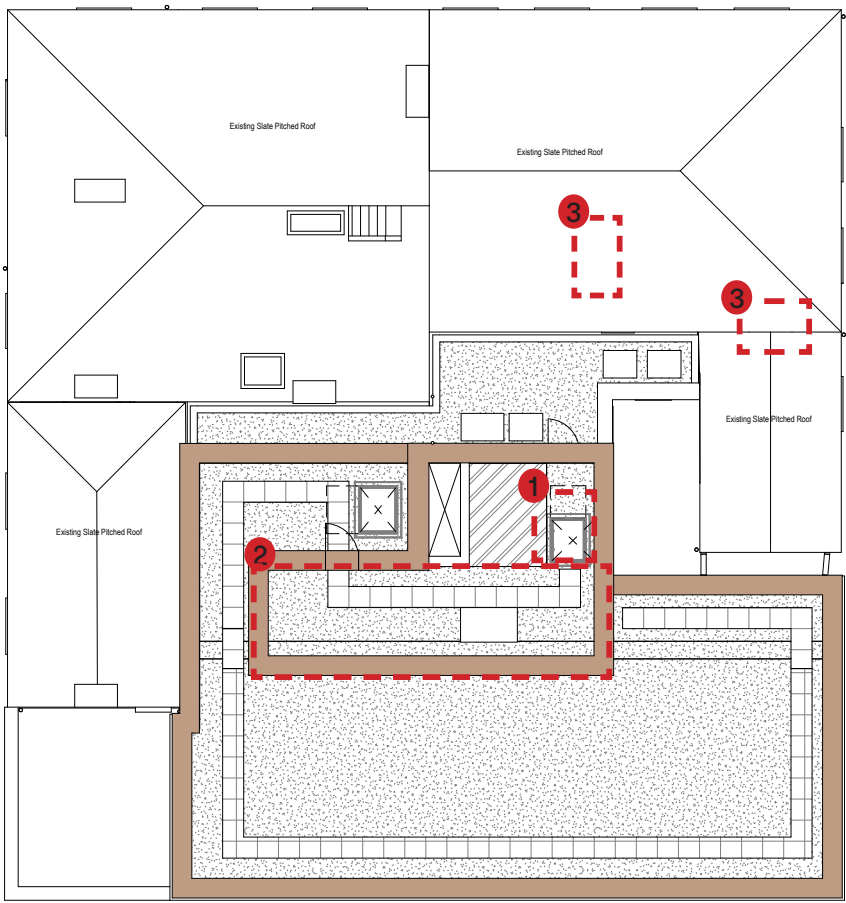
CURRENT PROPOSAL

- 1. Amendment to location of roof access hatch.
- 2. Plant screening extended due to increased plant demand to meet current regulation requirements for the building operation.
- 3. Proposed chimneys in previous application omitted.

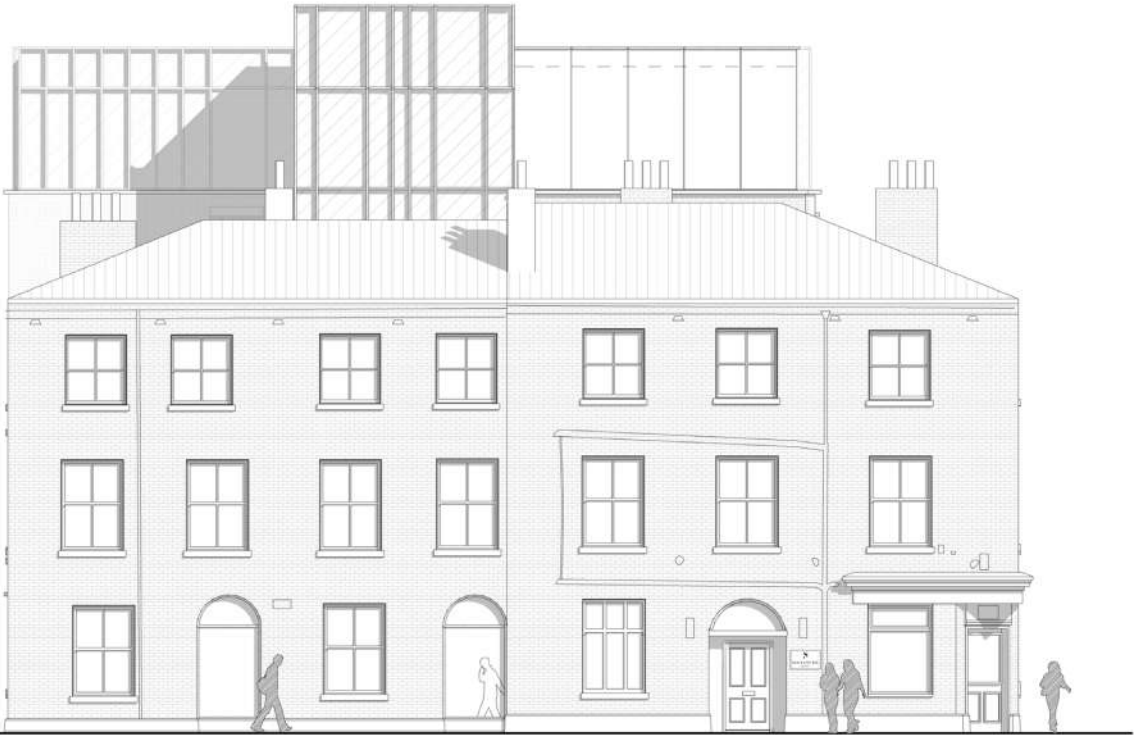
CONSENTED DRAWING

6.0 NORTH ELEVATION

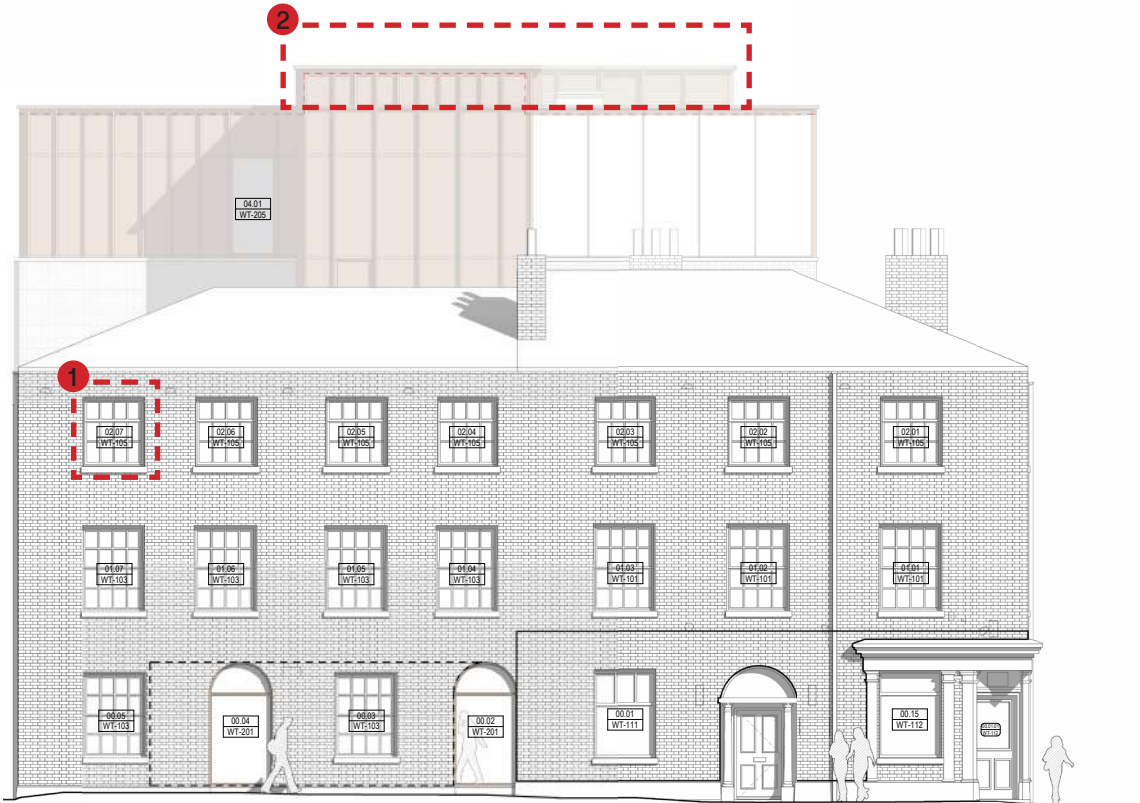
CURRENT PROPOSAL

- 1. '4 over 8' and '8 over 8' sashes re-introduced, as seen historically on the building.
- 2. Plant screening extended due to increased plant demand to meet current regulation requirements for the building operation and acoustic requirements.

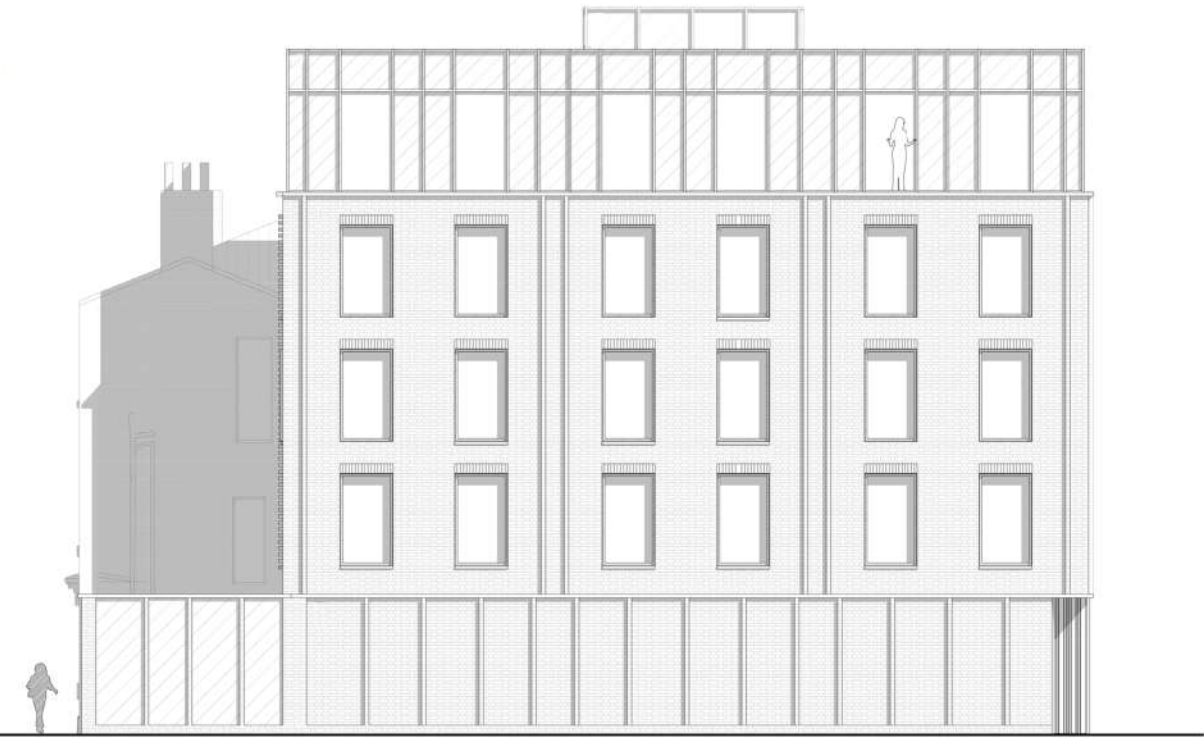
CONSENTED DRAWING

6.1 SOUTH ELEVATION

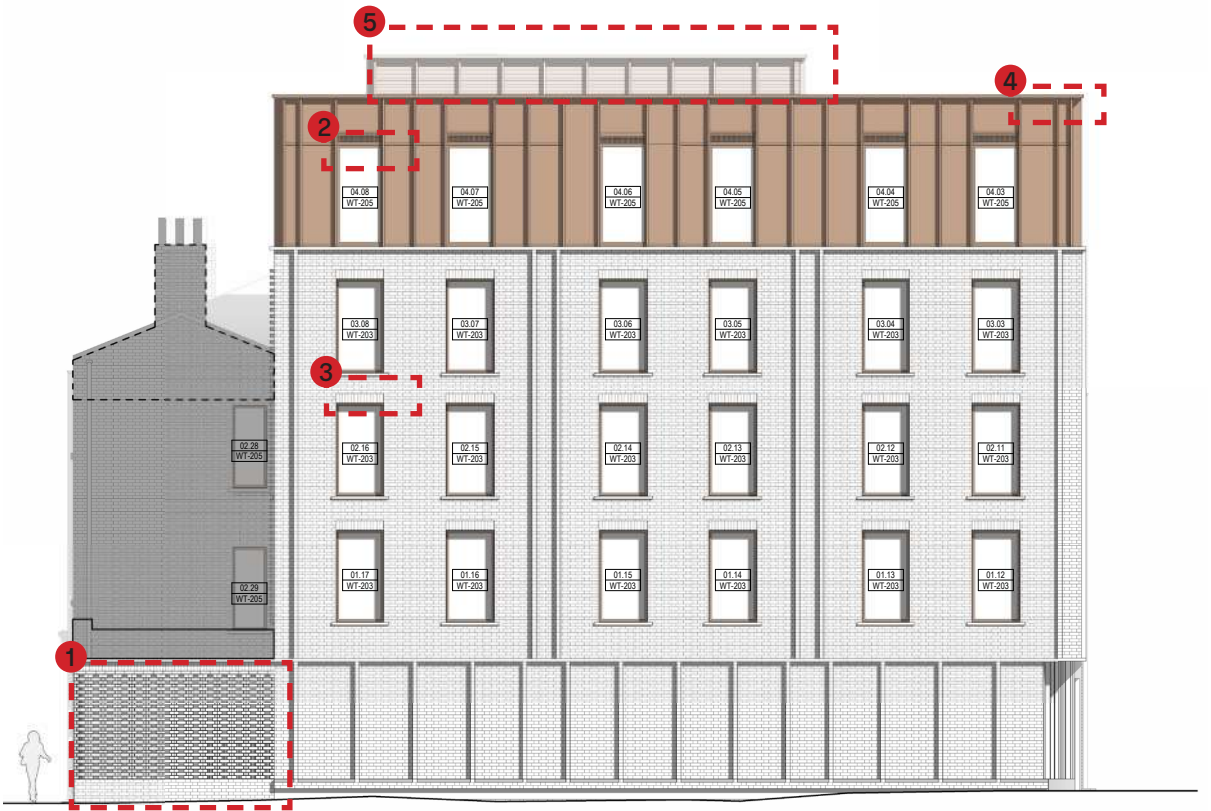
CURRENT PROPOSAL

- 1. Bin room elevation metal panels altered to hit-and-miss brickwork to provide required ventilation and continuity to the facade material.
- 2. Decorative panels added to heads of windows for room ventilation.
- 3. Soffit ventilation to brick areas for room ventilation included above windows.
- 4. Parapet height raised due to the addition of a blue roof.
- 5. Plant screening extended due to increased plant demand to meet current regulation requirements for the building operation and acoustic requirements.

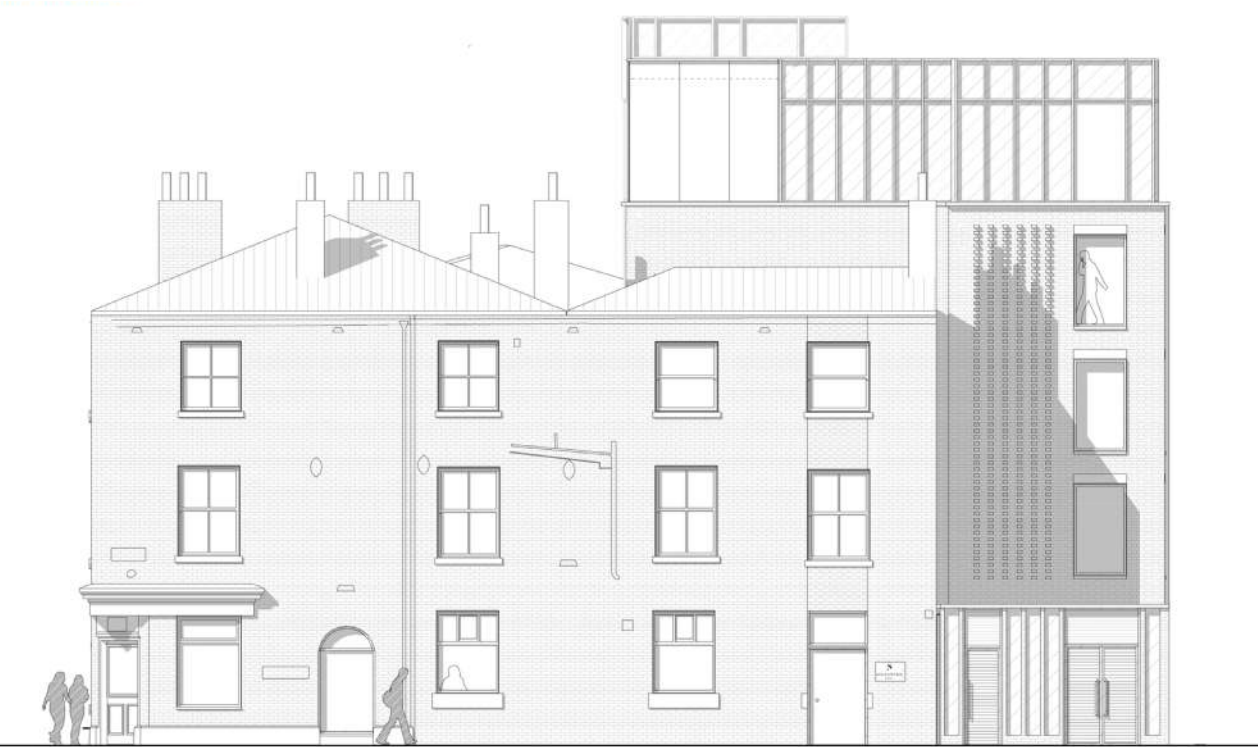
CONSENTED DRAWING

6.2 WEST ELEVATION

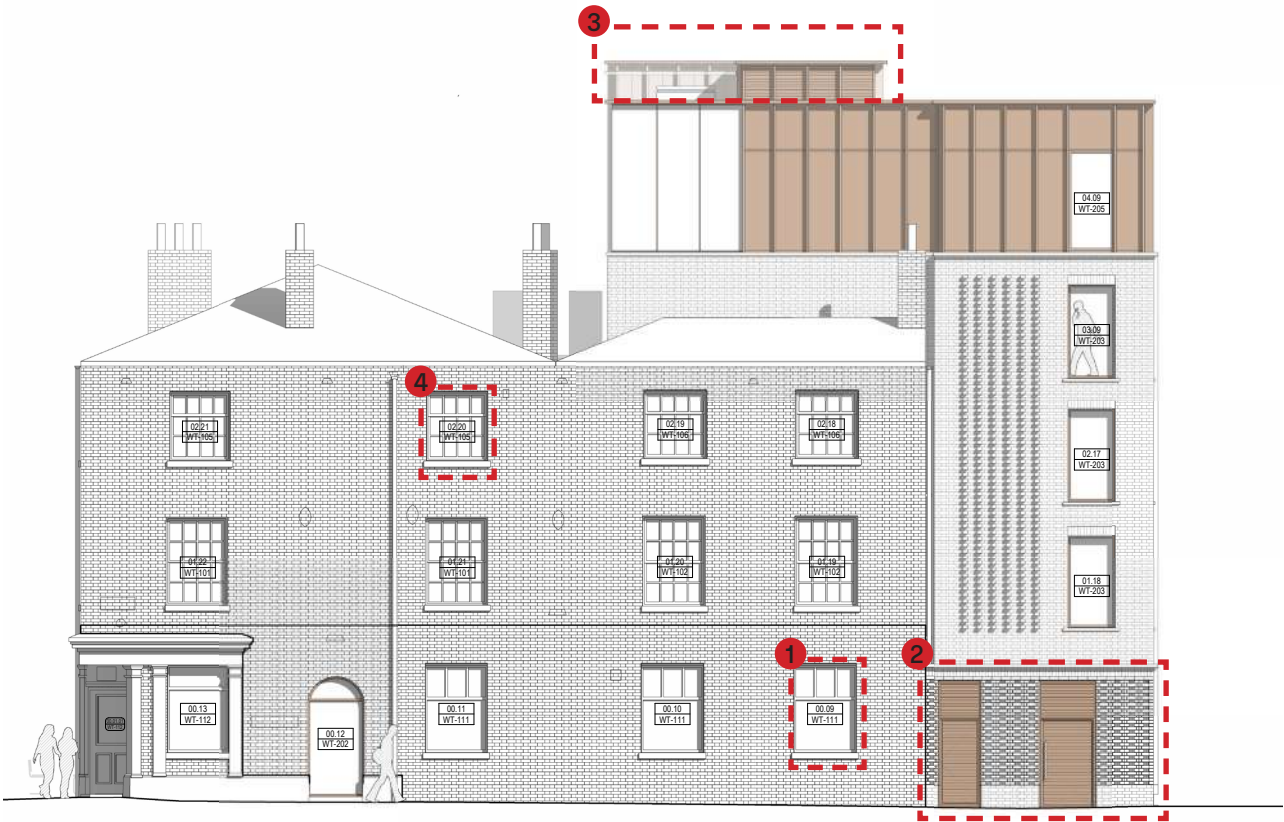
CURRENT PROPOSAL

- 1. Window retained, entry door relocated.
- 2. Bin room elevation metal panels altered to hit-and-miss brickwork to provide required ventilation and continuity to the facade material.
- 3. Plant screening extended due to increased plant demand to meet current regulation requirements for the building operation and acoustic requirements.
- 4. '4 over 8' and '8 over 8' sashes re-introduced, as seen historically on the building.

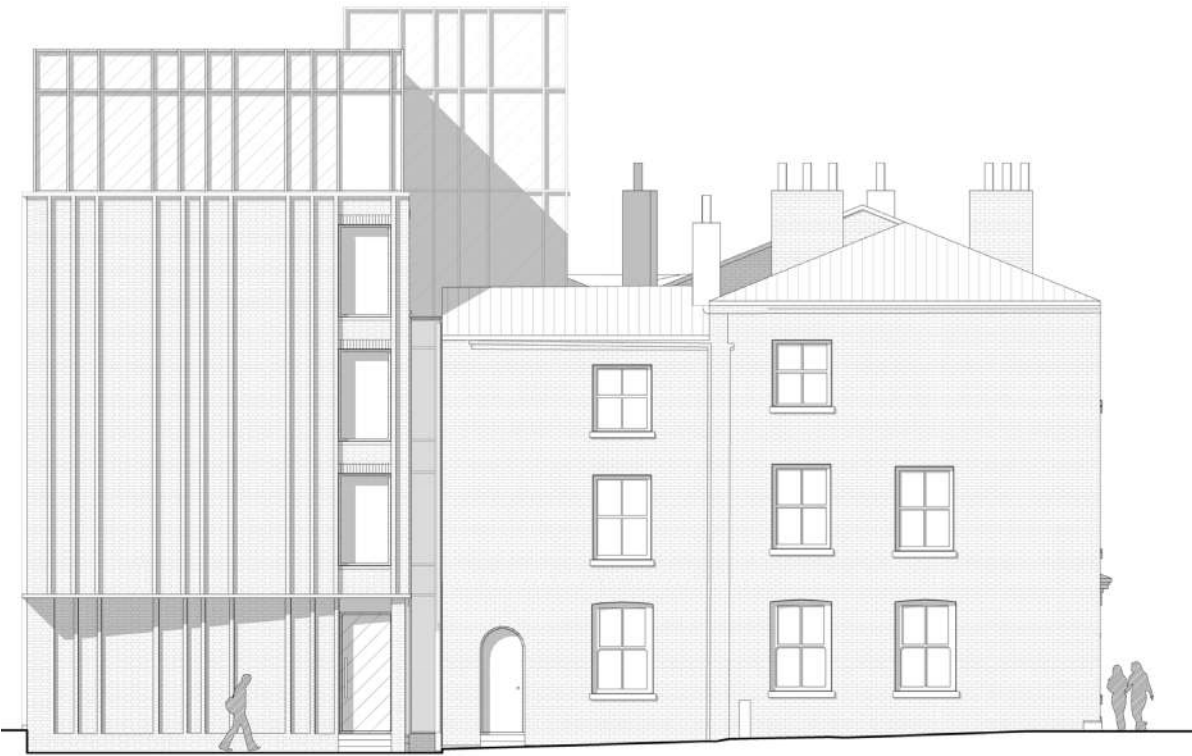
CONSENTED DRAWING

6.3 EAST ELEVATION

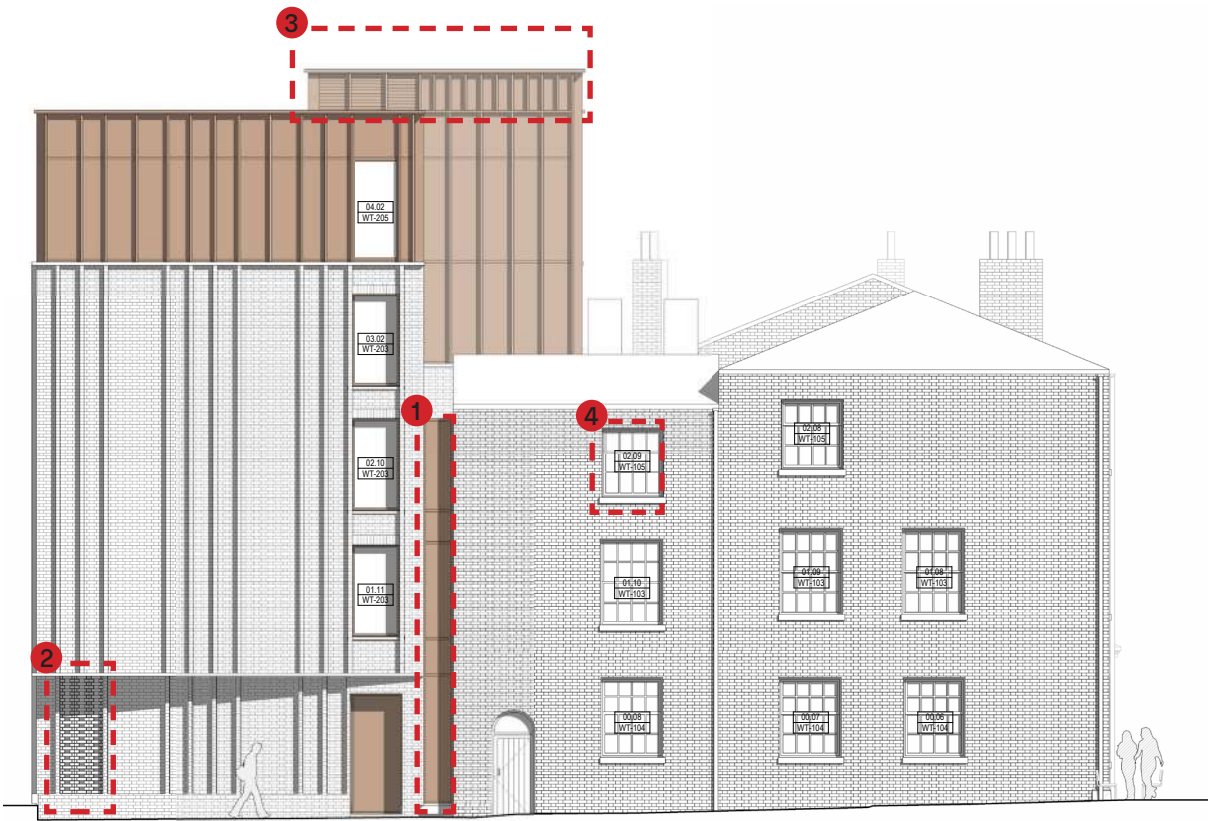
CURRENT PROPOSAL

- 1. Amendment to material from glazing to metal panels to provide clear distinction between the two building elements and conceal uninhabited area between the two buildings.
- 2. Addition of hit & miss brickwork discretely below cantilever to the rear of the building for spa plant ventilation.
- 3. Plant screening extended due to increased plant demand to meet current regulation requirements for the building operation and acoustic requirements.
- 4. '4 over 8' and '8 over 8' sashes re-introduced, as seen historically on the building.

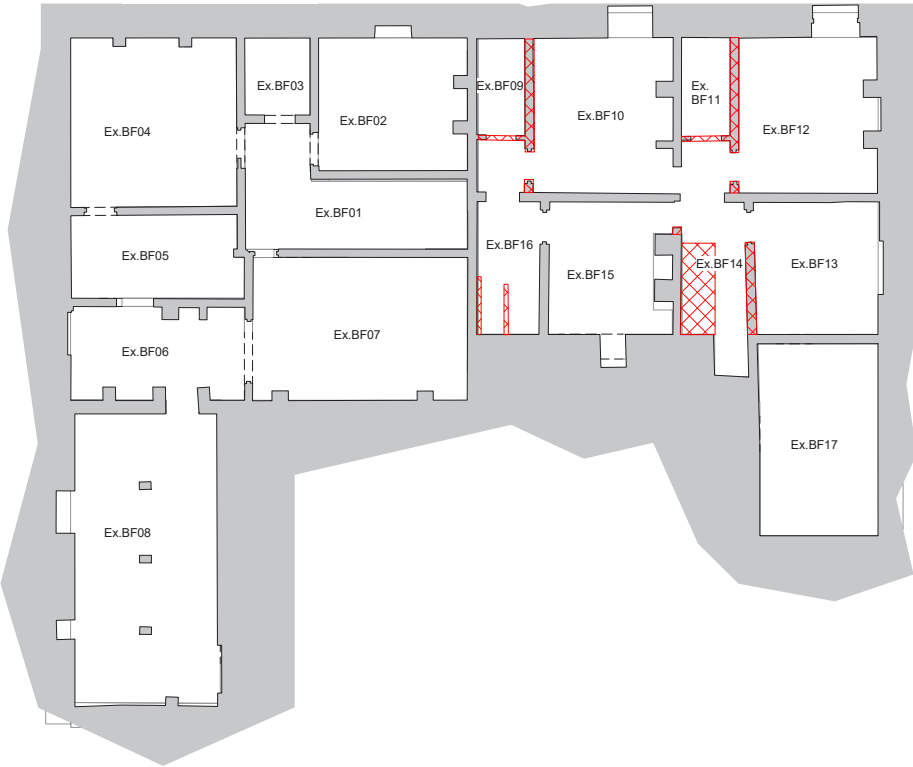
CONSENTED DRAWING

7.0 BASEMENT DEMOLITION PLANS

Following further investigation by the heritage consultant, amendments have been made to the demolition plans.
