# 1073 LIVERPOOL ROAD, MANCHESTER DESIGN AND ACCESS REPORT

TO PLANNING PERMISSION 117897/FO/2017

TIM GROOM ARCHITECTS

This report has been prepared by Tim Groom Architects to describe proposed non-material amendments to the Planning Application Number 117897/FO/2017 and support the Listed Building Consent Application for the revised scheme.

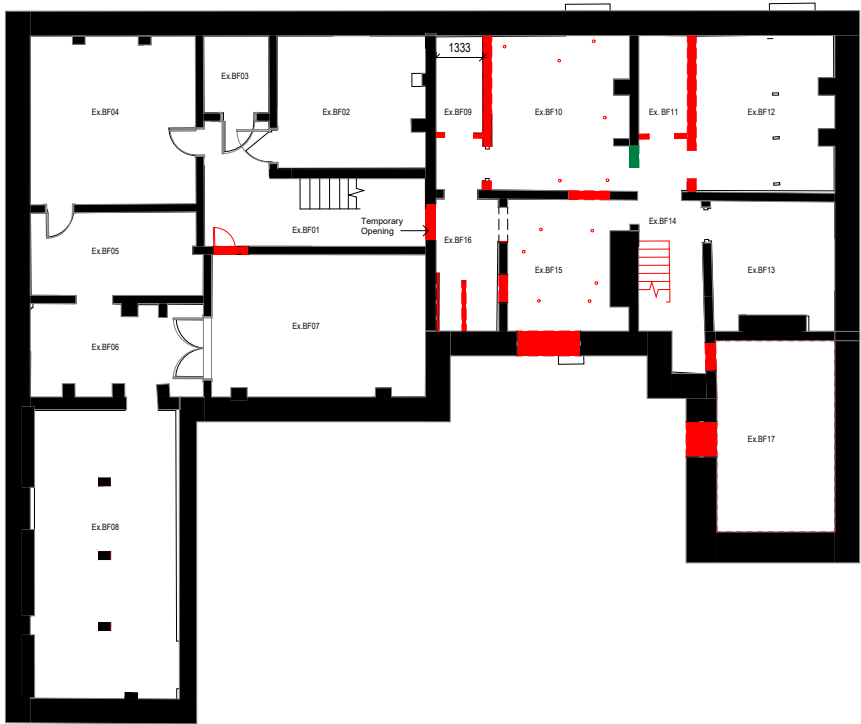
CURRENT PROPOSAL

Following further investigation by the heritage consultant, amendments have been made to the demolition plans.

- Demolished with consent.
- Demolition requiring amendment to consent.
- Consent to demolish in approved scheme (Demo plans read in conjunction with approved plans)
- Structures no longer remaining since consent.
- Existing elements to remain in-situ.

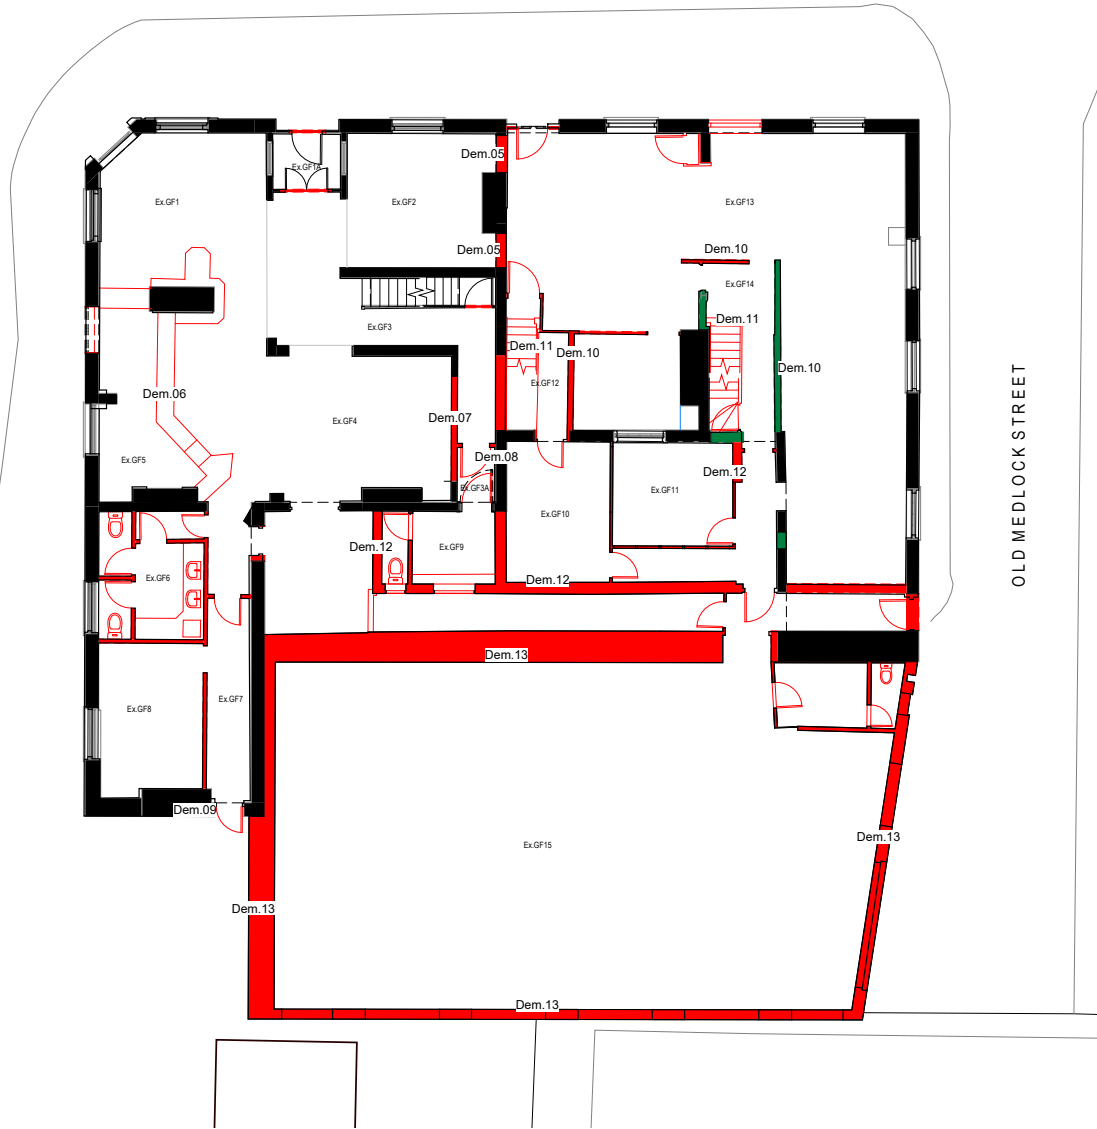
CURRENT PROPOSAL

Following further investigation by the heritage consultant, amendments have been made to the demolition plans.

- Demolished with consent.
- Demolition requiring amendment to consent.
- Consent to demolish in approved scheme (Demo plans read in conjunction with approved plans)
- Structures no longer remaining since consent.
- Existing elements to remain in-situ.

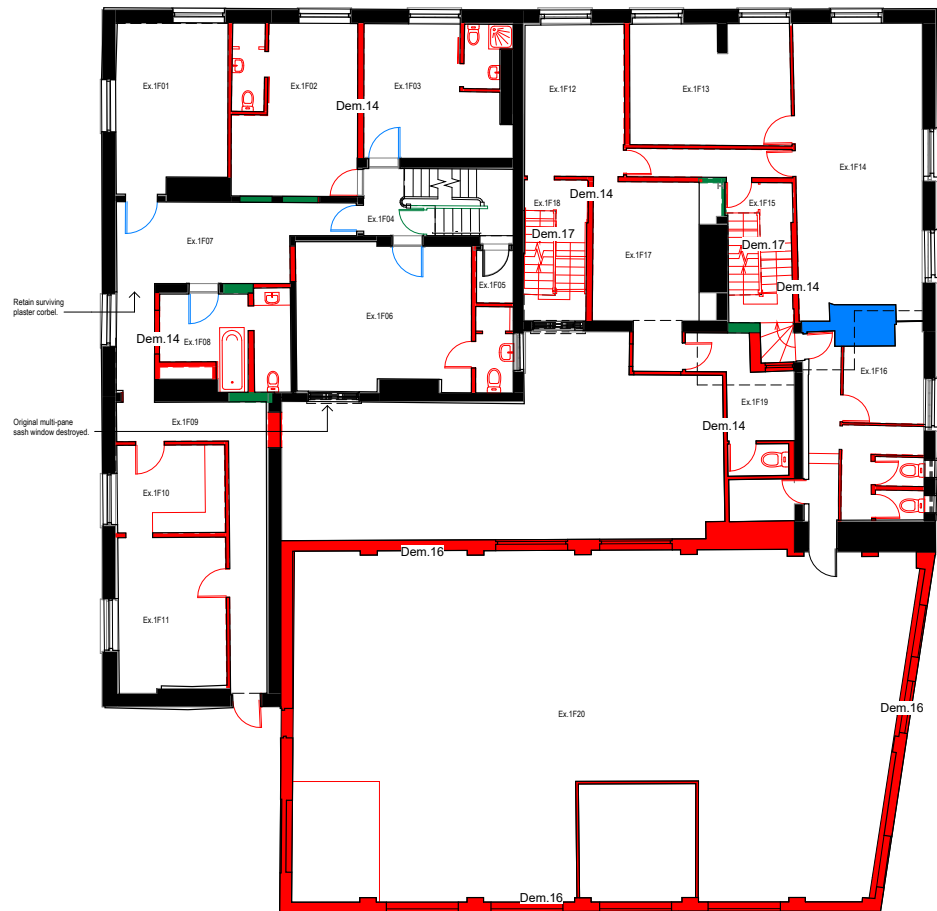
CURRENT PROPOSAL

Following further investigation by the heritage consultant, amendments have been made to the demolition plans.

- Demolished with consent.
- Demolition requiring amendment to consent.
- Consent to demolish in approved scheme (Demo plans read in conjunction with approved plans)
- Structures no longer remaining since consent.
- Existing elements to remain in-situ.

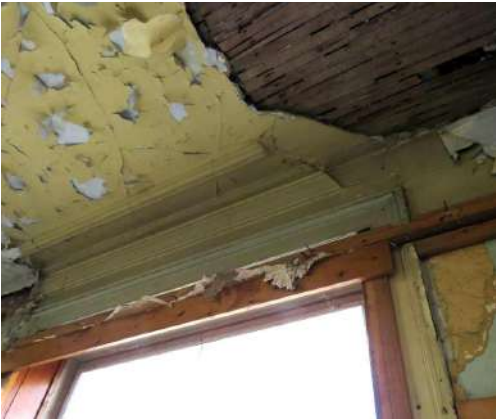
An area of newly uncovered original moulded timber window surround and plaster cornice above one of the windows to be used as a template.

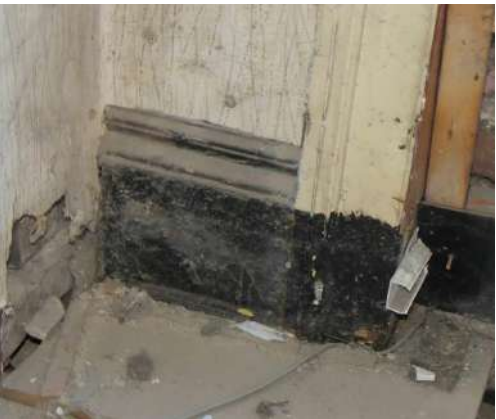
A small example of surviving original timber skirting to be used as a template for other areas.

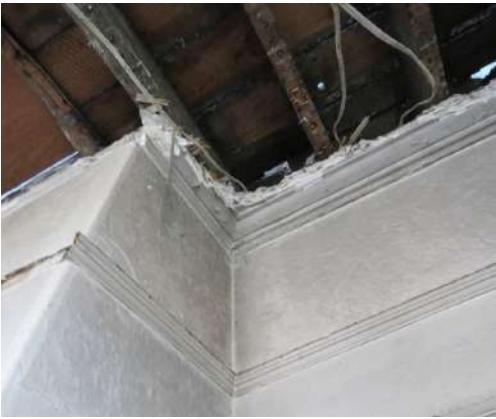
An area of partially surviving cornice to the alcove and small area of removed picture rail.

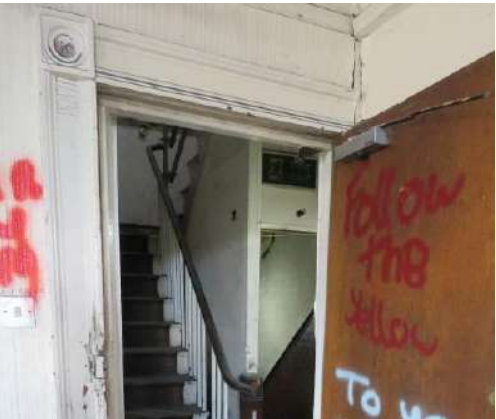
The original decorative architrave surrounding the door to be used as reference for other areas.

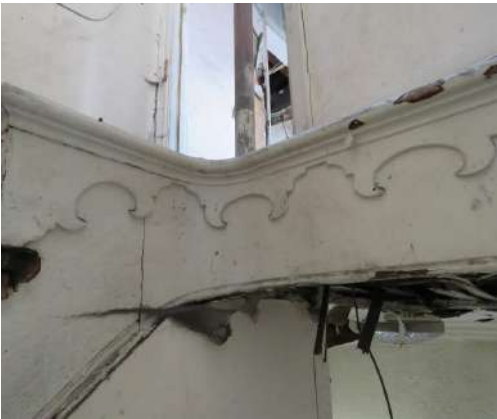
Detail of the original cut string carved decoration.

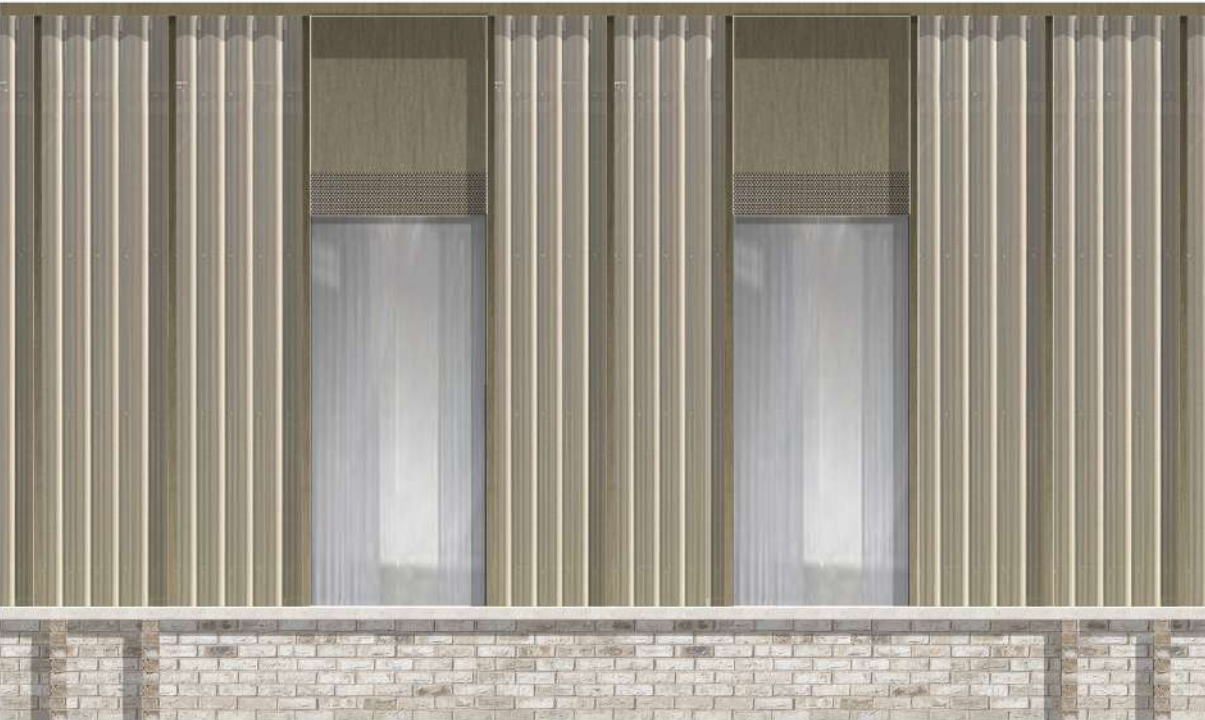
Fritted Glazing Study - Integrated Ventilation

The study investigates the use of a pleated aluminium panel to provide the texture and relief depicted in the visual.

The folded profile will provide visual interest as the light moves across the panels.

The decorative slim fins provide order and depth to the panels.

Louvres for the upper floor rooms are integrated into the aluminium panelling with a decorative perforations.

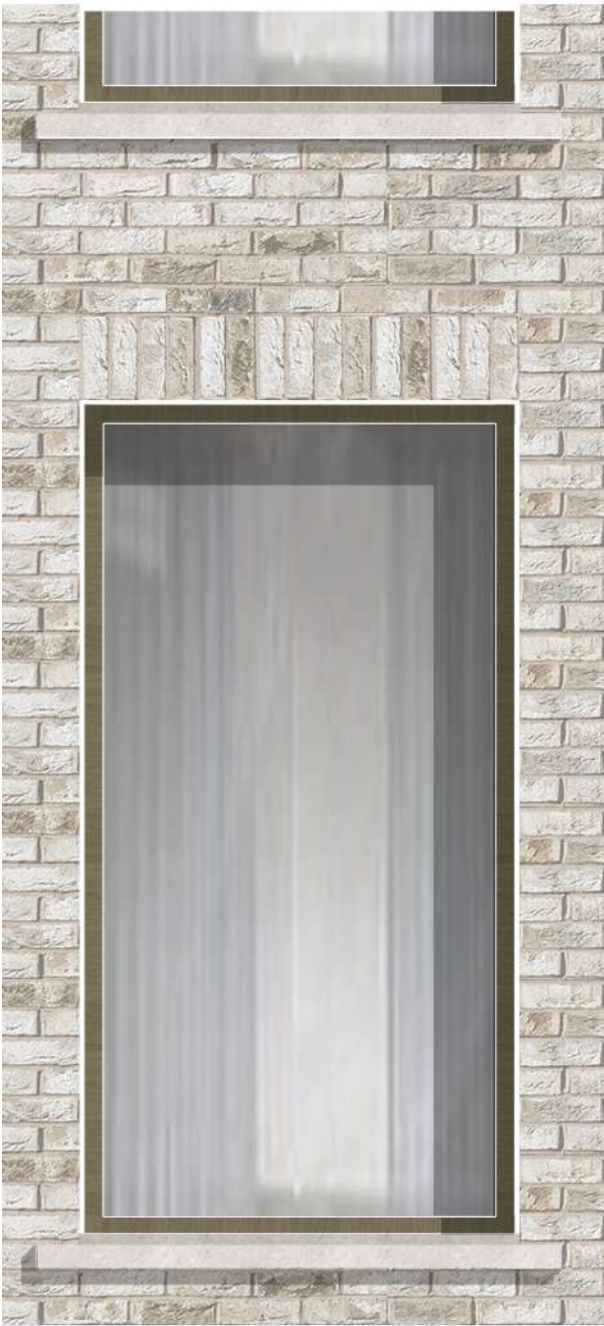
TYPICAL BRICKWORK OPENING

MCC raised concerns regarding the use of the proposals to utilise custom air bricks to provide the ventilation strategy for the rooms.

The design team have reviewed the proposals and have endeavoured to provide the ventilation to the soffit of the window.

A ventilation louvre would be discretely located behind a single brick reveal to the soffit. This would be colour matched to the window frames.

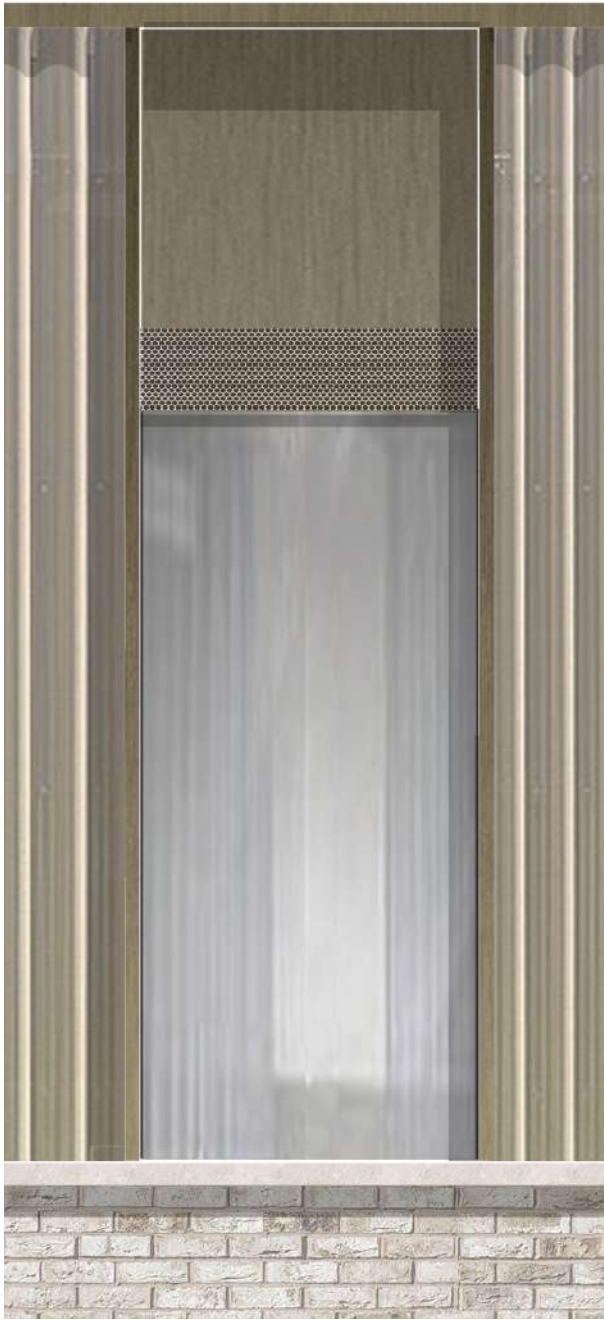
TYPICAL CLADDING OPENING

The ventilation method for the windows within the cladding is through discrete perforations in an aluminium panel above the window. This panel will be colour matched to the windows.

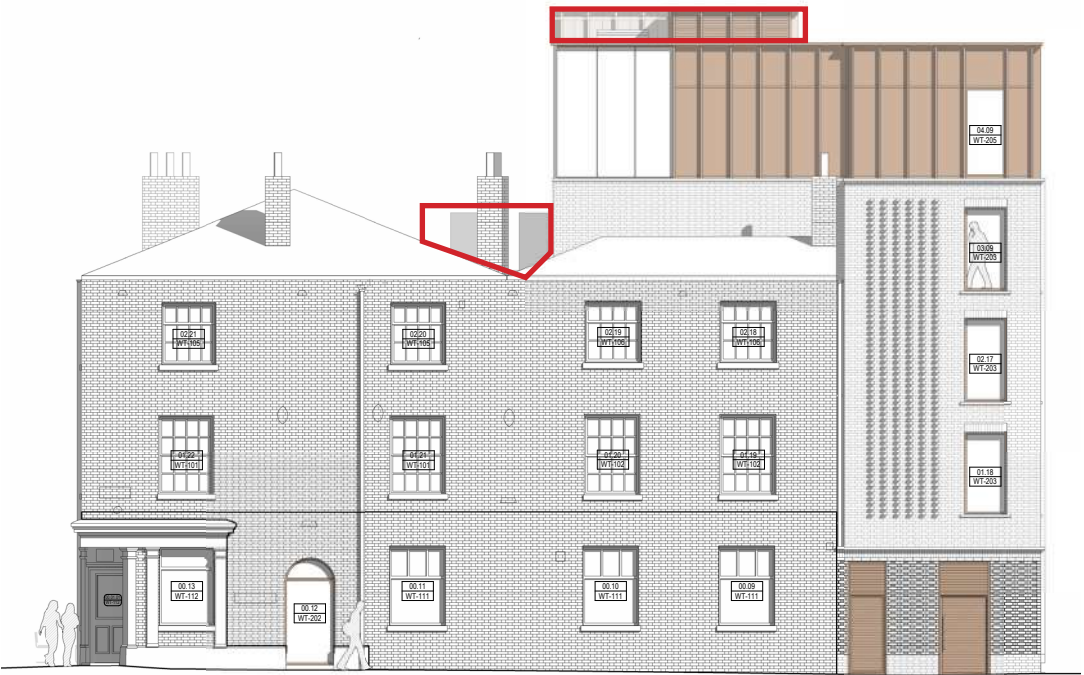
The Level 3 Roof sits below the eaves of the existing buildings and connects to the new extension which provides access. the sets the proposed equipment behind the pitch of the existing roofs.

The equipment to the upper roof is concealed behind a screen.
