Ref: 15-880-L1  
Date: 29<sup>th</sup> March 2022

## **GEOENVIRONMENTAL SITE REVIEW UPPER BROOK STREET, MANCHESTER**

E3P has been appointed by Property Alliance Group (PAG) 'the client' to undertake a preliminary review with respect to Geoenvironmental and Geotechnical conditions, potential abnormal development constraints and engineering solutions that require consideration as part of the future redevelopment of the site.

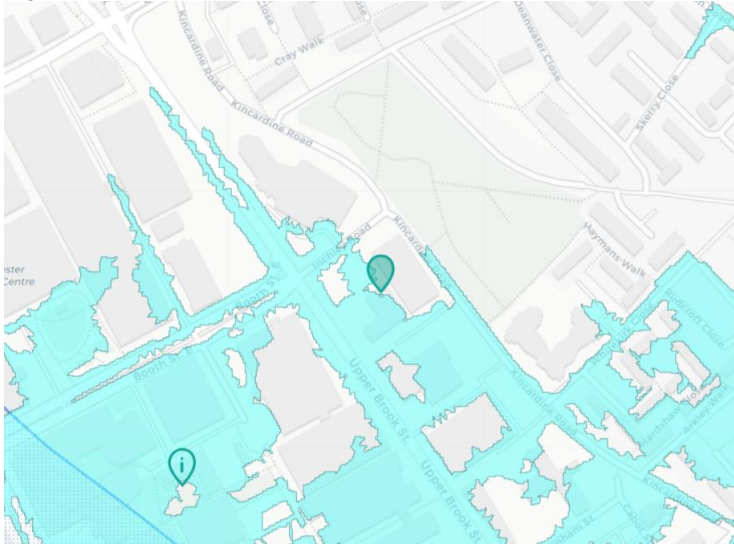
| <p><b>Flood Risk</b></p> | <p>The site is located within an area Classified as Flood Zone 2 (1000-year return event). The extent of Zone 2 Flood Risk is indicated in Figure 1 below.</p> <p><b>Figure 1 – Extent of Zone 2 Flood Risk</b></p> |

- ✚ Detailed flood risk hydrology modelling to assess the risk from Flood Zone 2 (1000 year return event).
- ✚ Detailed Ground Investigation and contaminated land risk assessment within the areas of motor vehicle repair workshops and ancillary areas.

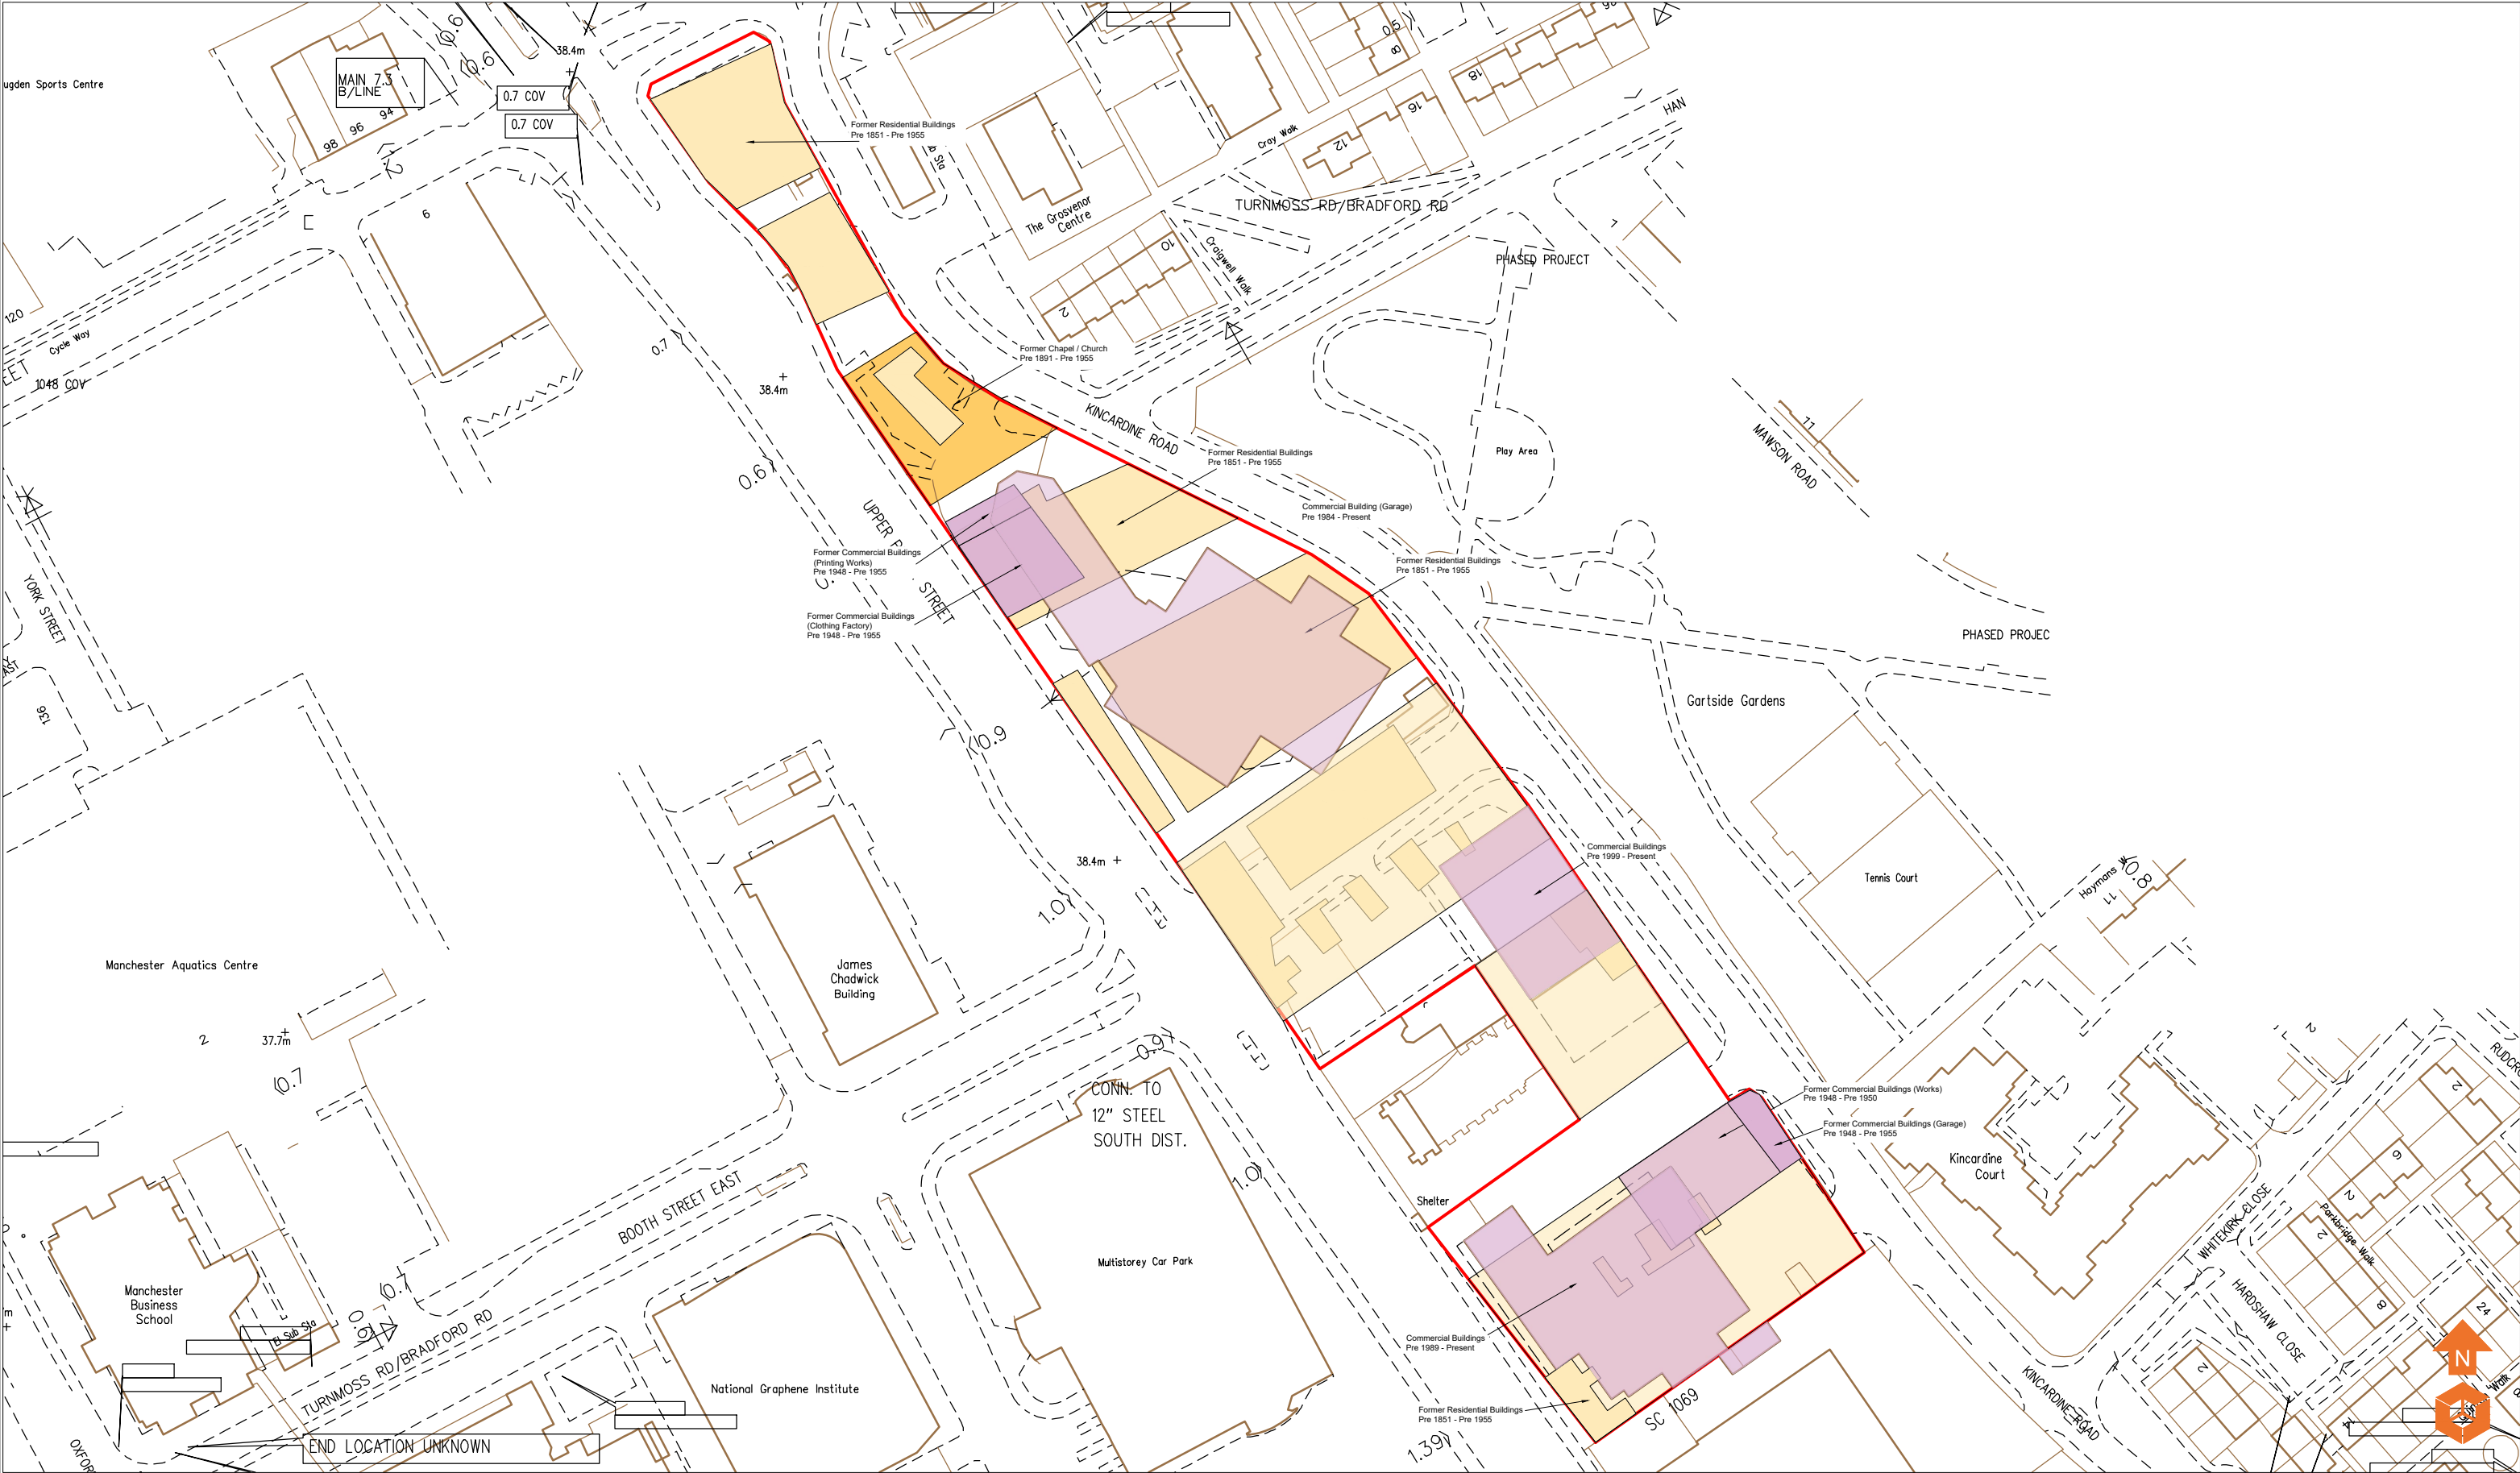
| <div>Historical Features</div> <div><div></div>Former Residential Buildings</div> <div><div></div>Former Commercial Buildings</div> <div><div></div>Former Chapel / Church</div> | Notes: | | | | | Client:<br><br>Property Alliance Group | Job No:<br><br>15-880 | Date:<br><br>29.03.2022 | <div><div><div></div></div>e3p</div> <div>Environmental Engineering Partnership Ltd<br/>Taylor Road, Trafford Park<br/>Urmston, Manchester, M41 7JQ<br/>Tel: 0161 707 9612<br/>E-mail: info@e3p.co.uk<br/>Website: www.e3p.co.uk</div> |

| <p><b>Site History</b></p> | <p>Historical mapping from the mid 19<sup>th</sup> Century indicates that the site was occupied by residential housing across the central and southern sectors with a Sunday School, Library and housing to the north.</p> <p>Numerous historical roads transected the site serving the historical housing, schools and small works.</p> <p>A print works and clothing factory are located immediately north of Inchley Rd from ~1931.</p> <p>The site appears to have suffered bomb damage in the mid-1940s (WW2).</p> <p>The southern sector was occupied by engineering works from the 1950s onwards.</p> <p>The entire site area was cleared in the 1960s which coincided with the infrastructure development (including the Mancunian Way to the north).</p> <p>The existing car dealership located in the northern sector was constructed in the mid-1970s, this area remains largely in the same configuration to the present day.</p> <p>The southern sector was subsequently developed as car dealerships and ancillary motor vehicle service and repair workshops in the early to mid-1990s.</p> <p>At this time, all buildings remain fully intact with boarding to windows to prevent unauthorized access.</p> <p>No pertinent adjacent historical land uses are identified that would be considered a significant environmental or geotechnical risk.</p> |

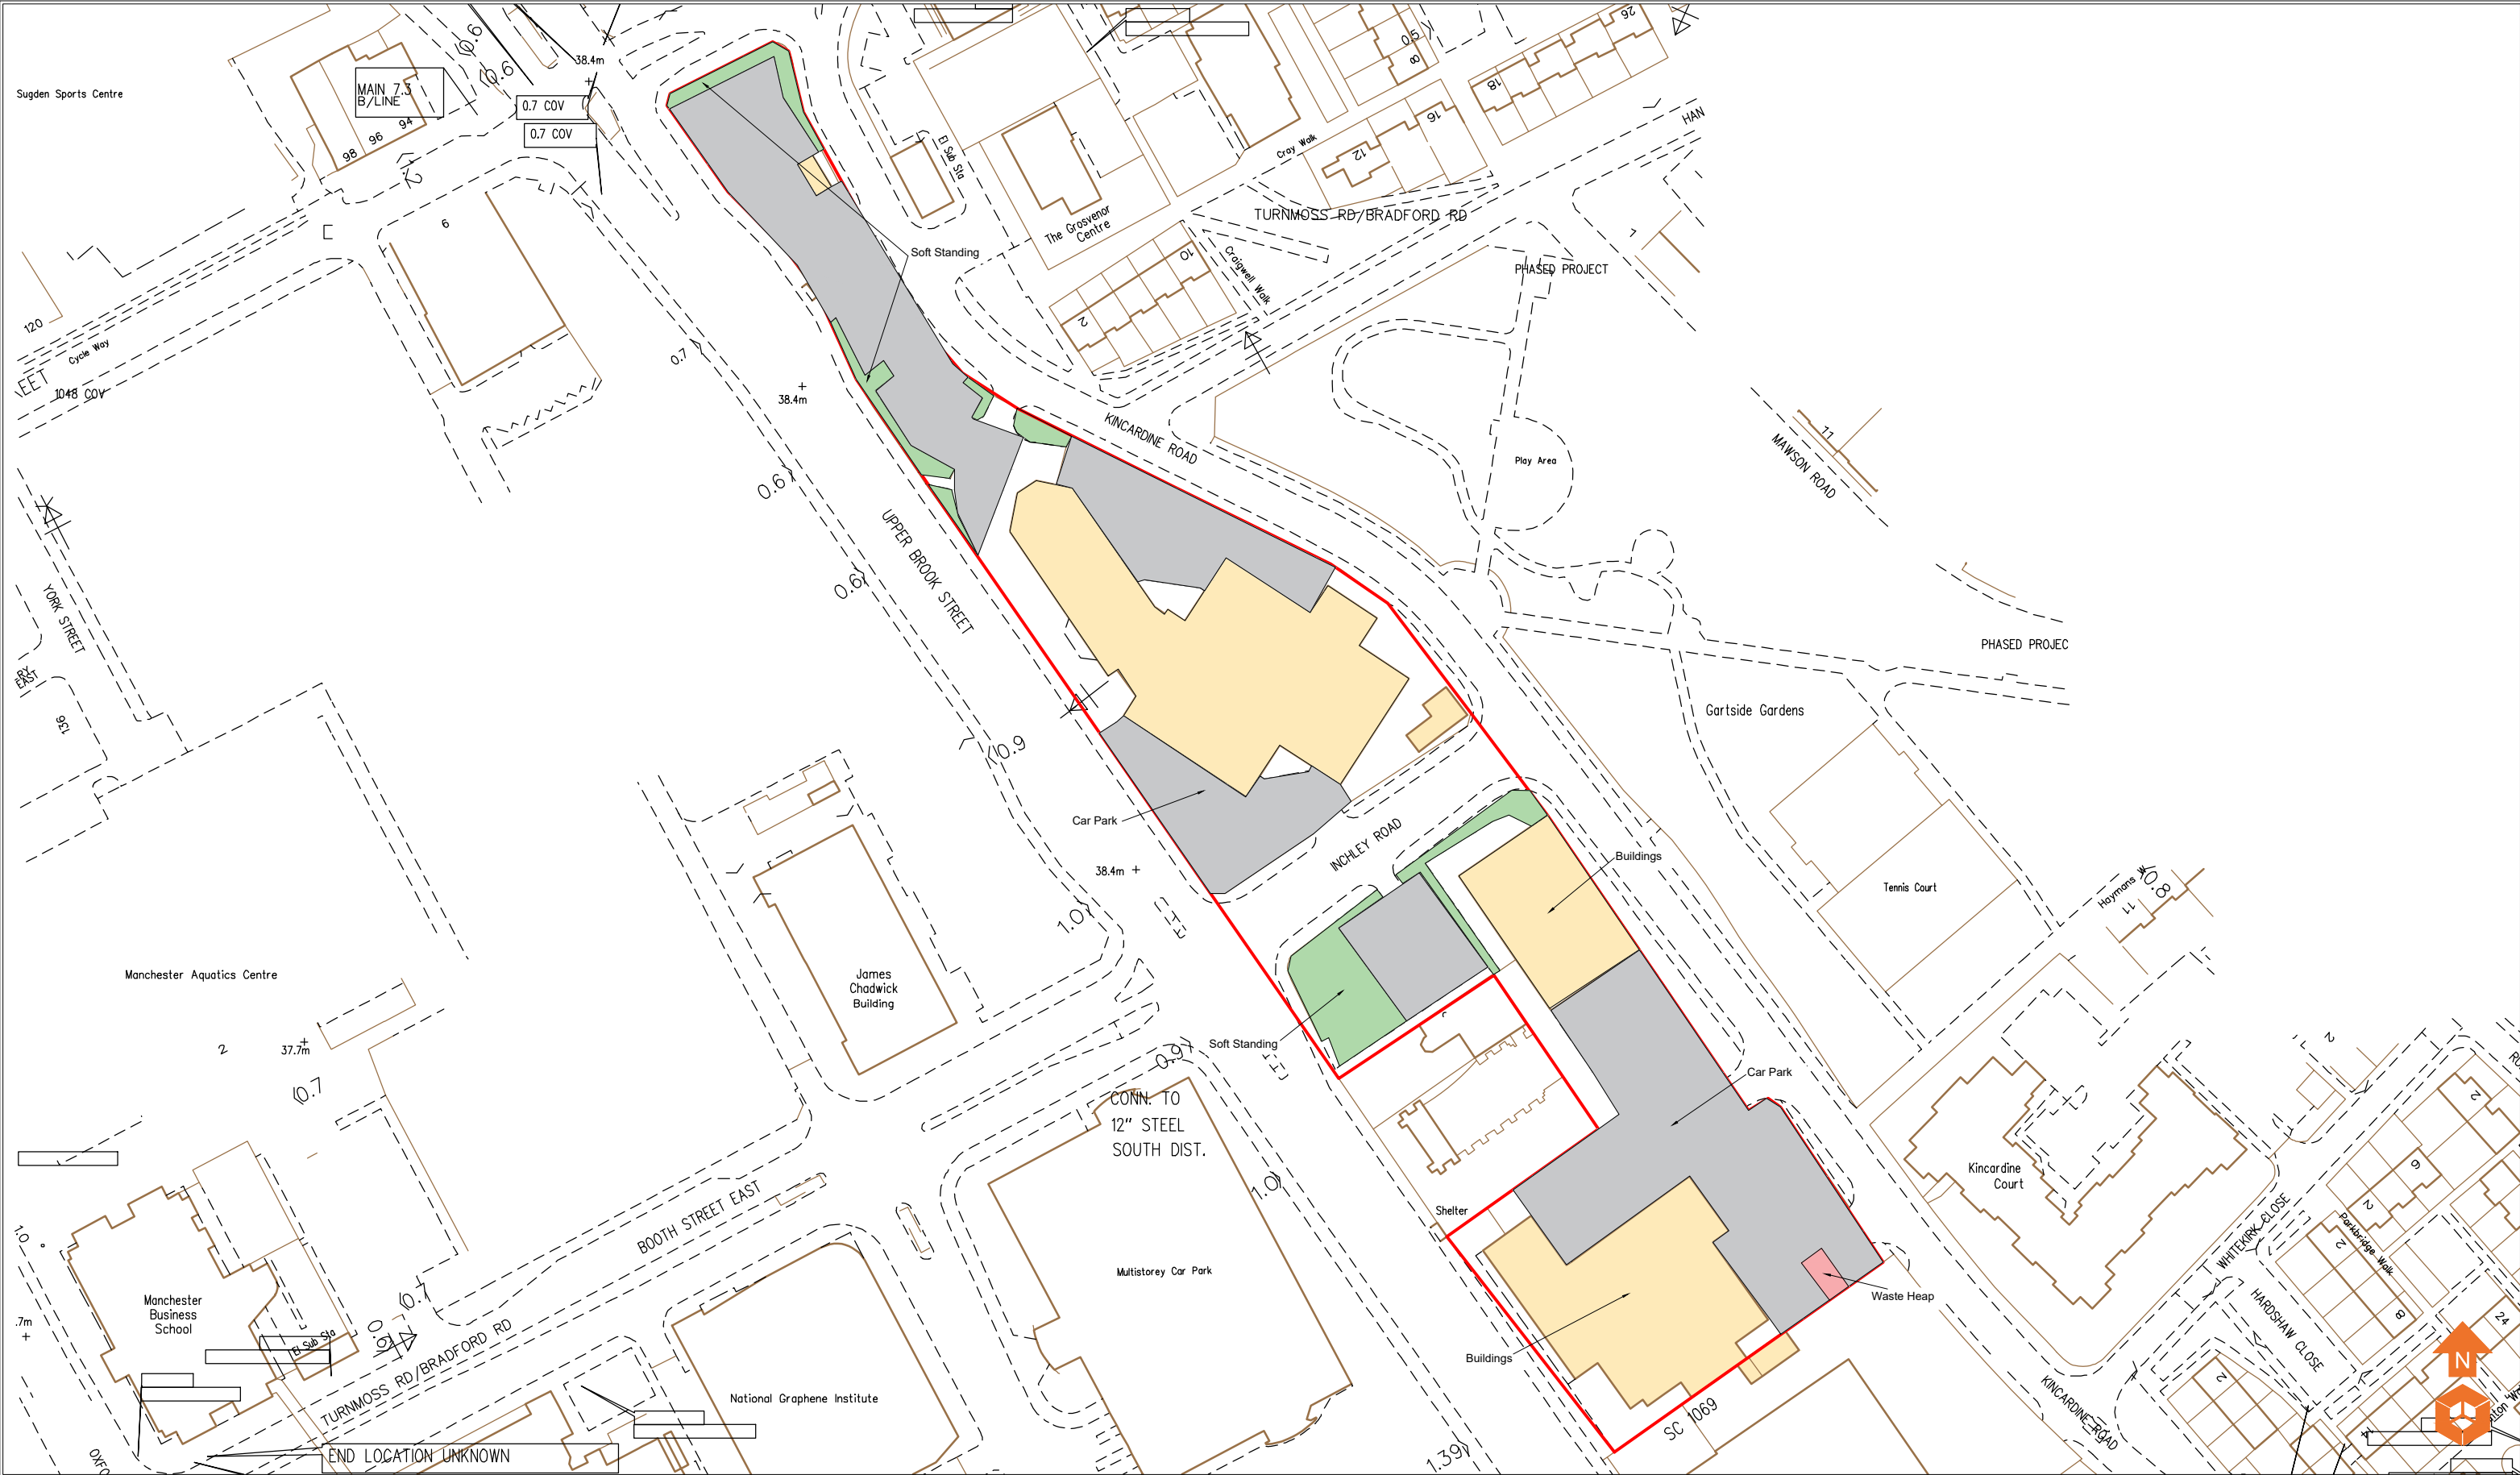
| <div>Site Features</div> <div><div></div>Buildings</div> <div><div></div>Car Parks</div> <div><div></div>Soft Standing</div> <div><div></div>Waste Heaps</div> | <div>Notes:</div> | <div>Client:</div> <div>Property Alliance Group</div> | <div>Job No:</div> <div>15-880</div> | <div>Date:</div> <div>29.03.2022</div> | <div><div><div></div></div>e3p</div> <div>Environmental Engineering Partnership Ltd<br/>Taylor Road, Trafford Park<br/>Urmston, Manchester, M41 7JQ<br/>Tel: 0161 707 9612<br/>E-mail: info@e3p.co.uk<br/>Website: www.e3p.co.uk</div> |

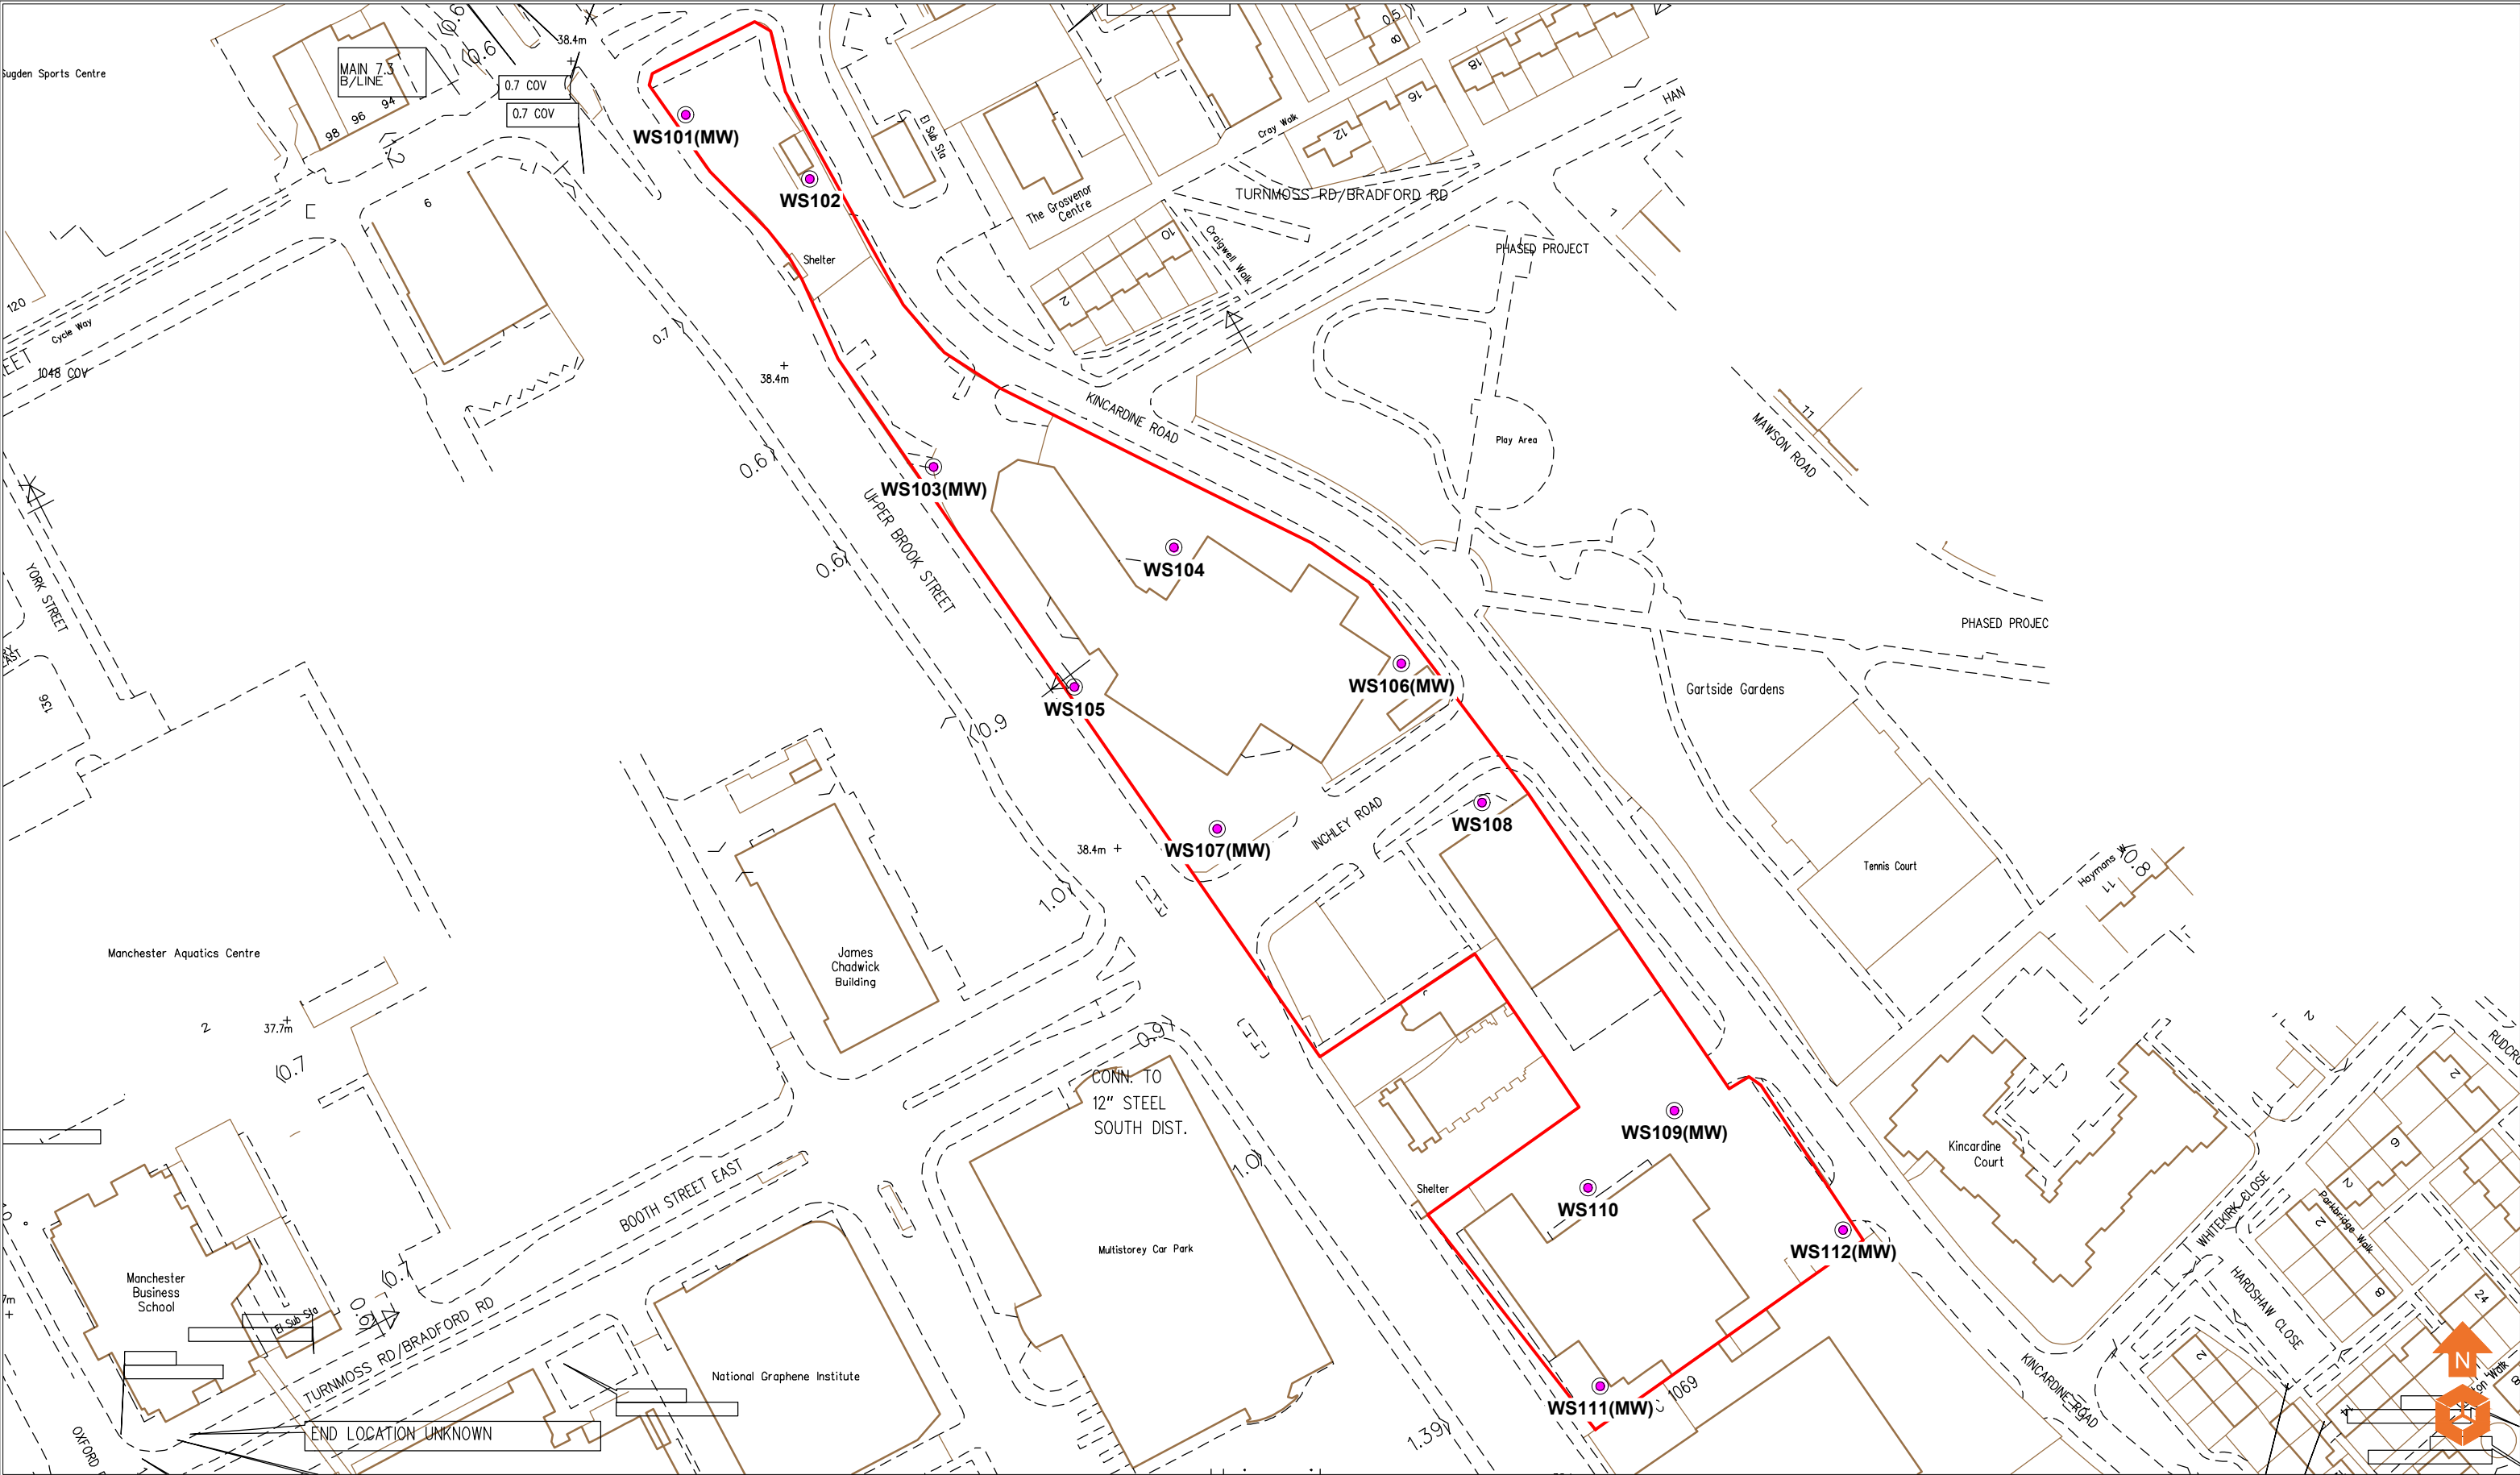
| <div>Location Symbols</div> <div><div><div></div></div>WS151</div> Approximate Window Sample Probehole Location (ROC Consulting - May 2021) <div><div><div></div></div>WS151(100)</div> Approximate Window Sample Probehole Location with Install (ROC Consulting - May 2021) | | | | | <div>Notes:</div> | | | | | <div>Client:</div> <div>Property Alliance Group</div> | | <div>Job No:</div> <div>15-880</div> | <div>Date:</div> <div>29.03.2022</div> | <div><div><div></div></div>e3p</div> <div>Environmental Engineering Partnership Ltd<br/>Taylor Road, Trafford Park<br/>Urmston, Manchester, M41 7JQ<br/>Tel: 0161 707 9612<br/>E-mail: <a href="mailto:info@e3p.co.uk">info@e3p.co.uk</a><br/>Website: <a href="http://www.e3p.co.uk">www.e3p.co.uk</a></div> | | | | |

| <b>RoC Consulting Phase 2<br/>Site Investigation<br/>January 2022</b> | <p>Ground Investigation works comprised the drilling of 12nr Window Sample boreholes to depths ranging between 1.36m and 5.45m.</p> <p>RoC stated that the exploratory holes were positioned to target areas where prior land uses have impacted soil and groundwater quality.</p> <p>The RoC Ground investigation confirms Made Ground from GL to a maximum proven depth of 3.40m with an average depth of 1.85m. Made Ground predominantly comprises historical demolition and upfill material.</p> <p>The Made Ground is underlain by variable cohesive and granular superficial drift deposits with rockhead inferred at a depth ranging between 2.30m and 3.70m.</p> <p>The Tier 1 contaminated land assessment identified elevated concentrations of inorganic metalloids and Polycyclic Aromatic Hydrocarbons (PAH) within the Made Ground when considering a residential end-use scenario with private gardens.</p> |

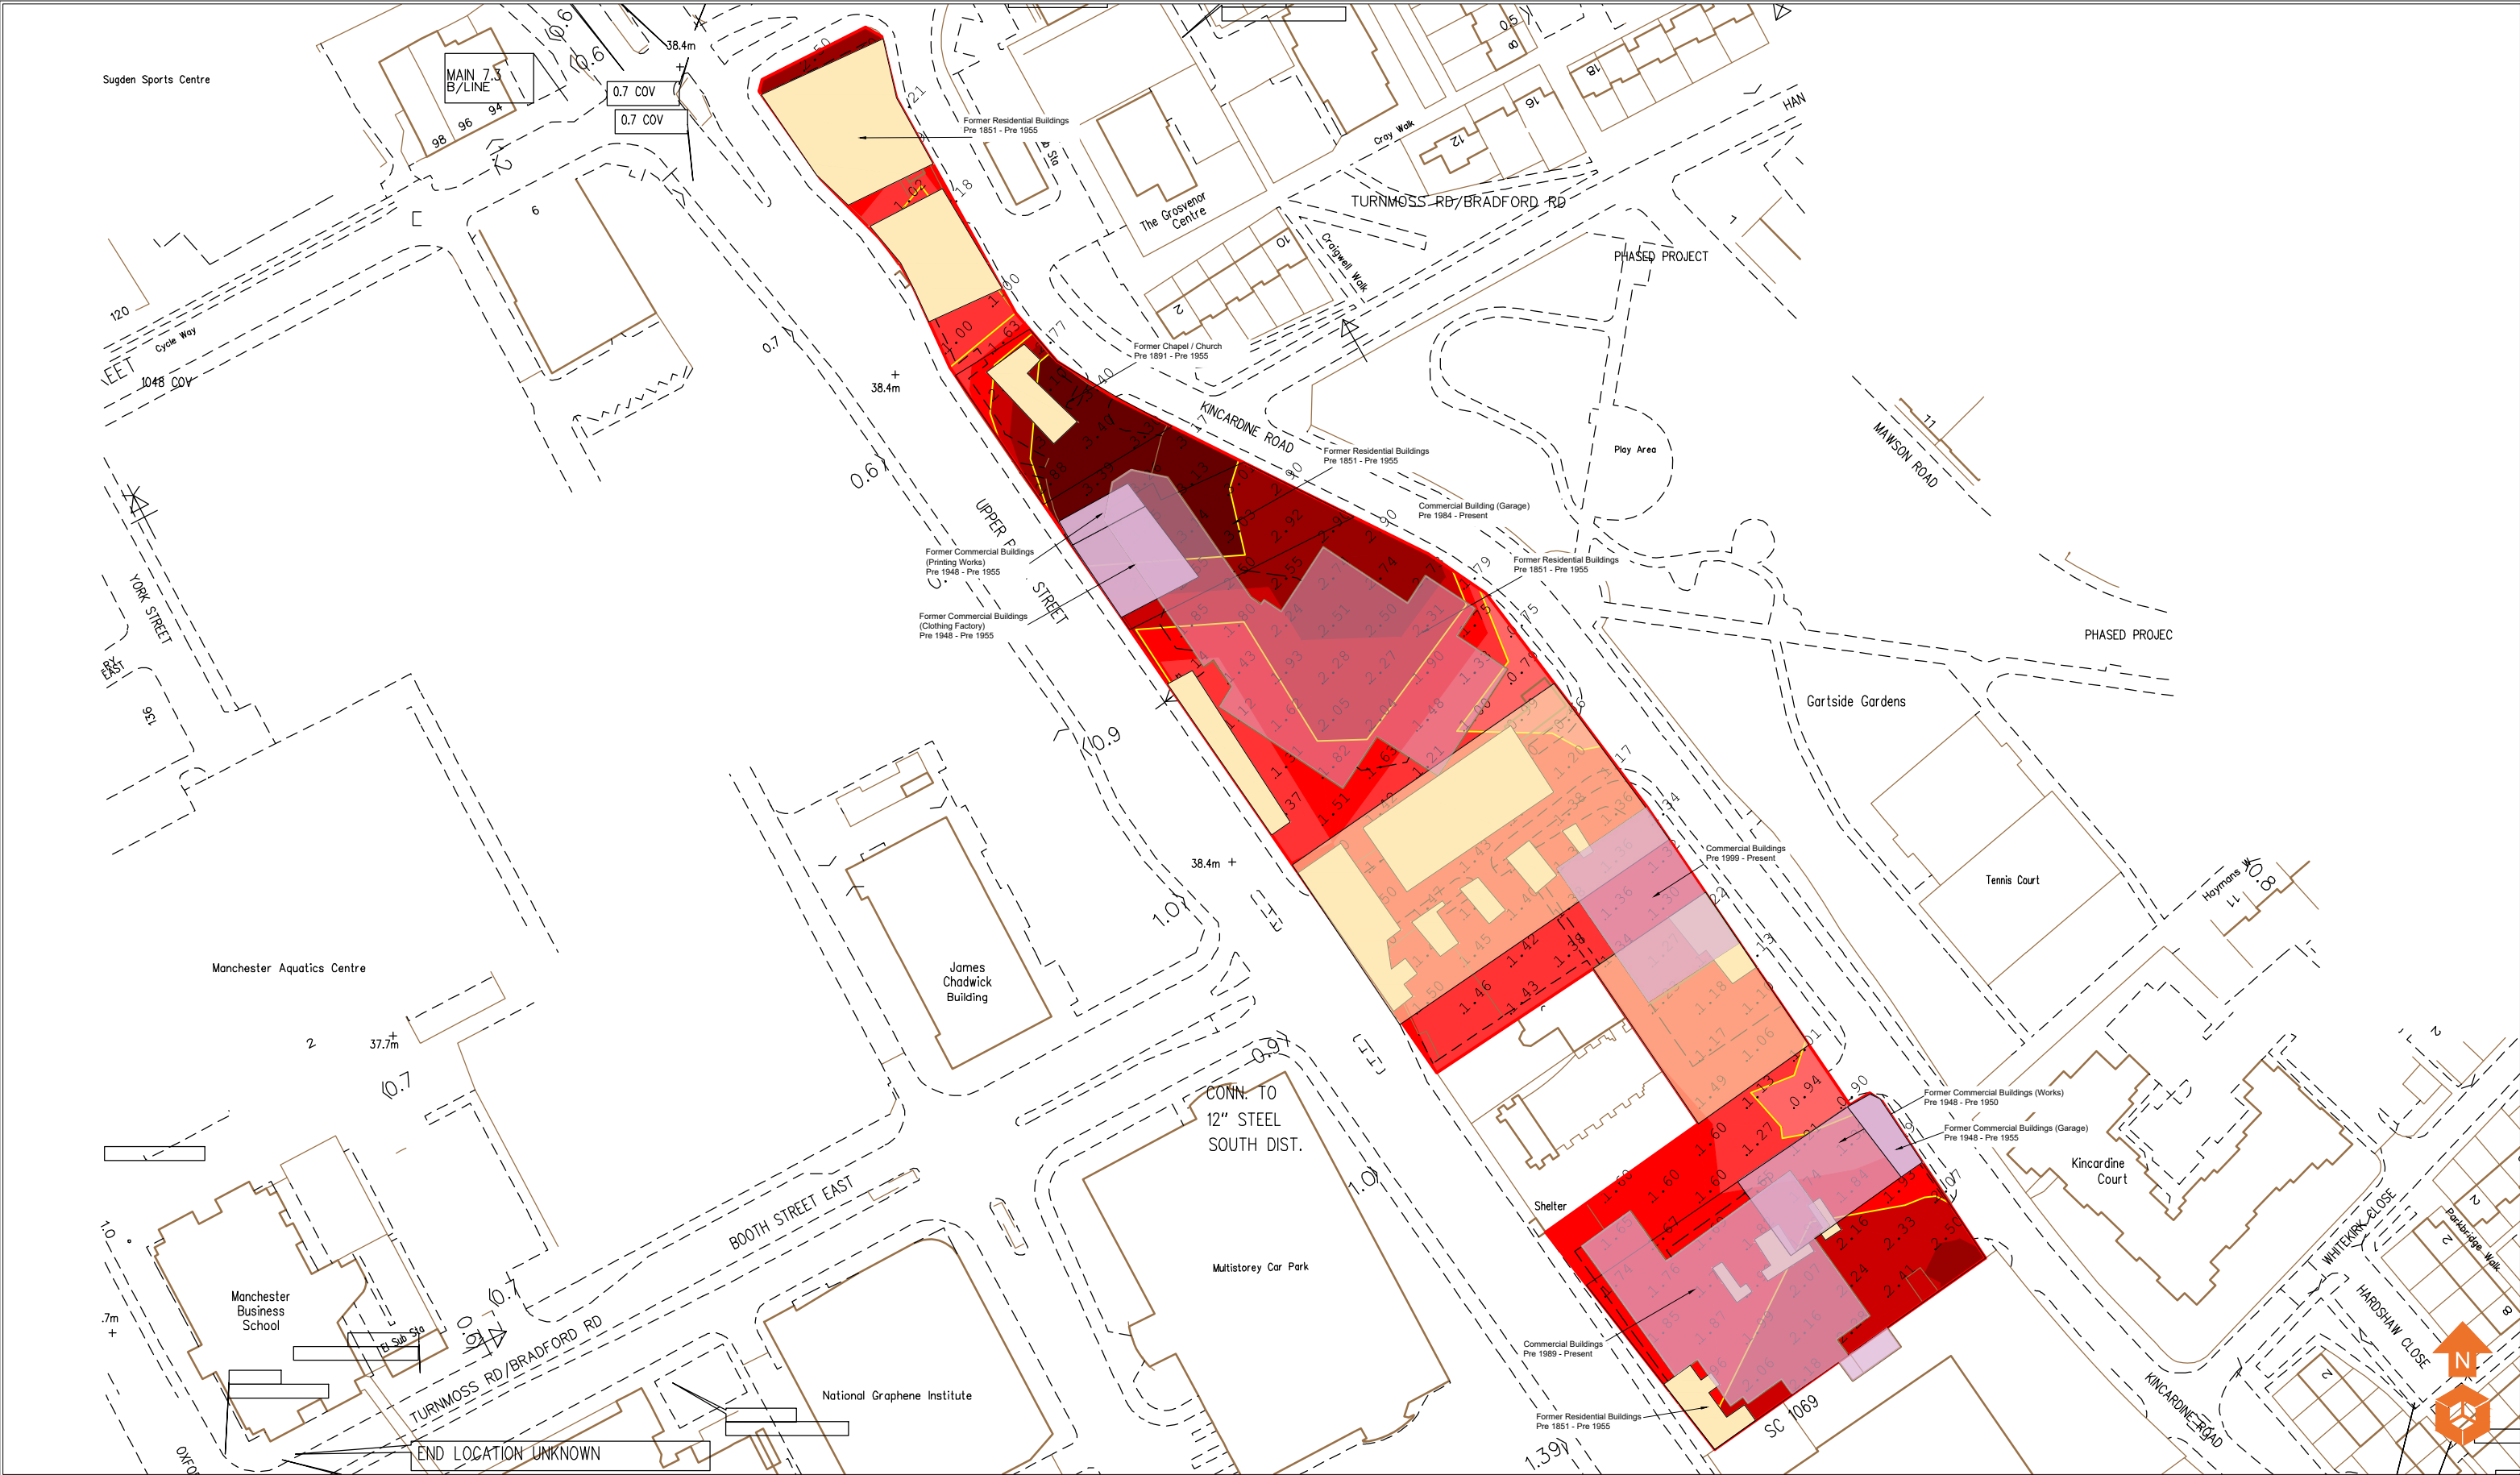
Location Symbols

Approximate Window Sample Probehole Location (ROC Consulting - May 2021)

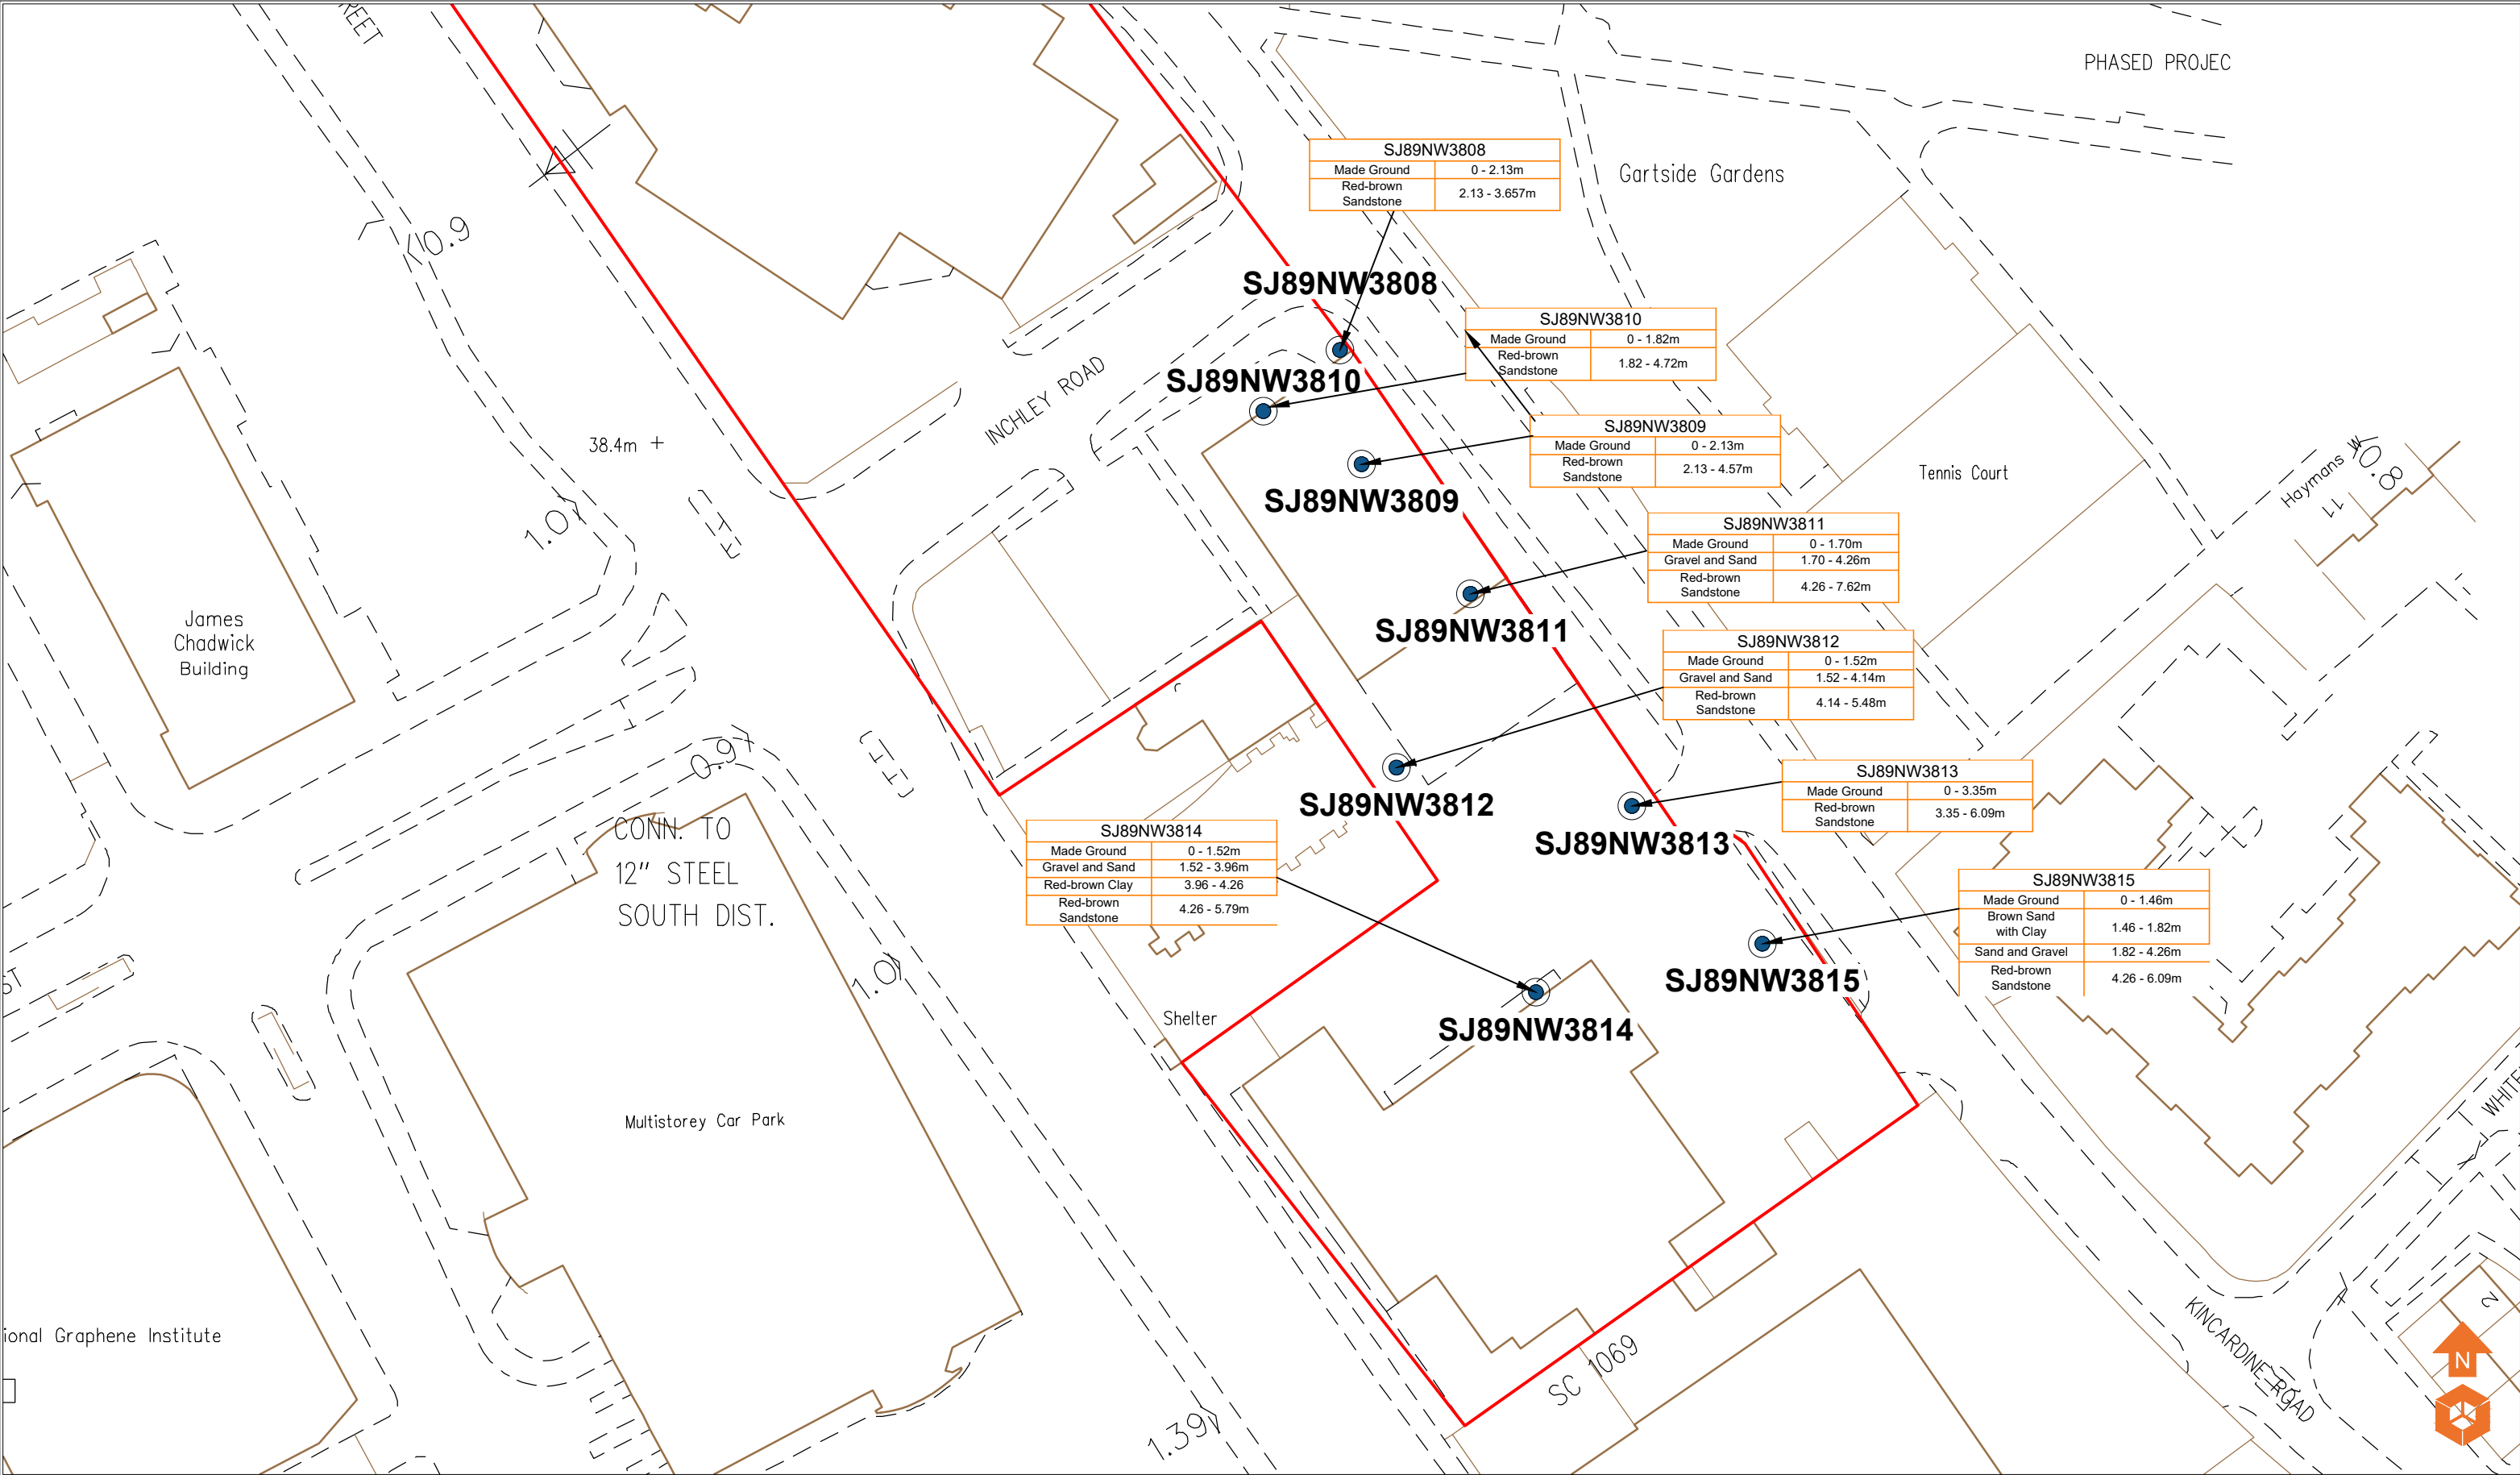
| <div>Location Symbols</div> <div><div><div></div></div><div>Approximate BGS Borehole Location</div></div> | <div>Notes:</div> | | | | | <div>Client:</div> <div>Property Alliance Group</div> | <div>Job No:</div> <div>15-880</div> | <div>Date:</div> <div>30.03.2022</div> | <div><div><div></div></div><div>e3p</div></div> <div>Environmental Engineering Partnership Ltd<br/>Taylor Road, Trafford Park<br/>Urmston, Manchester, M41 7JQ<br/>Tel: 0161 707 9612<br/>E-mail: <a href="mailto:info@e3p.co.uk">info@e3p.co.uk</a><br/>Website: <a href="http://www.e3p.co.uk">www.e3p.co.uk</a></div> |
