Intended for  
**Laing O'Rourke**

On behalf of  
**Manchester City Council**

Date  
**June 2023**

# **ABRAHAM MOSS LEISURE CENTRE & LIBRARY, MANCHESTER VALIDATION REPORT**

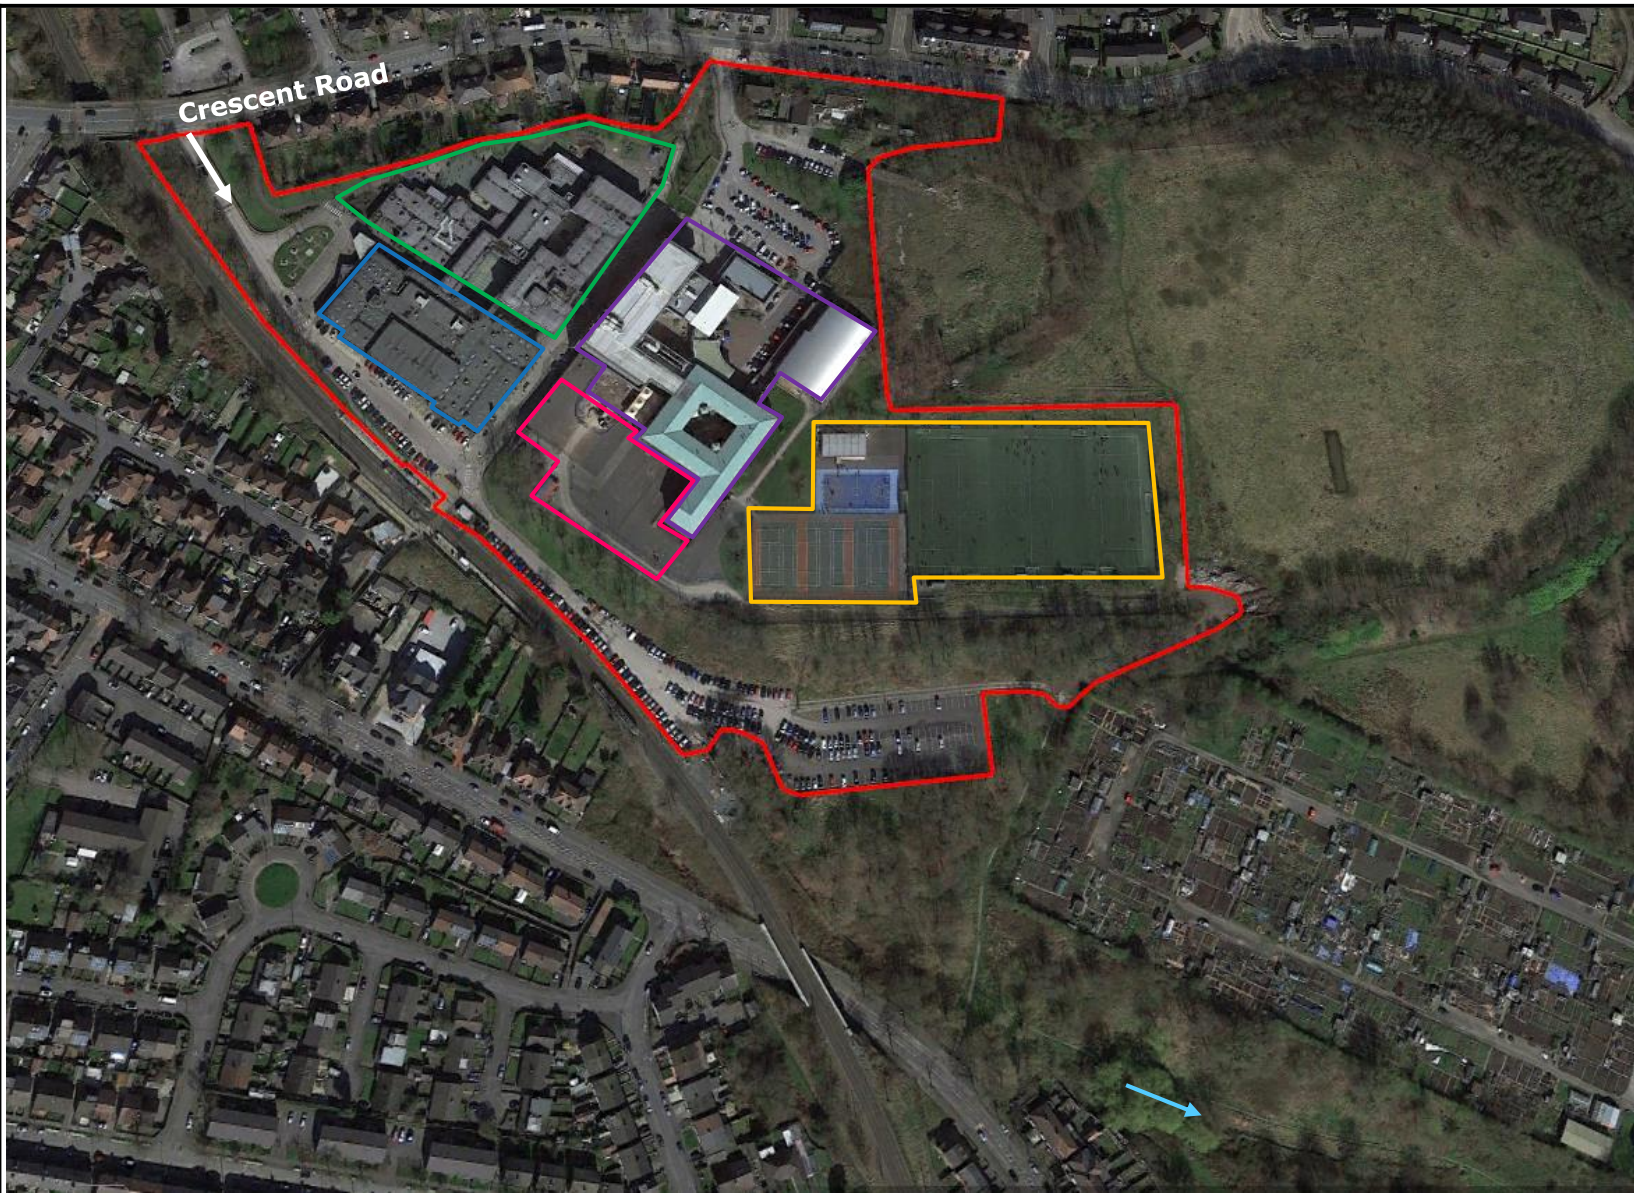
Figure 1620005164/E/01

- Site Boundary
- Abraham Moss Leisure Centre
- Primary School and FE College
- Secondary School
- Playground
- Sports Pitches
- Surface Water location and flow direction
