# PHASE 2 SITE INVESTIGATION

## Freight Island Event Space

Mayfield Partnership Ltd

## PHASE 2 SITE INVESTIGATION

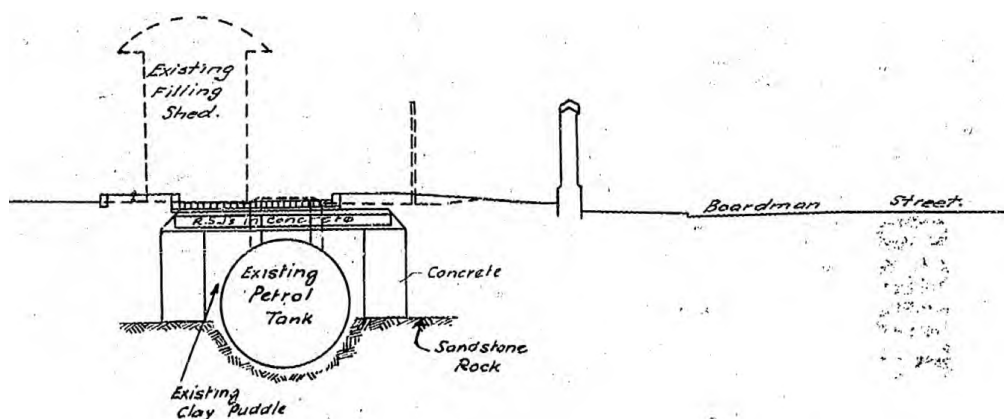
**Fig 3.0: Extract from LMSR Plan relating to Road Motor Petrol Depot improvement works**

- 3.3.4 The gantry structure in the centre of the site was a fuel office building with associated fuel pumps beneath a canopy roof, two fuel storage tanks were located below ground in this area. The structure in the east of the site was a filling shed with a tank located underneath. The plans appear to relate to planned improvement works and a schematic section of a new below ground fuel storage tank is provided (and reproduced below).

- 3.3.5 Records indicate the petrol tanks were contained below ground within a concrete trench structure partially cut into the Sandstone bedrock. The tanks themselves were enclosed within puddle clay, likely to contain any spillage or leakage. The records show tank locations from the original Road Motor depot construction as well as alterations associated with the proposed improvement works. The plans indicate the original below ground tanks were to be removed and replaced. An overlay showing current site features and proposed improvement works (drawing ES300) has been provided within Appendix A.

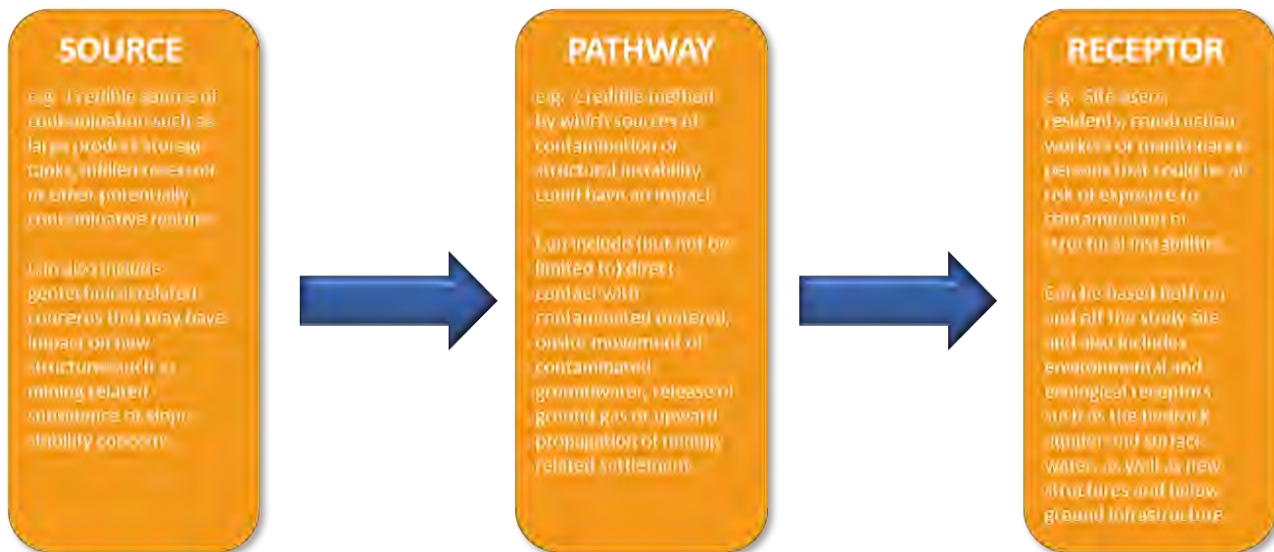
**Figure 8.0 Source Pathway Receptor Diagram**

- 8.0.1 The information obtained during the desk-based study has been reviewed to establish the Preliminary Conceptual Model for the site. This model is based around the Source / Pathway / Receptor methodology as outlined in Figure 8.0.

- 8.0.2 Risk assessment is the process of collating known information on a hazard or set hazards in order to establish actual or potential risks to receptors. The receptor may be human health, controlled waters, a sensitive local ecosystem or even construction materials. Receptors can be connected with the hazard under consideration via one or several exposure pathways (e.g. the pathway of direct skin contact and oral exposure).

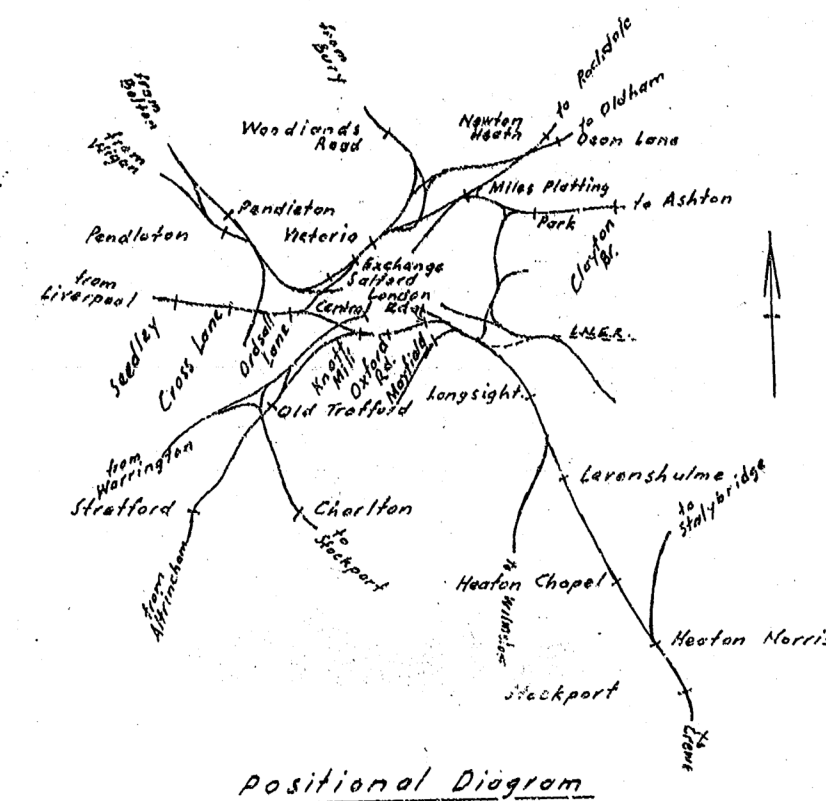
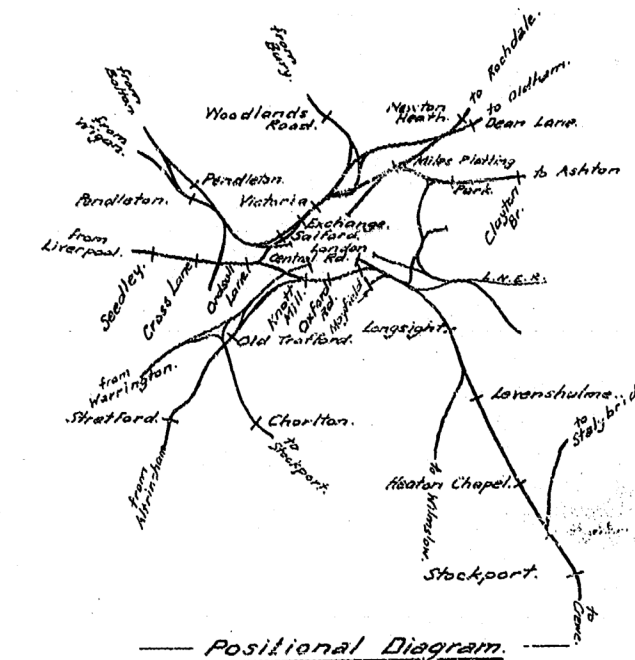
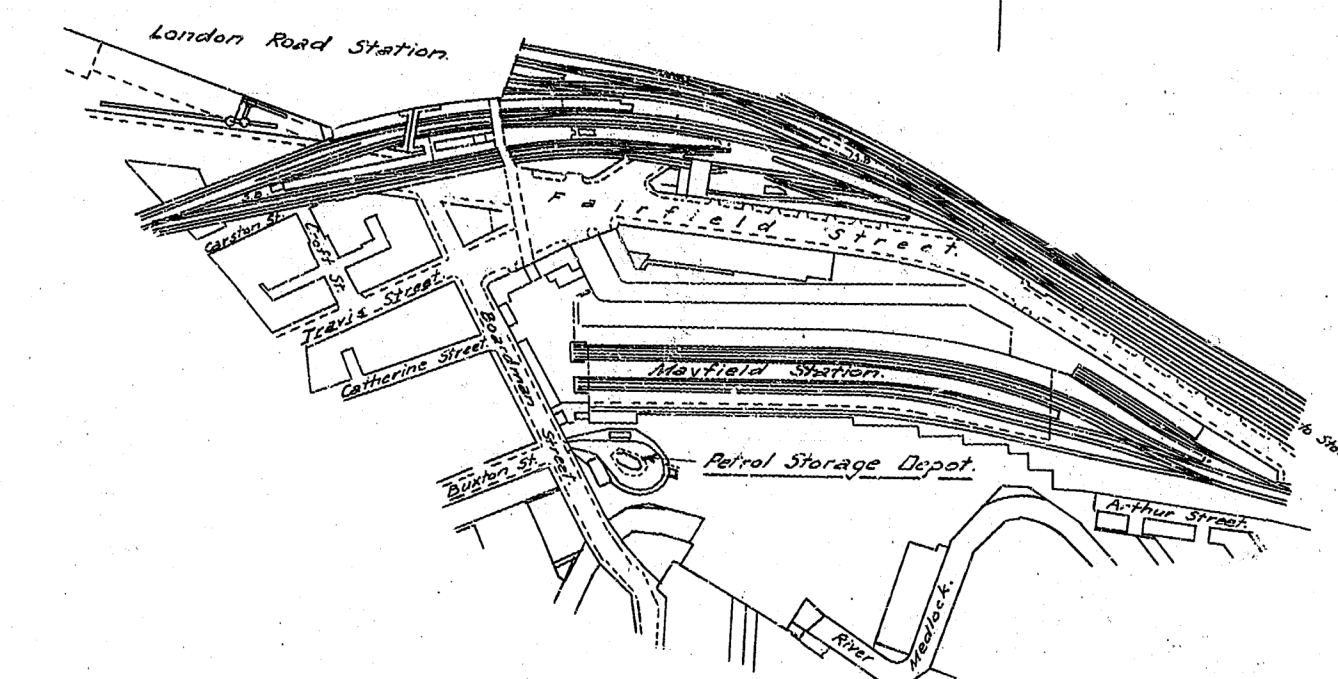
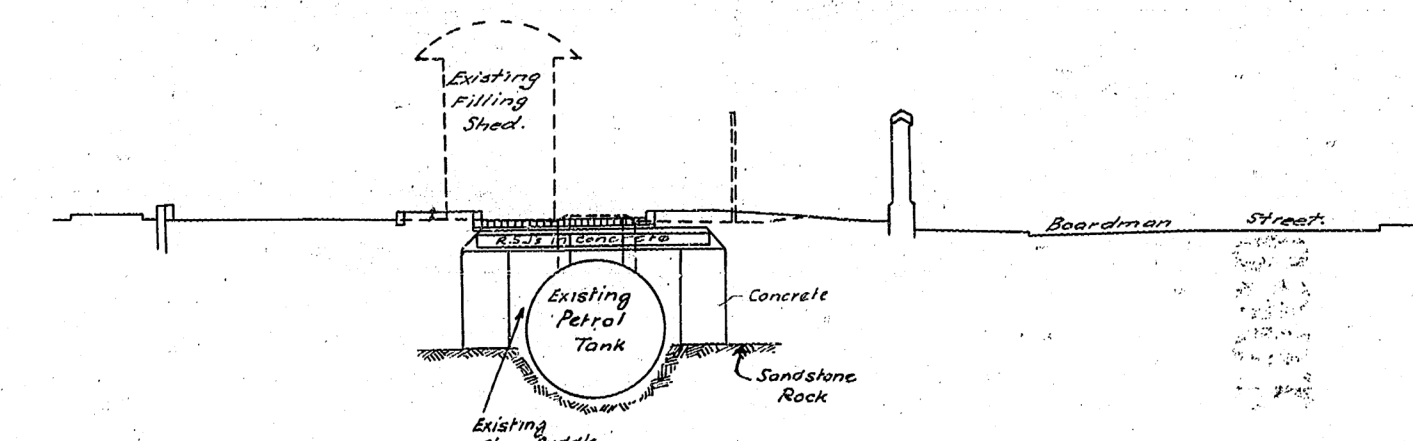
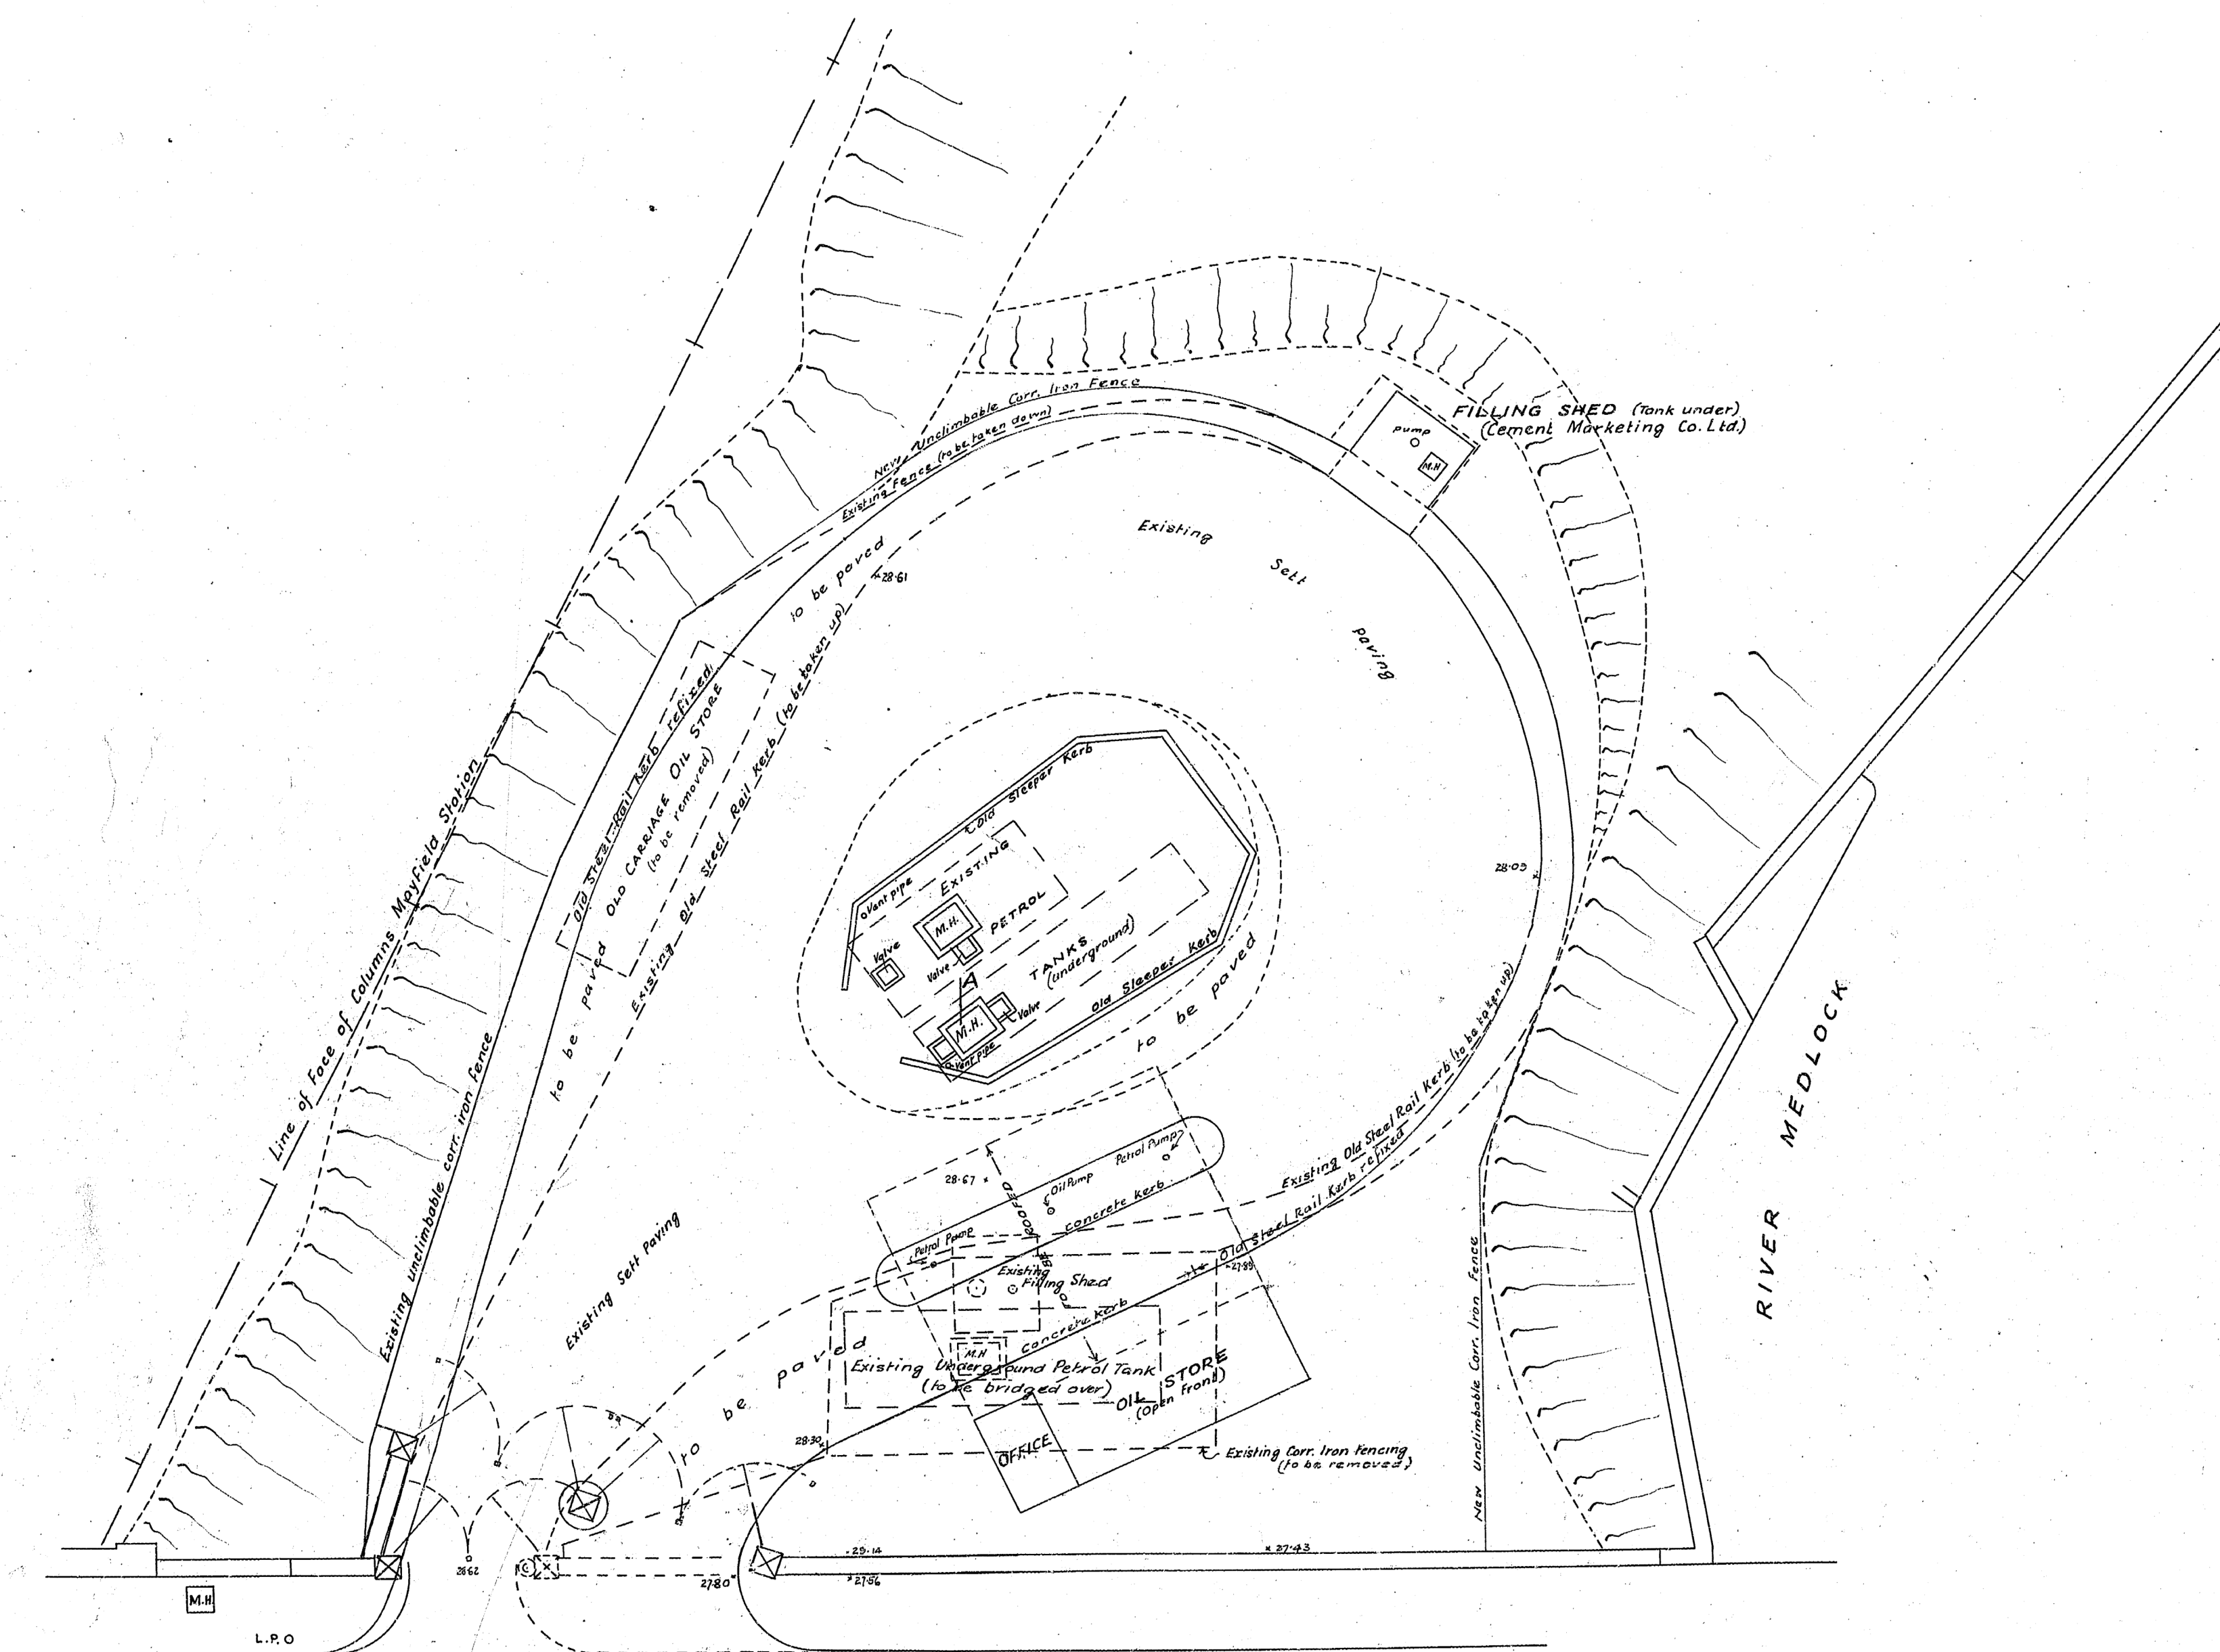
# LMSR - MANCHESTER - MAYFIELD PETROL INSTALLATION

**LMSR MANCHESTER MAYFIELD STN**

—Proposed alterations to Road Motor Dept. Petrol Depot.

Section on Line A-

- 3.3.3 Review of the layout plan for the “Road Motor Depot” (a copy of which is provided within Appendix A) indicates the site to have been accessible from Boardman Street (now Baring Street) and was surfaced by sett paving with concrete paving encircling a central gantry structure. The structure in the northern portion of the site was noted as an oil store, the structure in the west of the site was noted as a filling shed with a storage tank situated below ground,
