PLANNING RESPONSES  
SUNLIGHT HOUSE  
APRIL 2023

PLANNING RESPONSES  
SUNLIGHT HOUSE

EXTERNAL ALTERATIONS

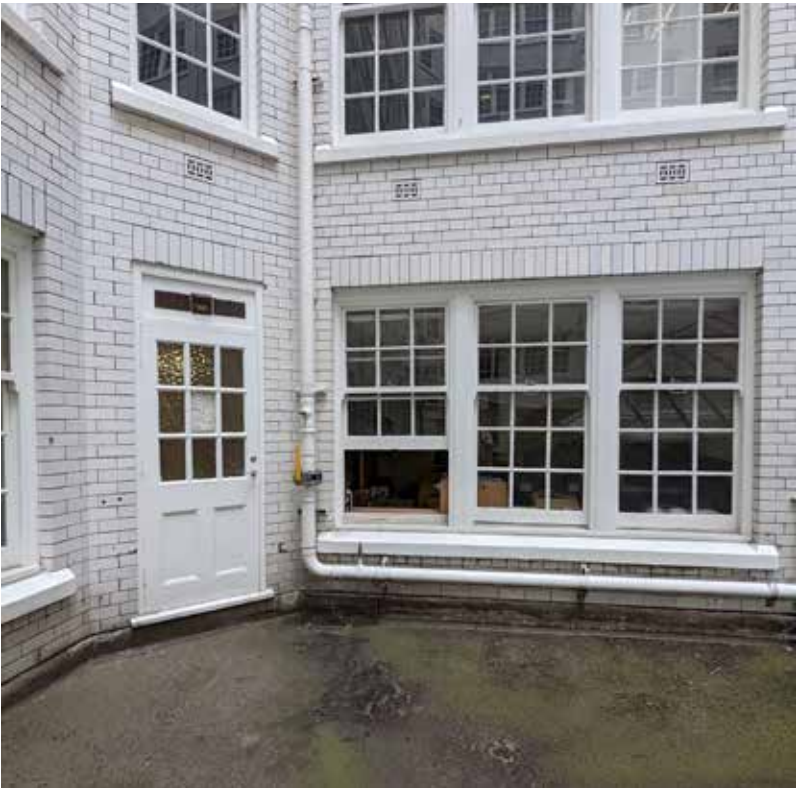
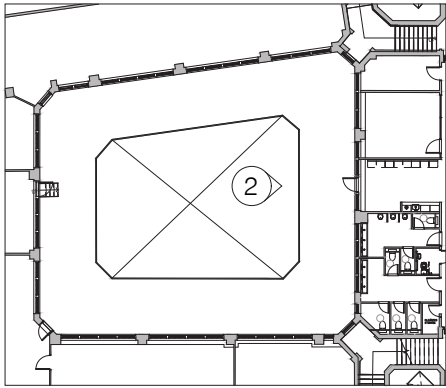
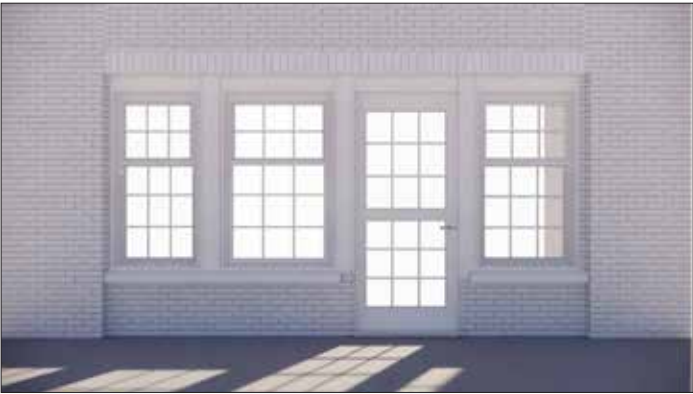
2. COURTYARD ACCESS DOOR

Drawing now produced. The doorway will be integrated into the window set rather than previously approved 'modern' doors as part of the new lift application. It will appear central from internal due to wall placement.

Design intent for new atrium door. To fit in existing opening from one external window to the atrium. Door mullions to match window mullion heights. Door to match style and finish to existing windows.

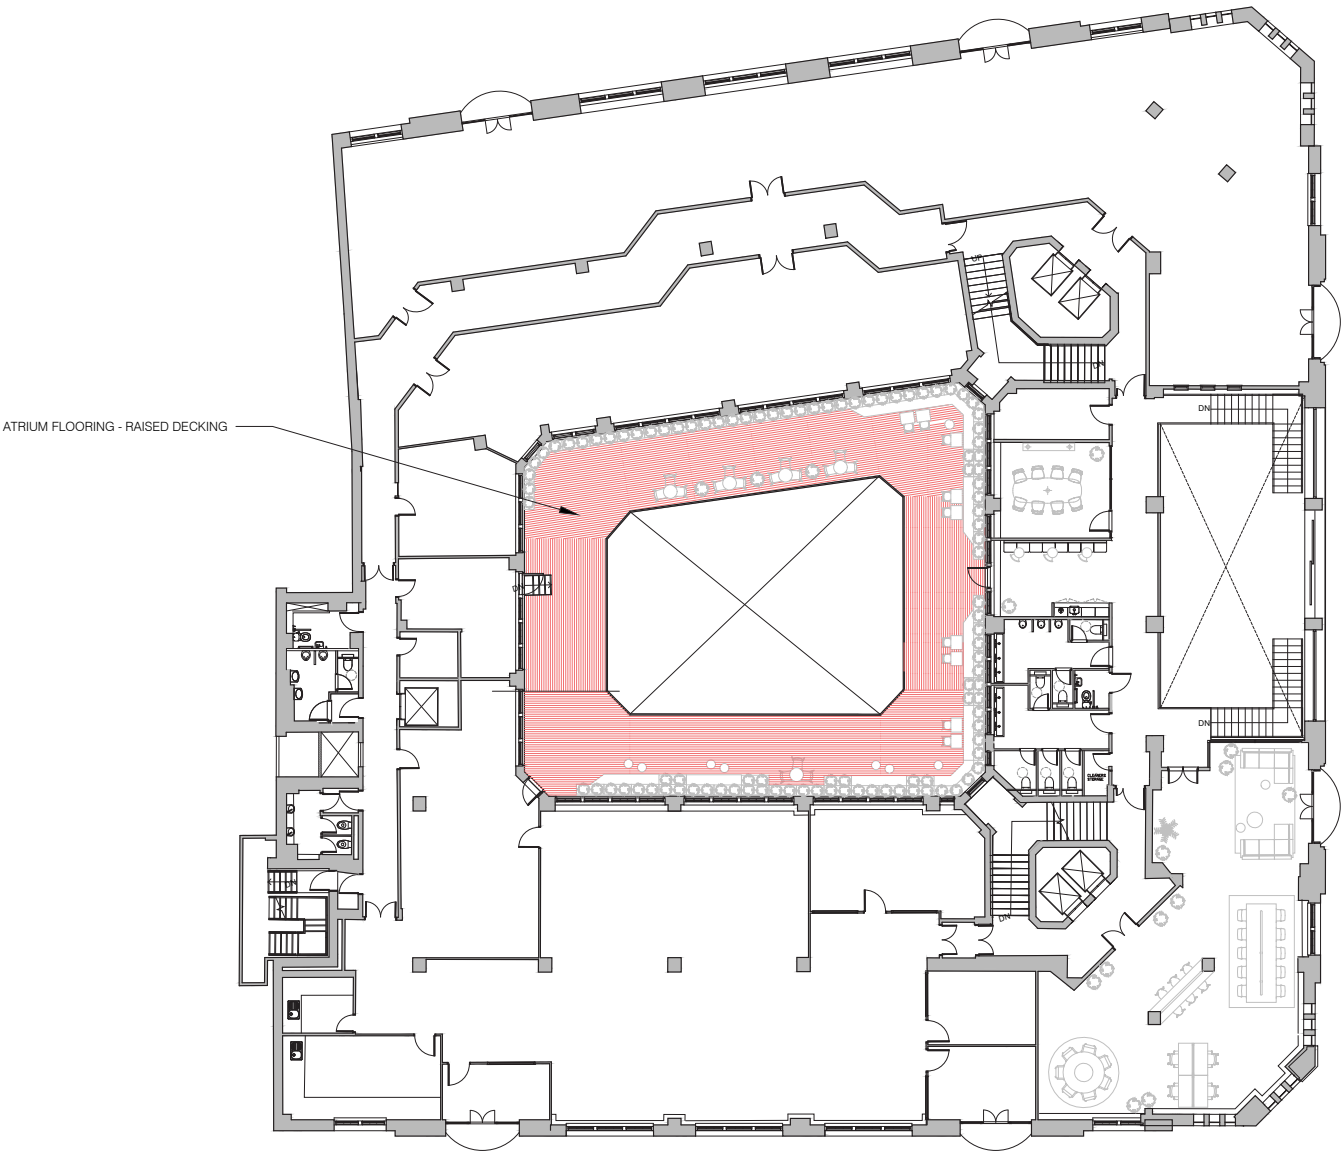
3. COURTYARD DETAILS

Further information provided with final materials to be approved by condition. Structural solution uses a metsec raised floor to span between existing structure and allow load sharing/better drainage/improved level access.

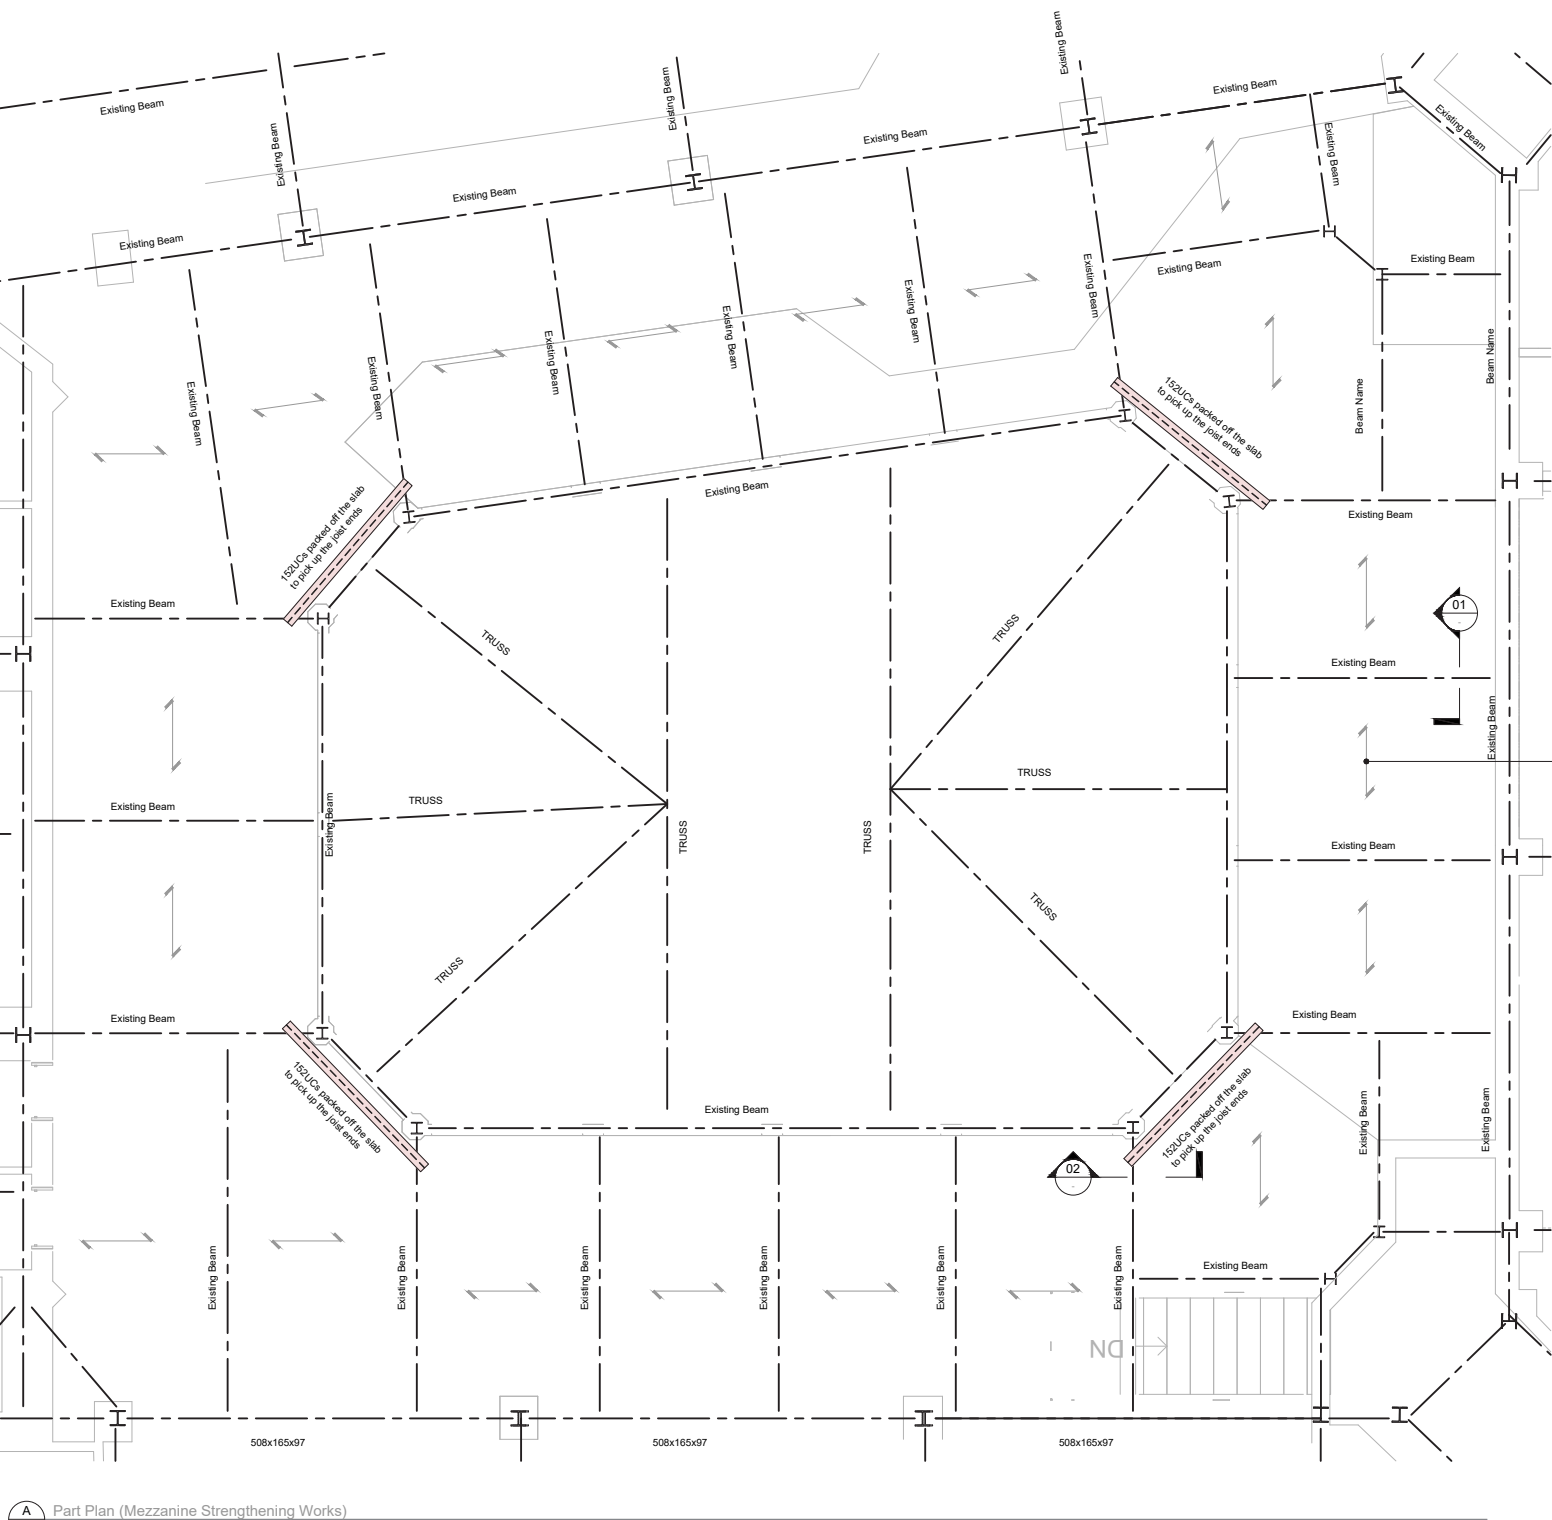
A Part Plan (Mezzanine Strengthening Works)  
1:10

Structural drawings showing proposed spanning solution.

142 M13 Metsec Joists at 400 c/c with 18 mm external grade plywood glued and screwed. Plywood to be waterproofed with sealing material

Contractor to survey and mark-out all existing beams on the surface of the slab to ensure bearing is made directly over the existing beam

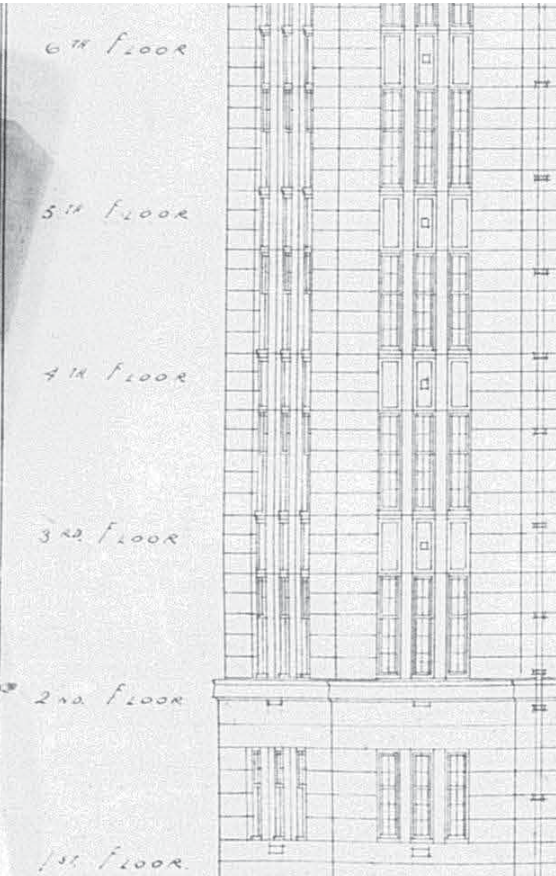
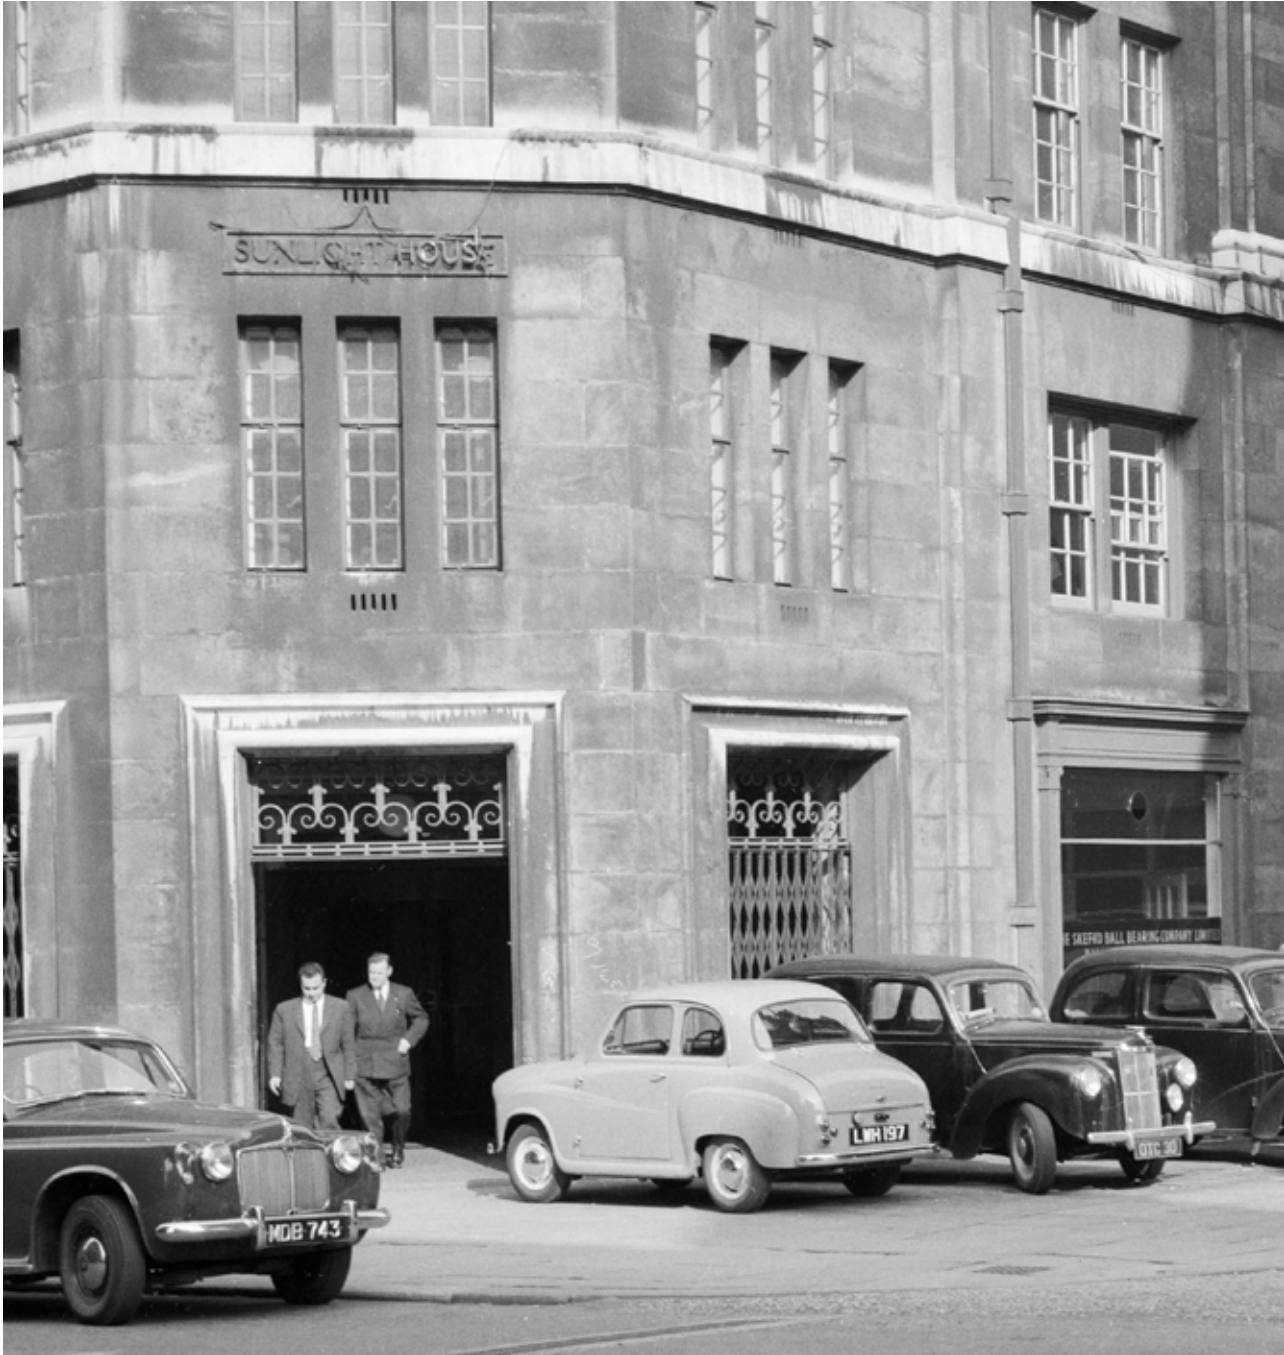
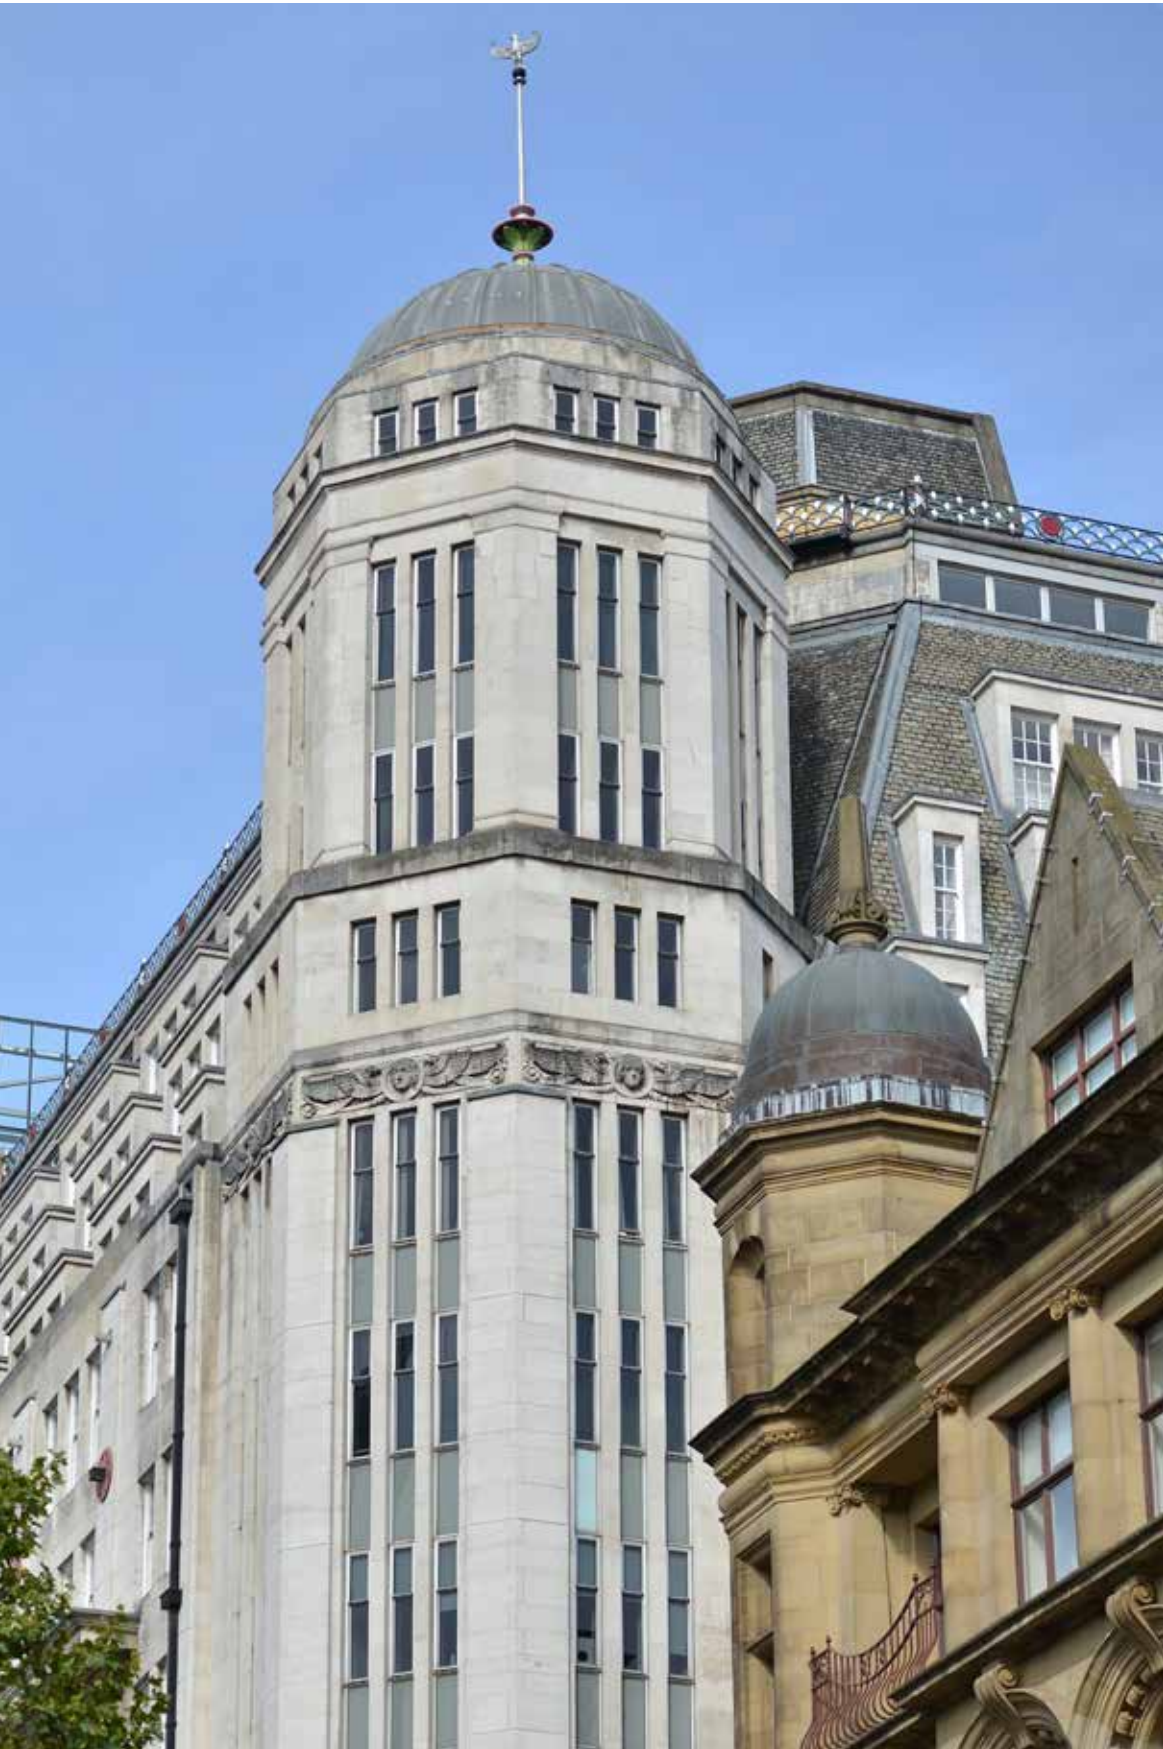
5. CORNER TURRET WINDOWS

Happy for the detail, material and design to be conditioned. We have archive photos and drawings indicating a smaller paned approach with spandrel panel.

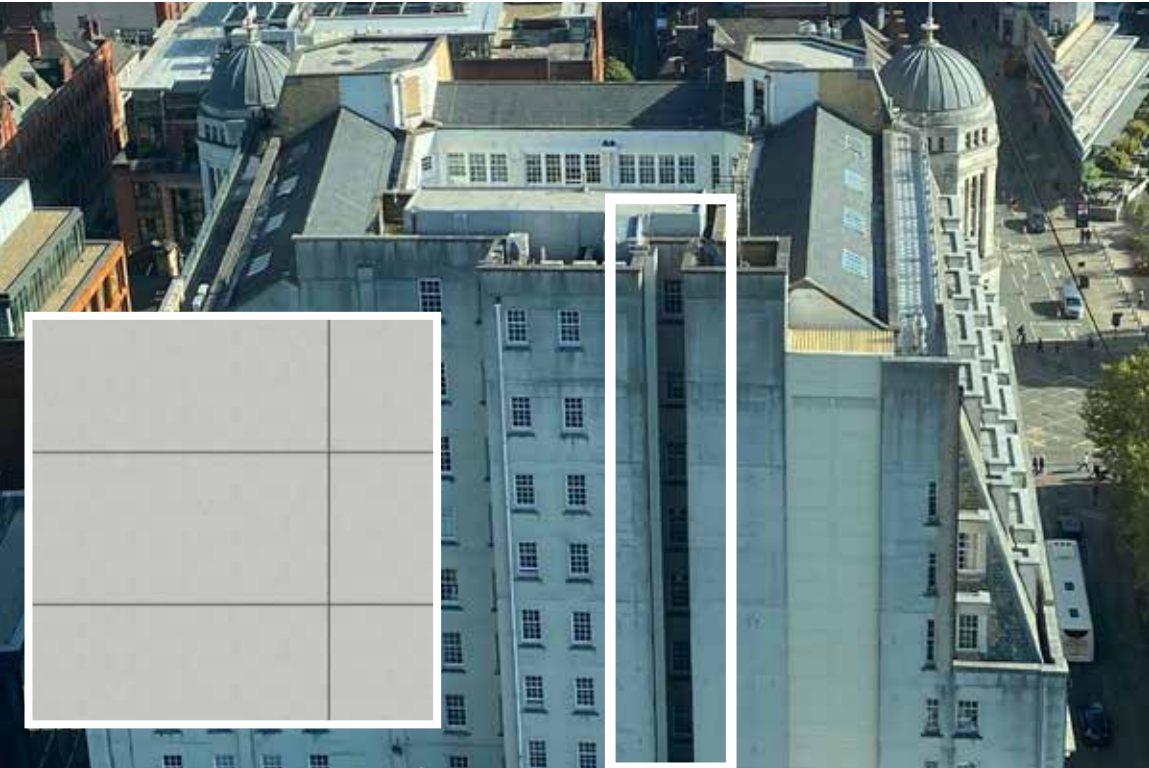
01 EXISTING WINDOW ELEVATION  
1:20

Drawing now provided to work within the frame opening. External riser finish to be a white rainscreen style system to match current rendered finish and existing ductwork casing.

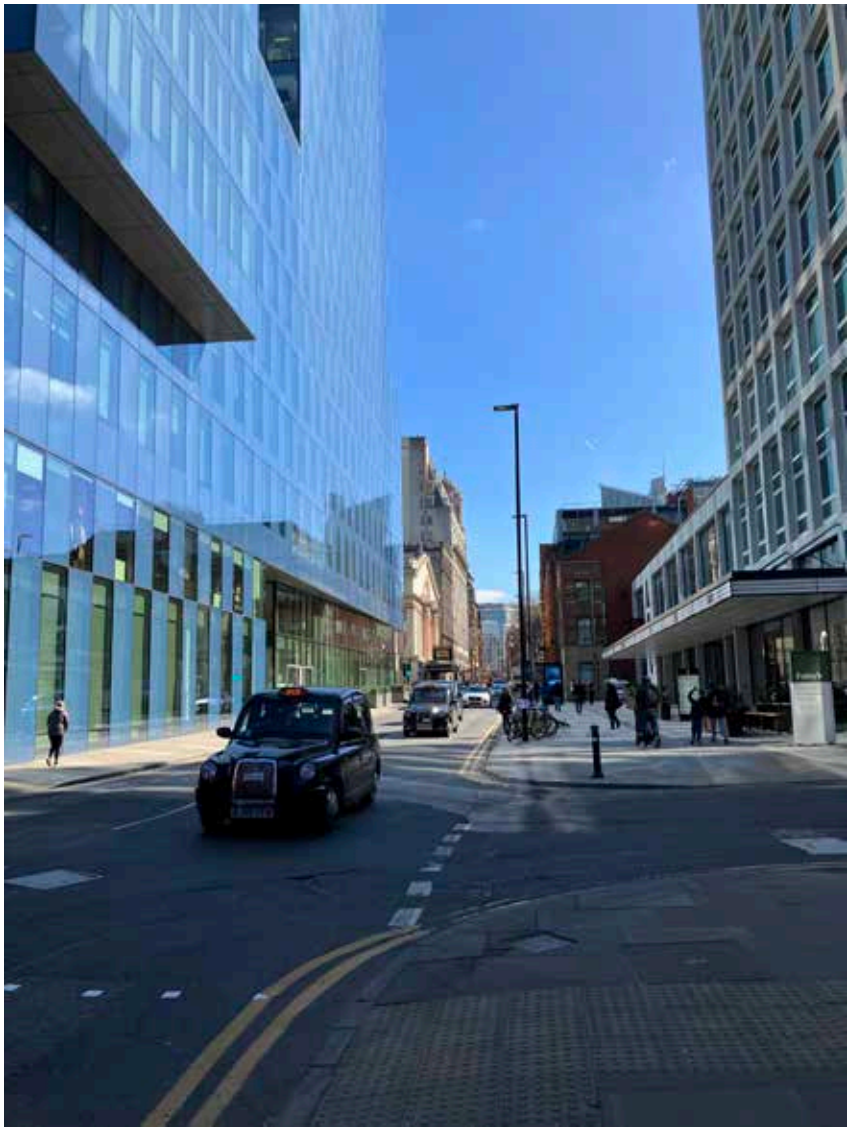
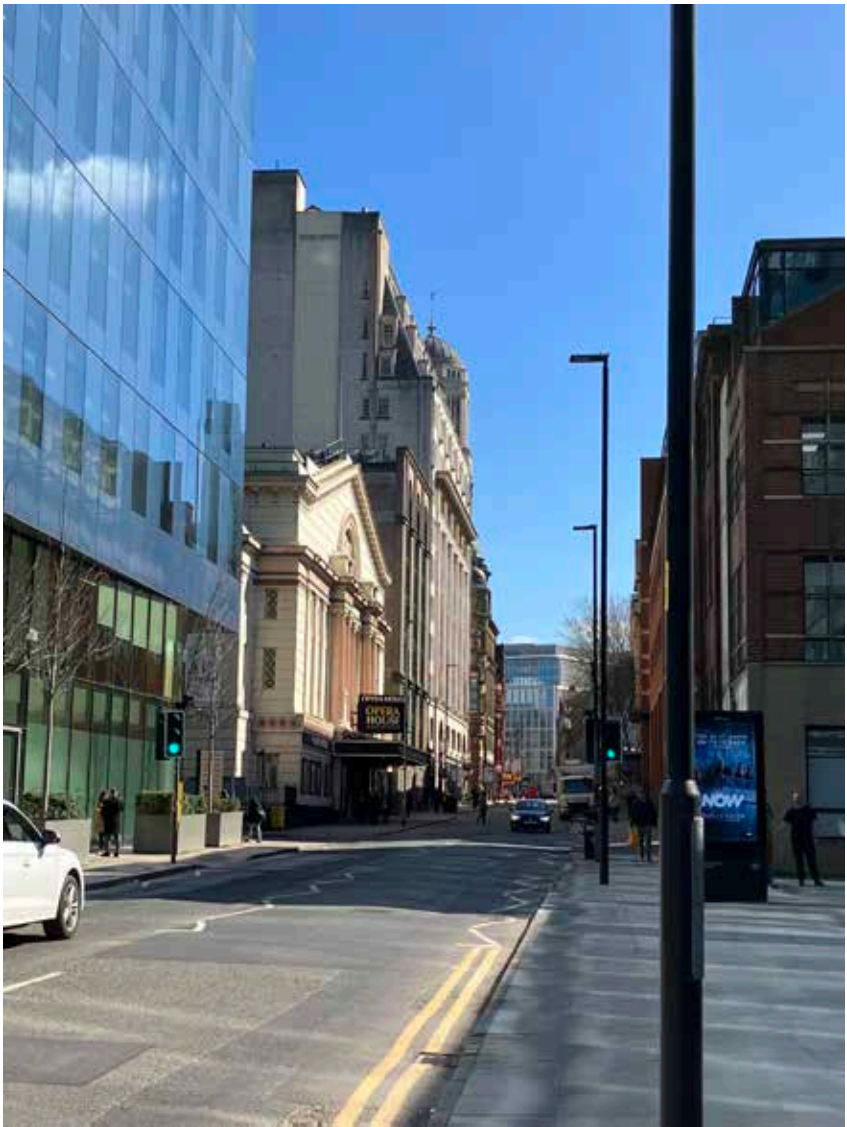
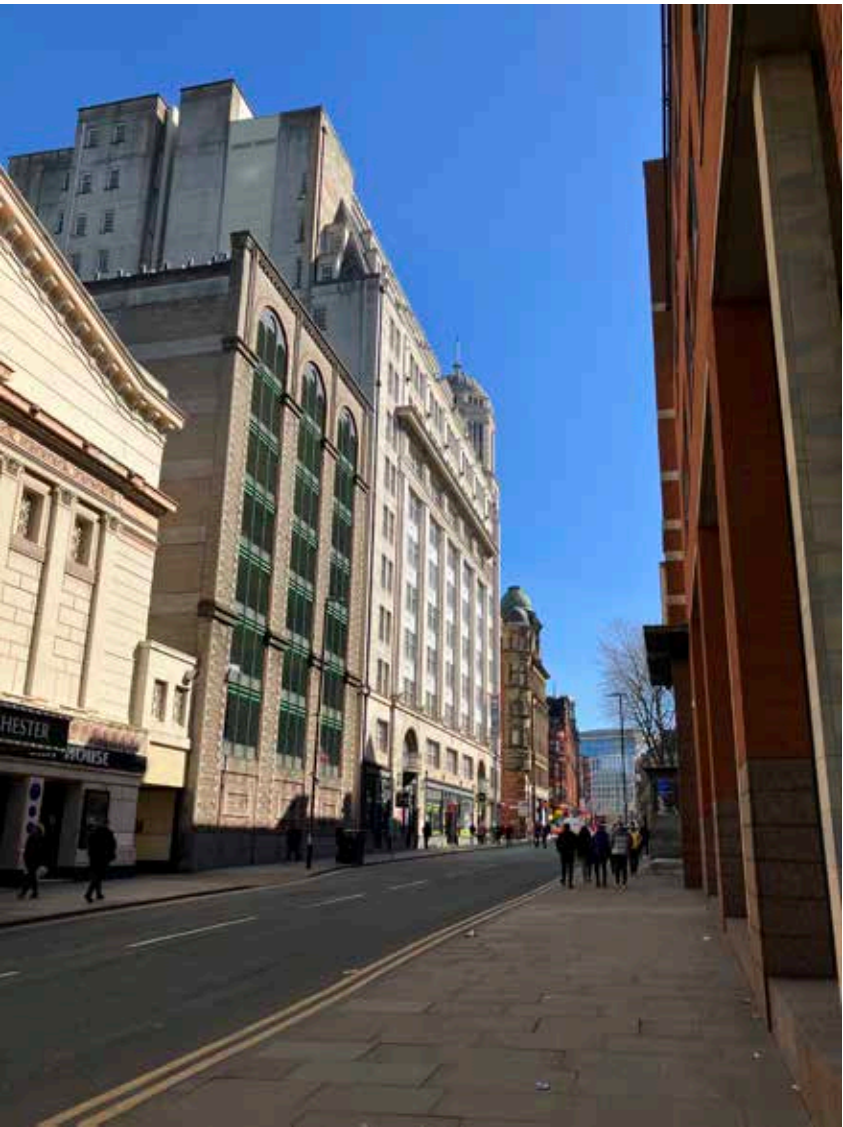
Key townscape views looking East along Quay Street demonstrating the impact of the tall mansard floors in masking the final roof pitch

- due to the shape of the steep mansard levels between 9 and 12 and then the further parapet to inset roof of level 13, the slopes above the vaulted ceiling of level 13 are not visible in street views.
- the proposed tile hanger fixing has been discussed further with heritage suppliers and is the preferred solution due to the reduced impact on original material and unknown substrate/roof structure under the tiling. The projection is limited to c. 200mm from the roof plane, meaning that even with projection the panels will still not be visible from any key views.

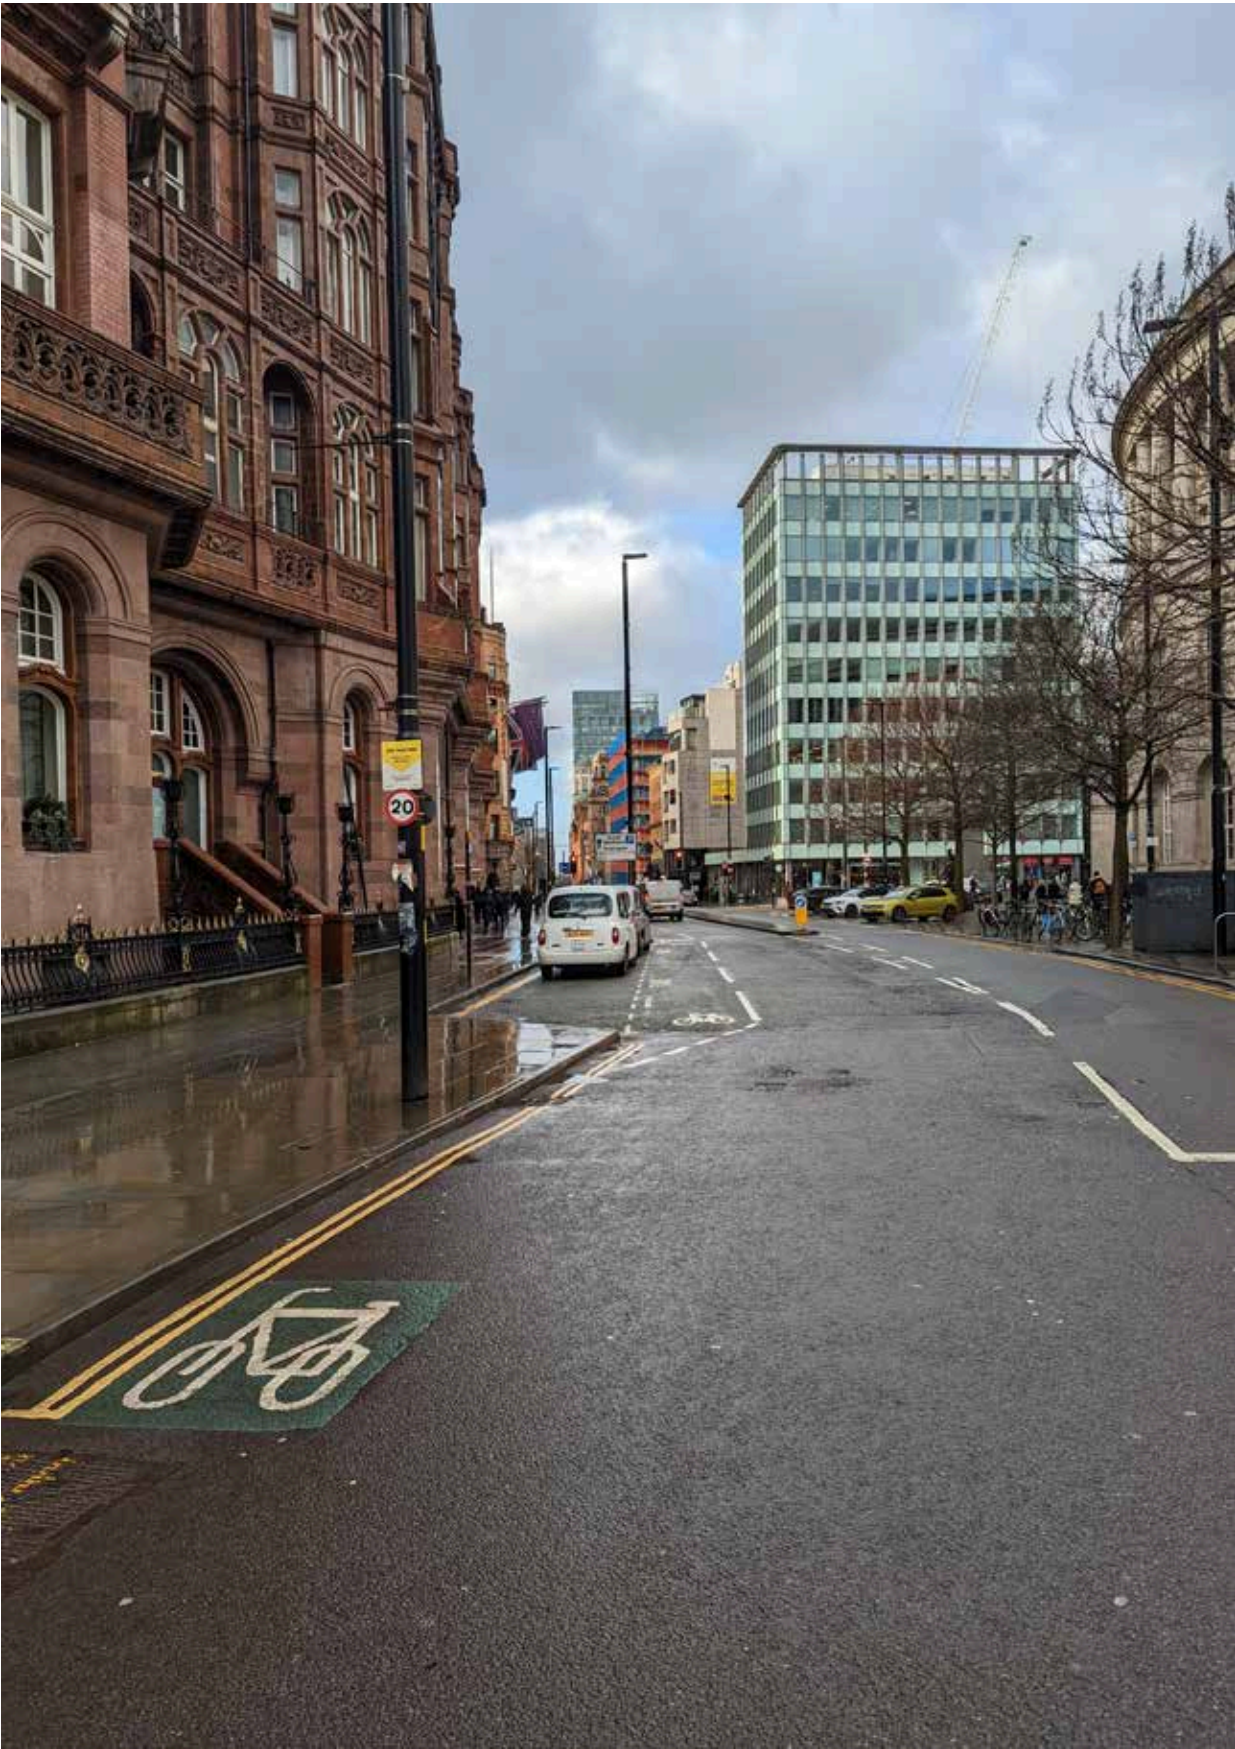
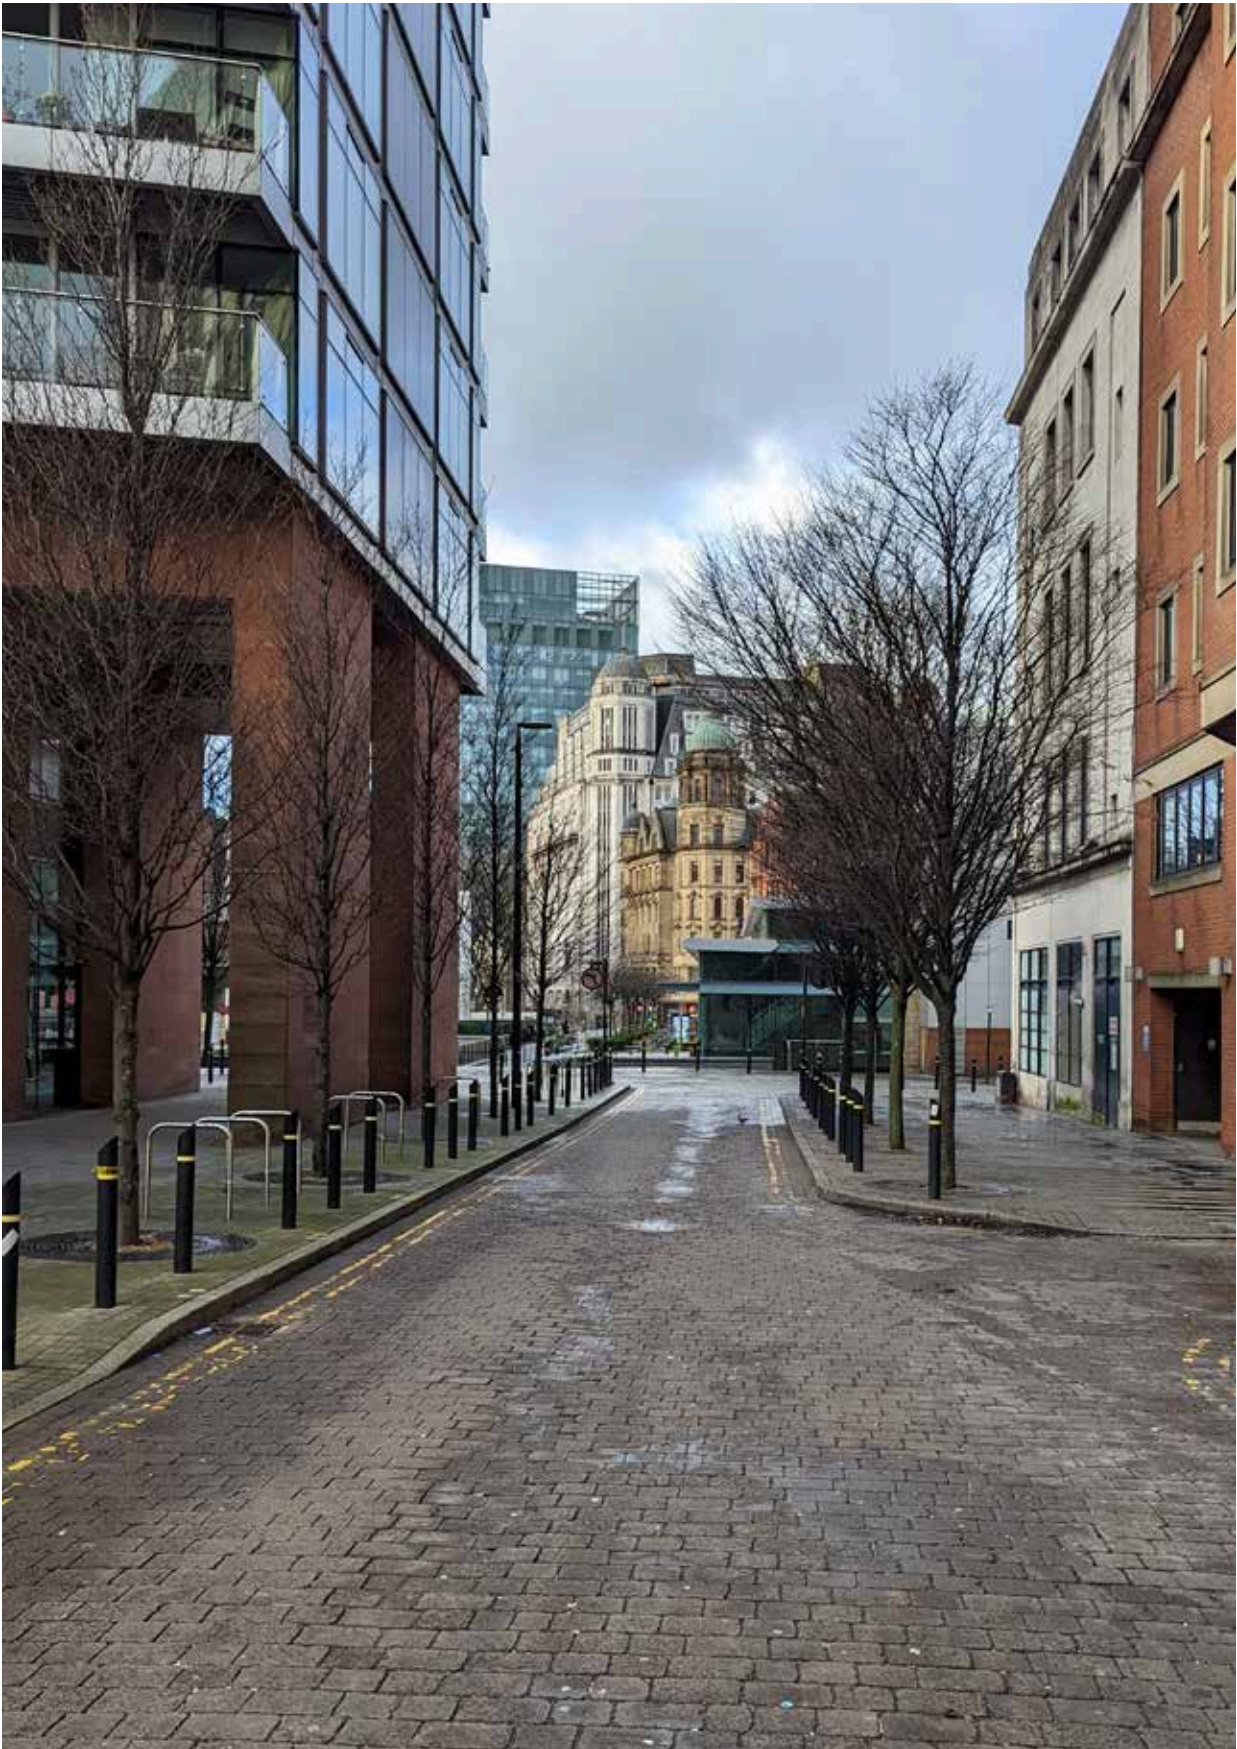
Key townscape views looking West demonstrating the impact of the tall mansard floors in masking the final roof pitch
