PLANNING RESPONSES  
SUNLIGHT HOUSE  
APRIL 2023

PLANNING RESPONSES  
SUNLIGHT HOUSE

EXTERNAL ALTERATIONS

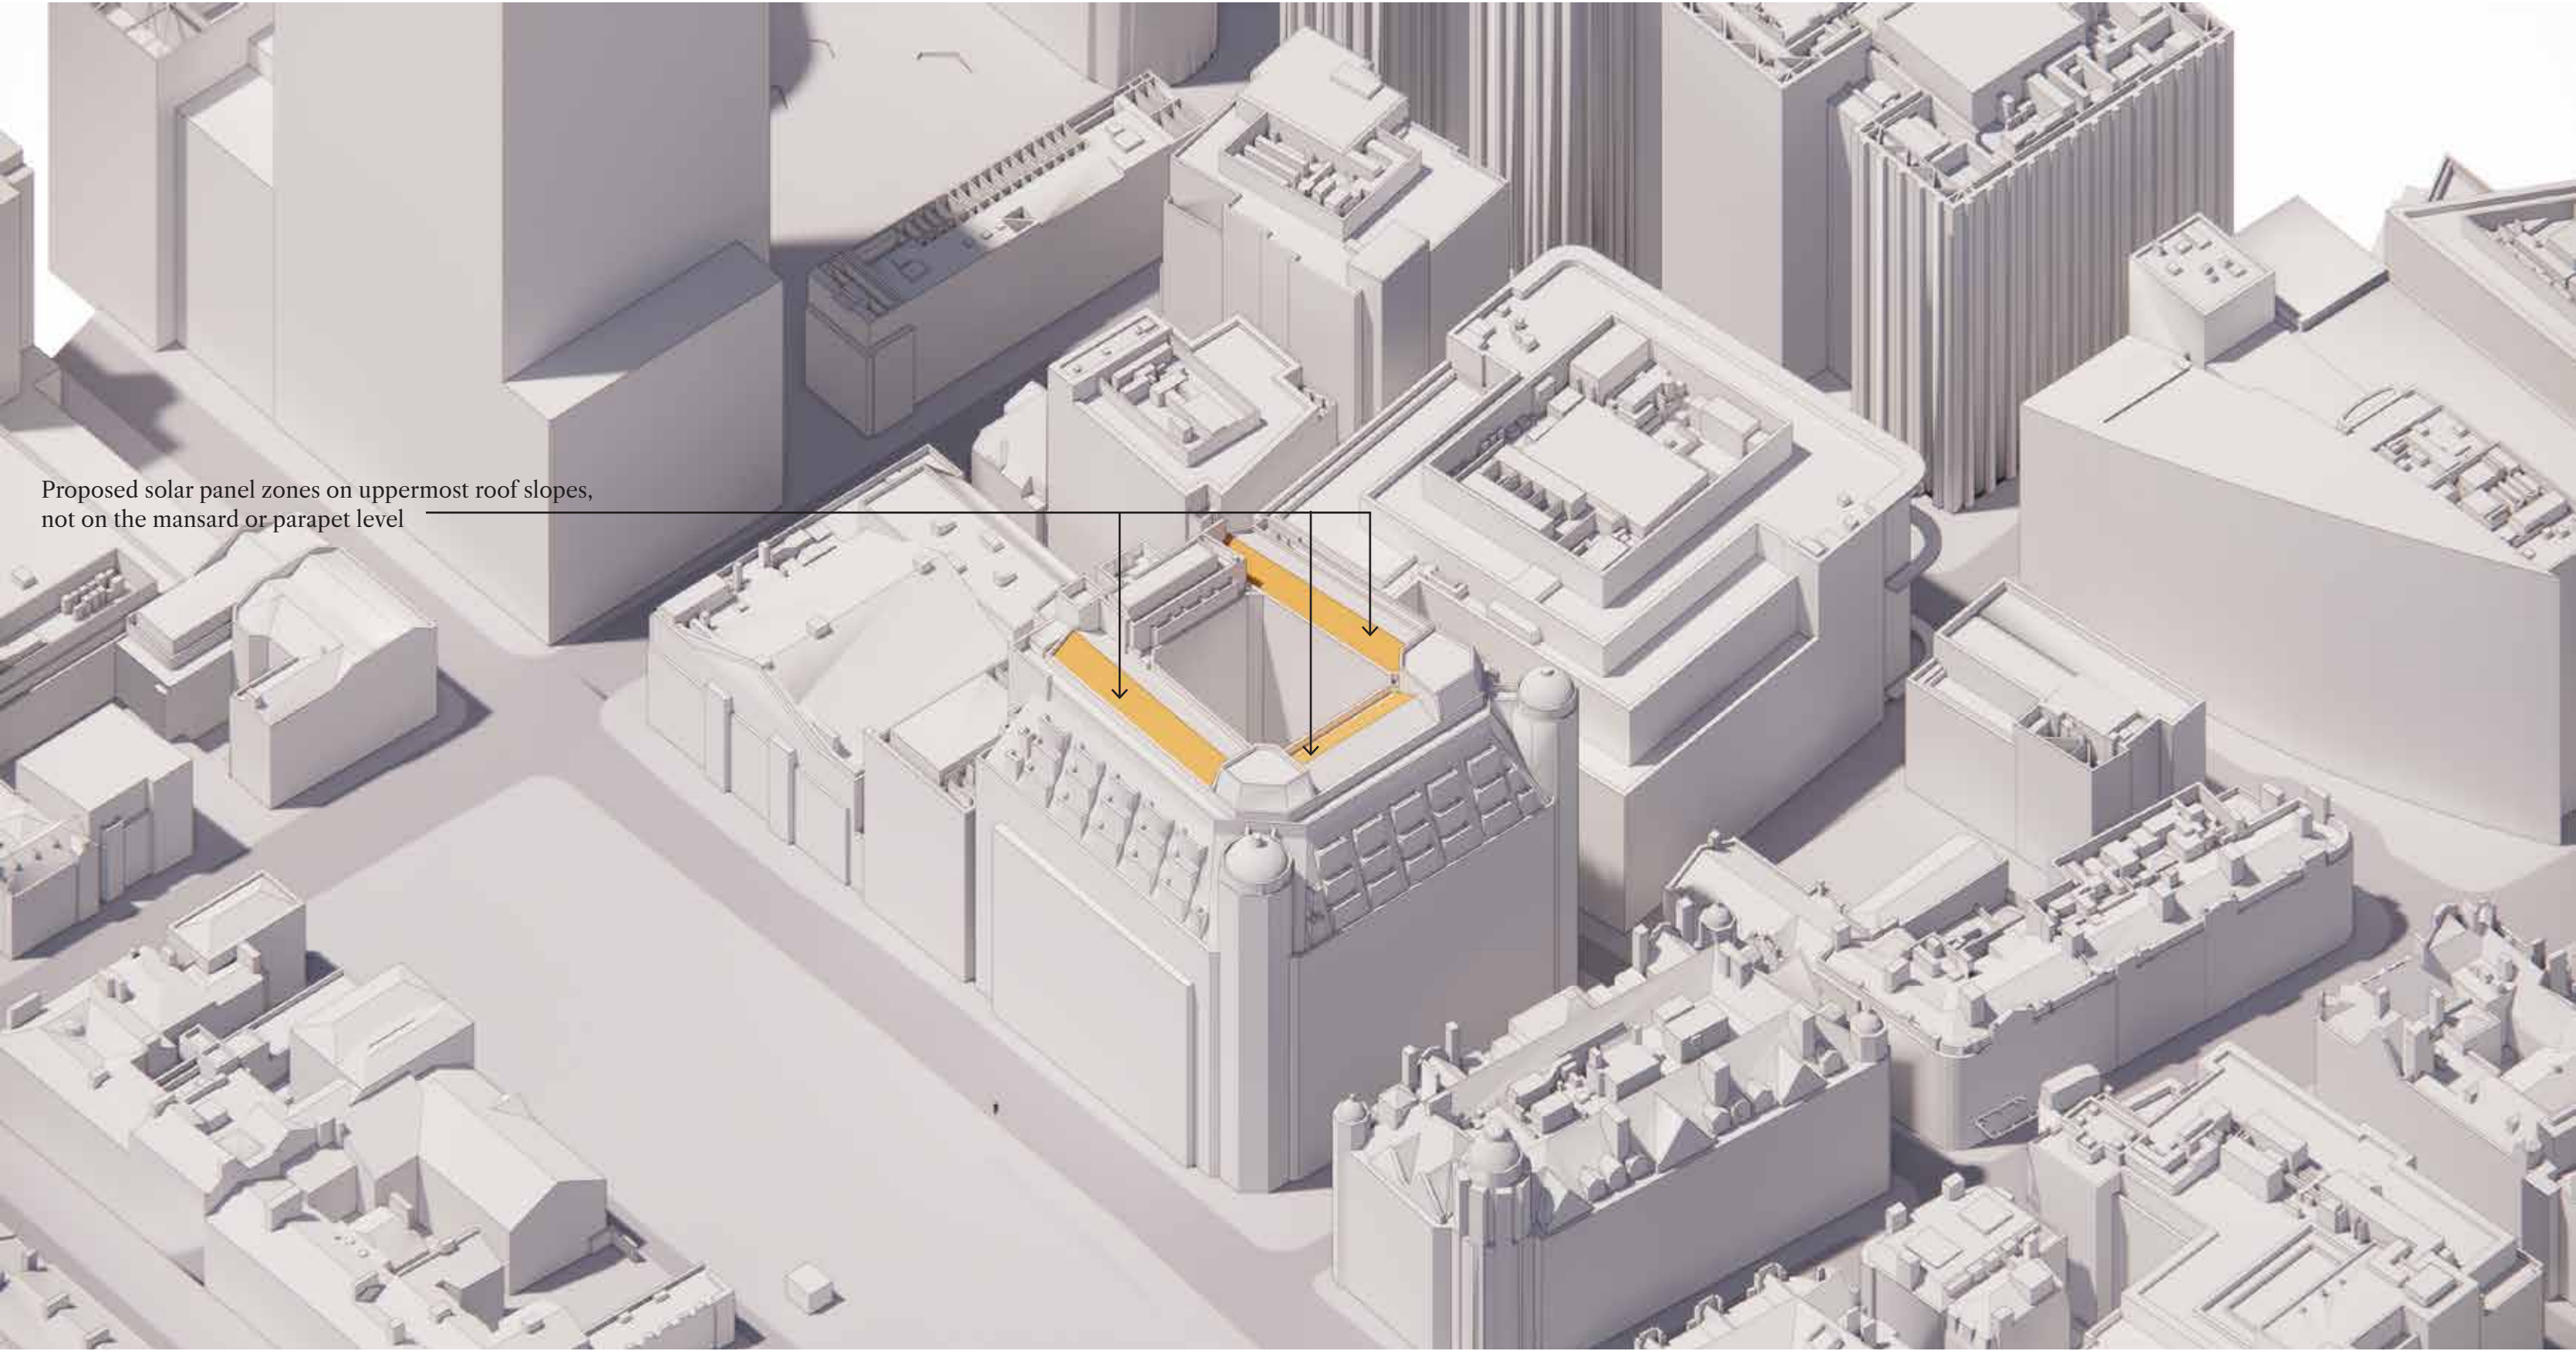
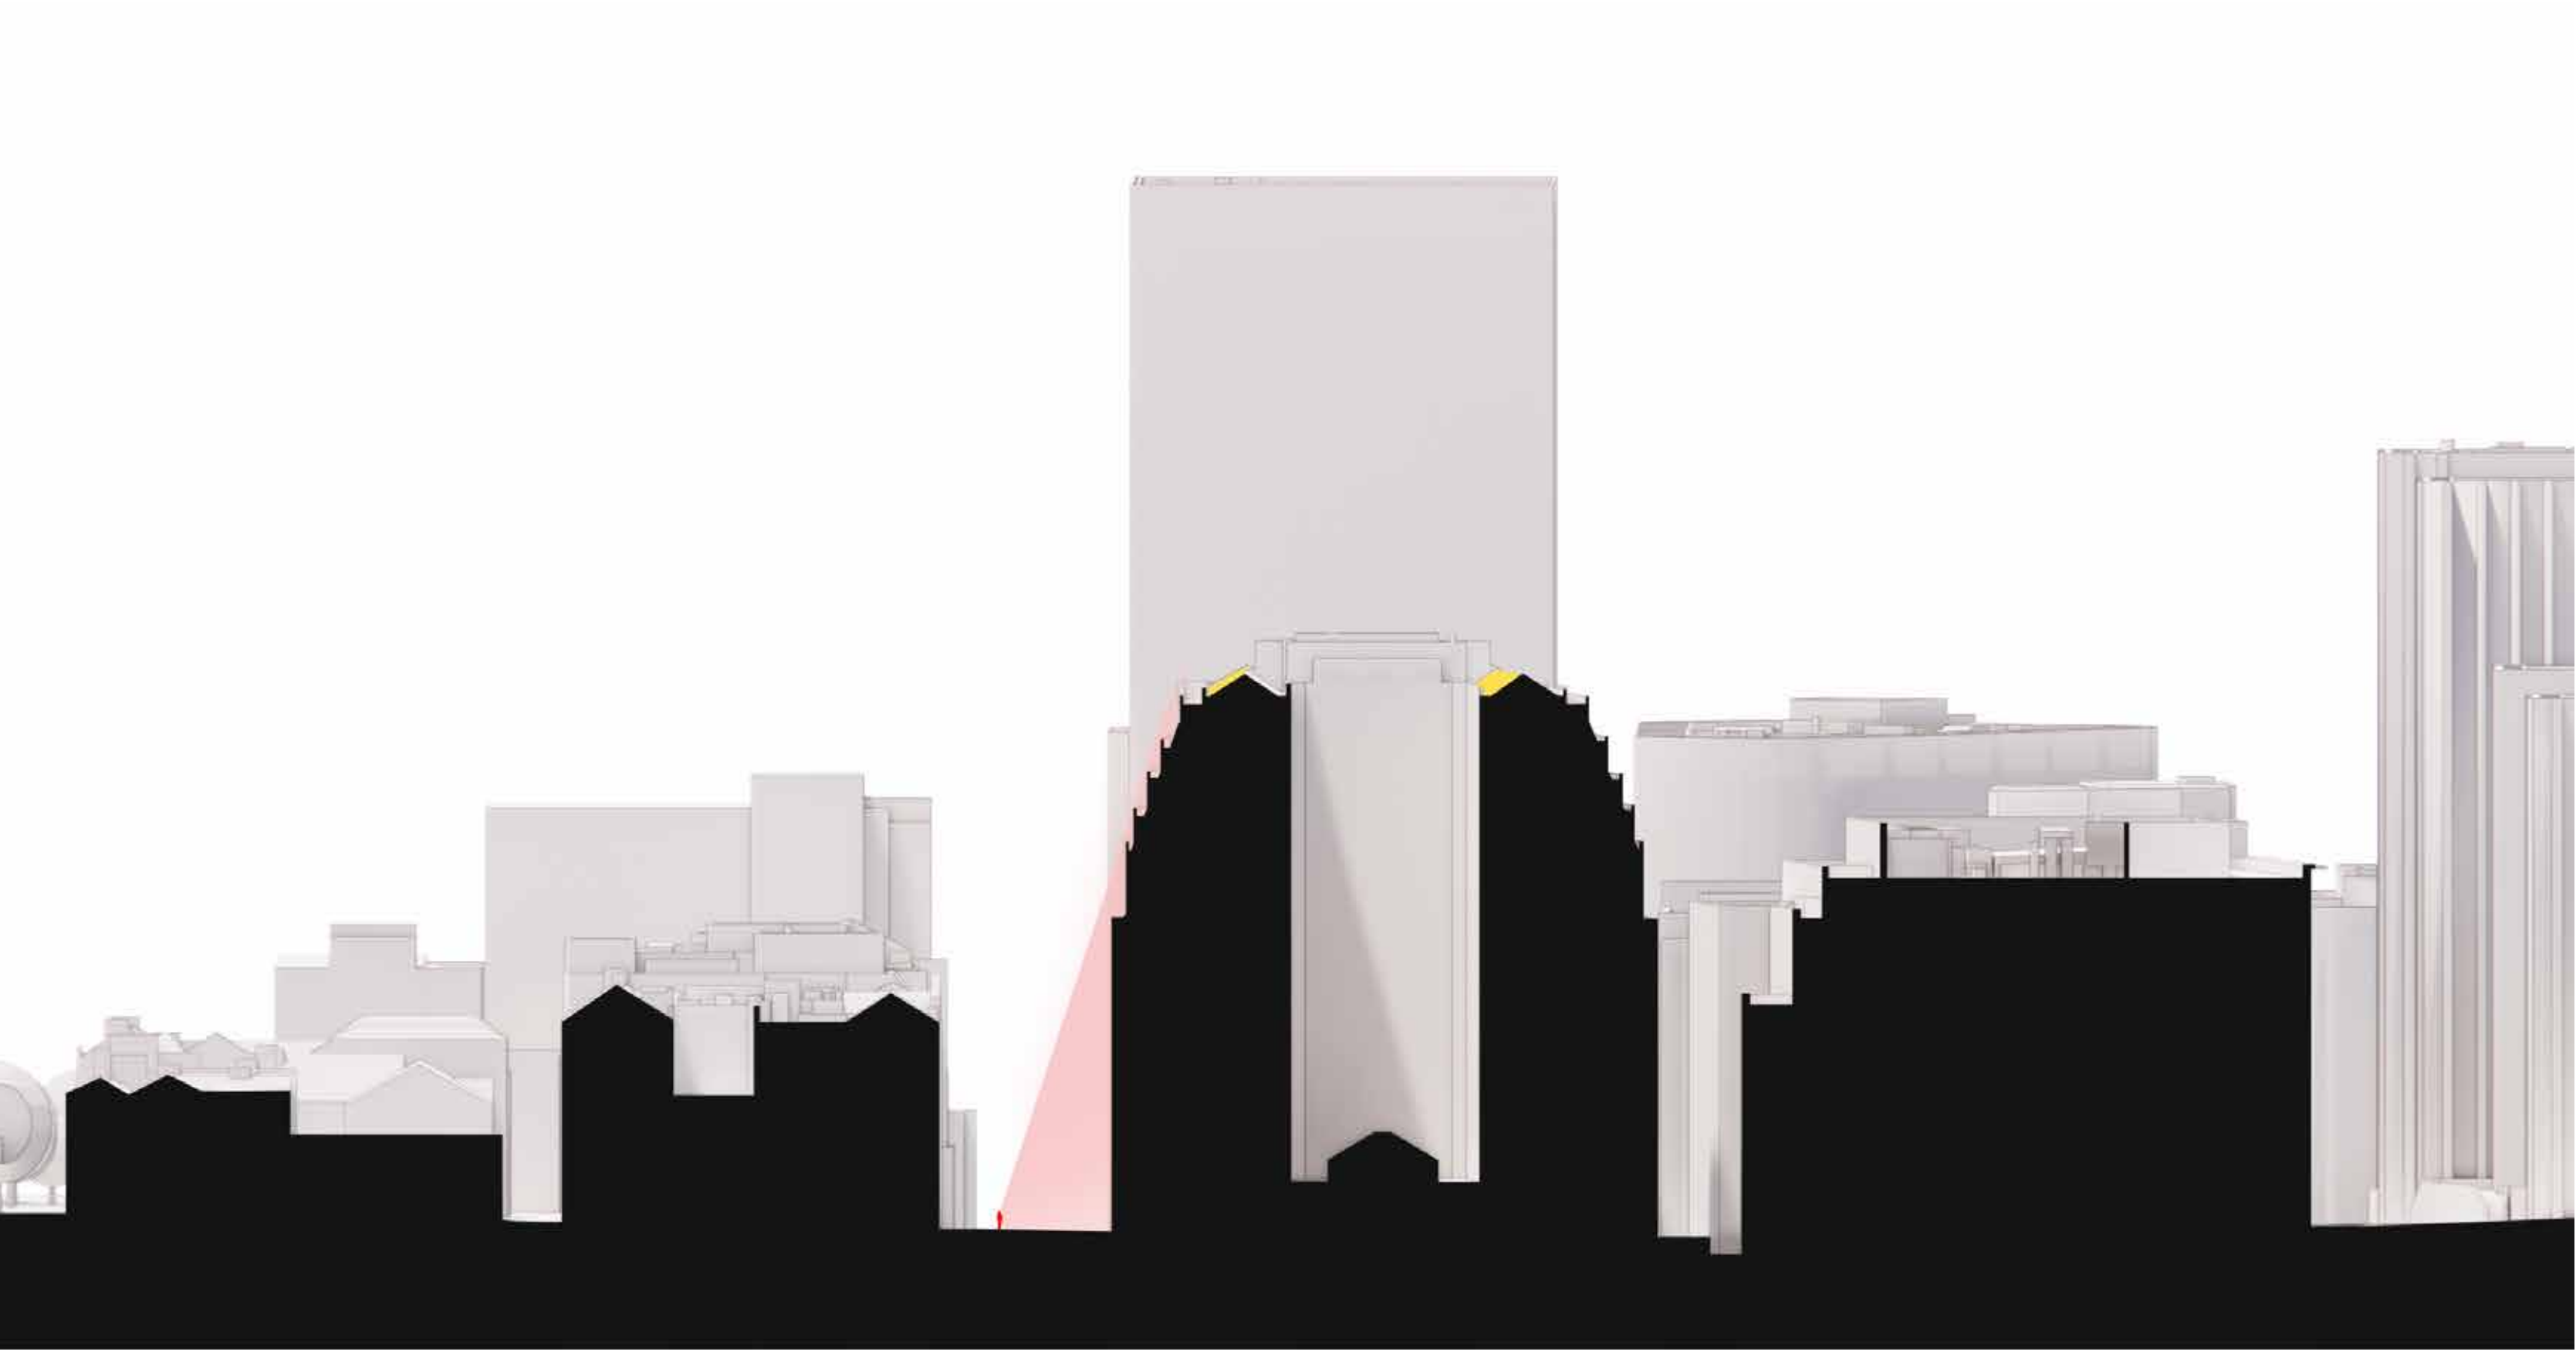
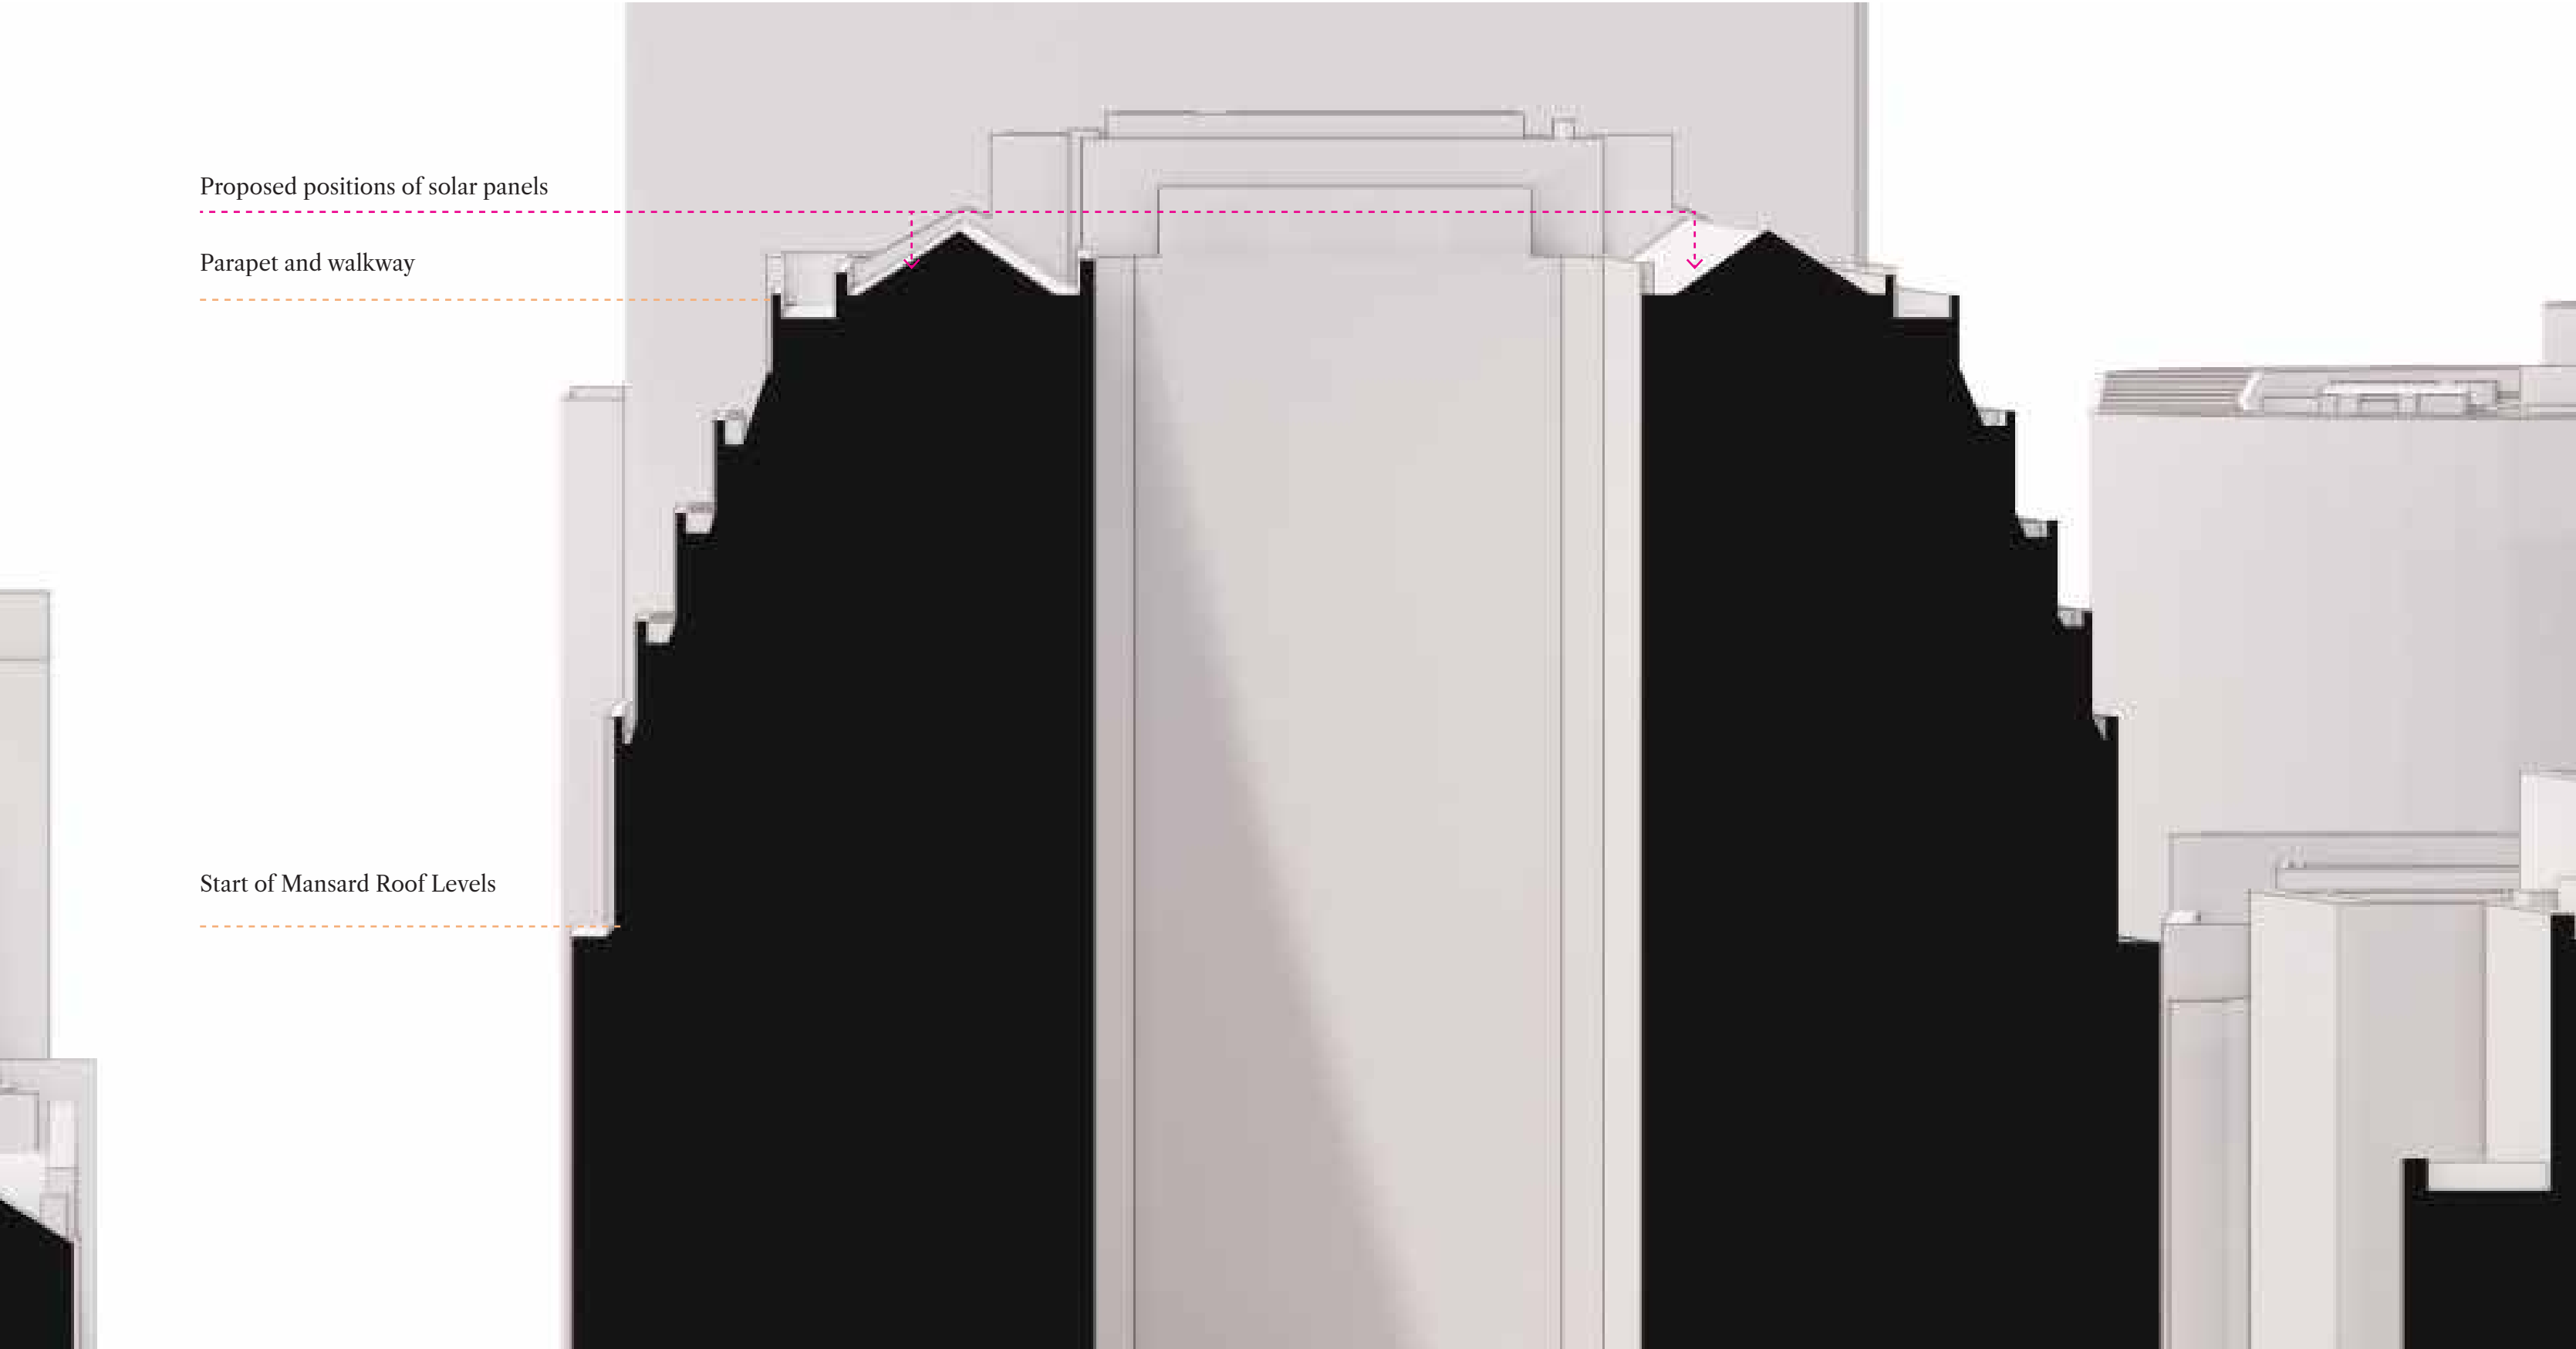
Proposed solar panel zones on uppermost roof slopes,  
not on the mansard or parapet level

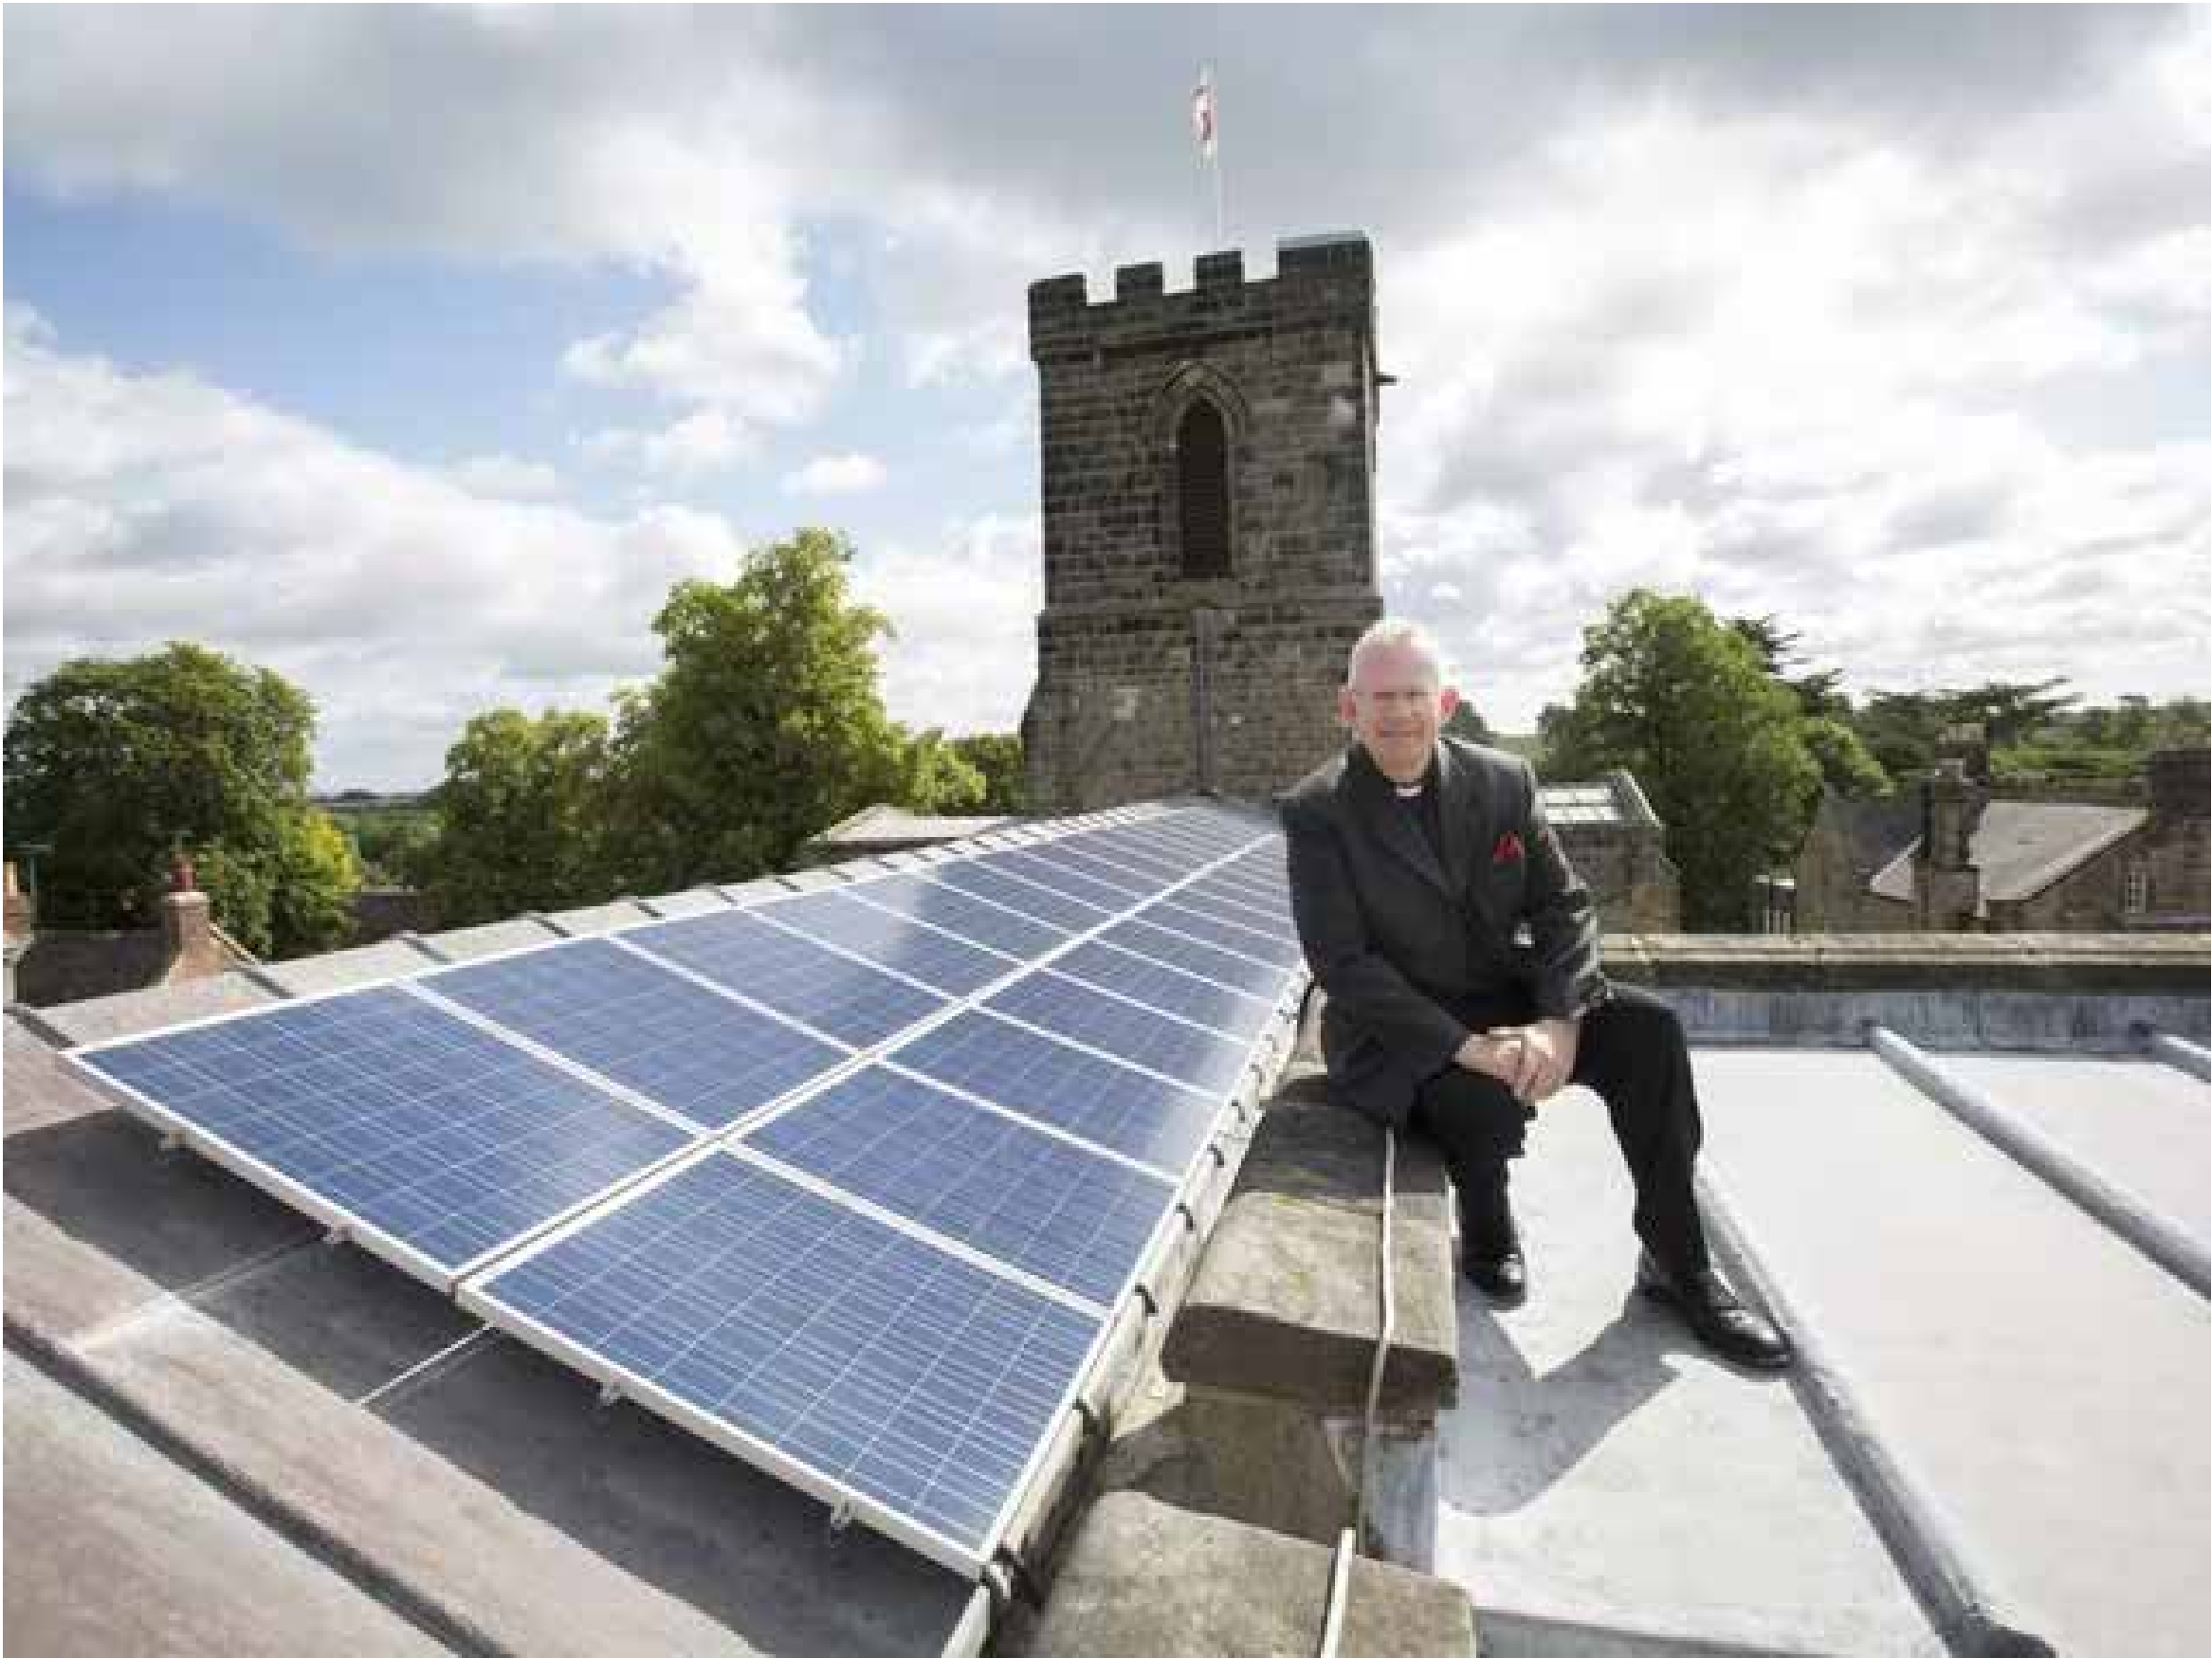
- projection is limited, particularly in this case, to around 200mm
- the tile hanger system is the least invasive in material terms but gives the same outward aesthetic
- it ensures the maximum amount of material is maintained on site

Facing | example of system installed on Grade I listed church roof

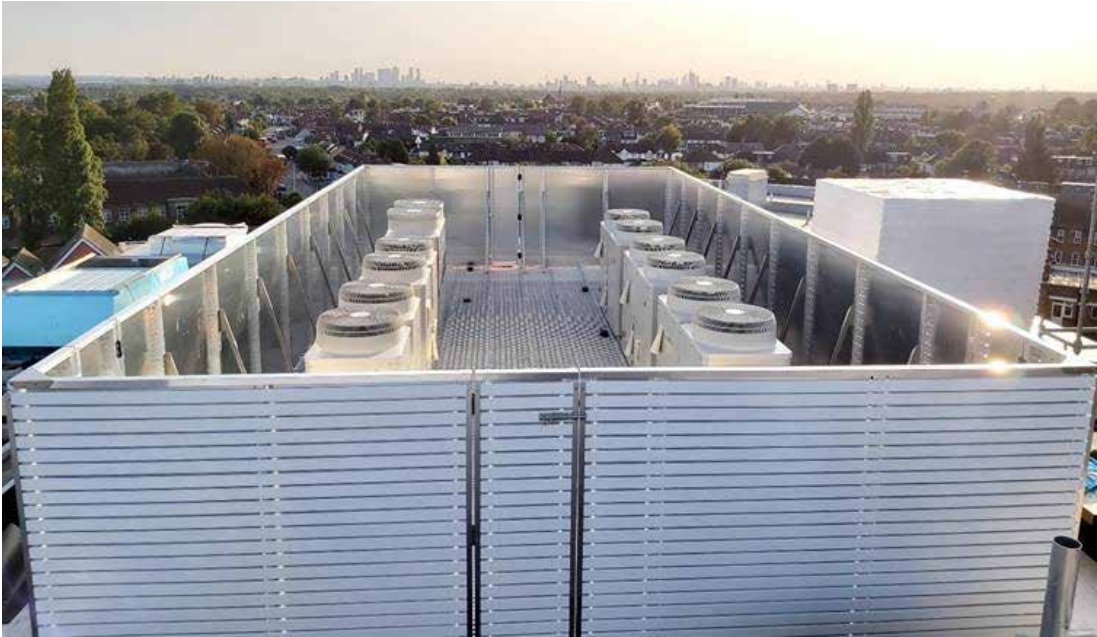
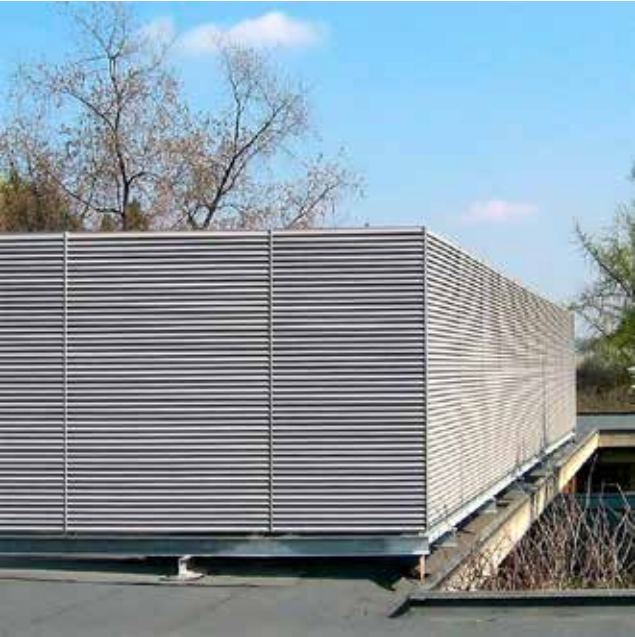
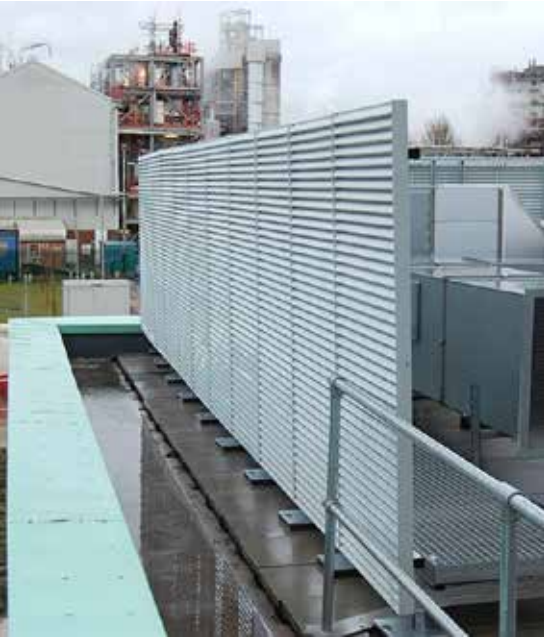
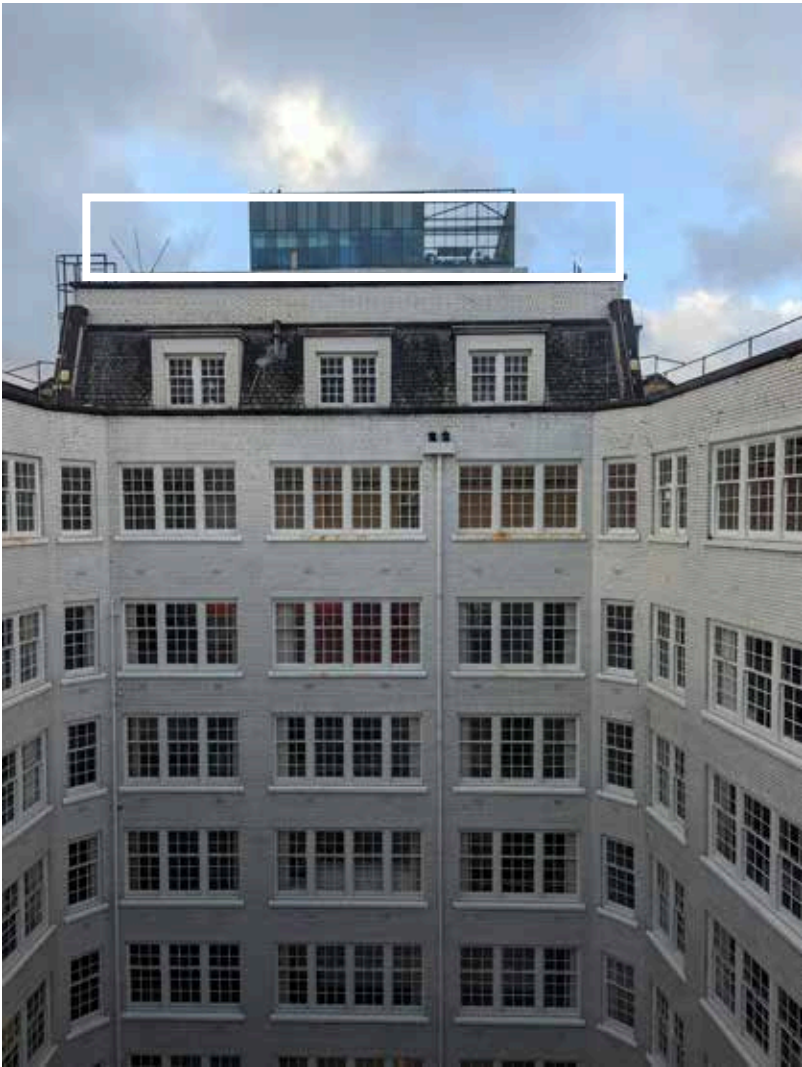
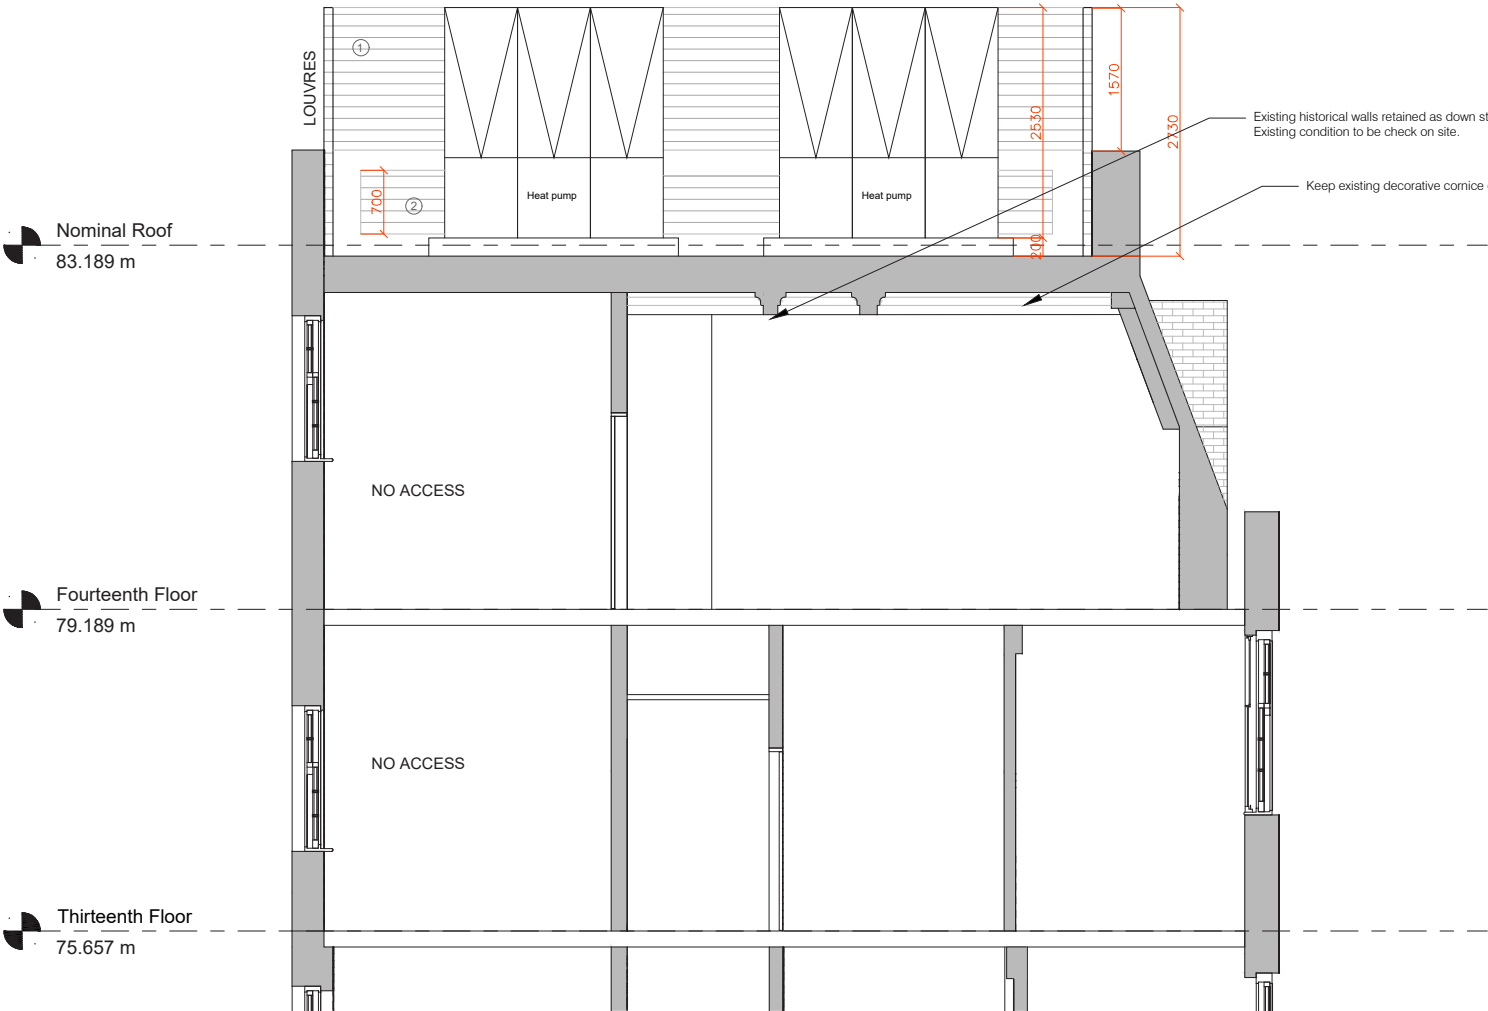
Further details are provided to support this. The acoustic report confirms no attenuation is required however we are proposing the screen for visible masking of the Air Source Heat Pumps. A reference image is below. Our preference is for a white finish, to continue the parapet below.

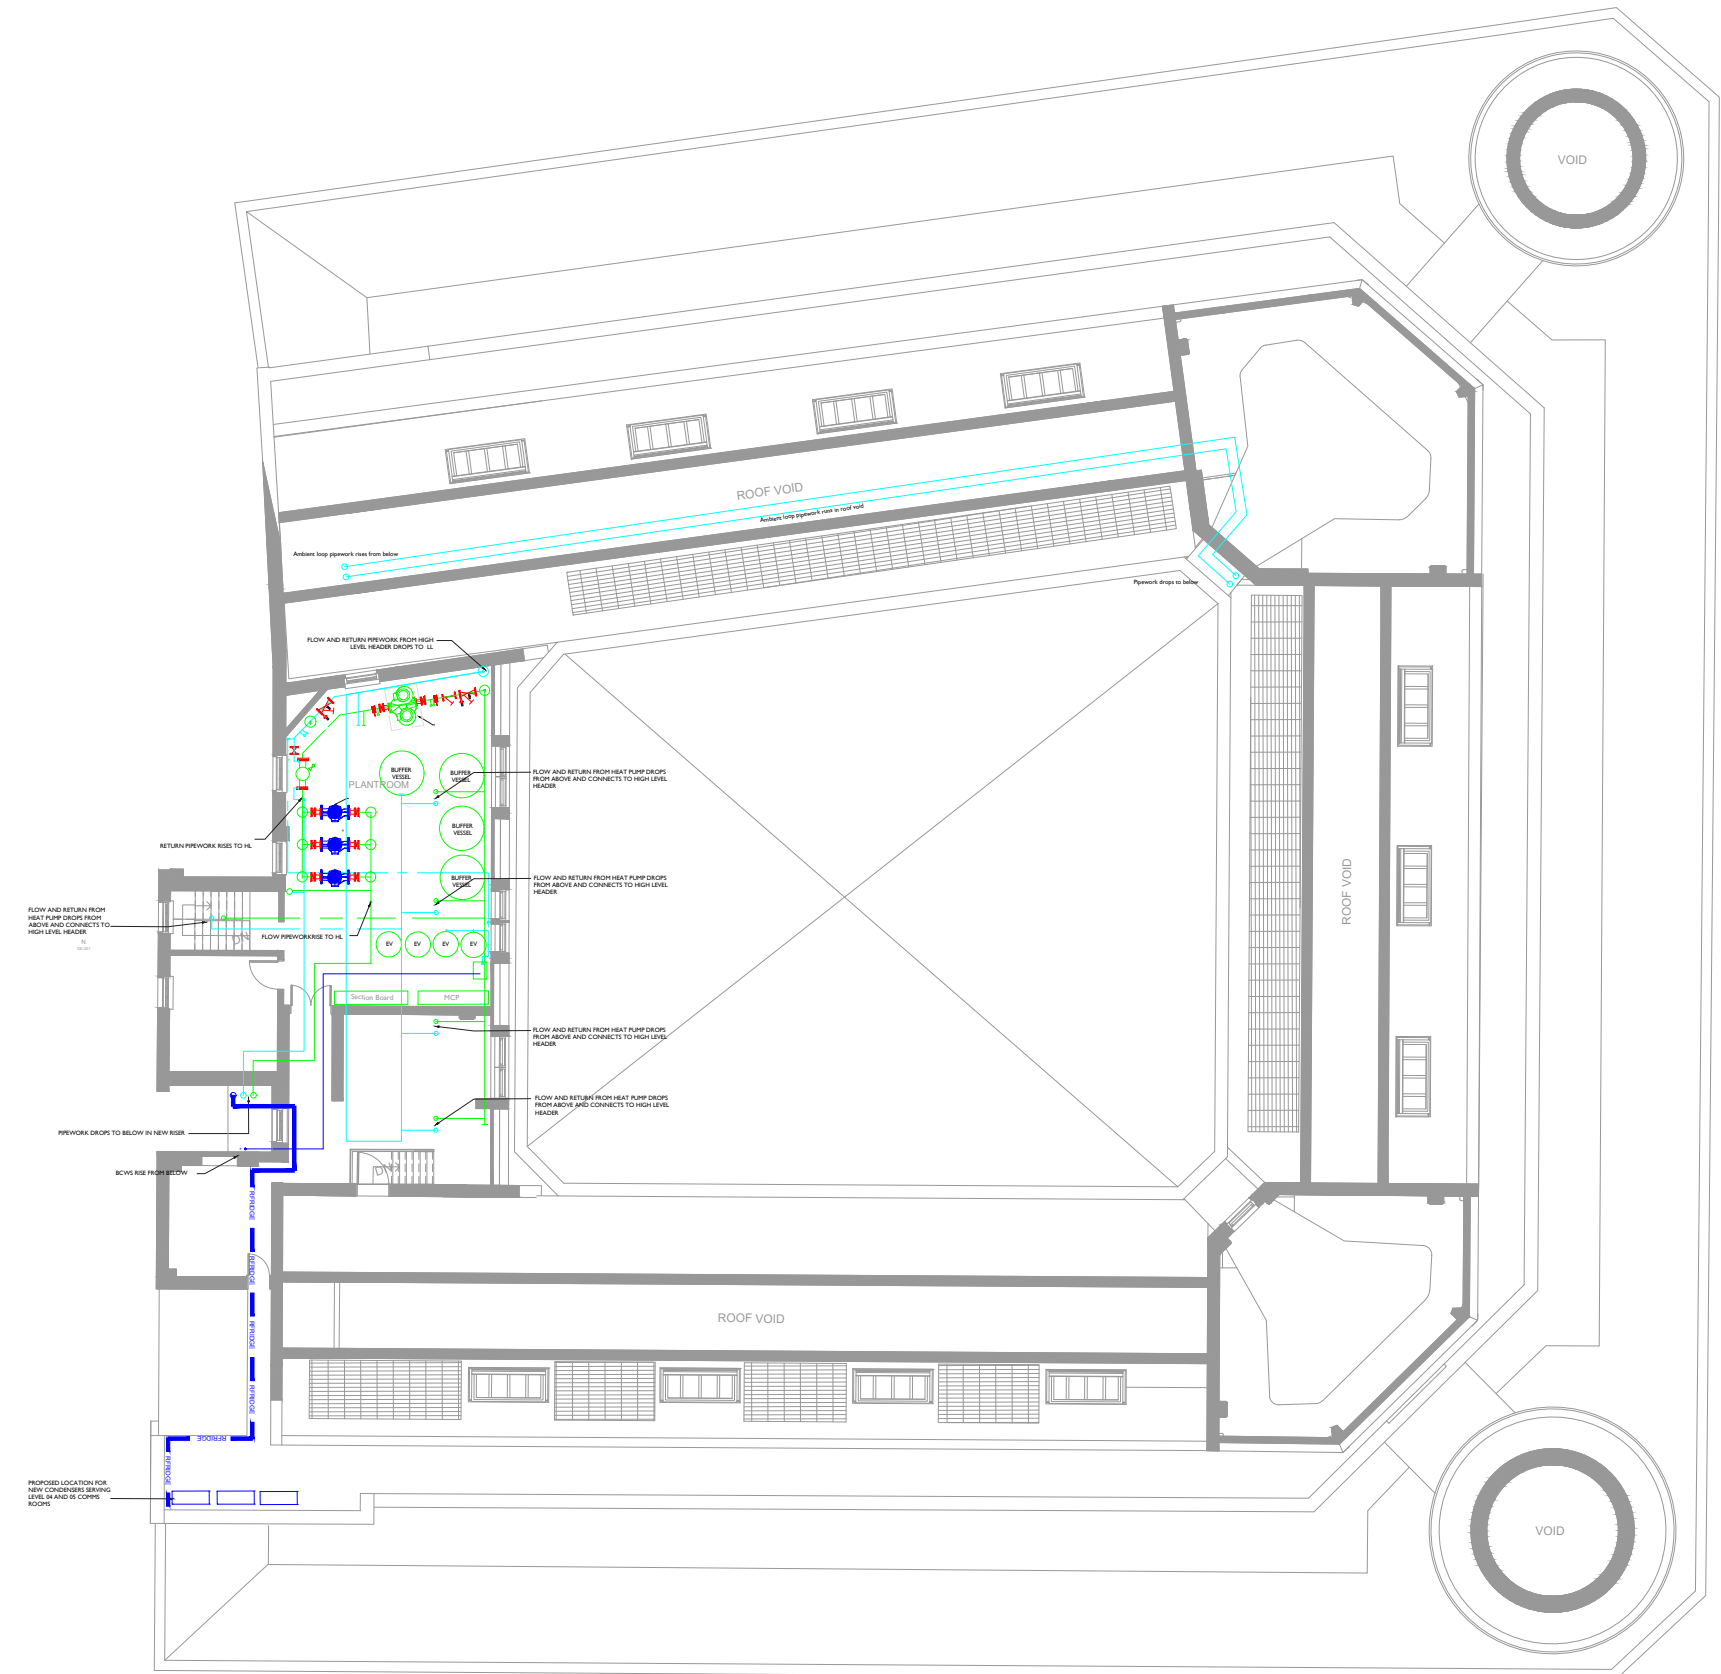
The existing connection routes from the equipment already in this location is to be re-used. The route uses the pitch of the roof at level 13 to cross the building to risers associated within the eastern cores while dropping straight down into the western risers.
