PLANNING RESPONSES  
SUNLIGHT HOUSE  
APRIL 2023

PLANNING RESPONSES  
SUNLIGHT HOUSE

EXTERNAL ALTERATIONS

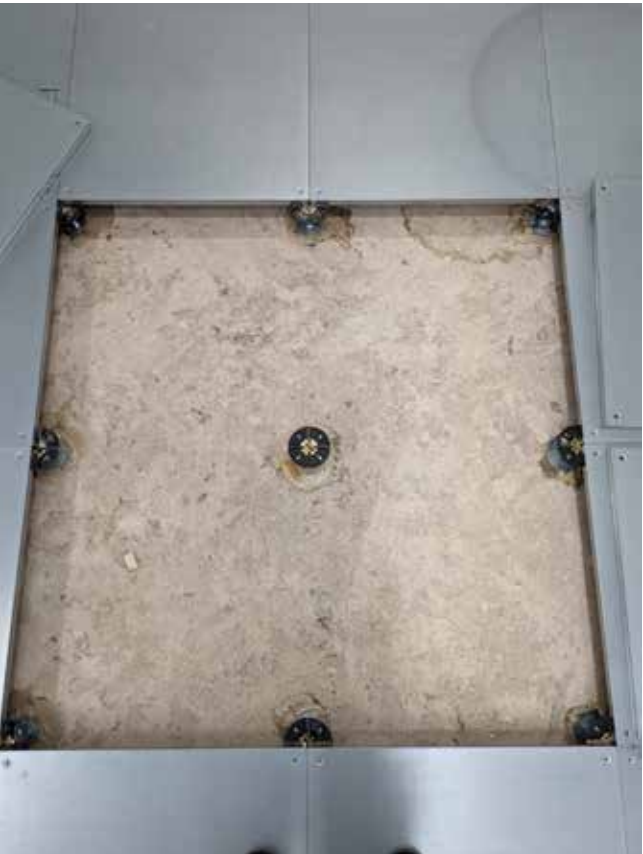
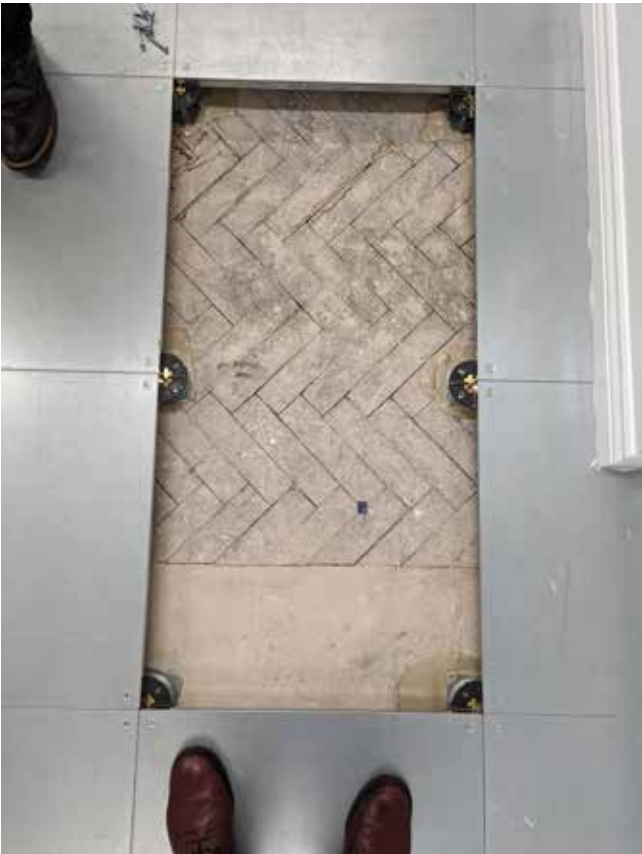
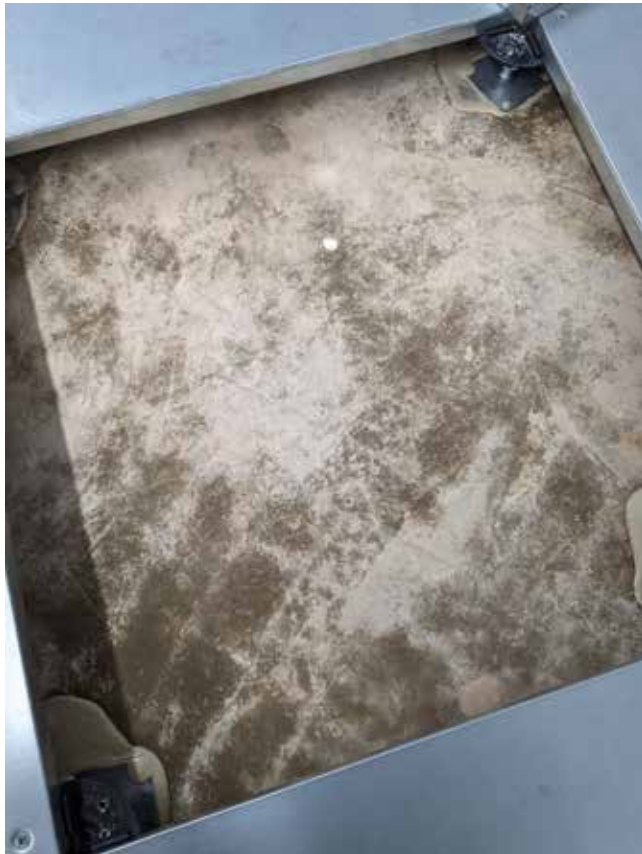
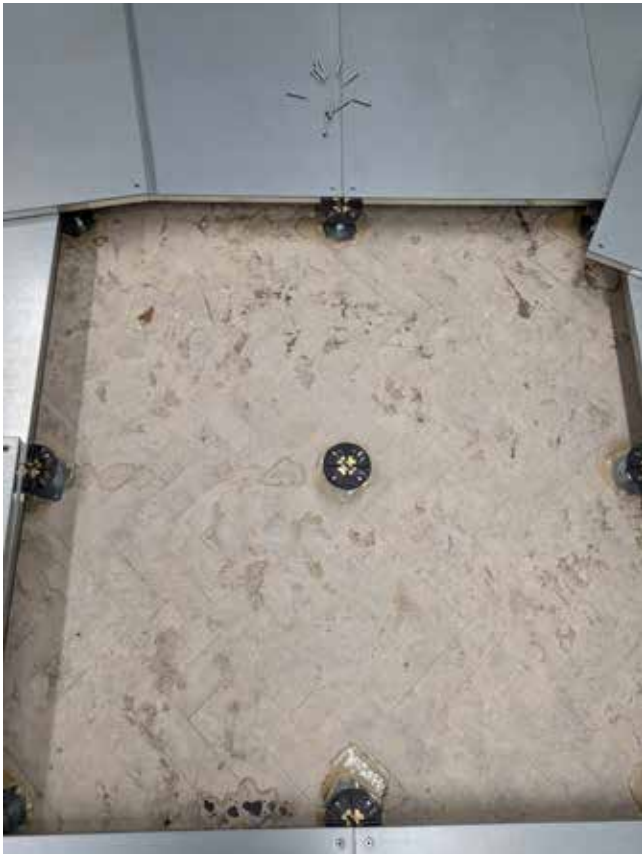
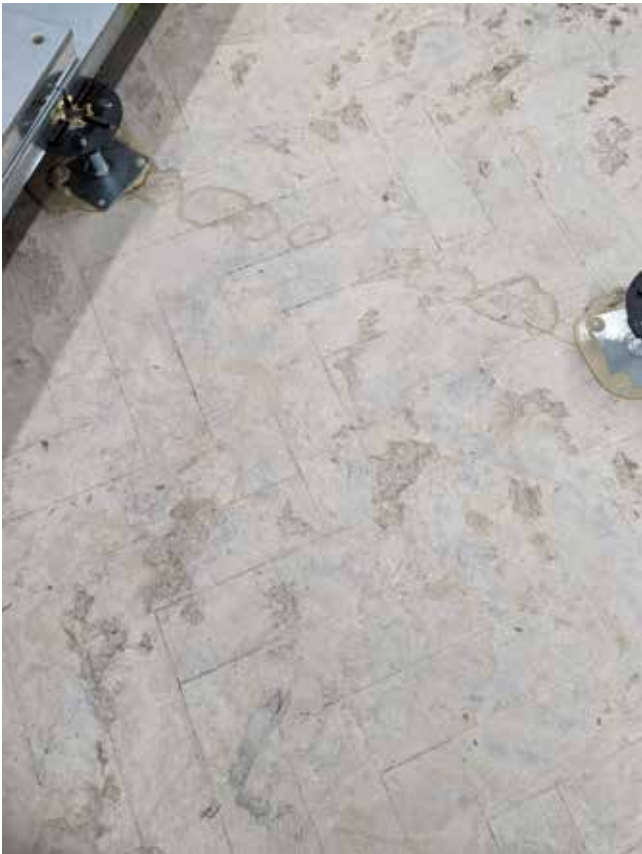
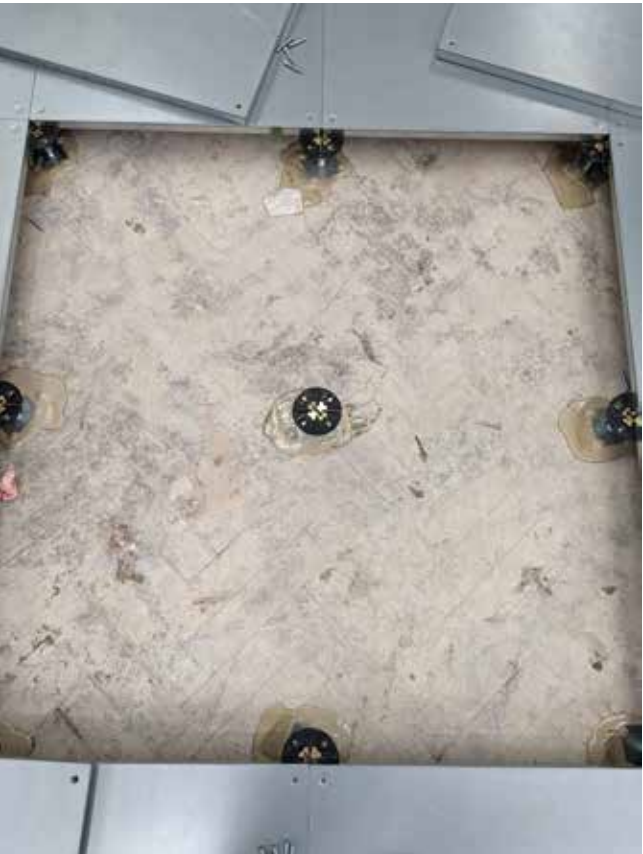
Above - scale of existing parquet to different areas around the building ranging from usable to hazardous.

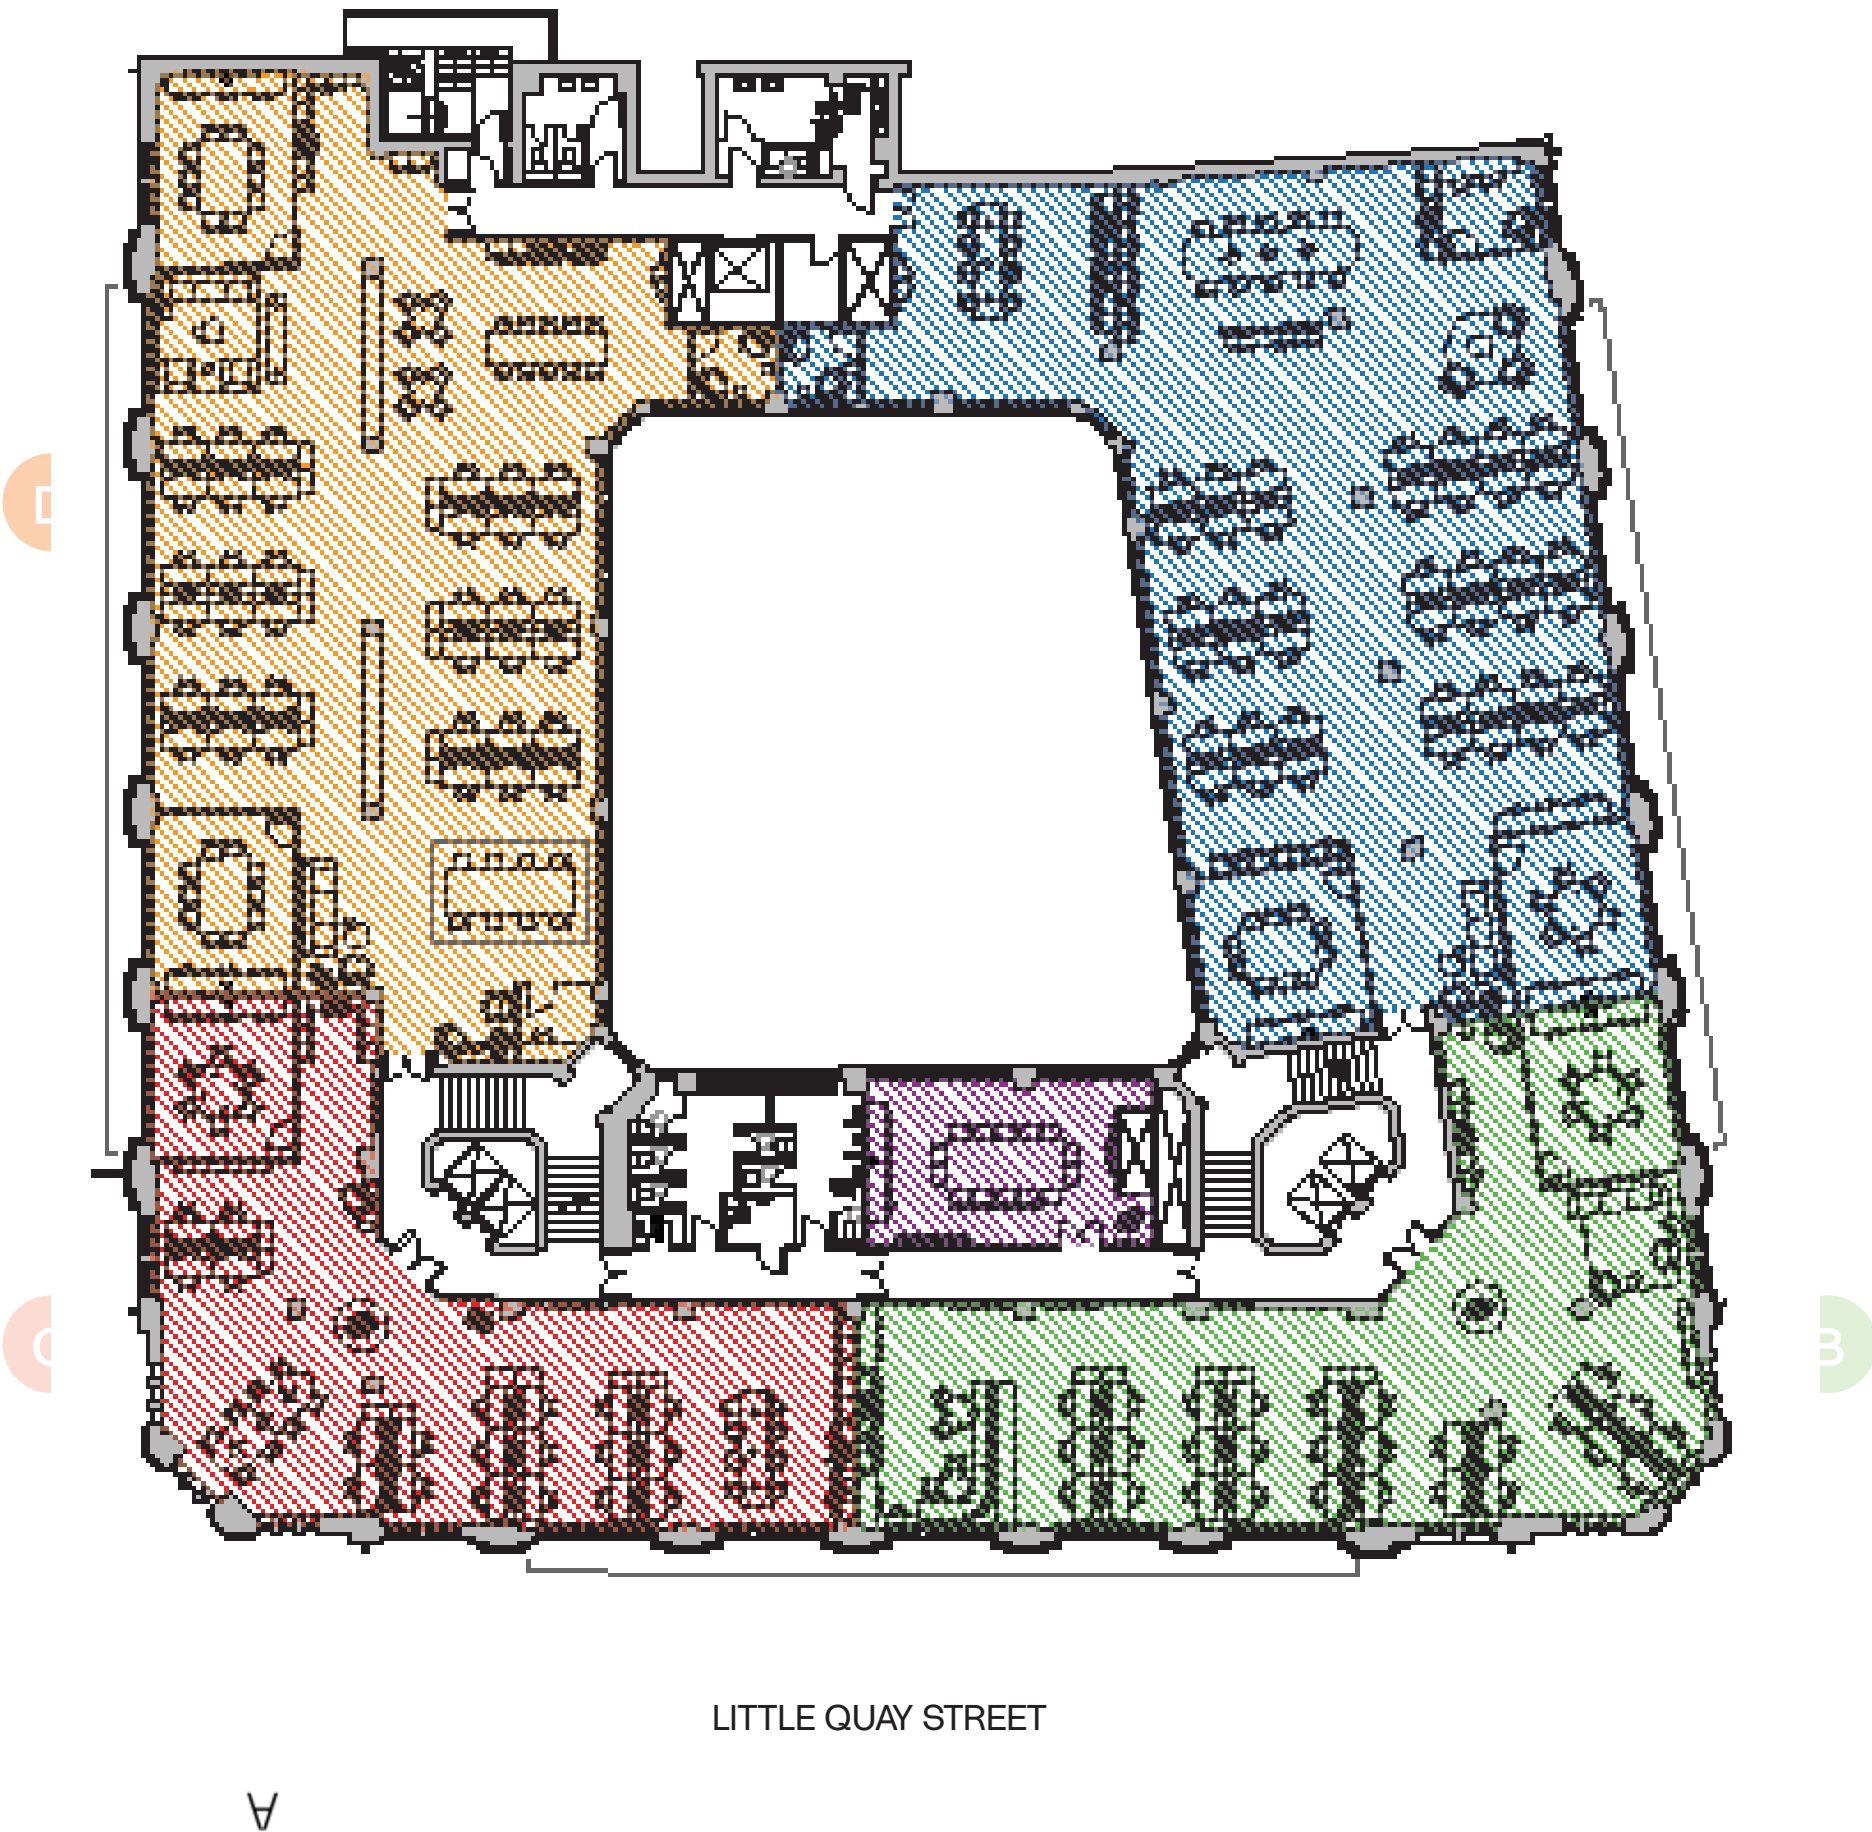
The maximum a floor would be proposed to split into individual tenancies would be 4 (with small shared 5th room) as shown. It would be positive to be able to discuss a revised tenant fitout guide to the previously approved confirming any potential meeting room subdivision within that space.

The applicant wishes to secure permission for works to the third floor as part of this application and further information can be provided on the specifics of this proposal.

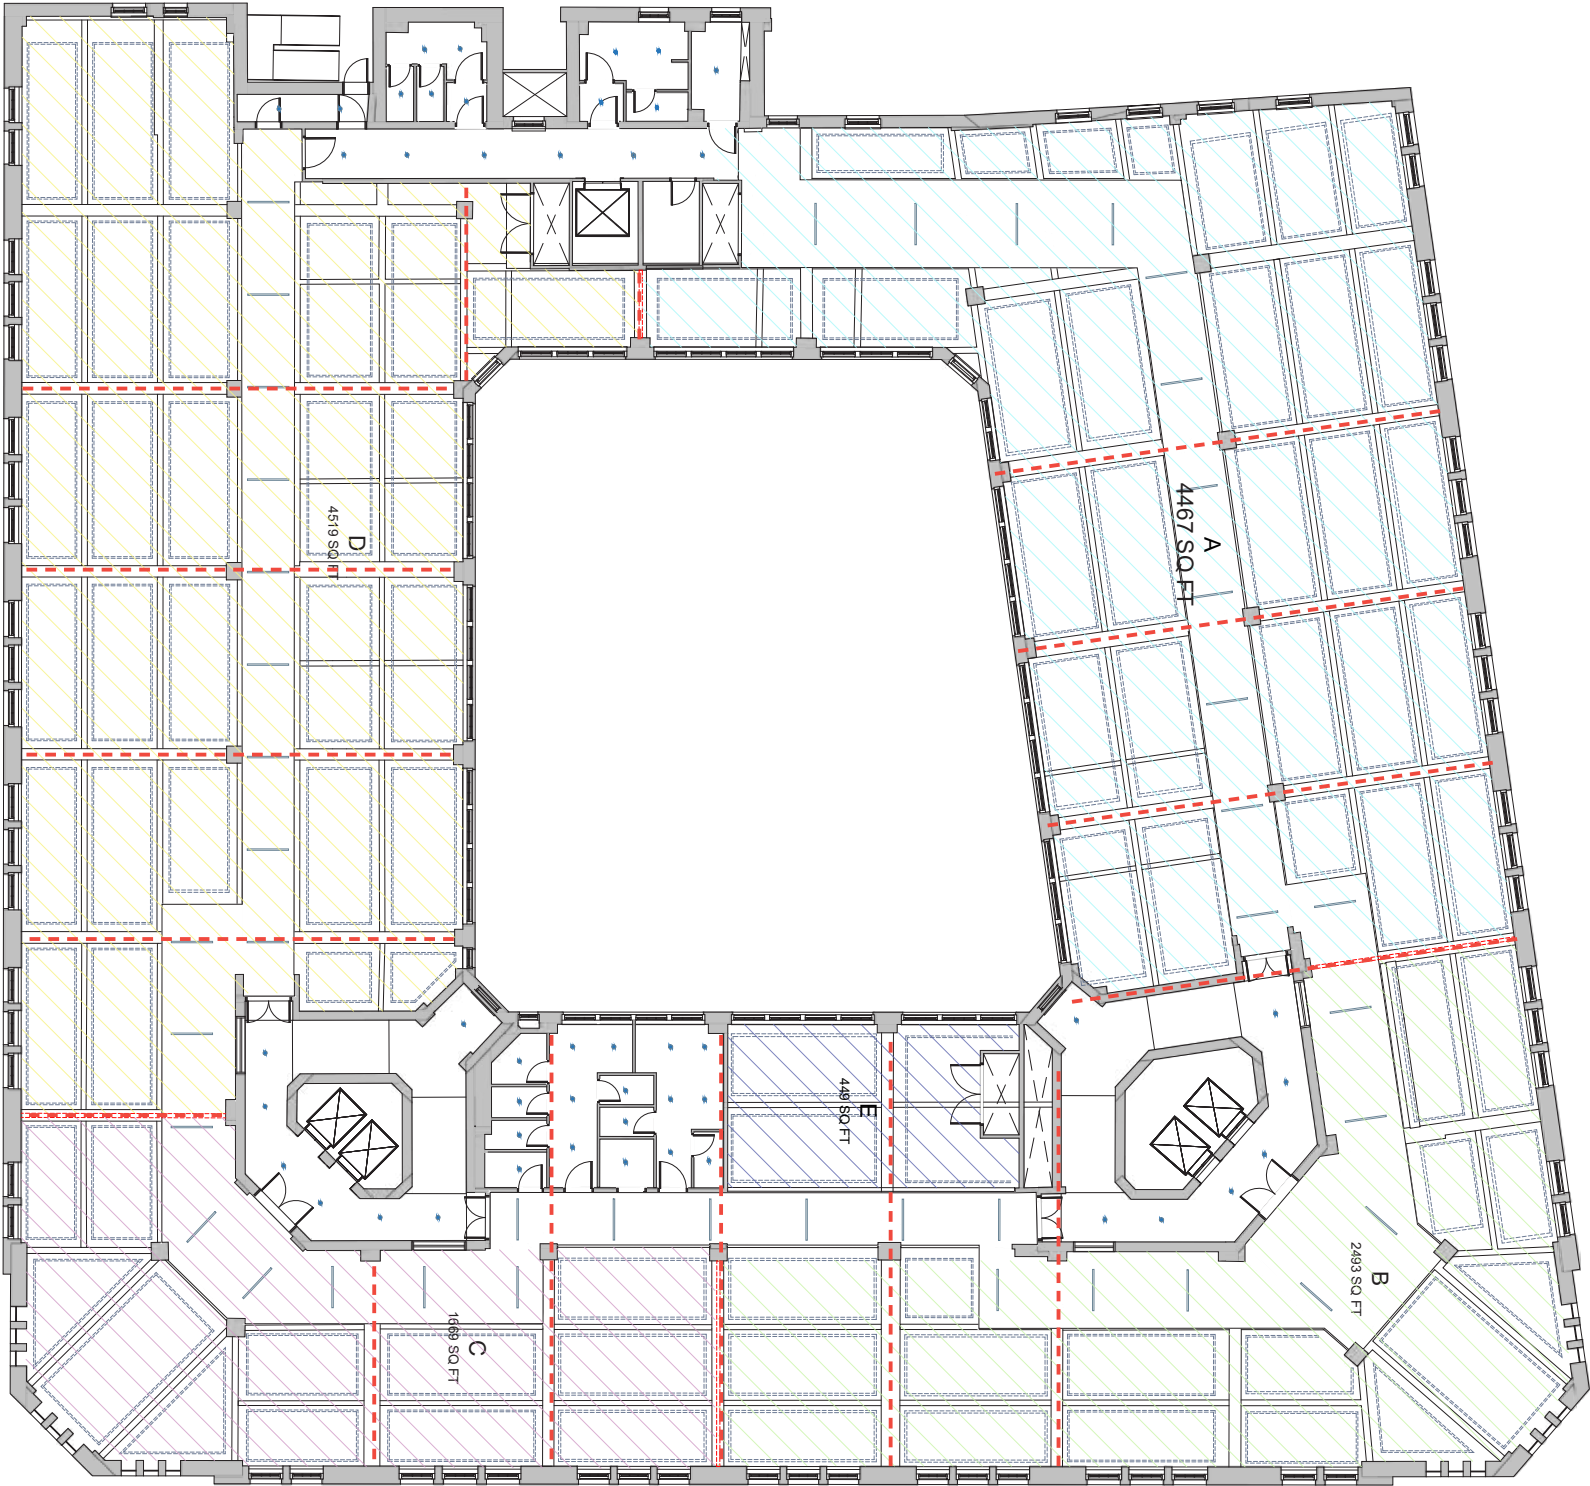
Example tenancy splits on a single floor using structural lines only. (dashed red lines)

Floor would be split into no more than 4 key tenancies with small suite/shared space between main cores.

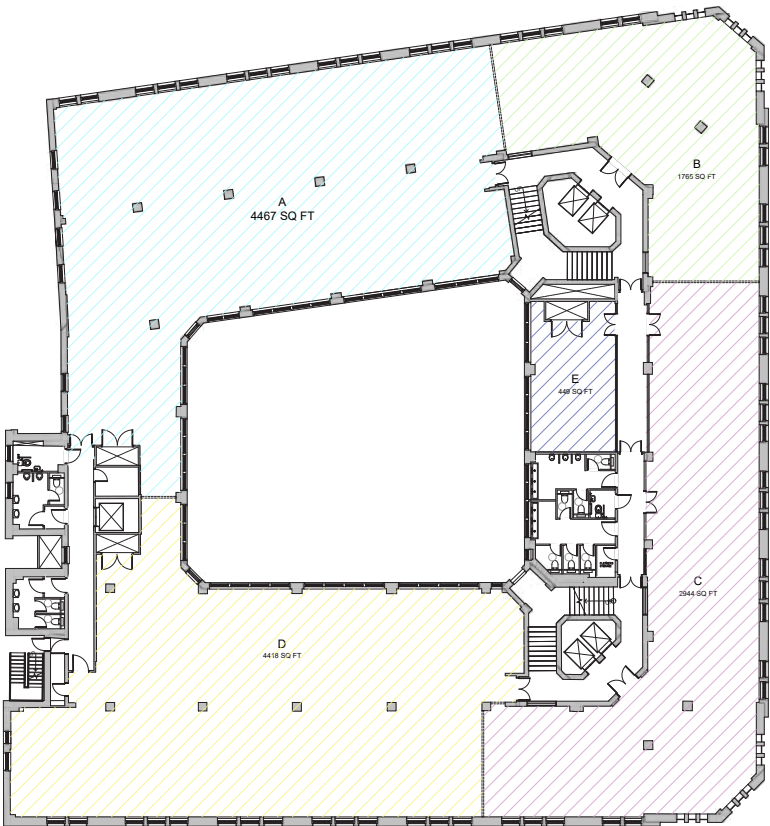
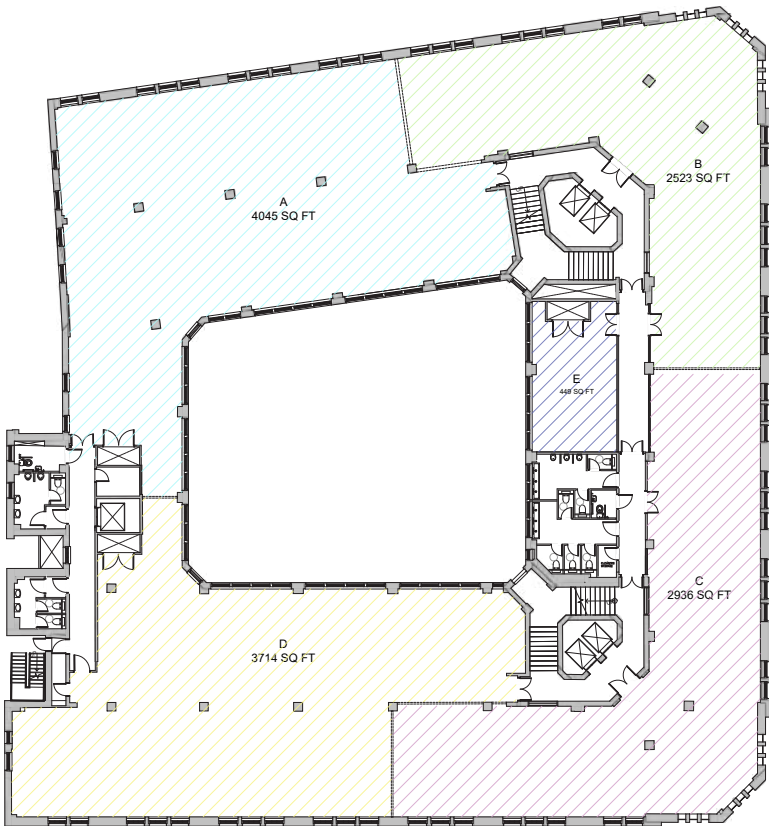
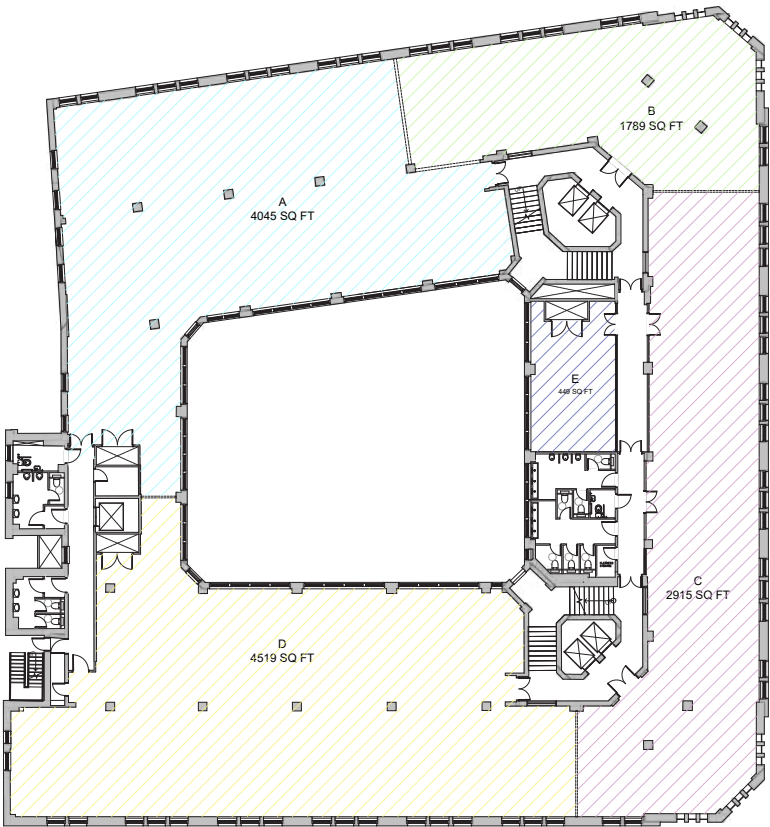
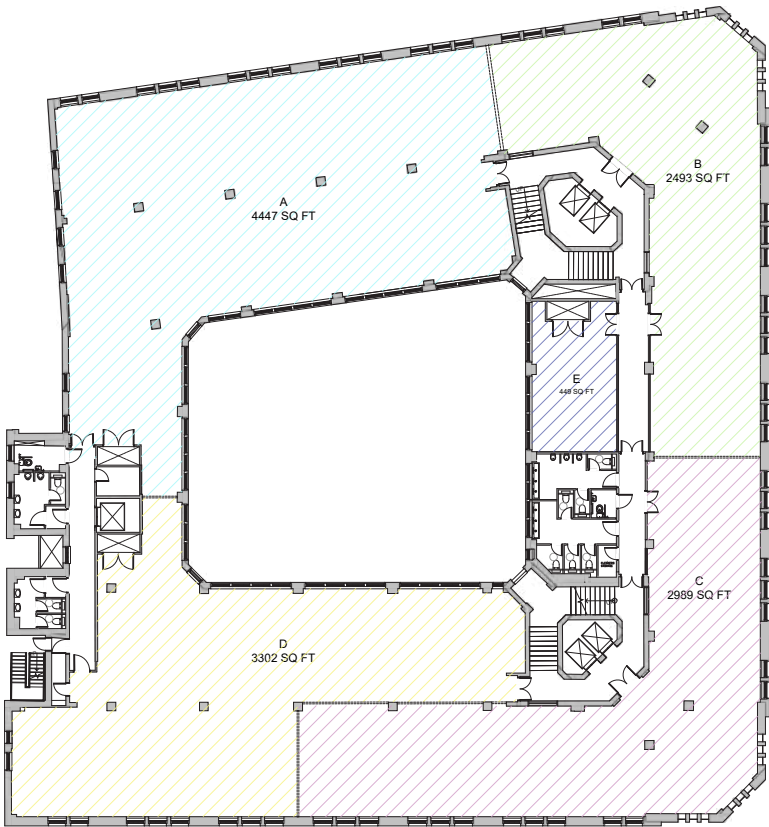
The maximum a floor would be proposed to split into individual tenancies would be 4 (with small shared 5th room) as shown. It would be positive to be able to discuss a revised tenant fitout guide to the previously approved confirming any potential meeting room subdivision within that space.

RIGHT  
Example tenancy splits on a single floor using structural lines

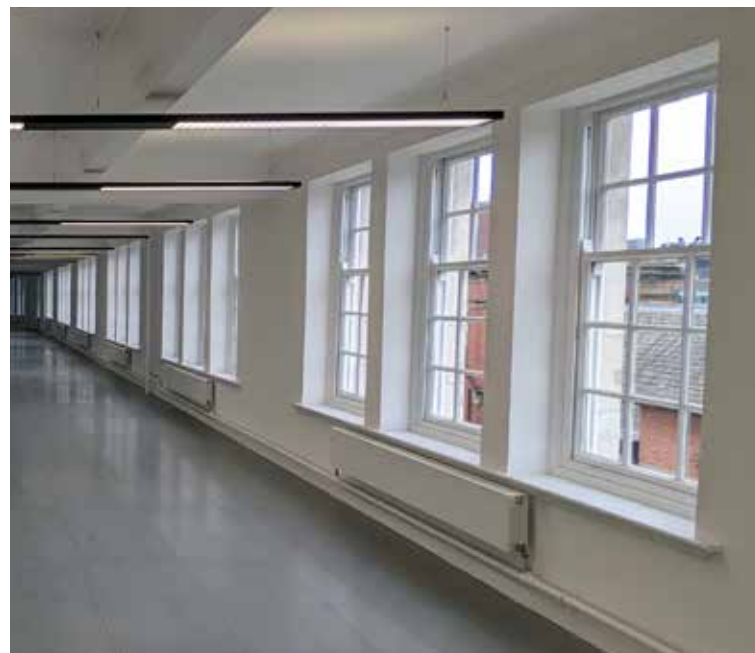
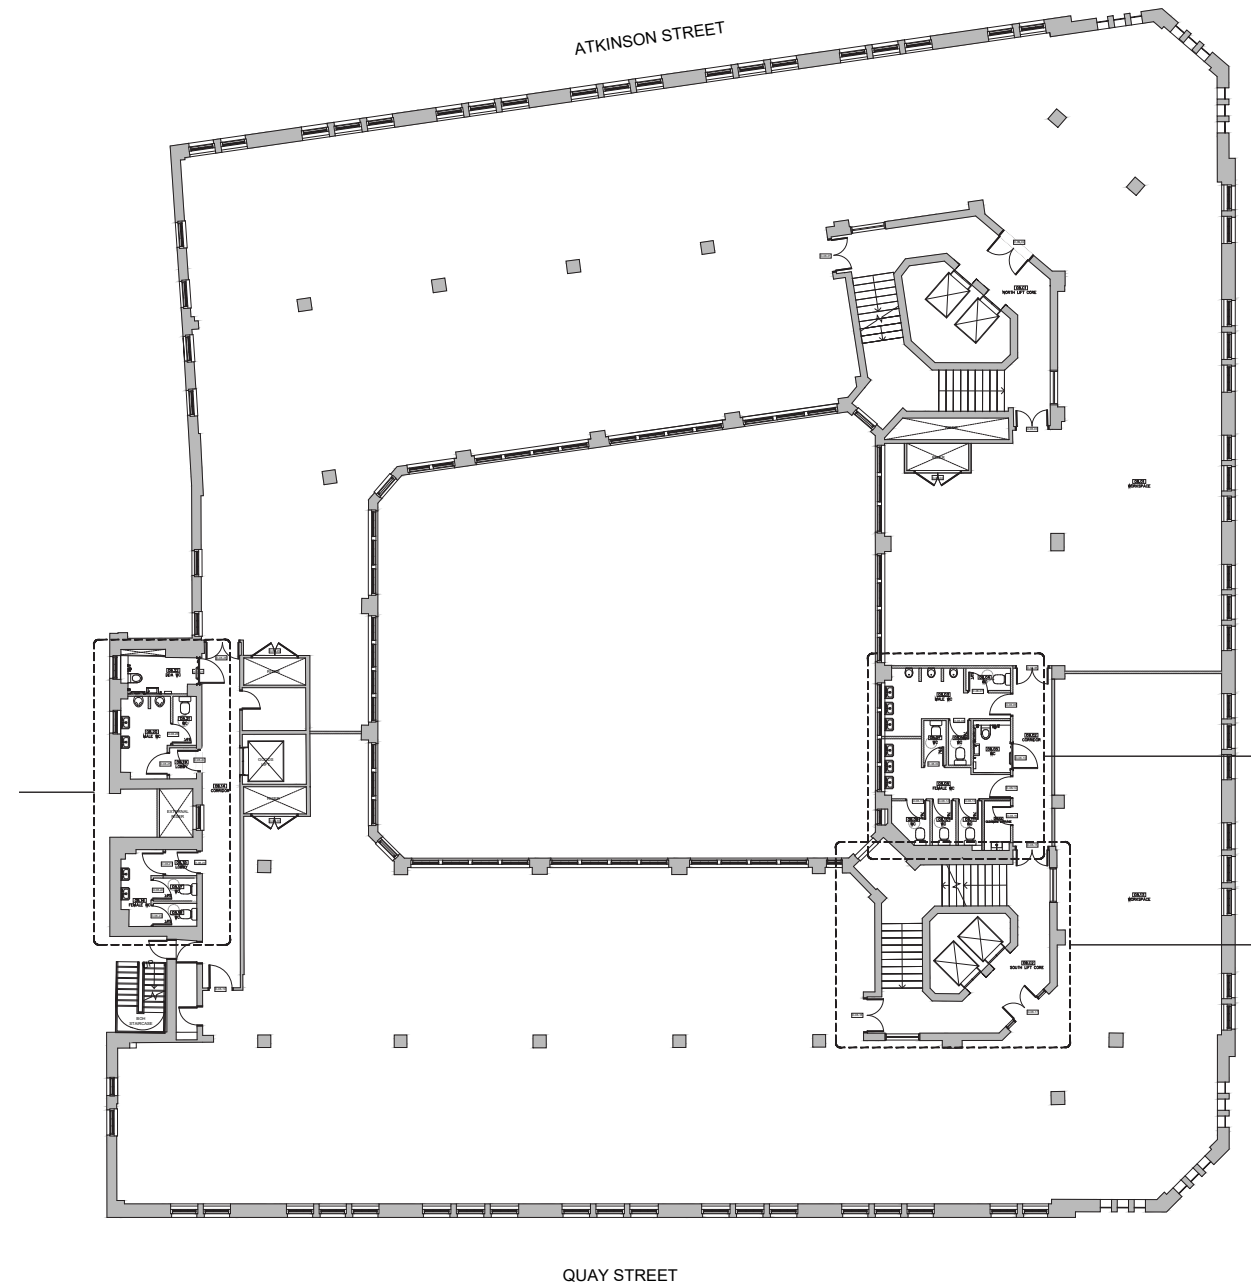
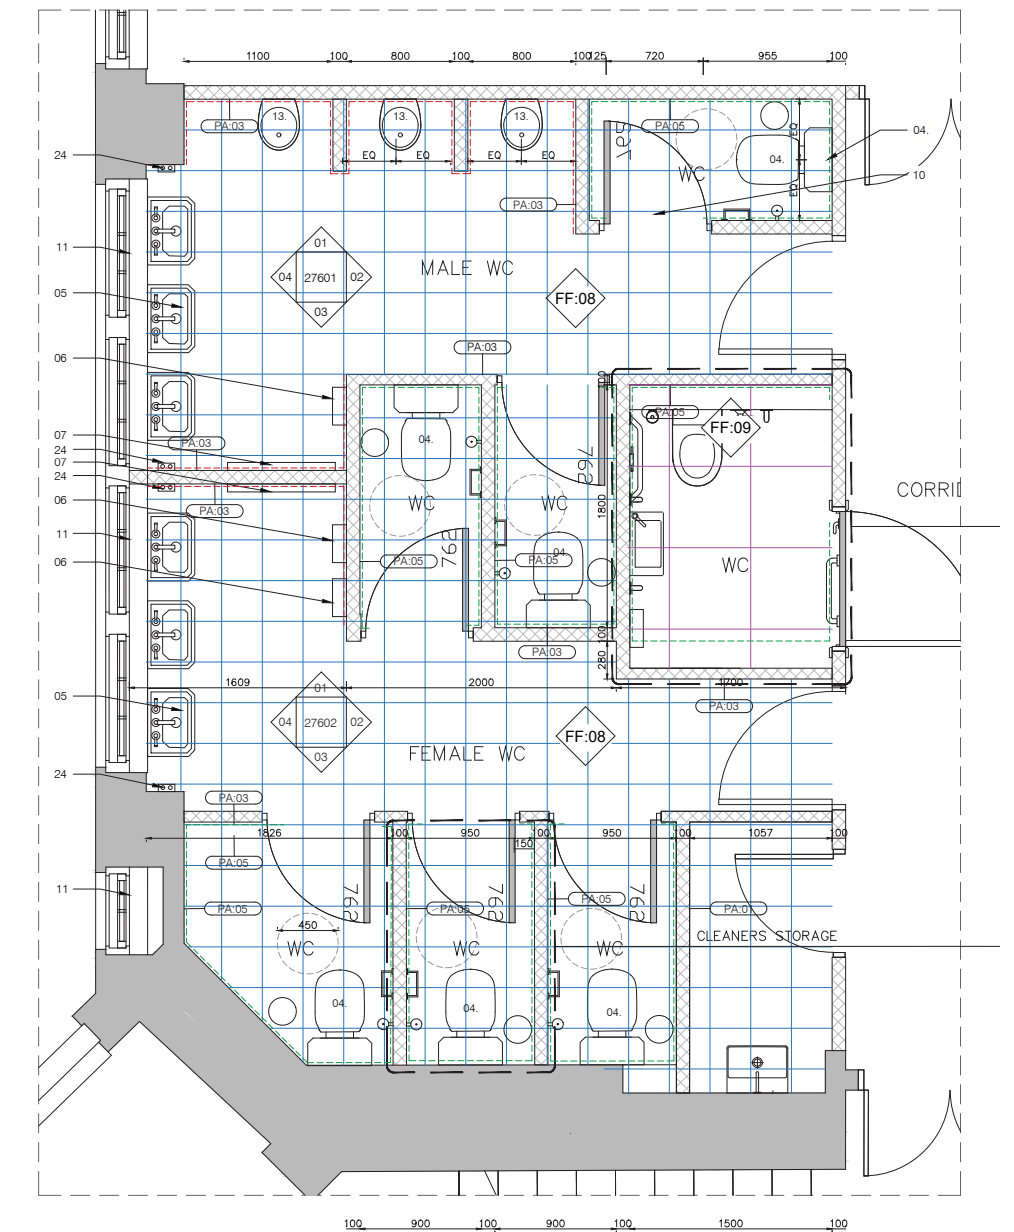
All partitions on a typical office floor look to use the principle of aligning to ceiling details. The only exception on a typical floor is where it is absolutely necessary within the WC core. There are examples throughout the building where this detail is achieved successfully. Additionally, we believe the window mullions were enhanced in width to allow for subdivision into smaller rooms throughout the building.

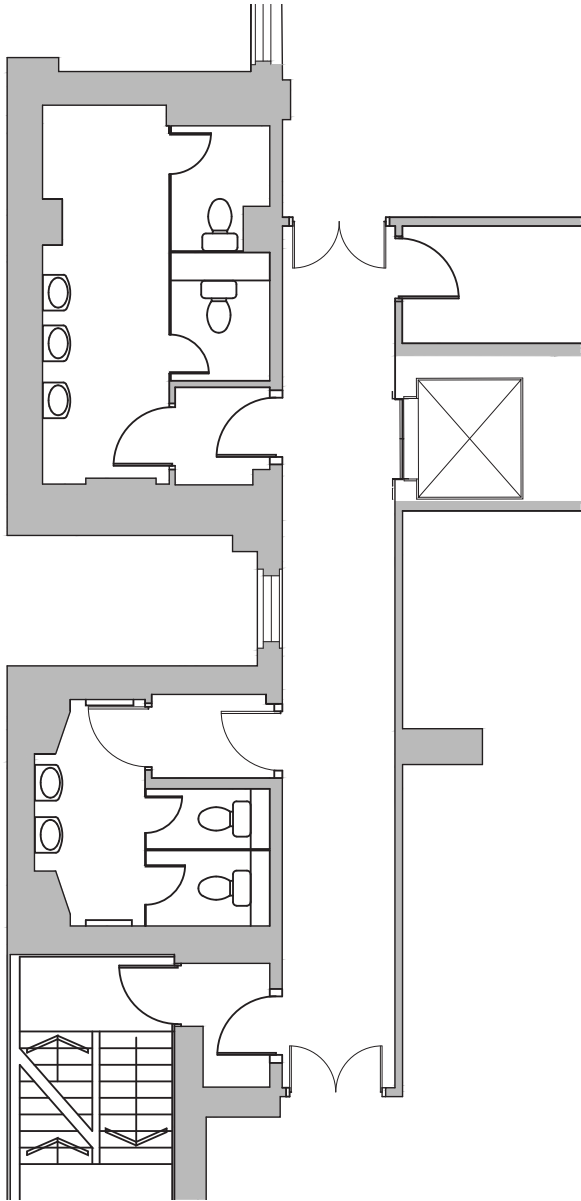
LEVEL 10 - EXISTING

The subdivision wall that has been added on various levels is a modern partition used to create kitchenettes, showers, accessible WCs in the originally larger male WC. Please refer to WC audit document for overall picture of current WC conditions. We are using it to introduce an accessible WC to all levels at both east and west cores to improve amenity within the building.

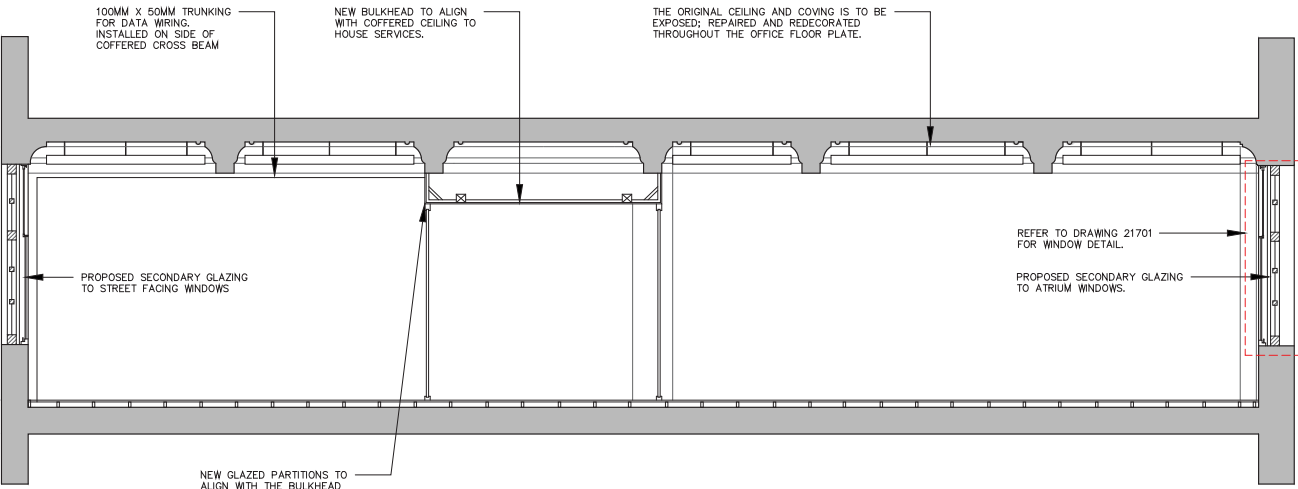
TYPICAL SECTION A-A @ 1:50

The glazed wall panels are proposed to interface in the same way as other partitions. The central set of glazed panels interface with the bulkhead rather than the ceiling coffer to further ensure a satisfactory condition. Additional drawings are to be supplied of proposed elevations.

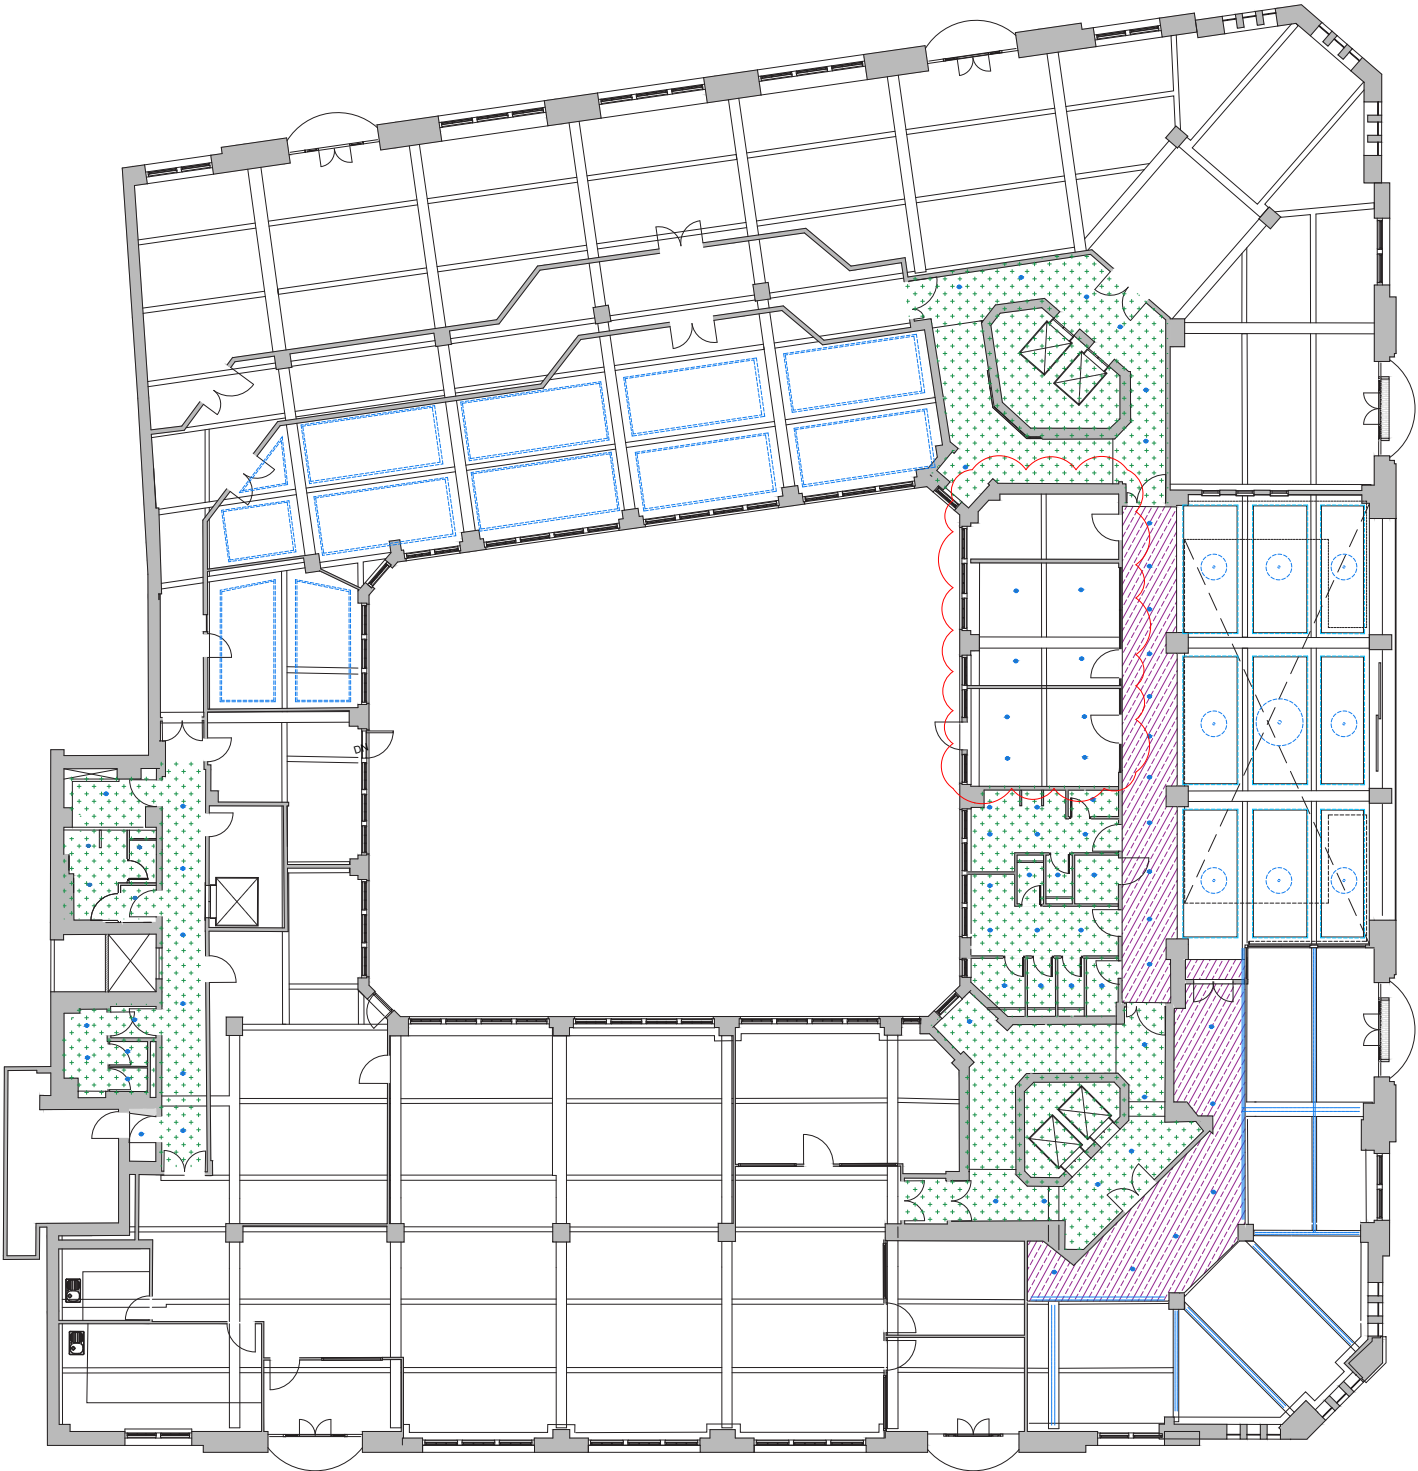
LEVEL 01

- Drawing key
- Existing exposed coffers. Make good and redecorate
  - Dropped plasterboard bulkhead
  - Plasterboard soffit
  - Under Coffer suspended track light
  - Coffer suspended light
  - Downlight
  - Recessed linear light
  - Lighting to bulkhead and plasterboard soffit is indicative only. Locations and fittings to be developed
  - Feature pendants

Drawing Title  
Proposed Reflected Ceiling Plan - Level 01

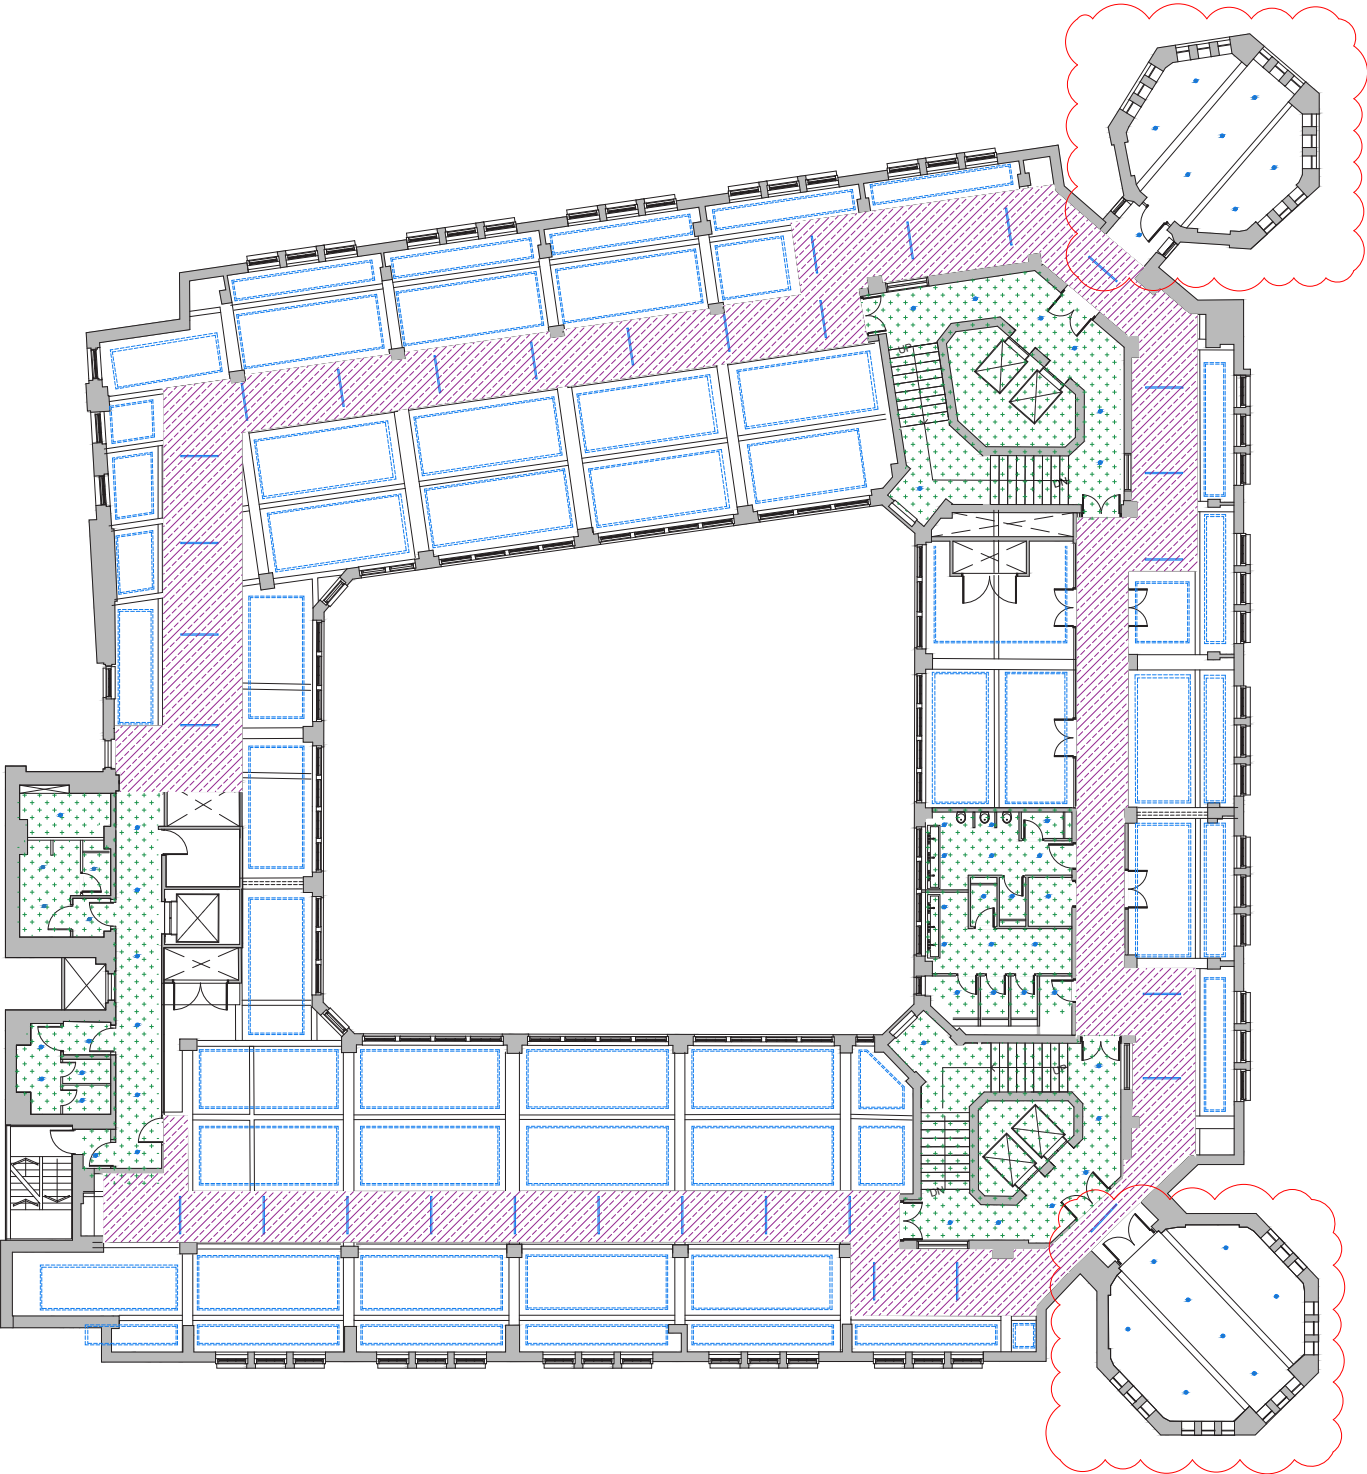
LEVEL 12

- Drawing key
- Existing exposed coffers. Make good and redecorate
  - Dropped plasterboard bulkhead
  - Plasterboard soffit
  - Coffer suspended light
  - Downlight
  - Recessed linear light
- Lighting to bulkhead and plasterboard soffit is indicative only. Locations and fittings to be developed

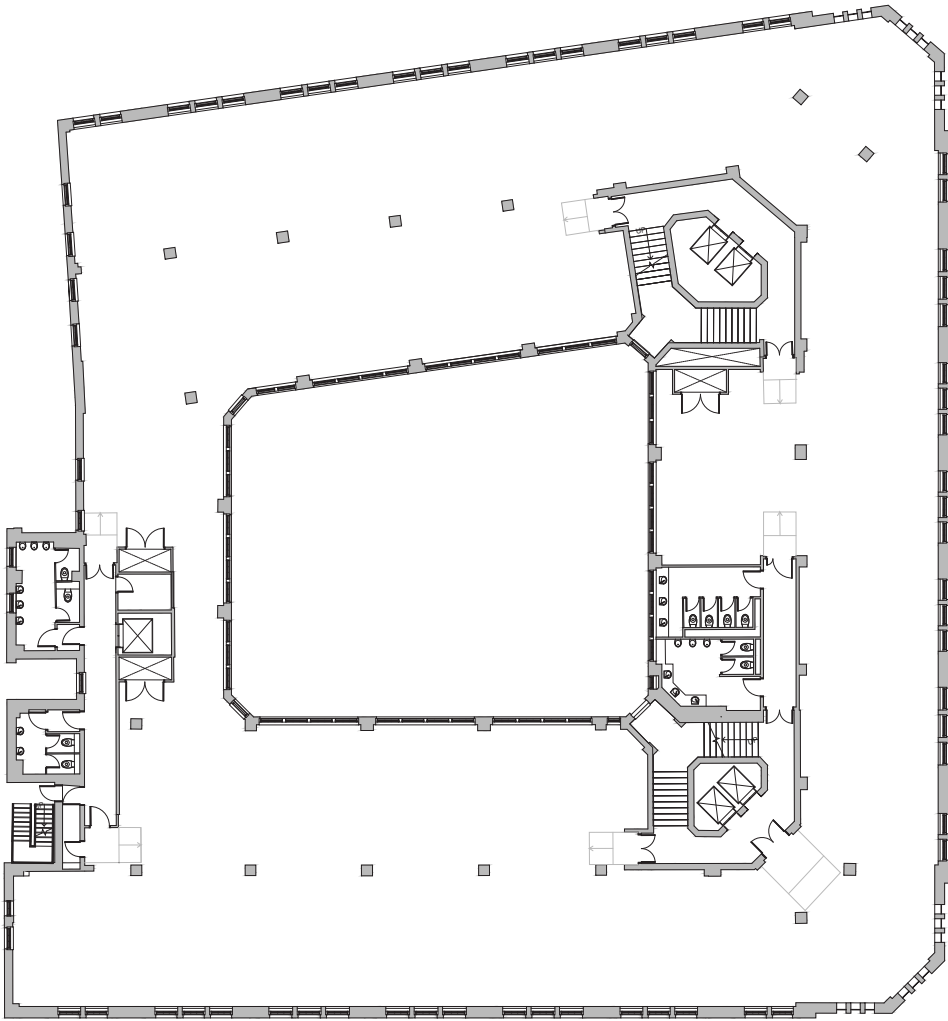
LEVEL 08 - EXISTING

Generally speaking the riser strategy looks to maintain and utilise existing risers where possible. In the areas where we are amending existing we would look to make good in a similar way to that was approved on level 8 previously.
