PLANNING RESPONSES  
SUNLIGHT HOUSE  
APRIL 2023

PLANNING RESPONSES  
SUNLIGHT HOUSE

EXTERNAL ALTERATIONS

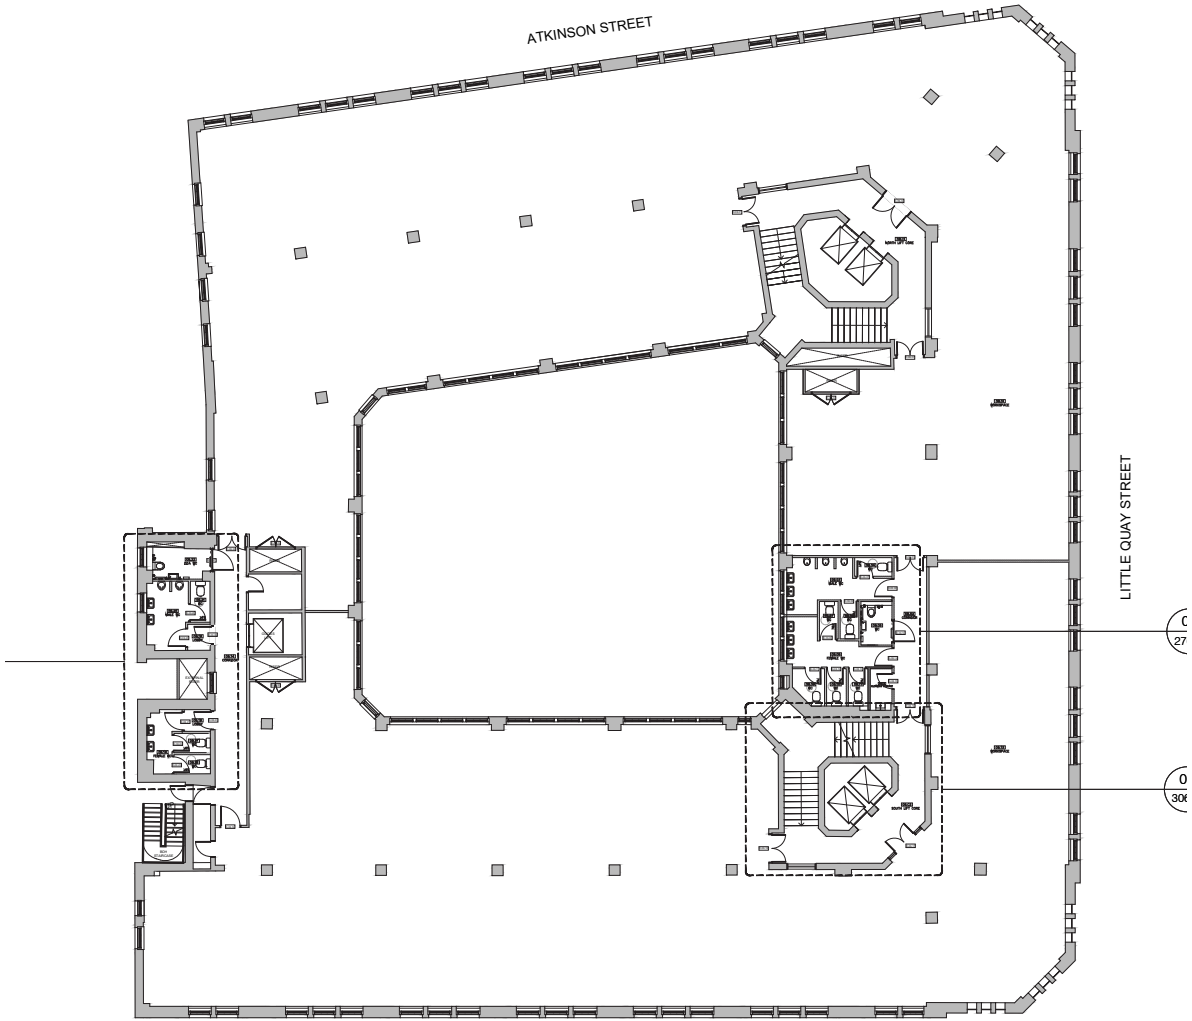
LEVEL 08 - PROPOSED

Generally speaking the riser strategy looks to maintain and utilise existing risers where possible. In the areas where we are amending existing we would look to make good in a similar way to that was approved on level 8 previously.

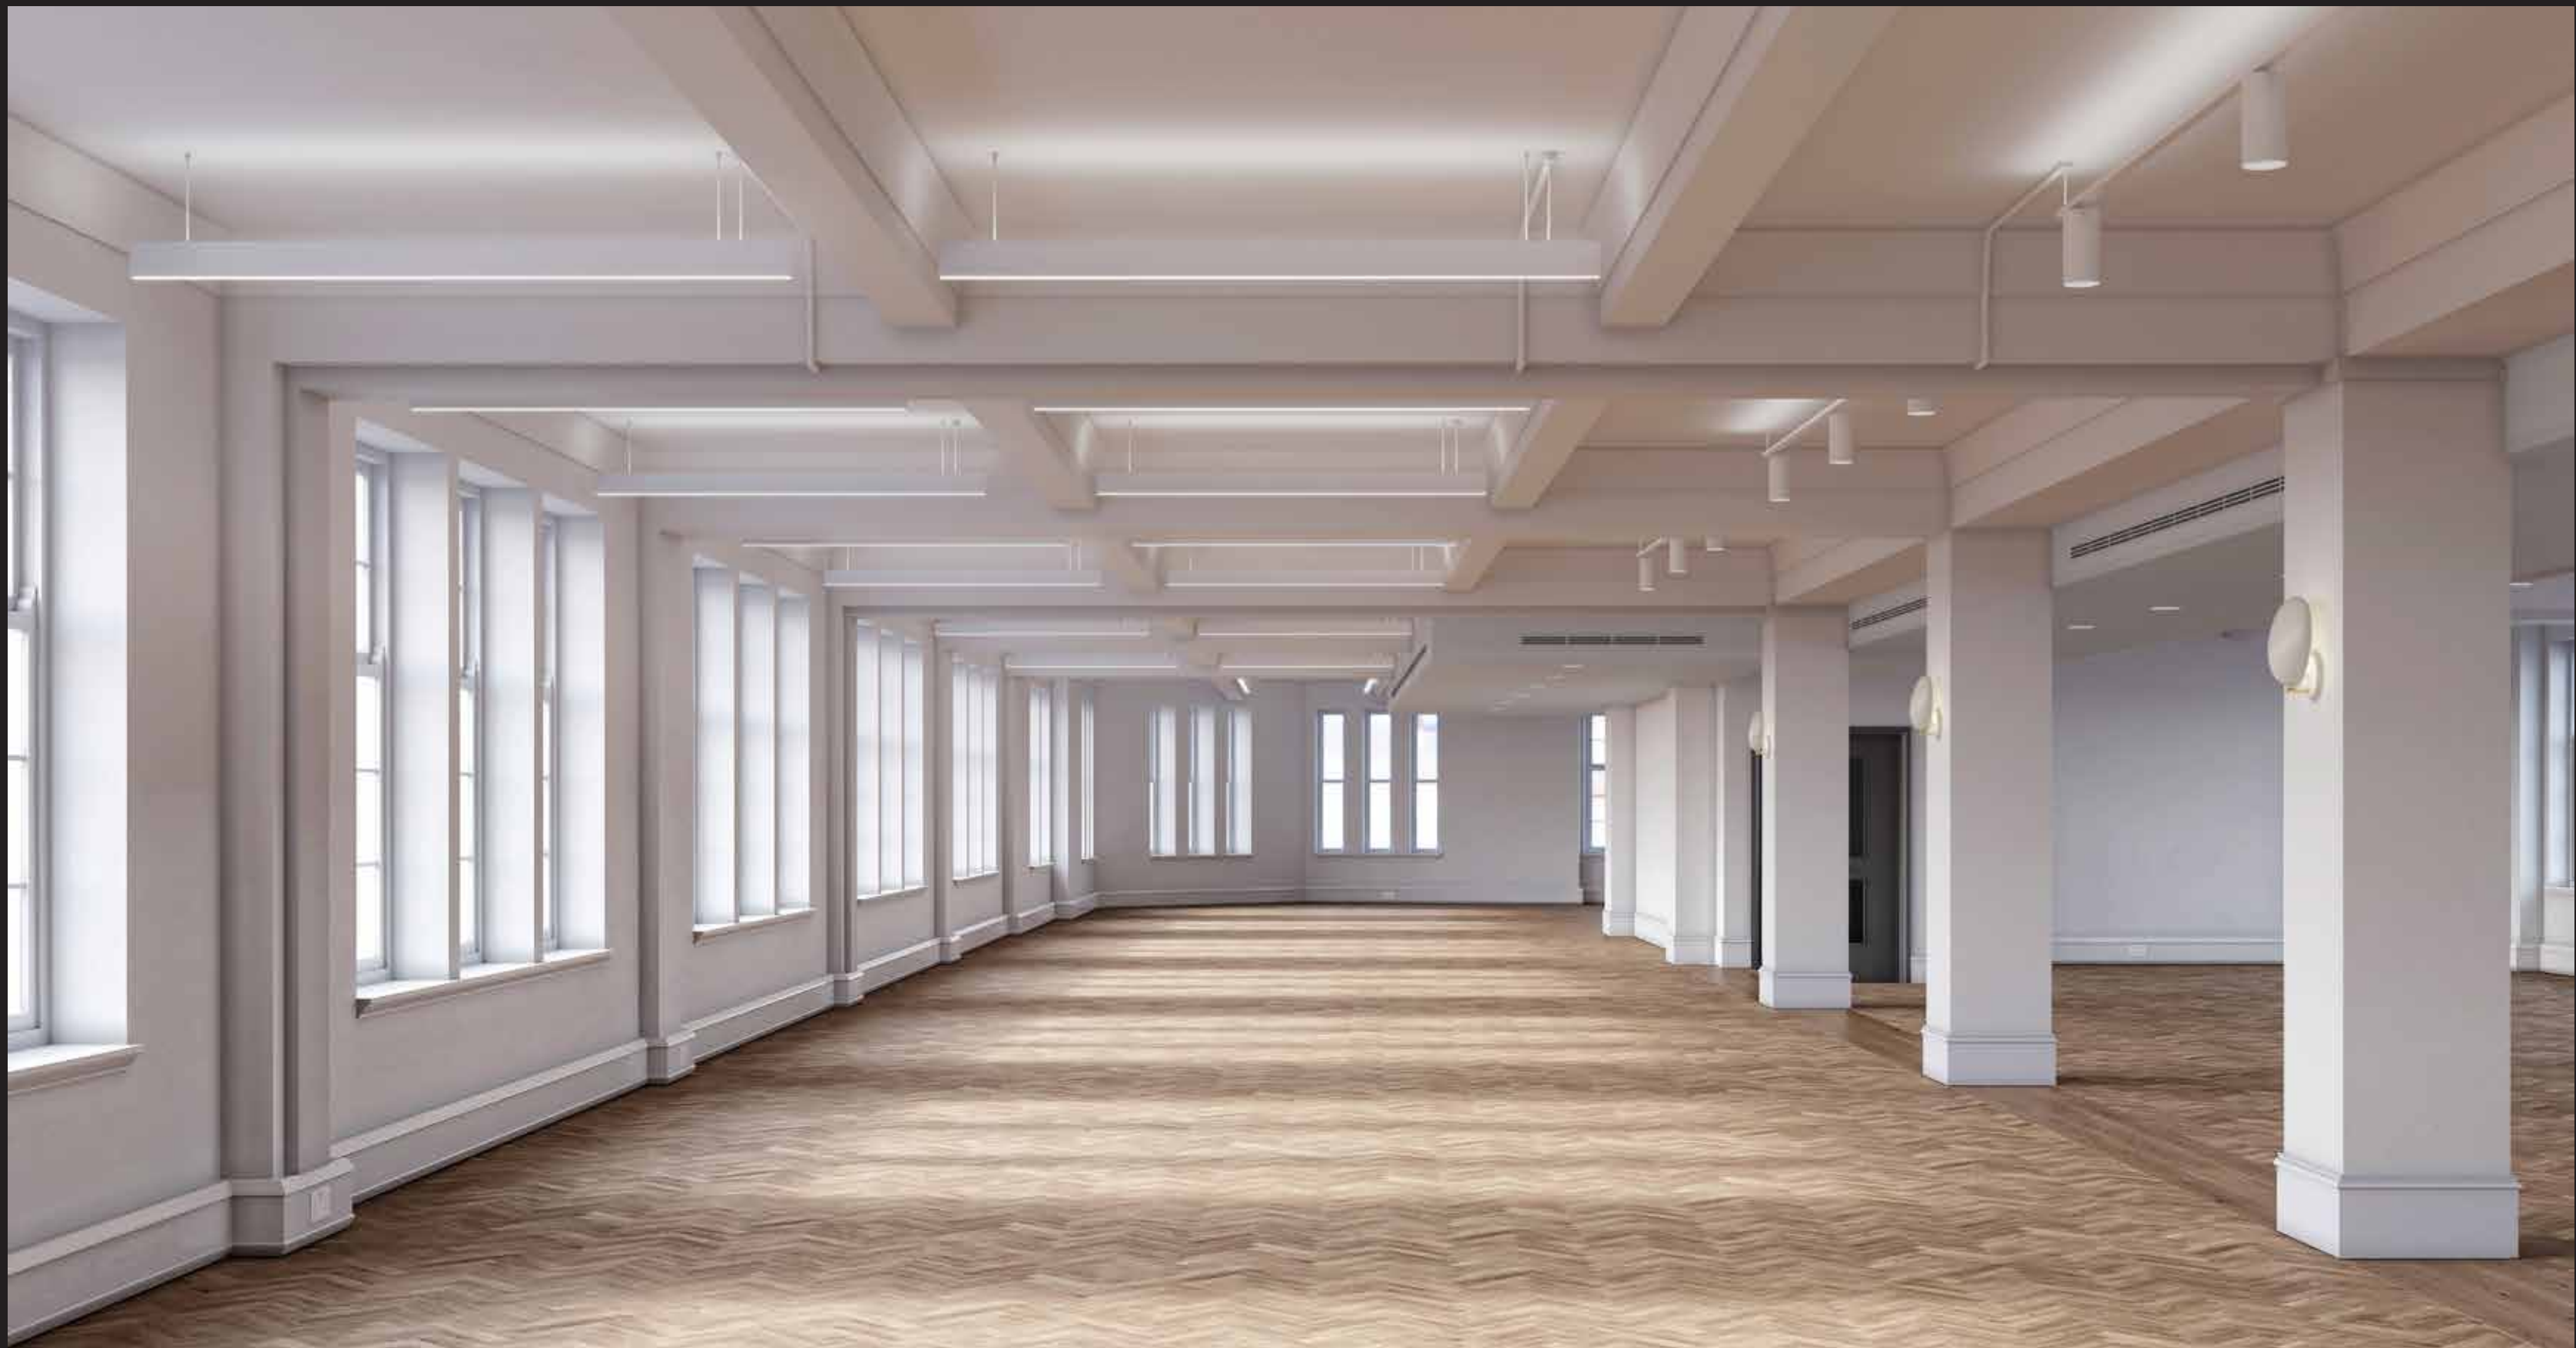
TYPICAL OFFICE GA

We have carefully considered the minimal amount of routing around the office space to celebrate the existing features. We are confining all significant circulation to the central bulkhead with FCU and pipework contained within the bulkehad itself. Where there are no raised access floors we are transferring power and data through trays aligned with the coffer details to perimeter trunking around the floorplate. We have sense checked this with Cat-B layouts to ensure this works in both conditions. Where raised access floor already exists on site the transfer of MEP is less of a concern.

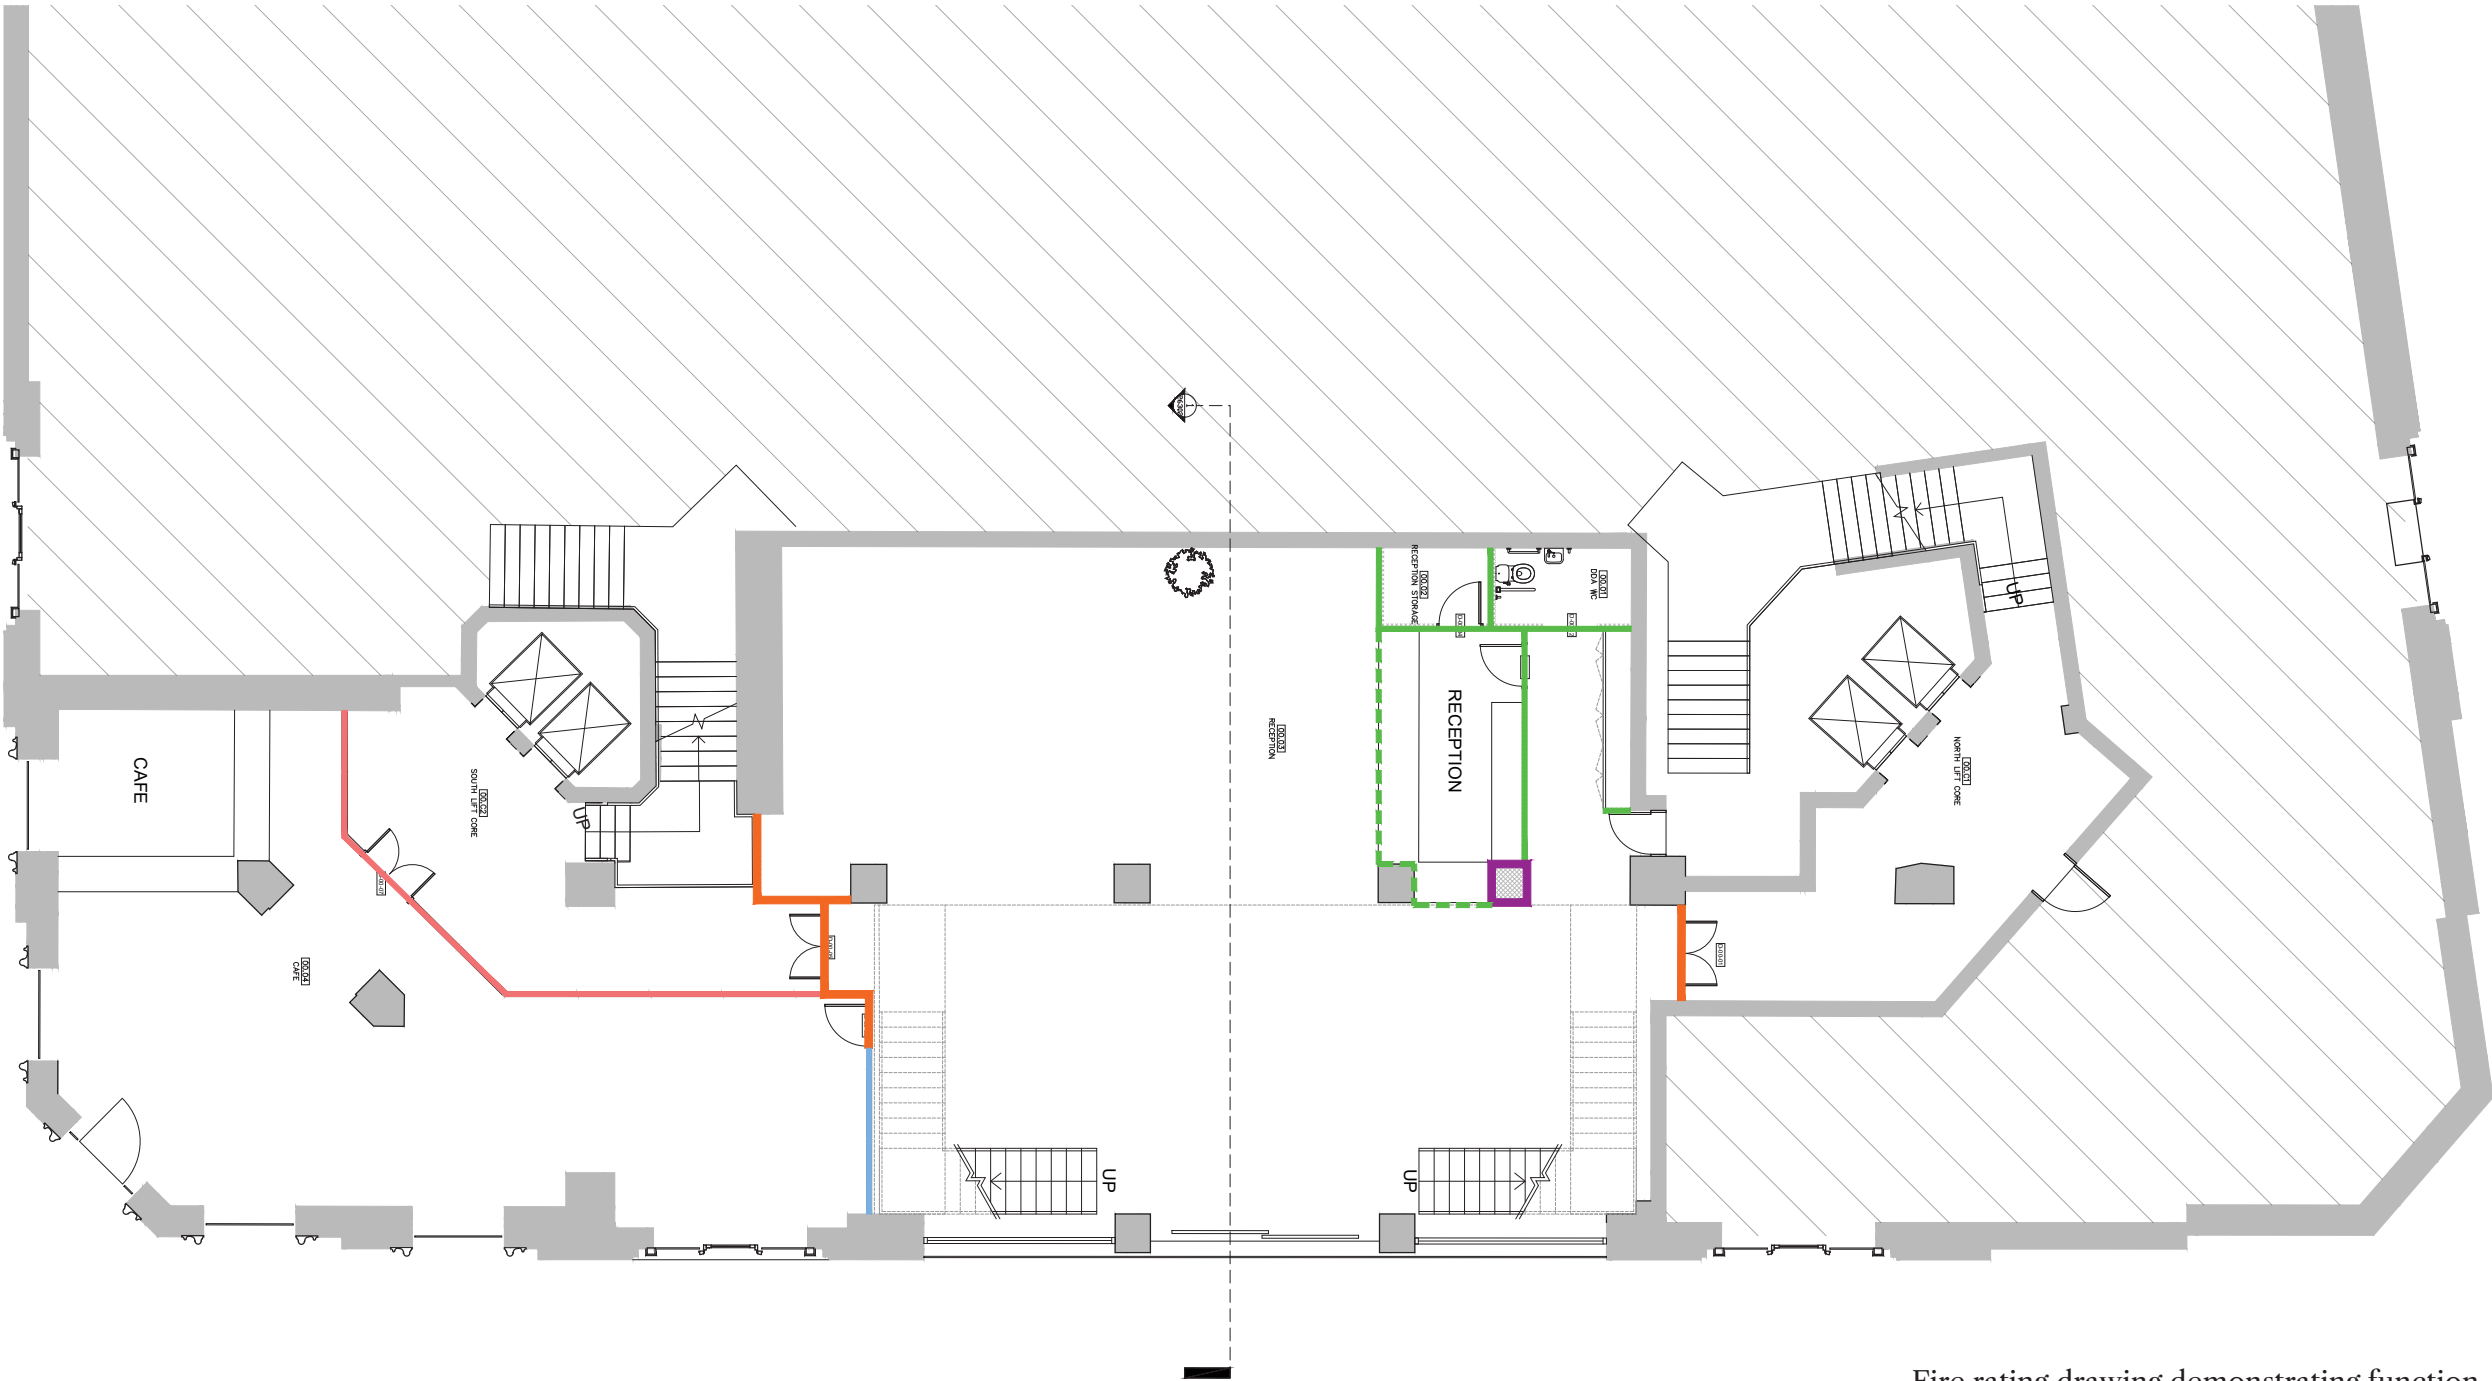
Fire rating drawing demonstrating function of wall and pocket doors in similar way to the north-eastern corner of the building.

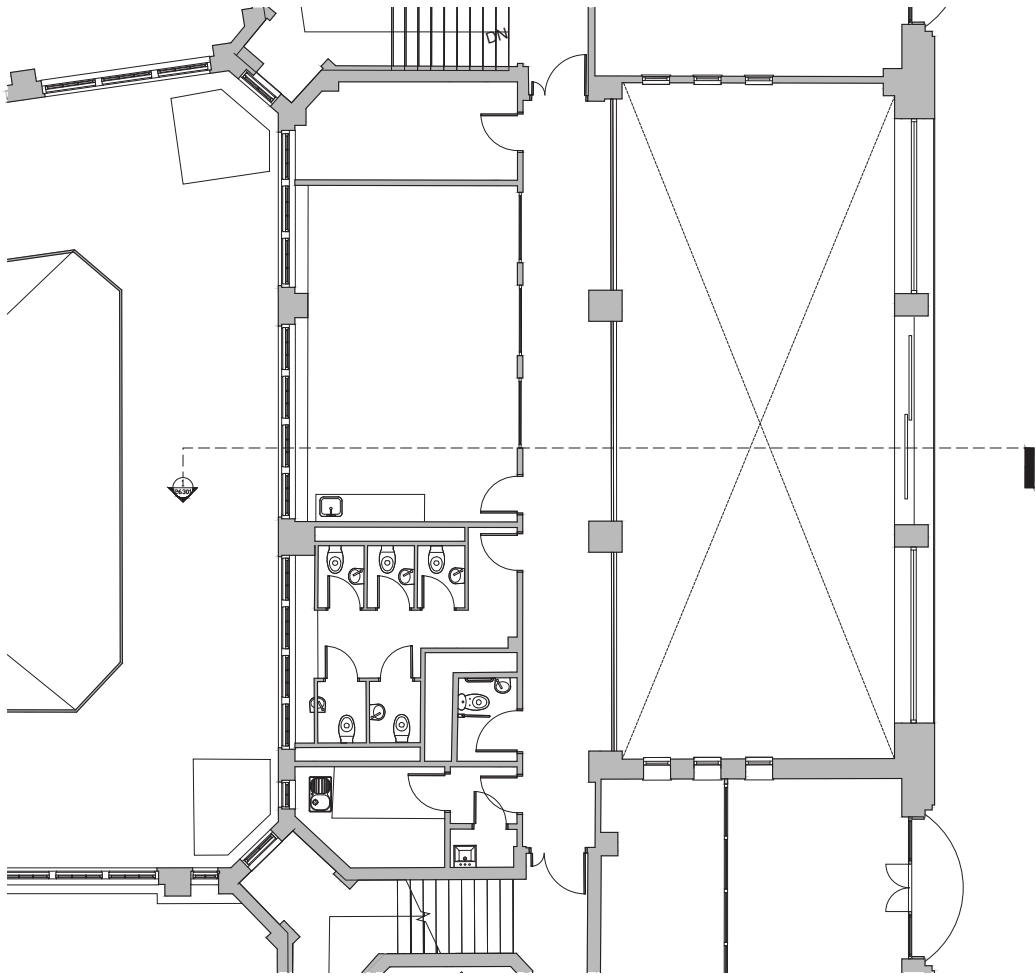
LEVEL 01 - EXISTING

While we have introduced a partition to form the meeting room, we feel this is balanced with the positive contribution of introducing the access door to the external space. We have also placed the partition here as it will be perceived as a central door internally with a window either side - given the sash sets are 4 windows currently (please see images overleaf)

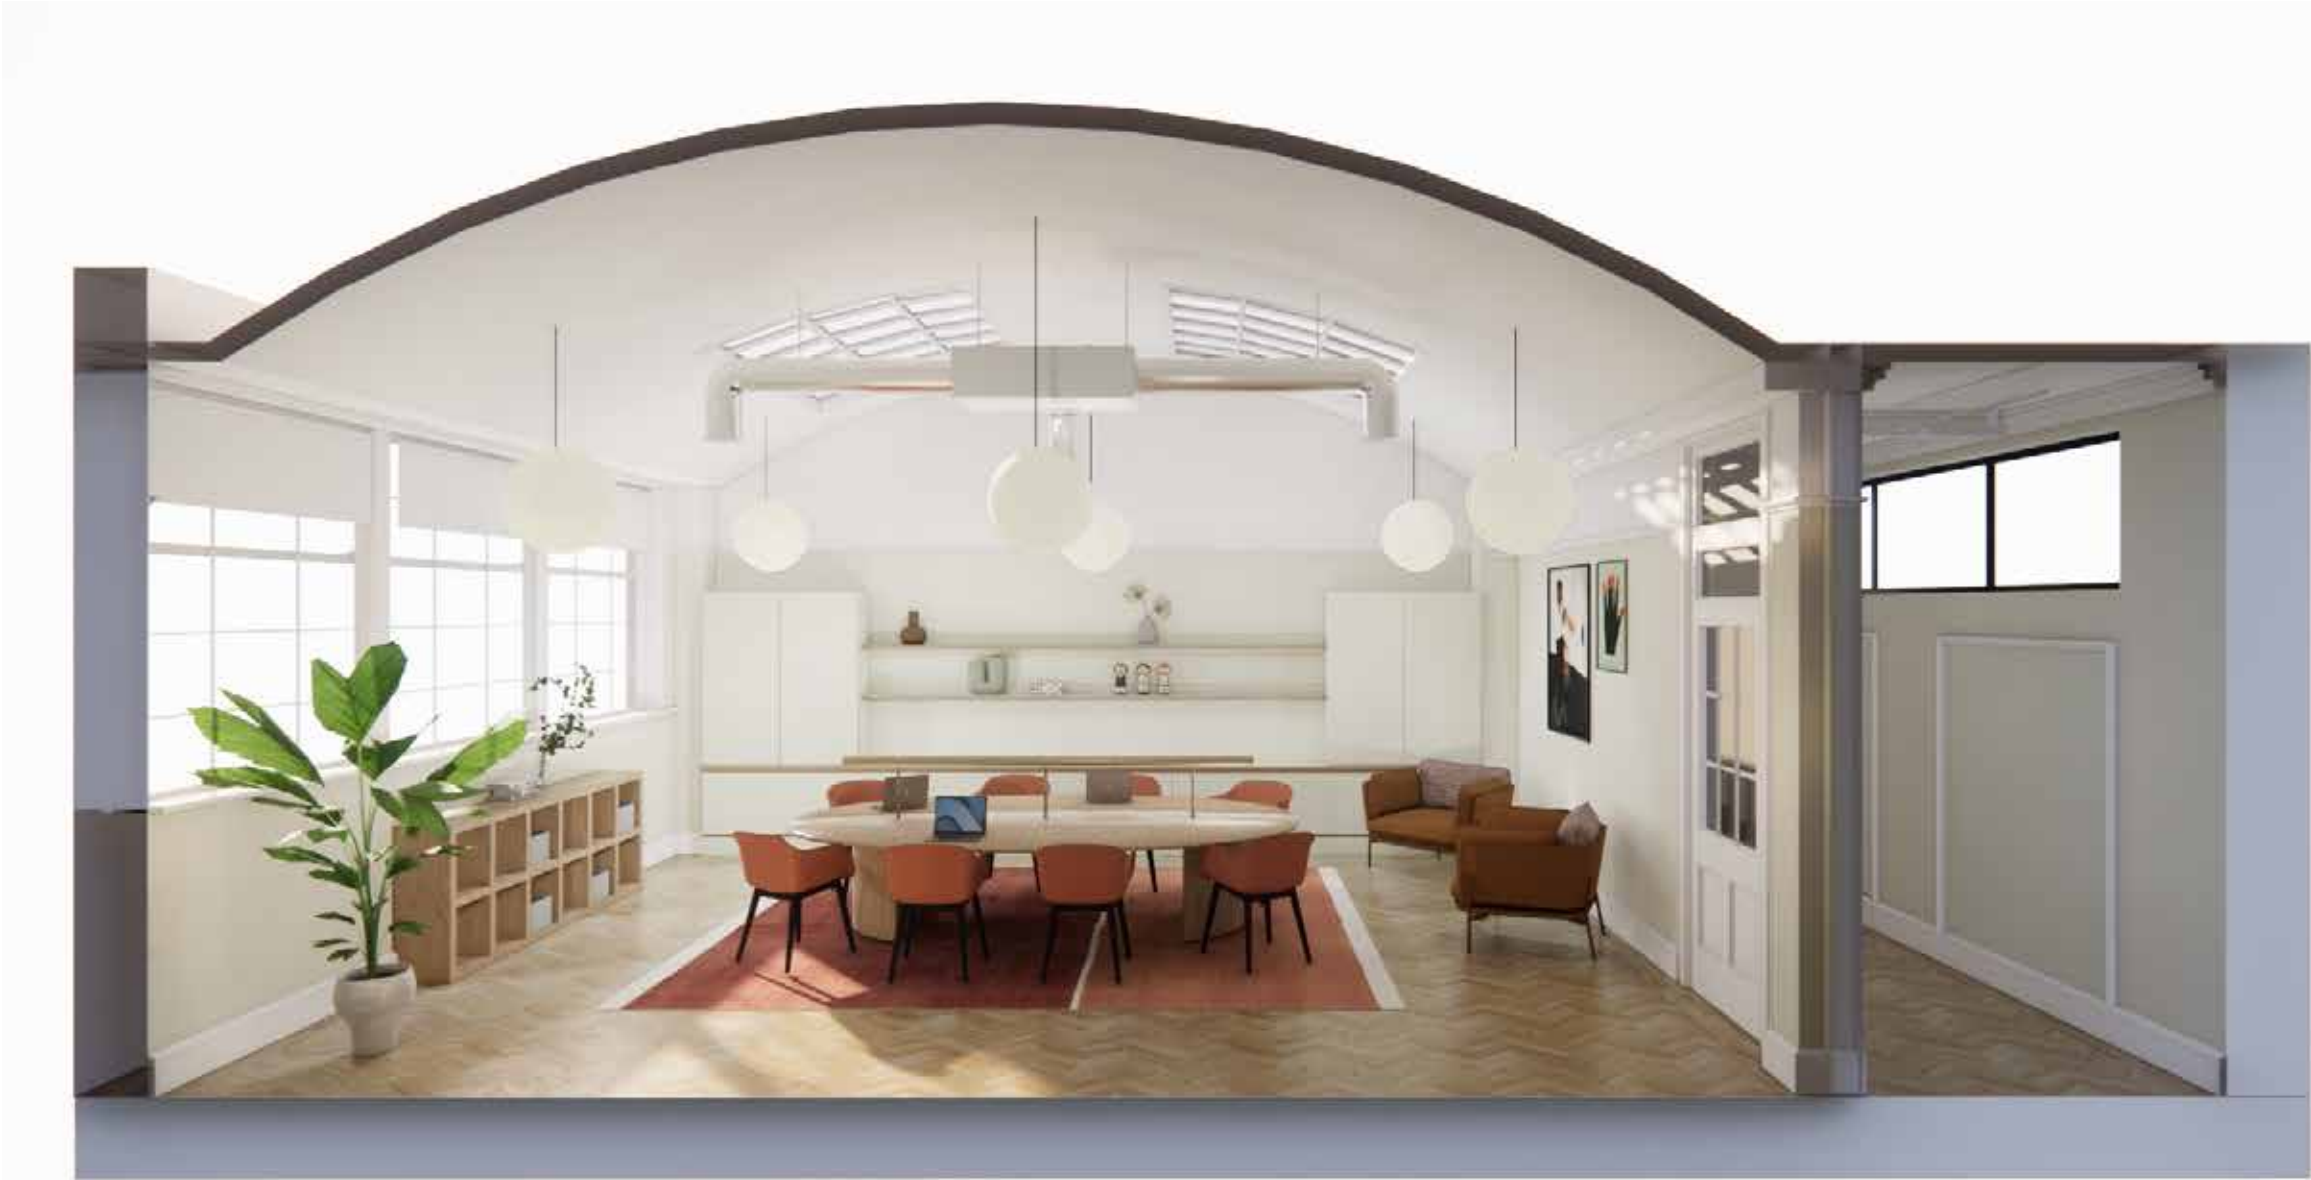
LEVEL 13 - WITH THE WALL AND CORRIDOR  
REMAINING IN SITU

- opening up the historic shelving to the corridor by removing the plasterboard covering
- seeking permission to re-introduce dividing walls to create smaller units along historic lines (aligned with structure - see overleaf)

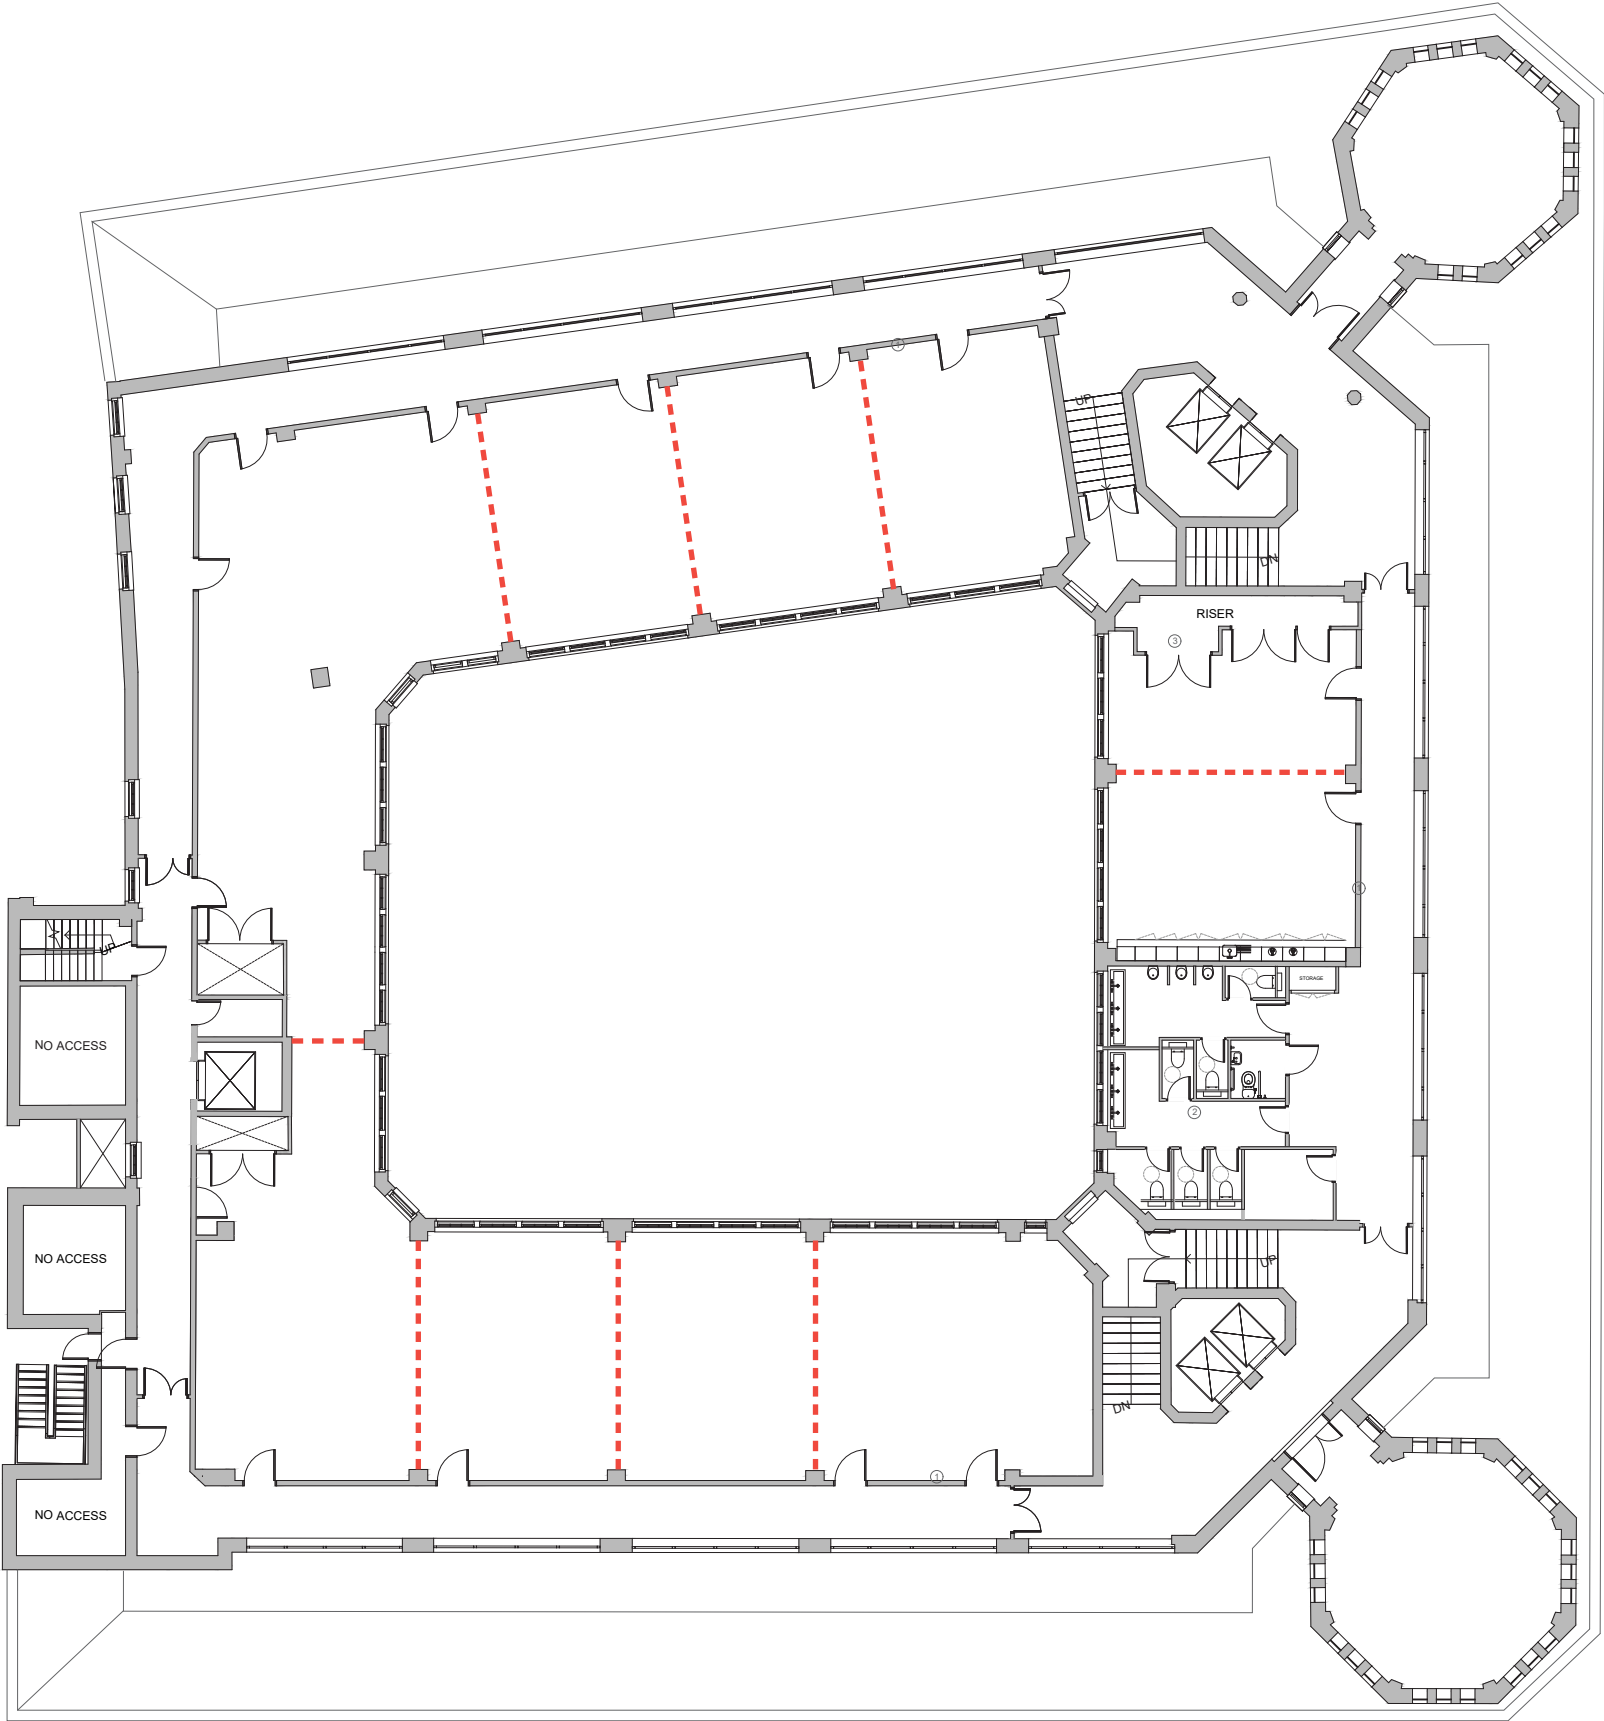
Example tenancy splits on a single floor using structural lines only. (dashed red lines)

Floor would be split into no more than 7 key tenancies with small meeting room/shared space/kitchen between main cores and rotunda meeting rooms.

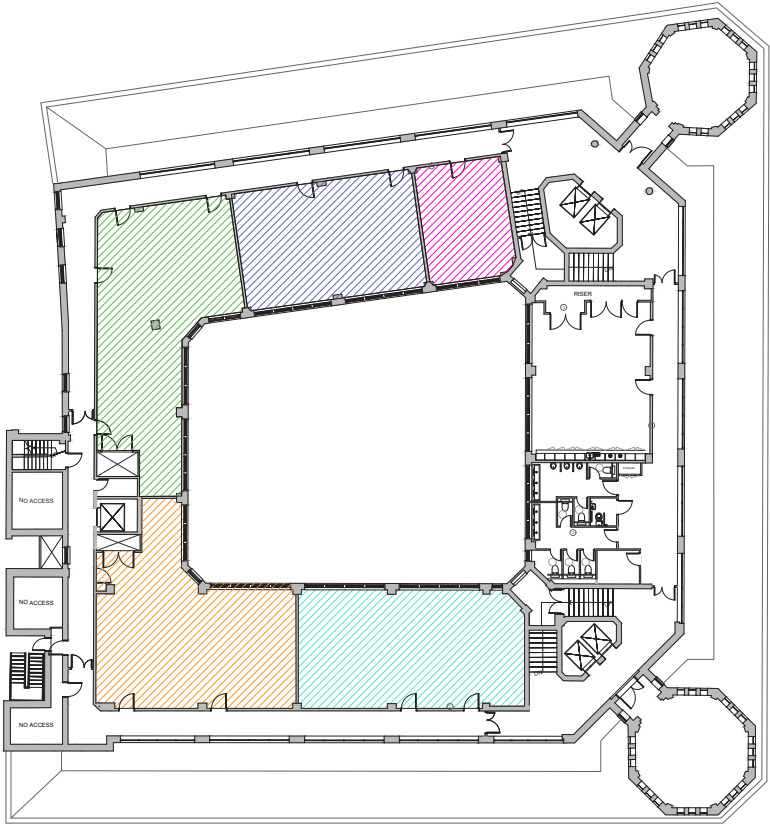
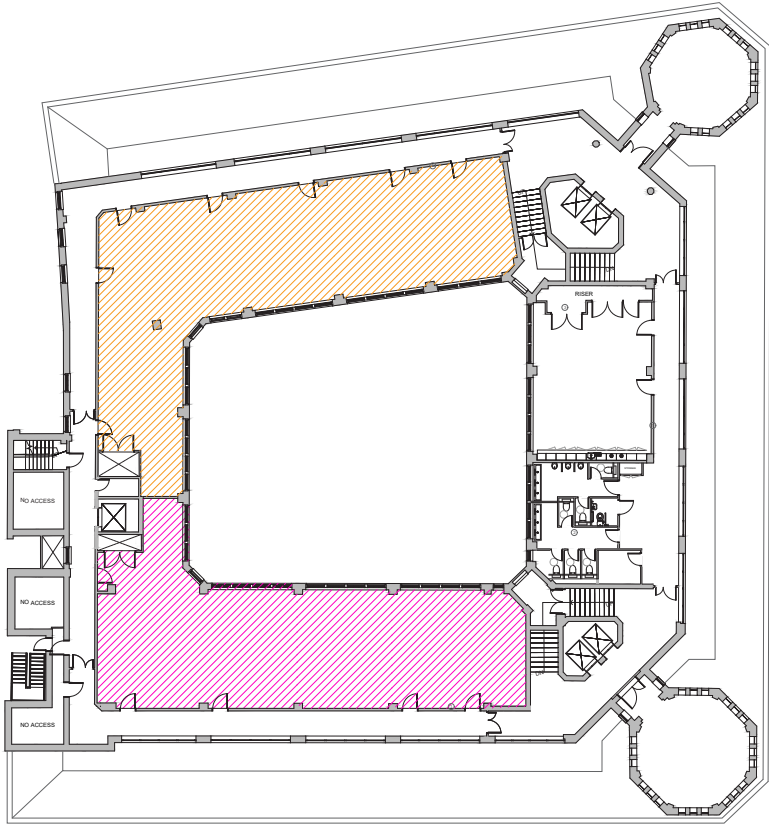
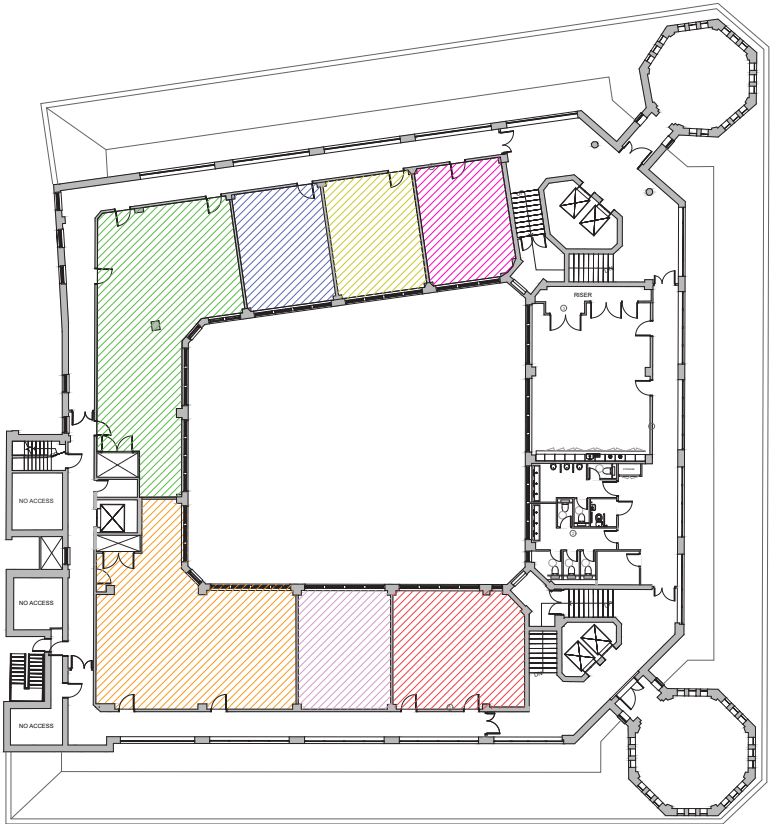
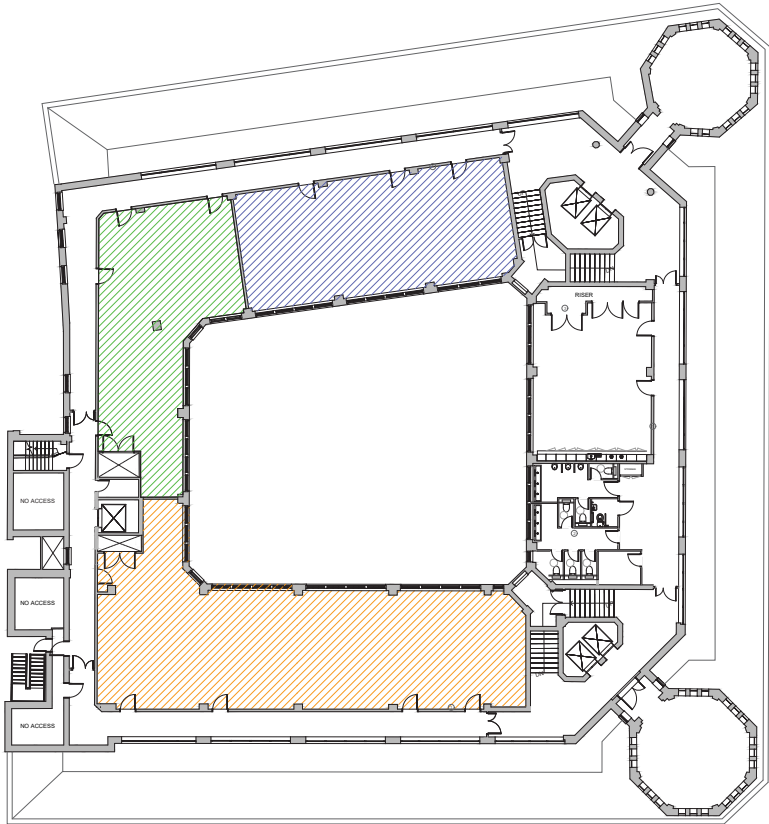
23. LEVEL 13 SUBDIVISION

Example tenancy splits on a single floor using structural lines only. (dashed red lines)

Floor would be split into no more than 7 key tenancies with small meeting room/shared space/kitchen between main cores and rotunda meeting rooms.

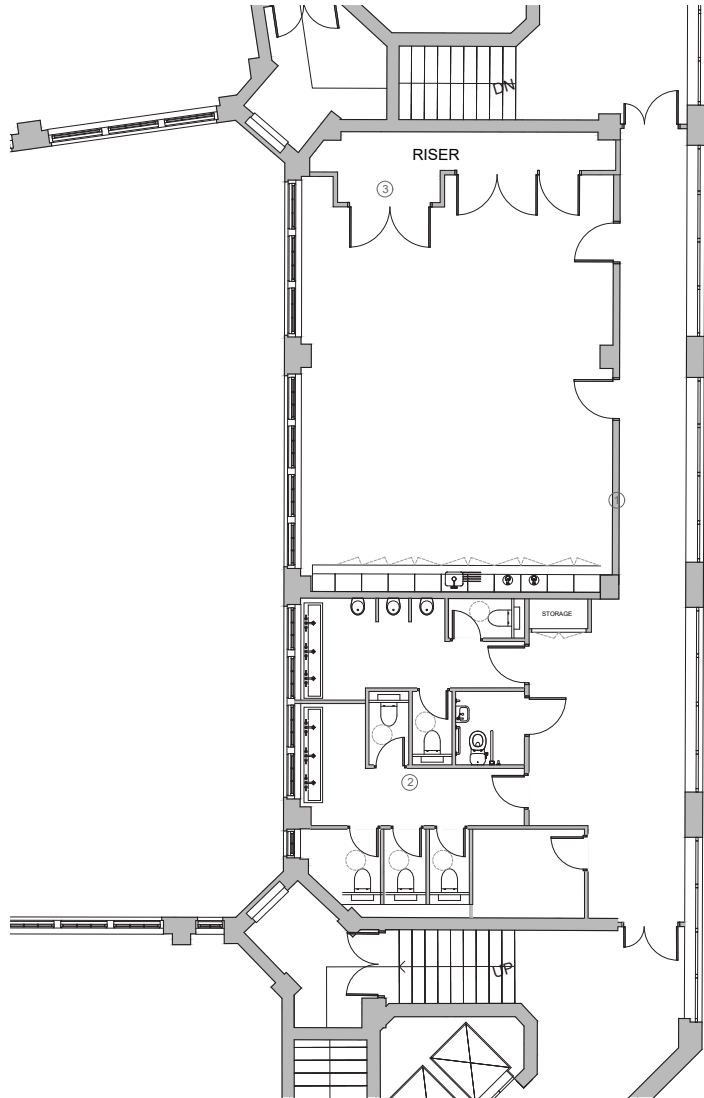
LEVEL 13 - PROPOSED

We have now corrected our incorrectly labelled drawing and amended the drawings to pull the riser back from the window.

The works to the plant and maintenance room appear to show new partitions that would cut across the window frames. A plasterboard soffit is also proposed which would block the impressive barrel vaulted ceilings and the skylight. The proposal needs to be amended in this regard. Further needs to the scope of the repair in this area needs to be provided to help justify the works. No details for instance have been provided with regards to unblocking covered rooflights and they are not shown on the reflected ceiling plans. Will the original cupboards in this area be reinstated?

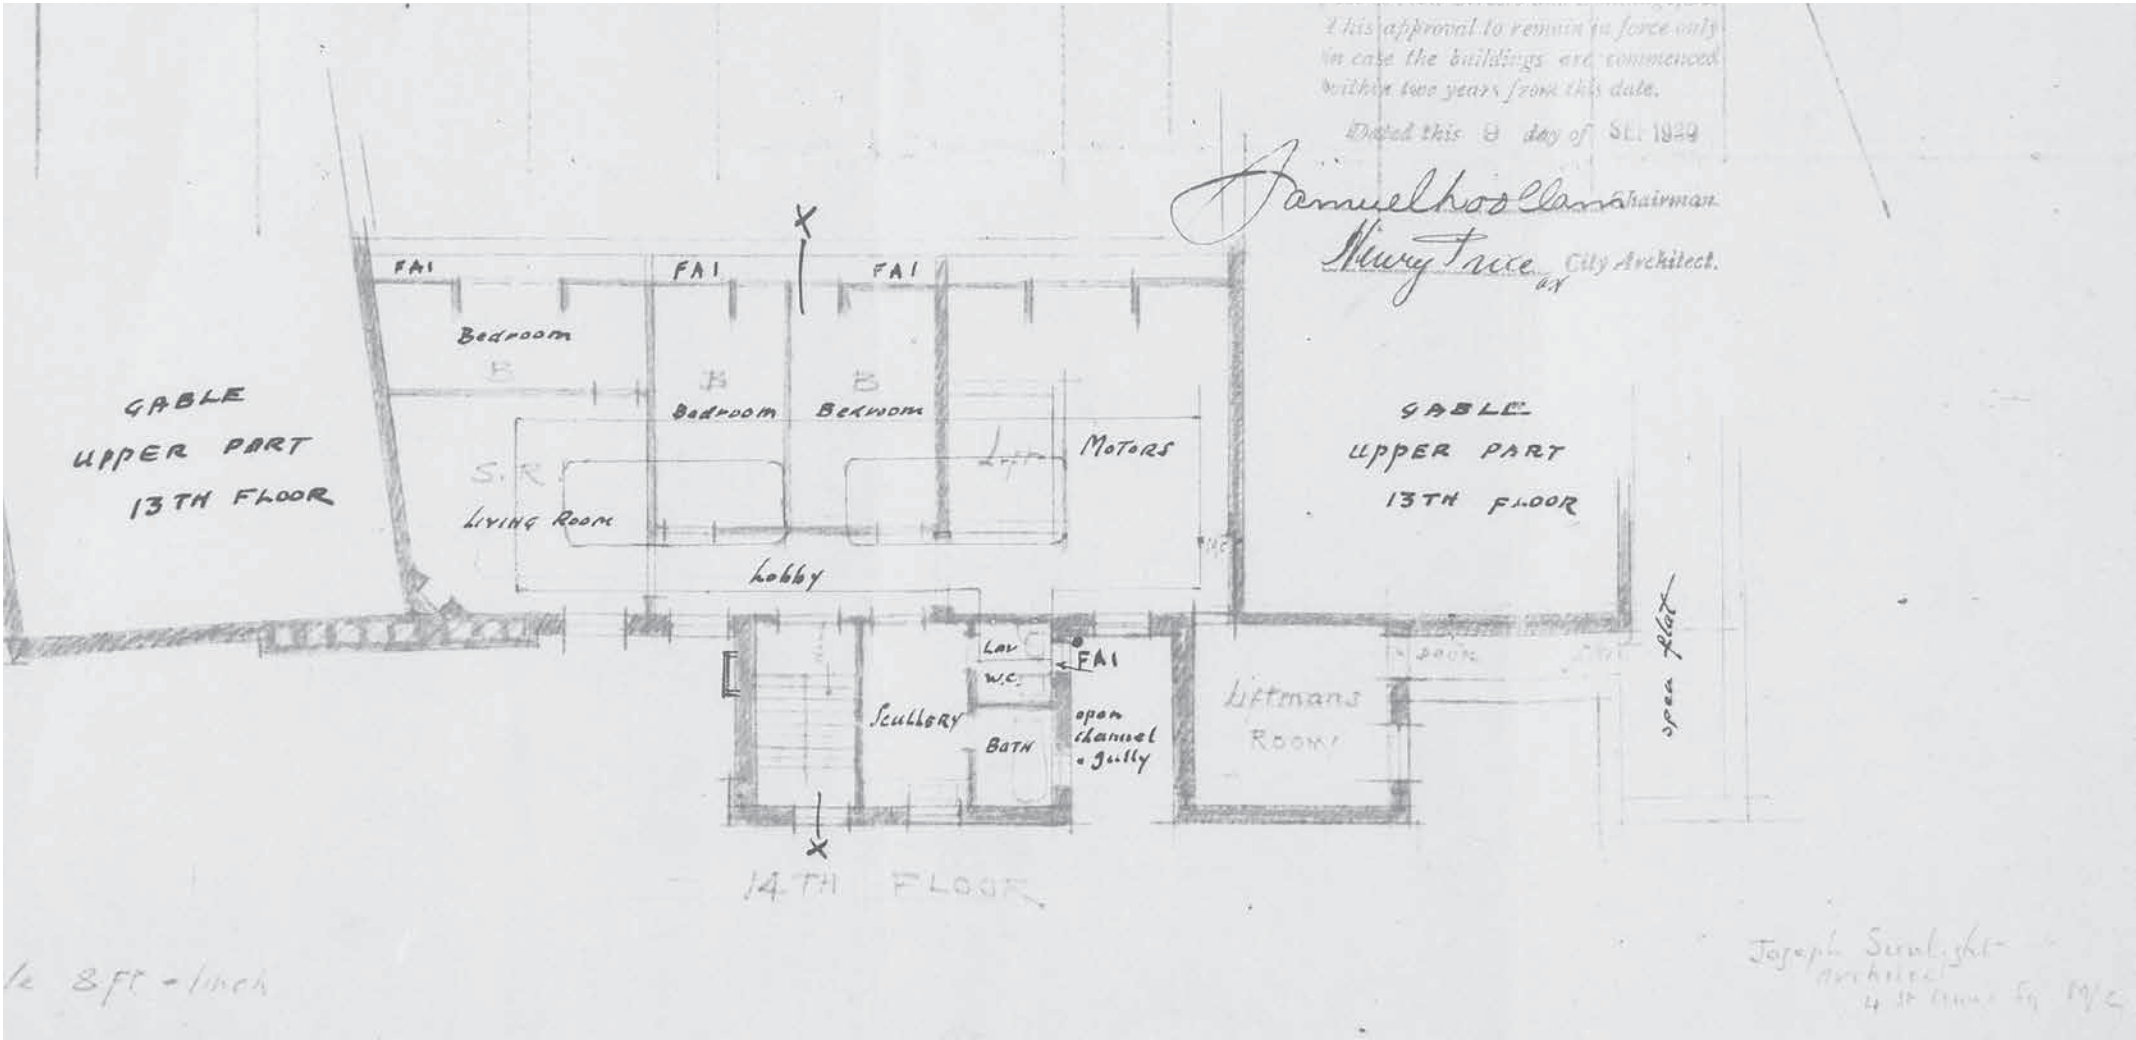
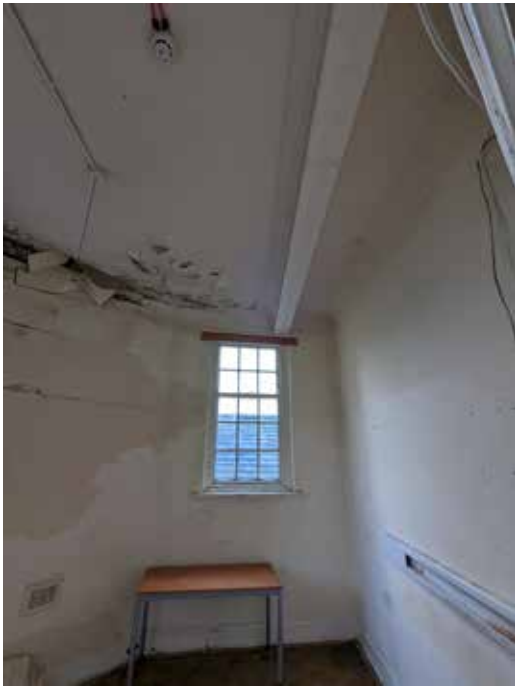
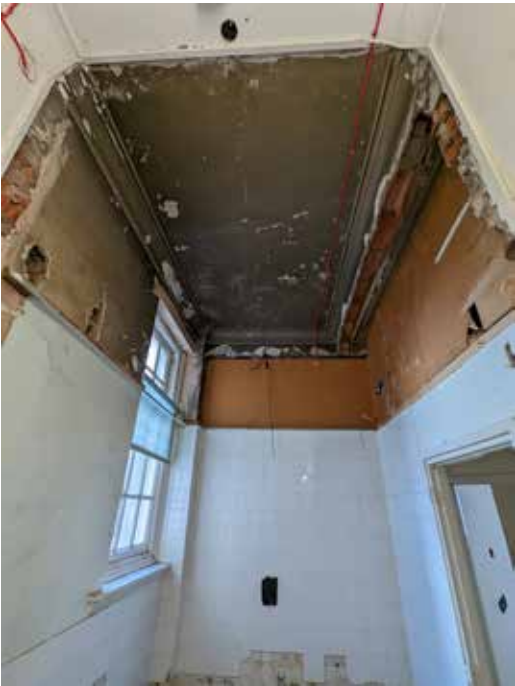
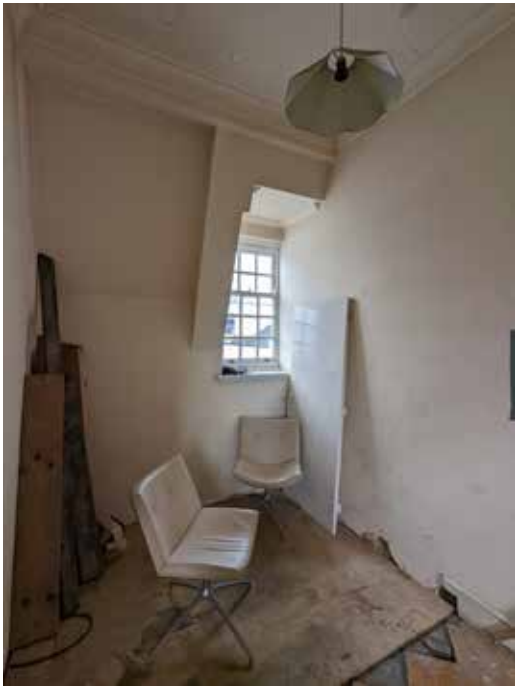
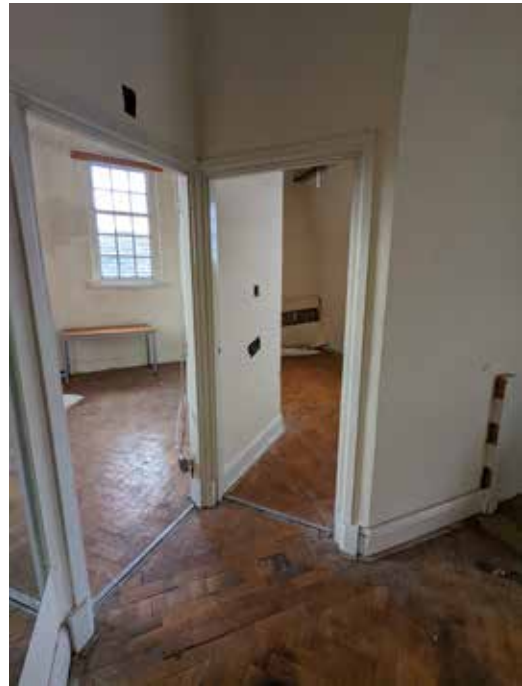
25. LEVEL 14 PLANT ROOM

We have assessed against original drawings and it appears that the partitions have at some point been amended (this is backed up by the downstand beam in the photo and RCP survey)

We could explore leaving the flooring in-situ - where possible but there will need to be a making good due to safety concerns. Regarding the partitions it would be helpful to understand whether a small downstand remaining would suffice given the large scale of equipment required in here and potential maintenance issues.

There is a dispute about the extent of original features in this space with elements of original floorplan, cornicing, window surrounds, parquet floor and white glazed tiles all evident in this space. Indeed, the photograph show the parquet floor largely intact. It is accepted that most of the partitions are modern but reflect the original subdivision. To that end the removal of the partitions would cause a degree of harm. Did you undertake a options analysis to look at alternative locations of the plant before deciding of this area? We would like to explore with you whether more of the original layout could be retained including partitions and repair and reinstatement of features such as the floor, ceilings, stairs, metal work and handrails.

The challenge we face in this area is the balance between access, maintenance and heritage. We discussed on site that this area was weighed up against the level 13 space as potential on site plant space, with this area deemed more appropriate due to its condition, inaccessibility and already housing significant lift and heating plant in the area.
