PLANNING RESPONSES  
SUNLIGHT HOUSE  
APRIL 2023

PLANNING RESPONSES  
SUNLIGHT HOUSE

EXTERNAL ALTERATIONS

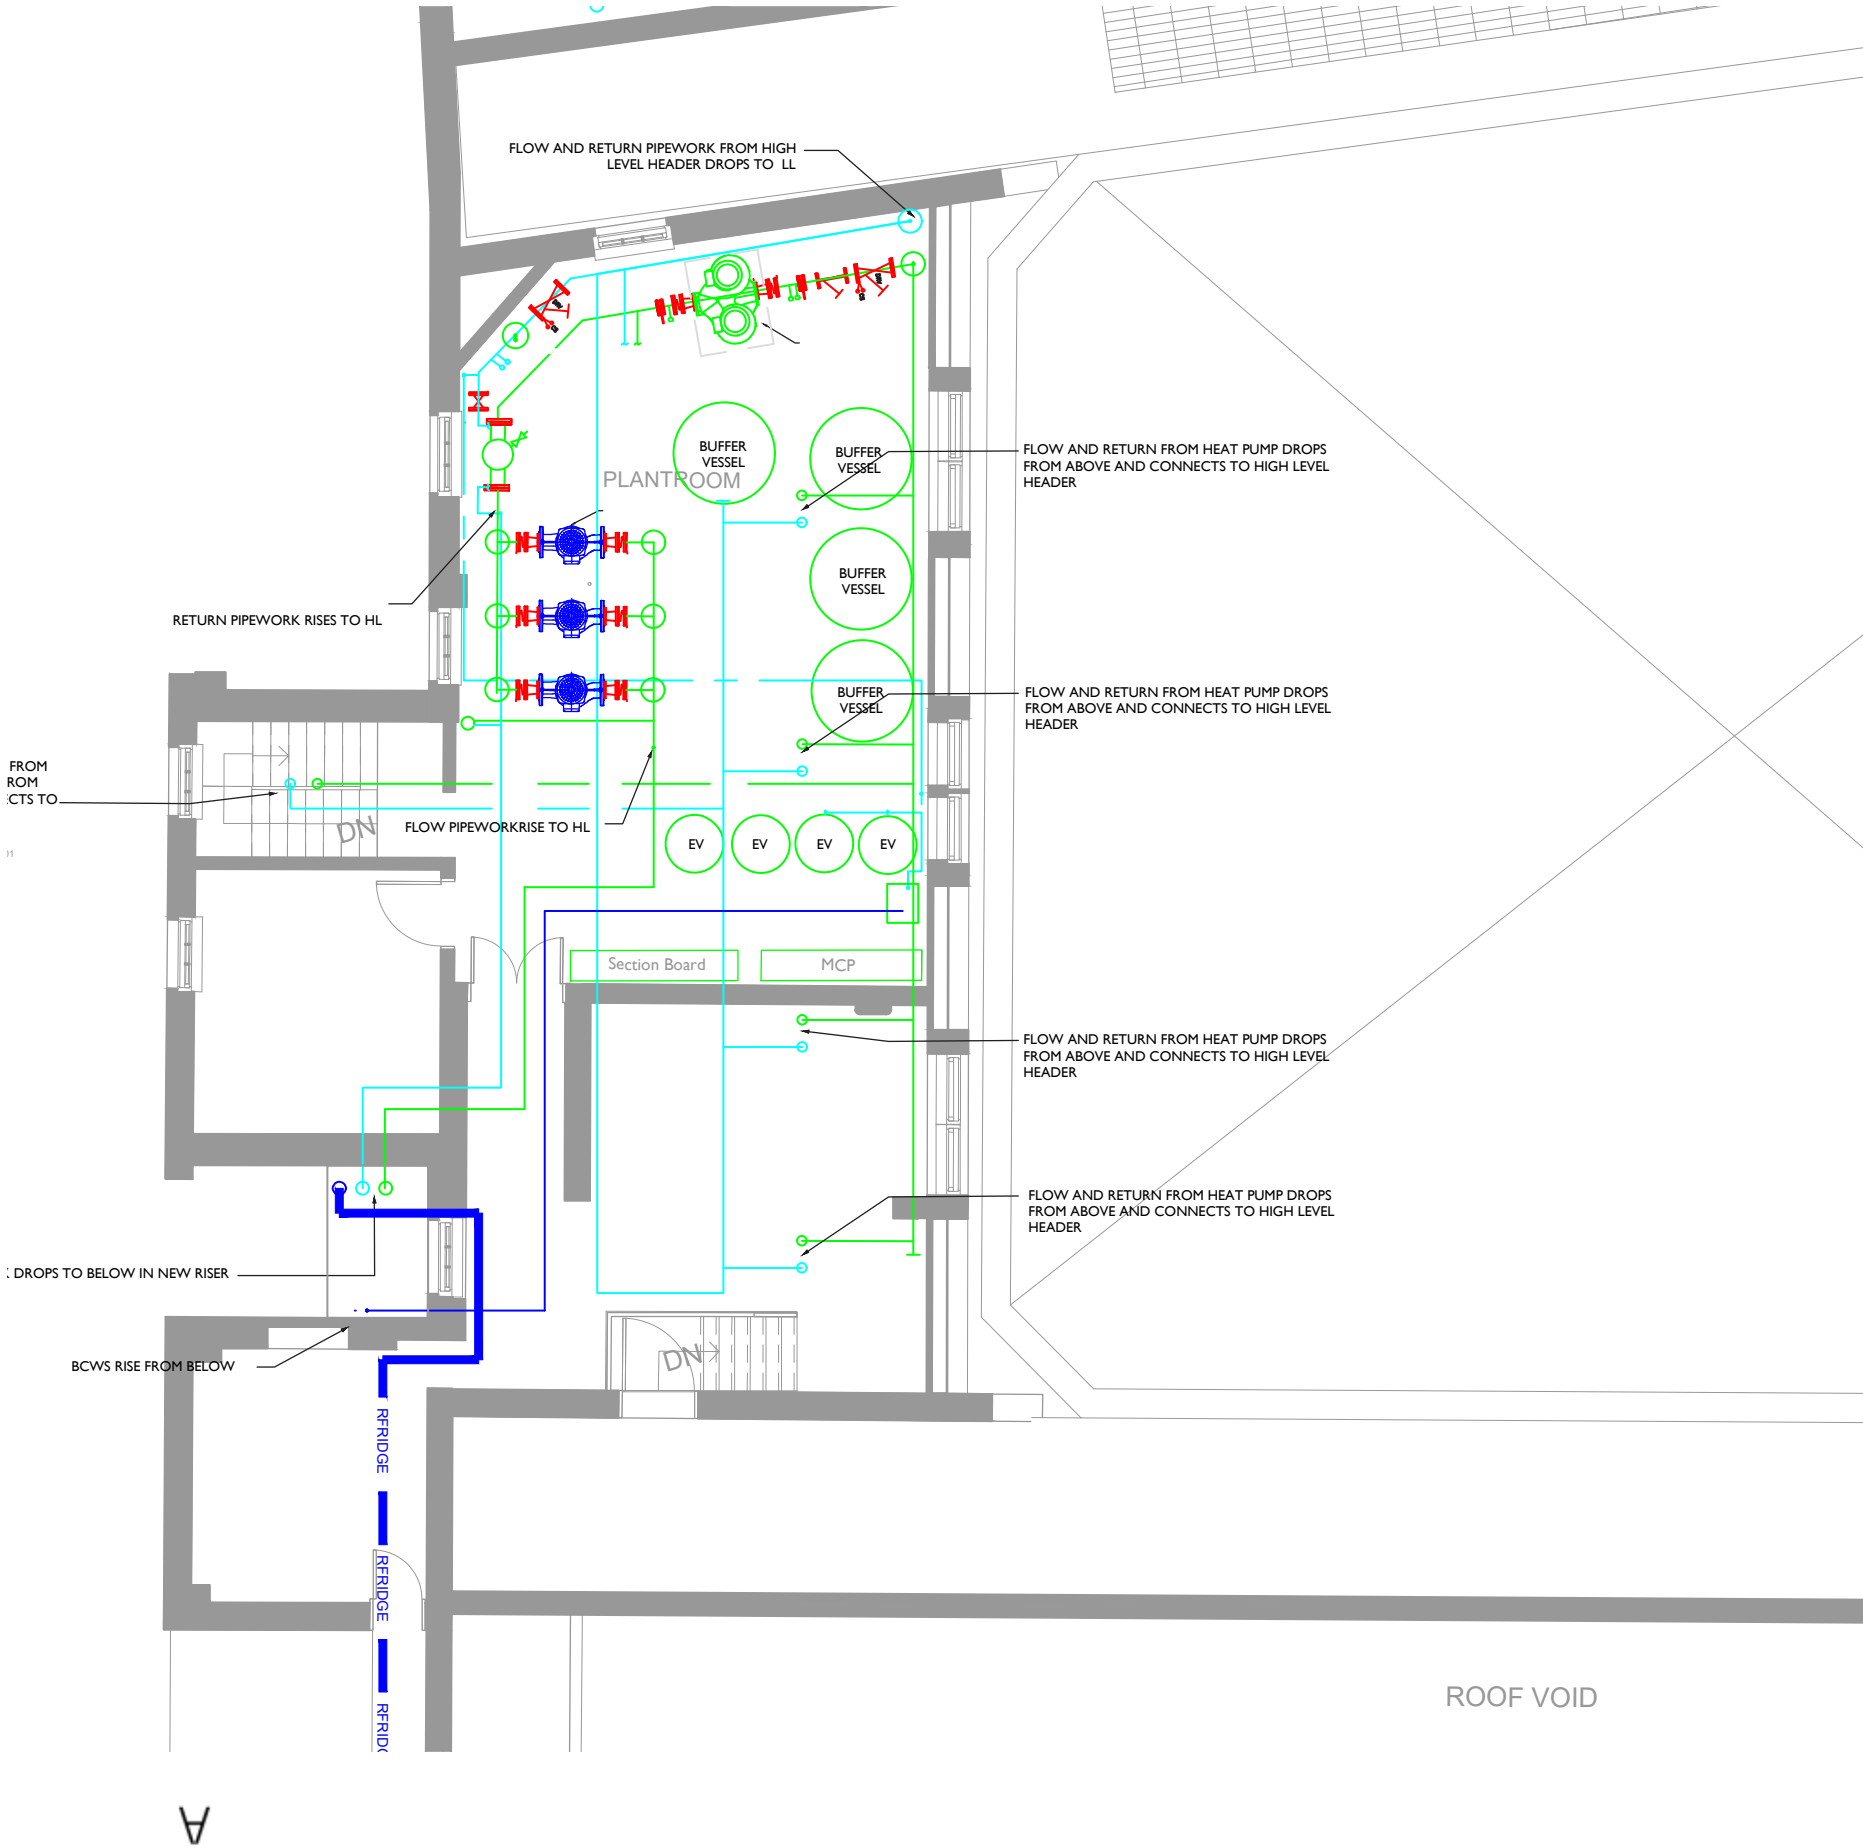
25. LEVEL 14 PLANT ROOM

In this diagram, the scale and size of proposed equipment is visible. Maintaining the small doorways and non original wall presents a problem for installation and maintenance of this kit.

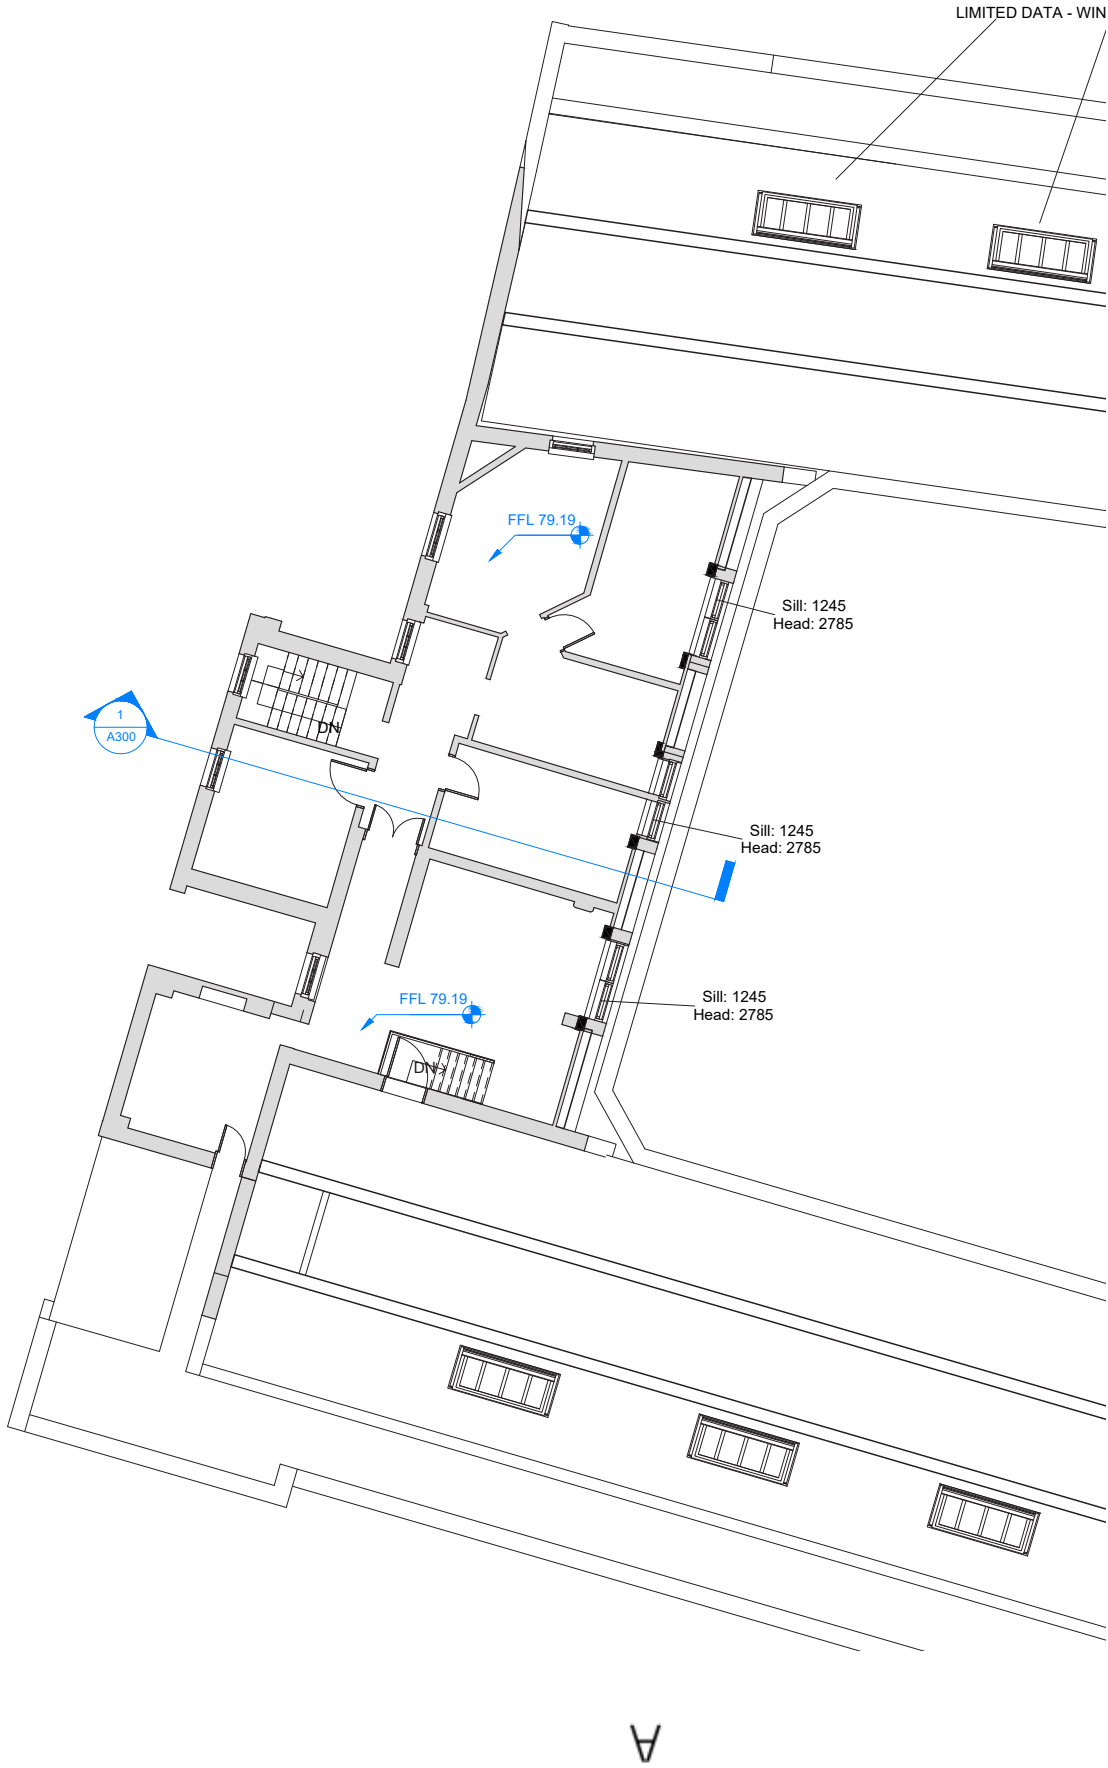
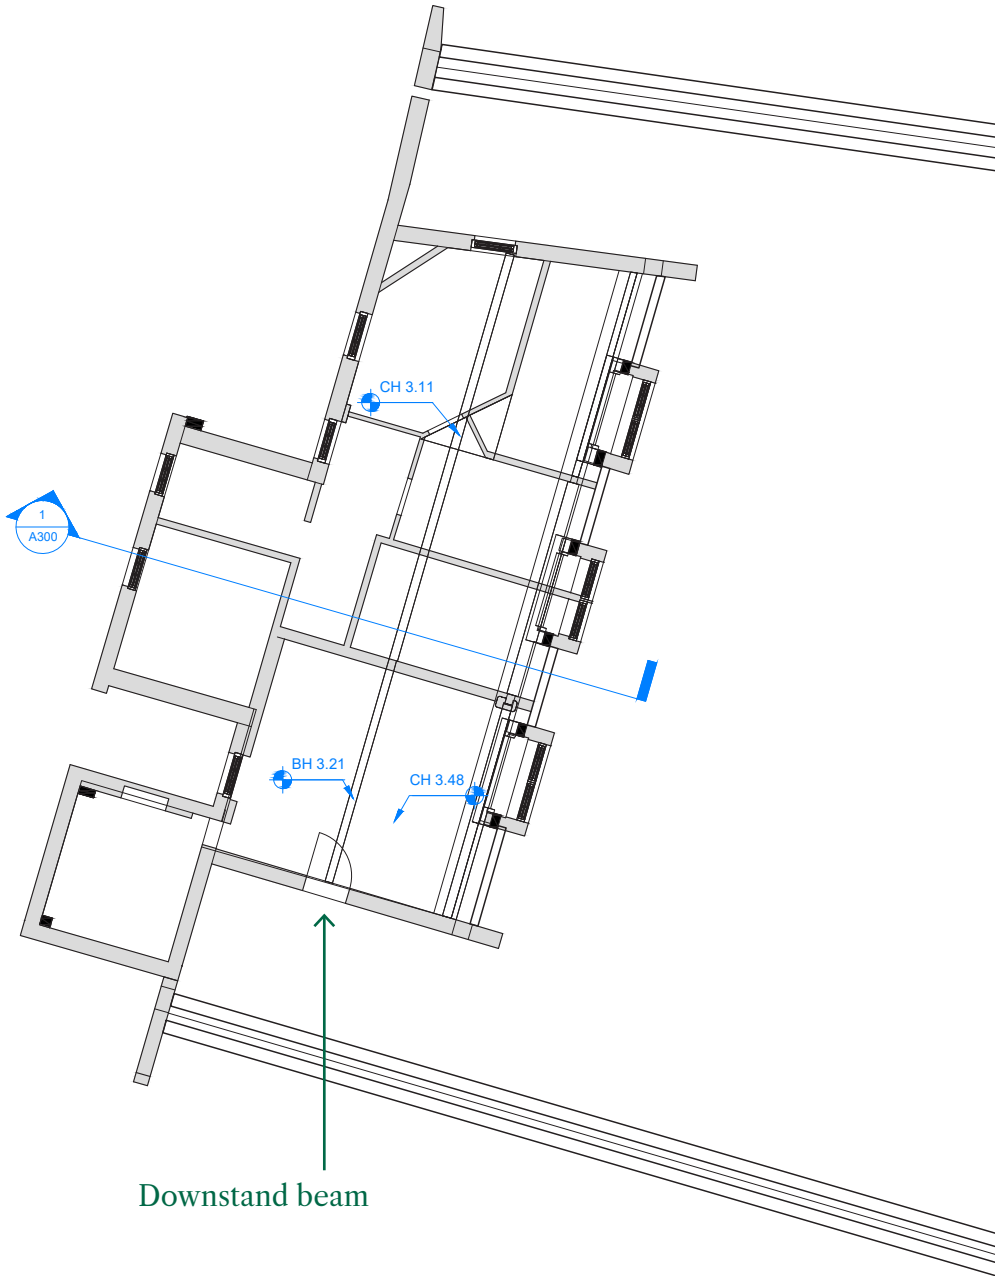
25. LEVEL 14 PLANT ROOM

Note on the facing RCP survey the misalignment between the downstand beam and the wall layout.

We have assessed against original drawings and it appears that the partitions have at some point been amended (this is backed up by the downstand beam in the photo and RCP survey)

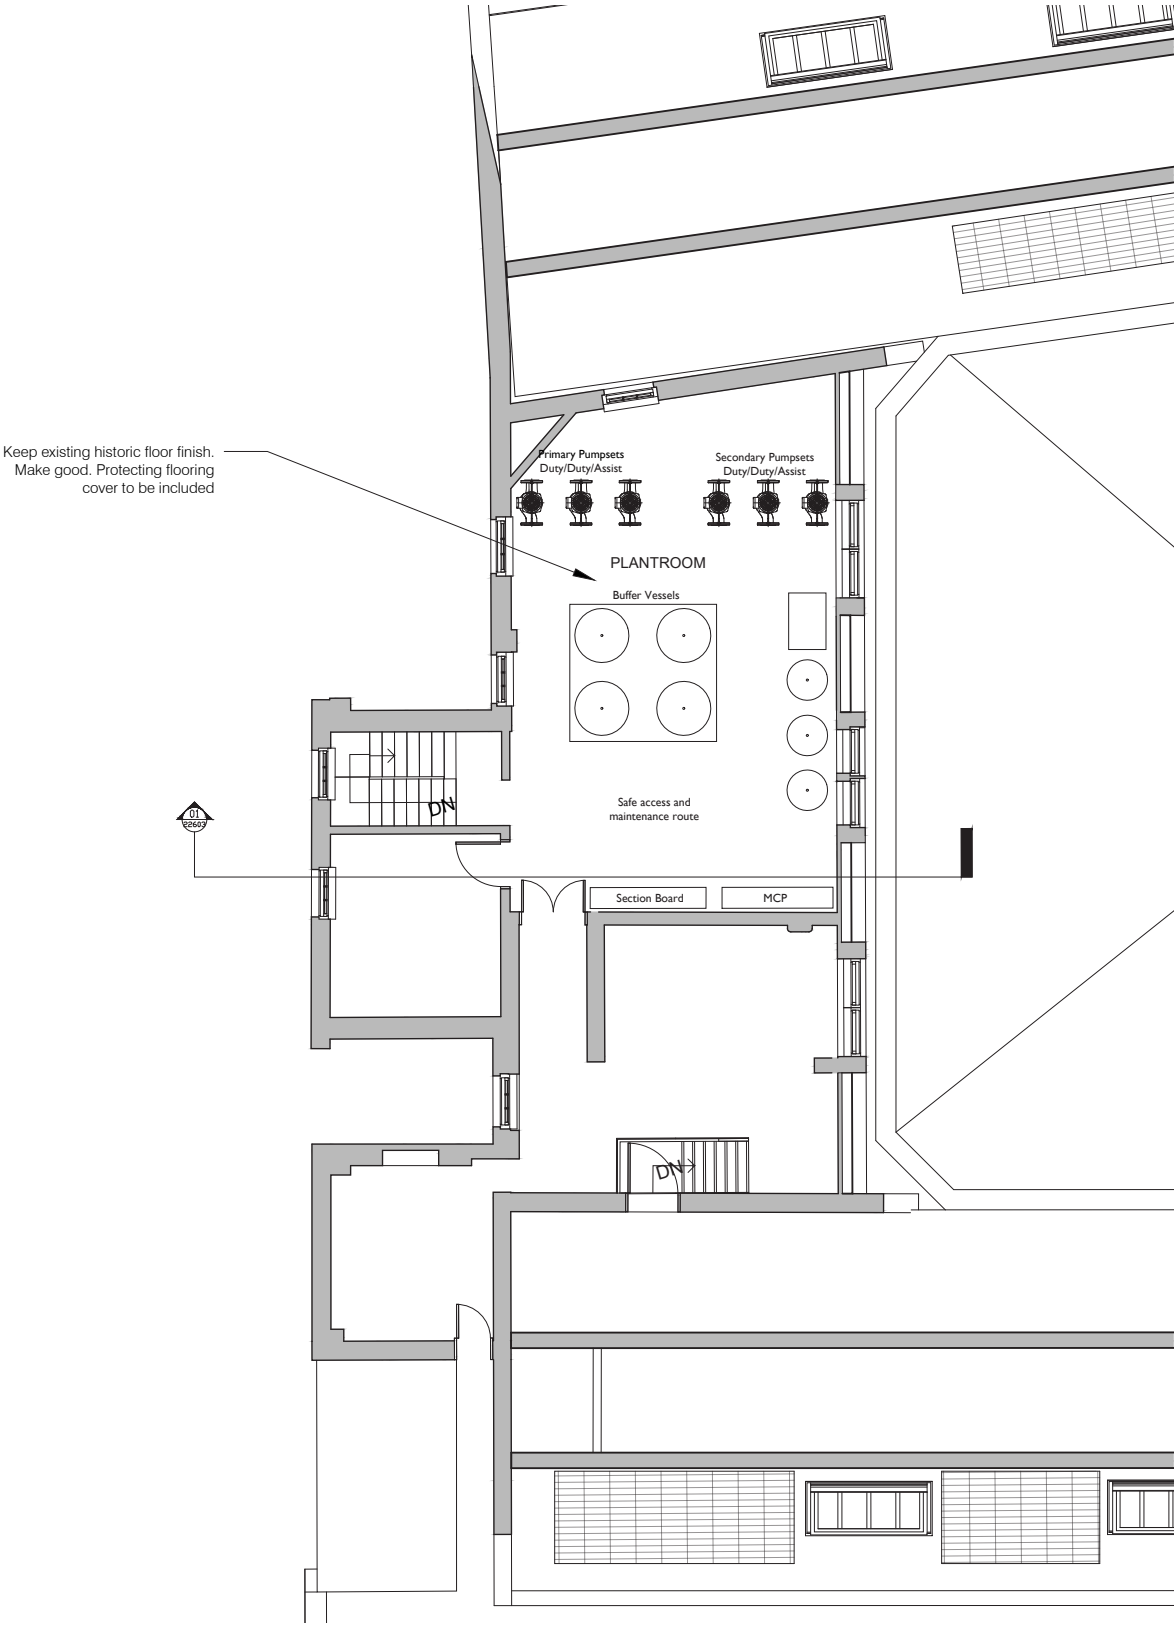
PROPOSED PLAN

Original partitions (in dashed pink line ) will be retained as downstands. Original ceiling will be repaired. Protective flooring cover will be included over existing heritage floor finish.

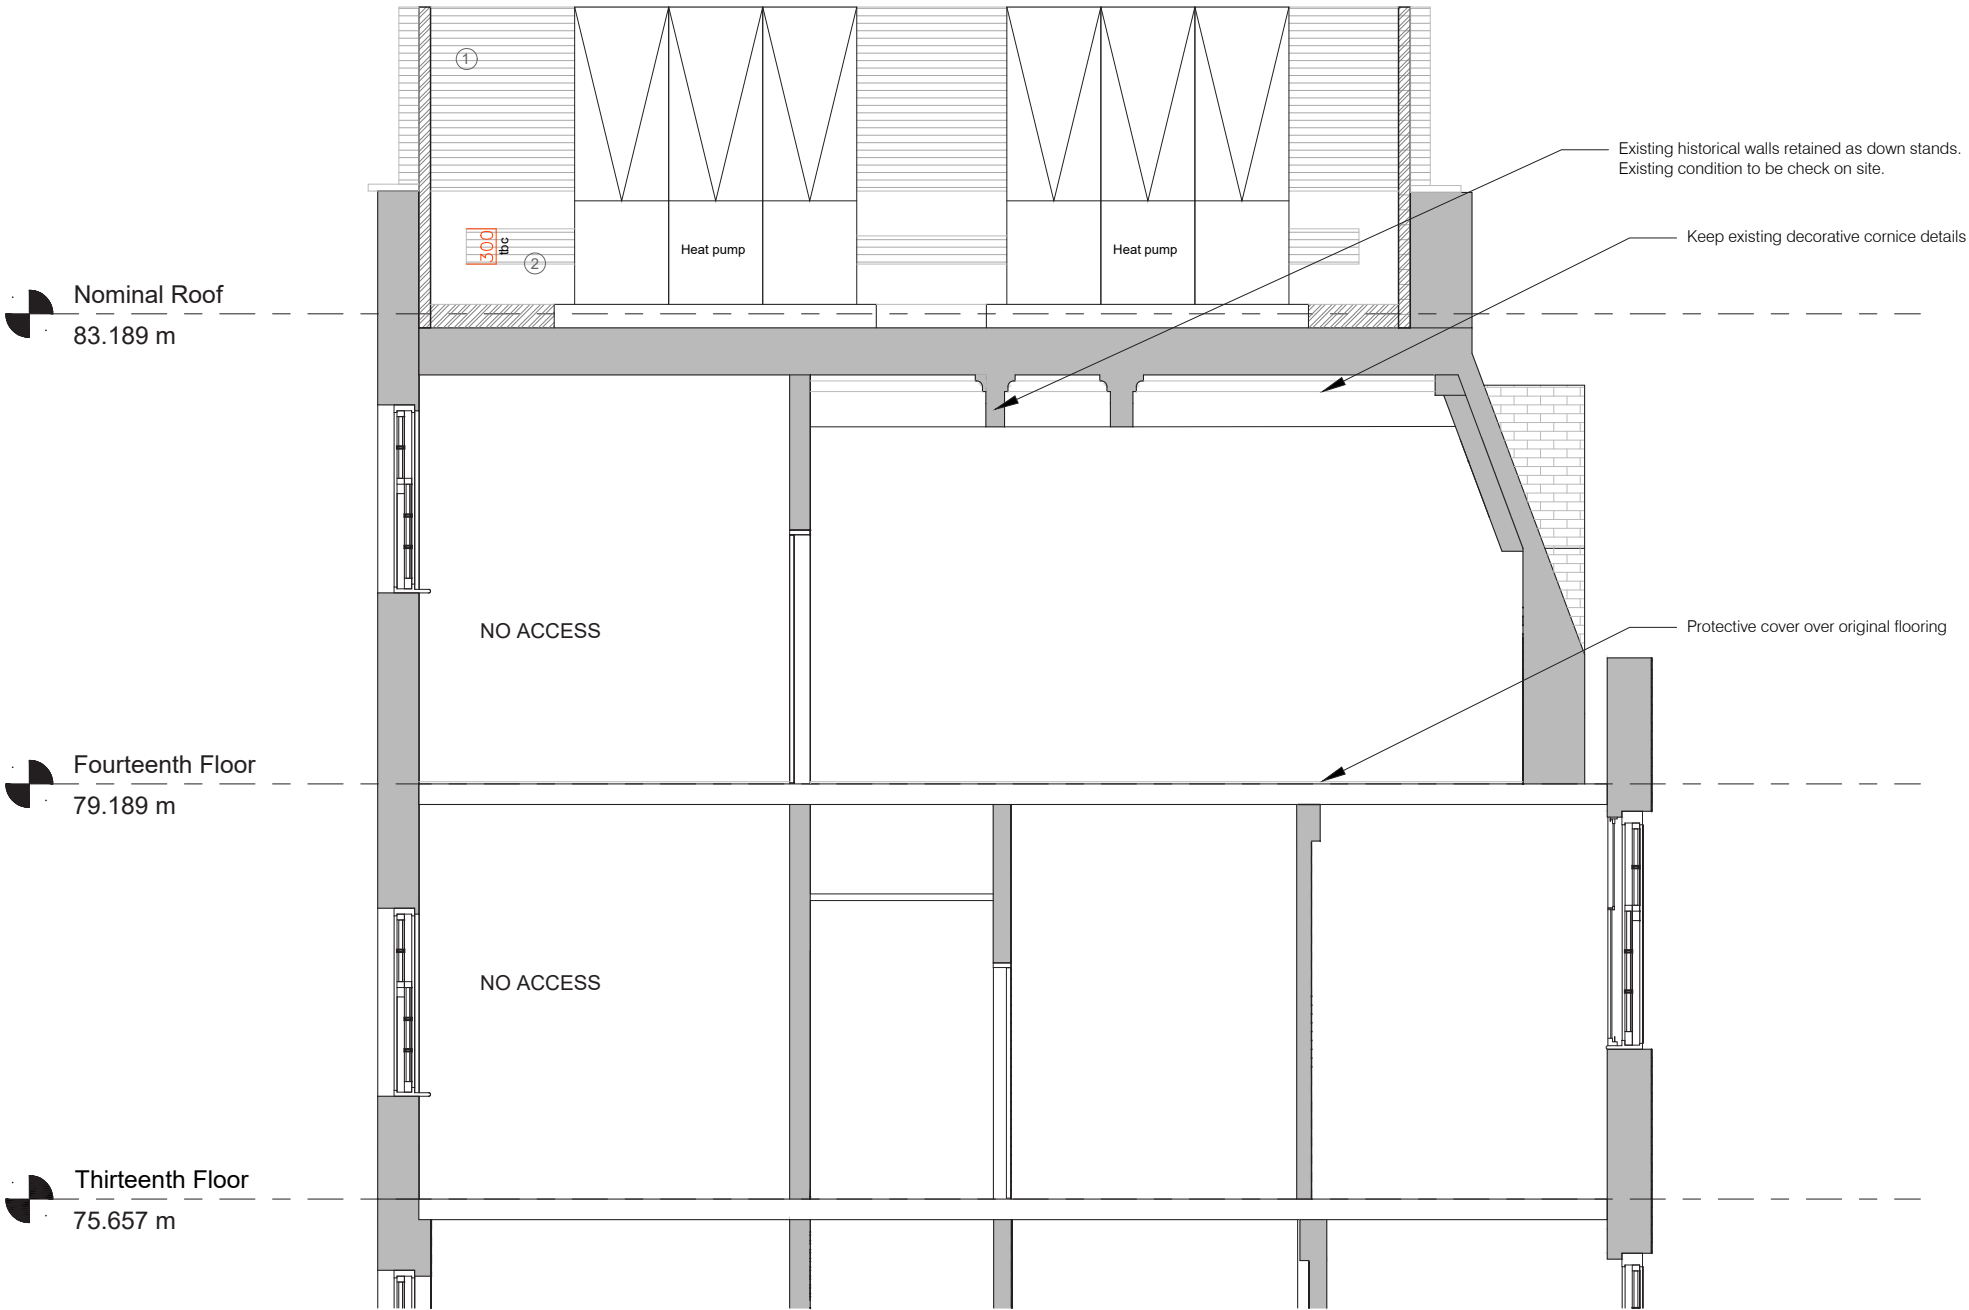
25. LEVEL 14 PLANT ROOM

Note - proposal is to create downstand nibs in wall current locations and maintain coffered ceiling to acknowledge their location.
