## file note

**Subject:** River Tib  
**Project:** Rylands Building - Manchester  
**Reference:** RBM-WHL-XX-XX-FN-S-0052\_P01  
**Author:** EAJC  
**Reviewer:** NGRC

### 1.0 Introduction

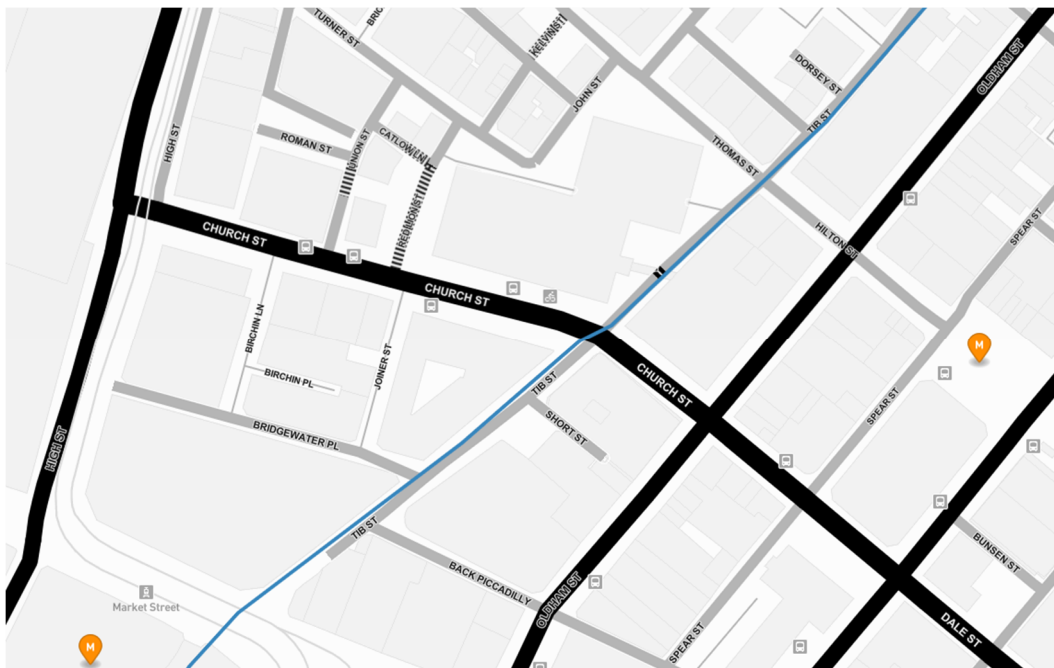
Figure 4.1: Extract: Hidden Manchester

The Hidden Manchester map indicates the River Tib to run along Tib Street at the same intersection with Hilton Street, which is indicated in the diagram below.

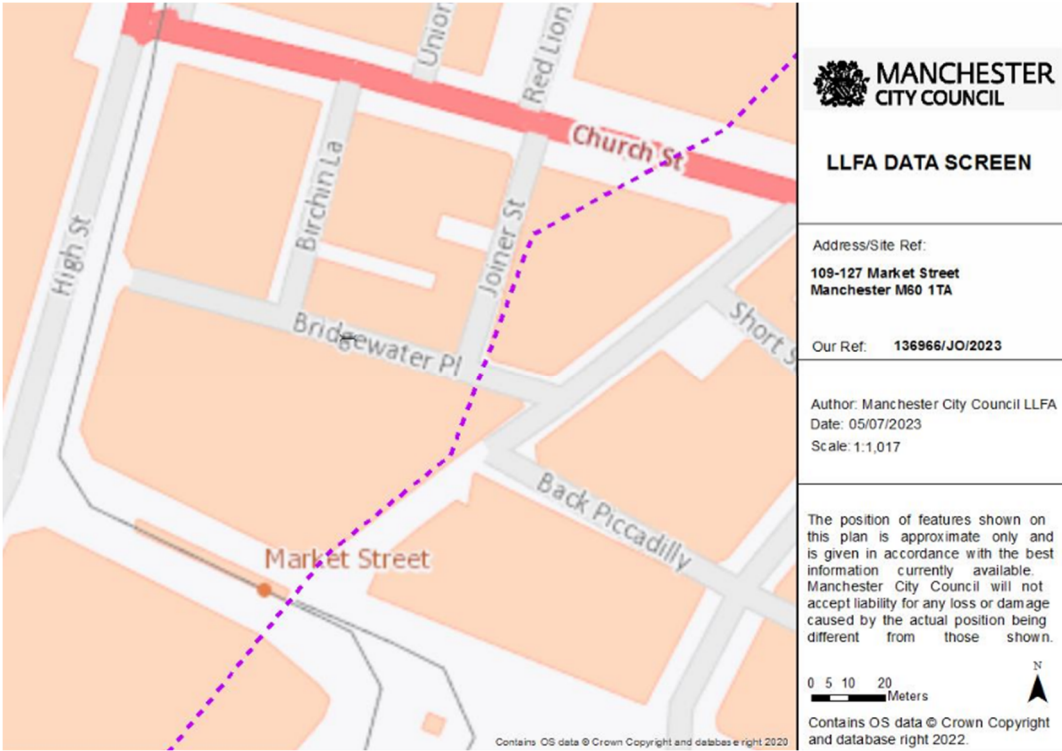
Figure 5.1: Extract: LLFA

The LLFA records appears to indicate the River Tib bisecting the northeast corner of the Rylands Building site and passing underneath the Transmission House development on Church Street, which is believed to have been piled.

This route of the River Tib within the LLFA records contradicts the information obtained from the various searches undertaken by the project team to date (set out above), which suggests that the LLFA maps may potentially be the original route of watercourse before it was culverted below Tib Street.

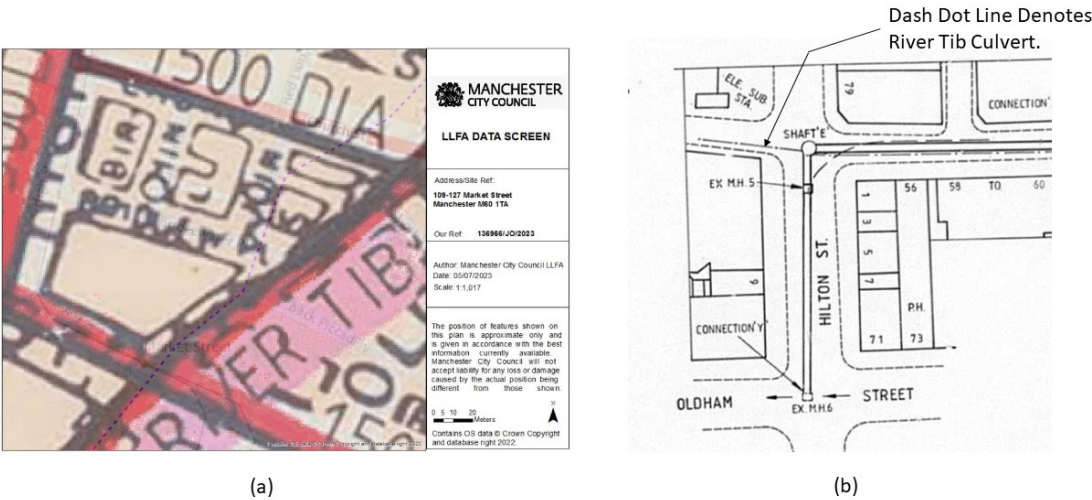
Figure 5.2: River Tib Hilton Street Intersection

The difference in paths of the River Tib is more clearly illustrated on the extract from the LLFA drawing over the city street map. This shows that the line of the River Tib runs parallel with Tib Street at a location where the 1985 record drawings clearly show the River being culverted along the length of Tib Street, see below.

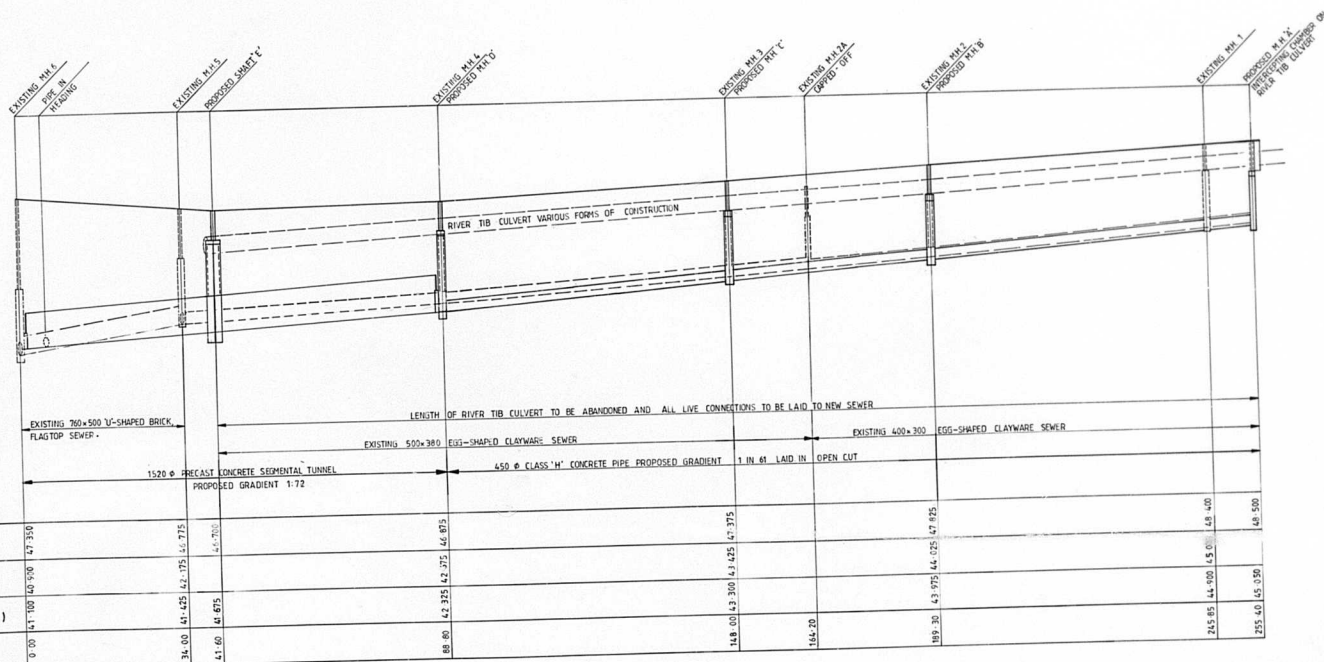
| <b>TIB ST. SEWER REPLACEMENT</b> | | |

EXISTING TIB STREET SEWER  
EXISTING RIVER TIB CULVERT  
EXISTING MANHOLES  
PROPOSED MANHOLES  
PROPOSED SEWER

The record drawing contained within Appendix A Figure 3.1 shows the sewer replacement along Tib Street which also includes a dot-dash line for the 'Existing River Tib Culvert'.

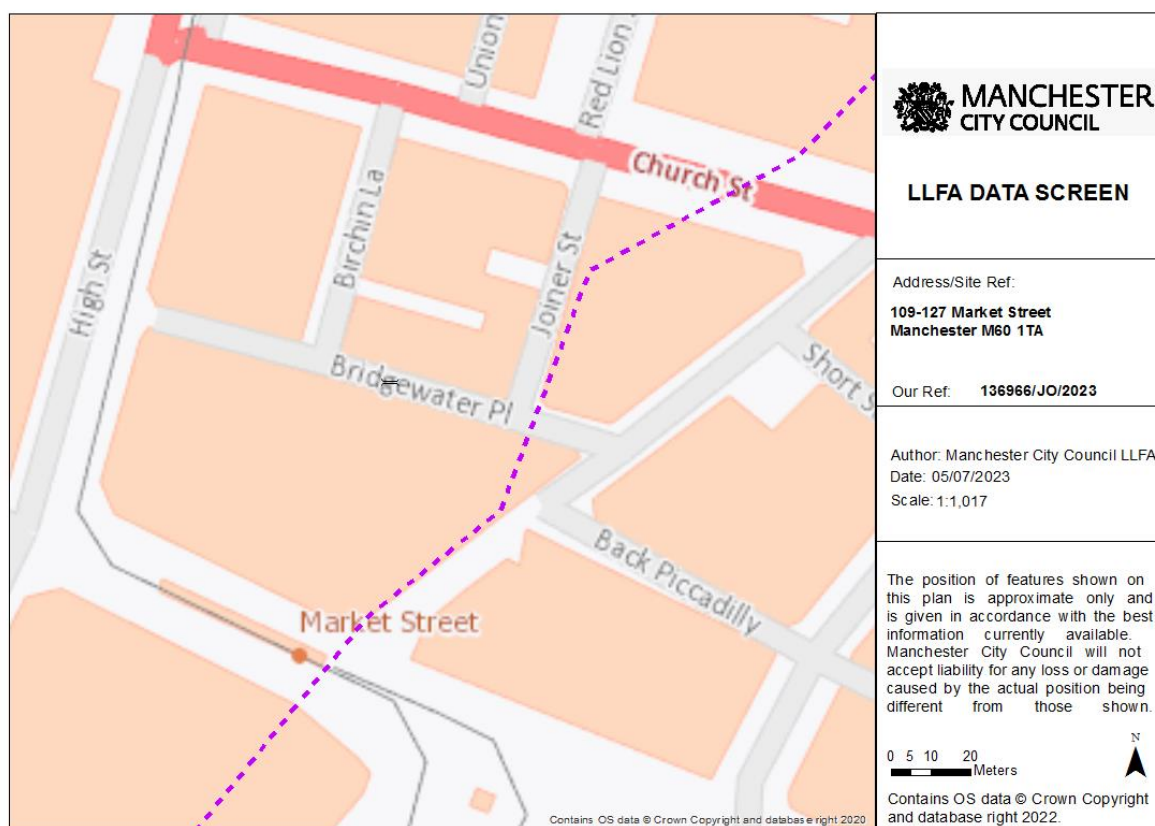
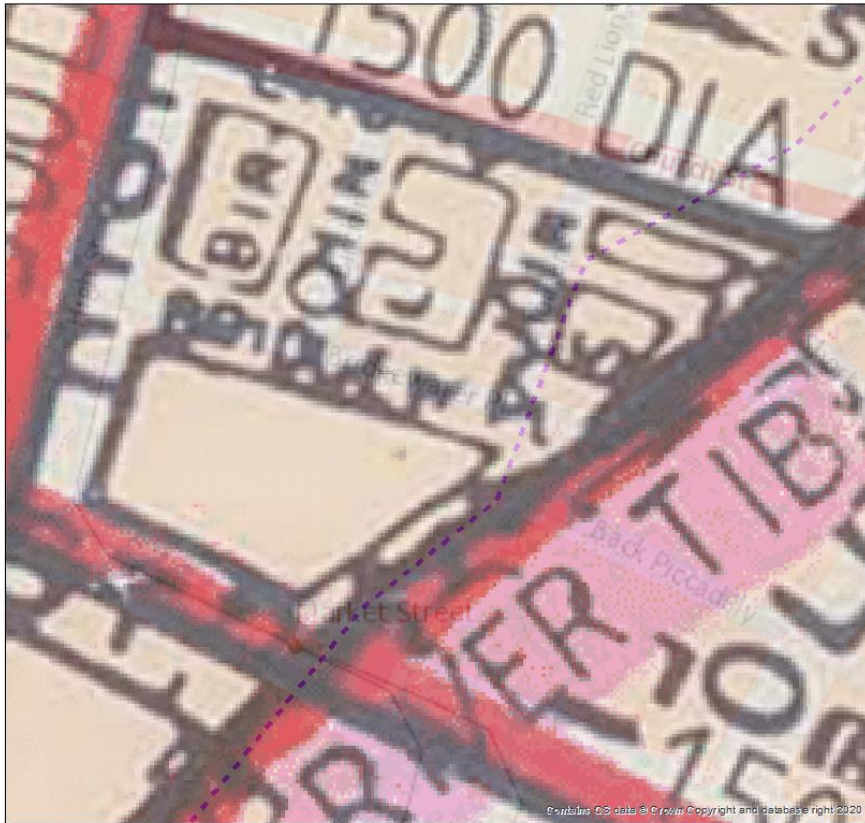
LLFA asset register extract showing indicative routes of the River Tib culverted ordinary watercourse. Our records in this location have not been verified with modern survey.
