# **Etihad Campus – Site Improvement Works**

## **Groundwater Risk Assessment**

**ETC-BHE-ZX-XX-RP-CG-0004**

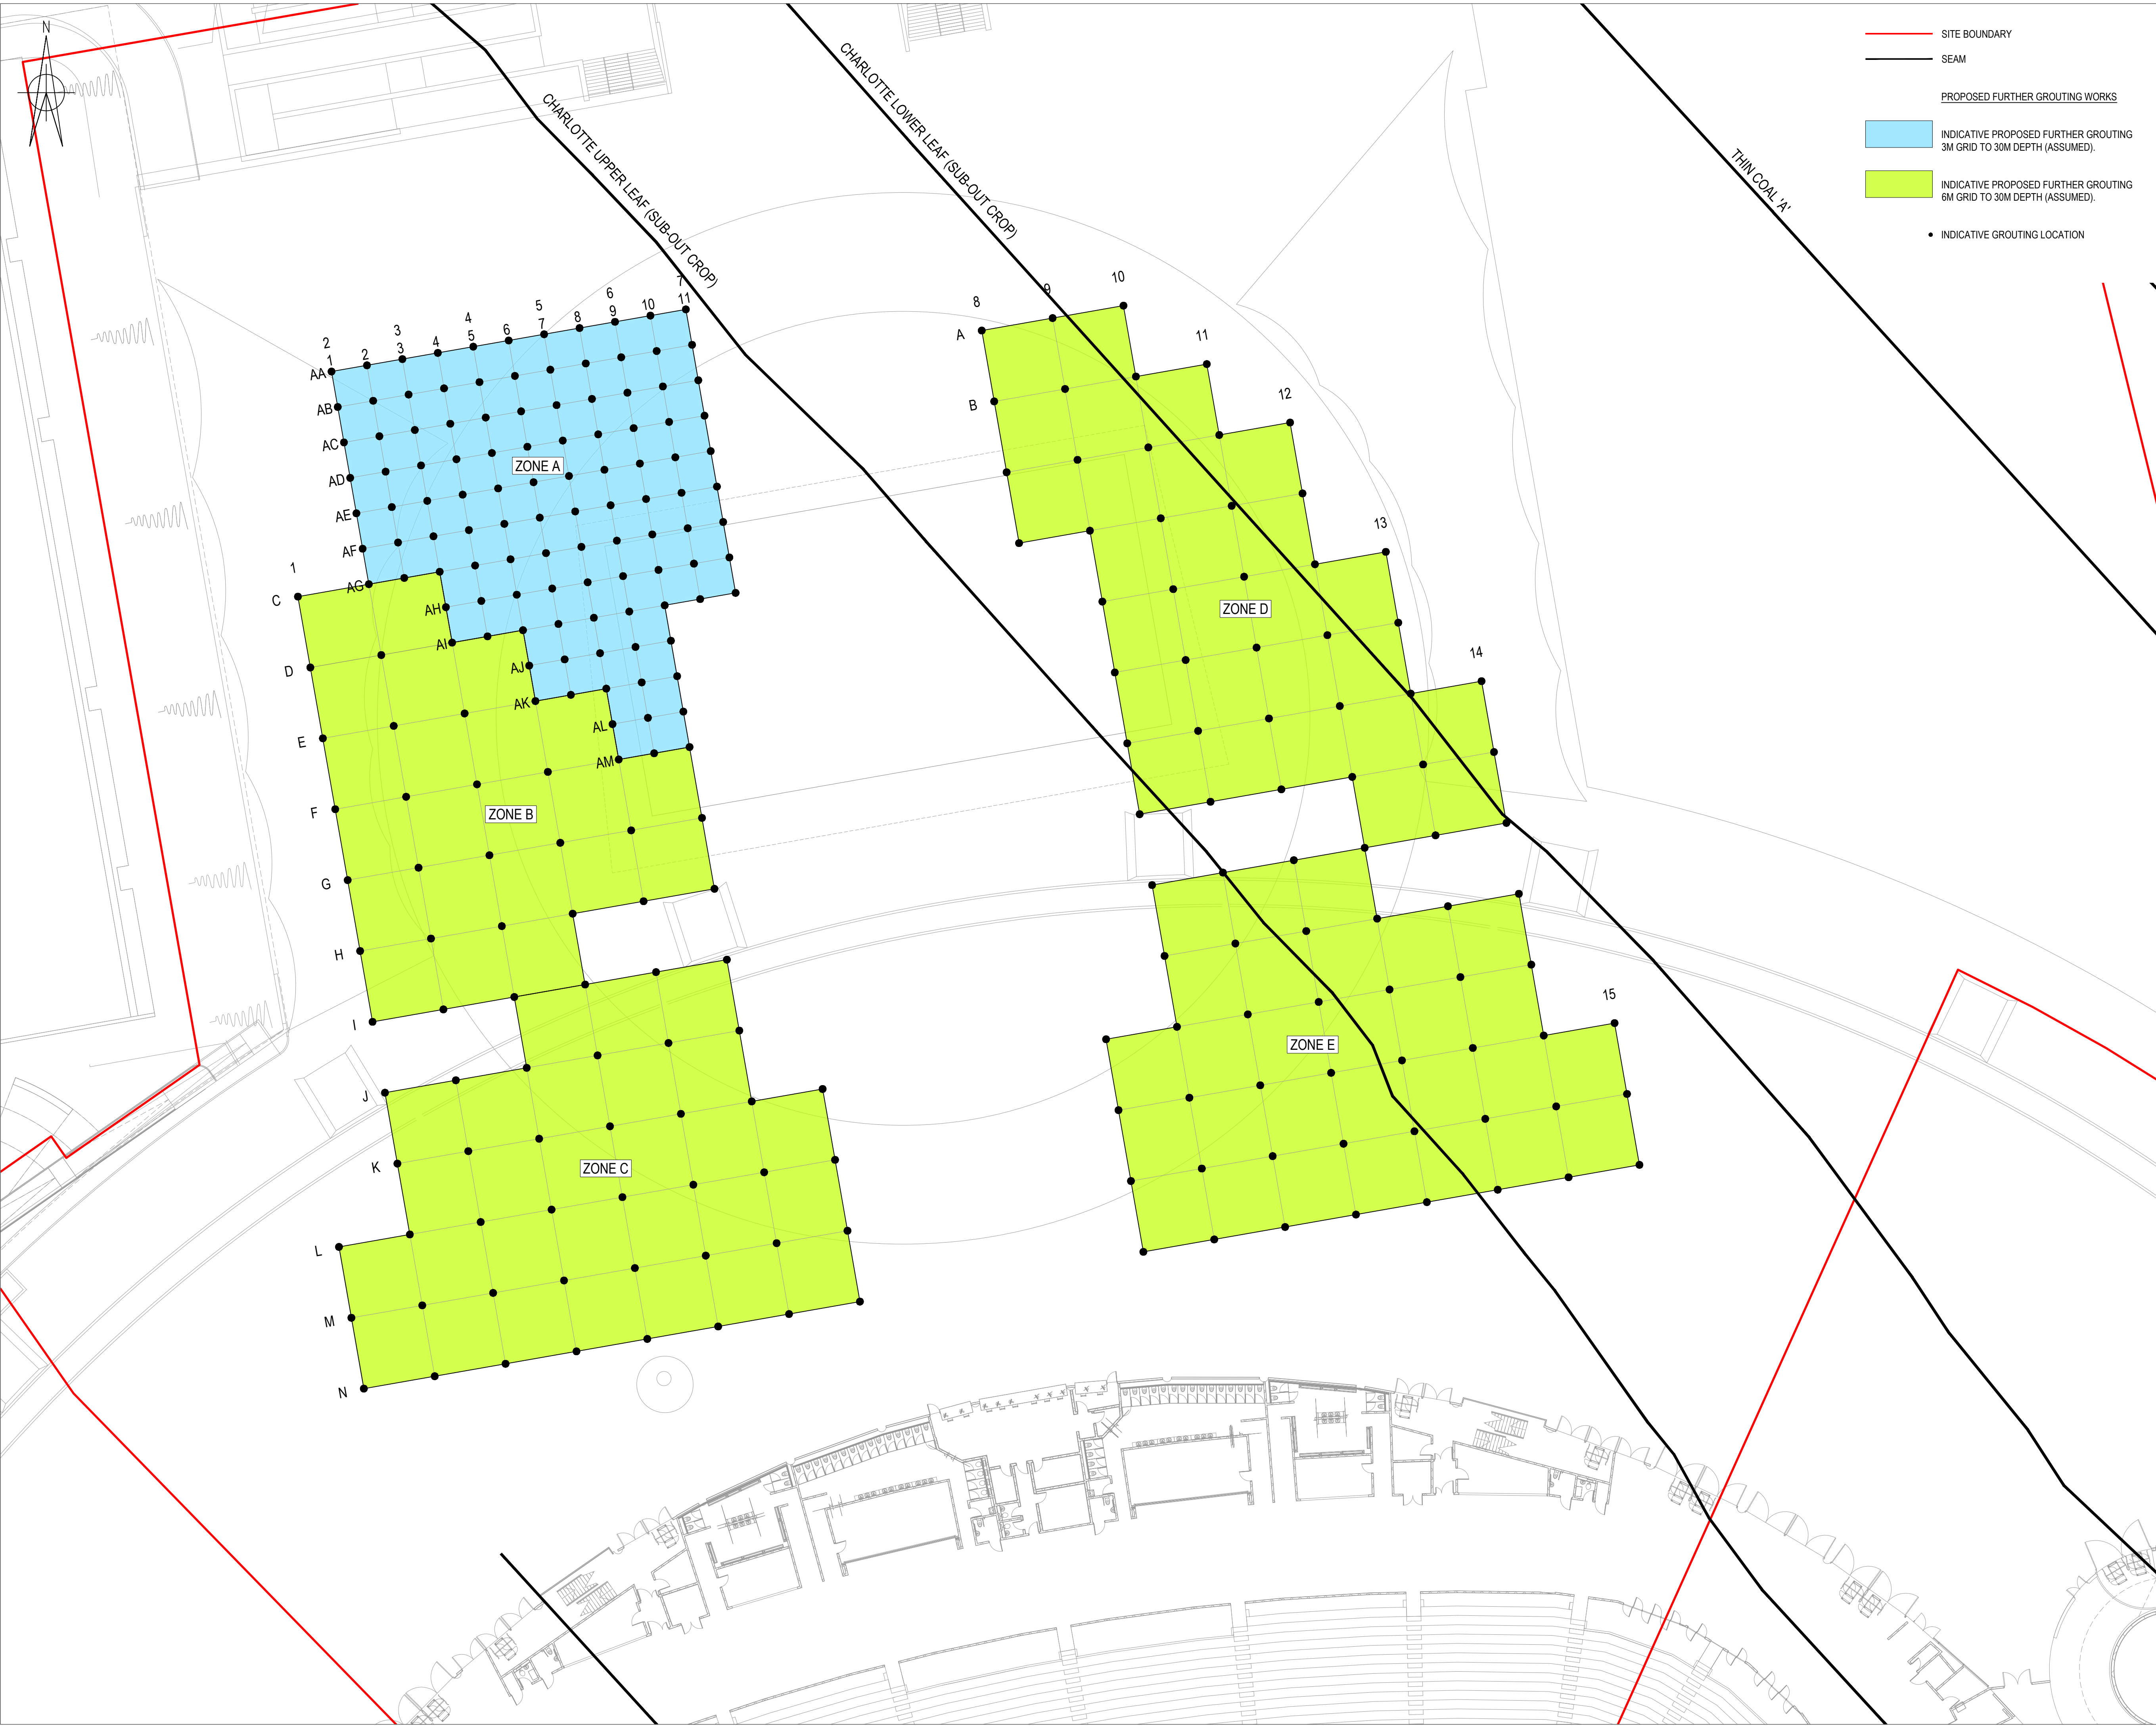
- SITE BOUNDARY
- SEAM
- PROPOSED FURTHER GROUTING WORKS
- INDICATIVE PROPOSED FURTHER GROUTING  
3M GRID TO 30M DEPTH (ASSUMED).
- INDICATIVE PROPOSED FURTHER GROUTING  
6M GRID TO 30M DEPTH (ASSUMED).
- INDICATIVE GROUTING LOCATION

- The Site will be probed to determine the area requiring treatment;
- The grouting grid will be determined by the conditions encountered on Site. The envisaged primary grid will likely be 6m x 6m, a secondary offset grid of 6m x 6m and the potential requirement for subsequent tertiary 3m x 3m grid subject to grout takes;

| Drawing Reference | Drawing Title |
|---|---|
| ETC-BHE-ZX-XX-DR-CG-1007 | Proposed Grouting Layout |
