## Land at Bennett Street, Manchester

# DRAFT Archaeological Evaluation Report

For Kellen Homes

December 2022

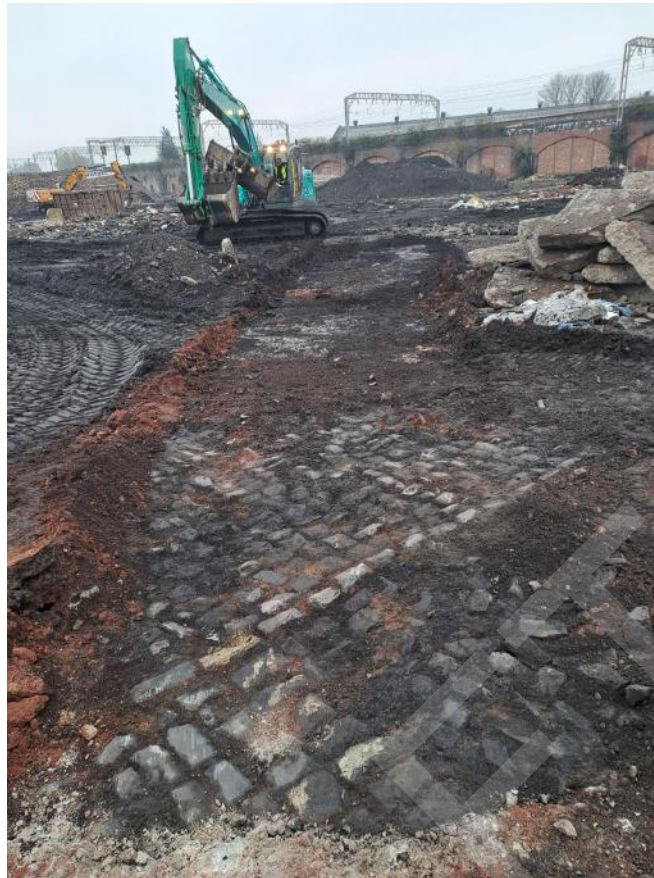
Plate 1 - Limestone setts in situ, overlying the location of Trench 2

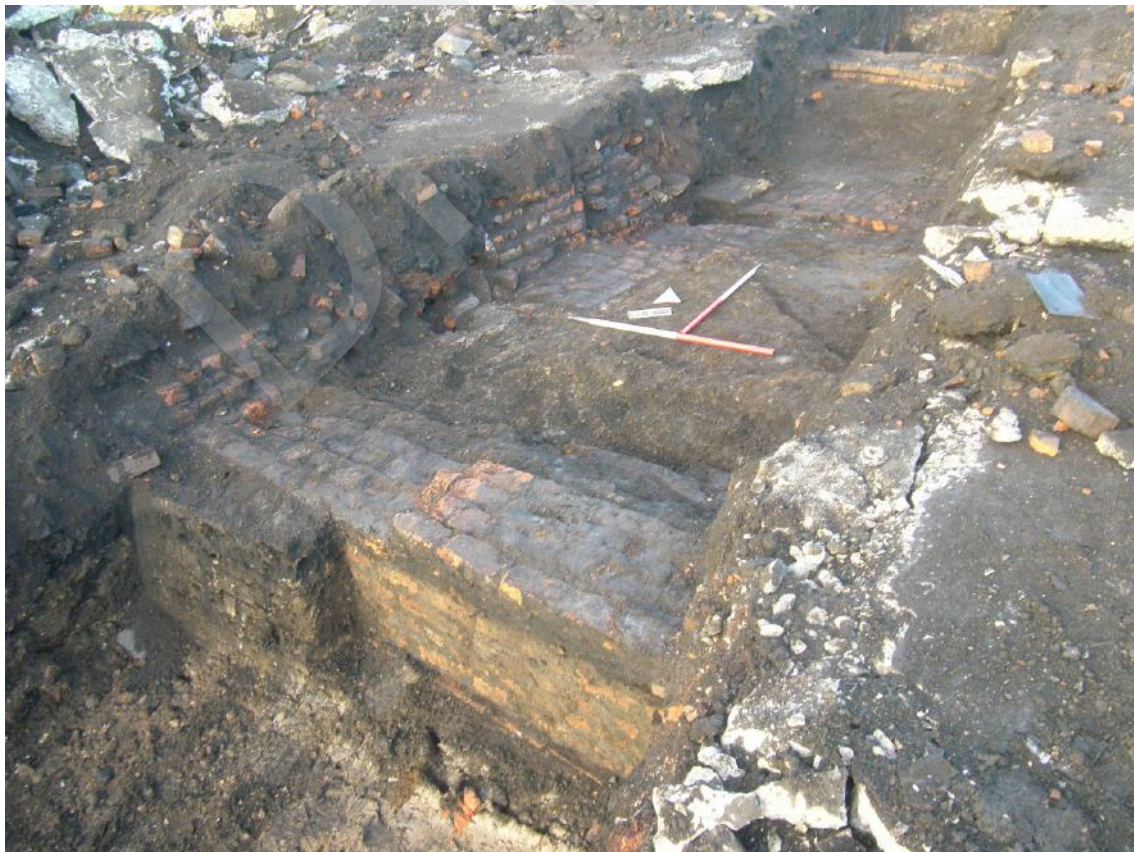
Plate 2 - Trench 1. Overview, looking north-west

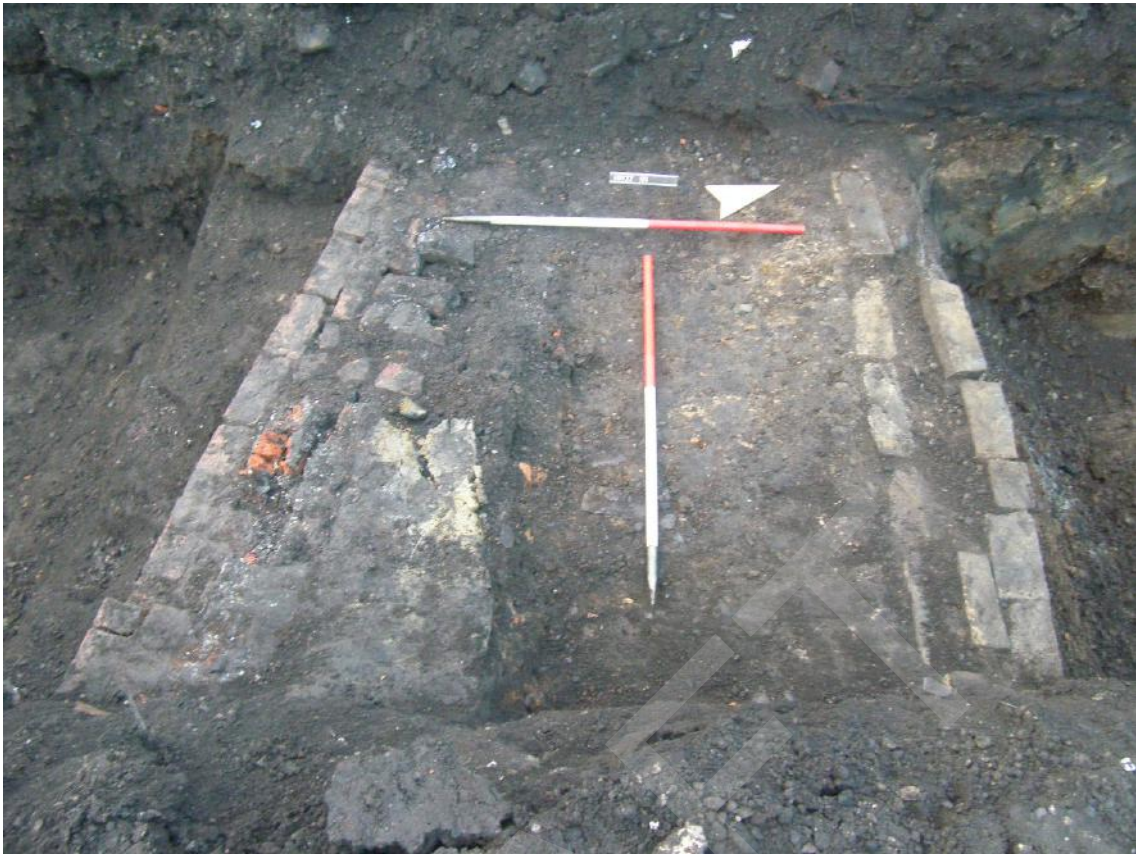
Plate 3 - Trench 1. Wall 101 and limestone setts 118

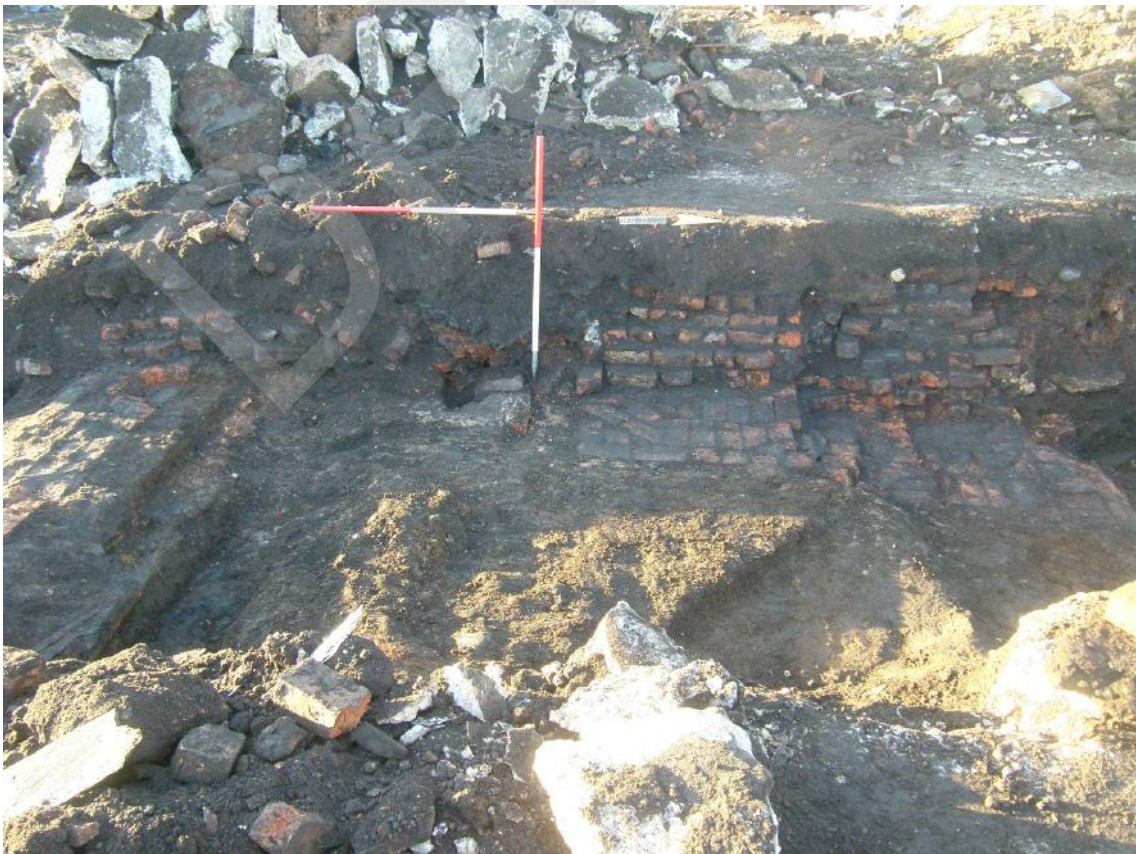
Plate 4 - Trench 1. North-east facing section showing structure 102

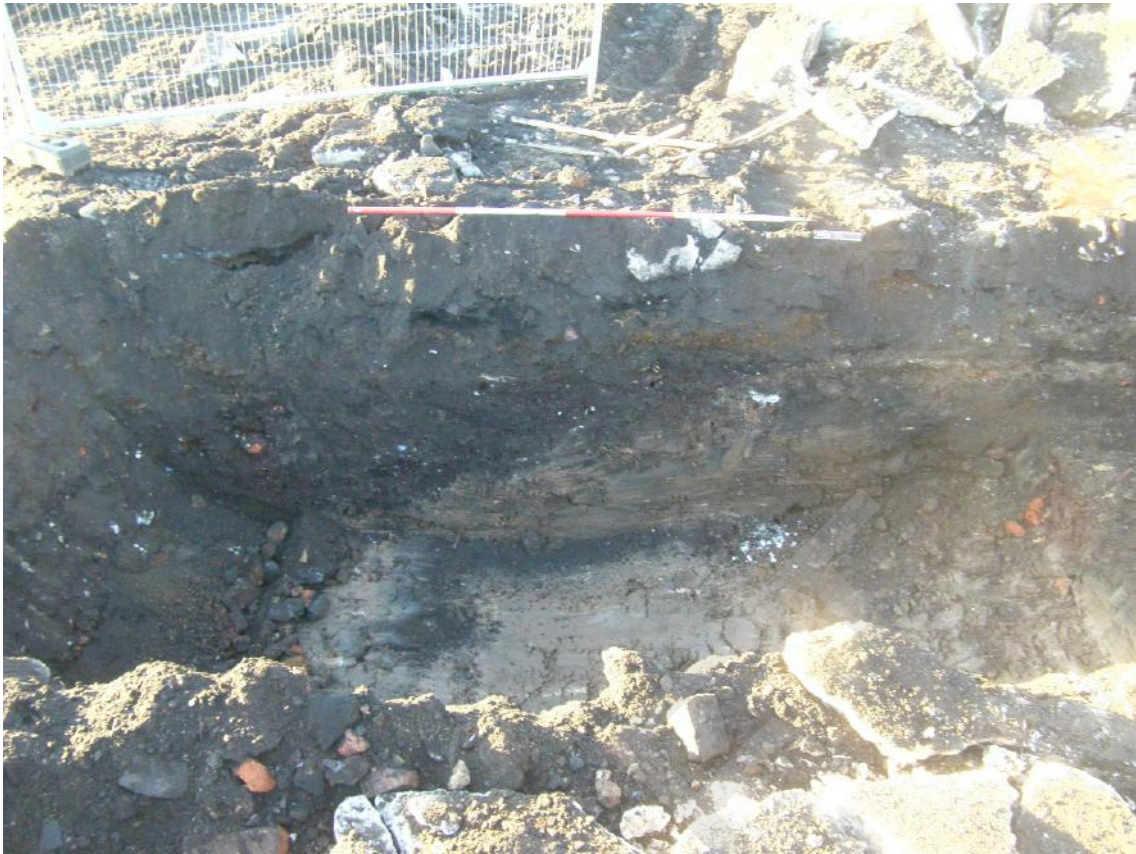
Plate 5 - Trench 1. North-east facing section of pit 120

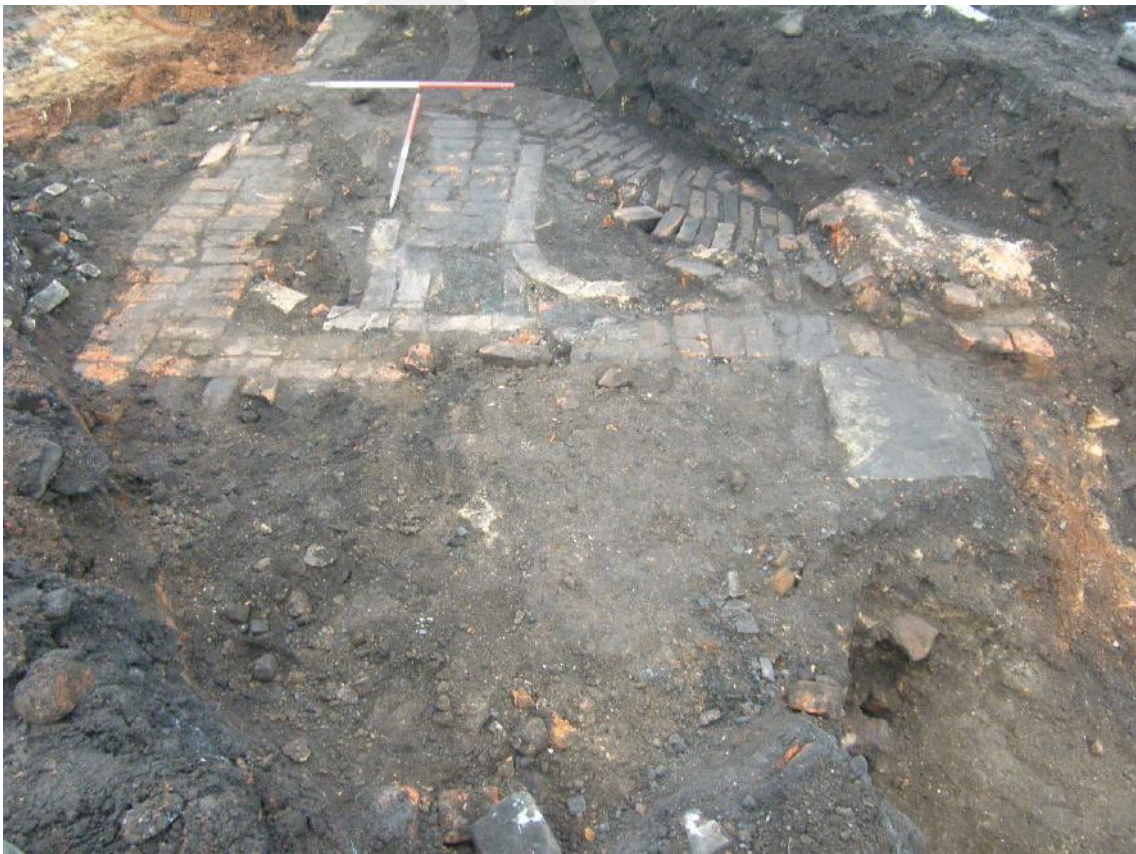
Plate 6 - Trench 2. Overview of brick structure 201, looking south-west

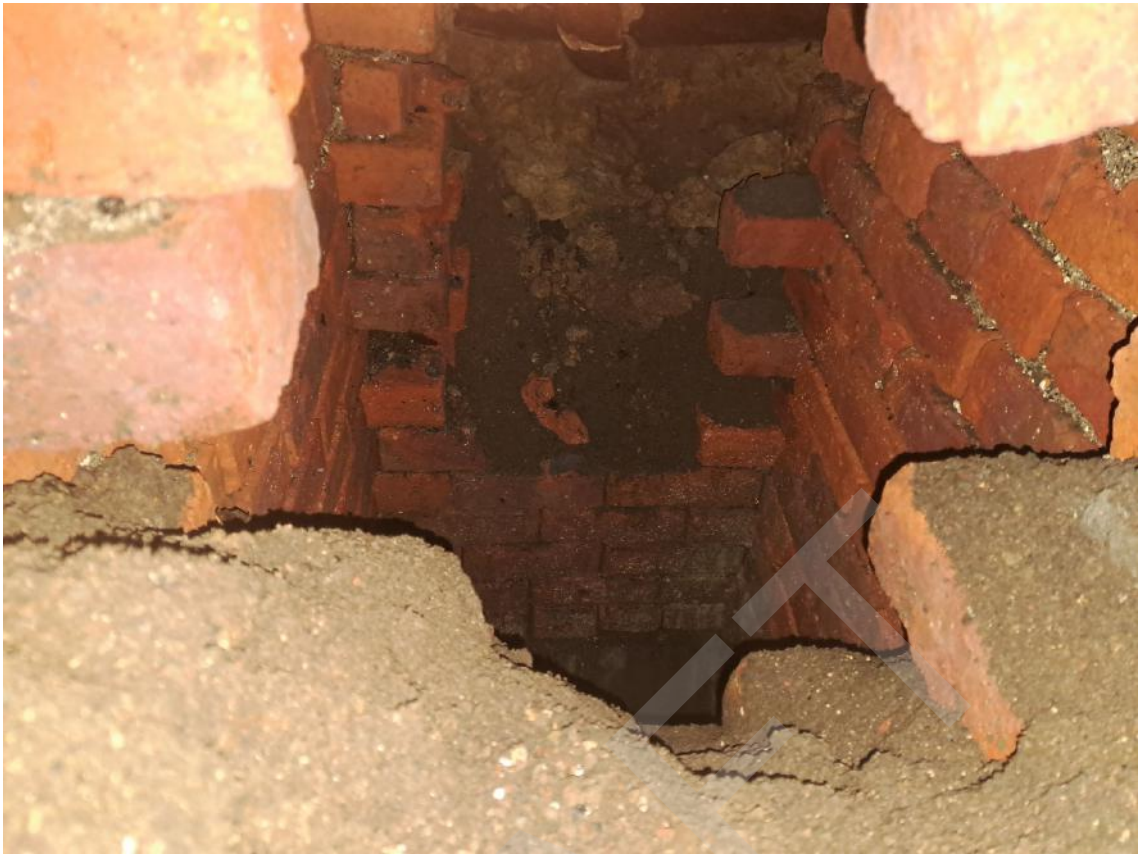
Plate 7 - Trench 2. Brick chute below platform 201

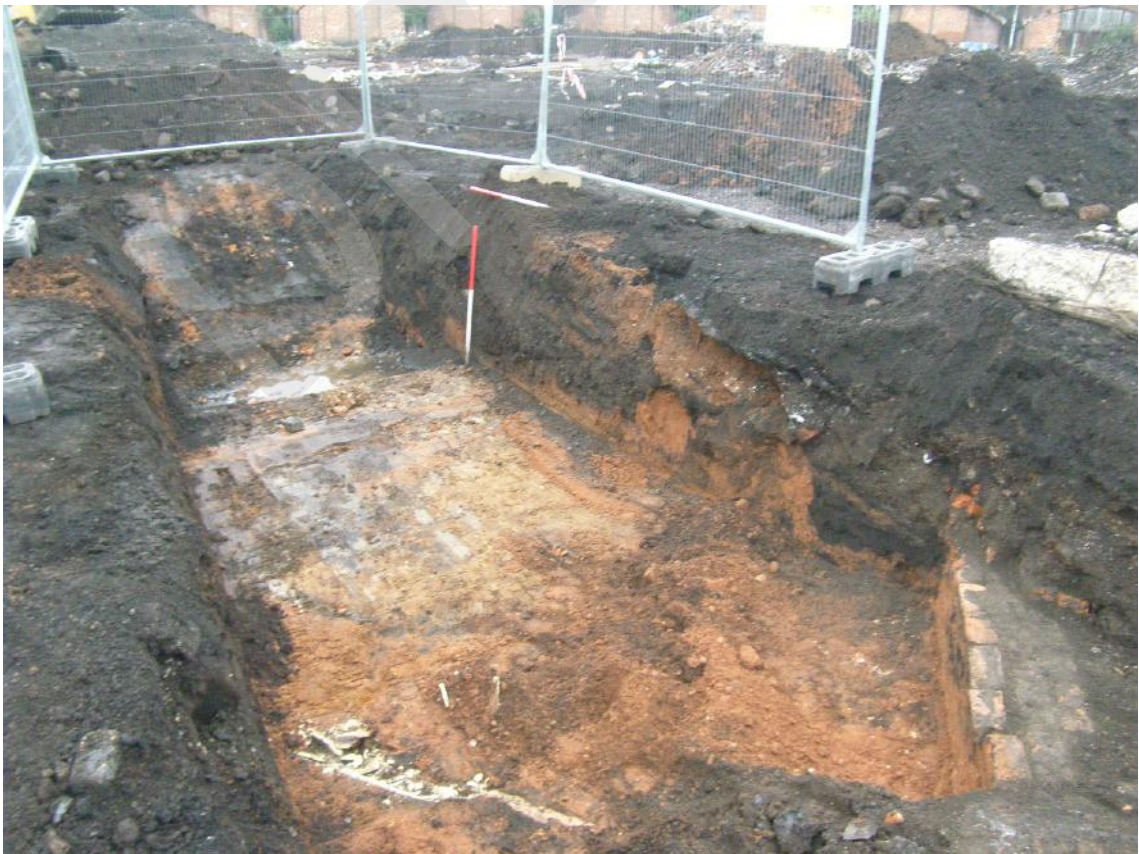
Plate 8 - Trench 2. Casting sand 208, to the south of platform 201

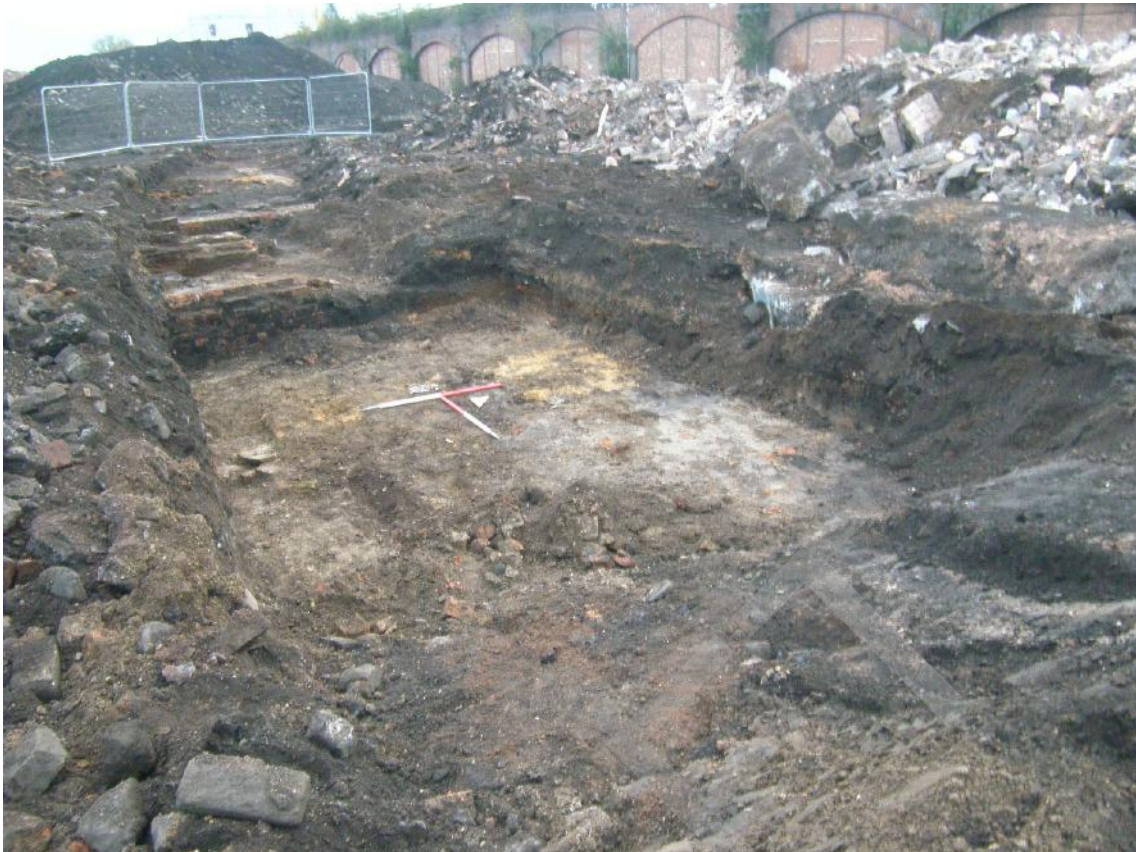
Plate 9 - Trench 3. Overview of north-western end of Trench 3 showing potential floor surfaces

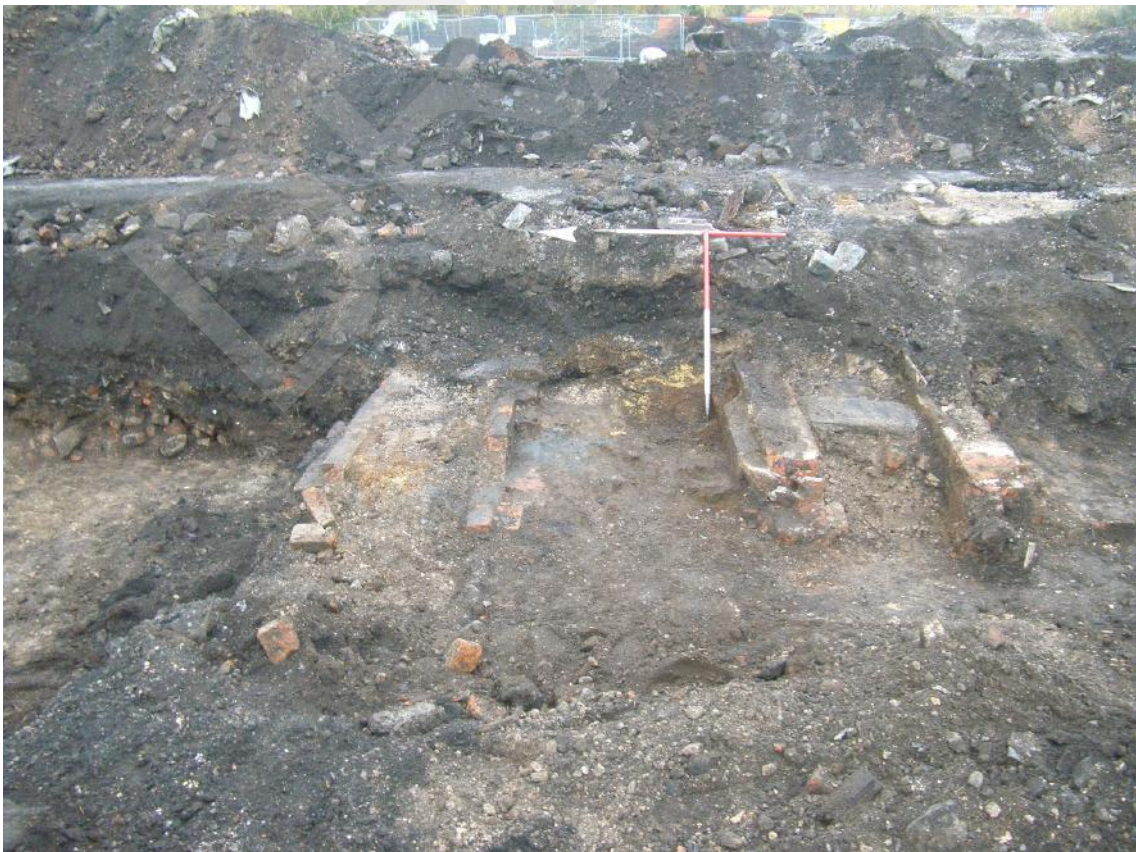
Plate 10 - Trench 3. Brick bays within structure 301

- 4.4.4 Structure **301** was 5m wide and was separated into three irregularly spaced bays defined by brick walls (Plate 10). Removal of the rubble within the northern bay revealed a loose, reddish brown sandy deposit containing degraded wood, corroded iron and slag (**314**).

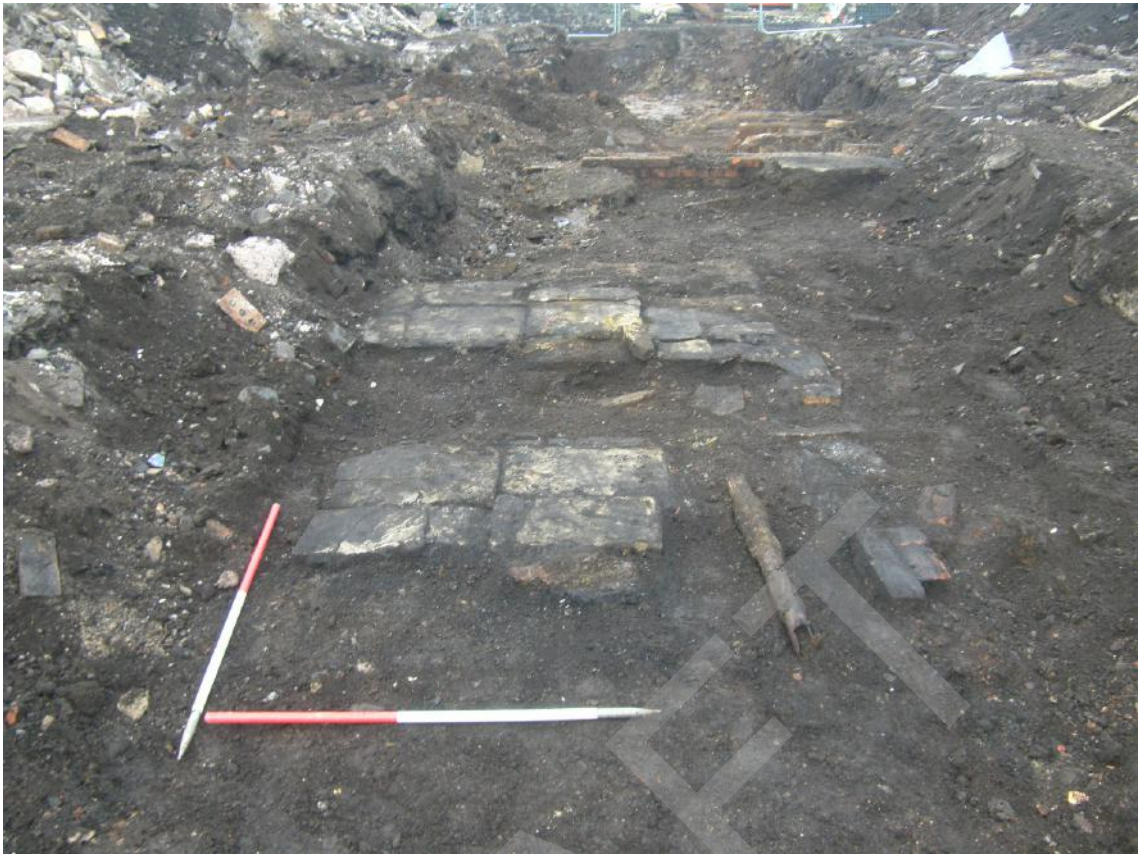
Plate 11 - Trench 3. Flagstone floor 303 and pipe trench 315, looking north-west

- 4.4.5 To the south of structure **301** was a heavily disturbed flagstone surface (**303**); one particular flagstone retained an iron fitting and had a heavy concentration of metallurgical waste adhering to it (Plate 11). A central area within **303** was devoid of flagstones and was potentially the location of metal processing equipment. A linear trench extending from this void to the south-east (**315**) contained a corroded length of iron pipe in situ, with a further length of iron pipe protruding upwards from the rubble to the east.

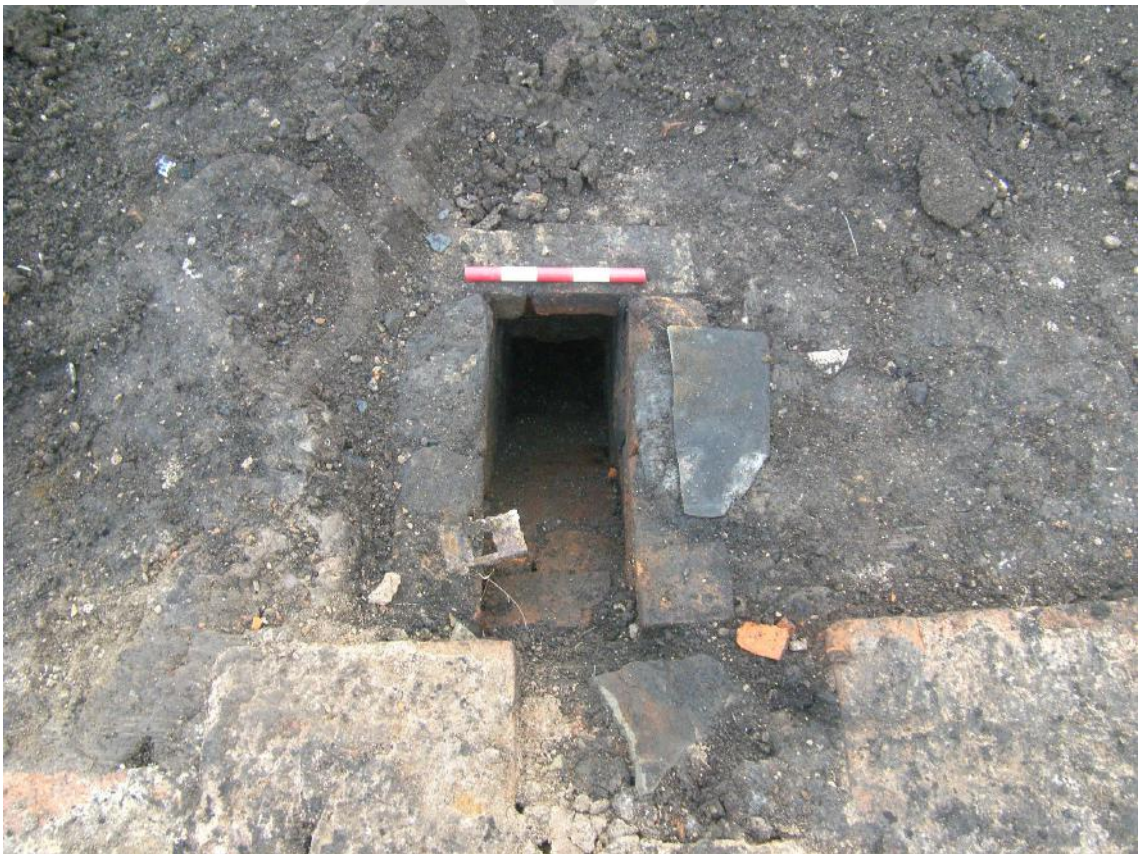
Plate 12 - Trench 3. Brick chute 317

- 4.4.6 On a parallel south-east alignment to pipe trench **315**, and c.2m to the west, was a brick footing (**302**), potentially for a wall, that continued over a span of 10m and beyond the south-east limit of Trench 1. A brick chute (**317**) measuring 0.4m by 0.6m adjoined the south-west face of **302** and retained an iron hinge that indicated it was originally covered by a hatch (Plate 12). Along the north-east face of **302** was a square cut (**310**) 2m wide that had been filled by orange sand (**311**). A

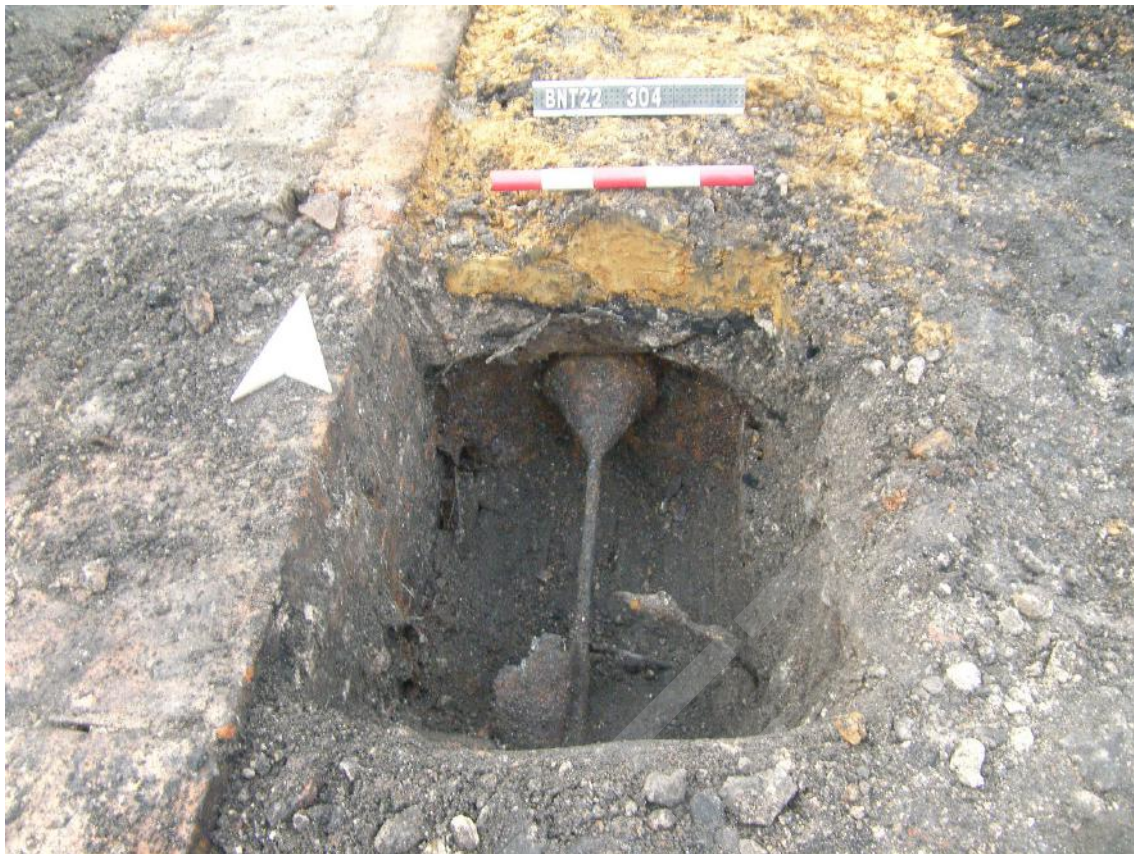
Plate 13 - Trench 3. In situ machinery 304, within cut 310

sondage excavated within cut **310** revealed a corroded iron cylinder (**304**) that appeared to be an element of machinery deliberately situated alongside brick footing **302** (Plate 13). It is possible that cut **310** contains further mechanical elements relating to **304** and to specific manufacturing processes that were being undertaken within the area of the foundry covered by Trench 1.

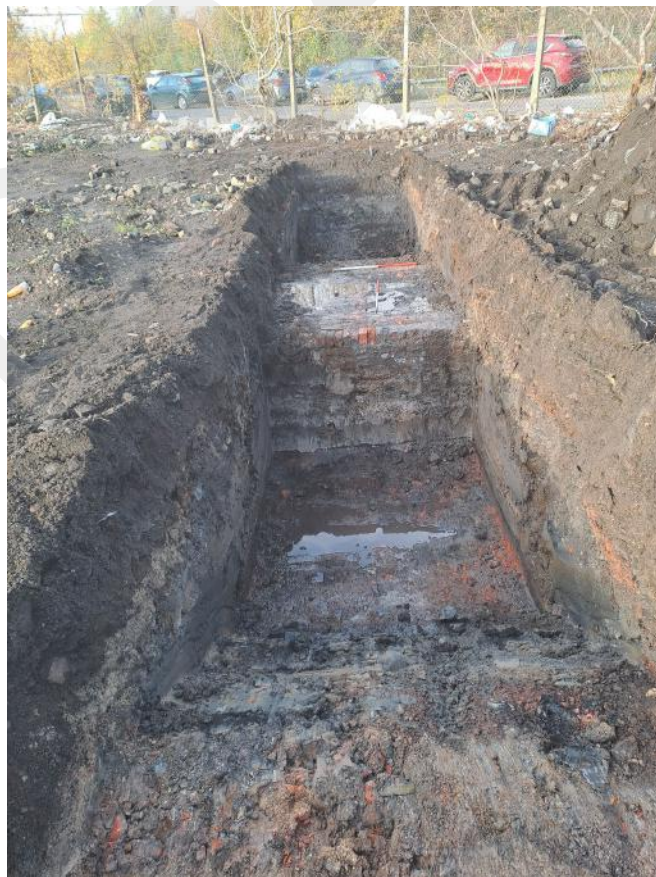
Plate 14 - Trench 4. Upstanding remains of weighing station and burnt horizon 403

- 4.5.3 A 1.2m-thick deposit of sand, clay and rubble (**402**) was removed from around the weighing station by machine and showed it to survive to a height of over 1m (Plate 14). Clay layer (**402**) had accumulated above a 0.2m-thick horizon of ash and burnt brick (**403**), which potentially marked the ground surface contemporary with the weighing station at a depth of 1.8m below the modern ground surface. The natural alluvial clay (**404**) was recorded below deposit **403** at a depth of 2m.

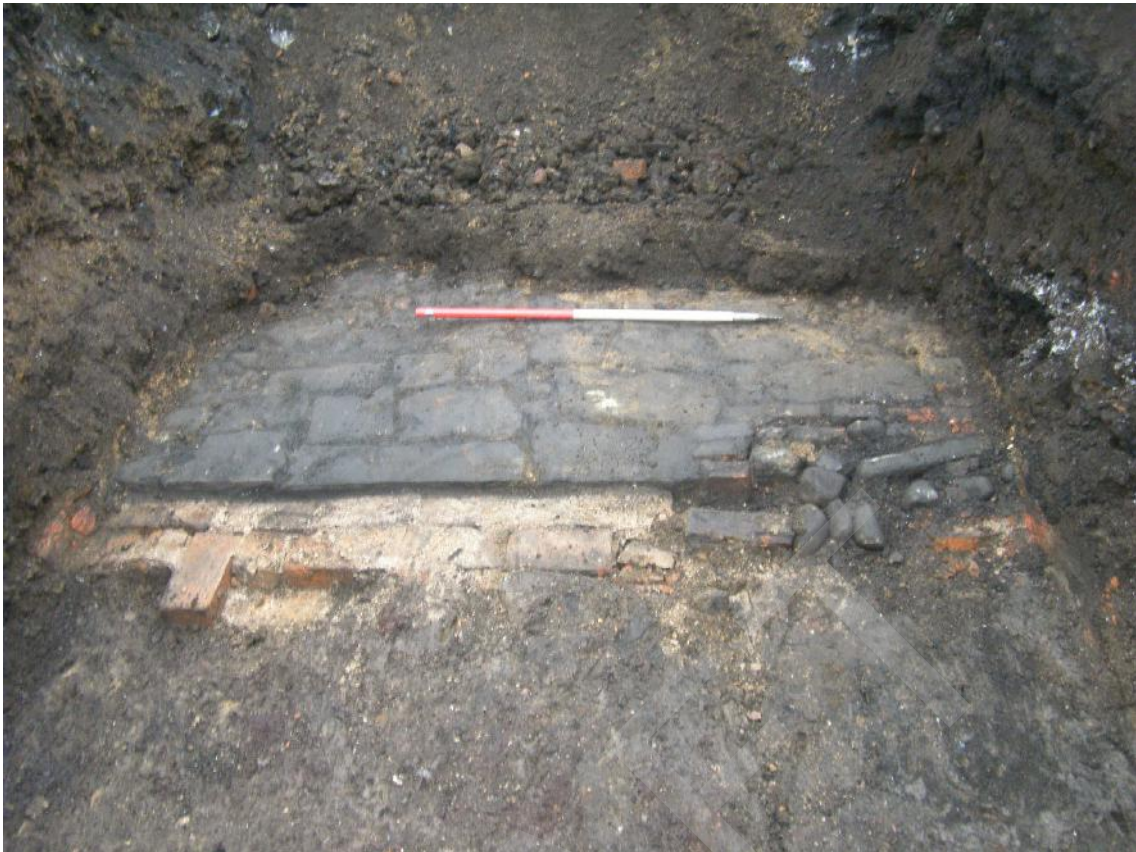
Plate 15 - Trench 5. Flagstone floor 501, looking north

- 4.6.1 Trench 5 measured 20m by 3m and was orientated north to south across Burgess Villa, as shown on the 1848 Ordnance Survey map.
- 4.6.2 Removal of 0.4m of modern overburden (**500**), 0.7m of tarmac (**509**) at the north end of the trench and a trench-wide demolition horizon (**508**) up to 1m thick, revealed the footings of a building likely belonging to Burgess Villa.
- 4.6.3 At the north end of the trench was a flagstone floor (**501**), extending 2m into the trench from the northern edge (Plate 15). Its southern limit was edged by two rows of brick, with a cobbled area at

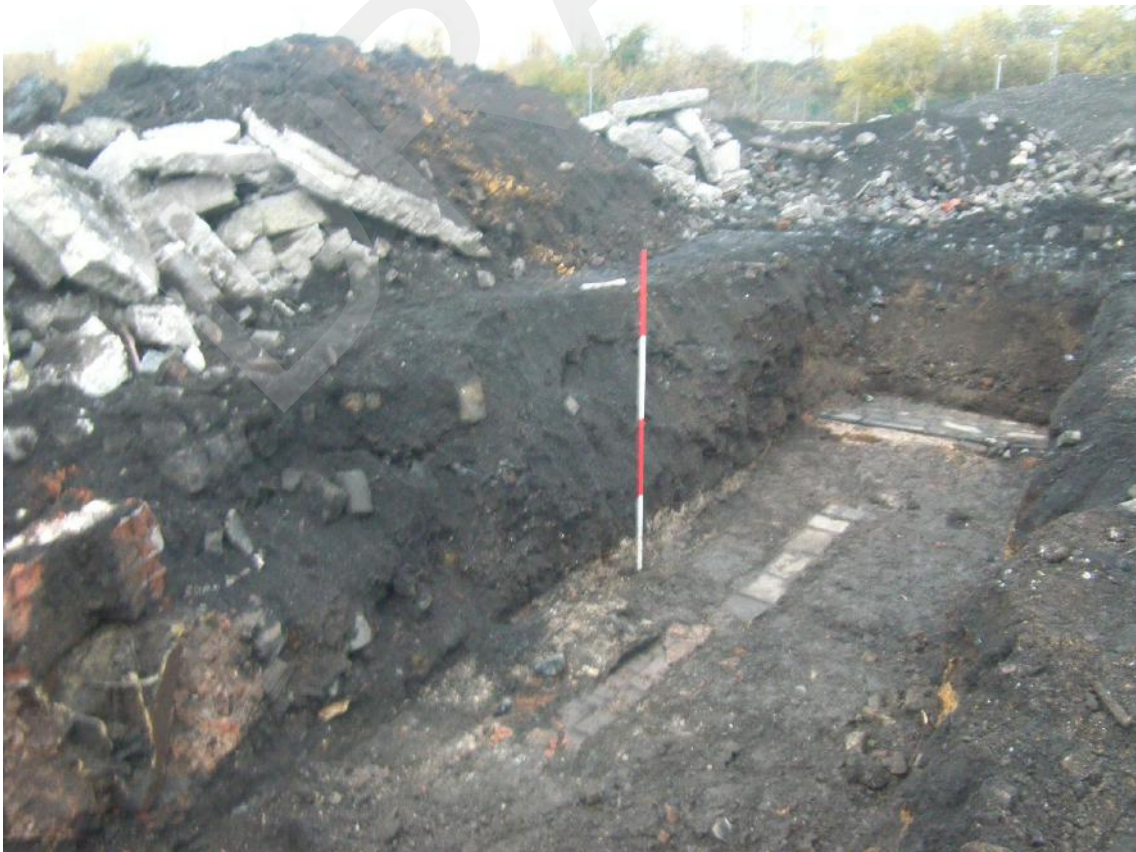
Plate 16 - Trench 5. Wall footing 502 and mortar deposit 511, looking north-west

- 4.6.4 Extending southwards from floor **501** was a wall footing (**502**) of sandstone slabs with two surviving courses of brickwork (Plate 16). Wall **502** appeared to define a room to the west, denoted by crushed brick and mortar (**511**) that probably would have been a foundation layer for a flagstone floor, like **501** to the north. A 2m-wide break between floor surface **501** and wall **502** plausibly related to a second doorway.

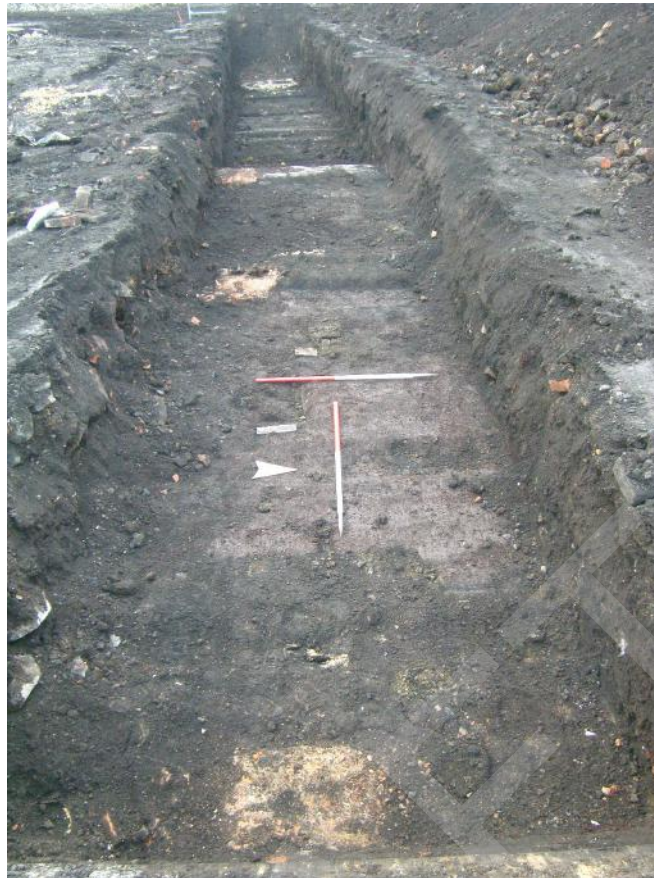
Plate 17 - Trench 6. Cinder surface 607, showing concrete pads set within cut 604

- 4.7.2 Removal of a 0.8m-thick horizon of demolition rubble (**600**) revealed a compacted surface of purple cinders (**607**) at the east end of the trench. An irregular east to west cut (**604**) had been made through surface **607** into which had been set three irregularly spaced square concrete pads (**601**, **602**, **603**, Plate 17). The pads each measured 0.6m by 0.6m with a thickness of 0.3m and were set within a black deposit of cinders (**608**) that contained domestic refuse and elements of a leather shoe. The location of the concrete pads strongly suggest they belonged to the earliest phase of the Hyde Road stadium and probably supported a superstructure that was largely wooden, no remains of which were identified.

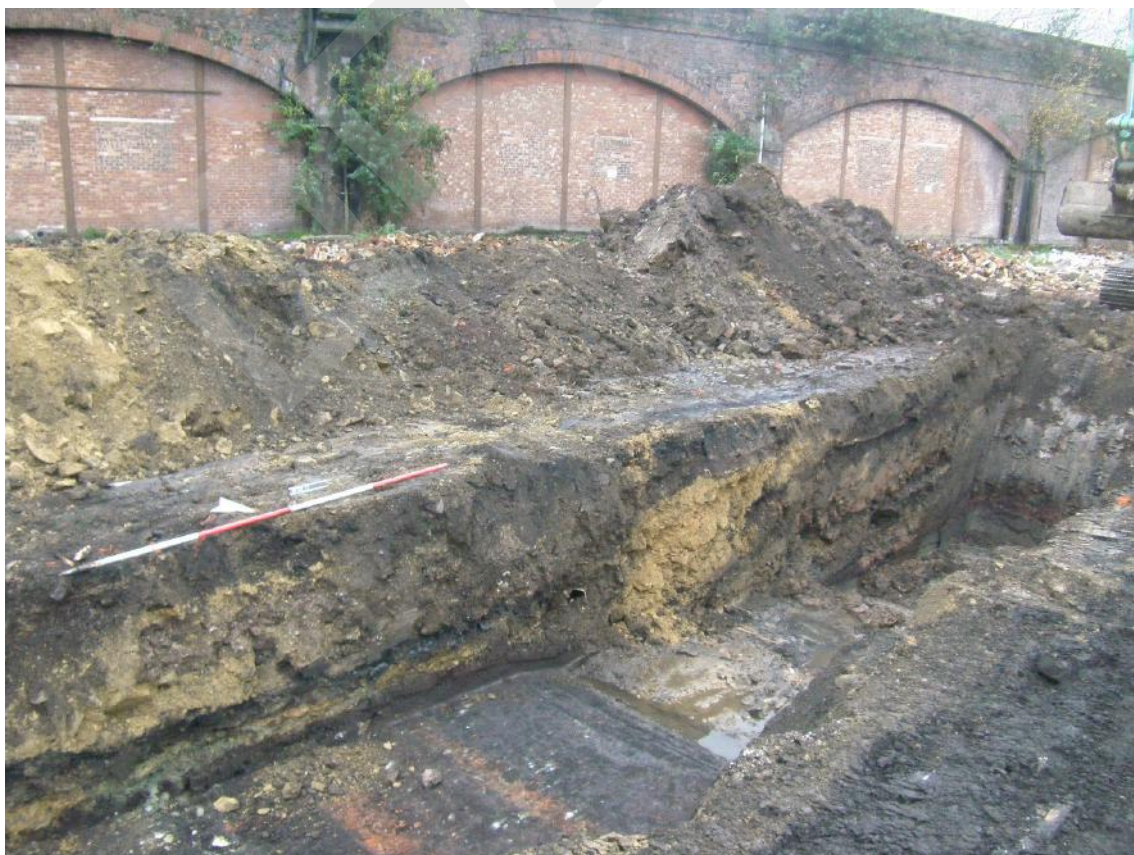
Plate 18 - Trench 7. North-east facing section showing loose sand deposit 708, sleeper 704, cinder surface 706, potential wall foot

- 4.8.2 Removal of 0.4m of modern overburden (**700**) revealed a disturbed section of railway sidings at the north-west end of the trench, comprising a 0.2m-thick cinder bedding deposit (**704**) within which survived a single wooden sleeper (Plate 18).

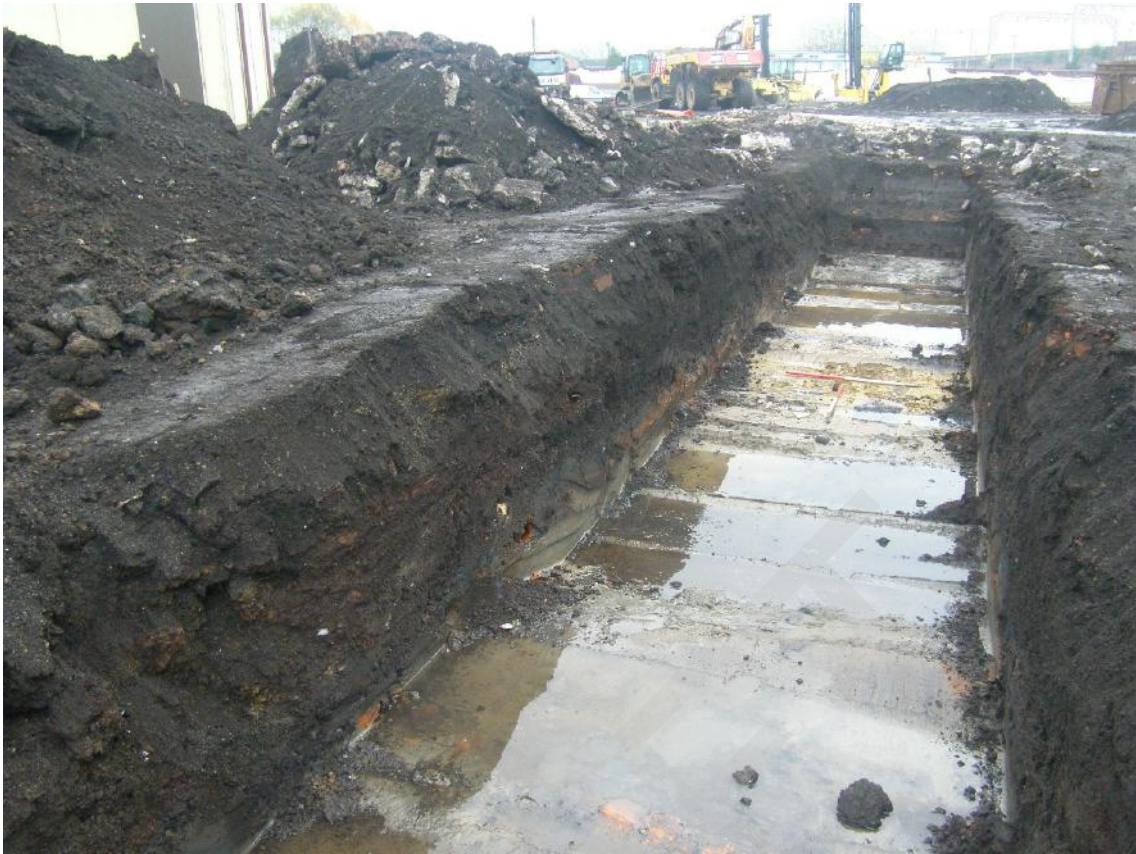
Plate 19 - Trench 8. Overview of trench, looking south-east

dating from the 19th and early 20th centuries (Plate 19, Plate 20).

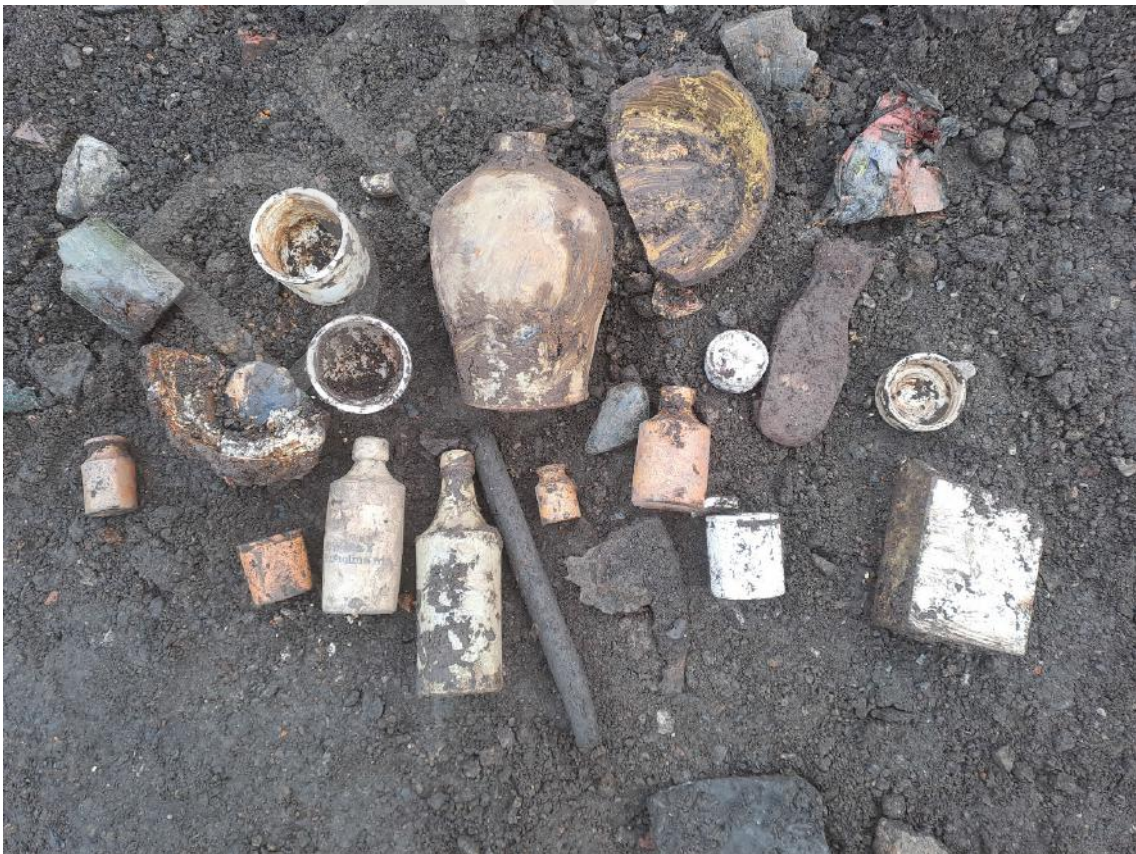
Plate 20 - Trench 8. Assemblage of finds recovered from midden deposit 801

Plate 20: Trench 8. Assemblage of finds recovered from midden deposit 801.
