# 10 Chorlton Green\_ Grade II Listed, Formerly Higginbottom Farmhouse

SEPTEMBER 2022

# Executive Summary

The purpose of this document is to demonstrate how our proposals to modify this Grade II listed farmhouse to a usable, comfortable family dwelling, whilst preserving and enhancing character of existing building. Our proposals include connecting the ground floor living accommodation by inserting a lightweight glazed extension, omitting a second staircase from the kitchen, and adding a second bathroom to serve the five existing bedrooms. We have developed our proposals in consultation with Dave Morris, formerly of the local planning authority, and Jenny Wetton, of JW Conservation.

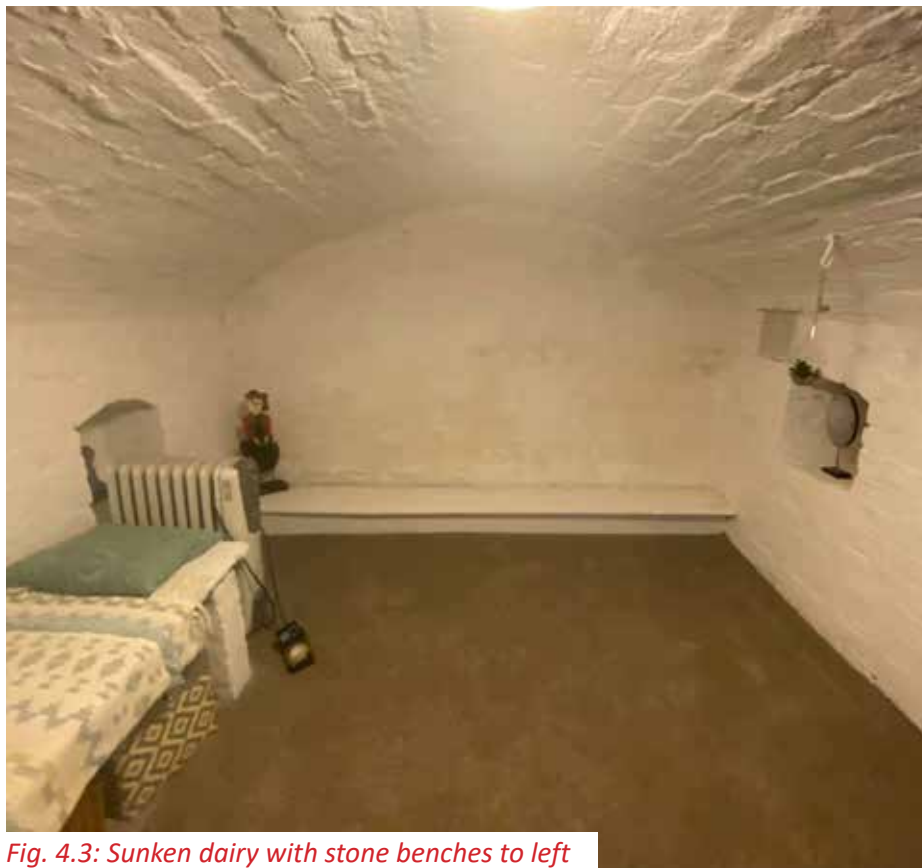
Fig. 4.3: Sunken dairy with stone benches to left

A two-storey rear range and low-level, sunken dairy were added later in the 19th Century. Higginbotham, a dairy farmer and market gardener, made these additions as a result of increased demand. The sunken dairy would have acted as cool storage space, with stone benches in both the Dairy and Morning Room acting as off-floor storage. At first-floor level, the rear range is inaccessible from the rest of the house - a separate staircase provides sole access to the first floor of this space. An external rear canopy was also constructed around the same period, which served as external storage out of direct sunlight.

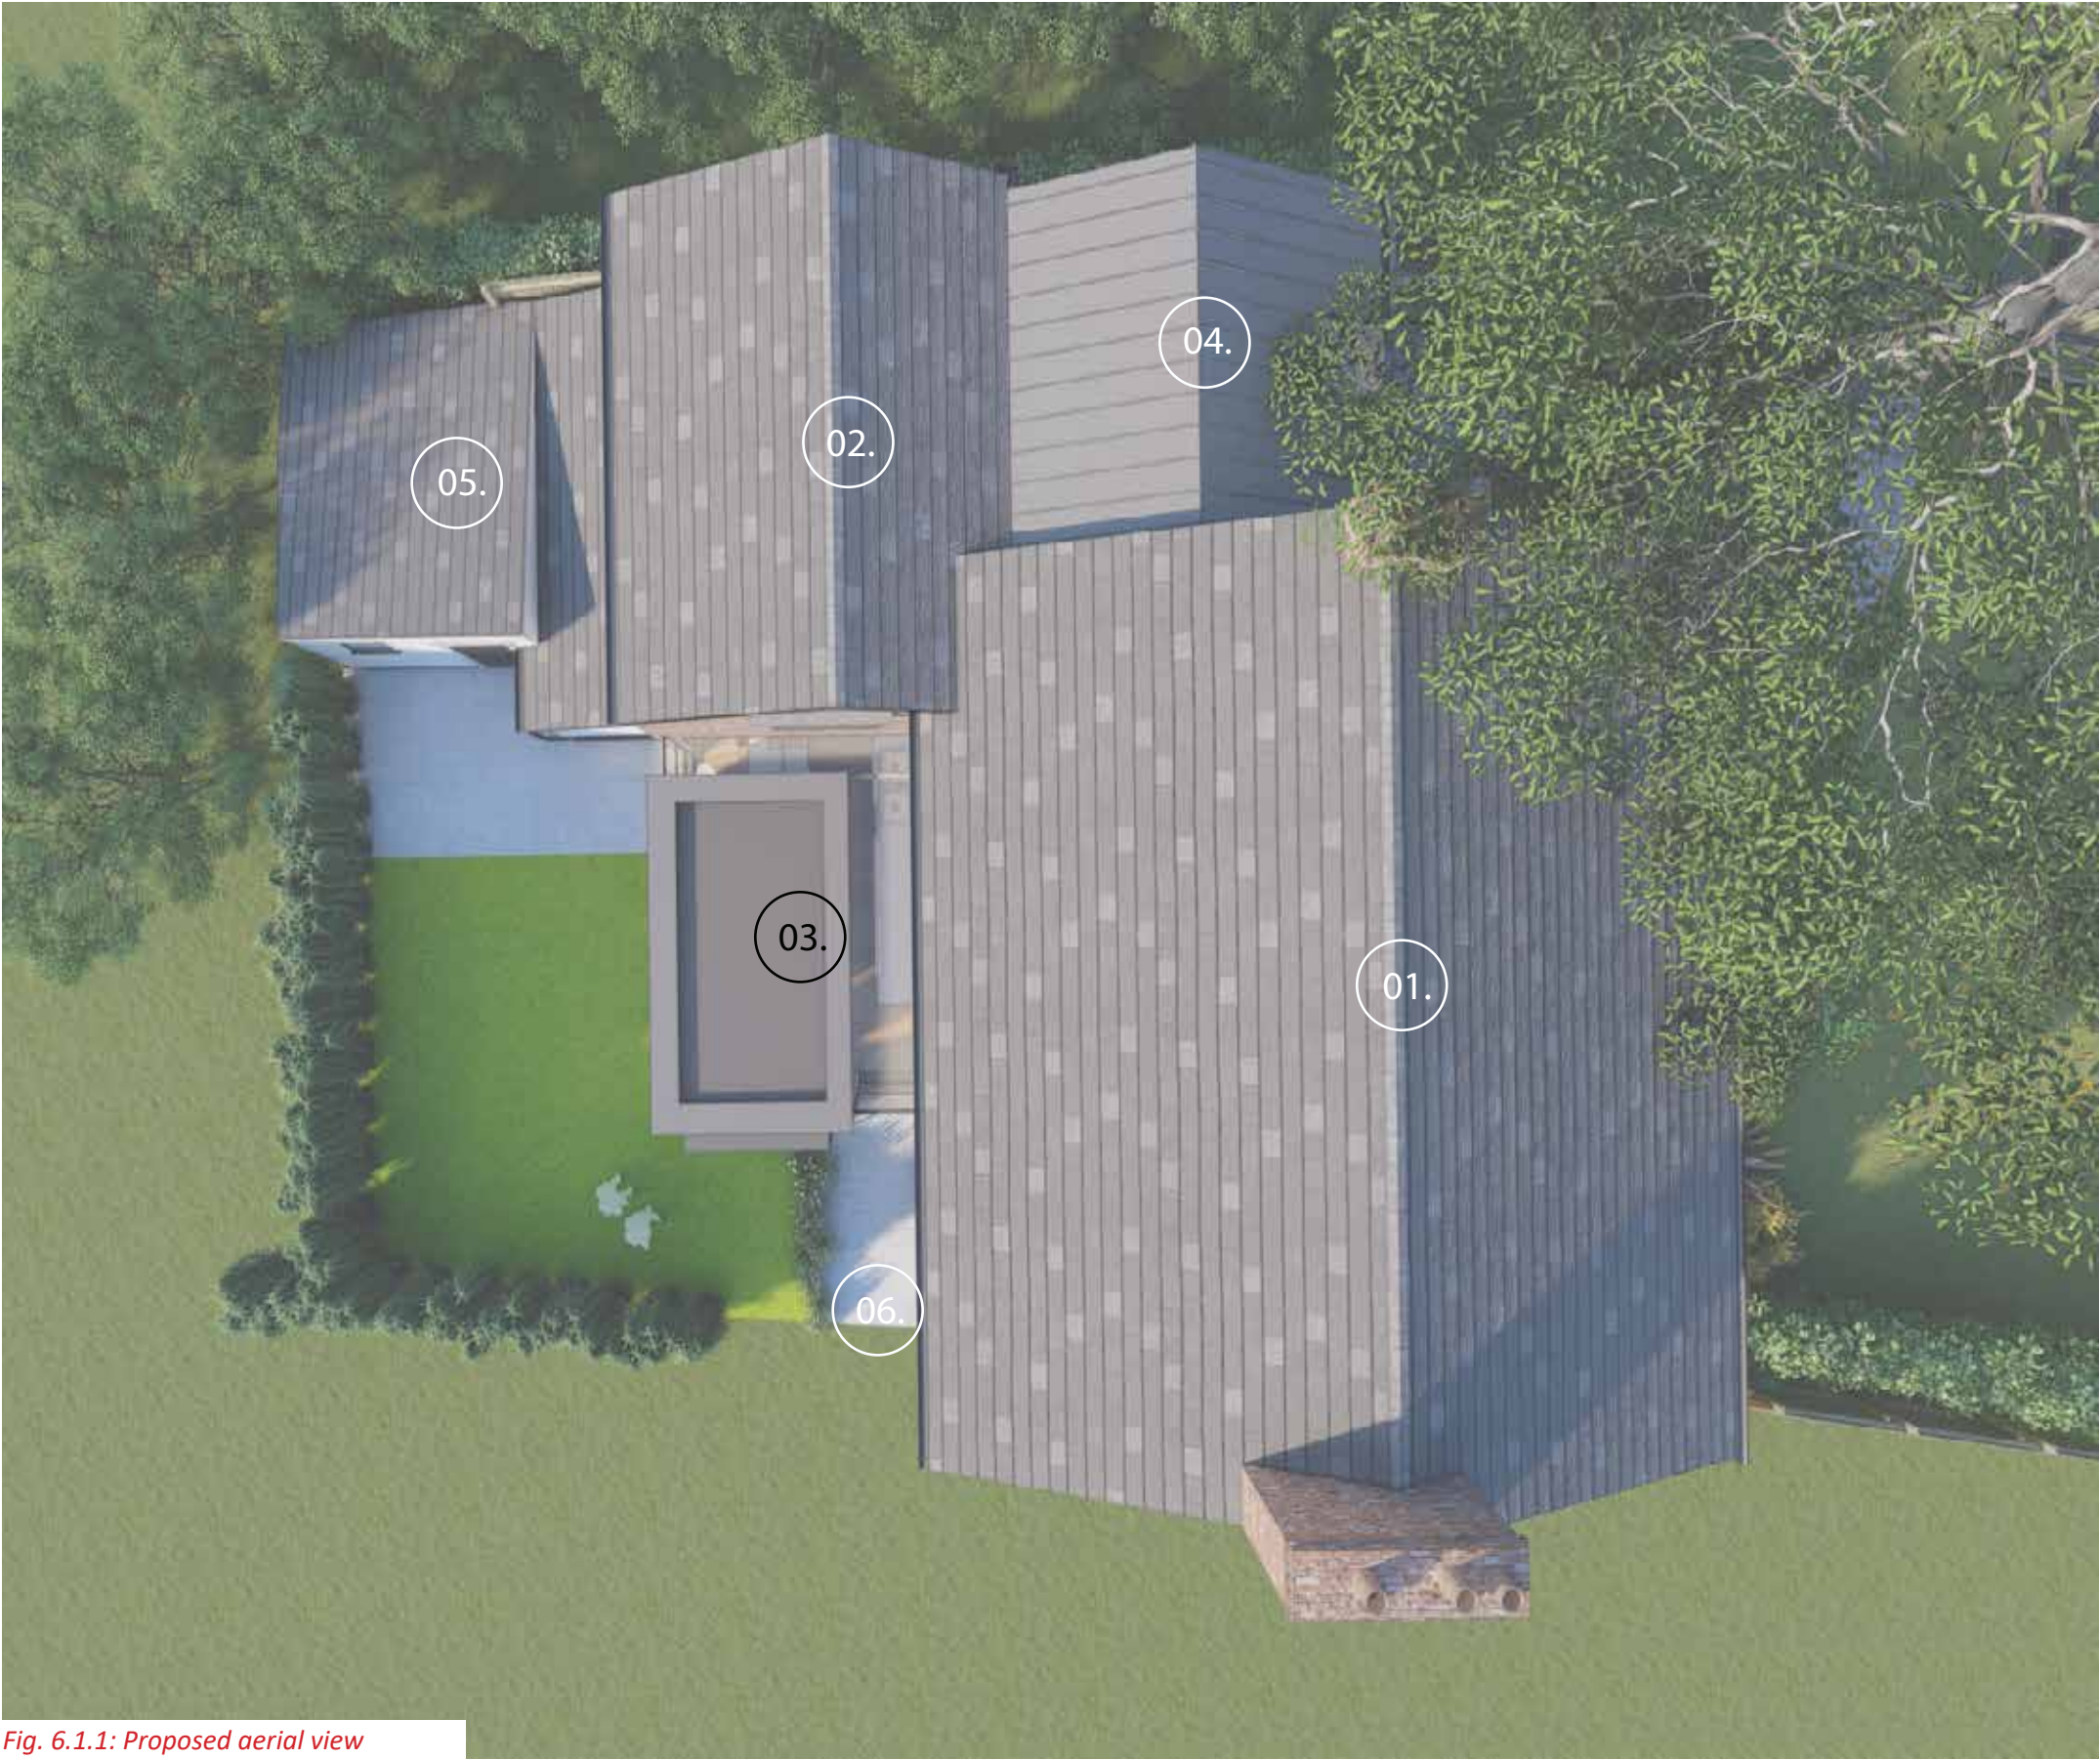
01. Proposed Site Plan

- 01. Original dwelling (early 19th Century)
- 02. Two-storey rear range (late 19th Century)
- 03. Proposed single-storey flat-roof extension
- 04. Proposed pitched roof extension over existing dairy
- 05. Existing outbuilding (early 20th Century)
- 06. Existing gated entry to rear garden

Fig. 6.1.1: Proposed aerial view

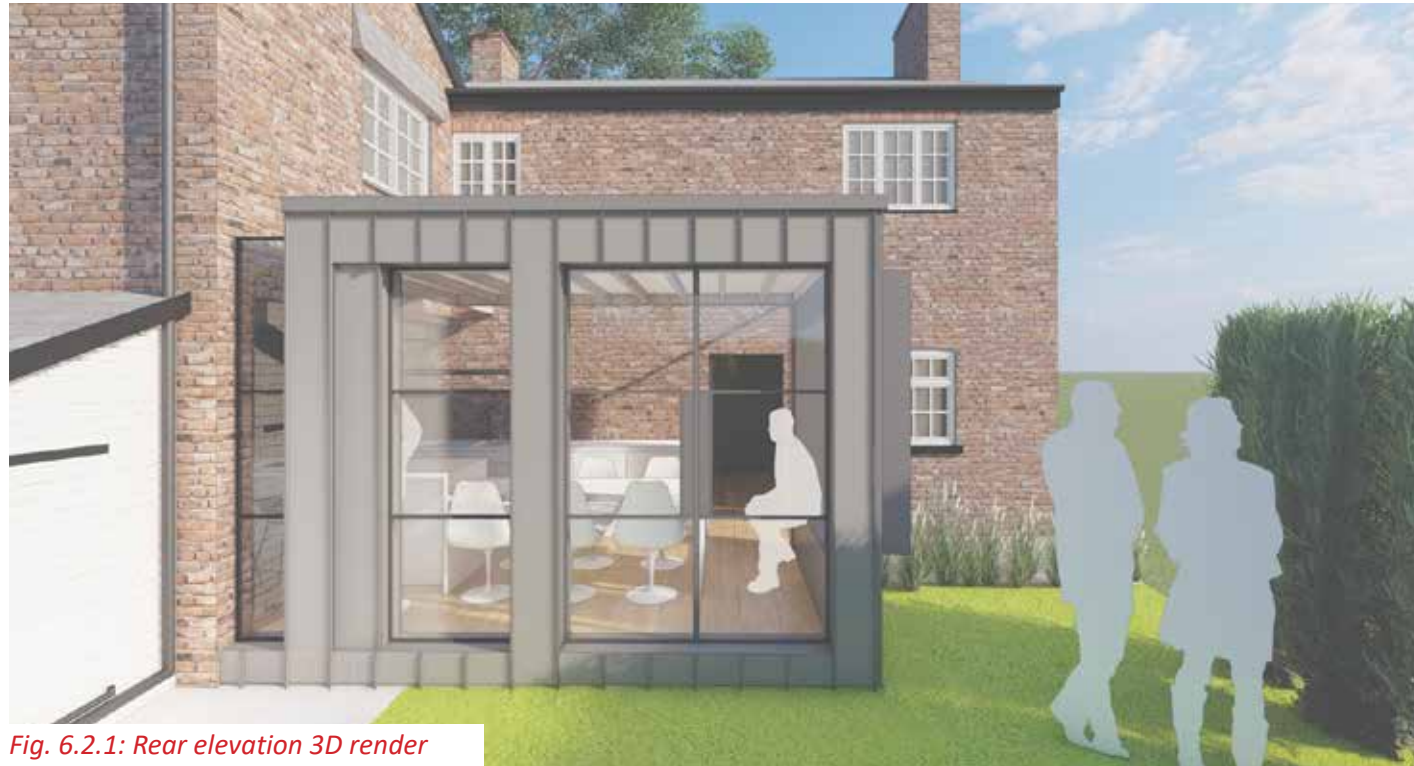
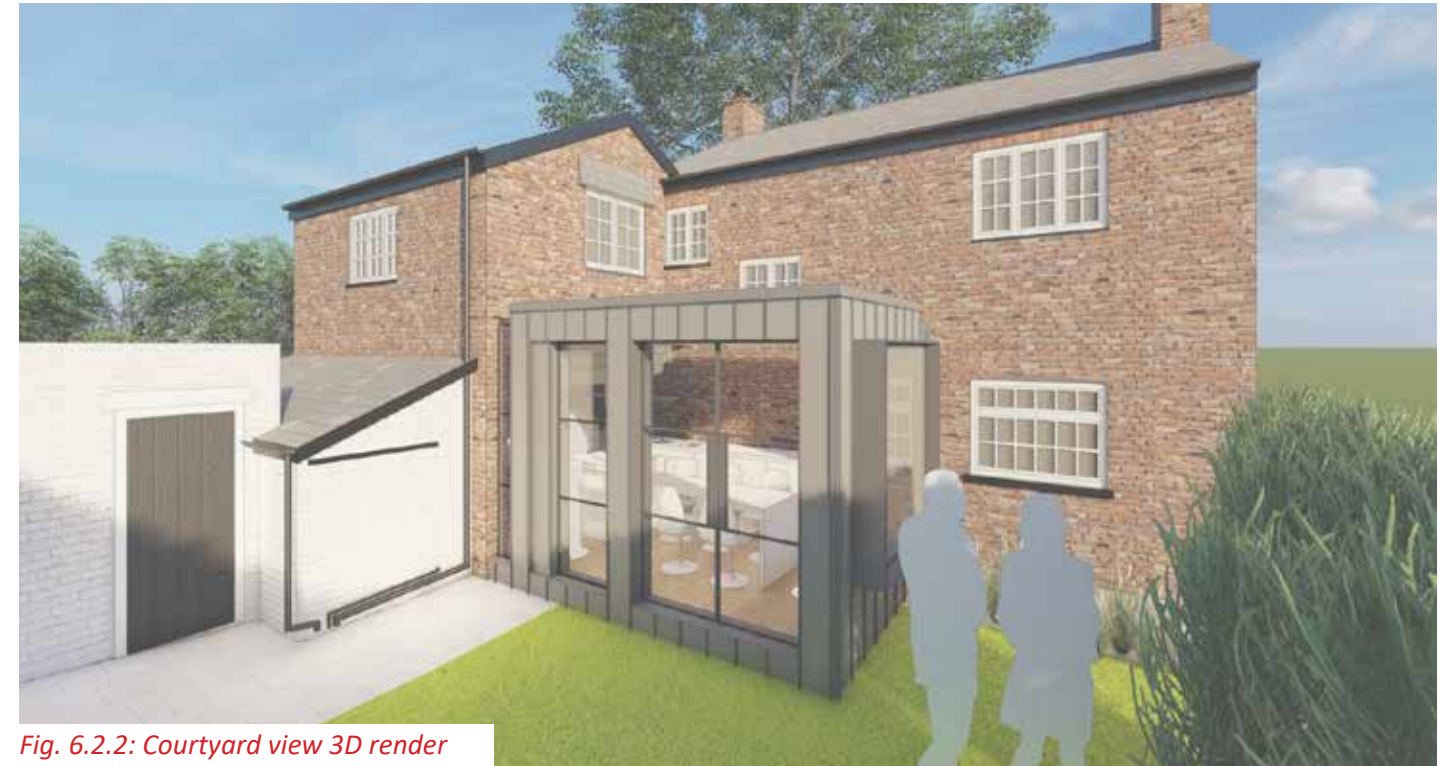
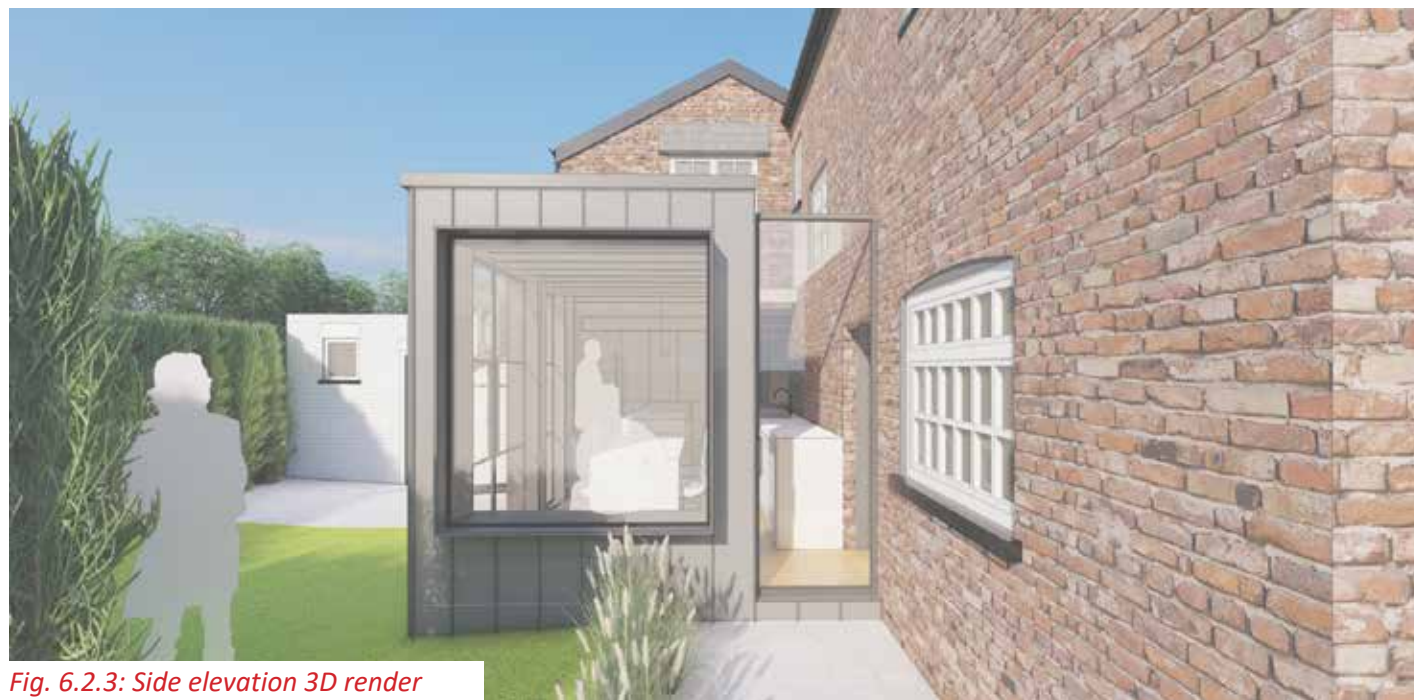
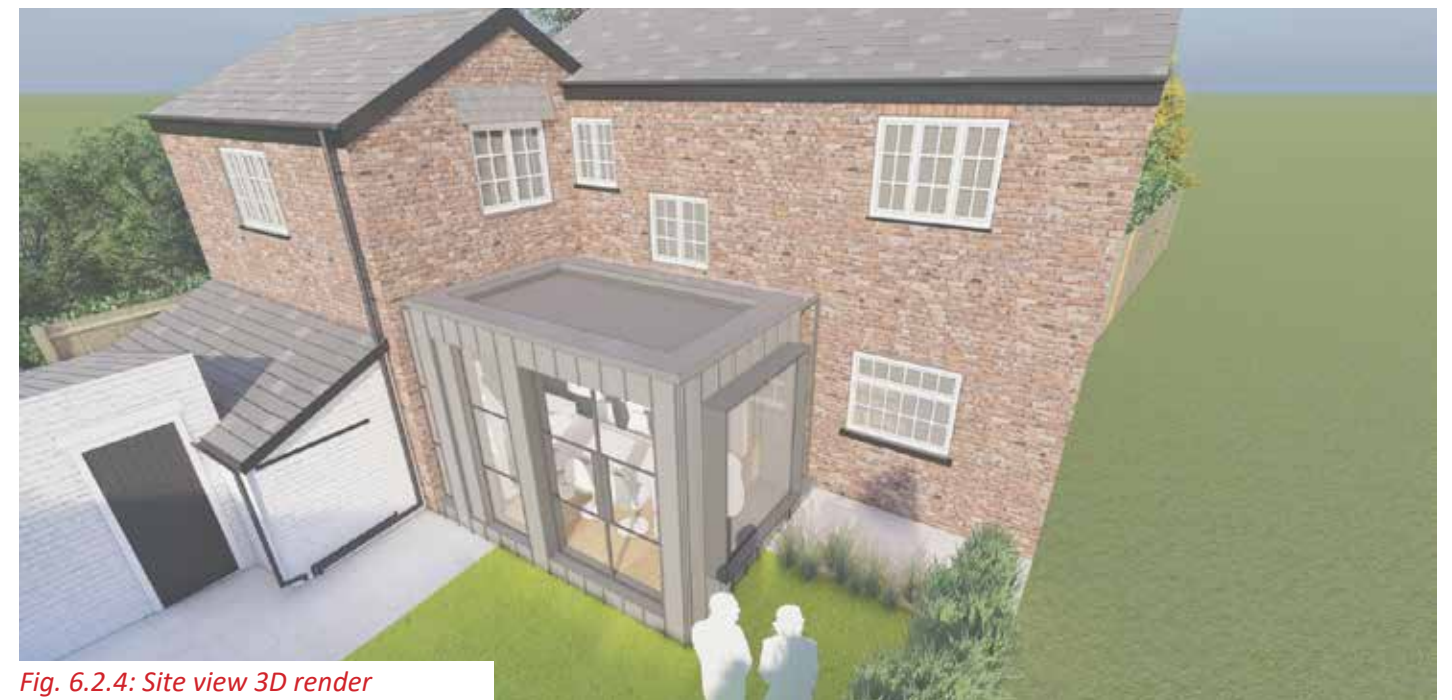
Fig. 6.2.1: Rear elevation 3D render

Fig. 6.2.2: Courtyard view 3D render

Fig. 6.2.3: Side elevation 3D render

Fig. 6.2.4: Site view 3D render

Our aim was to re-connect both the ground and first floor plans, and improve flow through the house, with minimal building intervention. Experiencing the disconnect of the rear range from the original dwelling, a modest single-storey rear extension vastly improved the flow and connections along the ground floor, while minimising breakthroughs in the existing fabric. A new kitchen / diner within the extension now connects directly to the lounge, catering much better for modern family life, while an additional run on the existing stair connects the first floor of the rear range with the rest of the property (this room is currently accessed via a separate stair in the kitchen).

A lightweight glazed up-and-over slot window touches the existing building lightly on both sides, whilst visually separating the proposal from the existing dwelling. Its scale, both vertically and horizontally, has been minimised so to act as a subservient mass to the existing. A strict 300mm grid defines both facades of the proposed extension, allowing for building elements to align and respond to the existing building - tying the proposal to its historic context.

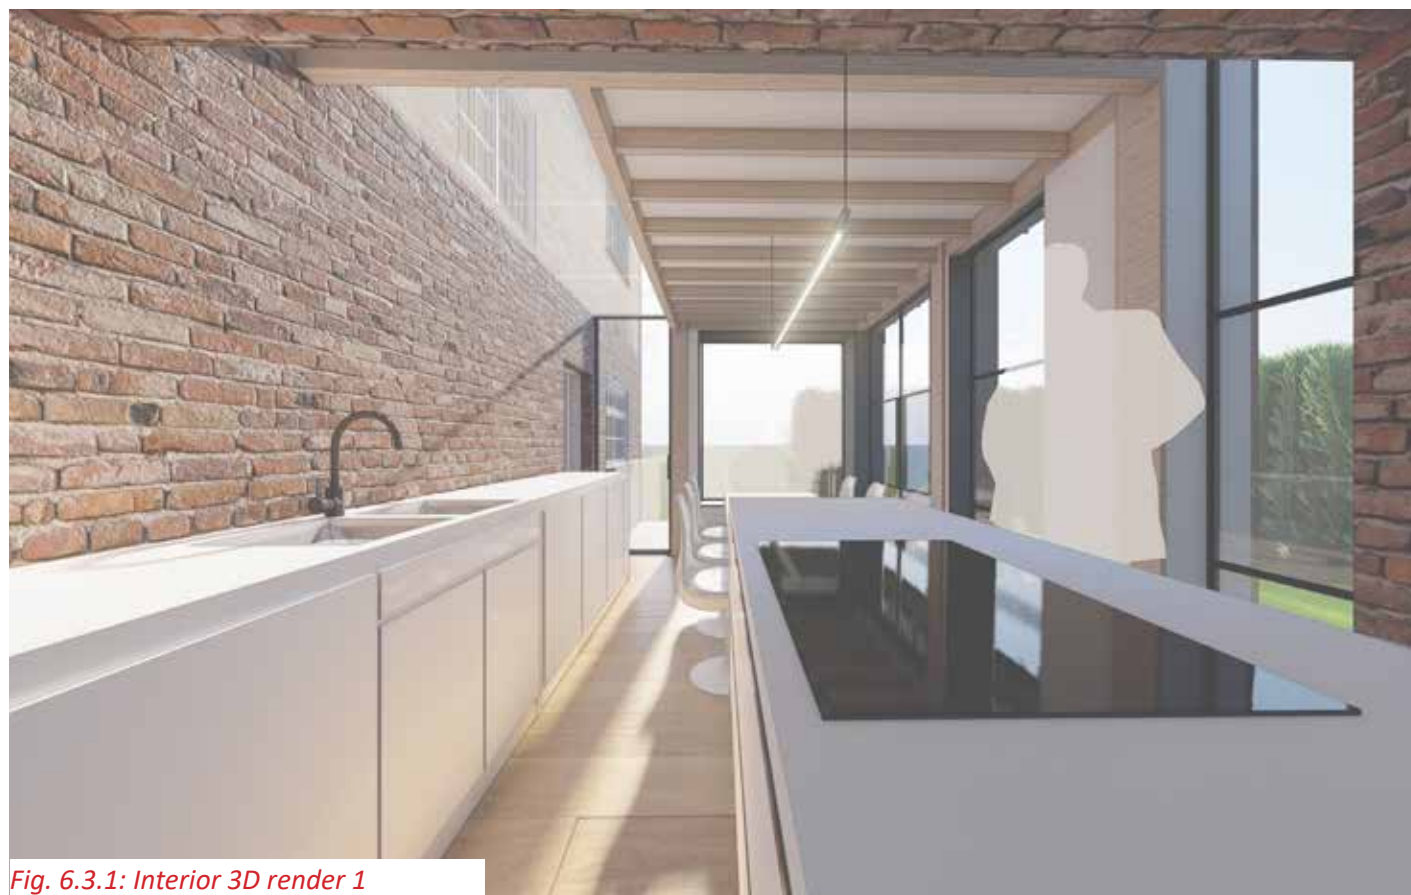
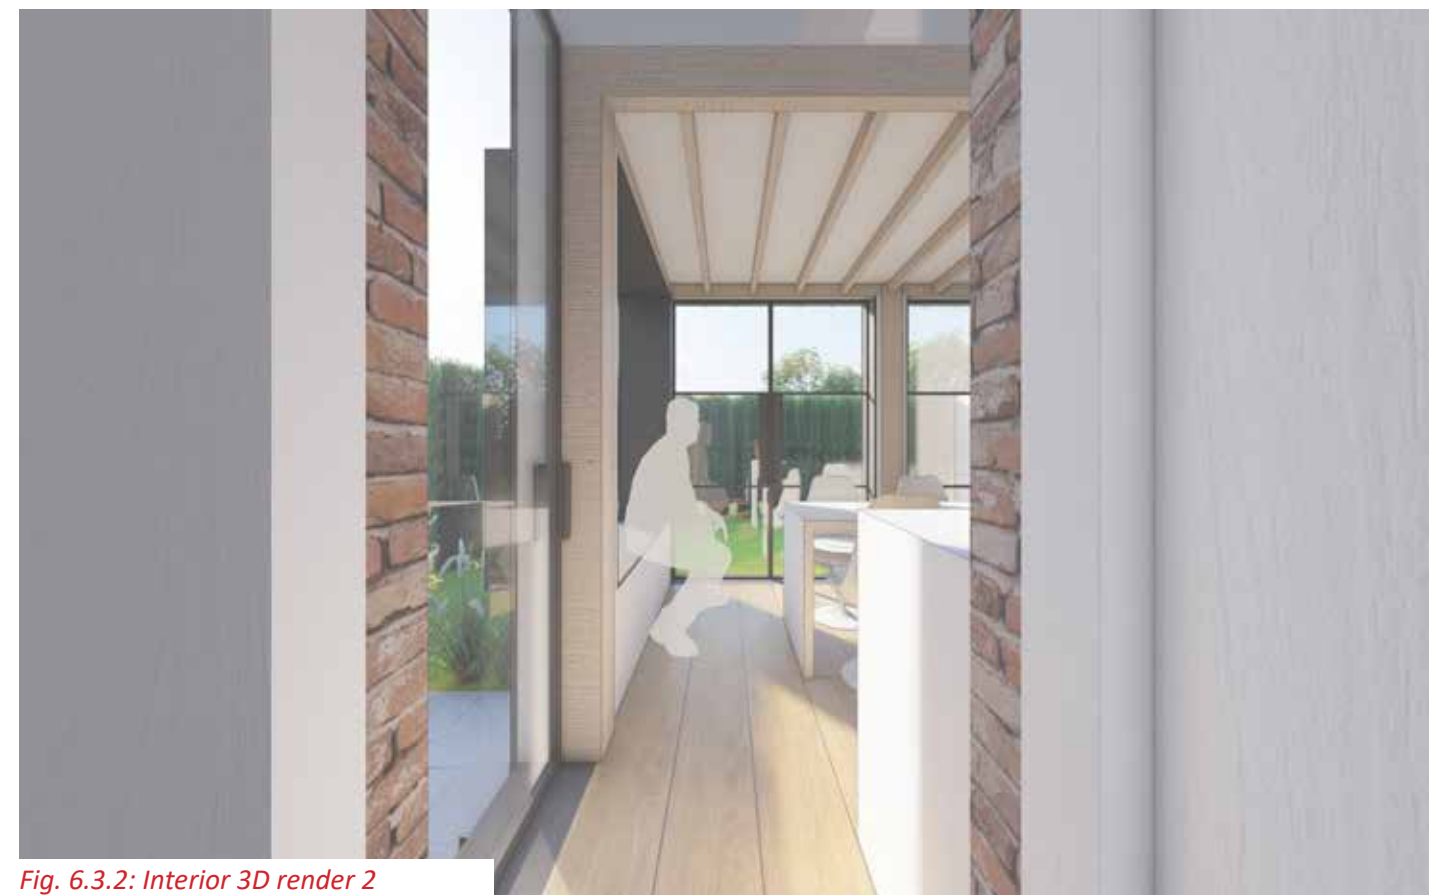
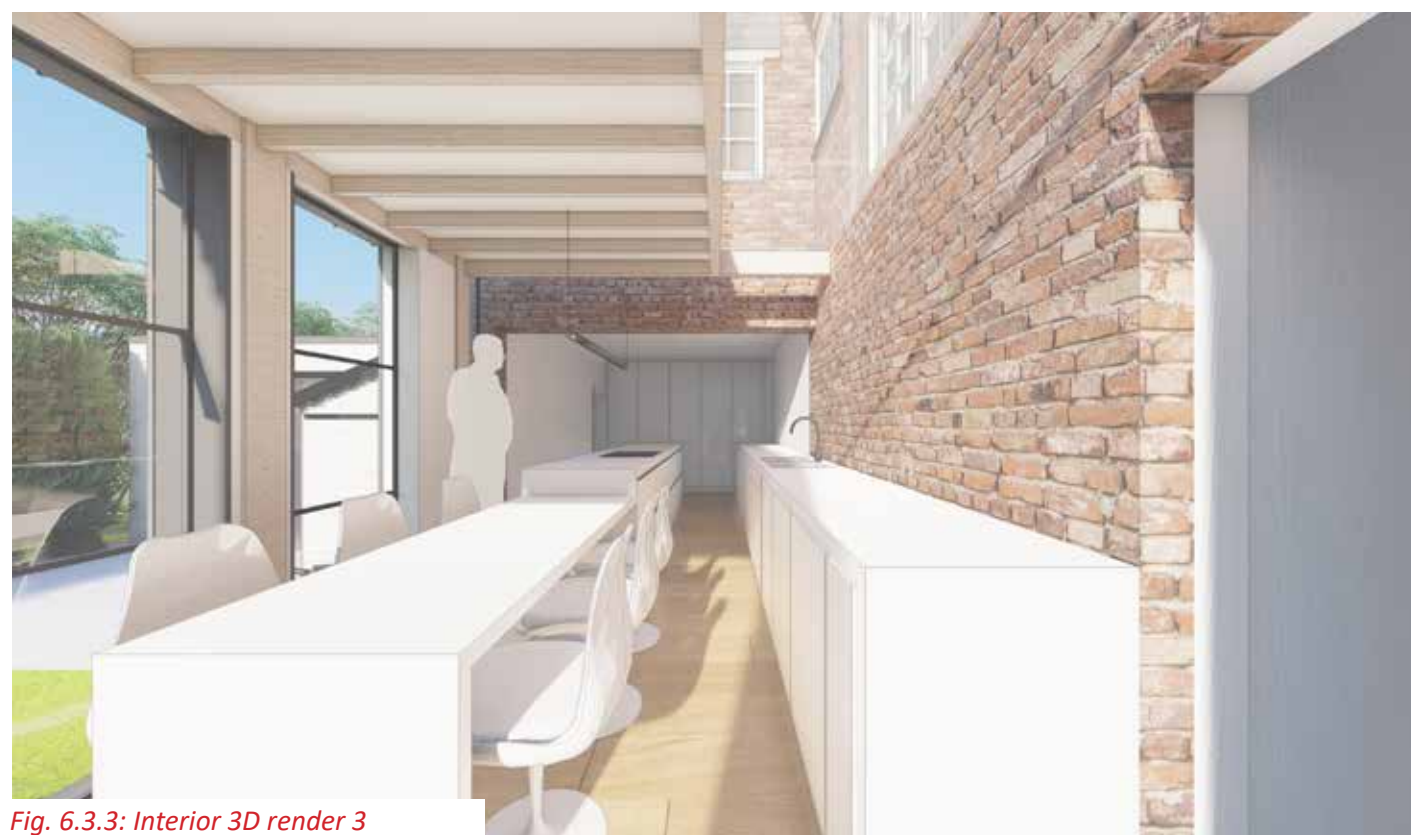
Fig. 6.3.1: Interior 3D render 1

Fig. 6.3.2: Interior 3D render 2

Fig. 6.3.3: Interior 3D render 3

A thin slot rooflight touches the existing building lightly and provides visual separation between old and new. Low-level kitchen units retain as much of the existing brick wall as possible, while allowing for plentiful glazing to the rear, meaning borrowed light floods deep into the plan. Aligned to existing openings and building elements along the rear facade, the proposal is respectful and subservient to the historic fabric, whilst its minimalist, paired back interiors draw the attention to the existing dwelling.

The lightweight glulam frame is left exposed, using materials softer in form and tone that also speak to the historic timber framed internal walls. A singular beam runs into the existing external wall of the farmhouse, while the rest of the threshold is defined by clear glass and soft join detail. The lightweight nature of the timber frame and soft join detail means the extension could at any point be removed with minimal disturbance to the existing building.

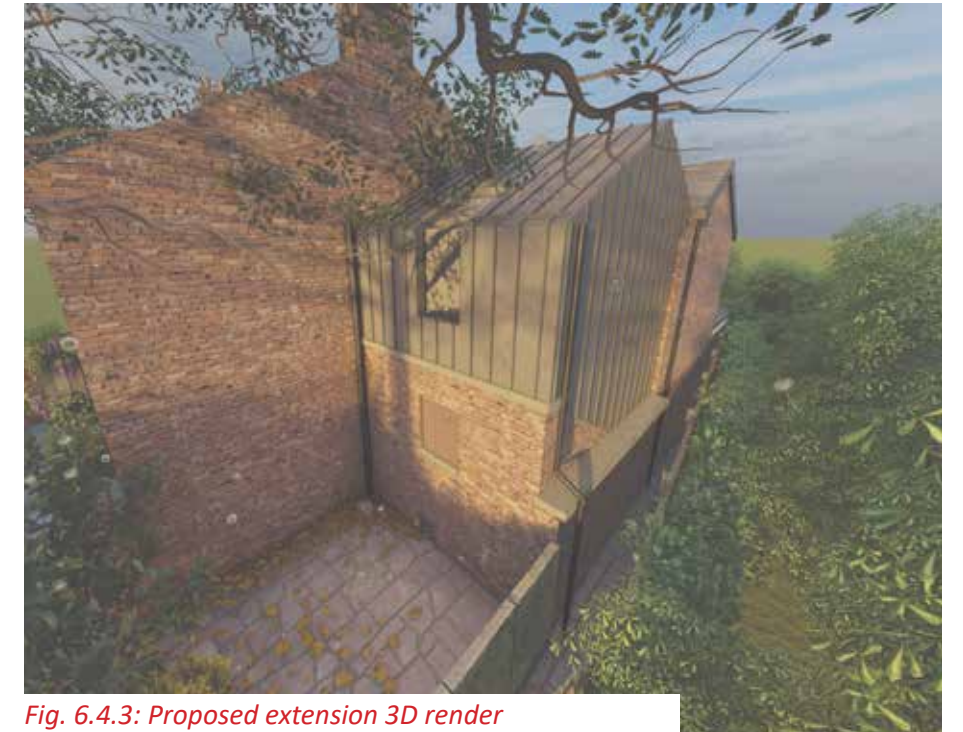
Fig. 6.4.1: Existing dairy 3D render

Fig. 6.4.2: Proposed extension construction 3D render

Fig. 6.4.3: Proposed extension 3D render

Currently, a mono-pitched roof sits above the dairy, with an inaccessible void space within the roof. A lightweight extension is proposed to sit above the existing sunken dairy space to the north, housing a walk-in wardrobe and en-suite to the master bedroom in the rear range first floor. The height and pitch of the roof will match that of the existing rear range adjacent, and be subservient to the original farmhouse.

A lightweight timber frame will be supported by a new blockwork plinth above the existing walls, while internal stud walls and a suspended lightweight timber floor will sit above the existing dairy space.

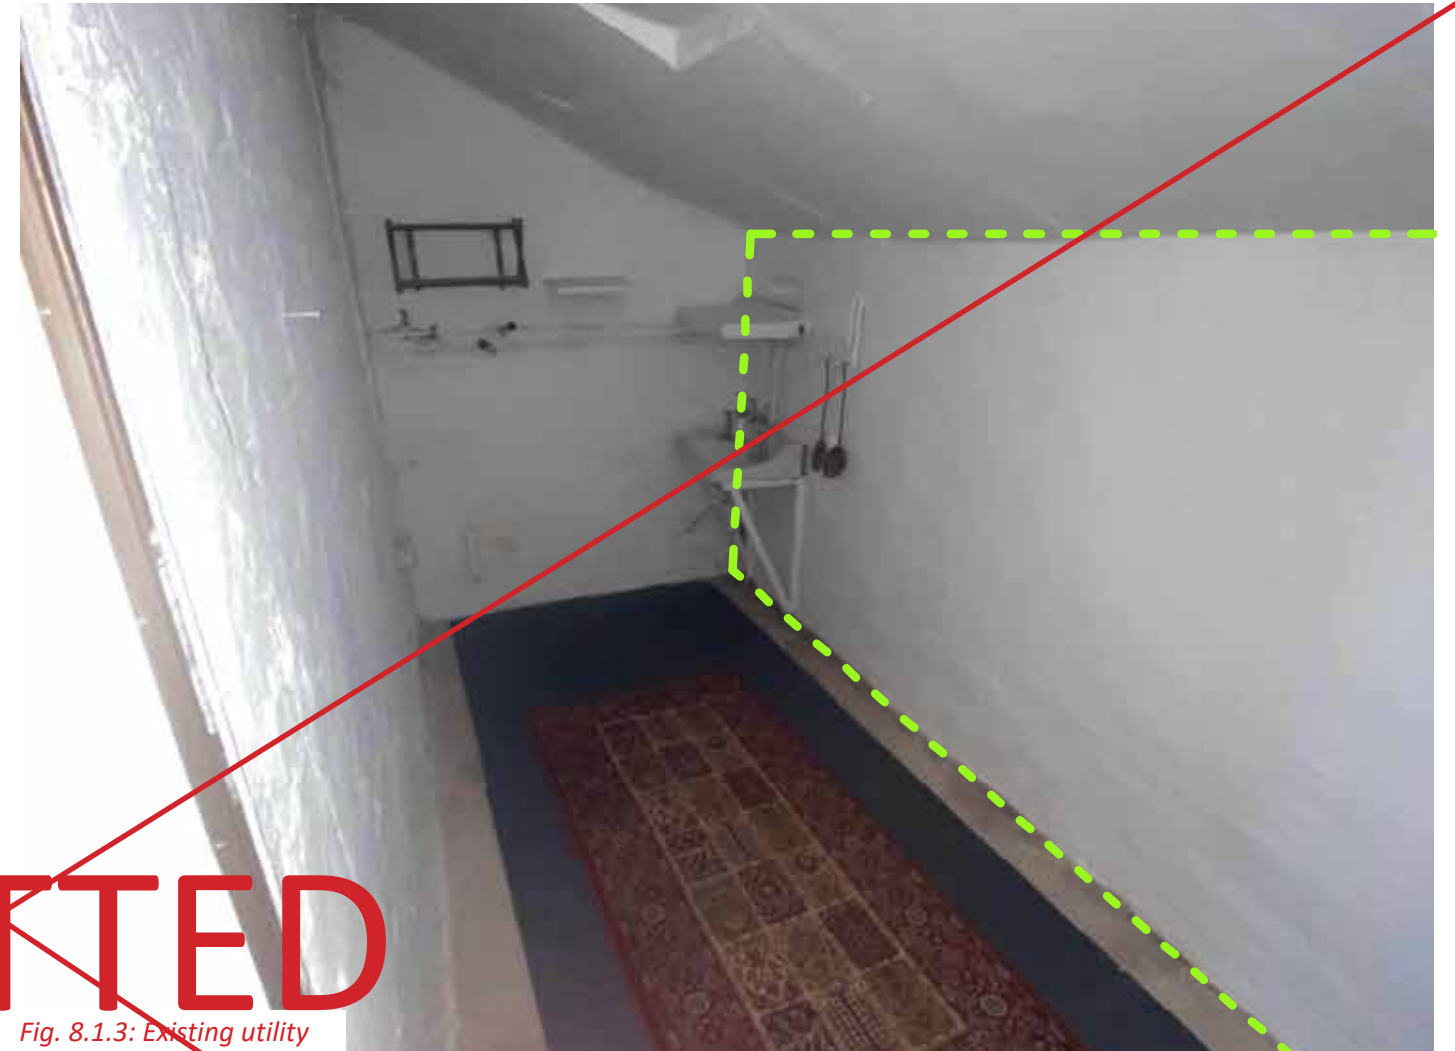
01. Demolition of wall between utility and outbuilding, along Gridline 1

We are proposing a new opening between the existing utility and outbuilding to create a usable gym space. Currently the utility has no natural light and is a tight, cramped space. The utility was a later addition to the property, built in the late 19th Century, and includes no special architectural detailing. The outbuilding, erected in the early 20th Century, is not built in the same architectural style as the historic house. The stepped wall to the north side of this room indicates more than one phase of construction - meaning that the wall may not be original. We are proposing to retain what is believed to be the historic part of the wall to the north of the room.

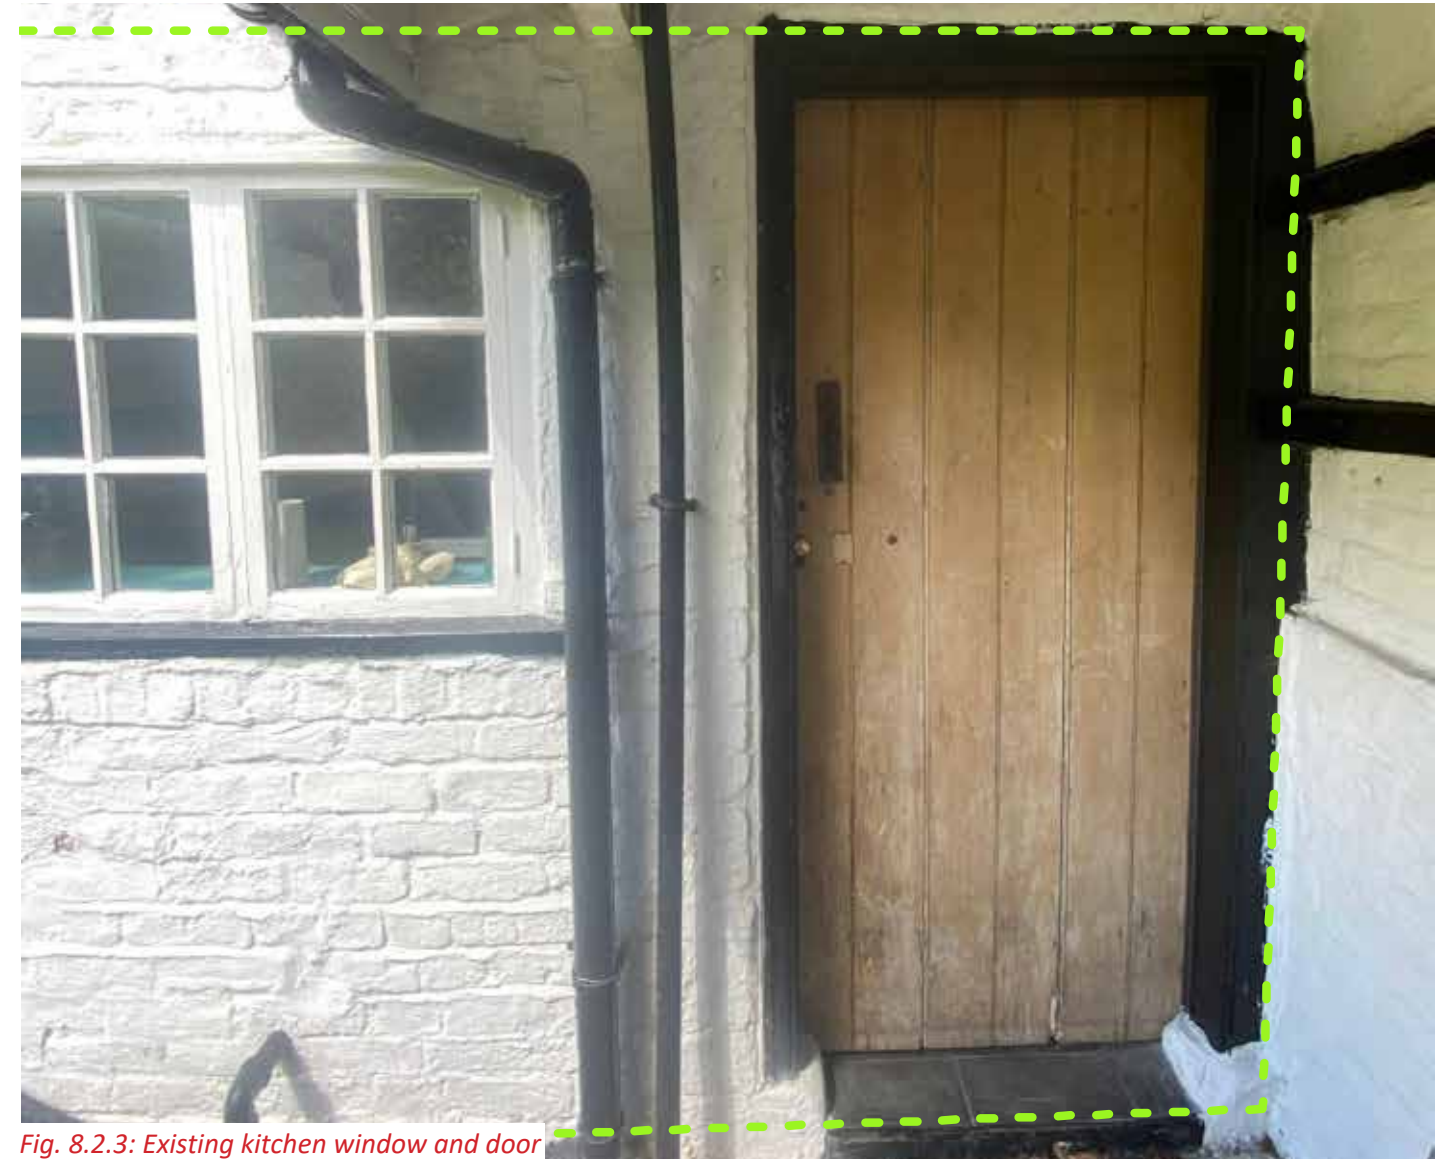
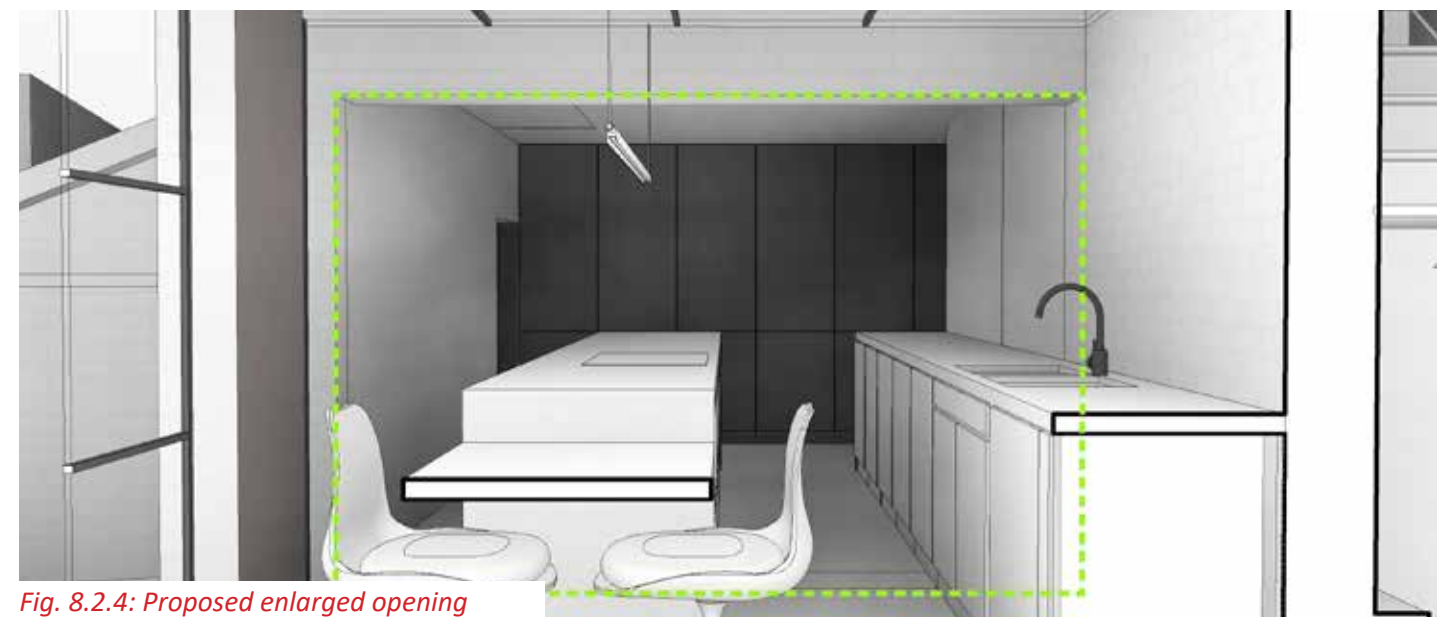
**02.** Enlarge existing window and door openings into one larger opening, along **Gridline D**

We are proposing to connect two existing openings on the south facade of the kitchen - located within the two-storey rear range - to create a larger opening. Currently a door sits beside a window with a high sill, which we propose to lower to floor level to create the larger opening. By doing this, we create a larger kitchen-diner, with plentiful natural light. The two-storey range is not part of the original building fabric, added later in the 19th Century. There is a suggestion the window was added at a later date, evidenced by the surrounding brickwork. A minimal steel lintel will support this new opening.

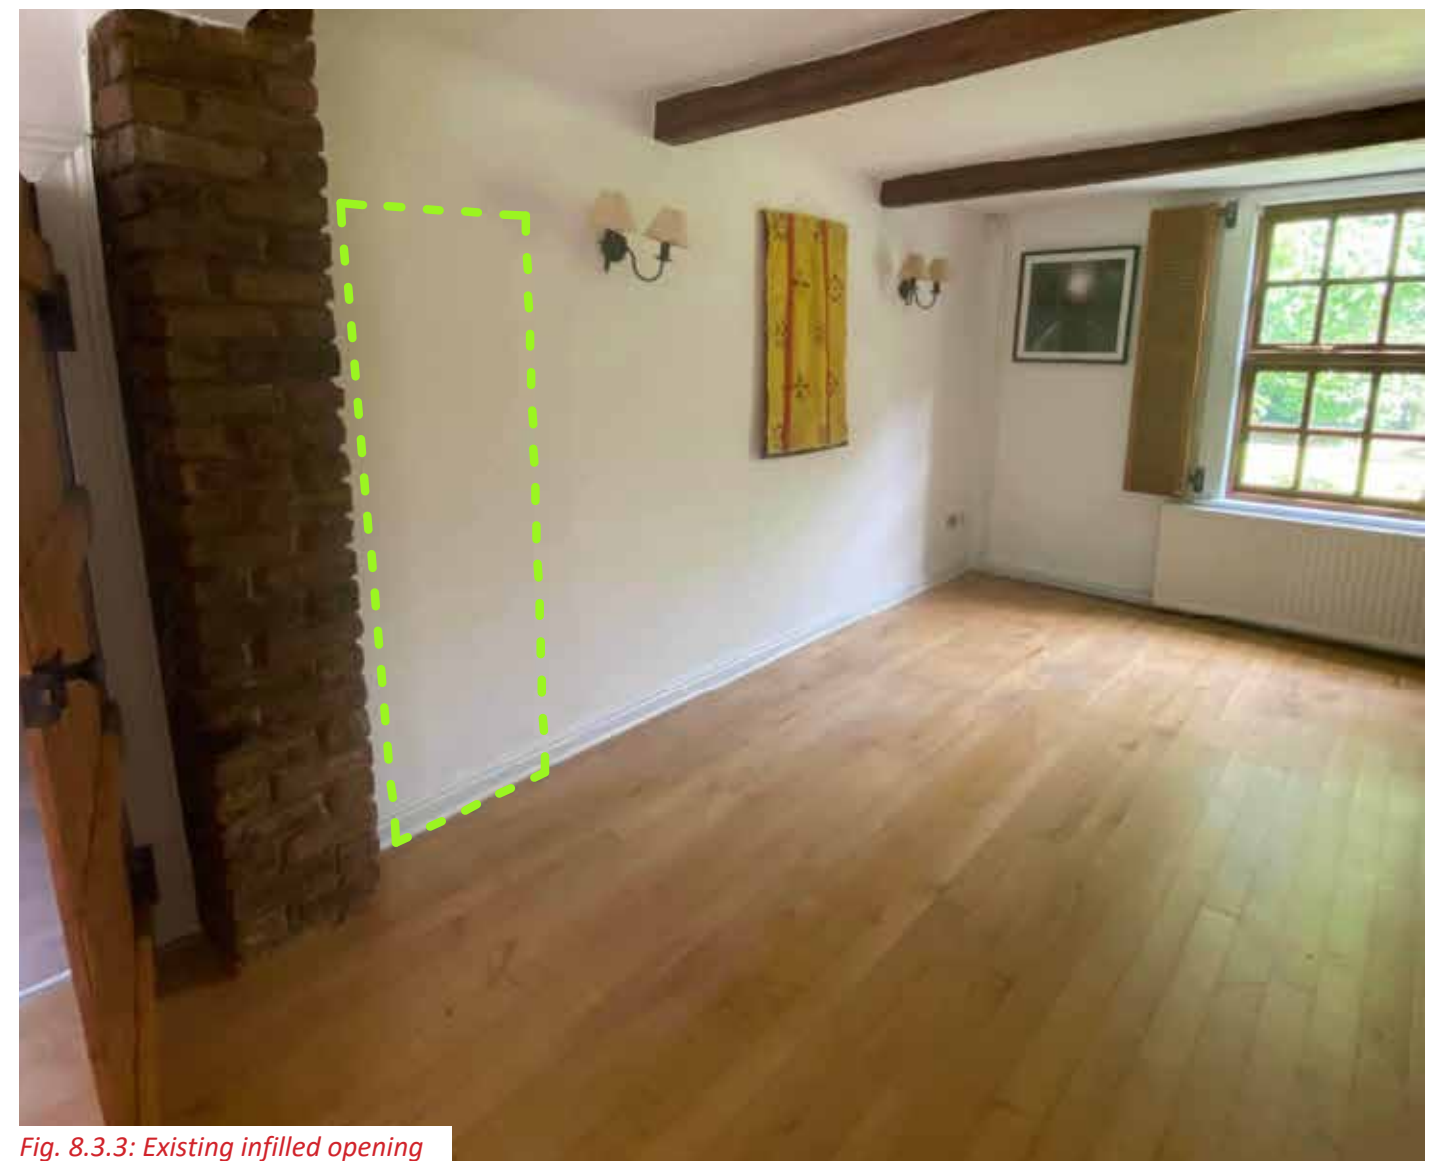
**03.** Re-instate historic opening between existing dining room and lounge, along Gridline B

Previous harmful alterations to the building have removed an internal wall between the two chambers to the south of the plan, resulting in the historic double-depth four room plan being lost. As a result, it also seems a historic opening between the two east chambers was in-filled. We are proposing to re-instate this internal wall, reverting back to the building's historic plan, and re-opening the previous door opening. This will re-instate important historic building fabric of architectural interest.

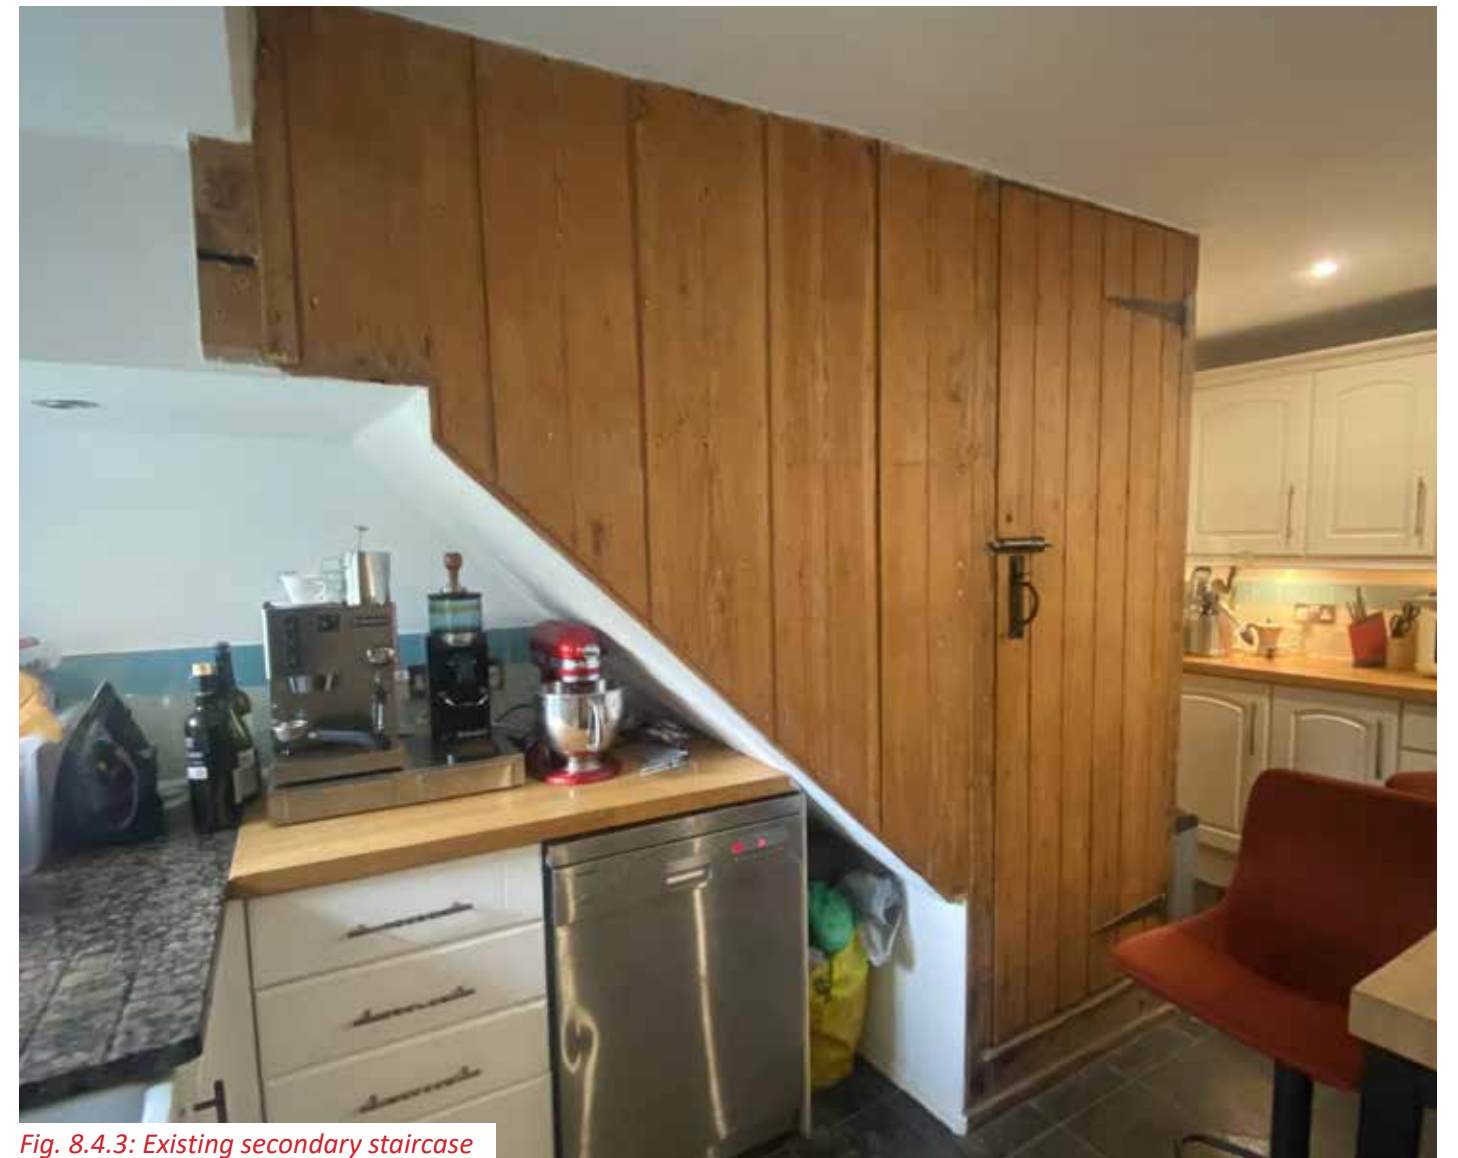
Fig. 8.4.3: Existing secondary staircase

Currently, the first floor of the two-storey range is disconnected from the rest of the plan; a secondary staircase provides access to this room only, disrupting flow across the plan. The staircase dominates the space, reducing the usable area within the kitchen and bedroom above. The timber balustrade to the first floor is a late 20th Century addition, and of no historic interest. Staircases within a kitchen can also pose a serious fire risk, so we believe removing this staircase is the best solution.
