# 10 Chorlton Green\_ Grade II Listed, Formerly Higginbottom Farmhouse

SEPTEMBER 2022

# Executive Summary

The purpose of this document is to demonstrate how our proposals to modify this Grade II listed farmhouse to a usable, comfortable family dwelling, whilst preserving and enhancing character of existing building. Our proposals include connecting the ground floor living accommodation by inserting a lightweight glazed extension, omitting a second staircase from the kitchen, and adding a second bathroom to serve the five existing bedrooms. We have developed our proposals in consultation with Dave Morris, formerly of the local planning authority, and Jenny Wetton, of JW Conservation.

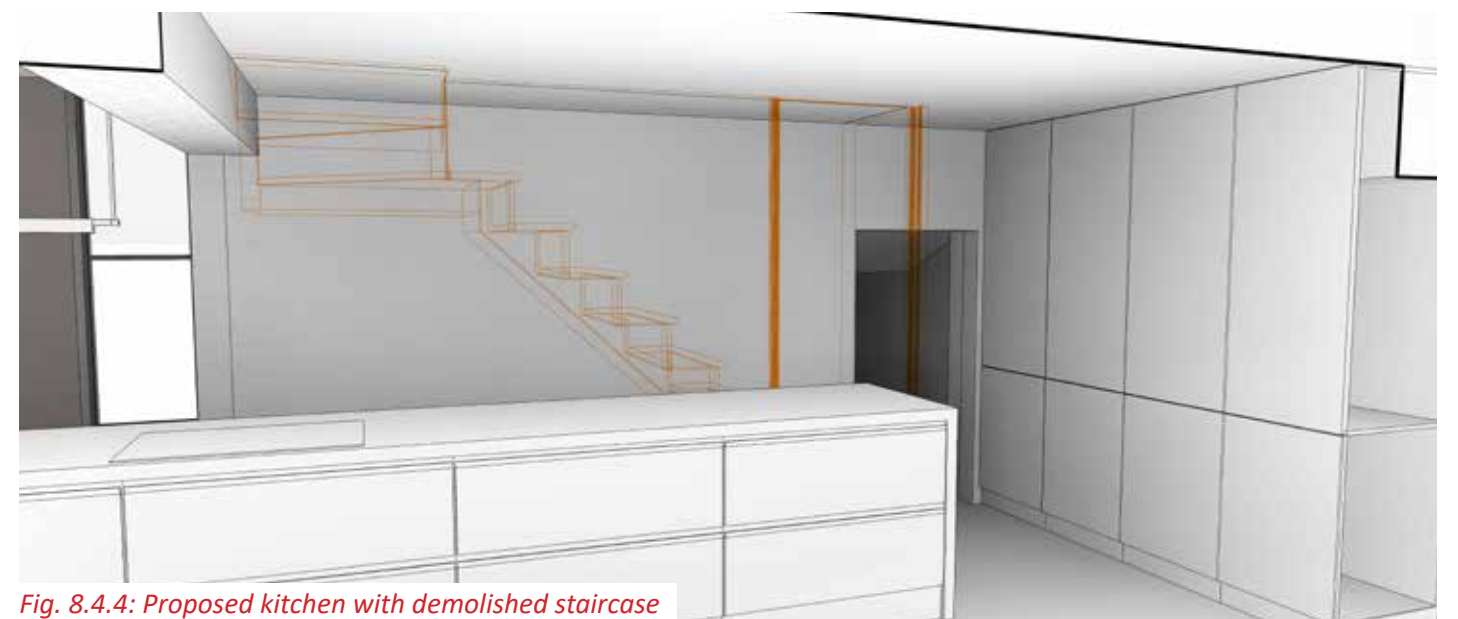
**04.** Omit secondary stair within kitchen and infill

Fig. 8.4.4: Proposed kitchen with demolished staircase

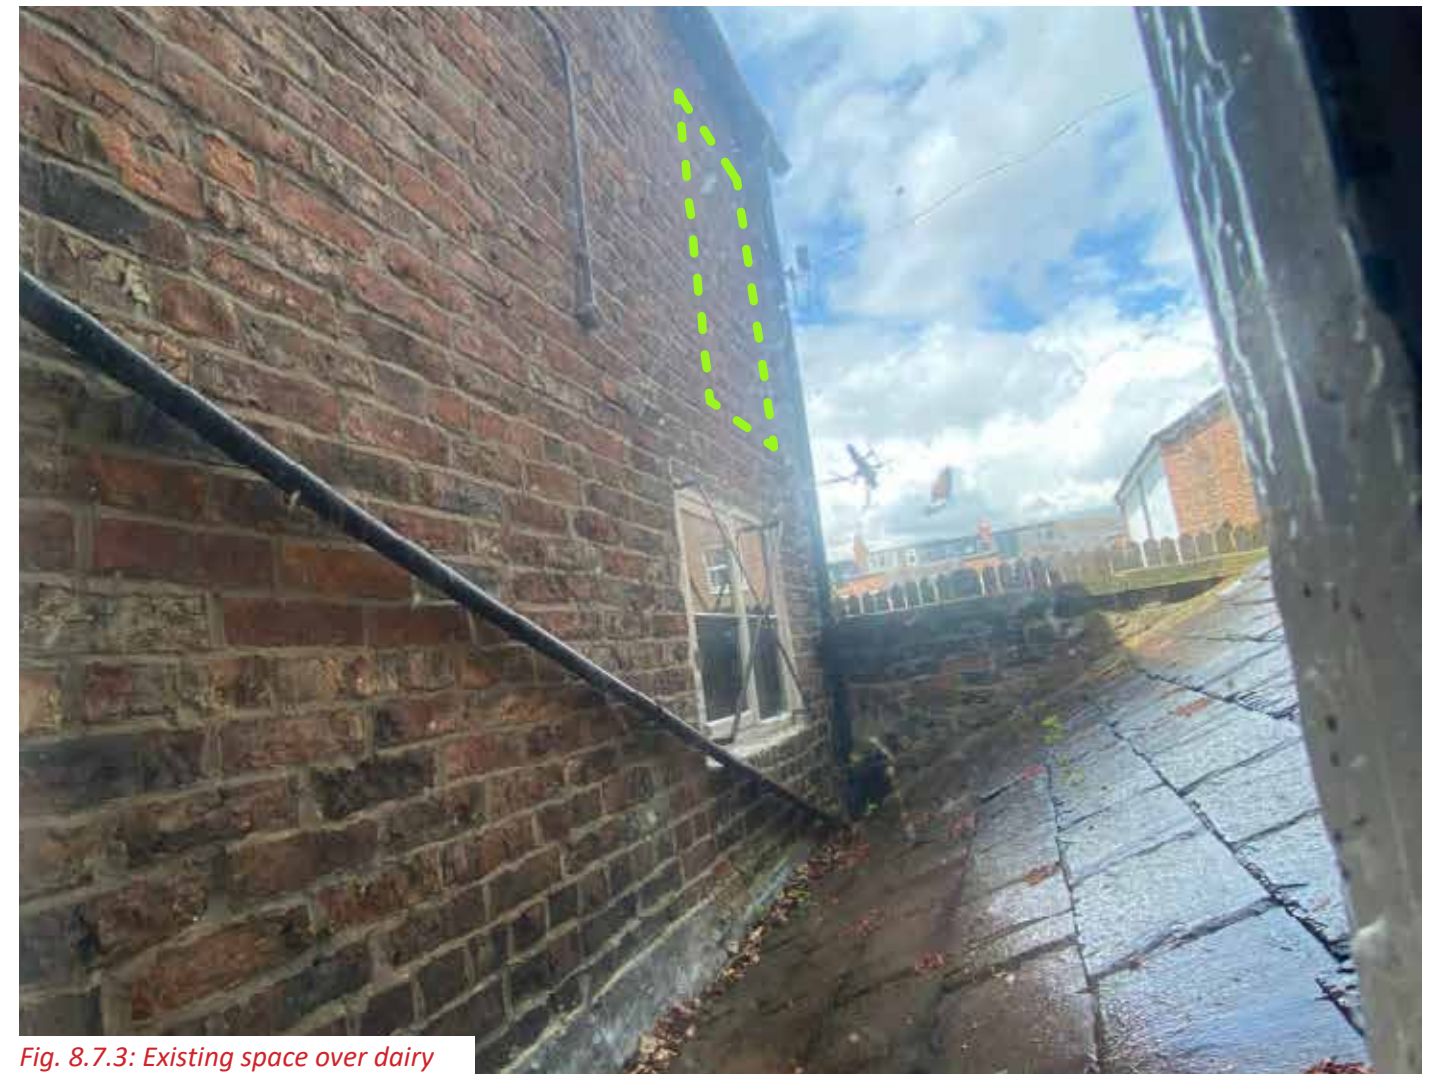
**07.** New opening from rear bedroom to lightweight extension, along Gridline F

The addition of a lightweight extension above the existing dairy space, housing an en-suite and dressing room necessitates a new opening along the east face of the two-storey range (late 19th Century brickwork) - a largely blank elevation, not visible from the front of the property. The skirting in this room evidences modernisation and the removal of historic fabric.

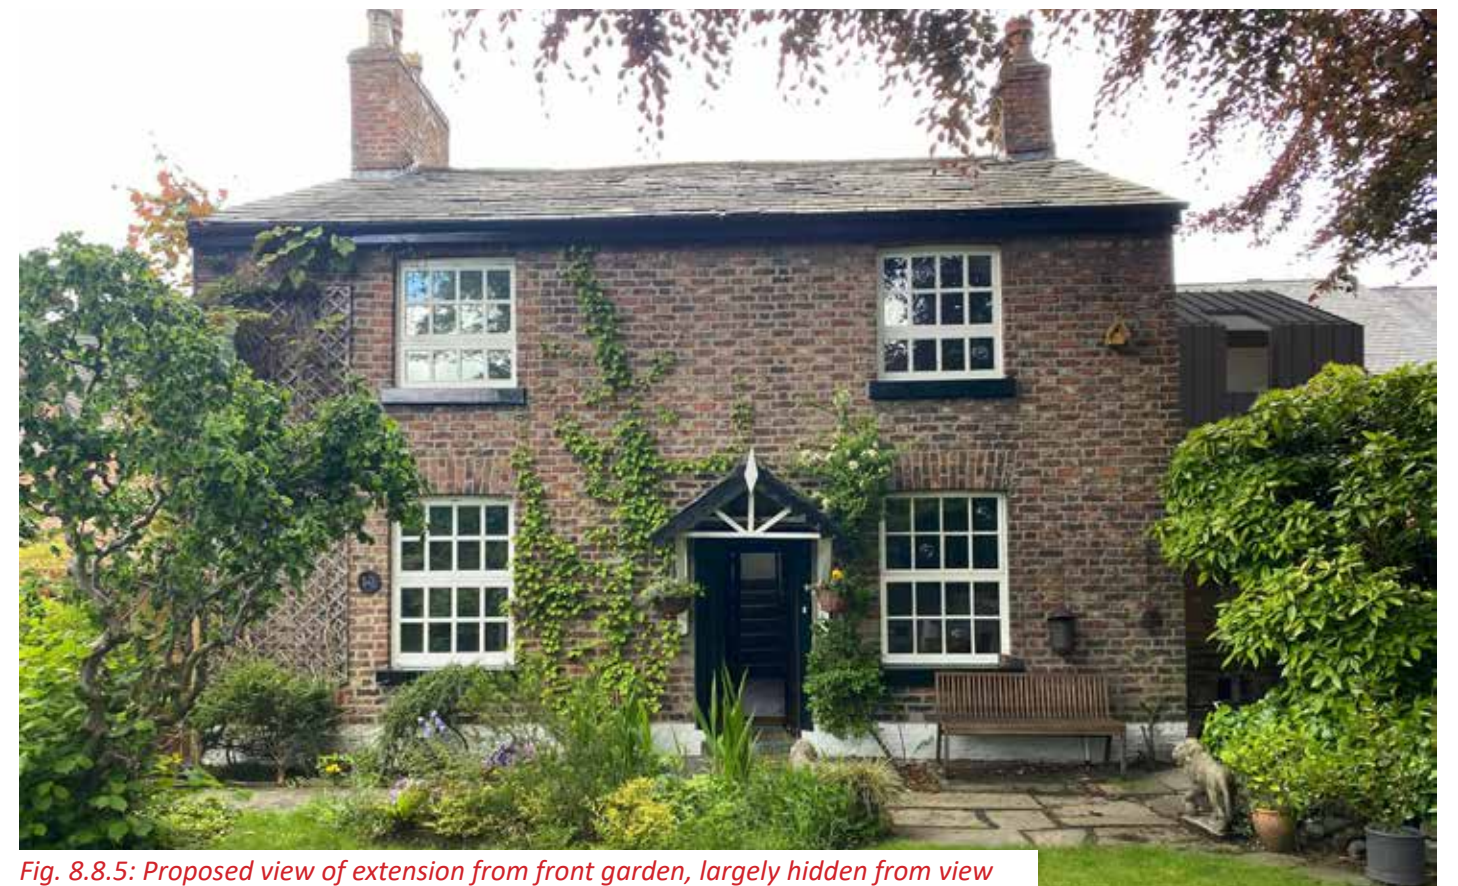
Fig. 8.8.5: Proposed view of extension from front garden, largely hidden from view

We are proposing a lightweight extension above the existing sunken dairy space. Currently, one bathroom is shared between five bedrooms, which we believe is inadequate for modern family living. We propose an additional bathroom, serving as an en-suite for the master bedroom within the two-storey range. The extension will also house a dressing area for the master bedroom. From the front of the property, the existing dairy is barely visible due to being set back from the primary facade, as well as the abundant mature vegetation to the front, as shown in the photo-matched render opposite (Fig. 8.8.5)

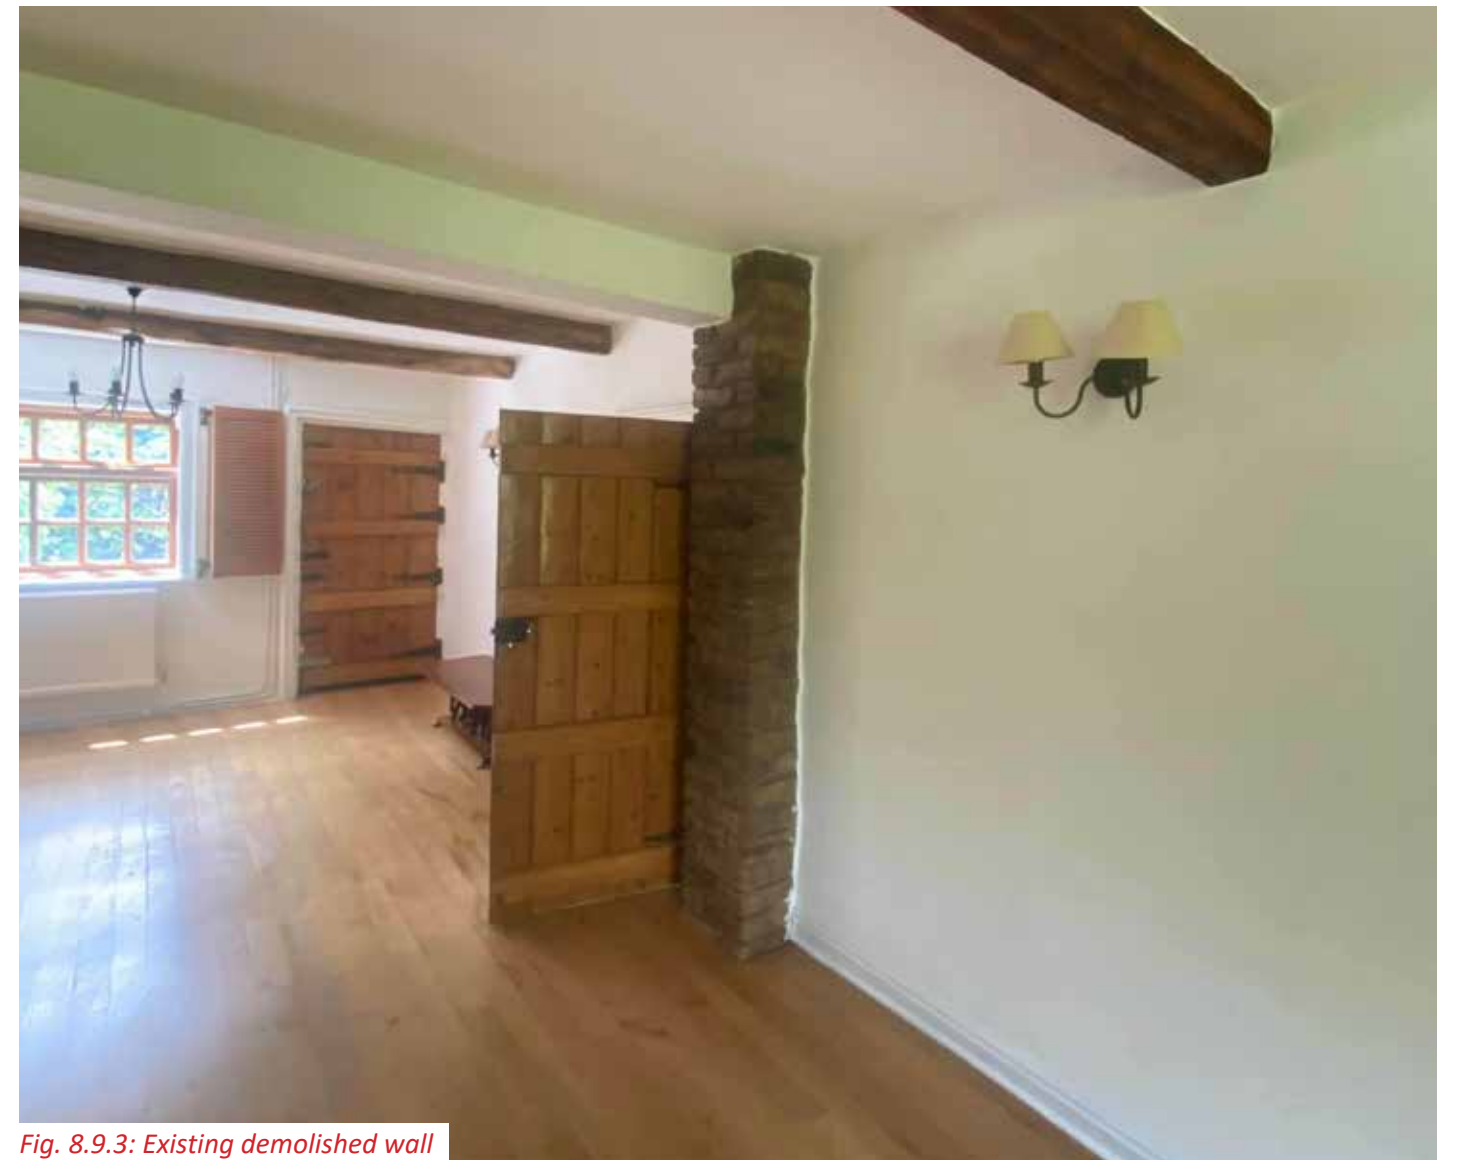
The existing lounge space has been greatly altered across the lifespan of the building. An internal wall has been removed that once divided it into two chambers, resulting in the historic double-depth, four-room plan being lost on the ground floor. We propose to re-instate this wall, re-introducing two chambers to the south of the plan.

Fig. 8.9.3: Existing demolished wall

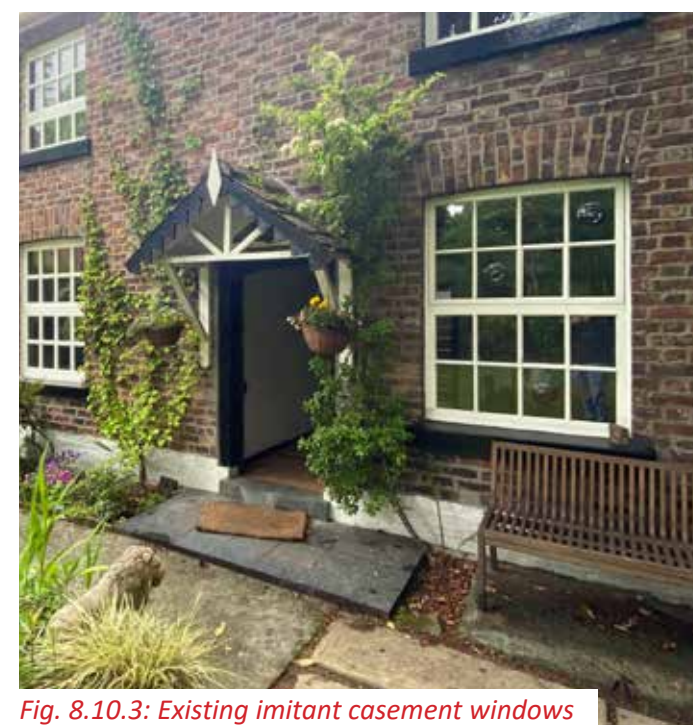
Fig. 8.10.3: Existing imitant casement windows

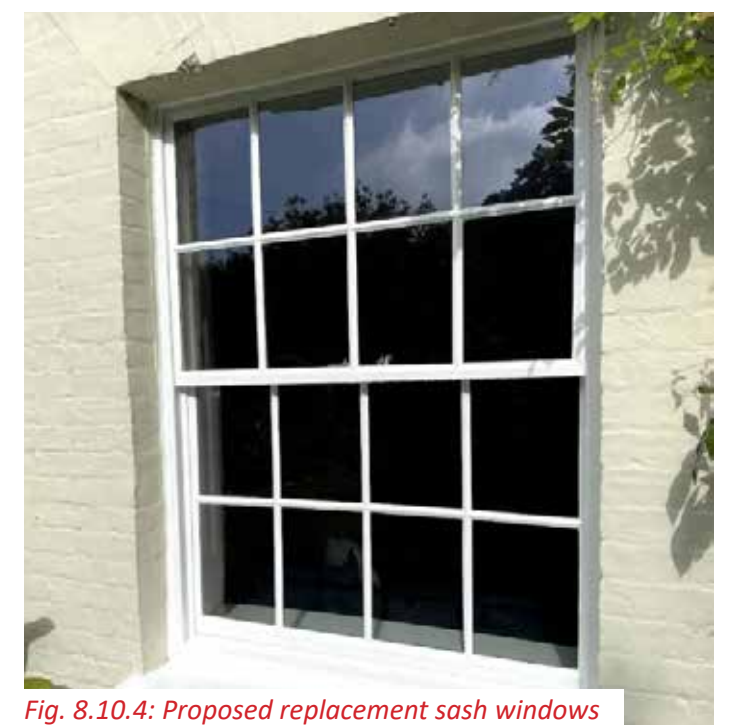
10. Replacing imitant casement windows with sashes, in keeping with the historic design

Fig. 8.10.4: Proposed replacement sash windows

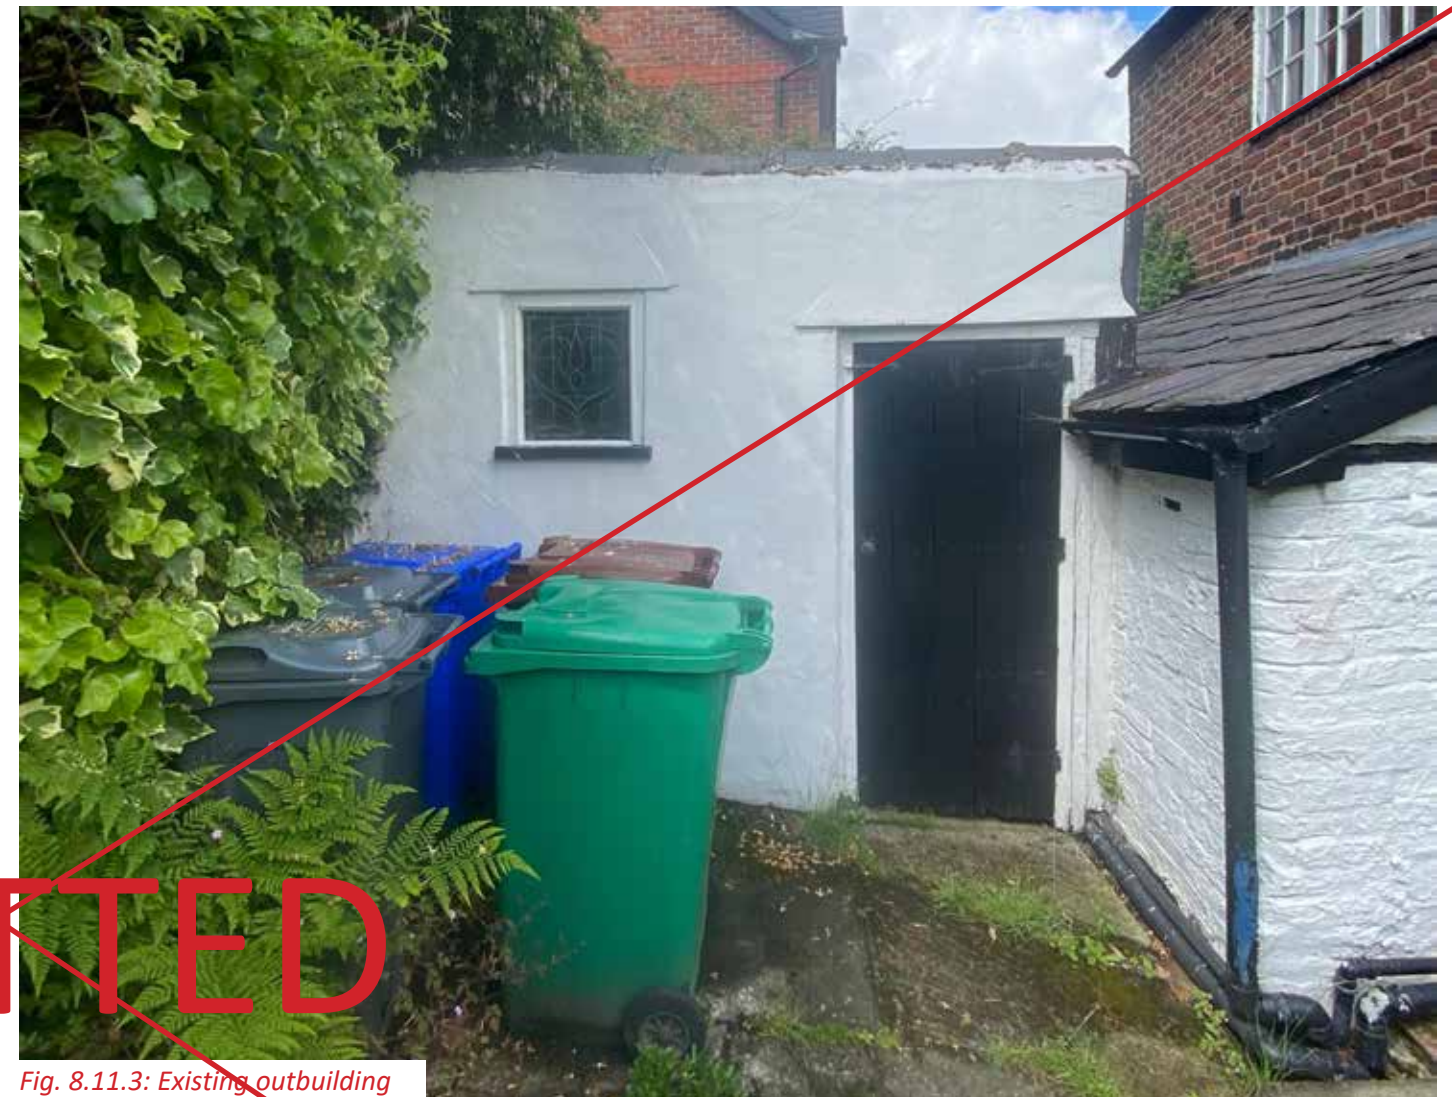
The existing outbuilding is in poor condition. Built in the 20th Century and containing little architectural interest, the components making up the facade are not original to the building. The head height internally within both spaces makes the space into an unuseable wasted space (just 1550mm along the western wall of the utility). Once insulation is included, this space becomes even more impractical. We proposed to bring the lost spaces back into use; removing the roof to the outbuilding and part of the utility, and building a flat roof limited to the height of the existing utility ridge. We also propose to work with the existing openings, with the existing door opening being retained, and the historic existing external door to the kitchen to be re-used within this existing opening. We also proposed to lower the sill of the small window, and insert a new conservation-style skylight to the new roof.

Fig. 8.11.3: Existing outbuilding

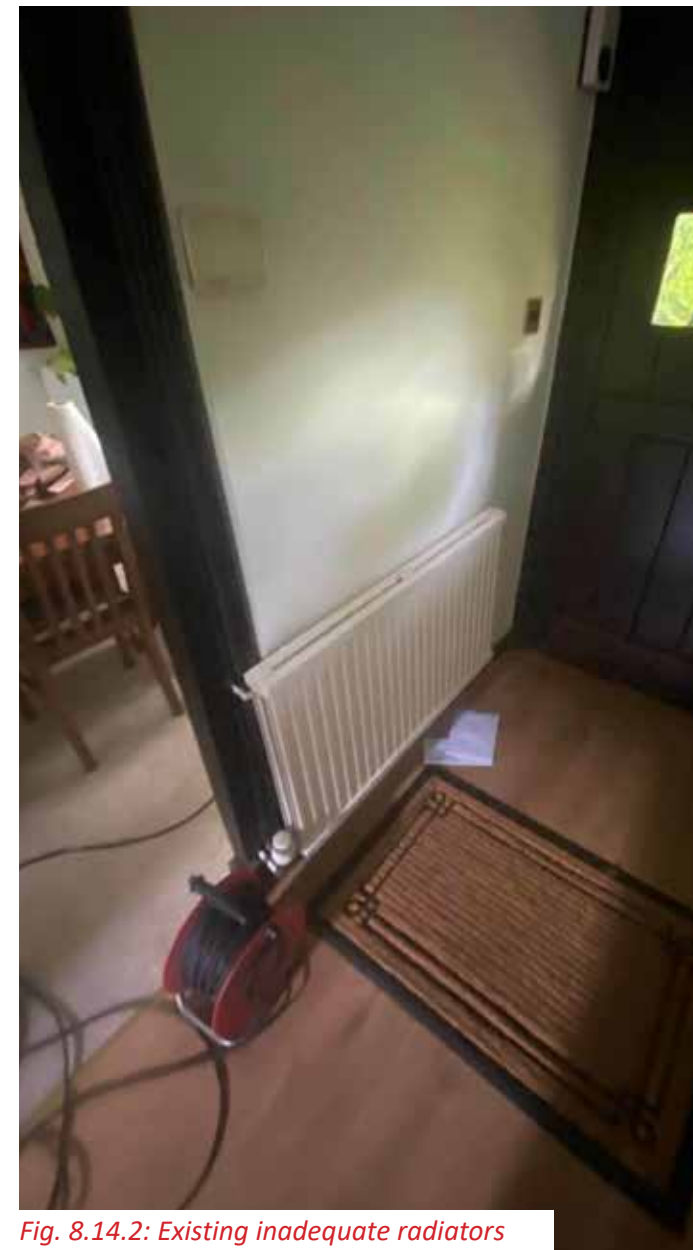
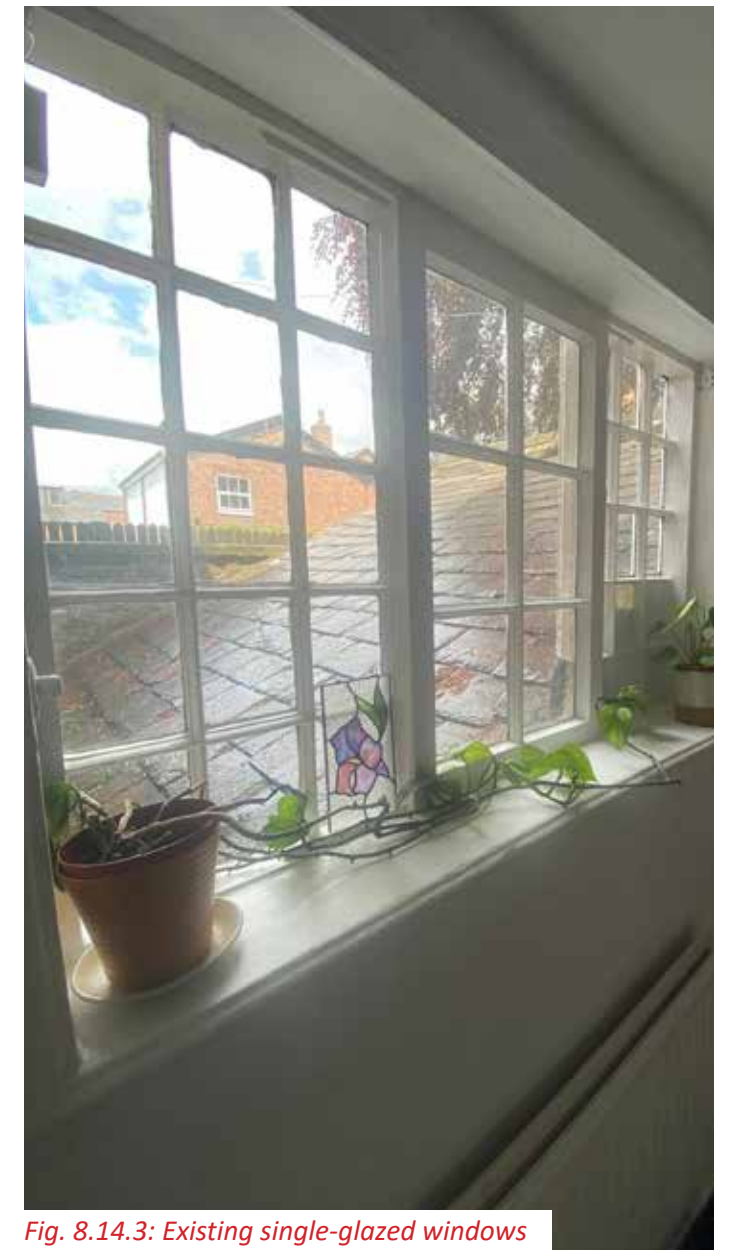
Fig. 8.14.1: Existing LO plan

The house is currently cold and inefficient. To bring the house into the 21st Century, and meet standards for thermal comfort and renewable energy, we are proposing to install an air source heat pump (ASHP) to heat the house.

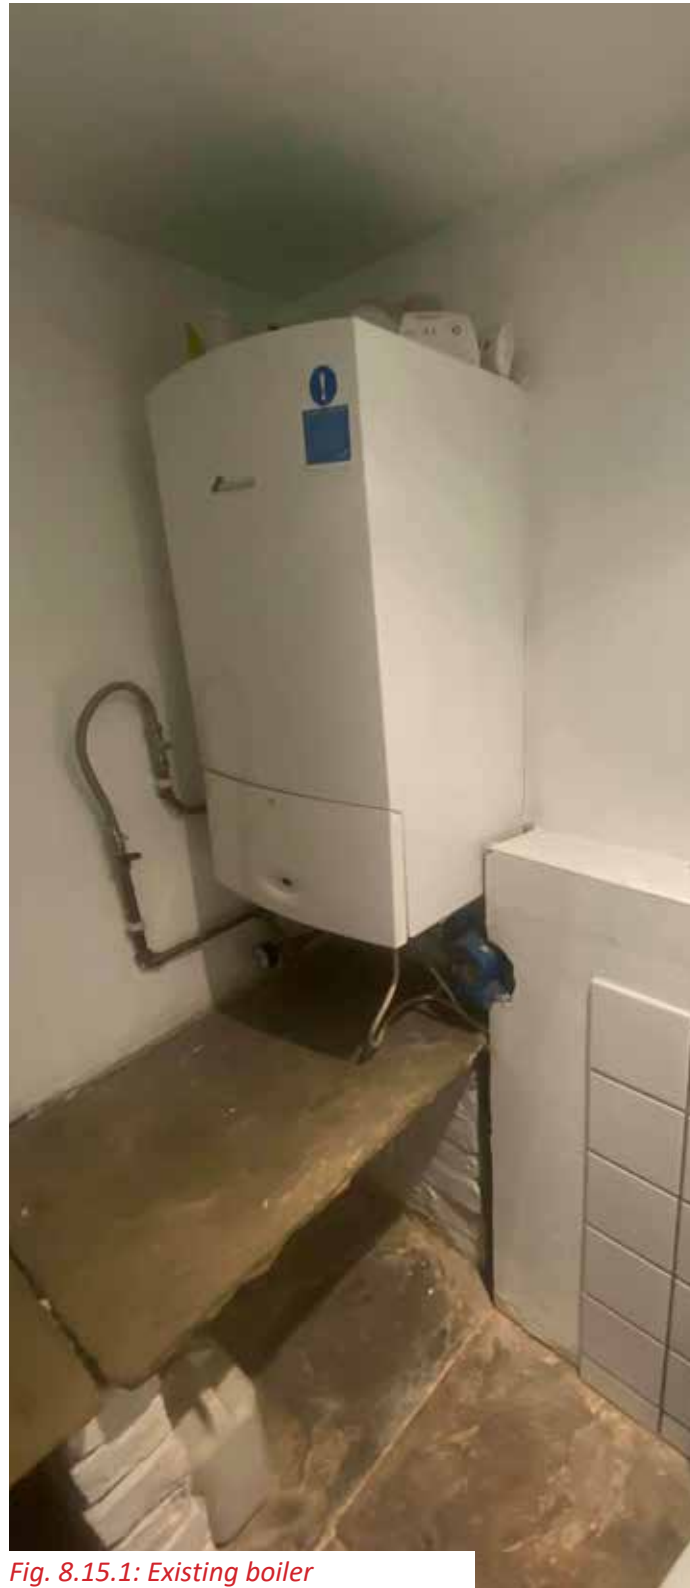
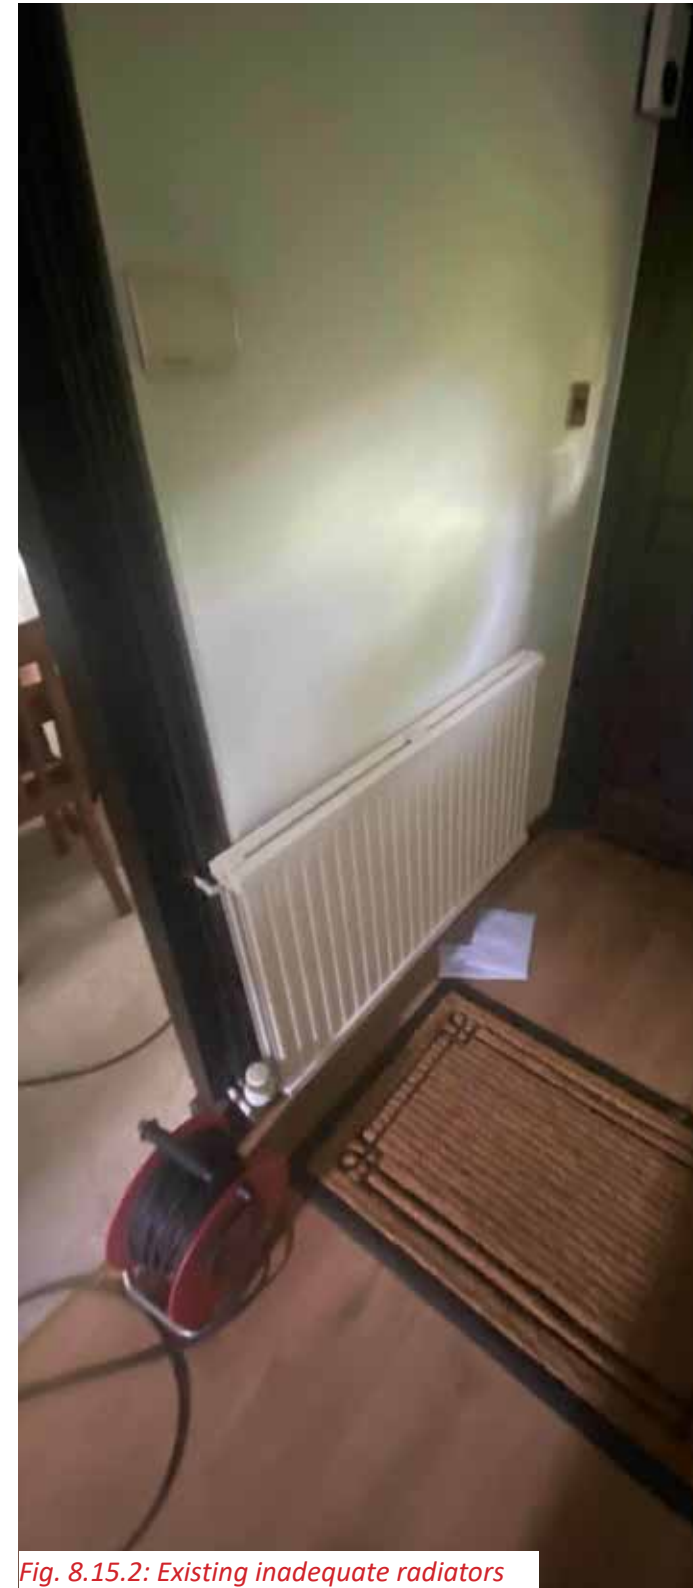
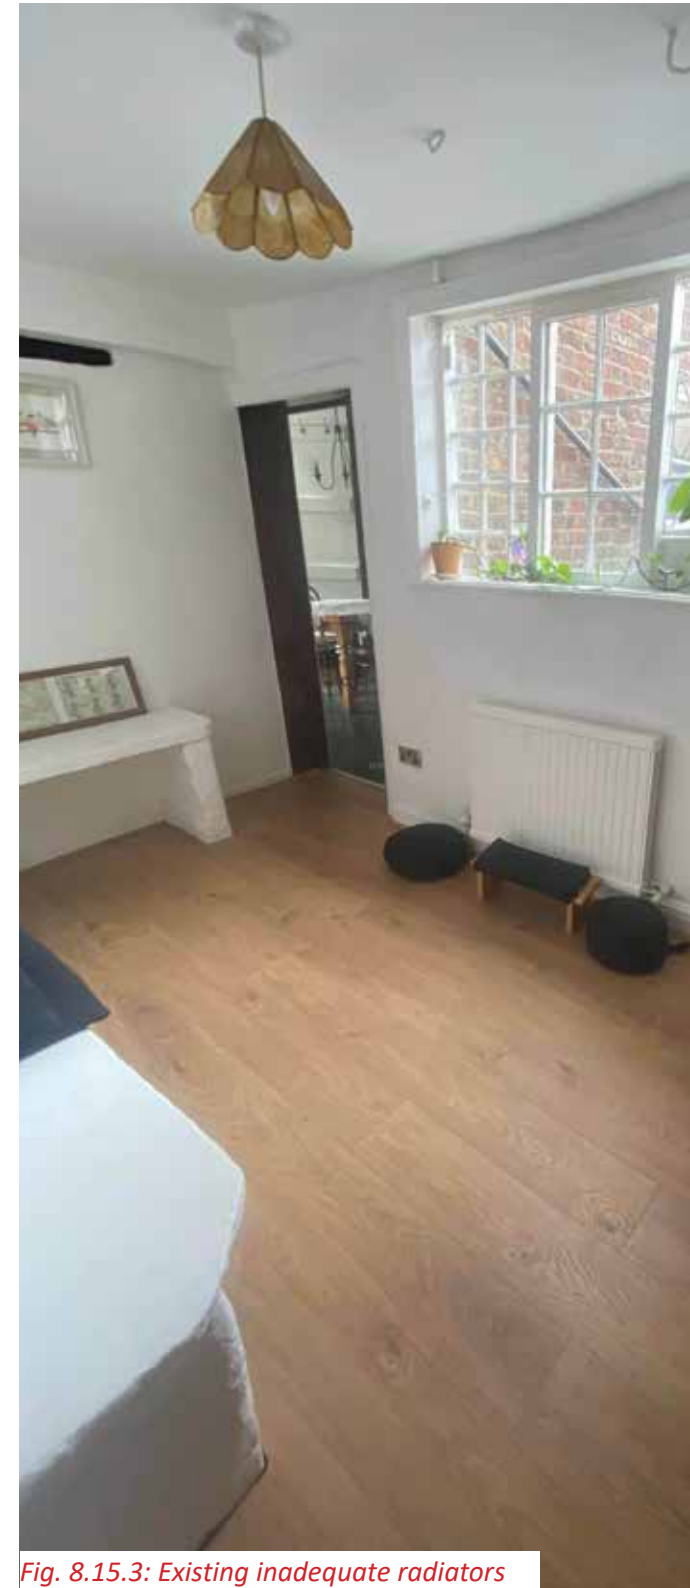
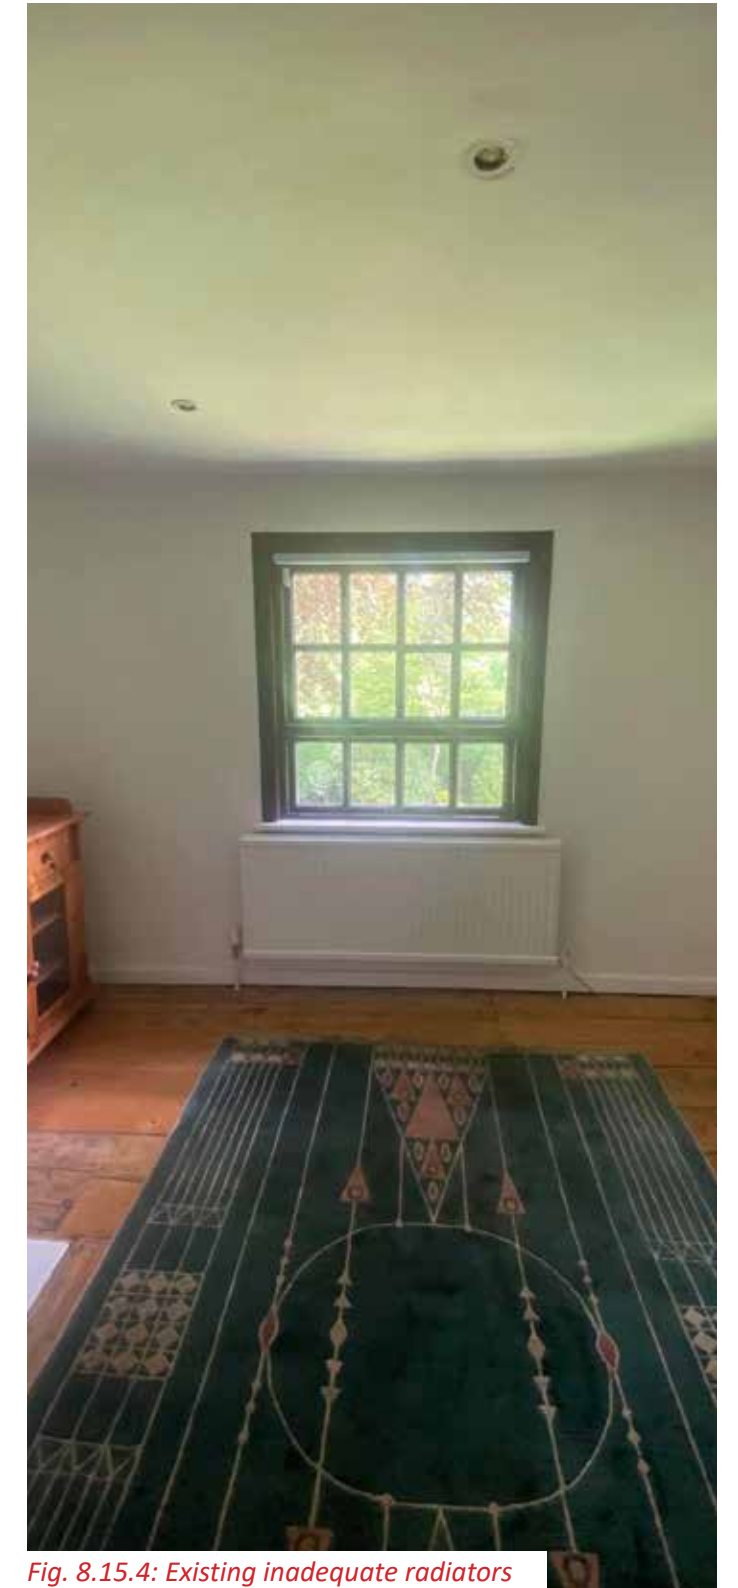
Fig. 8.15.1: Existing boiler

The radiators and boiler in the house are outdated and inefficient. We propose to replace all radiators and install a new, high-efficiency boiler to bring it up to modern-day standards.

| Ref. | Intervention | Description / Significance | Location | Benefit | Notes |
|---|---|---|---|---|---|
| 15 | Replace radiators and boiler throughout the house | Current boilers and radiators are not up to modern standards, house is cold and inefficient. Current radiator styling is unsympathetic and poorly considered. | | Public | Less energy consumption. Future-proofing building. |

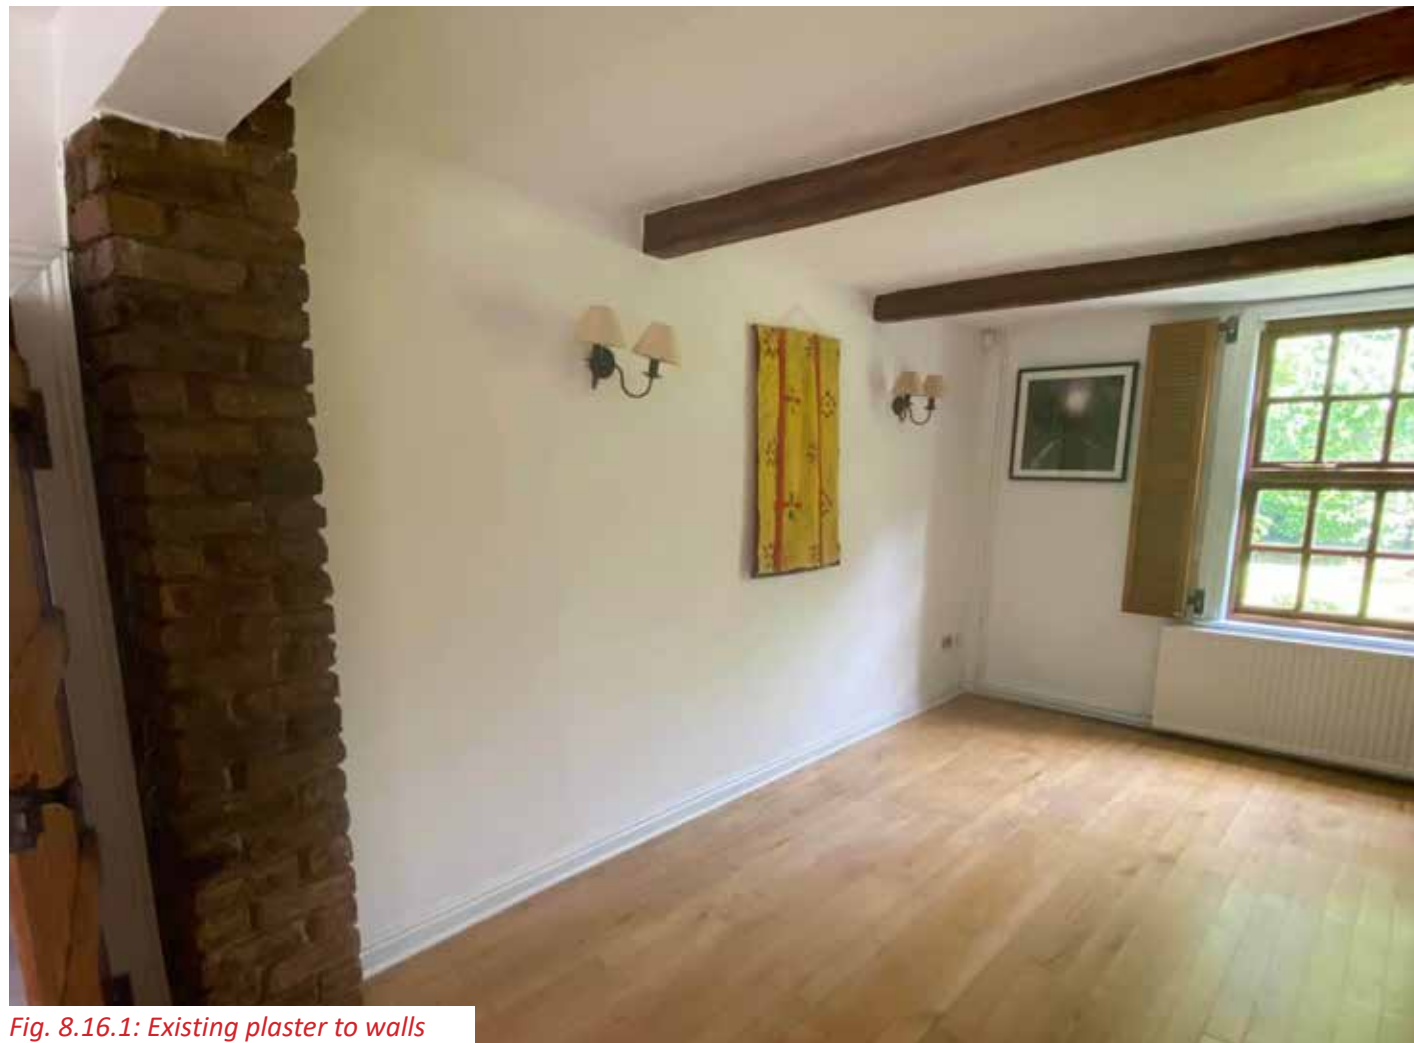
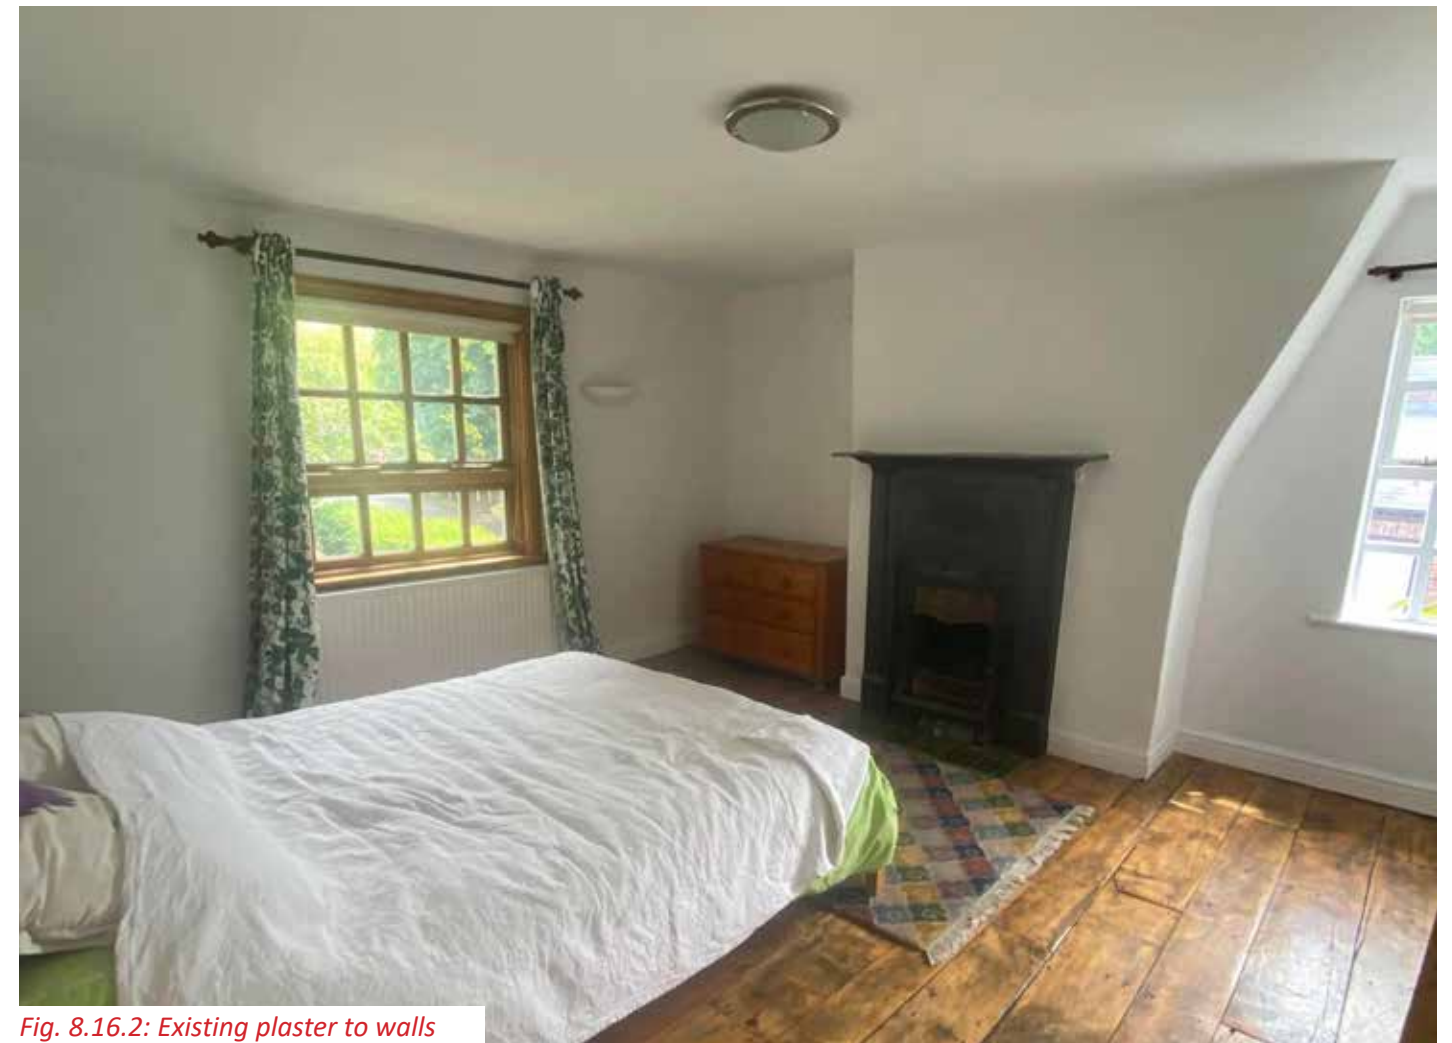
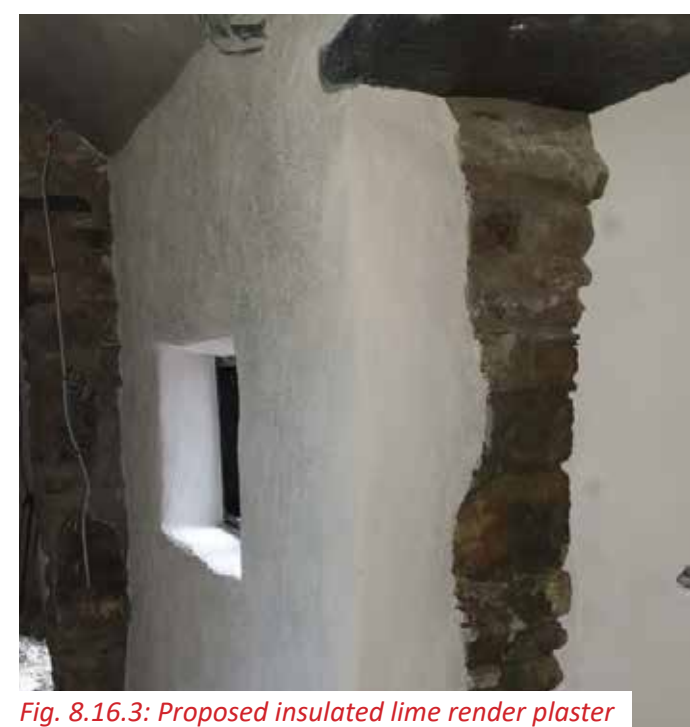
Fig. 8.16.1: Existing plaster to walls

The exterior walls of the property are made up of solid masonry. In order to keep the building breathable and provide adequate ventilation while upgrading thermal performance, we are proposing to internally line all walls with insulated lime render plaster. Visually, this will match the existing plaster to the interiors, while allowing for more breathability and reducing heat loss.
