# 10 Chorlton Green\_ Grade II Listed, Formerly Higginbottom Farmhouse

SEPTEMBER 2022

# Executive Summary

The purpose of this document is to demonstrate how our proposals to modify this Grade II listed farmhouse to a usable, comfortable family dwelling, whilst preserving and enhancing character of existing building. Our proposals include connecting the ground floor living accommodation by inserting a lightweight glazed extension, omitting a second staircase from the kitchen, and adding a second bathroom to serve the five existing bedrooms. We have developed our proposals in consultation with Dave Morris, formerly of the local planning authority, and Jenny Wetton, of JW Conservation.

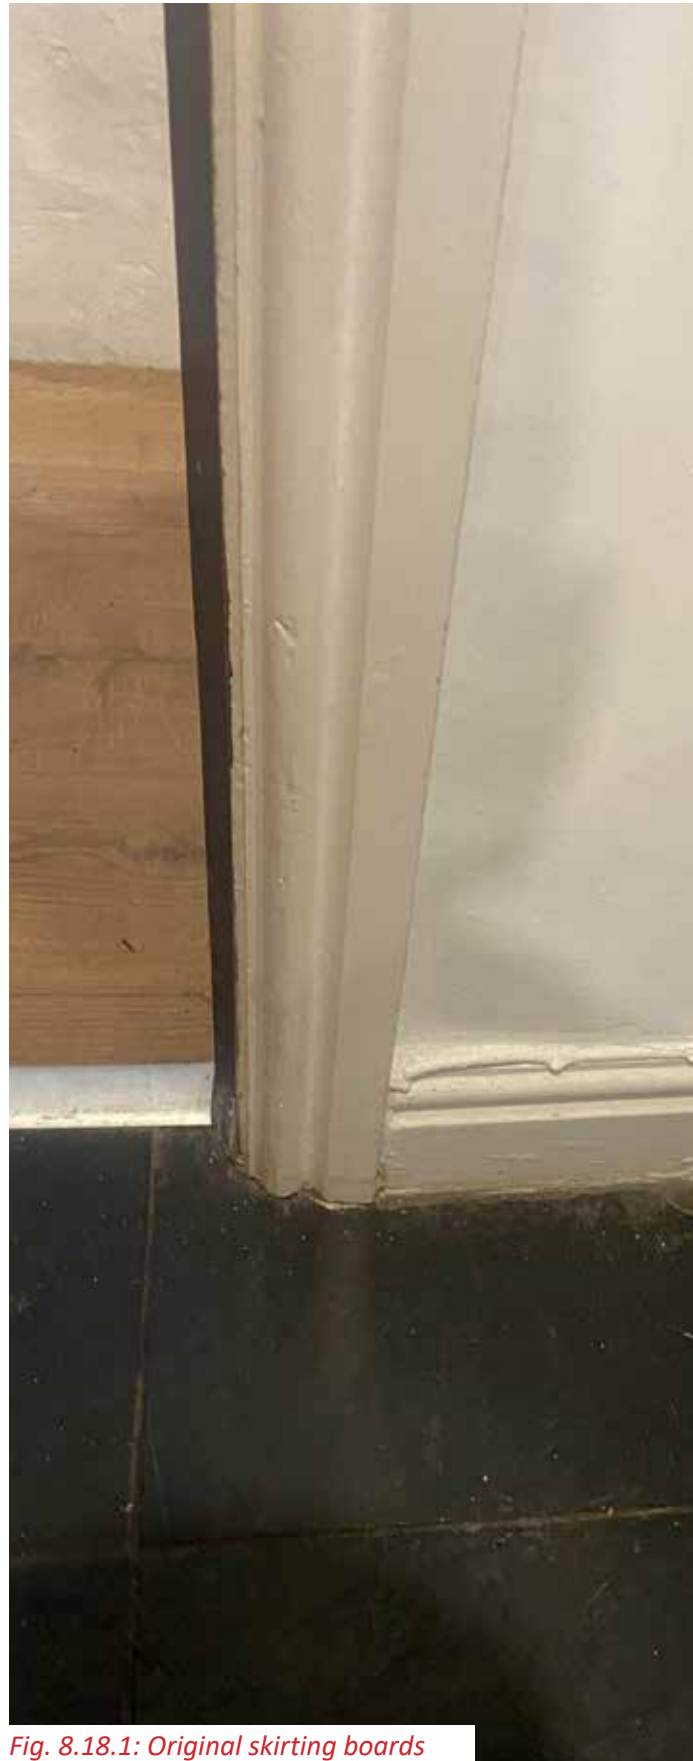
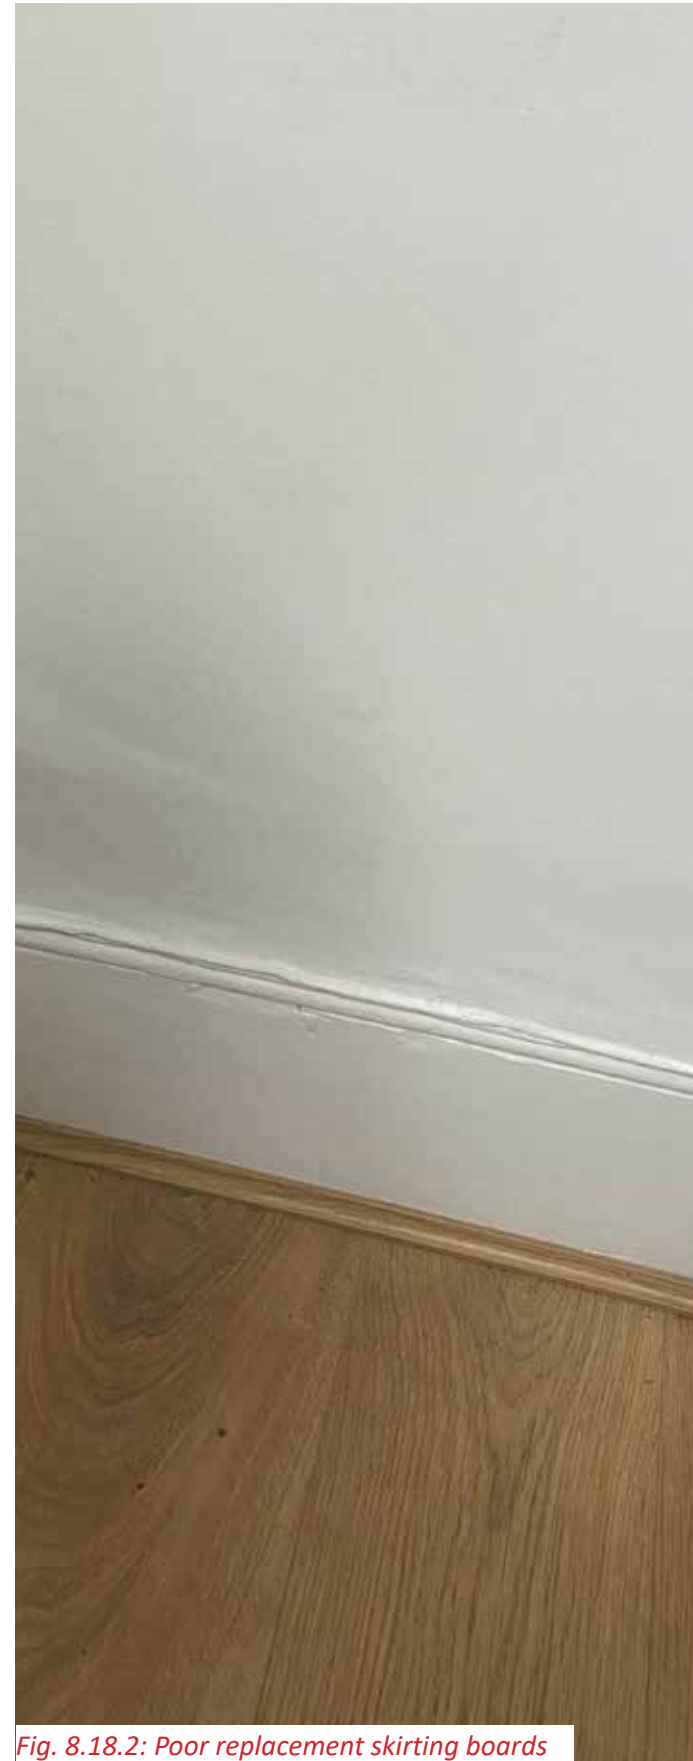
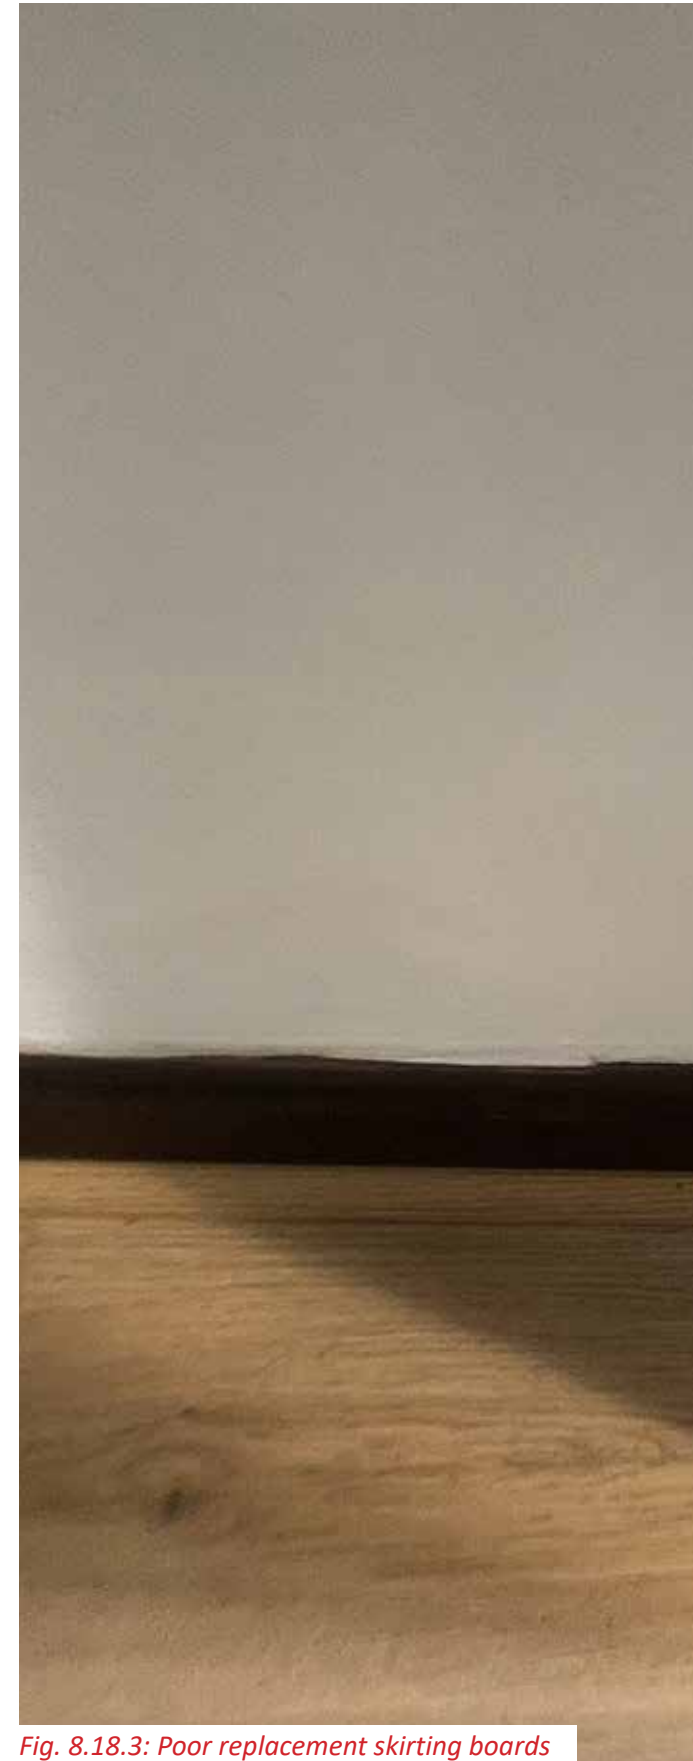
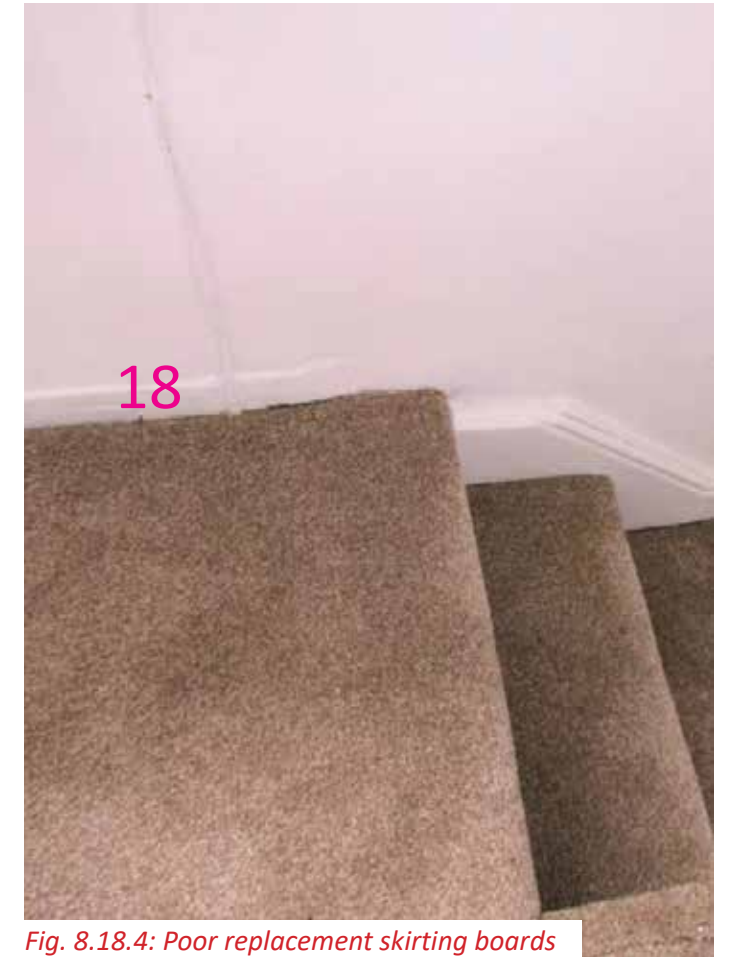
Fig. 8.18.1: Original skirting boards

Throughout the house, there is a mix of historic, original skirting and modern, poorly fitted alternatives. We propose to strip all the modern replacement joinery and skirting, replacing them with alternatives in the style of the original building.

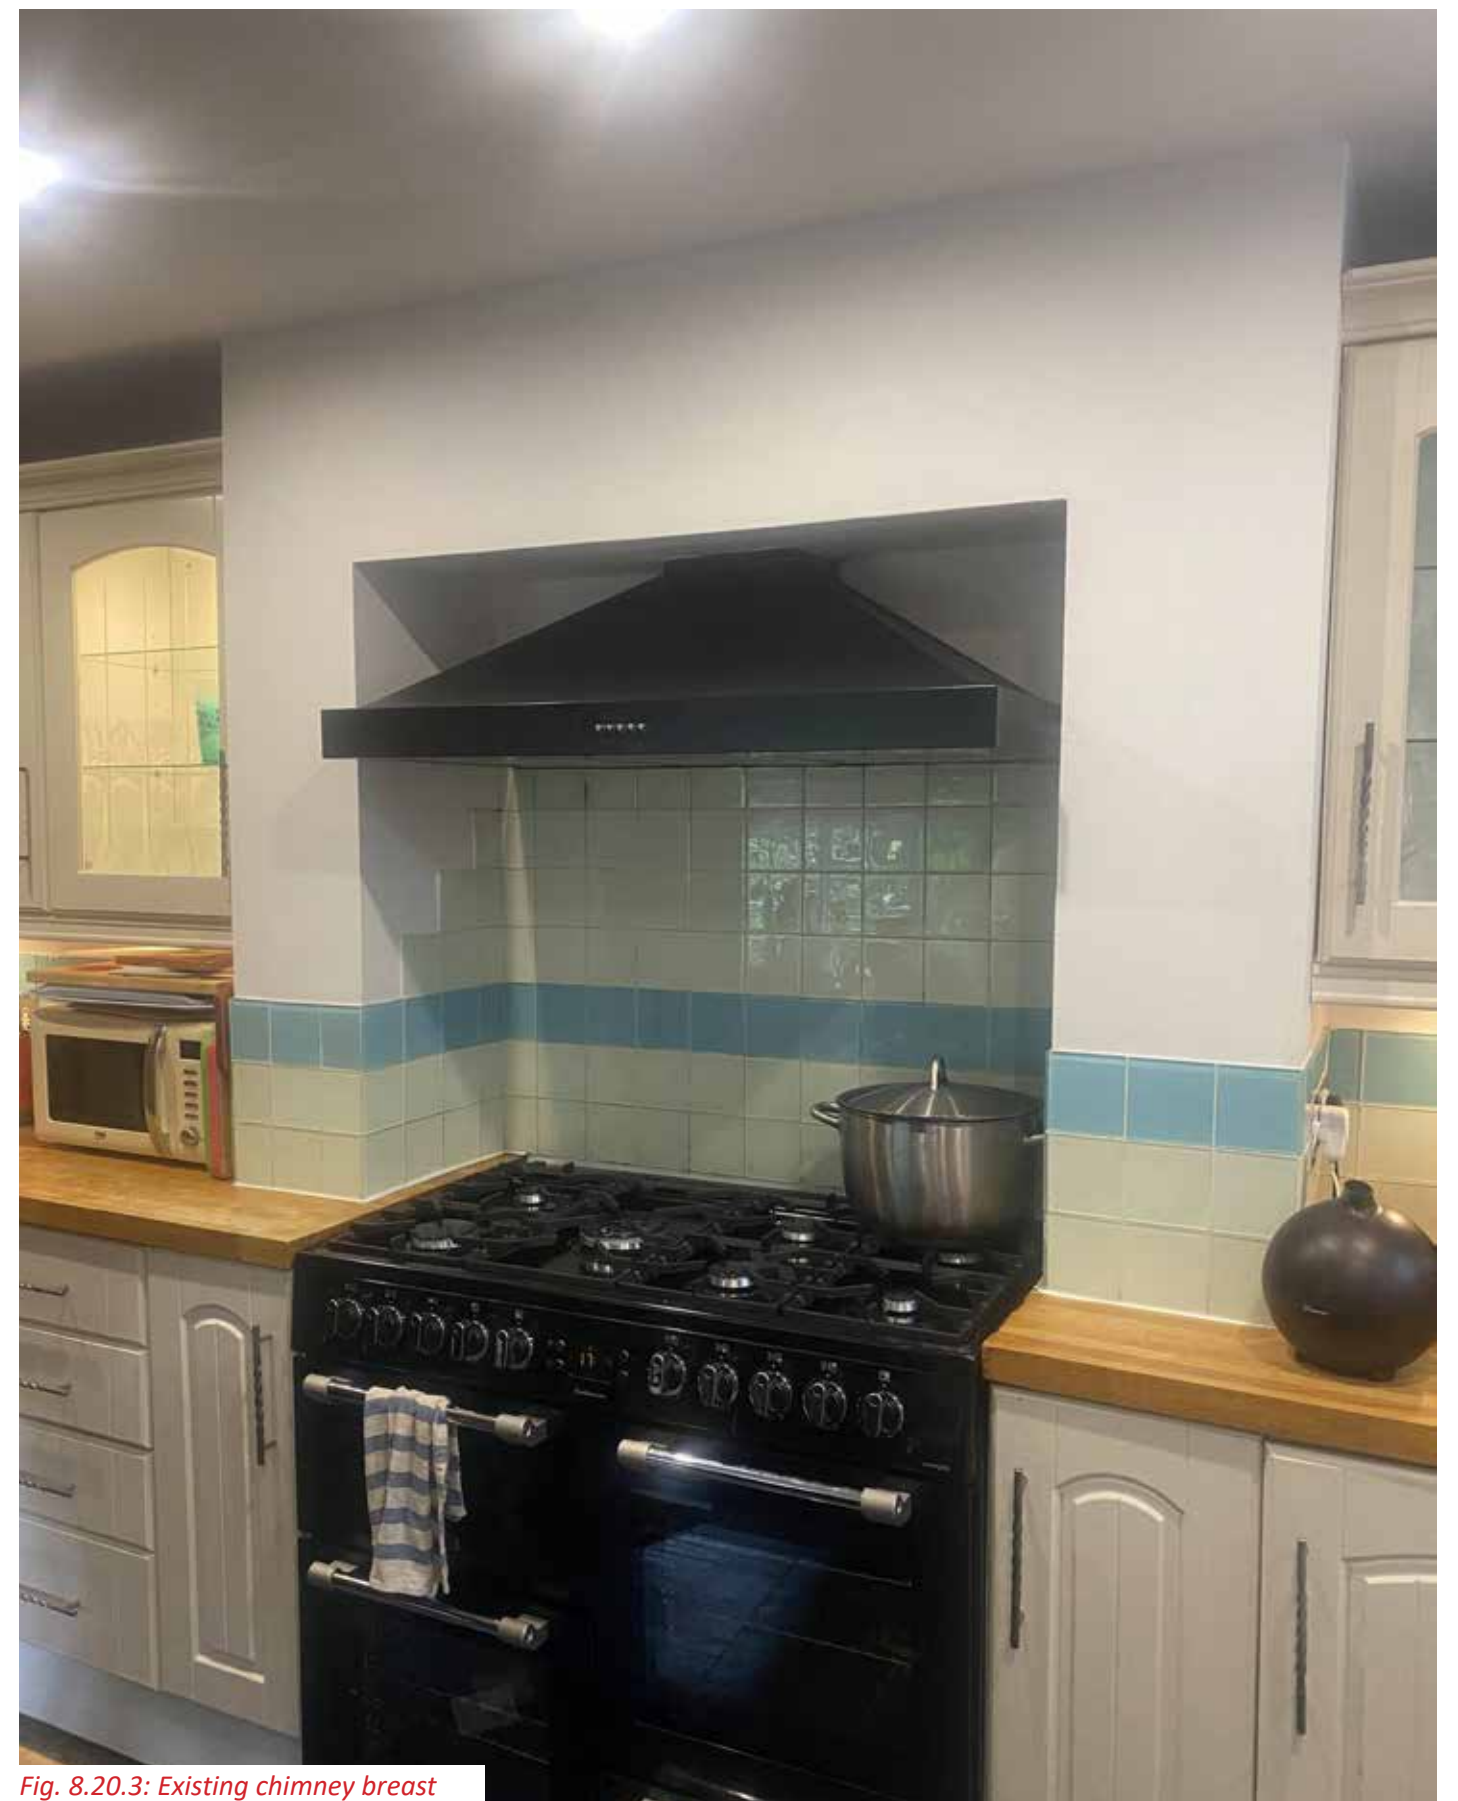
Fig. 8.20.1: Existing L0 plan

An existing chimney breast located in the kitchen appears to have been opened up, with just the surround retained, which now houses a range cooker. It has however been tiled over, and lost its character as a result. We propose to keep the fireplace with kitchen units built around it. We plan to strip the current tiles and plaster, either exposing the original brick or plastering over it using insulated lime render plaster.

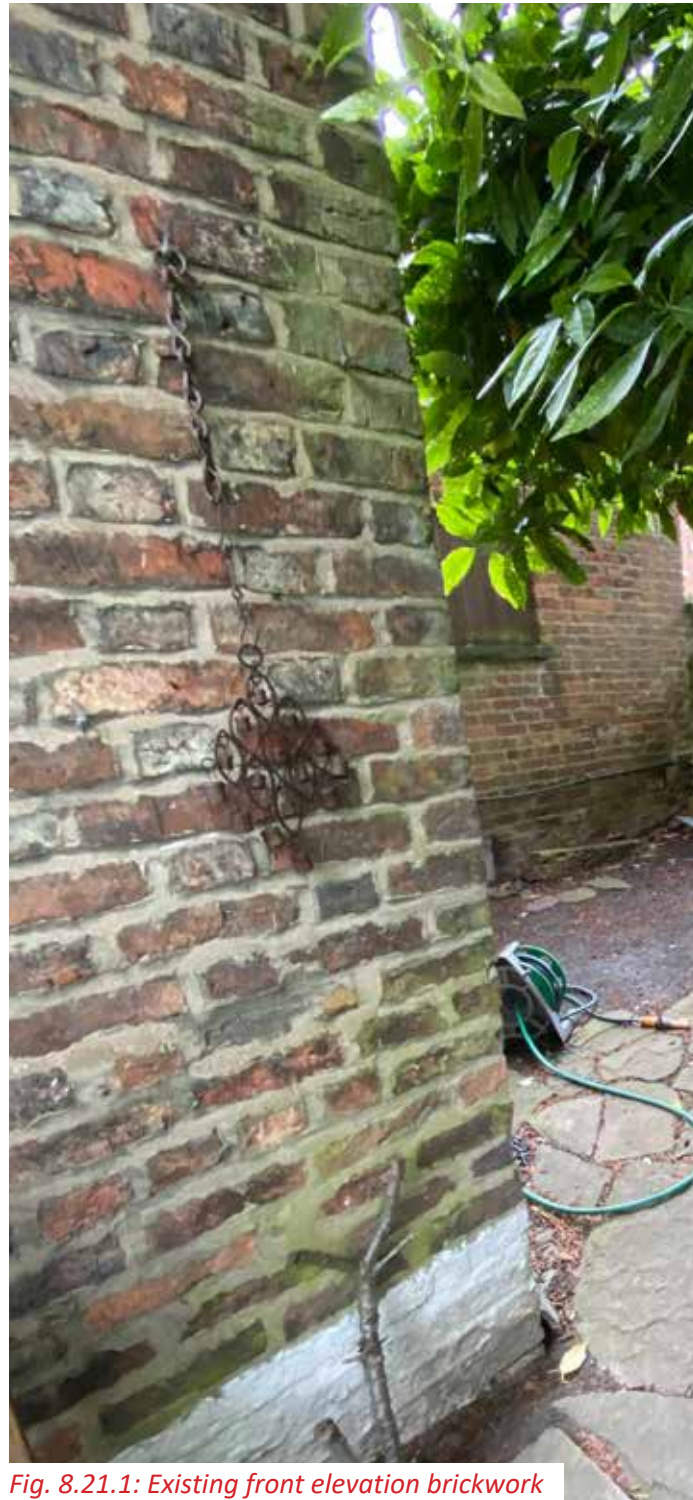
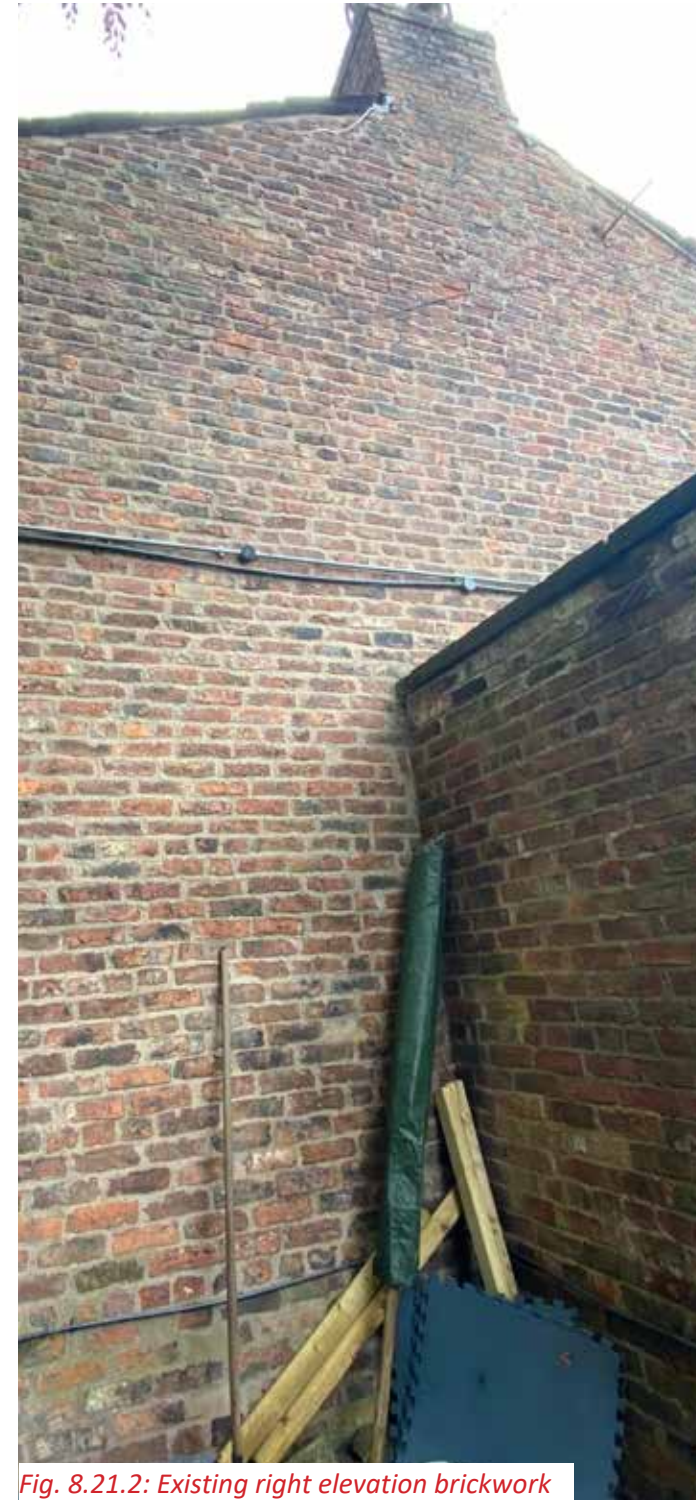
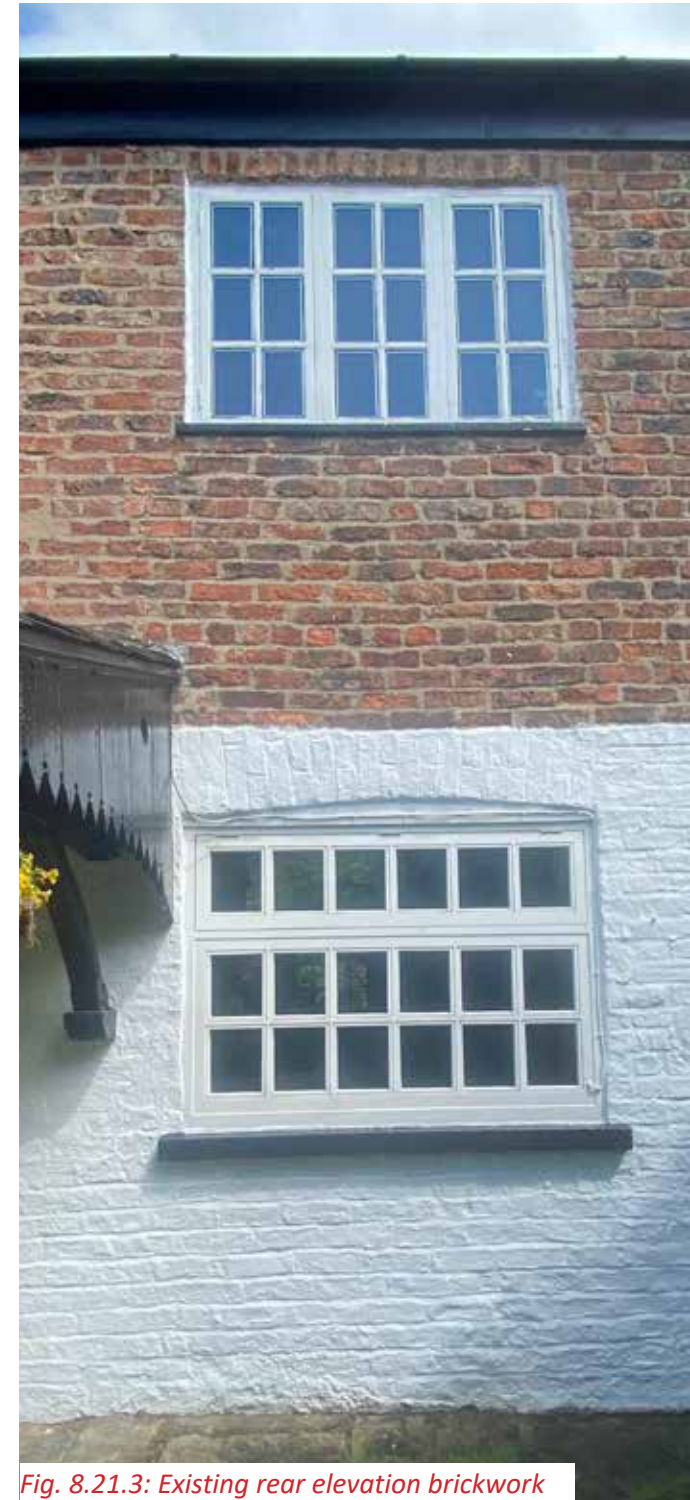
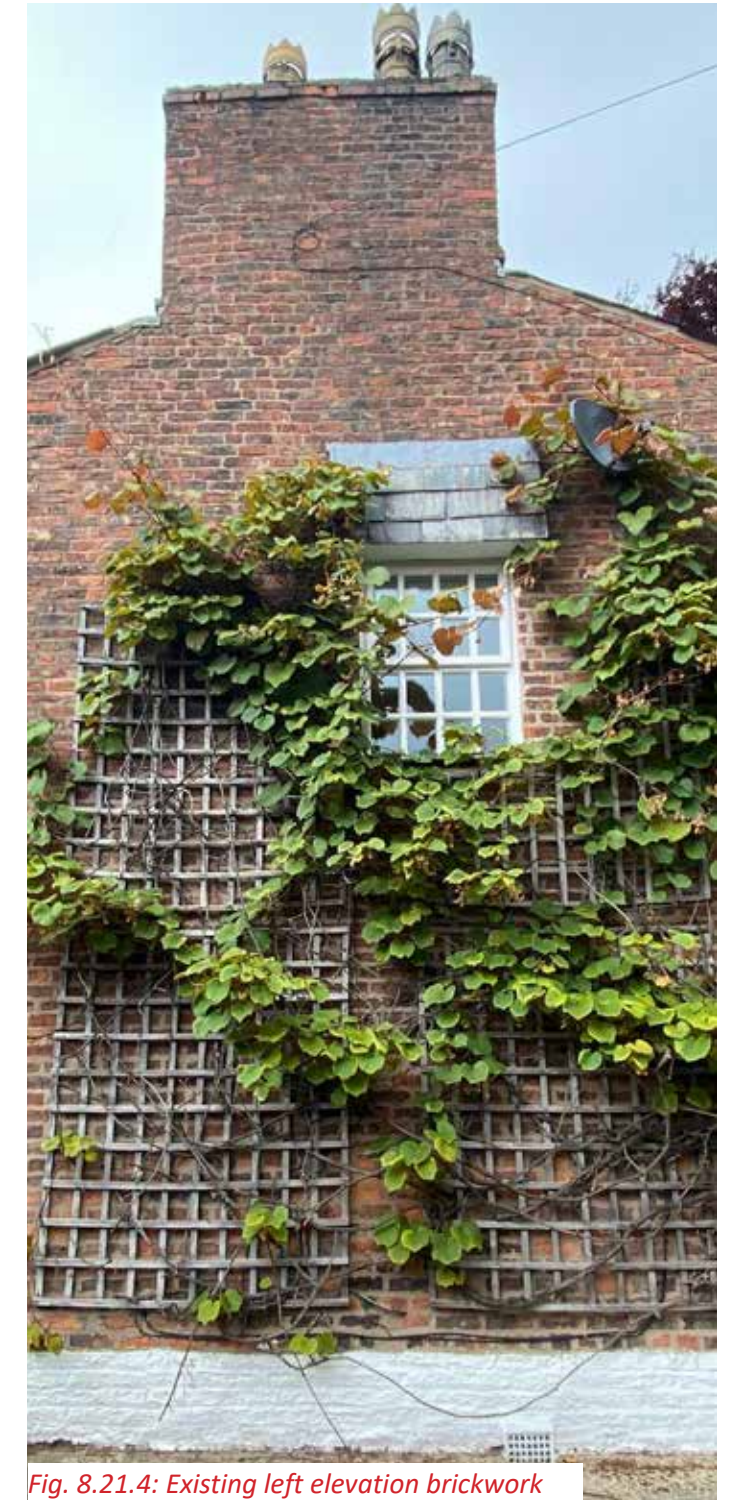
Fig. 8.21.1: Existing front elevation brickwork

Most of the brickwork is in a poor condition, which is detrimental to the character of the building. We propose the re-pointing of all brickwork in poor condition with lime mortar to improve the aesthetic of the exterior. We also propose to carefully remove the paintwork from the exterior of the building, allowing the brick to breathe.

| Ref. | Intervention | Description / Significance | Location | Benefit | Notes |
|---|---|---|---|---|---|
| 21 | Repoint all brickwork in poor condition using lime mortar | | All external walls | Public | More attractive exterior. Future-proofing building. |
