## Roof Structure Indicating Access Platform

| Project: | Fraser House | Eng: | MWS |
| Title: | Fourth floor structure | Date: | May'23 |
| No: | LM21346-DYSE-XX-ZZ-SK-S-0027 | Rev: | P01 |

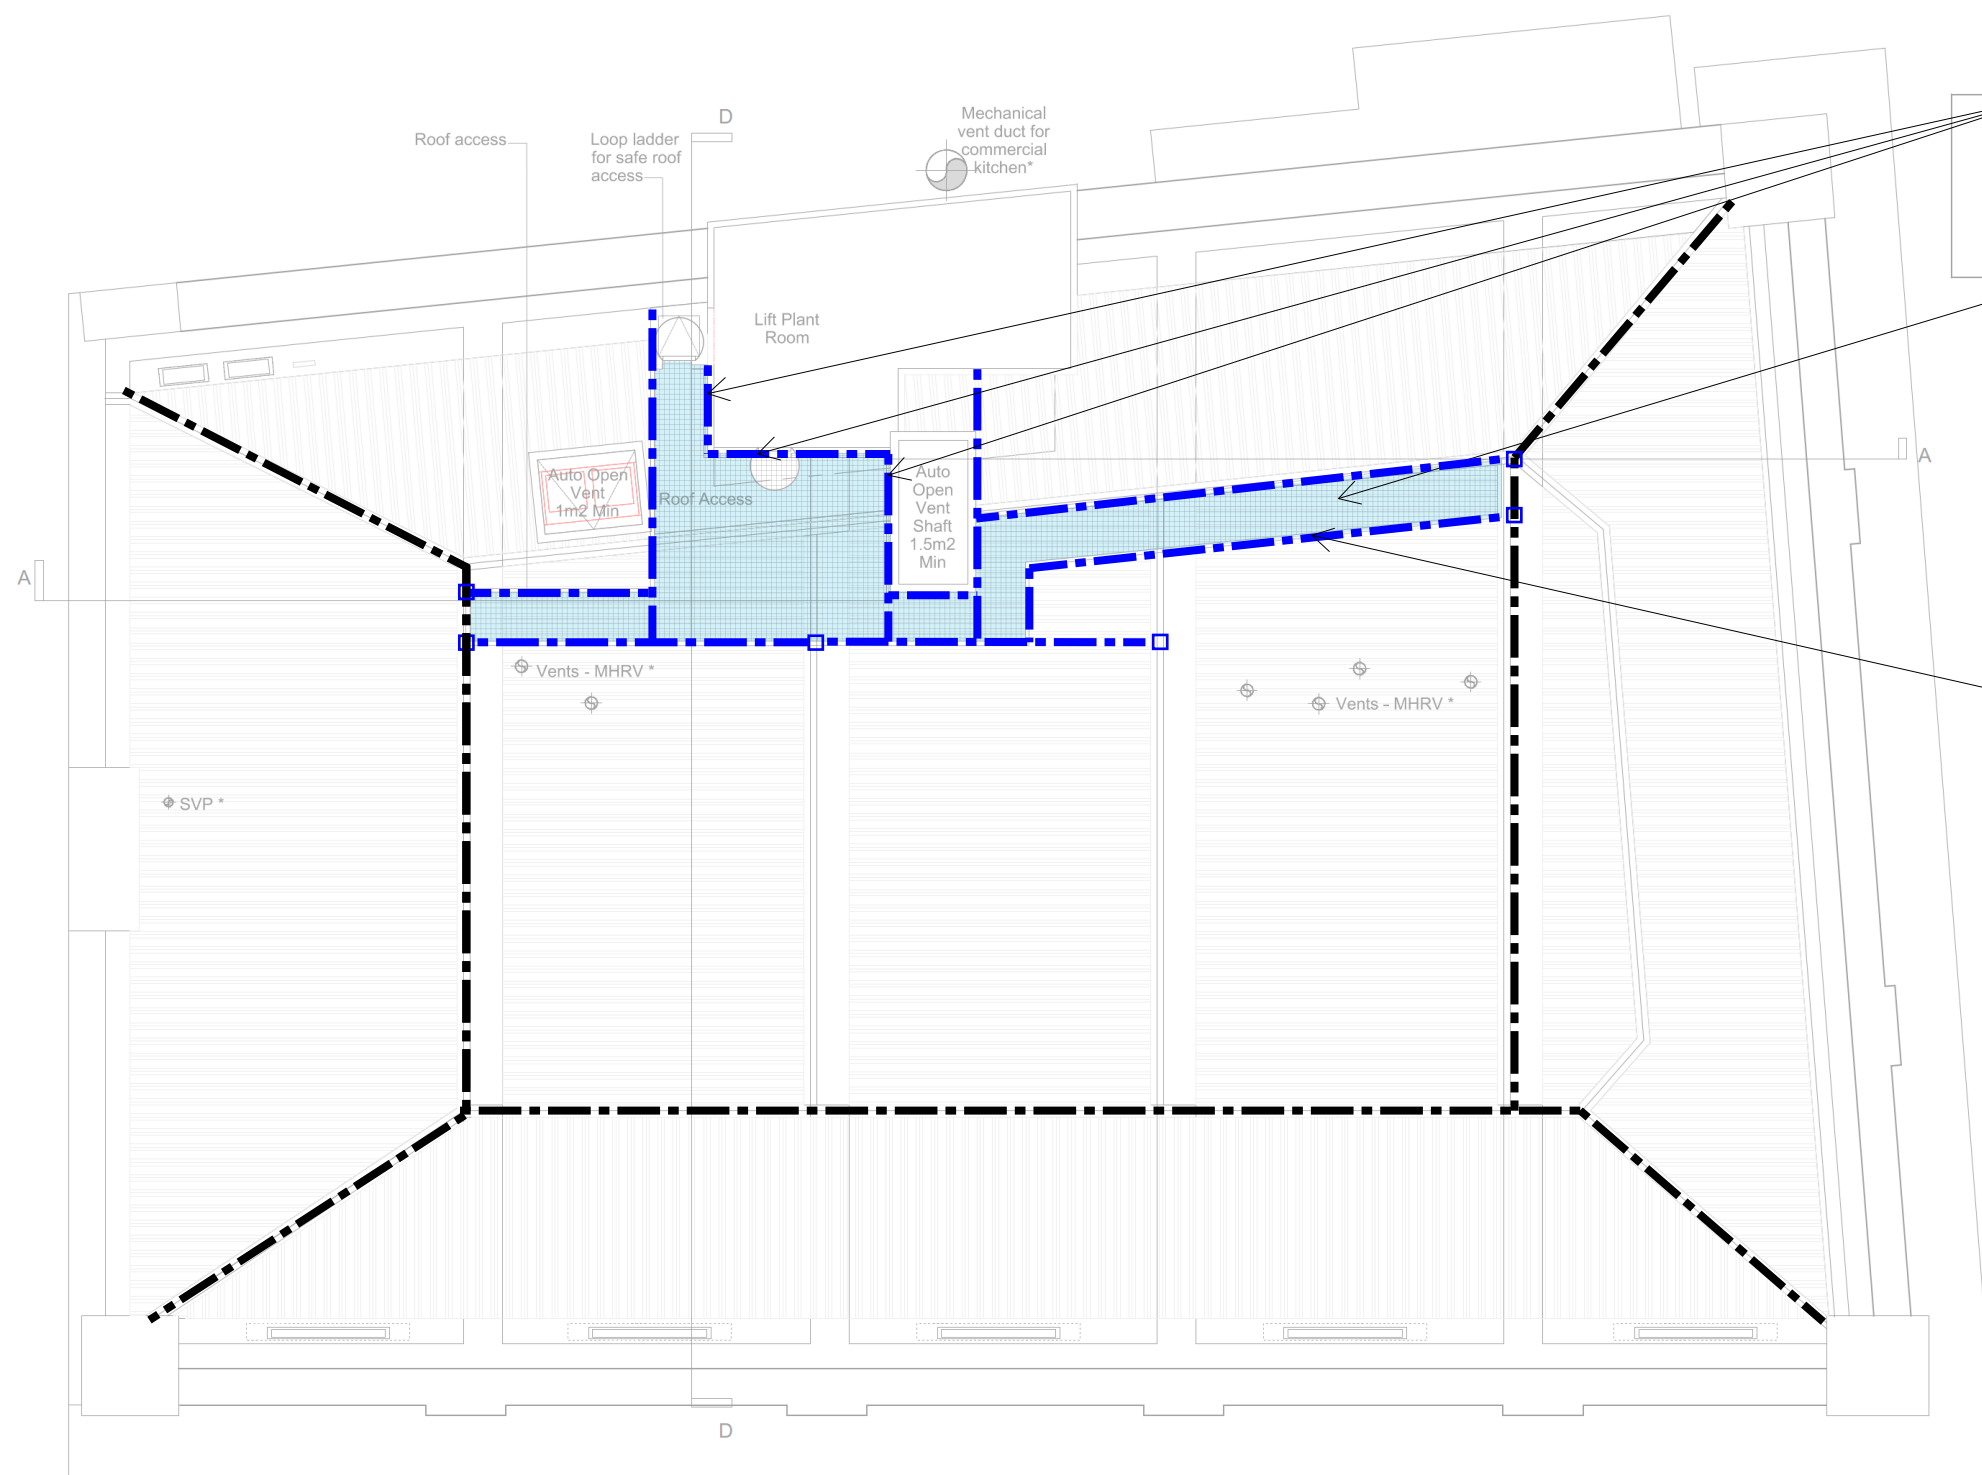
PFC steels to be face fixed to existing masonry wall.

Hatched area denotes galvanised durbar steel floor plate for platform.

Galvanised steel grillage to support access walkway fixed down to existing north light ridges, supported on stub column sections. Exact arrangement of platform fixings to be determined during detailed design.
