## First Floor Structure Indicating Second Floor Structure Over

| Project: | Fraser House | Eng: | MWS |
| Title: | First floor structure | Date: | May'23 |
| No: | LM21346-DYSE-XX-ZZ-SK-S-0023 | Rev: | P03 |

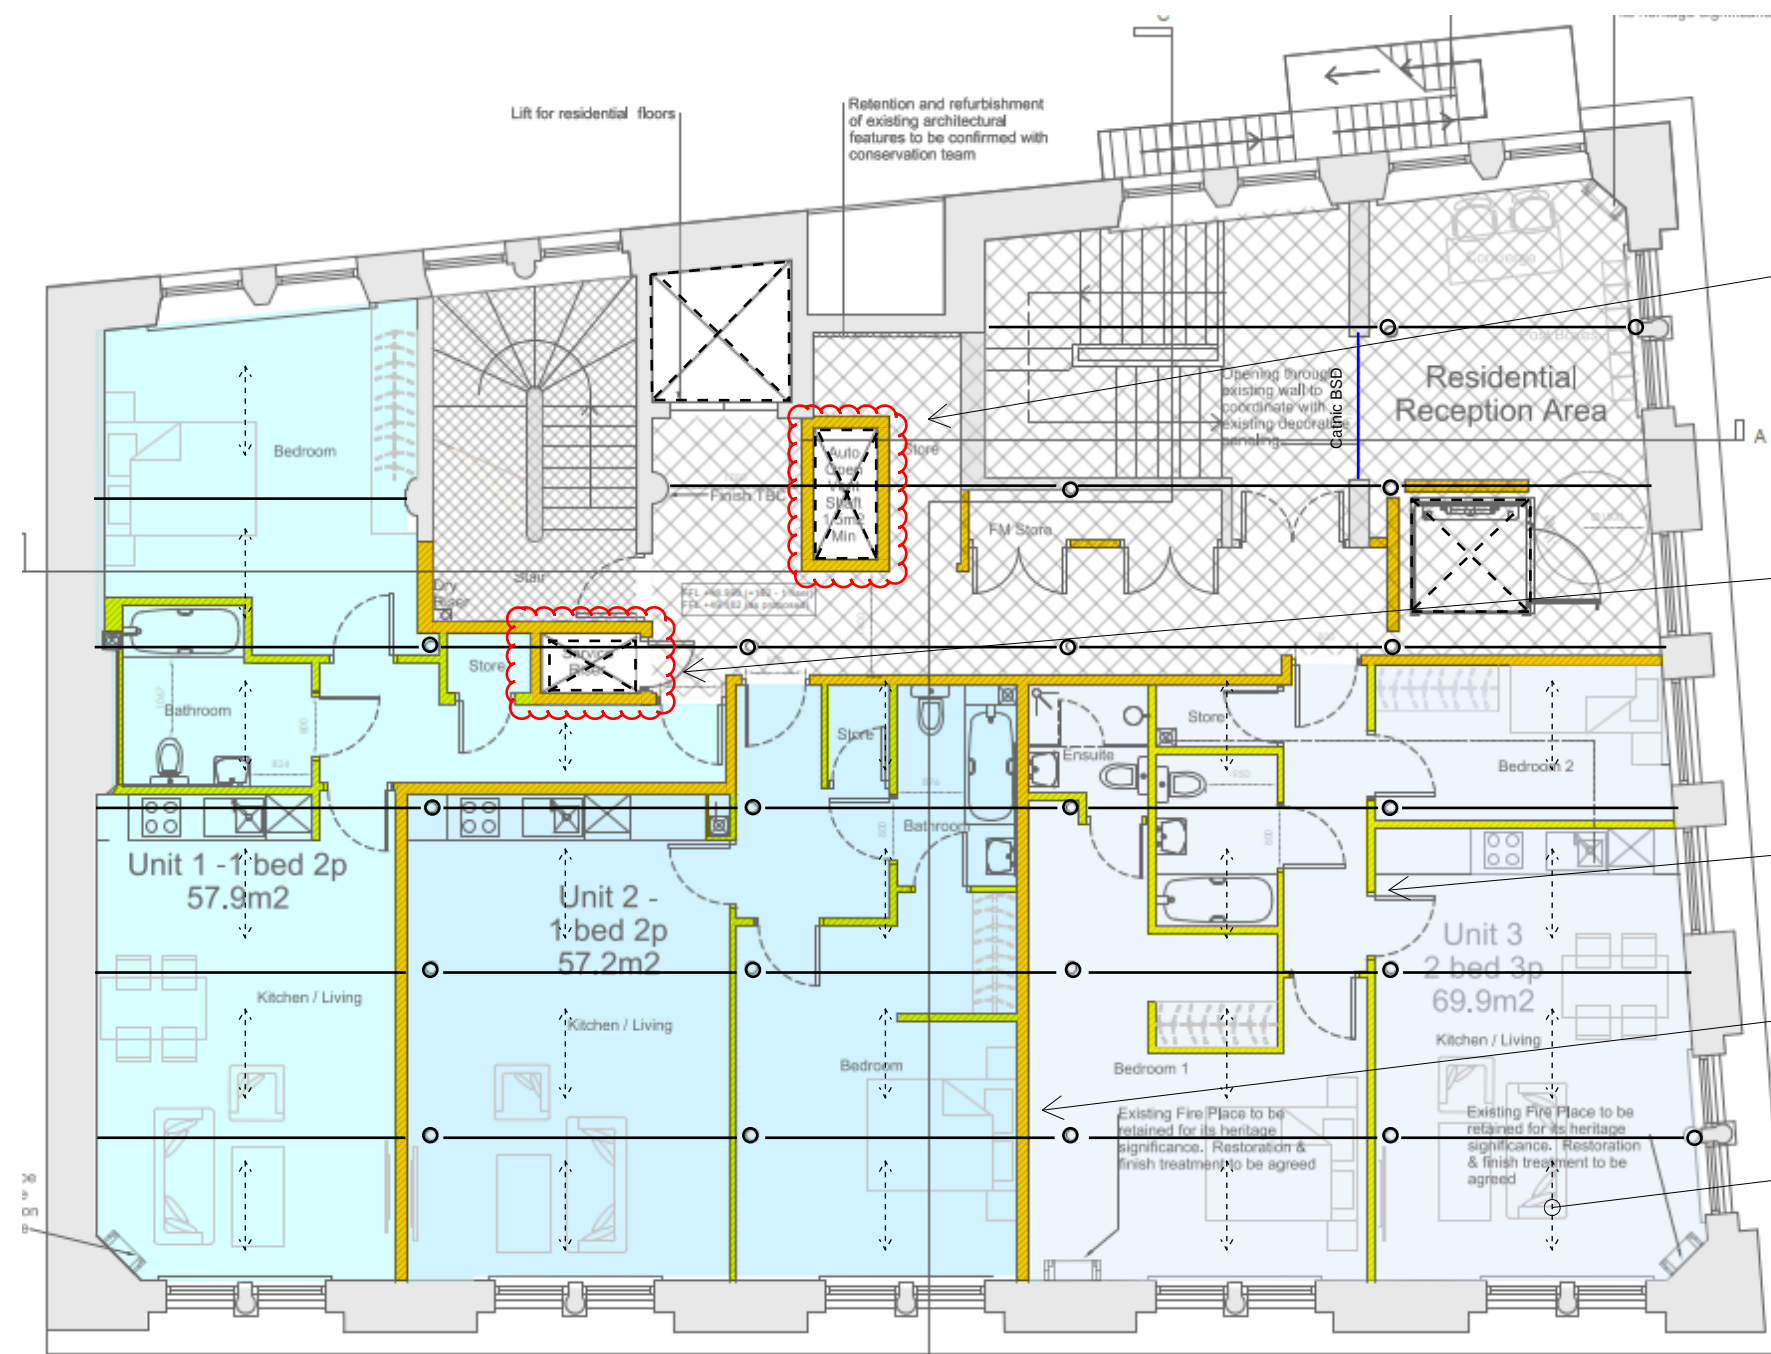
Location of smoke vent cuts through existing primary timber floor beam. Can smoke vent be moved to avoid additional significant structural framing to trim out void for smoke vent. Architects to confirm acceptance.

Location of service riser cuts through existing primary timber floor beam. Can beam continue to pass through service riser to avoid additional significant structural framing to trim out void for smoke vent. Architects & M&E consultants to confirm acceptance.

Non-structural studwork partitions to be built up off the existing timber floor structure.

Structural studwork walls to be built up off the existing timber floor structure.

New raised floor build up to architects design and details.
