**PROPOSED LATH AND PLASTER REPAIR DETAIL 1:2**

**PLASTER CEILING REPAIR METHODOLOGY**

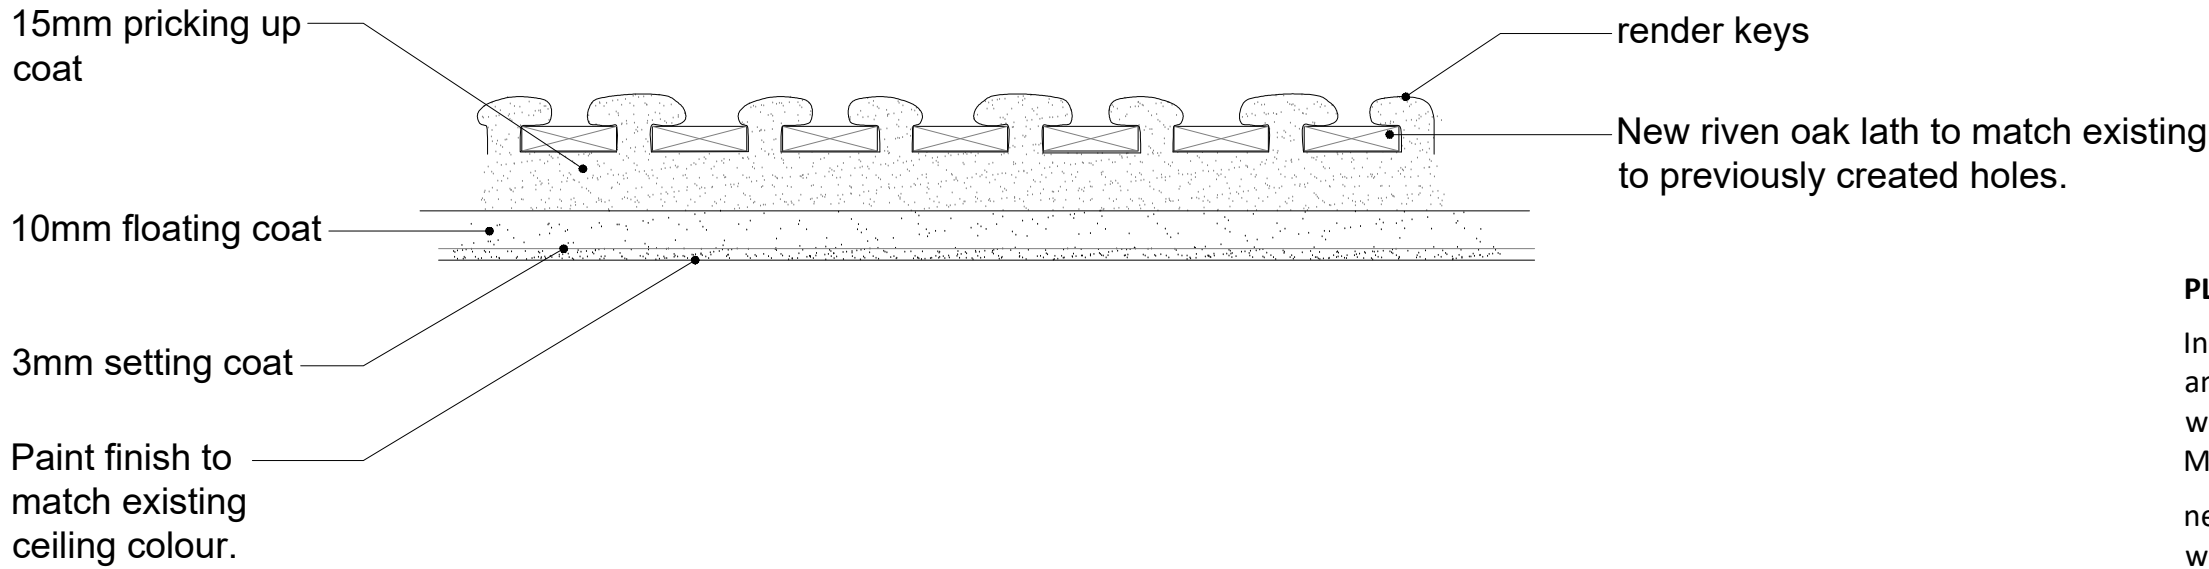
In areas where existing vents are to be removed in lath and plaster ceiling and these are to be patched, this will be repaired with replacement lath and the use of Mike Wye Lime Mortar.

new riven oak lath to match the existing are to be fixed where holes are to be infilled. The areas of ceiling will then be replastered with 15mm Mike Wye Haired Lime Mortar. This is to be push through the lath to form keys and to provide the initial Pricking up coat. This will then receive a floating coat of 10mm Unhaired Lime Mortar. The area will then receive a 3mm skim coat of Mike Wye Heritage Lime Plaster.

Repaired areas will receive new paint finishes to match the existing surrounding areas.
