## Bowlers Yard, Pollard Street, Ancoats Archaeological Evaluation

PLANNING REF. 126261/FO/2020

PROJECT INFORMATION:

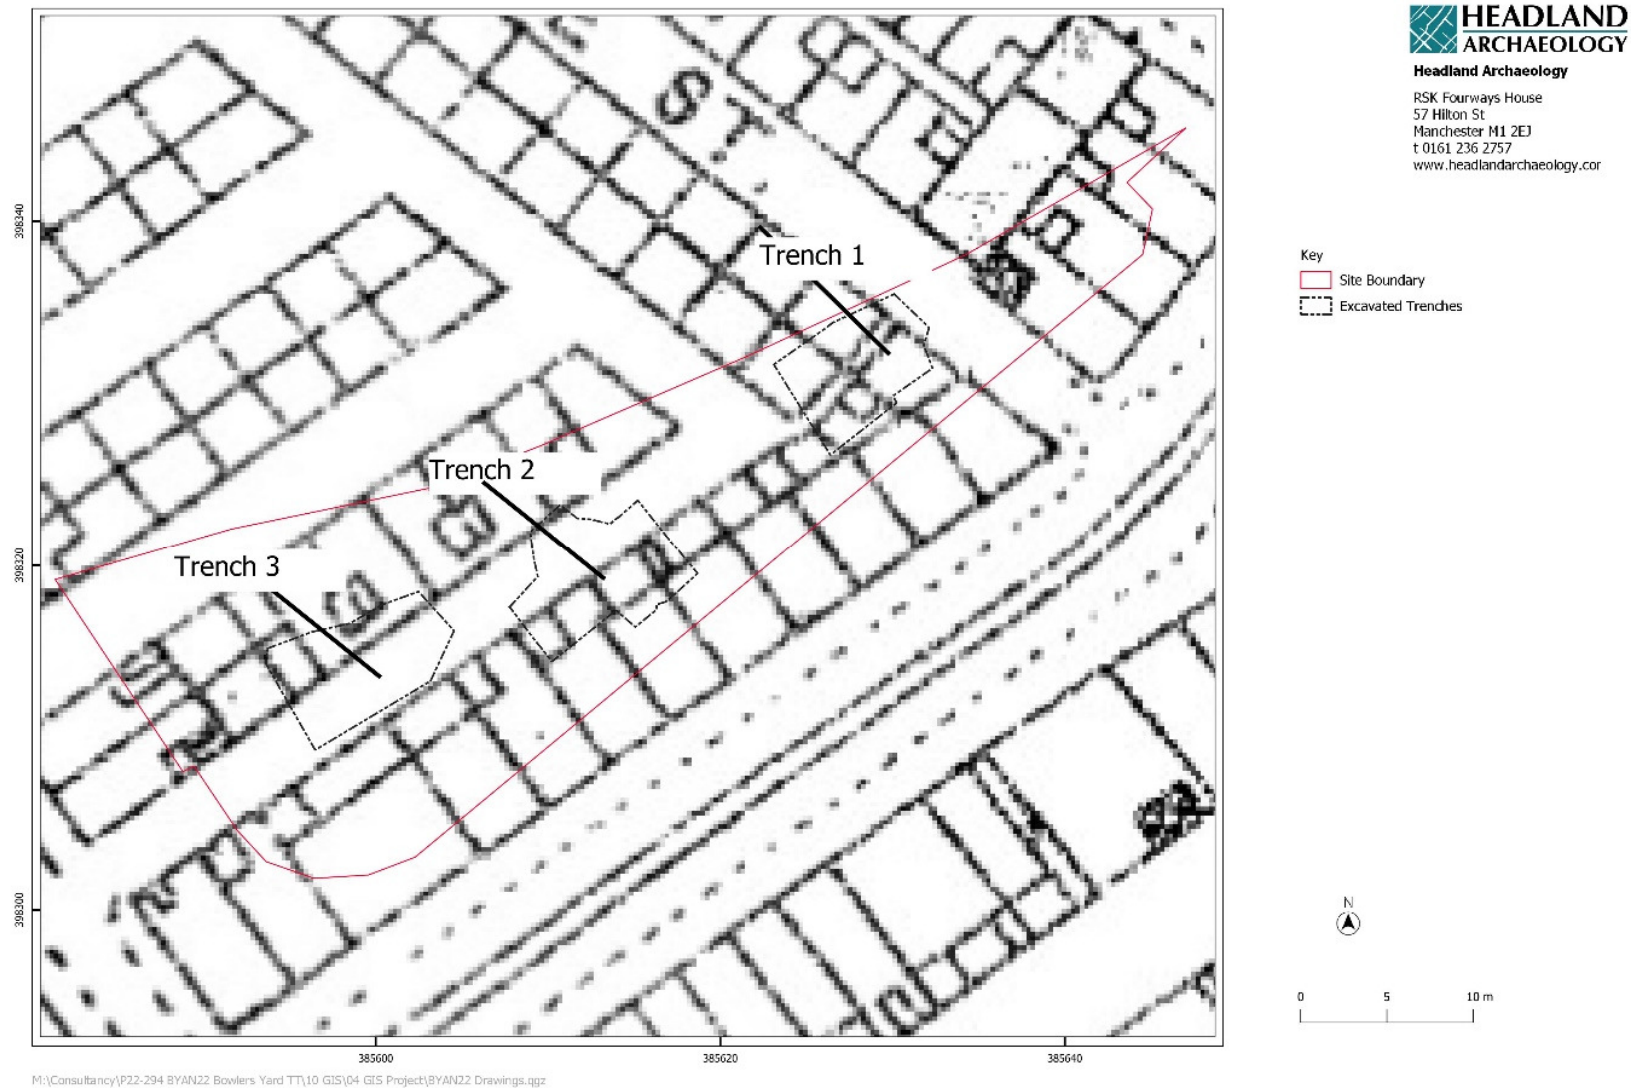
*Illus 2. Excavated Trenches superimposed upon the 1893 OS survey.*

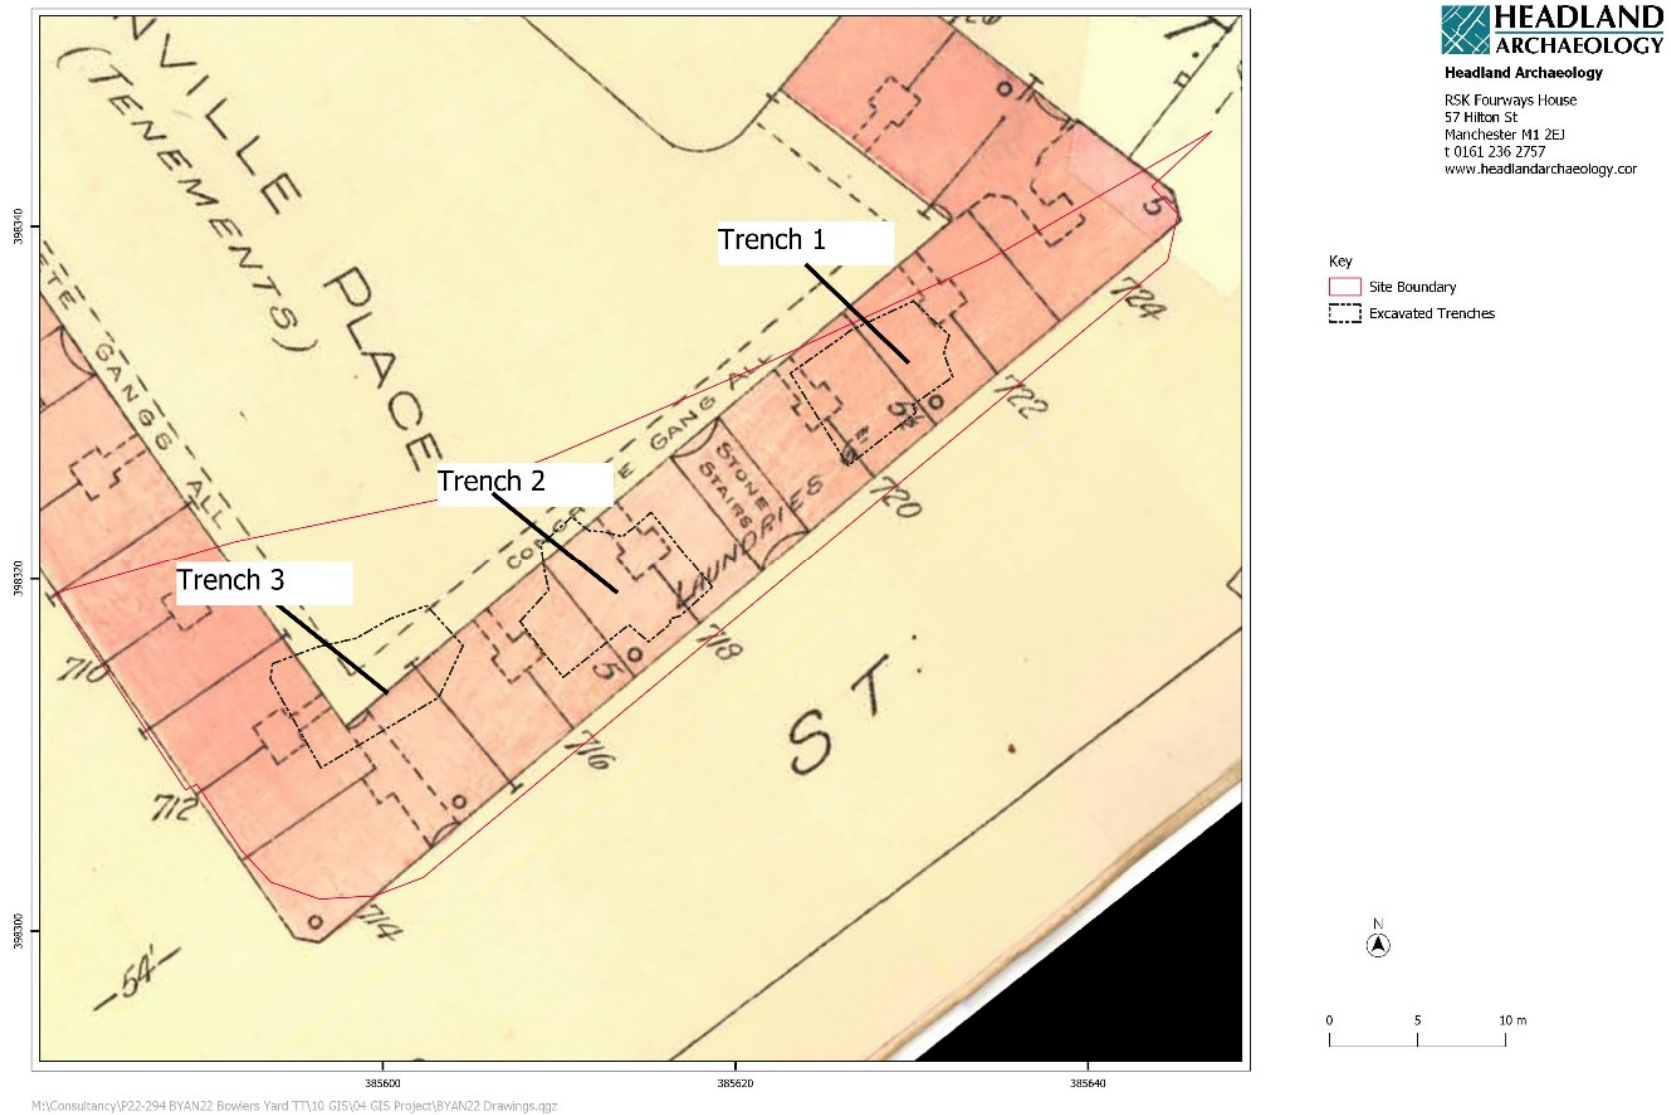
Illus 3. Excavated Trenches superimposed upon the 1928 Goad map

containing 135 apartments over five floors, with laundries on the 6th floor. The 1928 Goad map shows that there were no basements (Illus 3). Pollard Street was realigned and widened slightly during the construction of Granville Place, so just under 50% of the footprint of the earlier housing lies beyond the southern limit of the PDA.

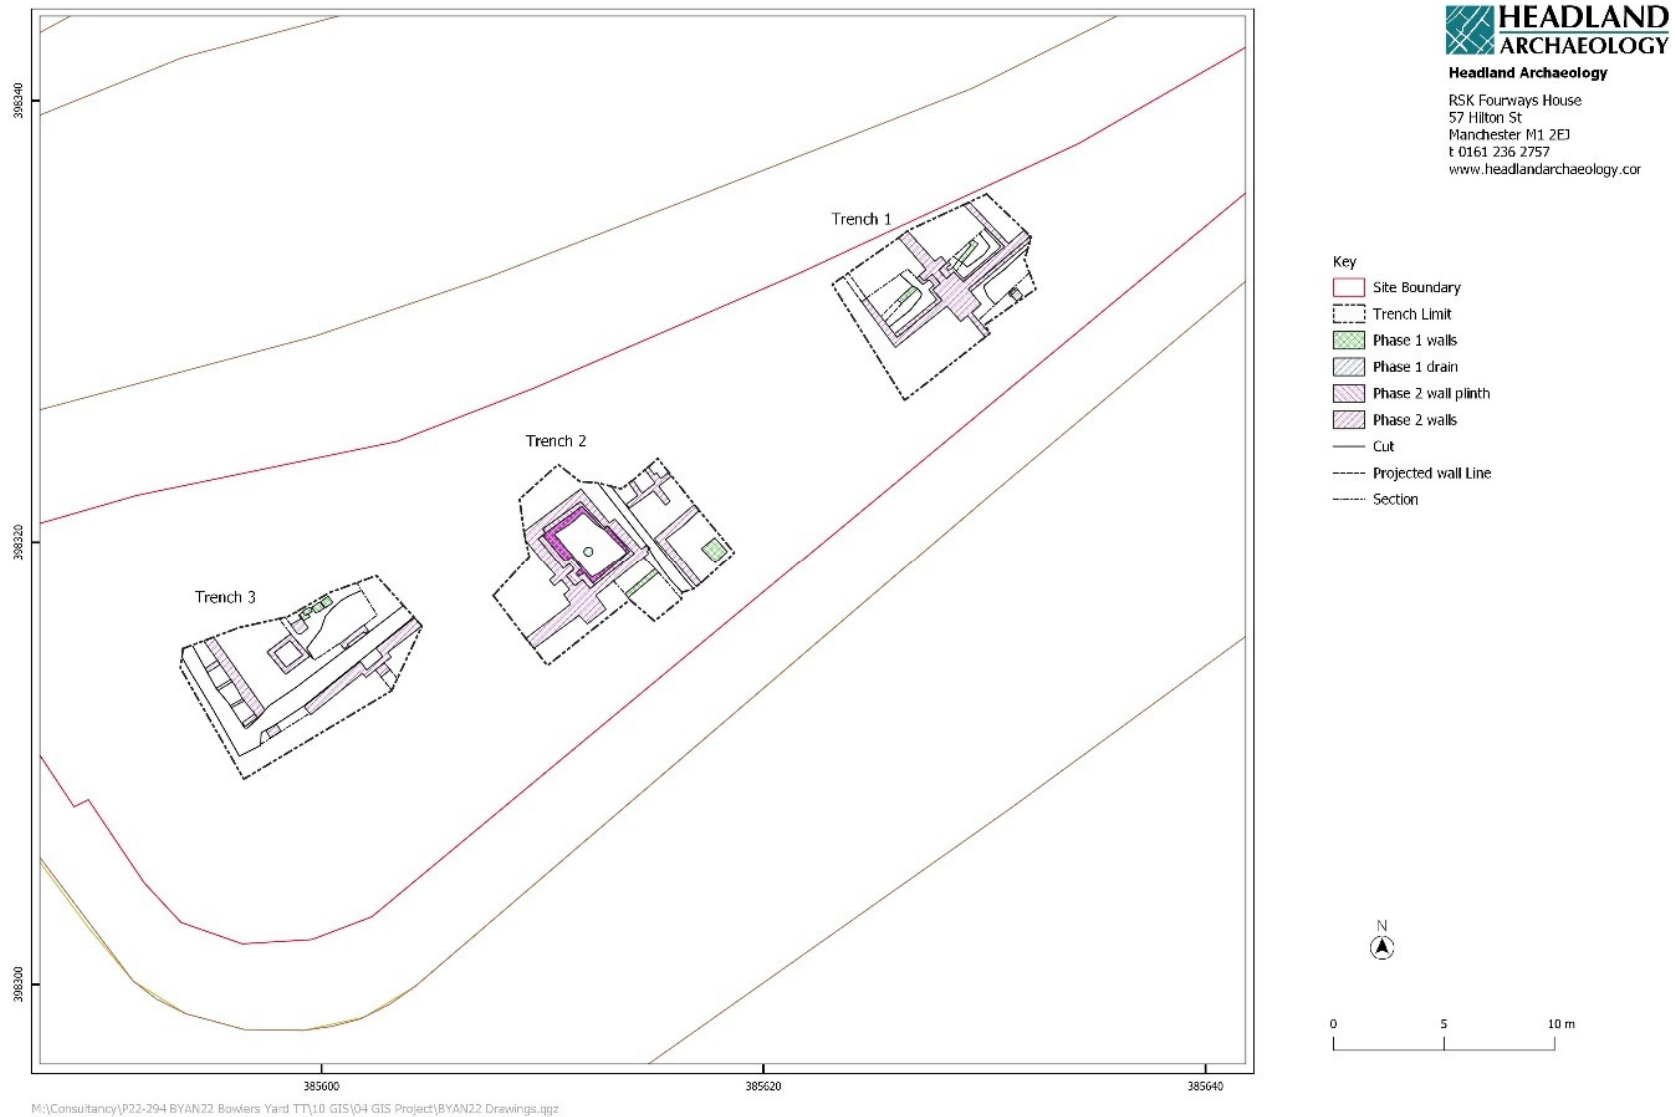
*Illus 4. Plan of excavated trenches.*

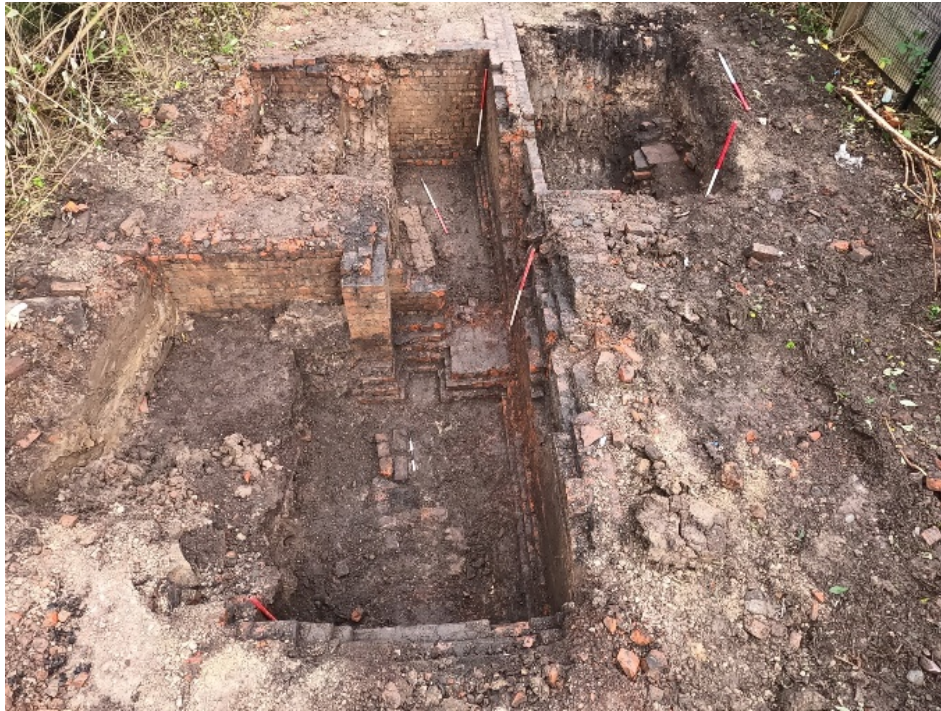
*Illus 6. Overview of Trench 1 looking east. The truncated walls of Phase 1 are visible at the base of the excavation.*

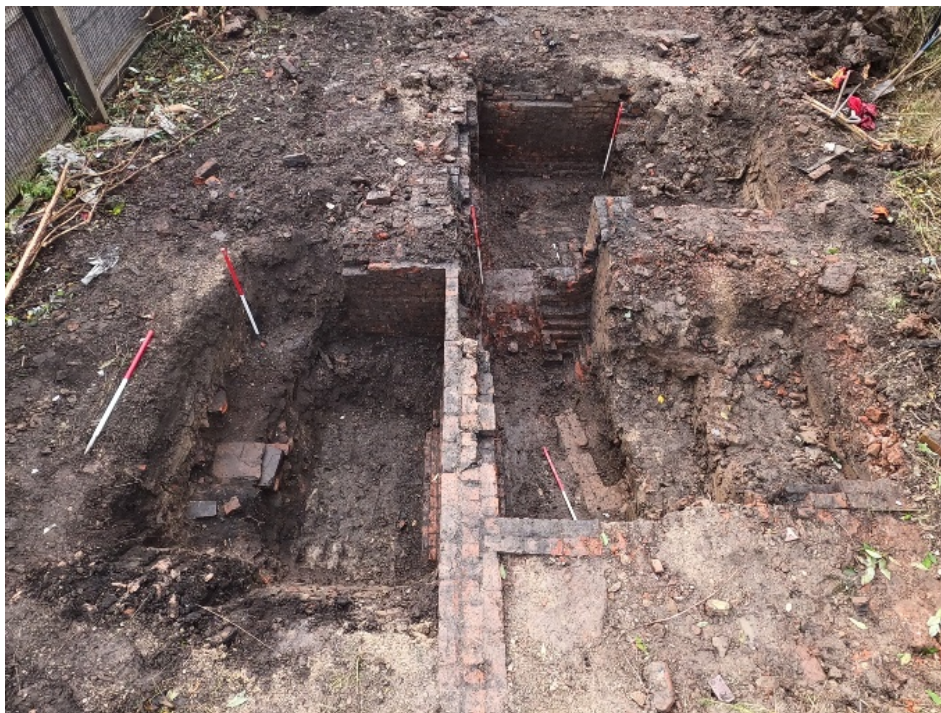
*Illus 7. Overview of Trench 1 looking west. The truncated walls of Phase 1 are visible at the base of the excavation. Drain [111]/[112] is to the south (left).*

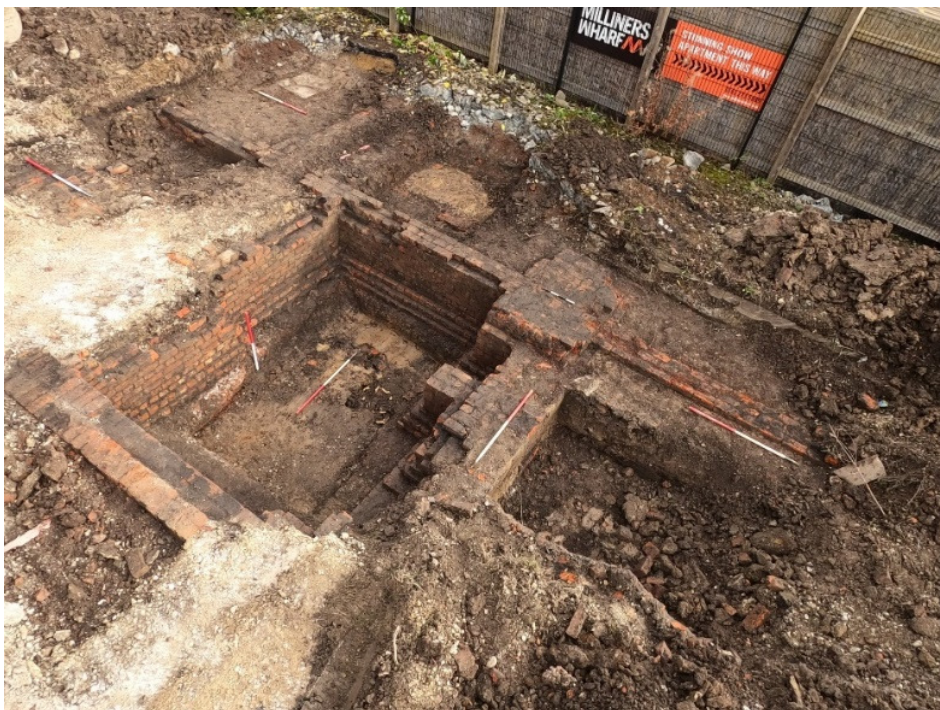
*Illus 9 Overview of Trench 2 looking south-east.*

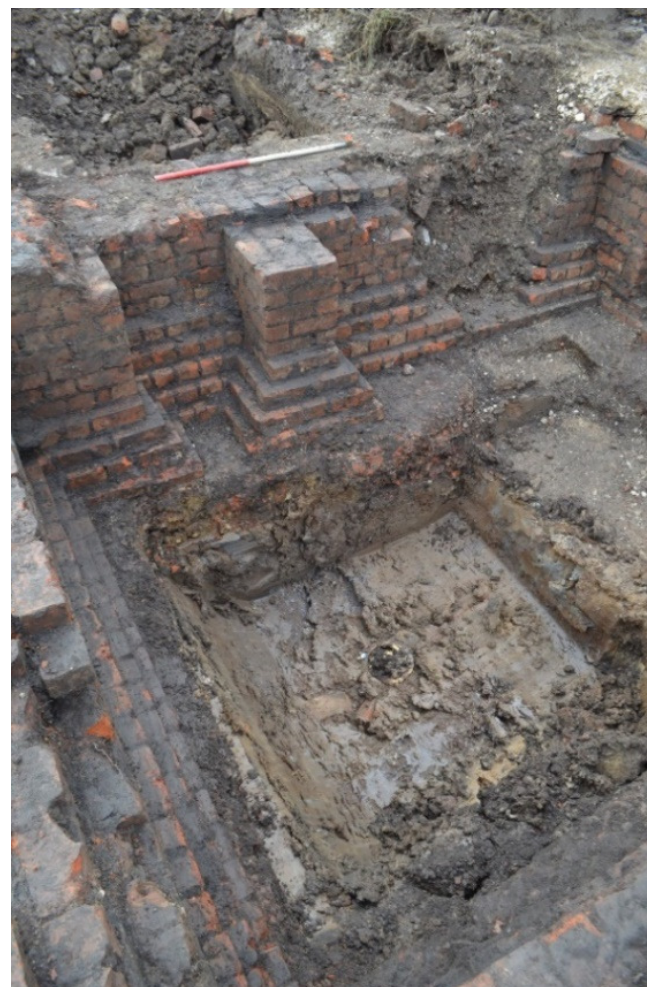
*Illus 10. Drain [218] at base of Trench 2.*

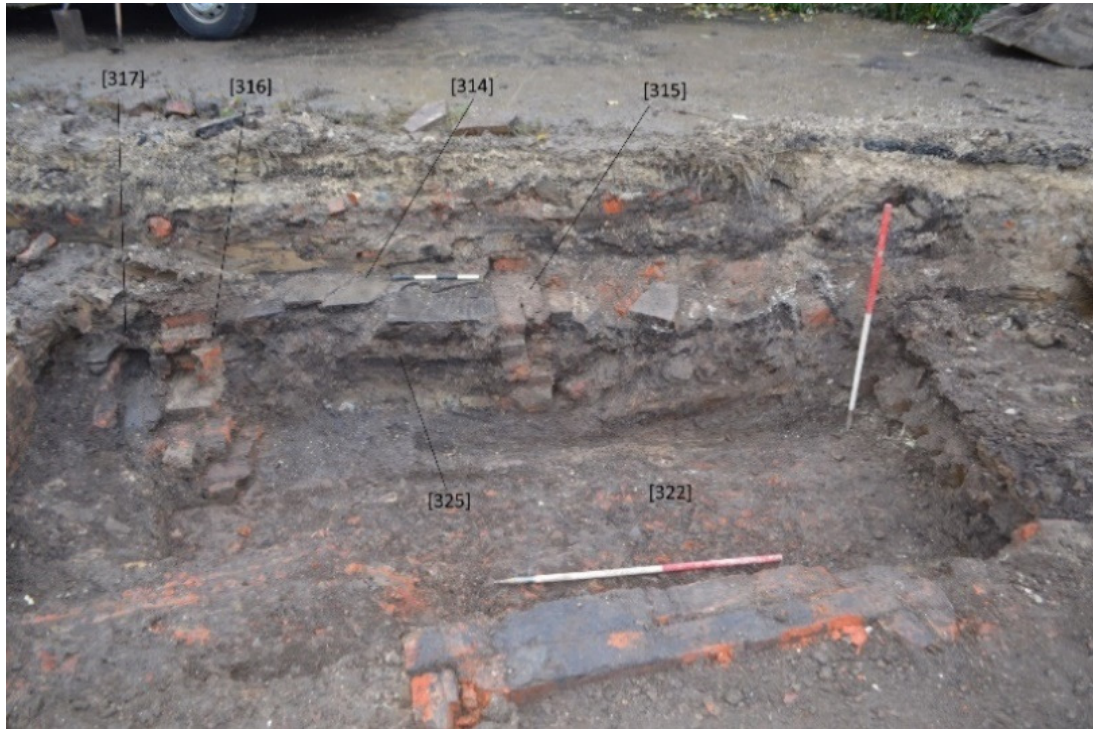
*Illus 11. Trench 3 Phase 1 deposits*
