## HERITAGE IMPACT STATEMENT

### Broomcroft Hall, Ford Lane, Didsbury, M20 2RU

1.1 This statement forms part of a planning application to replace the conservatory at Broomcroft Hall, Ford Lane, Didsbury, M20 2RU.

PN 8443 PROPOSED REPLACEMENT OF CONSERVATORY AT BROOMCROFT HALL, FORD  
LANE, DIDSBURY, M20 2RU.

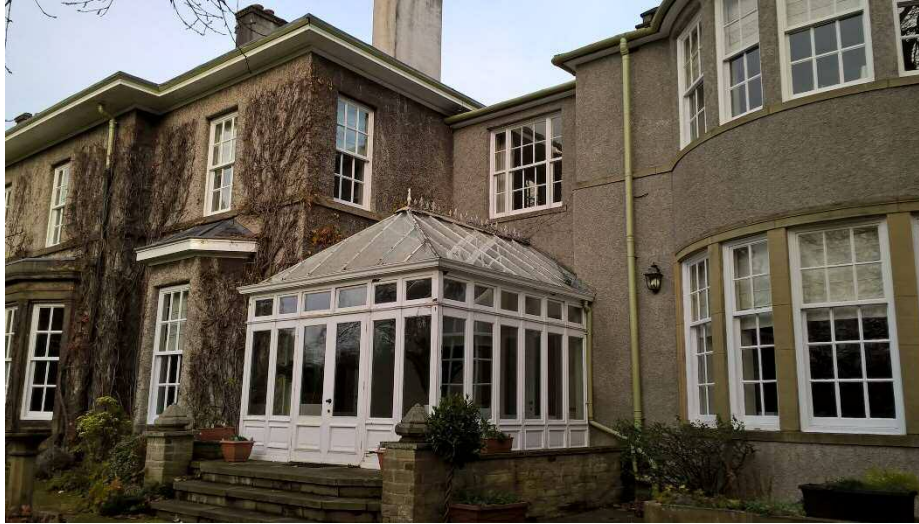
**Photo 1.** Existing conservatory.

2.1 Planning permission is sought to replace the conservatory on the south elevation of Broomcroft Hall, facing the gardens. (Photo 1 and Photo 2, Appendix 1) The conservatory is a single storey, timber frame construction, built off a concrete floor slab. It abuts the rendered walls of Broomcroft Hall on two sides. (Plan 1, Appendix 1) The conservatory roof construction is timber frame with aluminium cappings, forming a hipped pitched roof with a decorative ridge cresting.

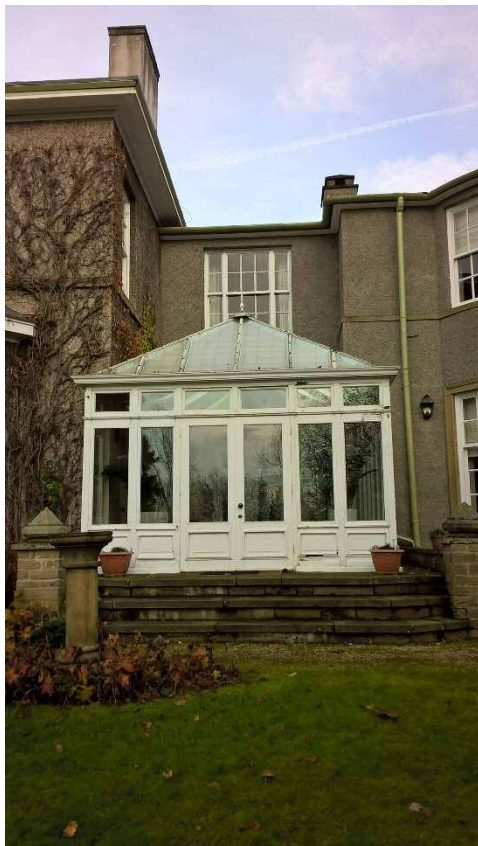
**Photo 2.** Existing conservatory.

In the design review for the replacement conservatory roof the university investigated with a specialist supplier whether the side gutter could be accessed via a MEWP. With the MEWP positioned at the bottom of the steps (Photo 2, Appendix 1), the specialist supplier was unable to find a machine specification that would allow access up and over the conservatory and into the side gutter.

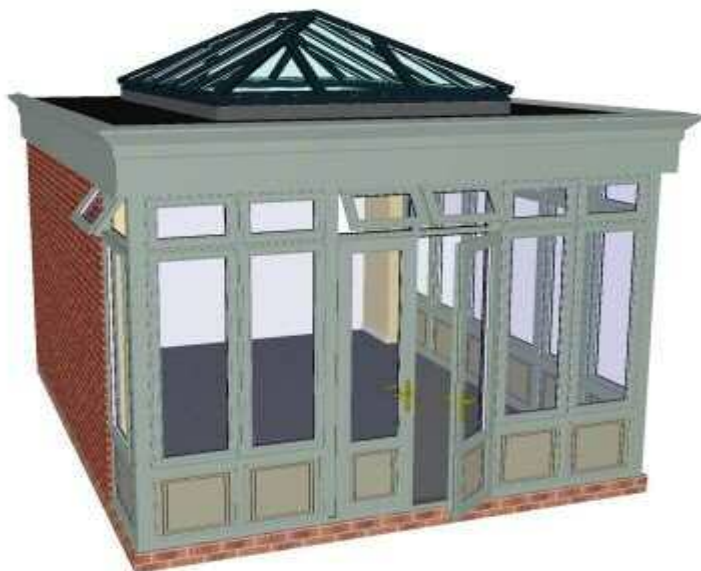
**Image 1.** Proposed conservatory. Please note brick wall shown represents the existing Broomcroft Hall wall – where the conservatory abuts the Hall's structure.

The new frame will be constructed from Accoya timber so will match the existing timber frame. The arrangement of the window fixed lights, opening lights and the doors will match the existing. (Image 1 and Image 2, Appendix 1 and Drawing 071AA-8443-A103)

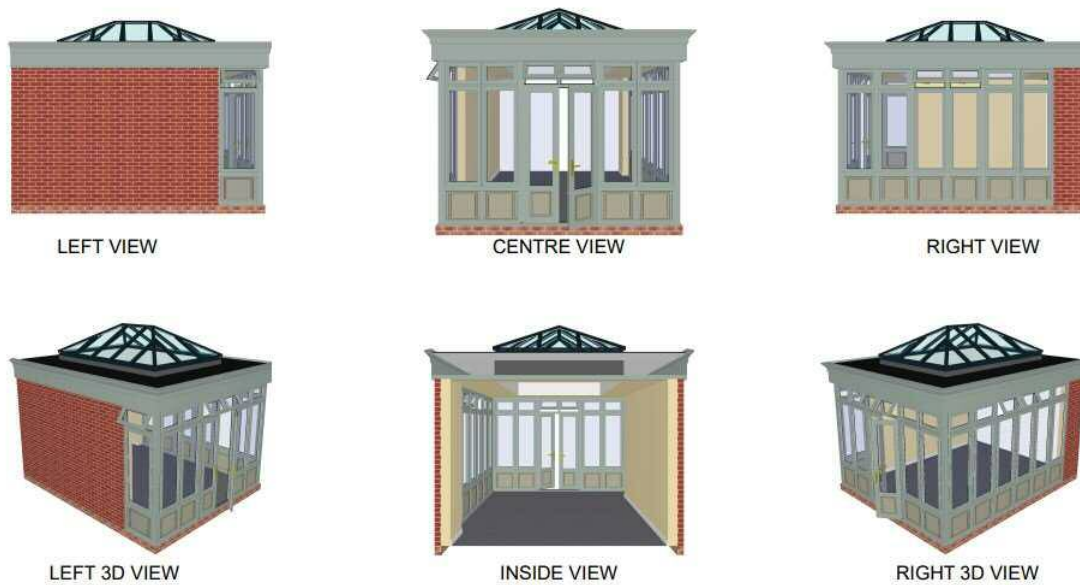
**Image 2.** Proposed conservatory. Please note brick walls shown represents the existing Broomcroft Hall walls – where the conservatory abuts the Hall's structure.

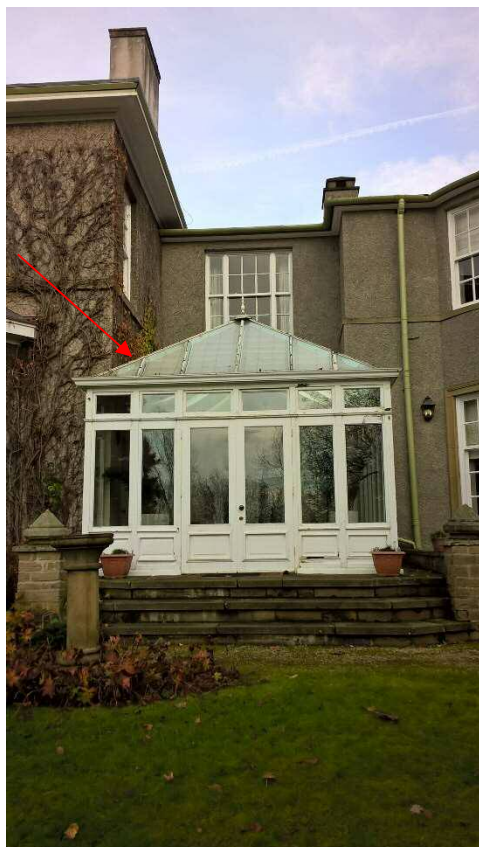
**Photo 6.** Highlighting side gutter which becomes heavily blocked with leaves and debris

The construction of the existing conservatory roof is a timber frame with aluminium cappings forming a hipped pitched roof with a decorative ridge cresting. Safe access to the side gutter, (highlighted on Photo 6 and Plan 2, Appendix 1) is not possible, causing the gutter to become heavily blocked with leaves and debris (Photo 7, Appendix 1). Excerpts from pages 5 and 6 of the Arcadis report below:

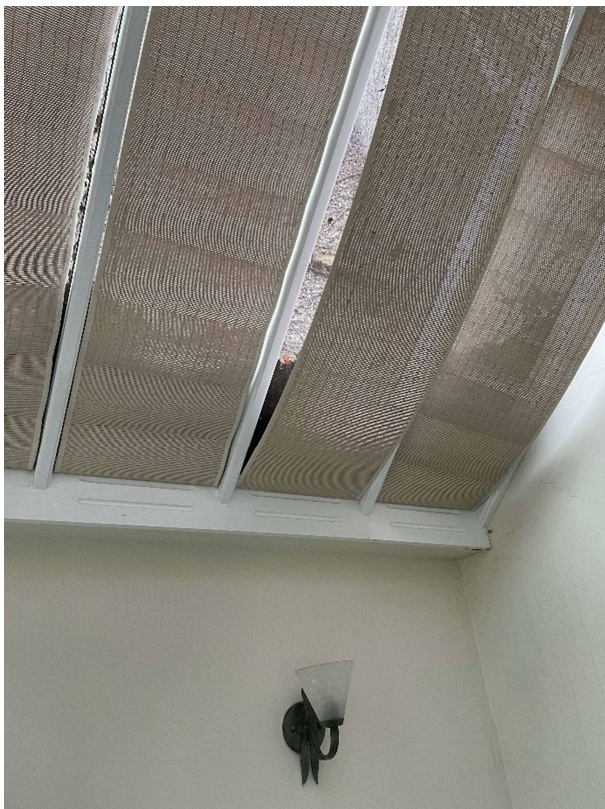
**Photo 7.** Internal photo showing build-up of leaves and debris in side gutter.
