# Gorton Community Hub

## Flood Risk Assessment and Detailed Drainage Strategy

Curtins Ref: GCH-CUR-XX-XX-RP-C-0002

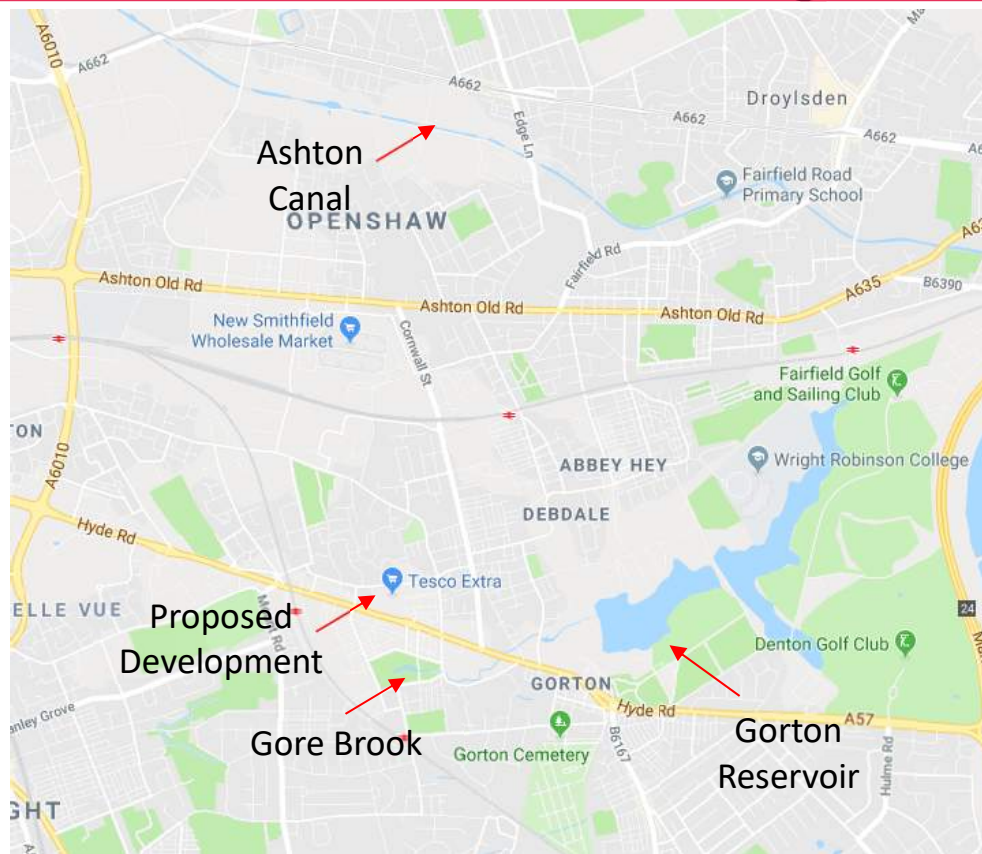
**Figure 2 Existing Watercourses**

- Gore Brook, a watercourse that runs 300m to the south of the site. The watercourse is designated as a main river and therefore falls under the jurisdiction of the EA. The watercourse flows in a westerly direction through the urban area to discharge at the intersections of Chorlton and Fallowfield brook. These watercourses are part of the Upper Mersey Catchments.
- Ashton Canal and Peak Forest Canal runs 2.0km to the north of the site. The canal runs east to west through urban area to discharge into the Rochdale Canal.

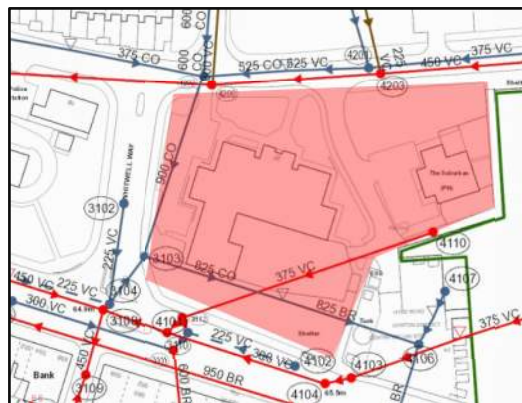
### Figure 3 Public Sewer Records

- There is a 900mm diameter public surface water gravity sewer entering the main building site from the north-west corner from UU MH 4202. This pipe runs north-south along the western boundary towards UU MH 3103 on the south-west corner of the site. The 900mm diameter pipe then flows west-east along the southern site boundary towards UU MH4106 on the adjacent Tesco site. The pipe has a 6m easement (measured 3m either side from the centreline of the pipe).
- A second 375mm diameter public combined gravity sewer, enters the site from the eastern boundary from UU MH 4110 flowing south-west towards UU MH 4112.

The public sewer records indicate that public sewers are recorded in all roads surrounding the development.

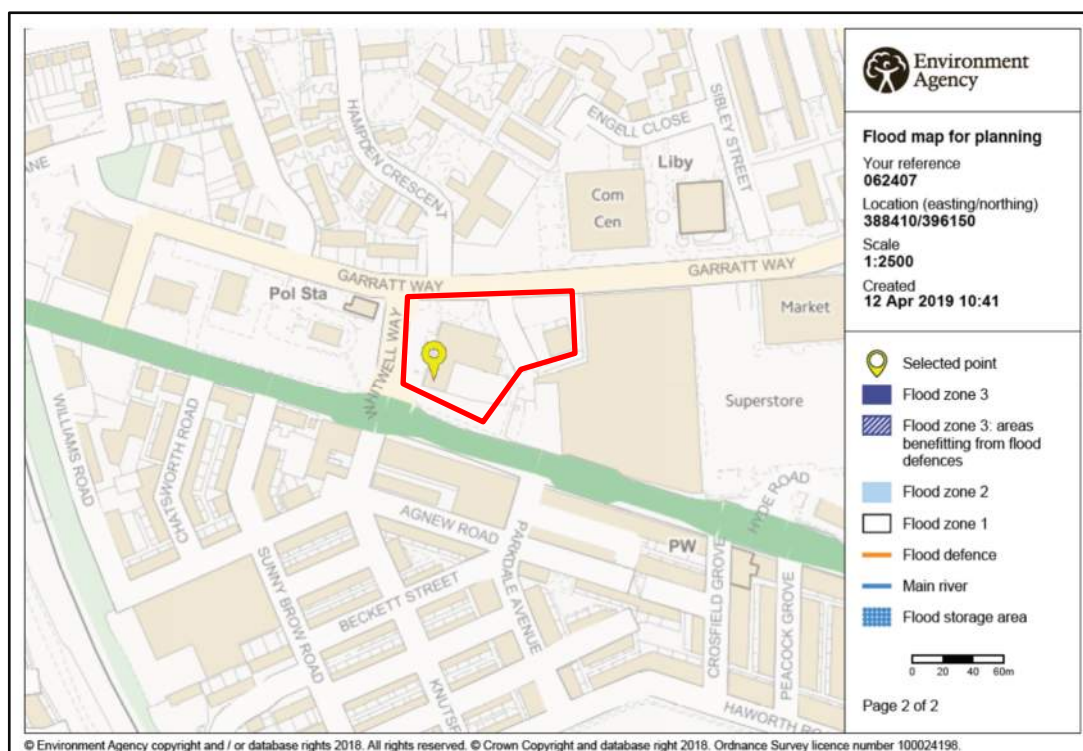
**Figure 4.1: Environment Agency Map – Flood Map for Planning (Rivers and Sea)**

Flooding to the site from rivers and seas is indicated in Figure 4-1 and it can be seen that the entire proposed site is located within an area classified as Flood Zone 1, therefore the site is considered to be at low risk from fluvial flooding.

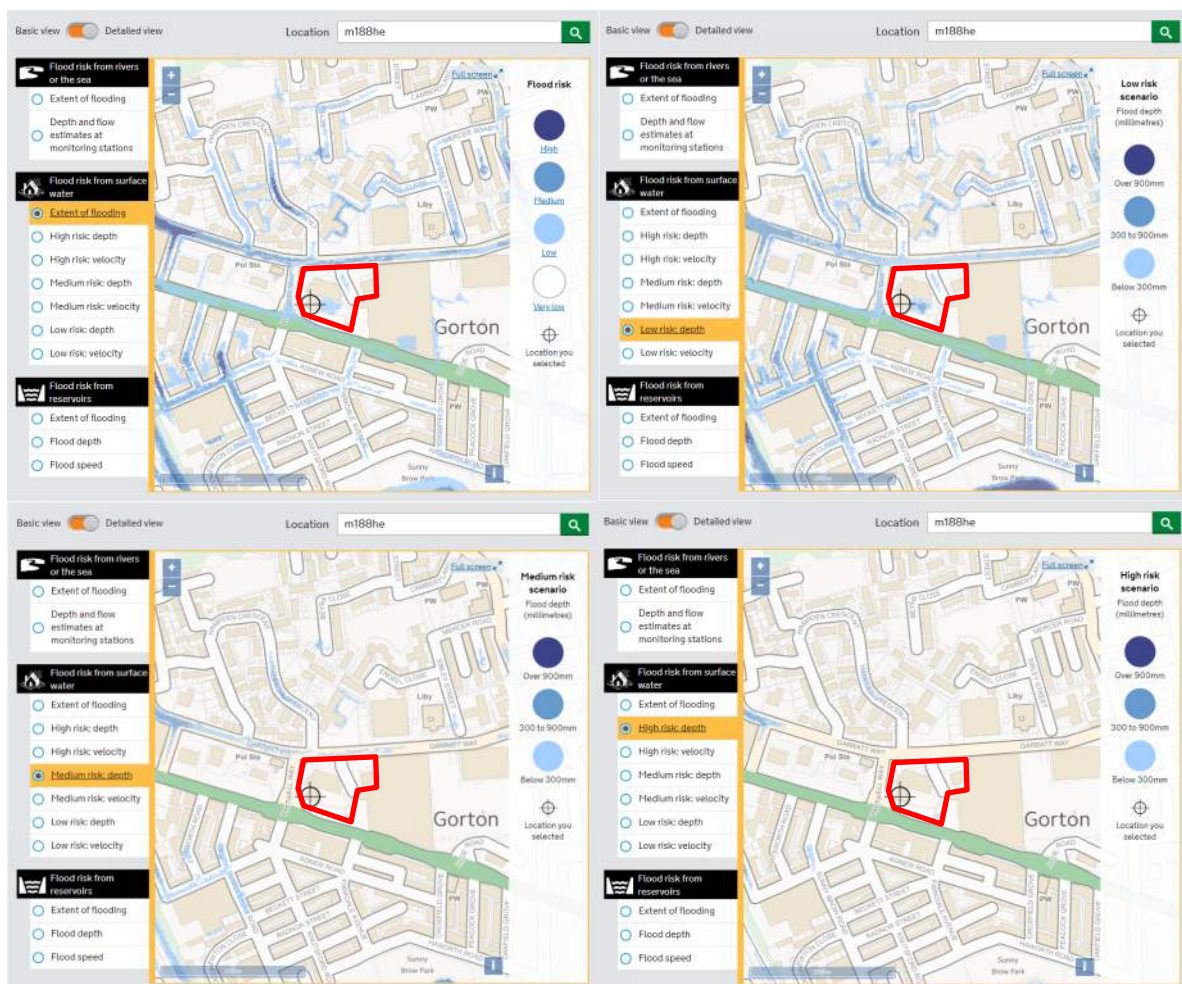
**Figure 4.2: Environment Agency Flood Risk from Surface Water**

Extracts of the Environment Agency 'Flood Risk from Surface Water' maps showing overall extent of flood risk, together with Low Risk (annual chance of flooding of between 0.1% and 1%), Medium Risk (annual chance of flooding of between 1% and 3.3%) and High Risk (annual chance of flooding of greater than 3.3%) are shown in Figure 4-2 following with the site area outlined **RED**.

Map A indicates the overall flood risk from surface water to the site and indicates the site to be have a low risk of flooding from this source.

The UK Government surface water flood maps indicate that there are localised areas of low risk of surface water flooding within the existing enclosed parking areas of the main building site, when reviewed against topographic survey ground levels are considered to be caused by localised low points within the site containing surface water. However, it is known that the site is well served by existing positive drainage features.

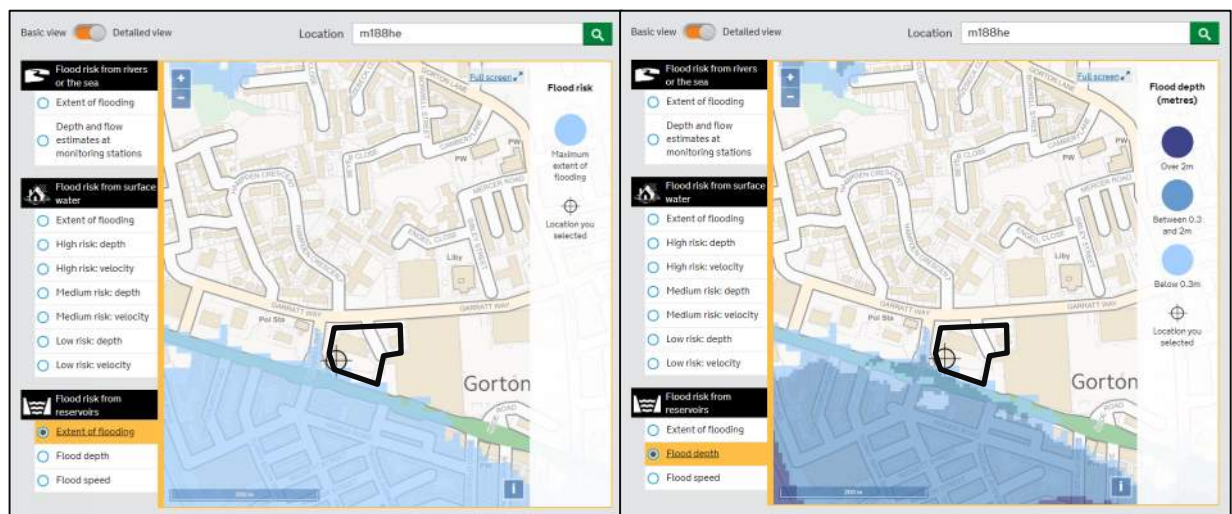
**Figure 4.3: Risk of Flooding from Reservoirs - Extent of Flooding**

The Long-Term Flood Risk from Reservoirs map, Figure 4-3, shows the largest area that might be flooded if a reservoir were to fail and release the water it holds. Since this is a prediction of a worst-case scenario, it is very low risk that a reservoir flood would be this large.

The map indicates the site is on the borderline of areas at risk of flooding from this source. Given the risk of flooding from these events being this large, the site is at low risk of flooding from reservoirs. The closest Reservoir to the site is the Gorton Lower and Upper (Debdale) reservoirs which are located 1.0km to the east of the site.

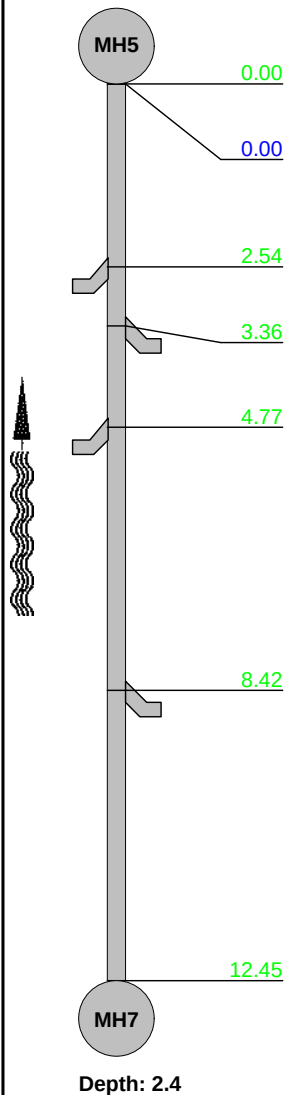
Start node type, manhole, reference number : MH5

Water level, 10% of the vertical dimension

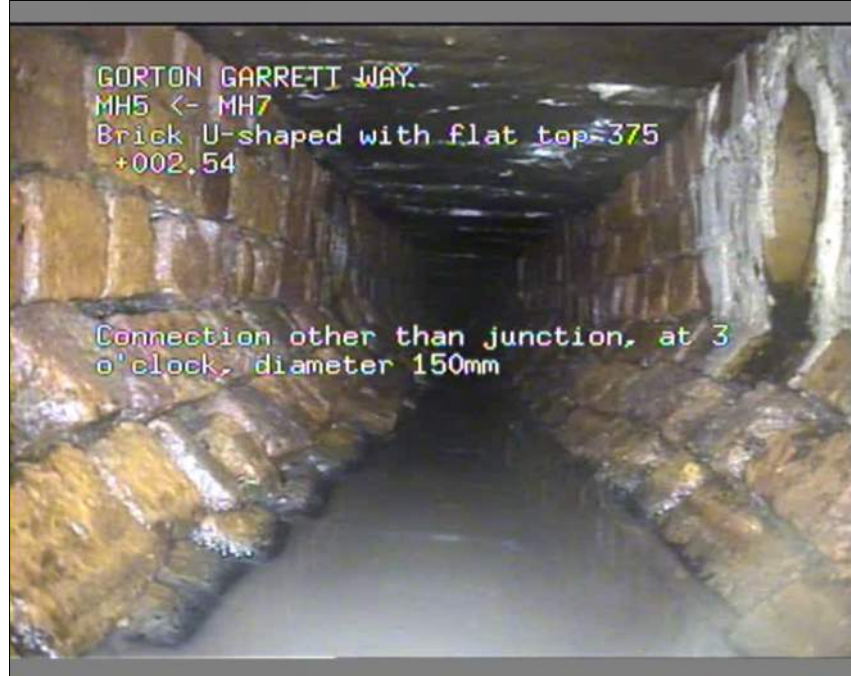
Photo: 1\_1\_9\_A.JPG

2.54m, Connection other than junction, at 3 o'clock, diameter 150mm

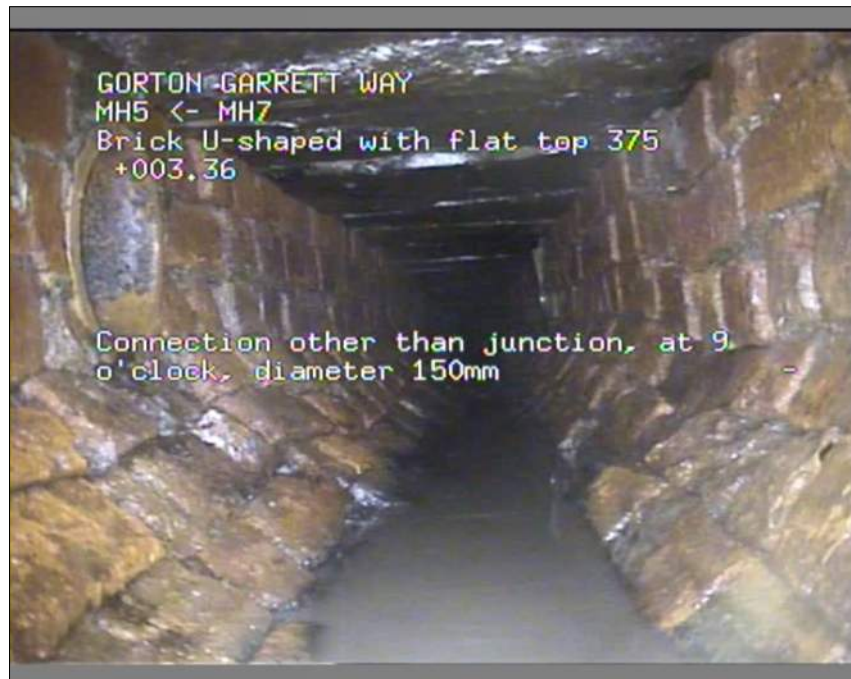
Photo: 1\_1\_10\_A.JPG

3.36m, Connection other than junction, at 9 o'clock, diameter 150mm

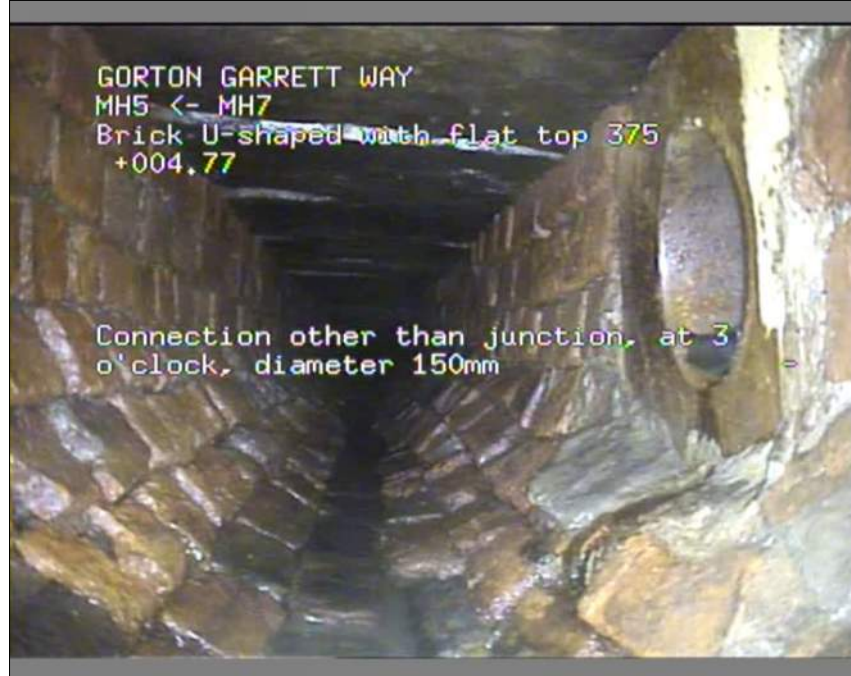
Photo: 1\_1\_11\_A.JPG

4.77m, Connection other than junction, at 3 o'clock, diameter 150mm

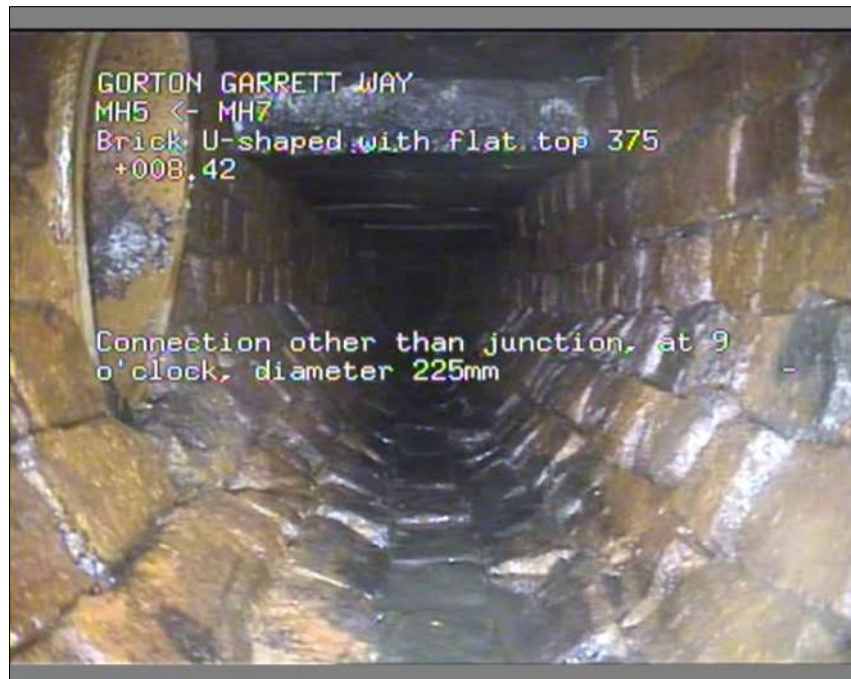
Photo: 1\_1\_12\_A.JPG

8.42m, Connection other than junction, at 9 o'clock, diameter 225mm

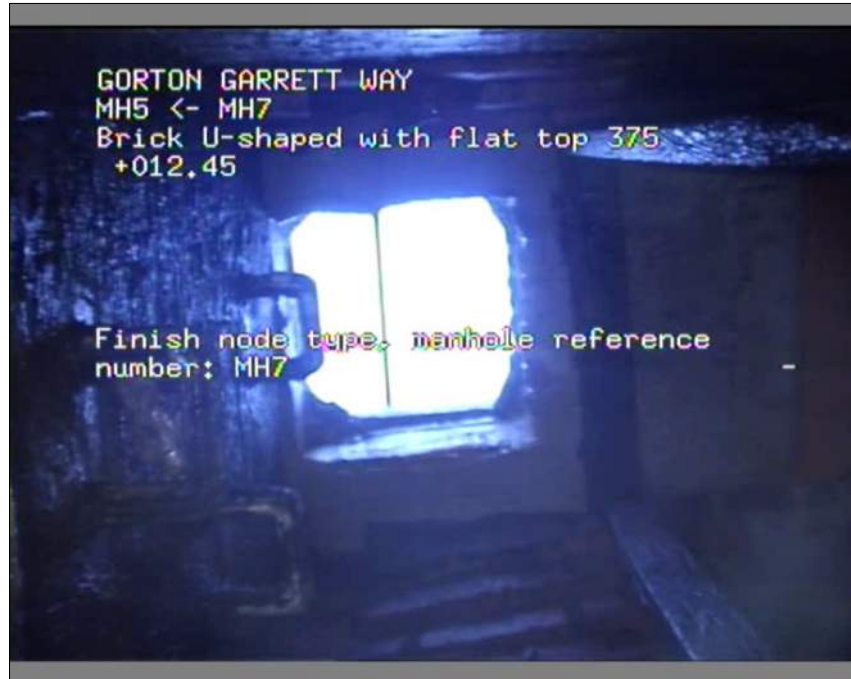
Photo: 1\_1\_13\_A.JPG  
12.45m, Finish node type, manhole reference number: MH7

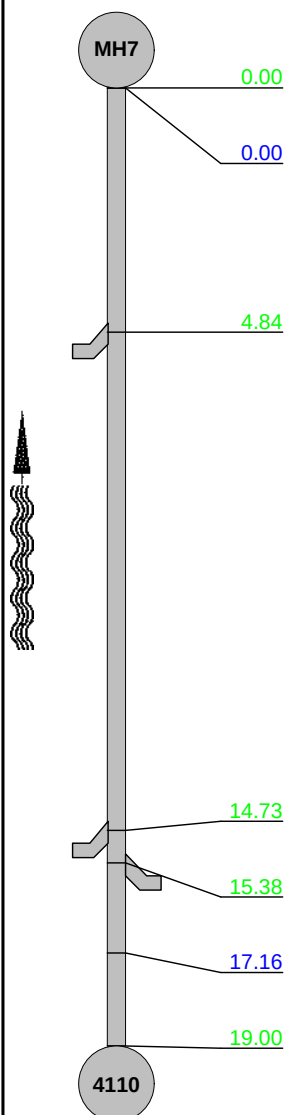
Start node type, manhole, reference number : MH7

Water level, 05% of the vertical dimension

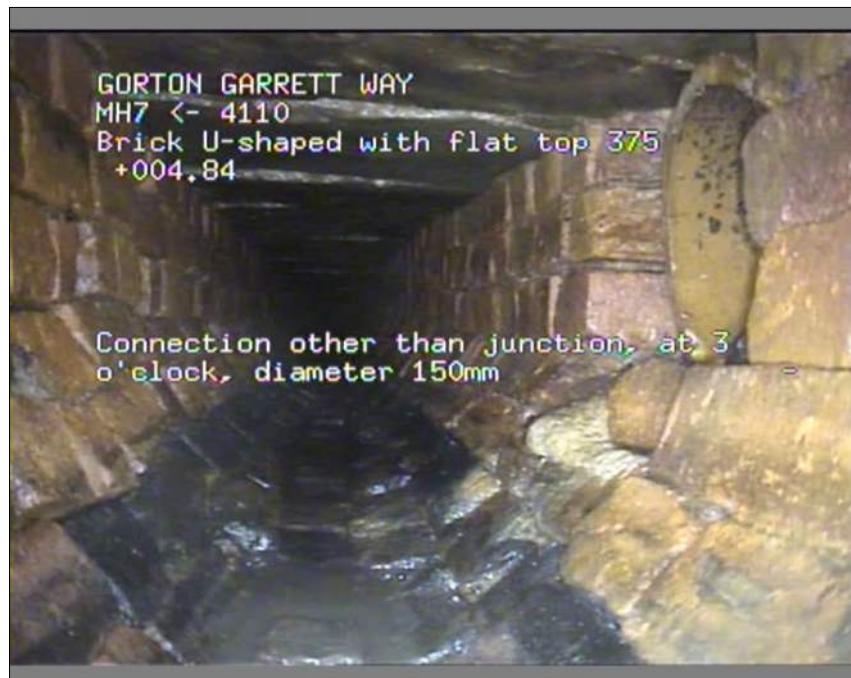
Photo: 3\_3\_16\_A.JPG

4.84m, Connection other than junction, at 3 o'clock, diameter 150mm

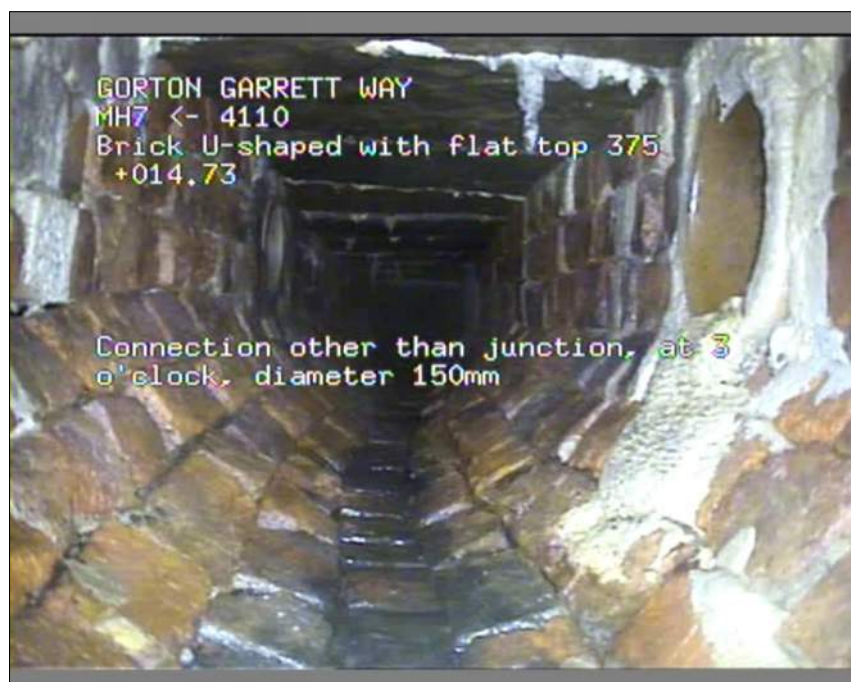
Photo: 3\_3\_17\_A.JPG

14.73m, Connection other than junction, at 3 o'clock, diameter 150mm

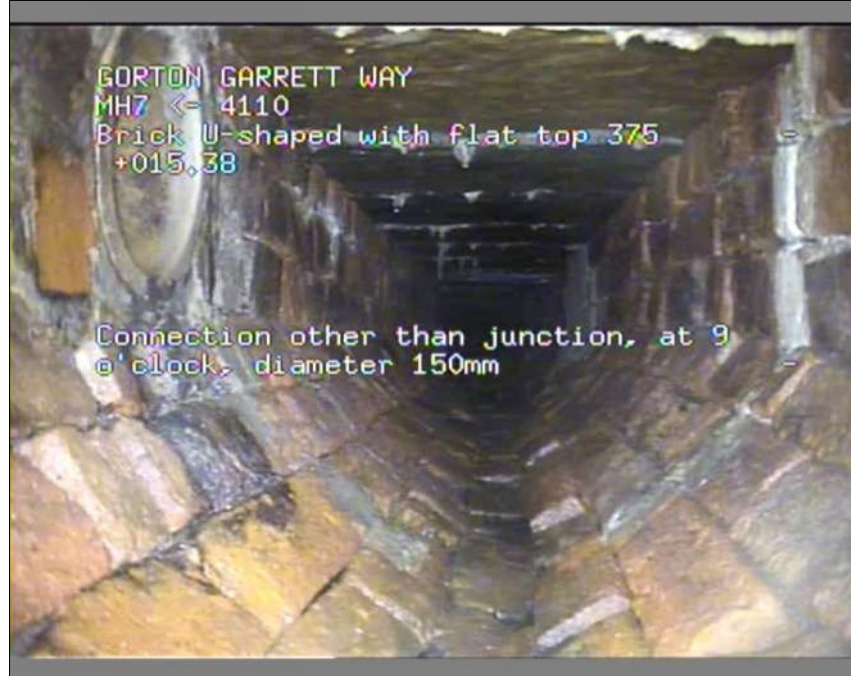
Photo: 3\_3\_18\_A.JPG  
15.38m, Connection other than junction, at 9 o'clock, diameter 150mm

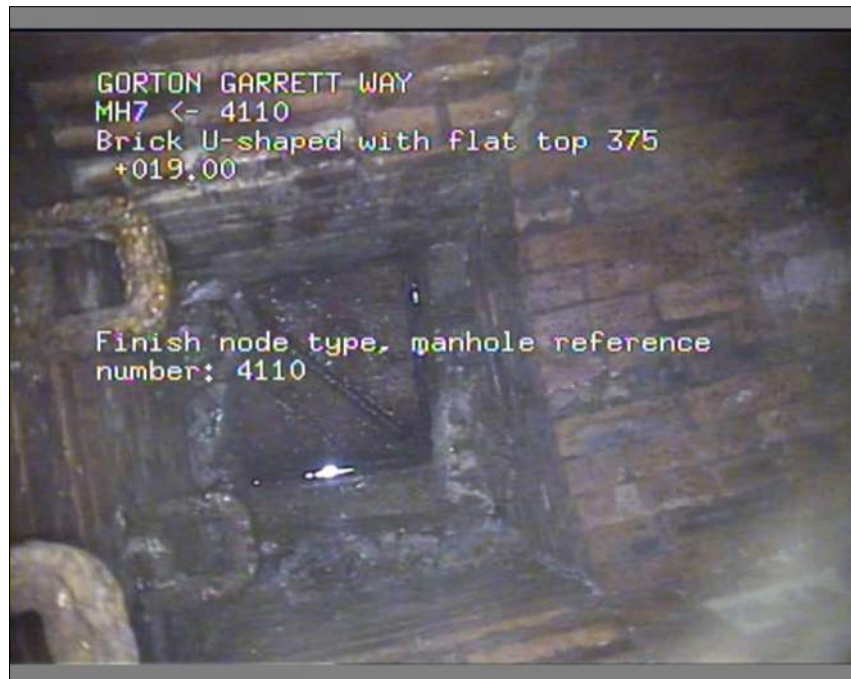
Photo: 3\_3\_20\_A.JPG  
19m, Finish node type, manhole reference number: 4110

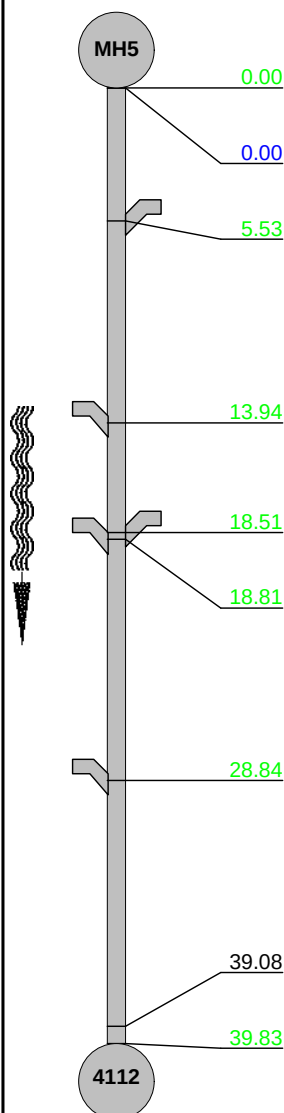
Start node type, manhole, reference number : MH5

Water level, 05% of the vertical dimension

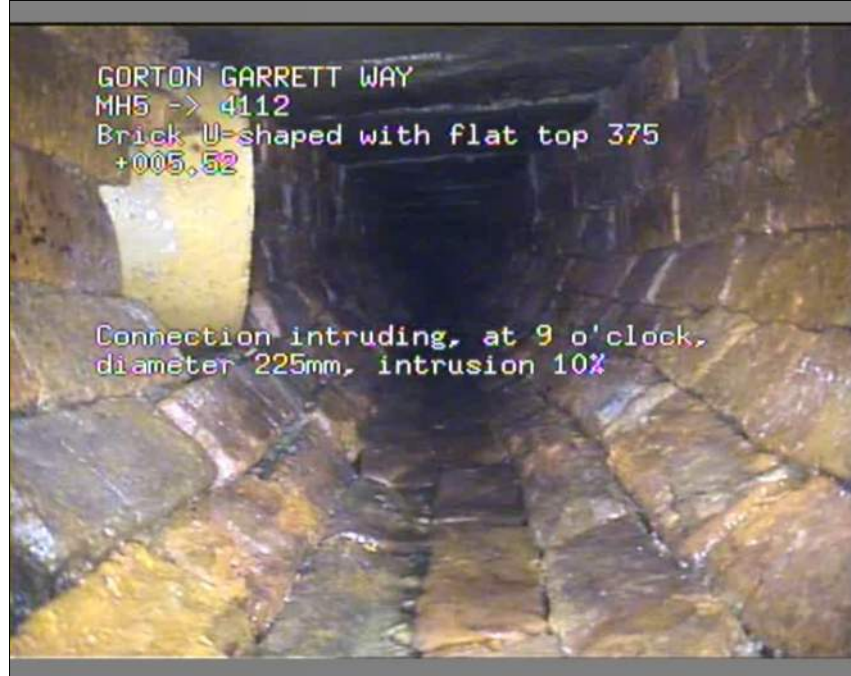
Photo: 4\_4\_23\_A.JPG

5.53m, Connection intruding, at 9 o'clock, diameter 225mm, intrusion 10%

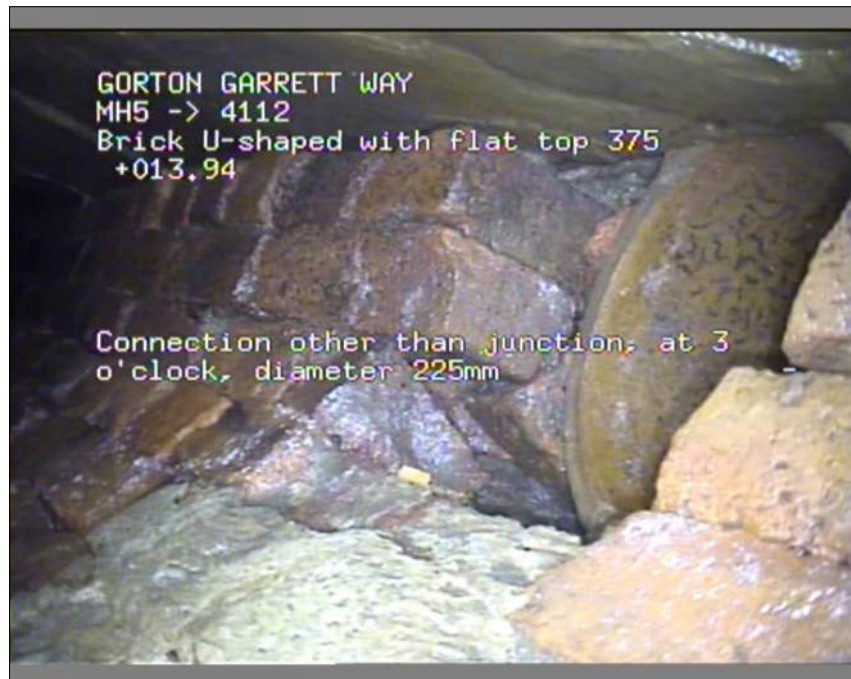
Photo: 4\_4\_24\_A.JPG

13.94m, Connection other than junction, at 3 o'clock, diameter 225mm

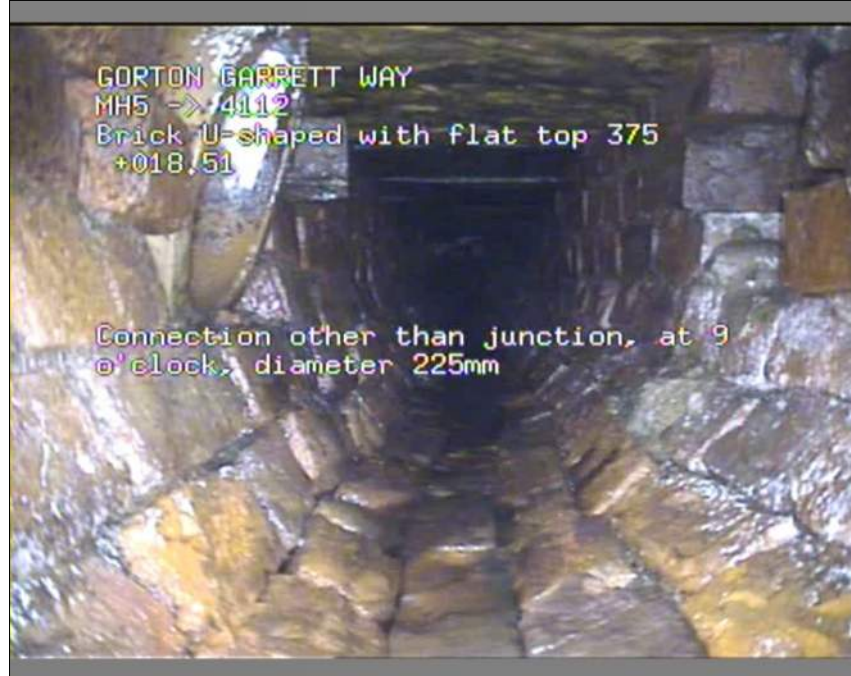
Photo: 4\_4\_25\_A.JPG

18.51m, Connection other than junction, at 9 o'clock, diameter 225mm

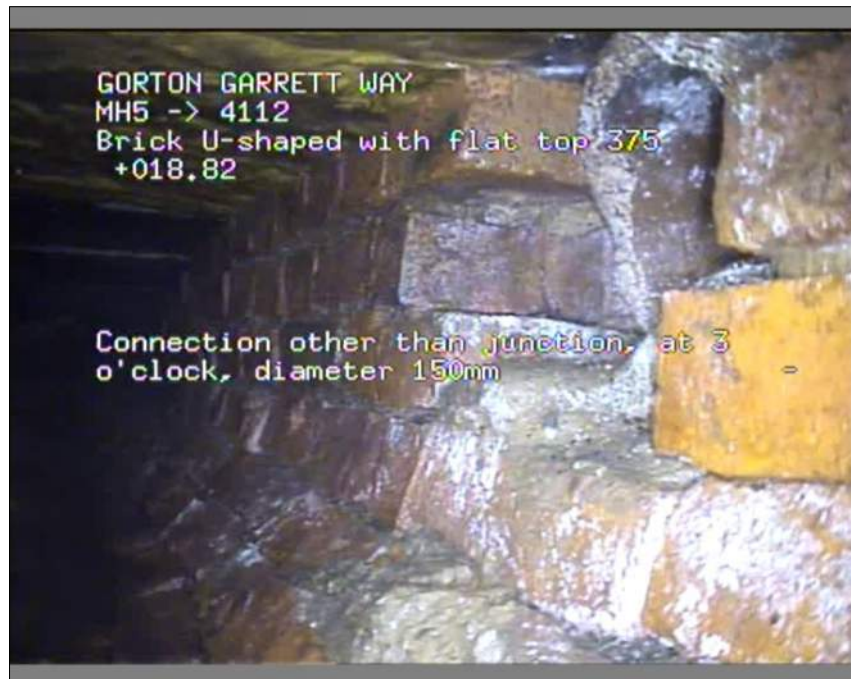
Photo: 4\_4\_26\_A.JPG

18.81m, Connection other than junction, at 3 o'clock, diameter 150mm

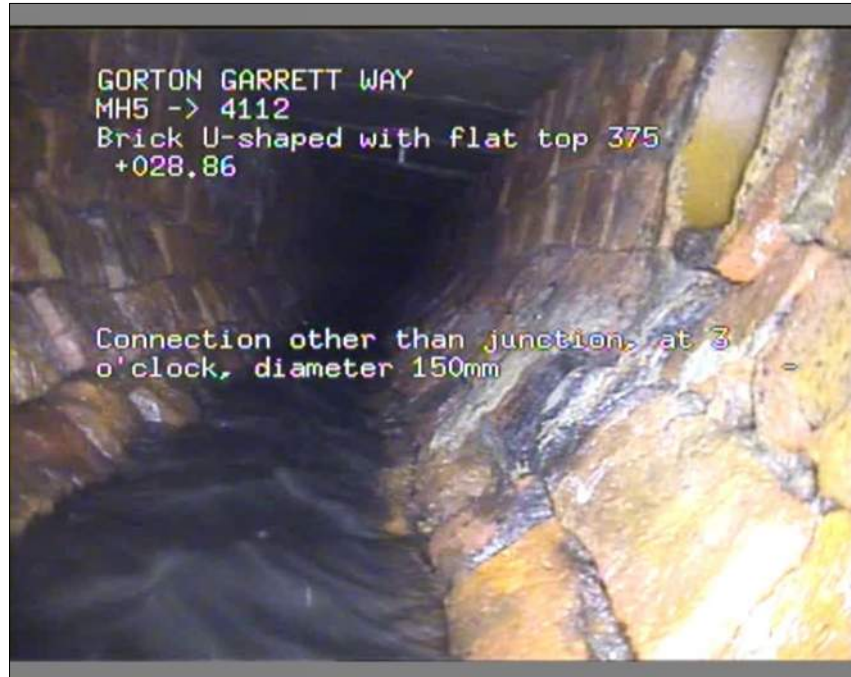
Photo: 4\_4\_27\_A.JPG  
28.84m, Connection other than junction, at 3 o'clock, diameter 150mm

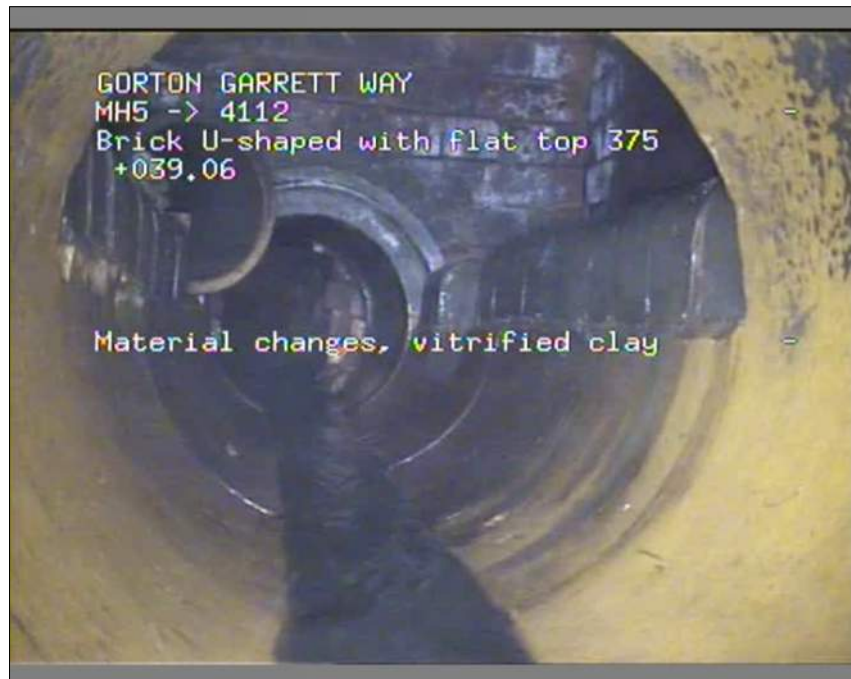
Photo: 4\_4\_28\_A.JPG  
39.08m, Material changes, vitrified clay

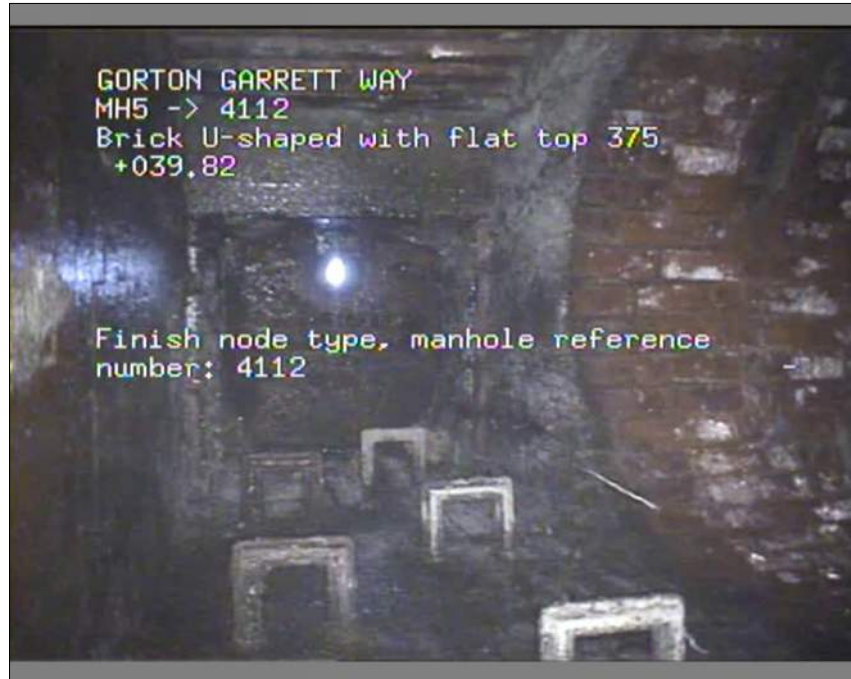
Photo: 4\_4\_29\_A.JPG  
39.83m, Finish node type, manhole reference number: 4112

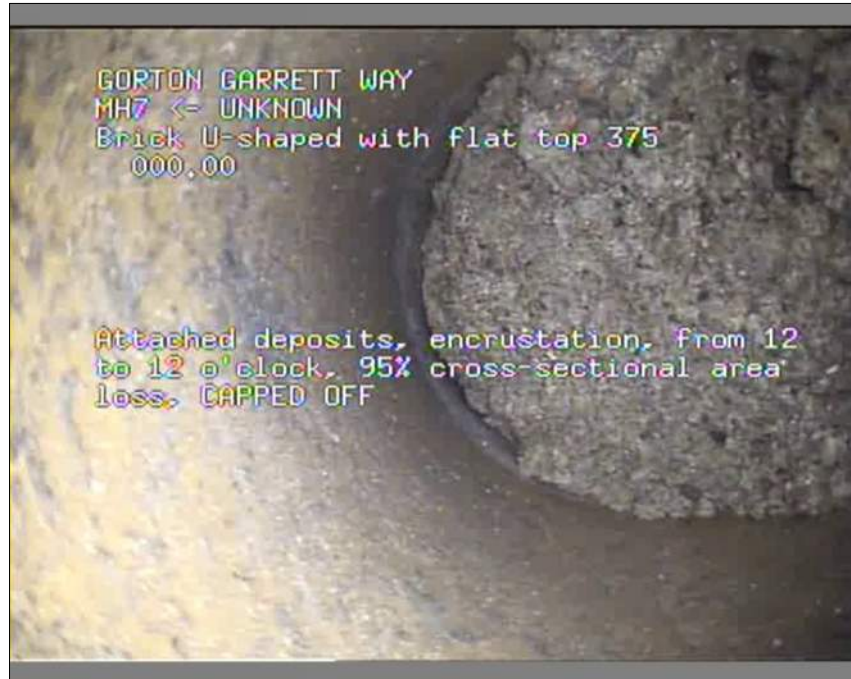
Photo: 5\_5\_33\_A.JPG

0m, Attached deposits, encrustation, from 12 to 12 o'clock, 95% cross-sectional area loss

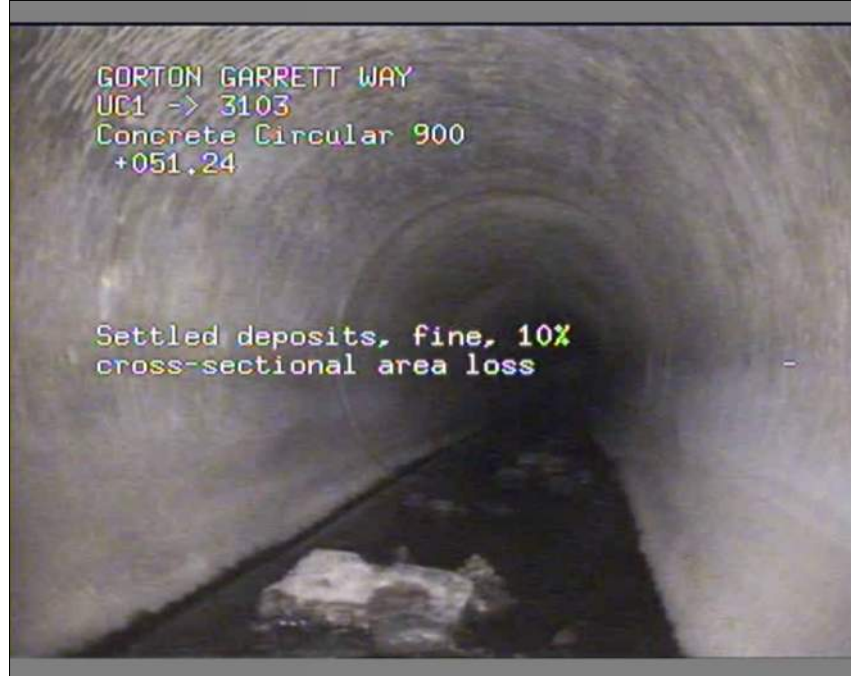
Photo: 6\_6\_38\_A.JPG  
 51.24m, Settled deposits, fine, 10% cross-sectional area loss

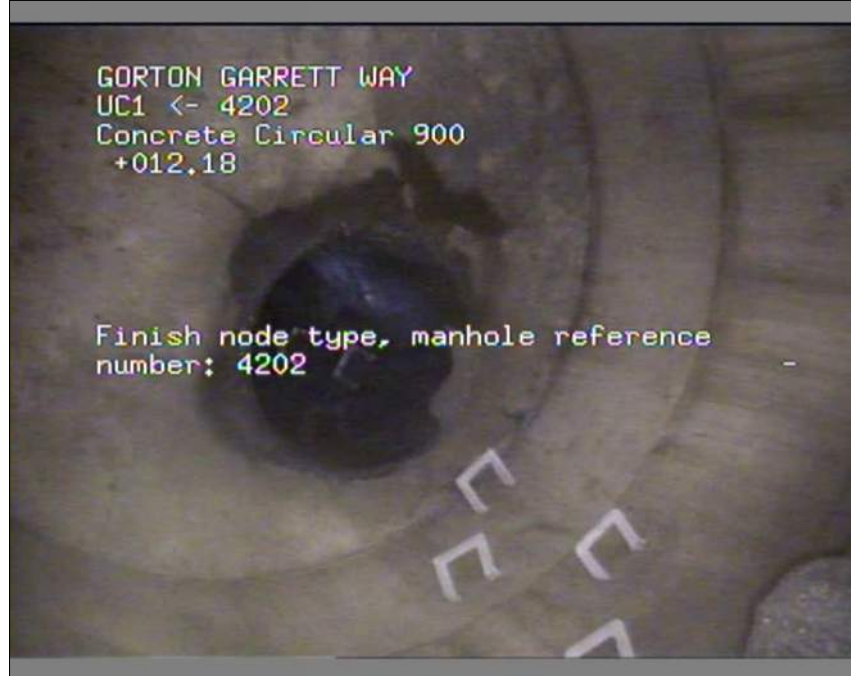
Photo: 7\_7\_42\_A.JPG  
12.18m, Finish node type, manhole reference number: 4202

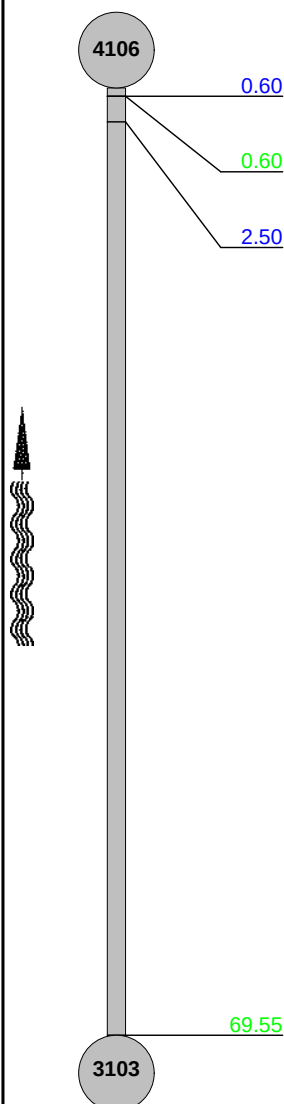
Water level, 15% of the vertical dimension

Start node type, manhole, reference number : 4106

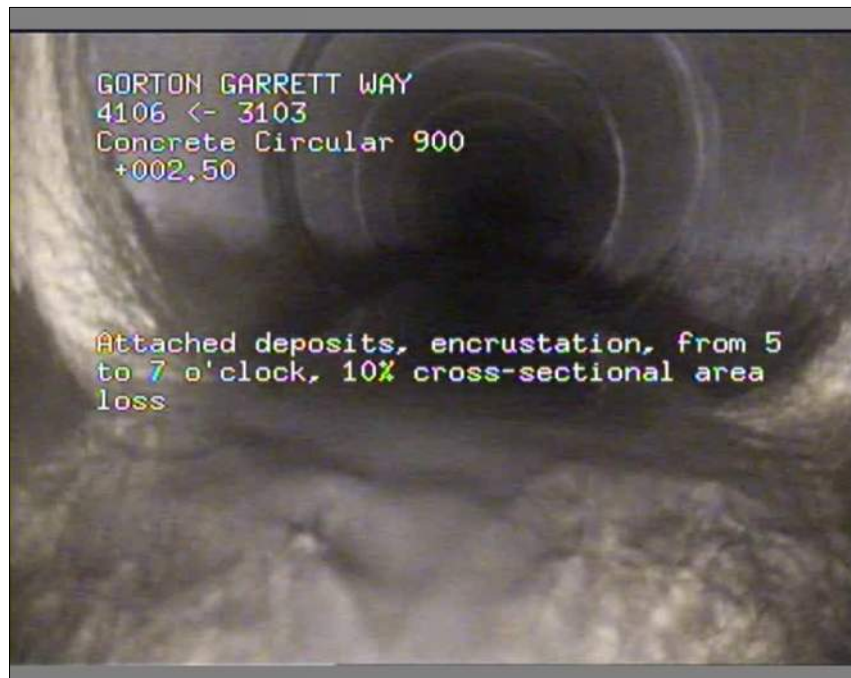
Photo: 8\_8\_46\_A.JPG

2.5m, Attached deposits, encrustation, from 5 to 7 o'clock, 10% cross-sectional area loss

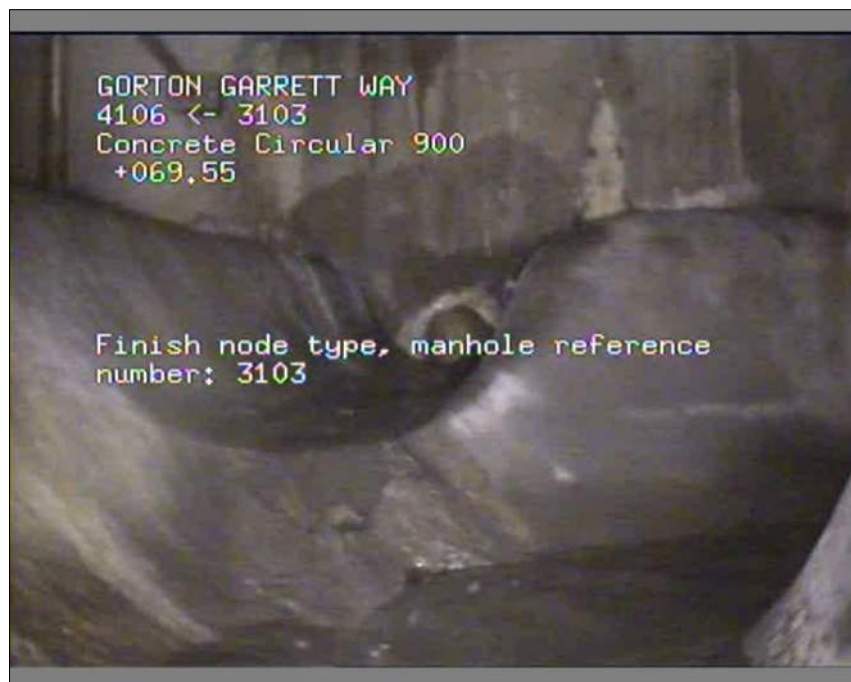
Photo: 8\_8\_47\_A.JPG

69.55m, Finish node type, manhole reference number: 3103

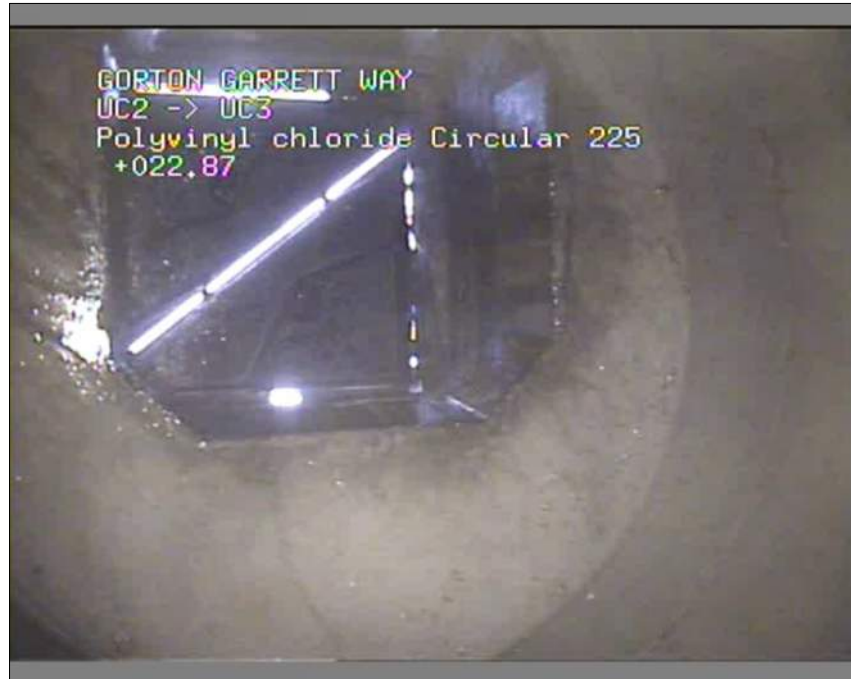
Photo: 9\_9\_57\_A.JPG  
22.87m, Finish node type, manhole reference number: UC3

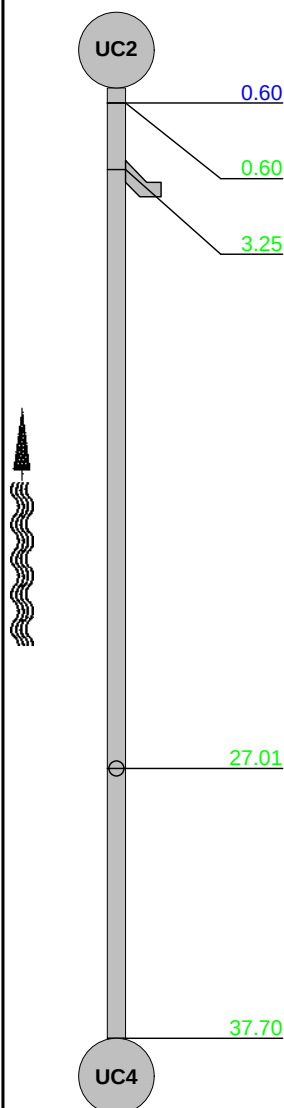
Water level, 05% of the vertical dimension

Start node type, manhole, reference number : UC2

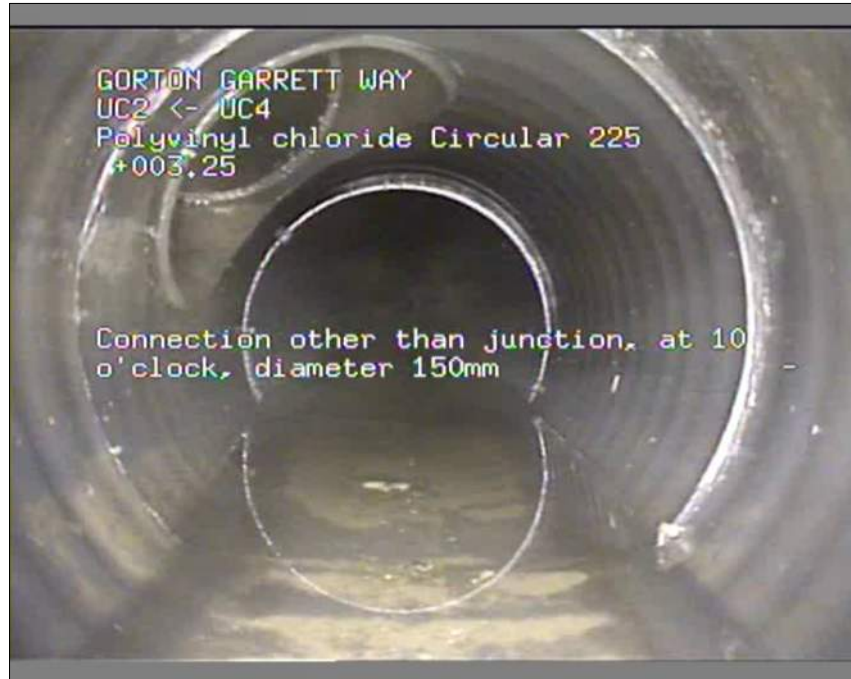
Photo: 10\_10\_62\_A.JPG

3.25m, Connection other than junction, at 10 o'clock, diameter 150mm

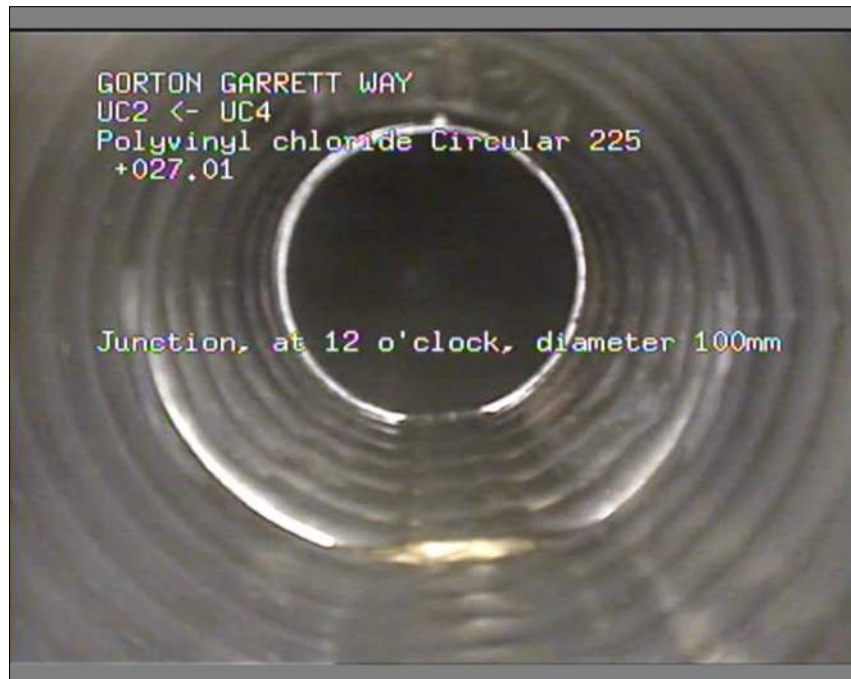
Photo: 10\_10\_63\_A.JPG

27.01m, Junction, at 12 o'clock, diameter 100mm

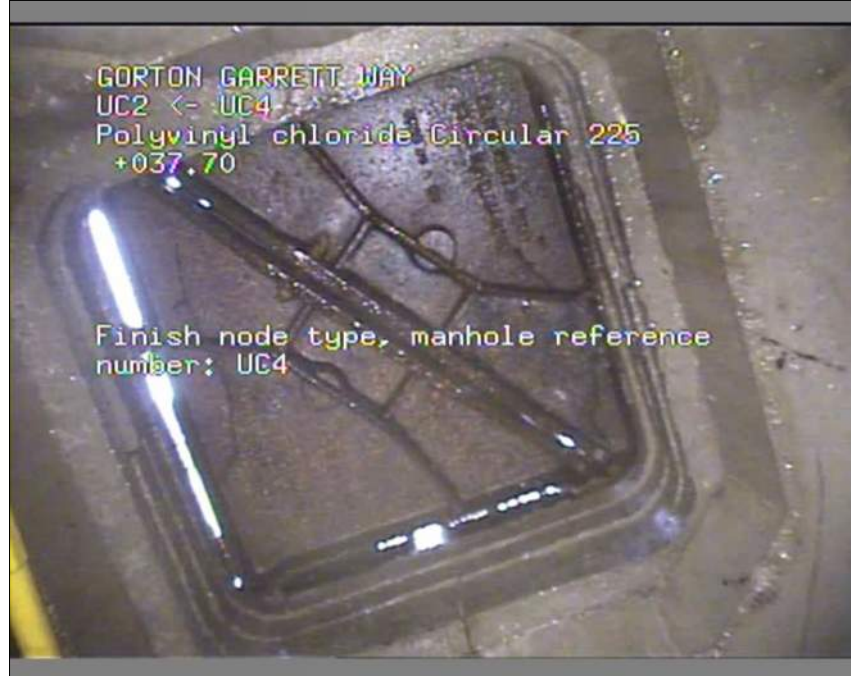
Photo: 10\_10\_64\_A.JPG  
 37.7m, Finish node type, manhole reference number: UC4

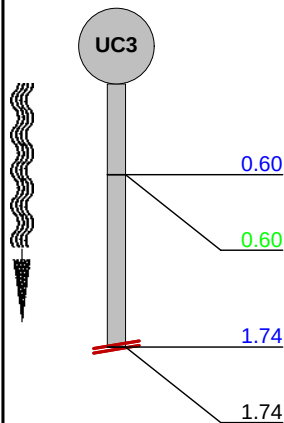
Water level, 05% of the vertical dimension

Start node type, manhole, reference number : UC3

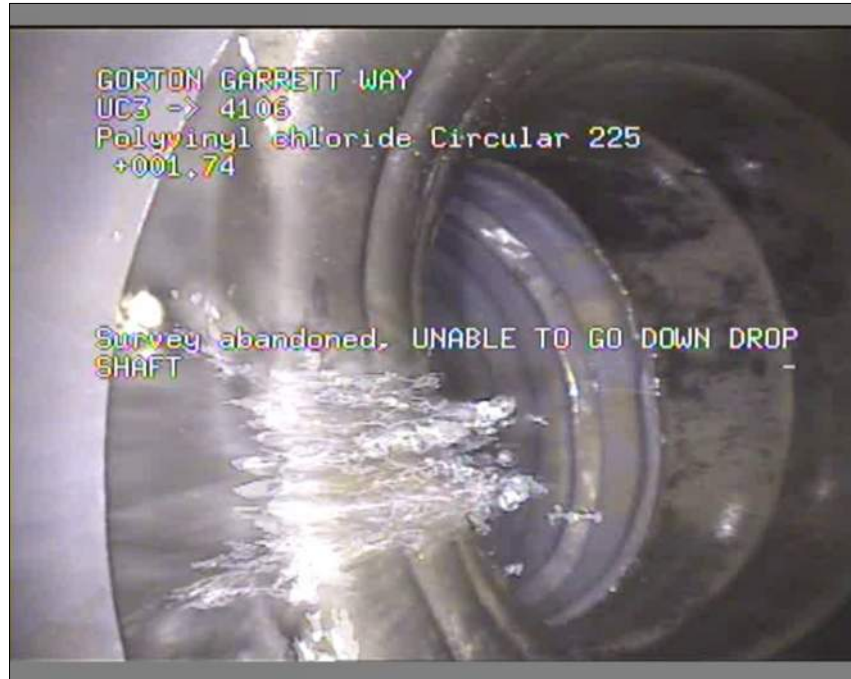
Photo: 11\_11\_61\_A.JPG  
1.74m, Survey abandoned

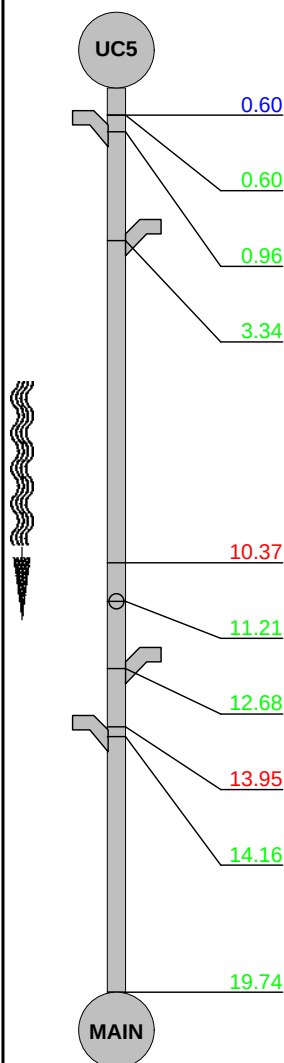
**1:165 Position**  
**Depth: 2.9**

Water level, 05% of the vertical dimension

Start node type, manhole, reference number : UC5

Fracture, multiple, from 12 to 12 o'clock

Junction, at 12 o'clock, diameter 150mm Remarks: BROKEN

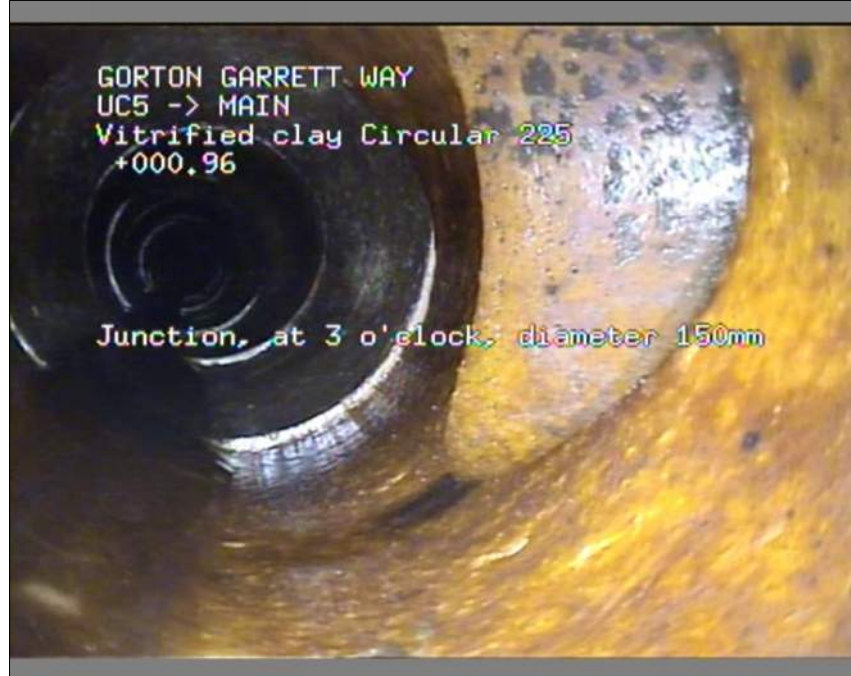
Photo: 12\_12\_67\_A.JPG  
0.96m, Junction, at 3 o'clock, diameter 150mm
