# Gorton Community Hub

## Flood Risk Assessment and Detailed Drainage Strategy

Curtins Ref: GCH-CUR-XX-XX-RP-C-0002

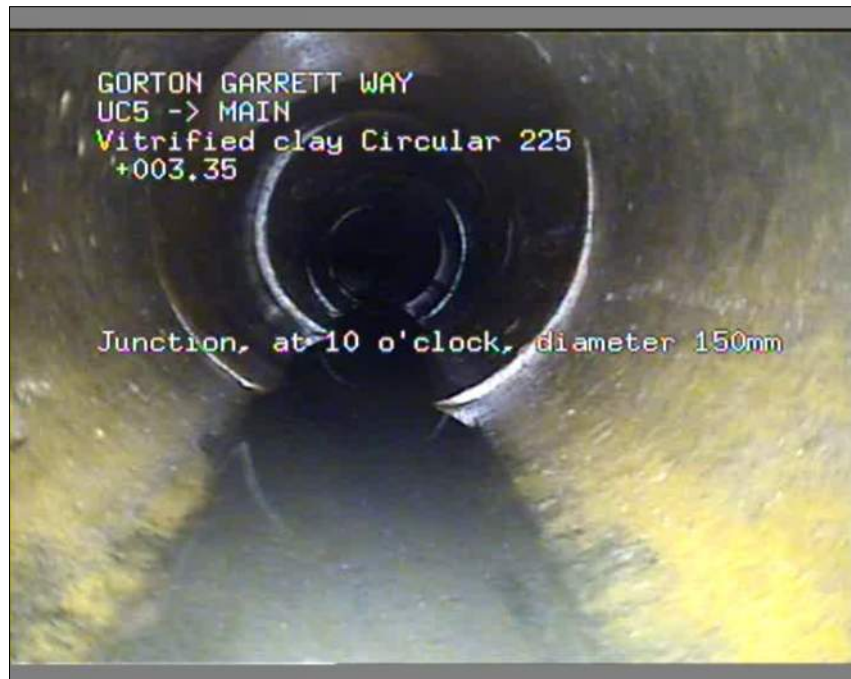
Photo: 12\_12\_68\_A.JPG  
3.34m, Junction, at 10 o'clock, diameter 150mm

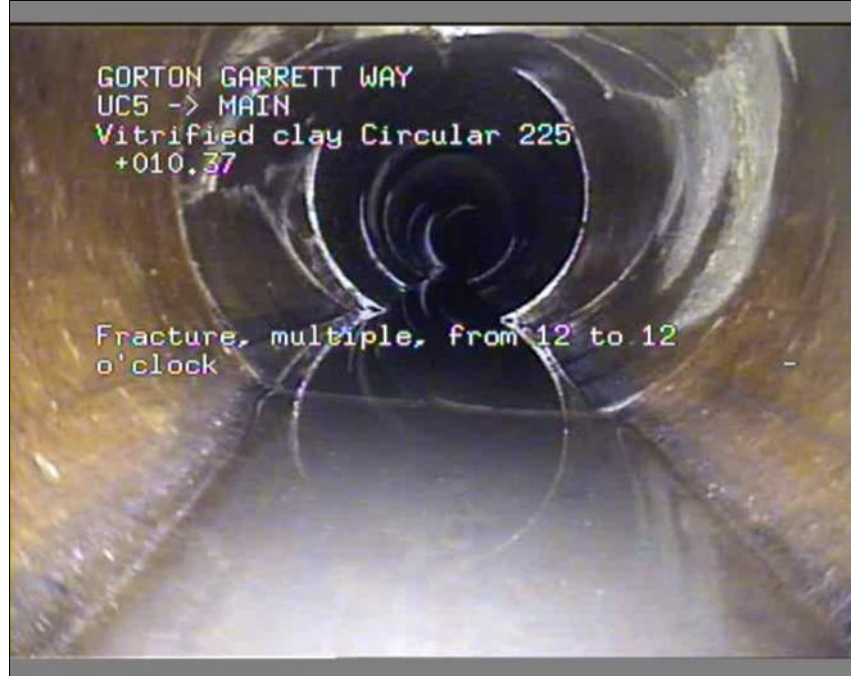
Photo: 12\_12\_69\_A.JPG  
10.37m, Fracture, multiple, from 12 to 12 o'clock

Fracture, multiple, from 12 to 12 o'clock

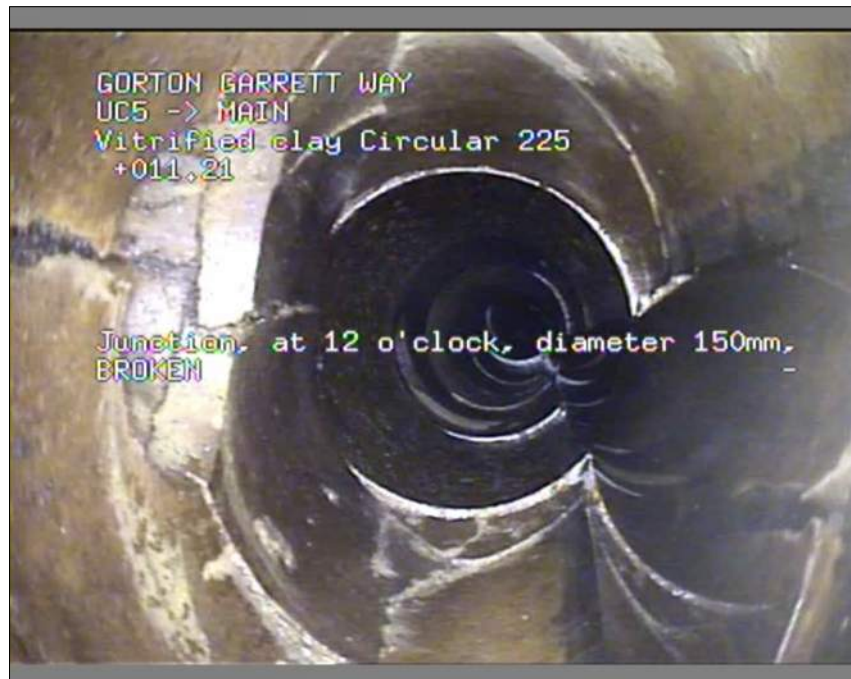
Photo: 12\_12\_70\_A.JPG  
11.21m, Junction, at 12 o'clock, diameter 150mm

Junction, at 12 o'clock, diameter 150mm Remarks: BROKEN

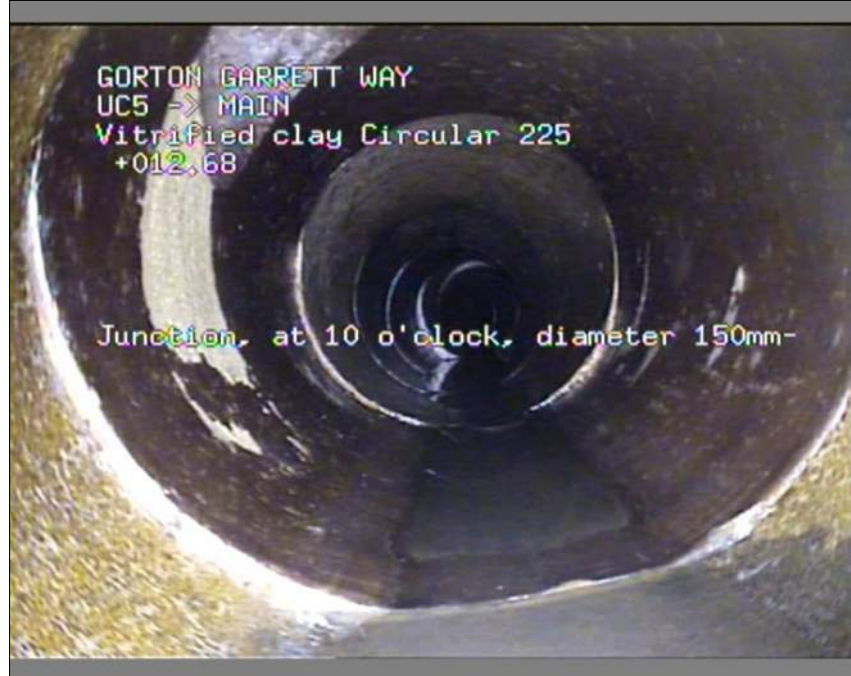
Photo: 12\_12\_71\_A.JPG  
12.68m, Junction, at 10 o'clock, diameter 150mm

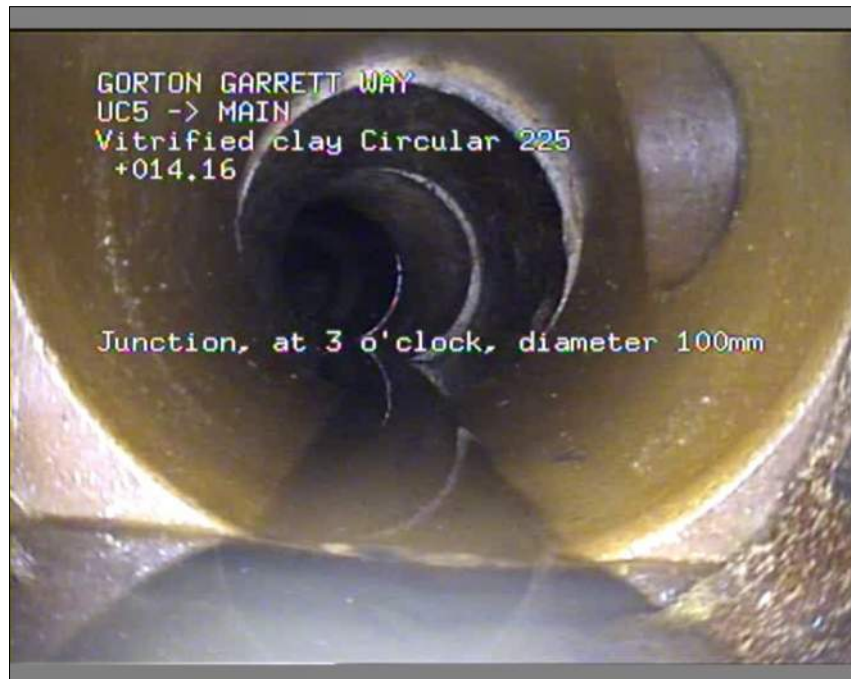
Photo: 12\_12\_73\_A.JPG  
14.16m, Junction, at 3 o'clock, diameter 100mm

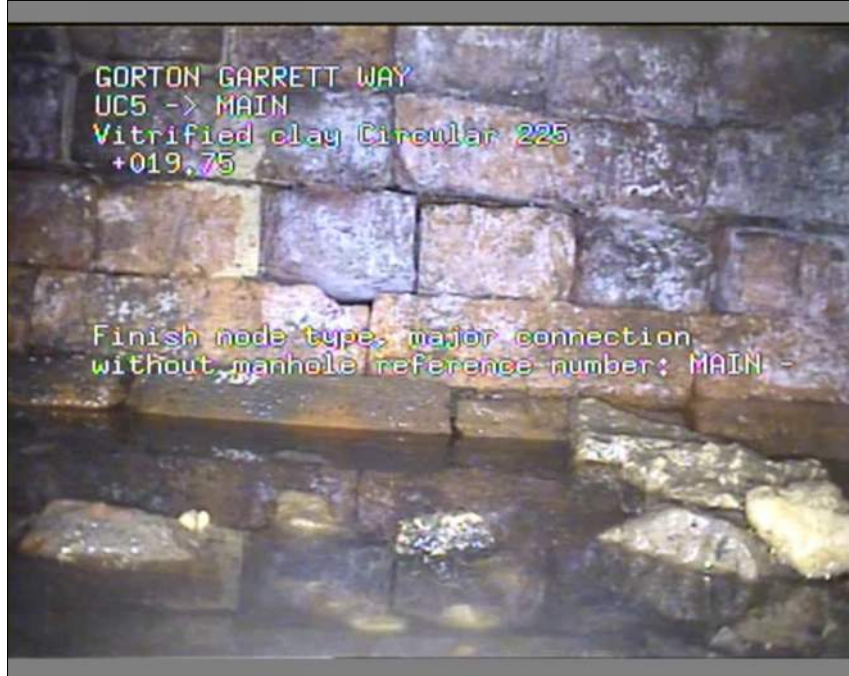
Photo: 12\_12\_74\_A.JPG

19.74m, Finish node type, major connection without manhole reference number: MAIN

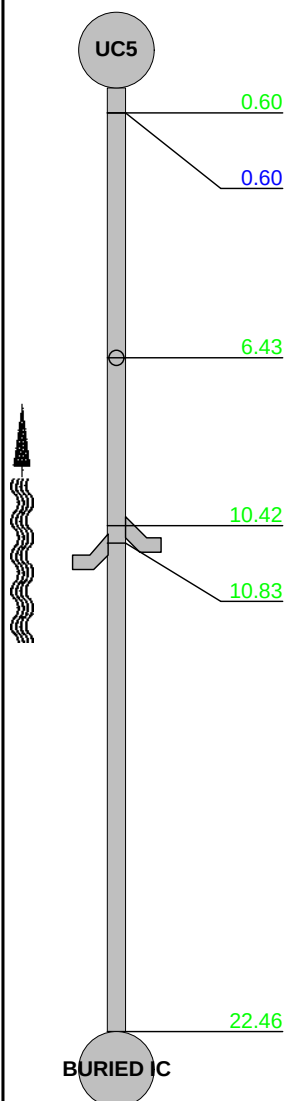
**1:180 Position**  
**Depth: 2.9**

Start node type, manhole, reference number : UC5

Water level, 15% of the vertical dimension

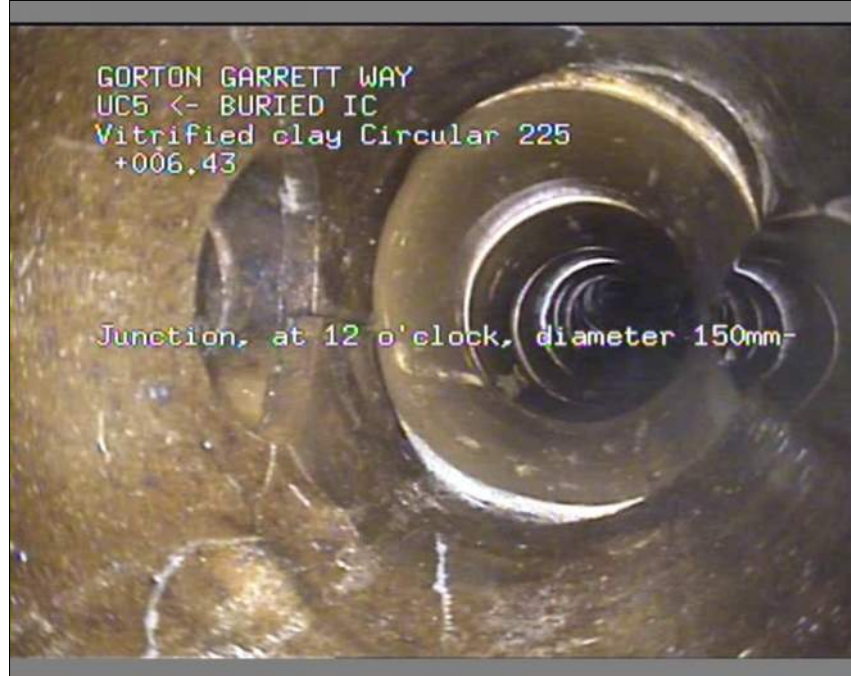
Photo: 13\_13\_79\_A.JPG  
6.43m, Junction, at 12 o'clock, diameter 150mm

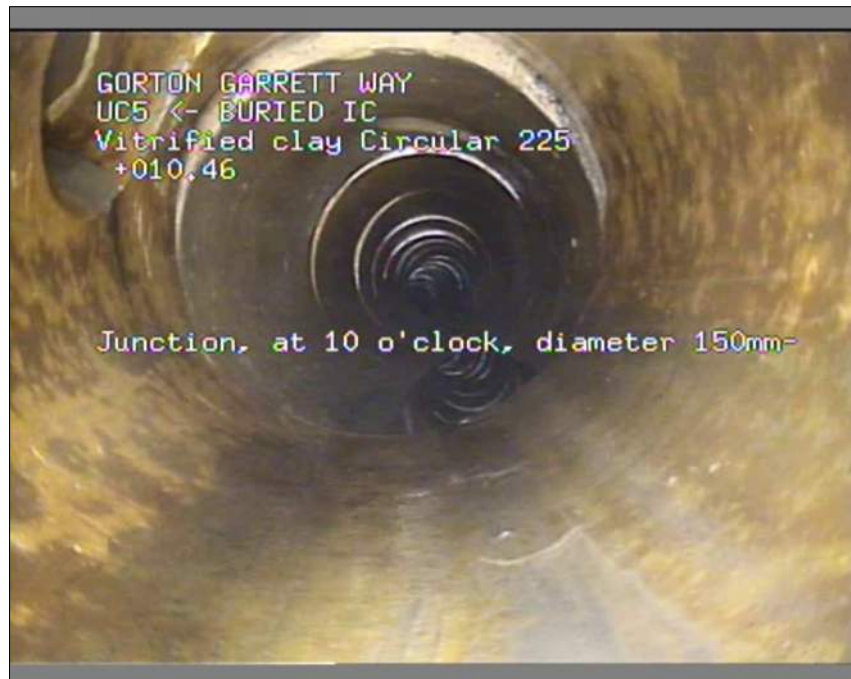
Photo: 13\_13\_80\_A.JPG  
10.42m, Junction, at 10 o'clock, diameter 150mm

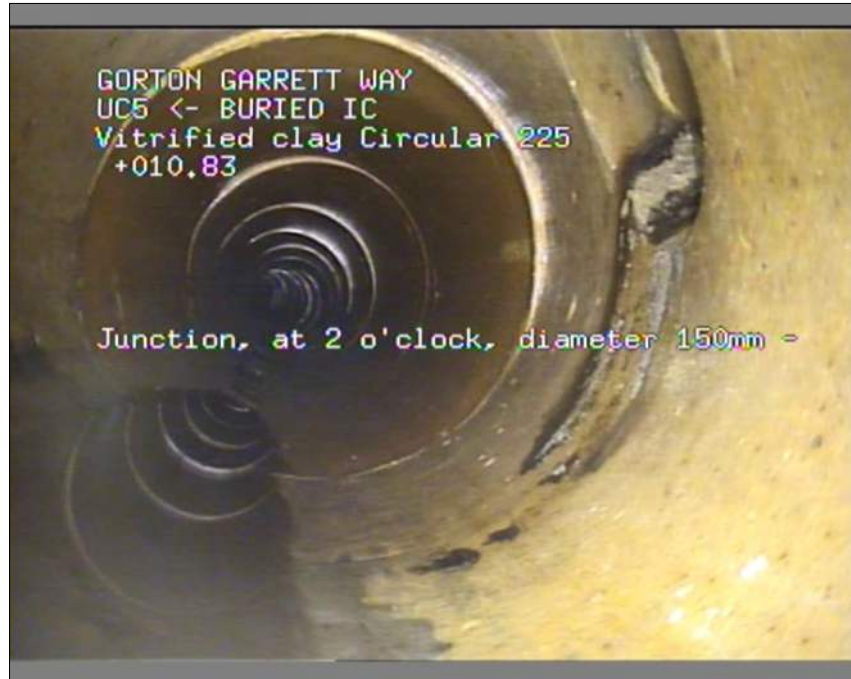
Photo: 13\_13\_81\_A.JPG  
 10.83m, Junction, at 2 o'clock, diameter 150mm

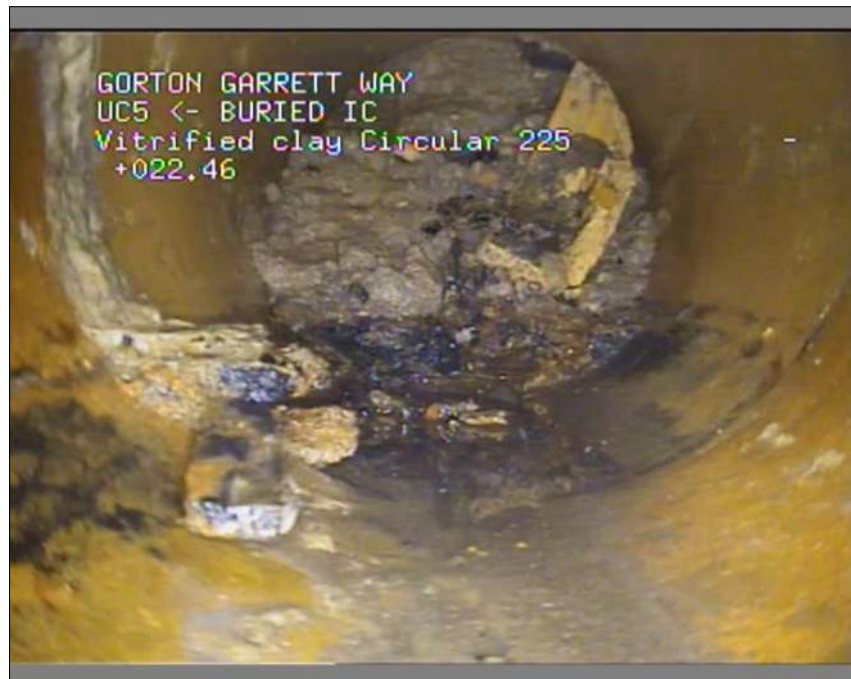
Photo: 13\_13\_82\_A.JPG  
 22.46m, Finish node type, inspection chamber reference number: BURIED IC

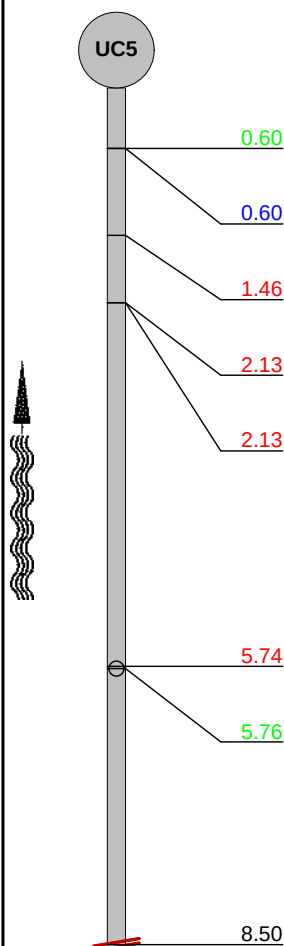
**1:75 Position**  
**Depth: 2.9**

Start node type, manhole, reference number : UC5

Water level, 05% of the vertical dimension

Crack, longitudinal, at 2 o'clock

Crack, longitudinal, at 9 o'clock

Fracture, multiple, from 12 to 12 o'clock

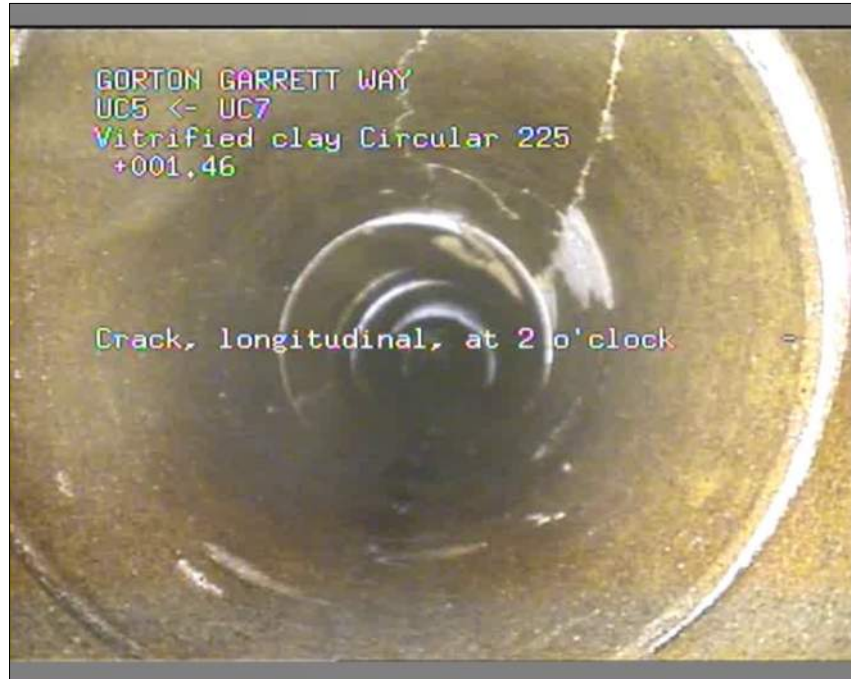
Photo: 15\_15\_85\_A.JPG  
 1.46m, Crack, longitudinal, at 2 o'clock

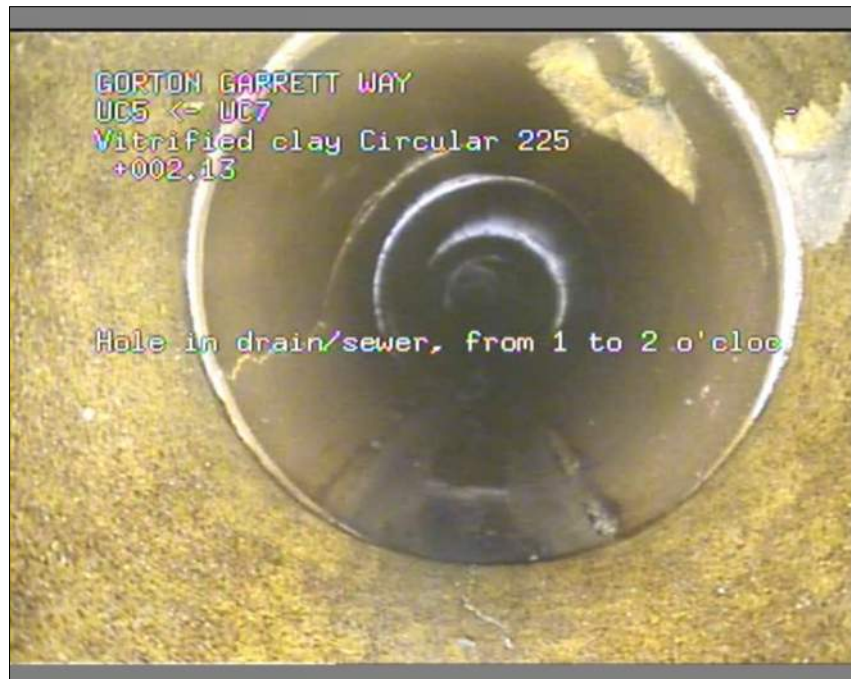
Photo: 15\_15\_86\_A.JPG  
 2.13m, Hole in drain/ sewer, from 1 to 2 o'clock

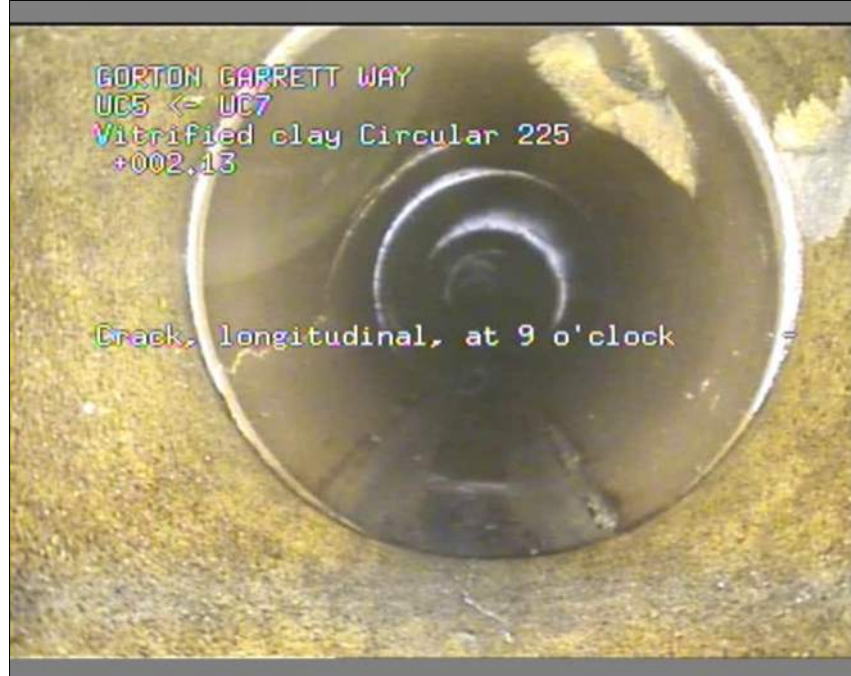
Photo: 15\_15\_88\_A.JPG  
2.13m, Crack, longitudinal, at 9 o'clock

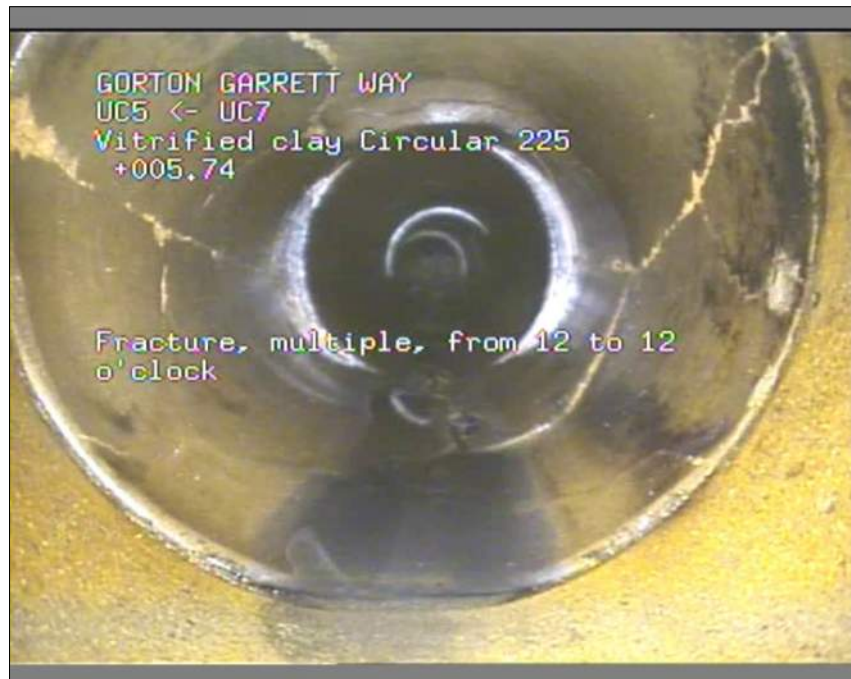
Photo: 15\_15\_89\_A.JPG  
5.74m, Fracture, multiple, from 12 to 12 o'clock

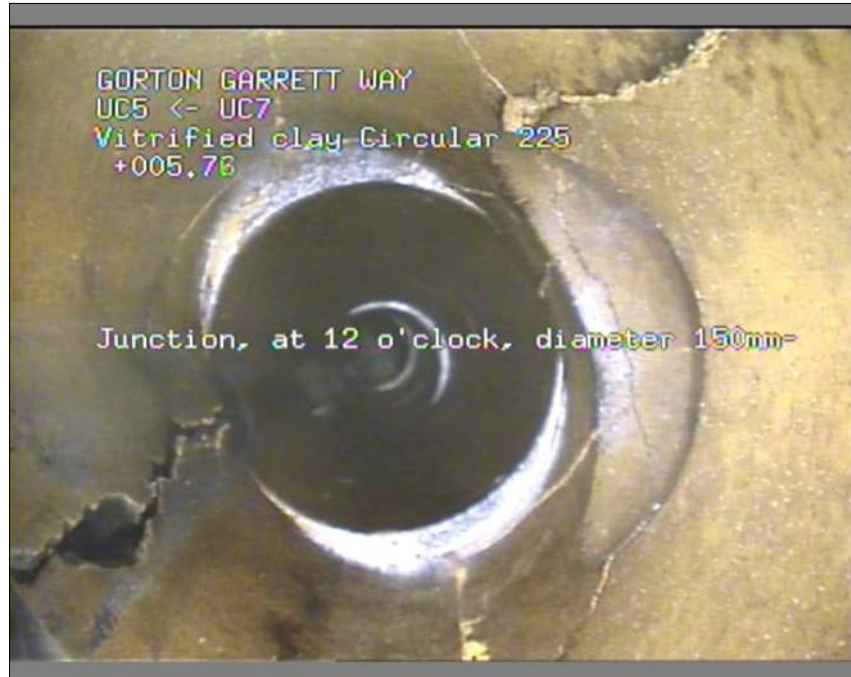
Photo: 15\_15\_90\_A.JPG  
 5.76m, Junction, at 12 o'clock, diameter 150mm

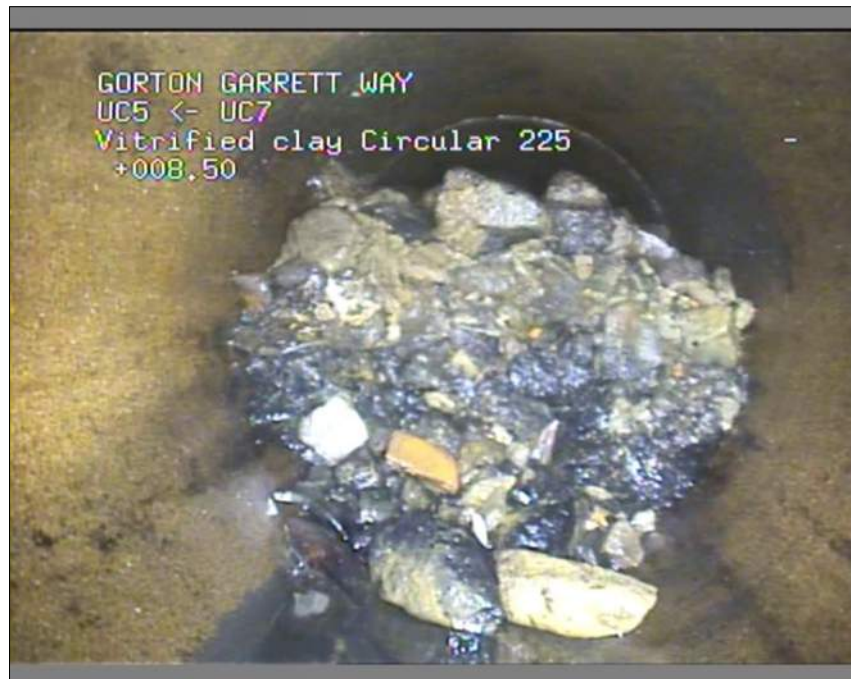
Photo: 15\_15\_91\_A.JPG  
 8.5m, Survey abandoned

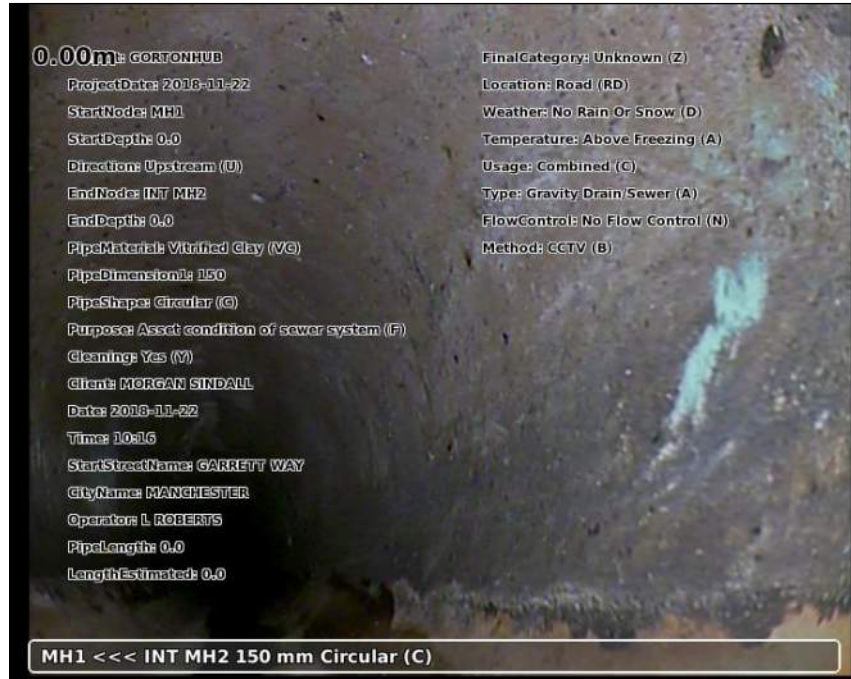
Photo: 20181122-101845-snap0000.jpg  
 0m, Start node type manhole reference number: MH1

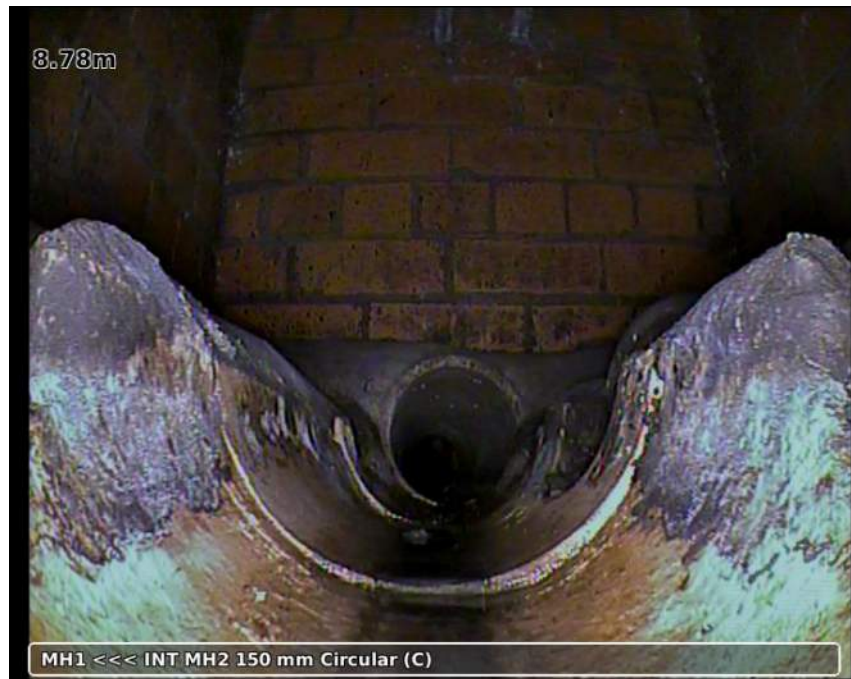
Photo: 20181122-101845-snap0001.jpg  
 8.78m, Finish node type manhole reference number: INT MH2

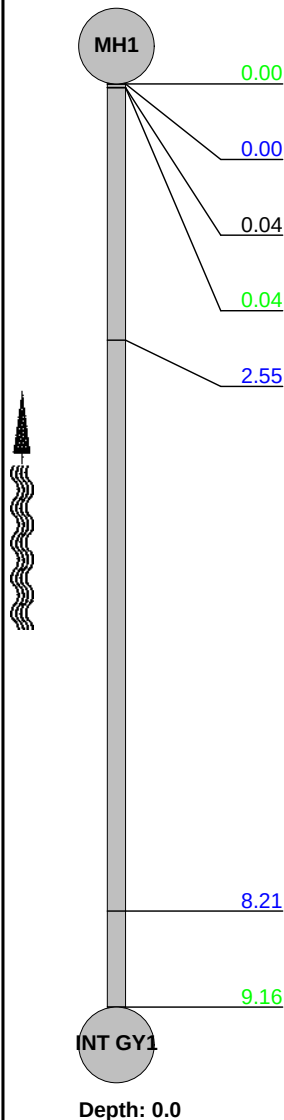
**1:75 Position**  
**Depth: 0.0**

Start node type manhole reference number: MH1

Water level 05 % of the vertical dimension

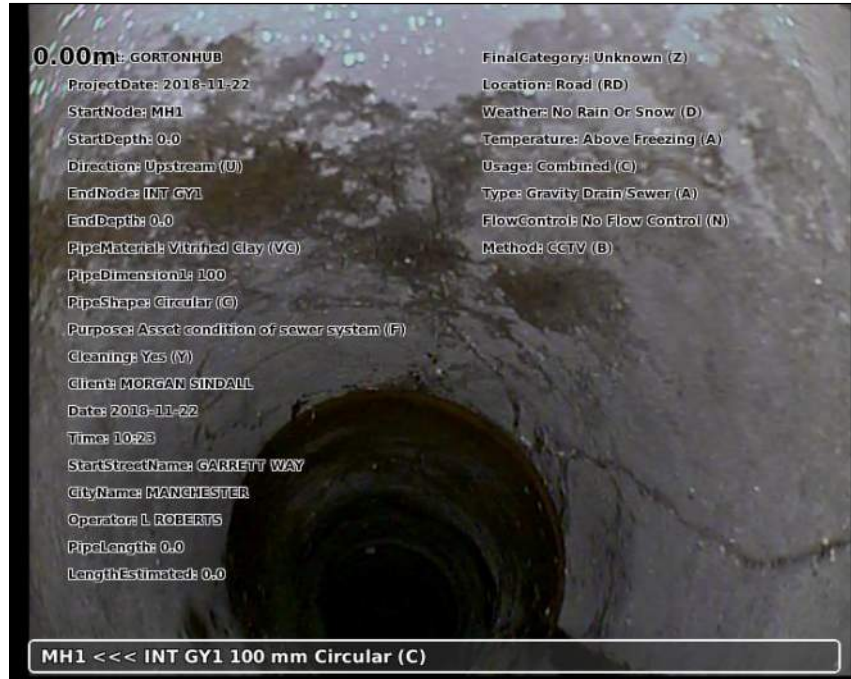
Photo: 20181122-102339-snap0000.jpg  
 0m, Start node type manhole reference number: MH1

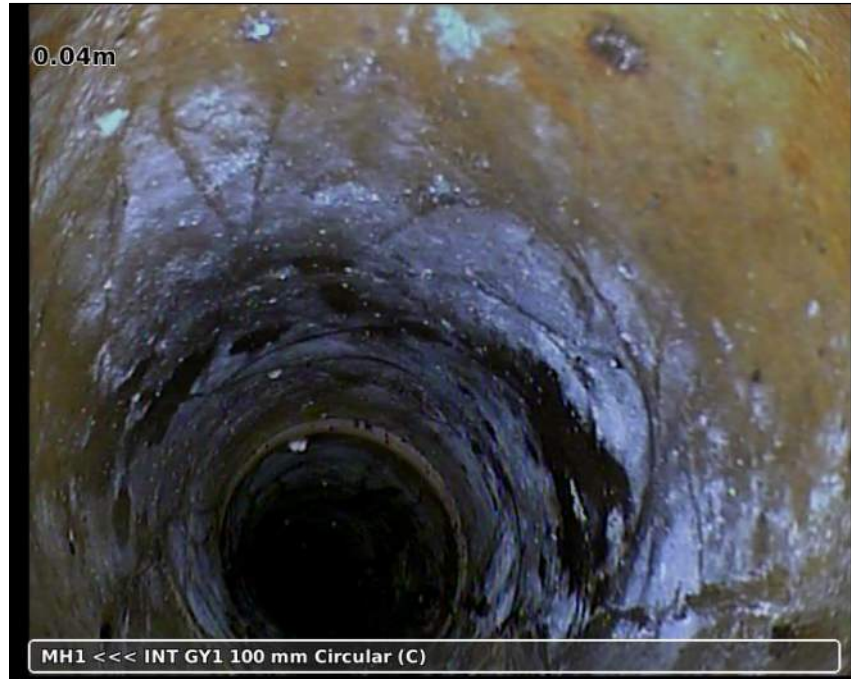
Photo: 20181122-102339-snap0002.jpg  
 0.04m, Junction from/at 06 o'clock diameter: 100 mm

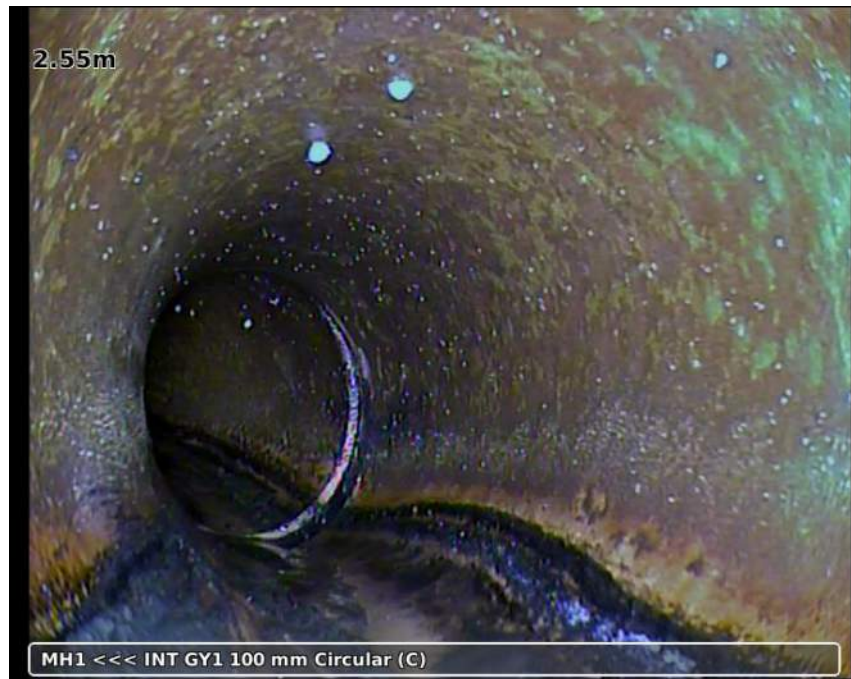
Photo: 20181122-102339-snap0003.jpg  
 2.55m, Line deviates left

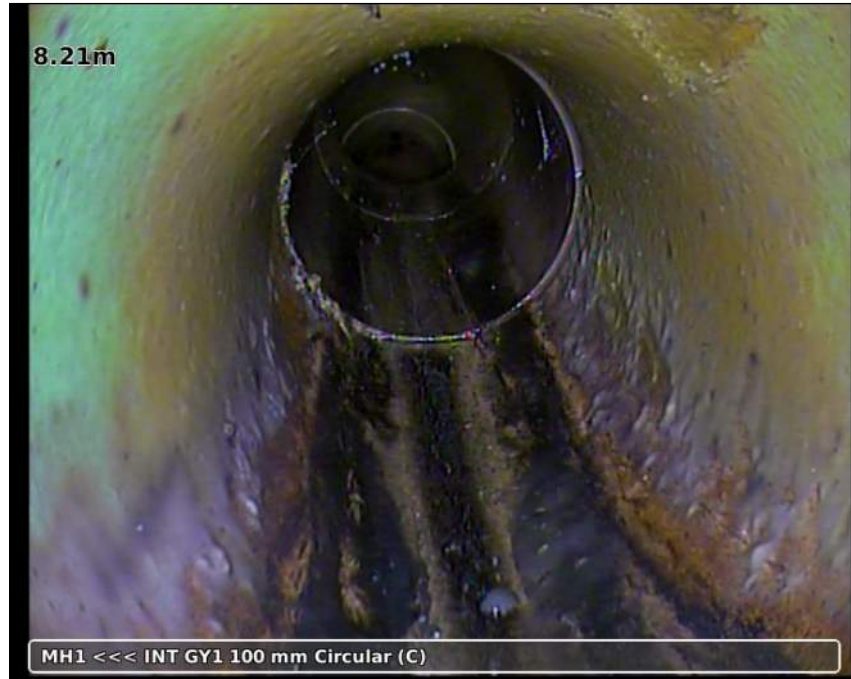
Photo: 20181122-102339-snap0004.jpg  
 8.21m, Line deviates up

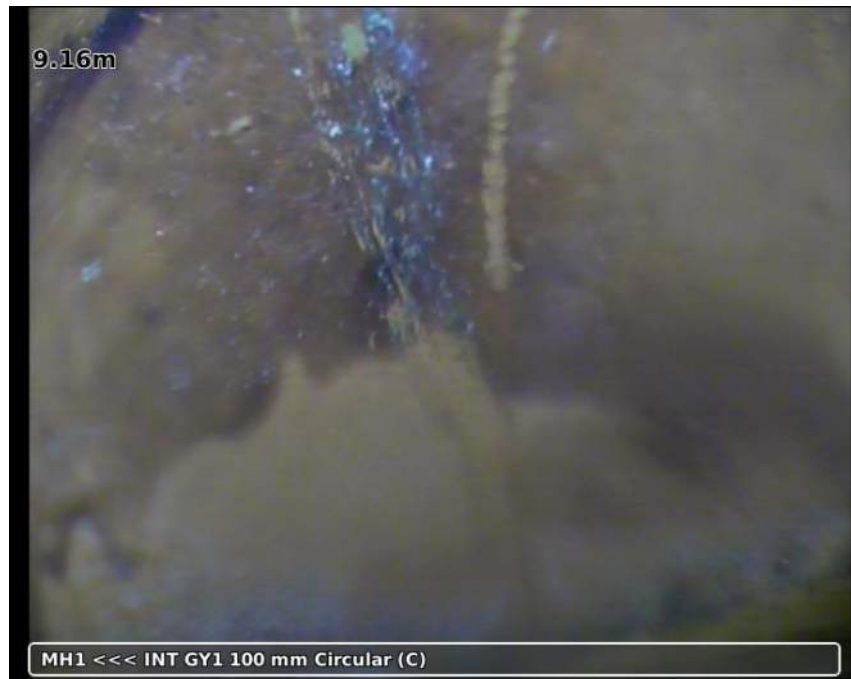
Photo: 20181122-102339-snap0005.jpg  
 9.16m, Finish node type gully reference number: INT GY1

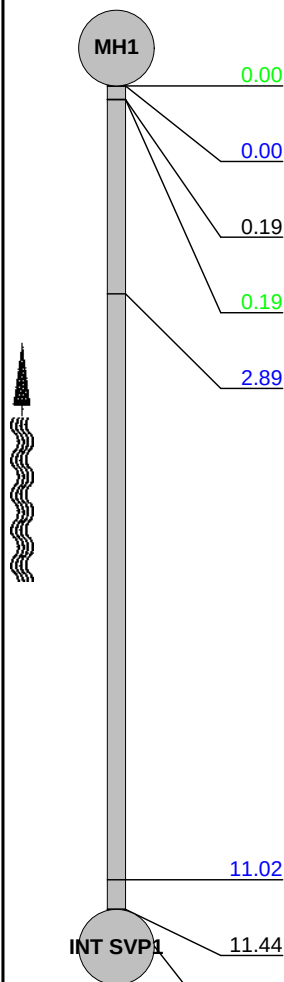
1:105 Position  
Depth: 0.0

Start node type manhole reference number: MH1

Water level 05 % of the vertical dimension

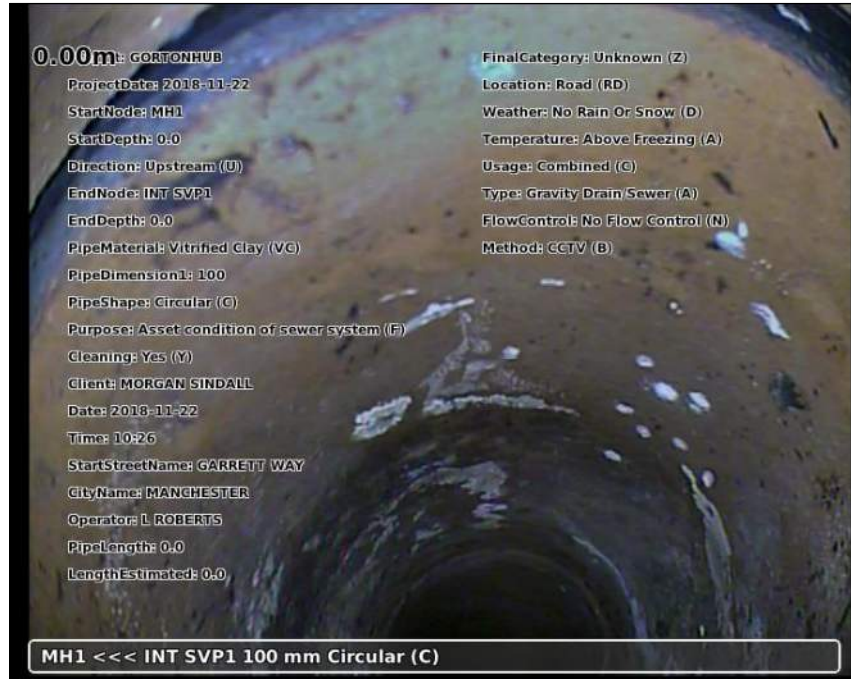
Photo: 20181122-102650-snap0000.jpg  
 0m, Start node type manhole reference number: MH1

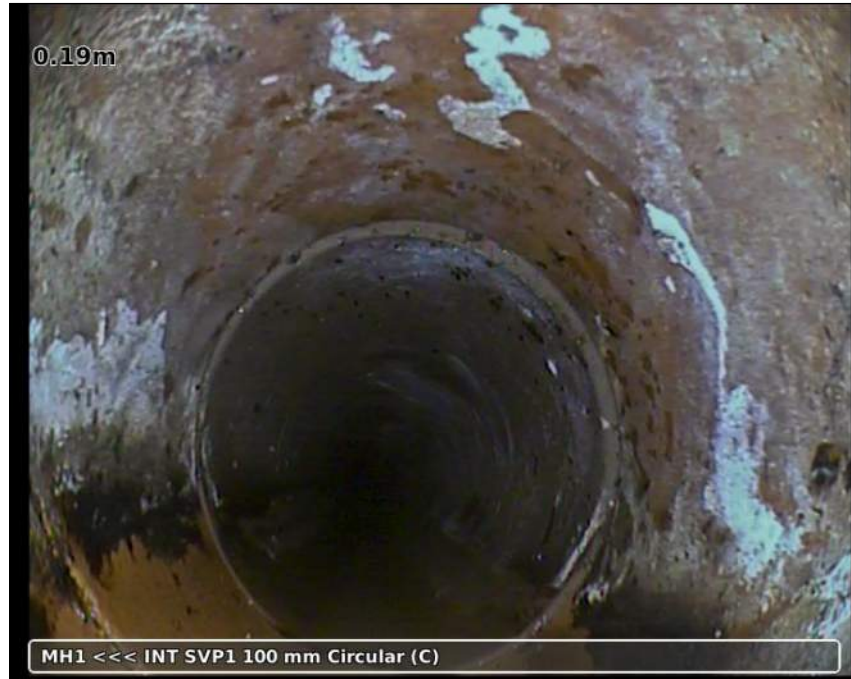
Photo: 20181122-102650-snap0002.jpg  
 0.19m, Junction from/at 06 o'clock diameter: 100 mm

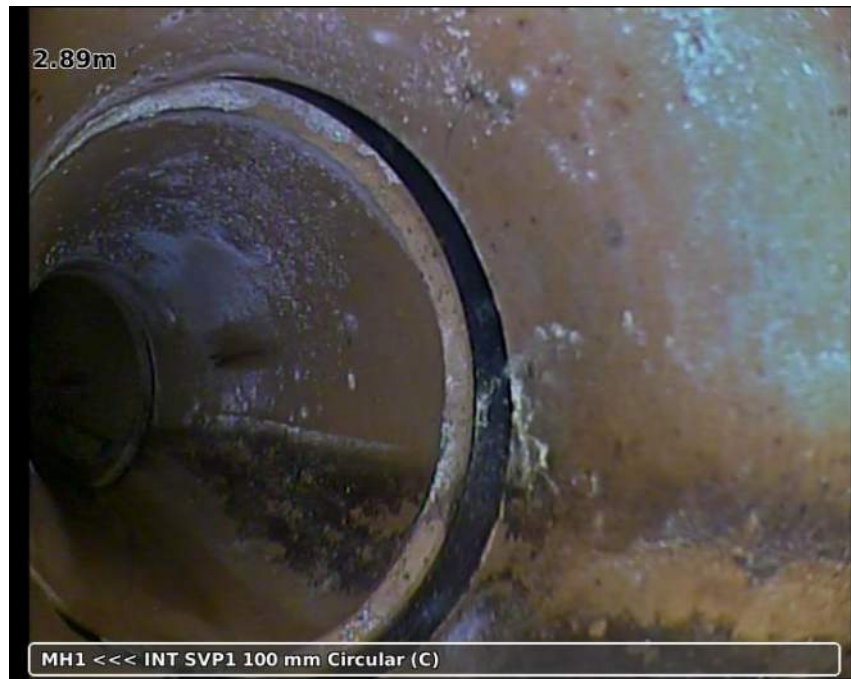
Photo: 20181122-102650-snap0003.jpg  
 2.89m, Line deviates left

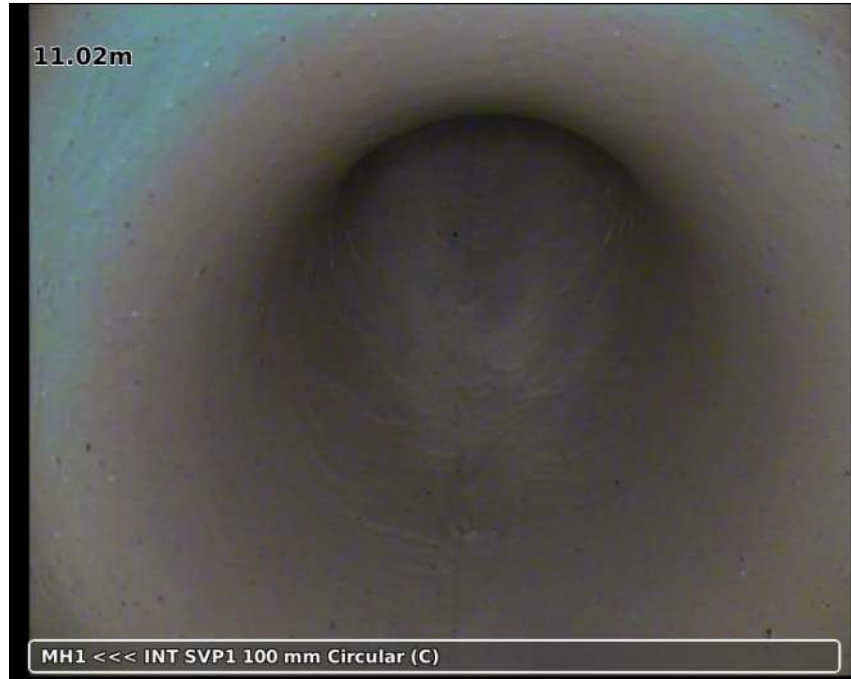
Photo: 20181122-102650-snap0004.jpg  
 11.02m, Line deviates up

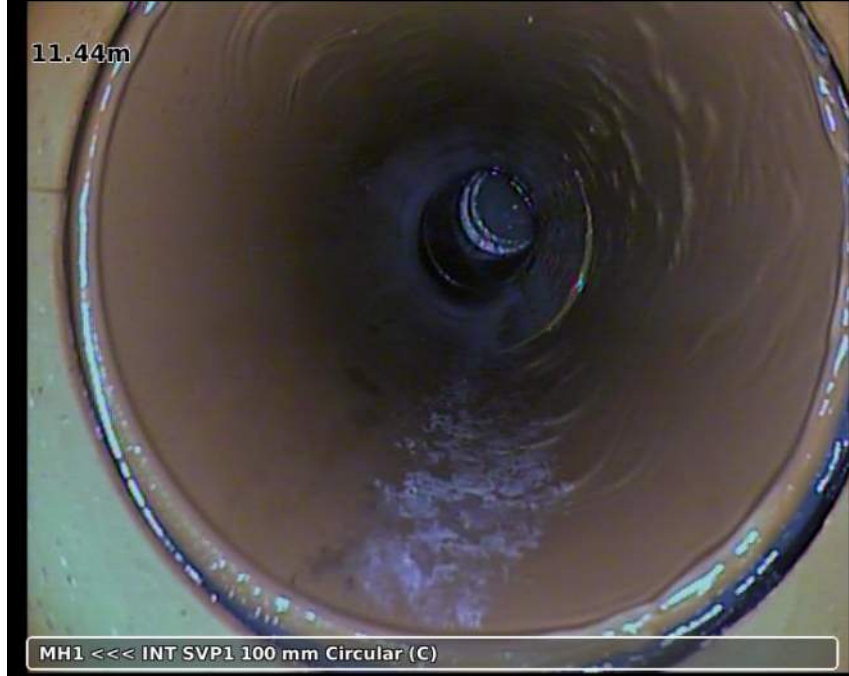
Photo: 20181122-102650-snap0006.jpg

11.44m, Finish node type other special chamber reference number: INT SVP1

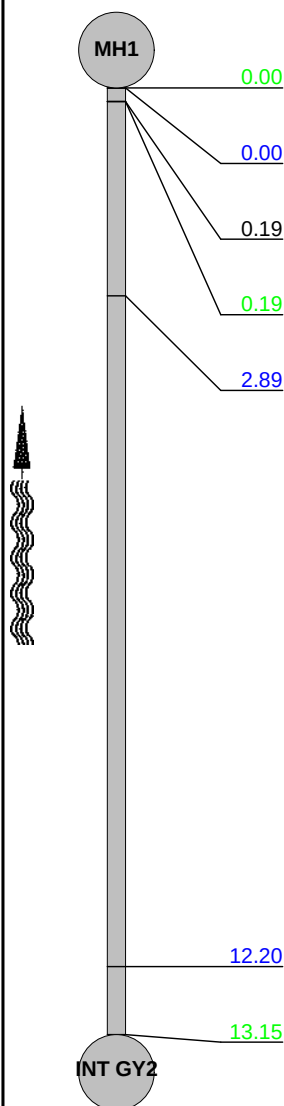
**1:105 Position**  
**Depth: 0.0**

Start node type manhole reference number: MH1

Water level 05 % of the vertical dimension

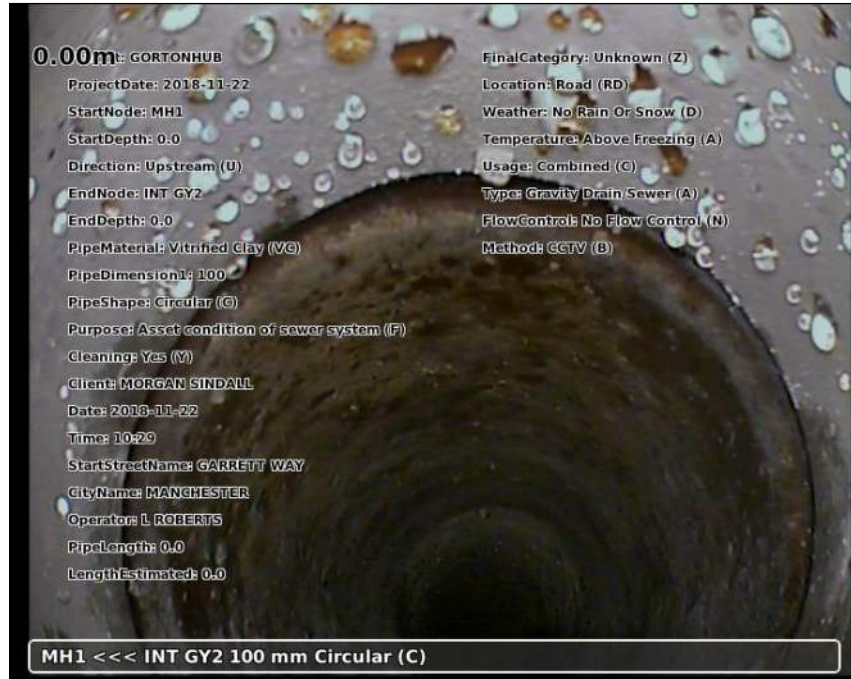
Photo: 20181122-103009-snap0000.jpg  
 0m, Start node type manhole reference number: MH1

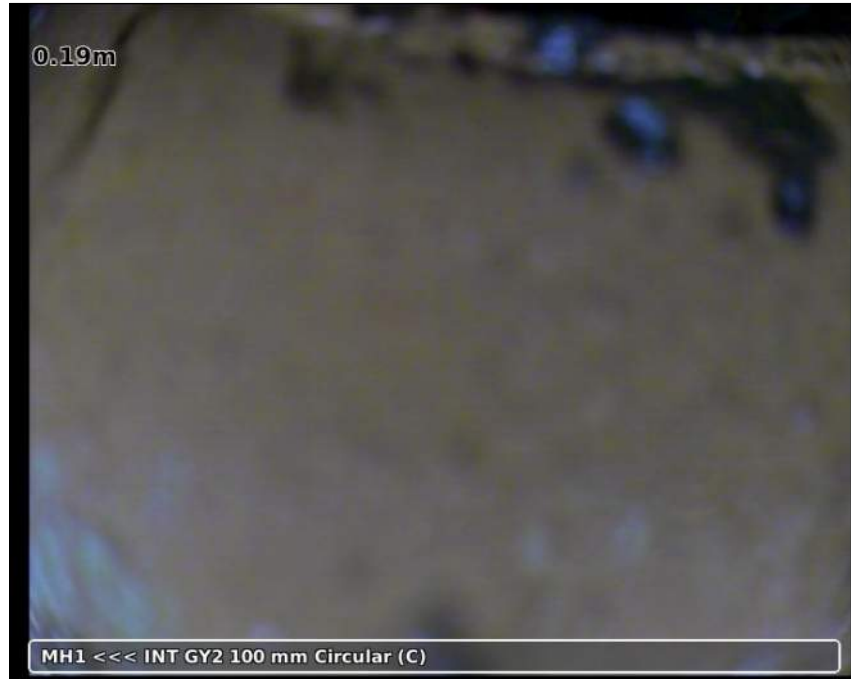
Photo: 20181122-103009-snap0002.jpg  
 0.19m, Junction from/at 06 o'clock diameter: 100 mm

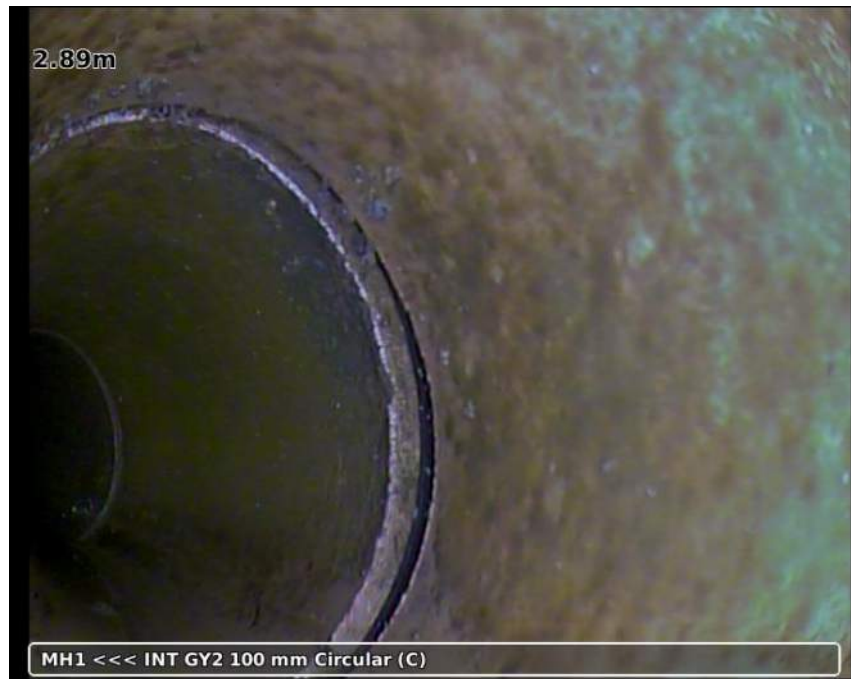
Photo: 20181122-103009-snap0003.jpg  
 2.89m, Line deviates left

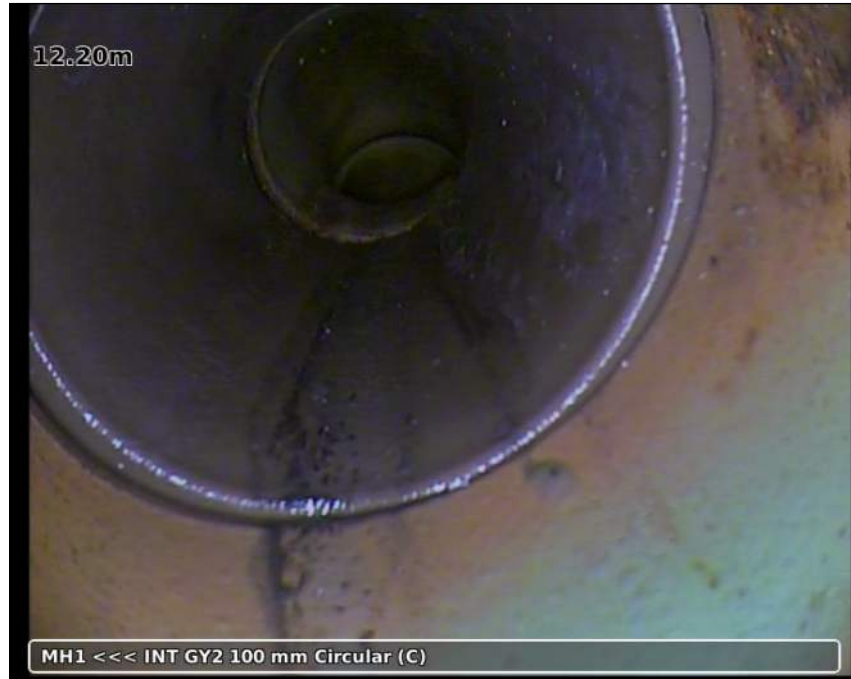
Photo: 20181122-103009-snap0004.jpg  
 12.2m, Line deviates up

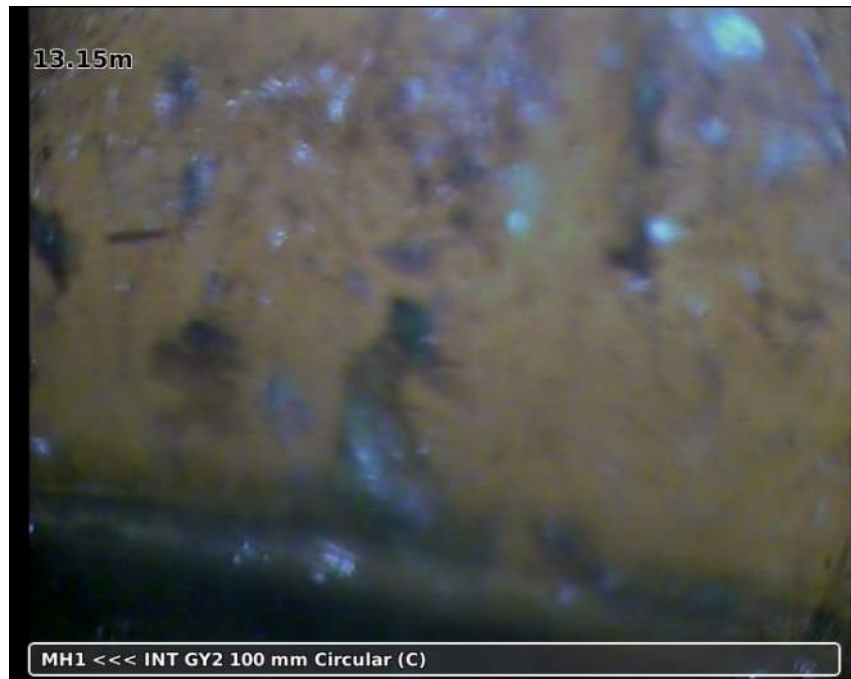
Photo: 20181122-103009-snap0005.jpg  
 13.15m, Finish node type gully reference number: INT GY2

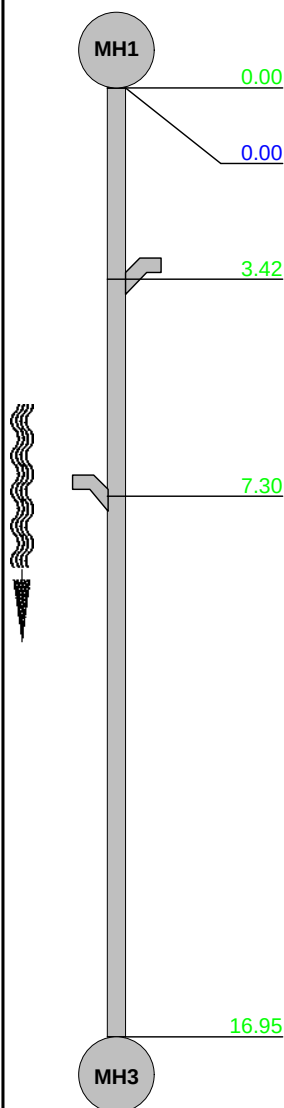
Start node type manhole reference number: MH1

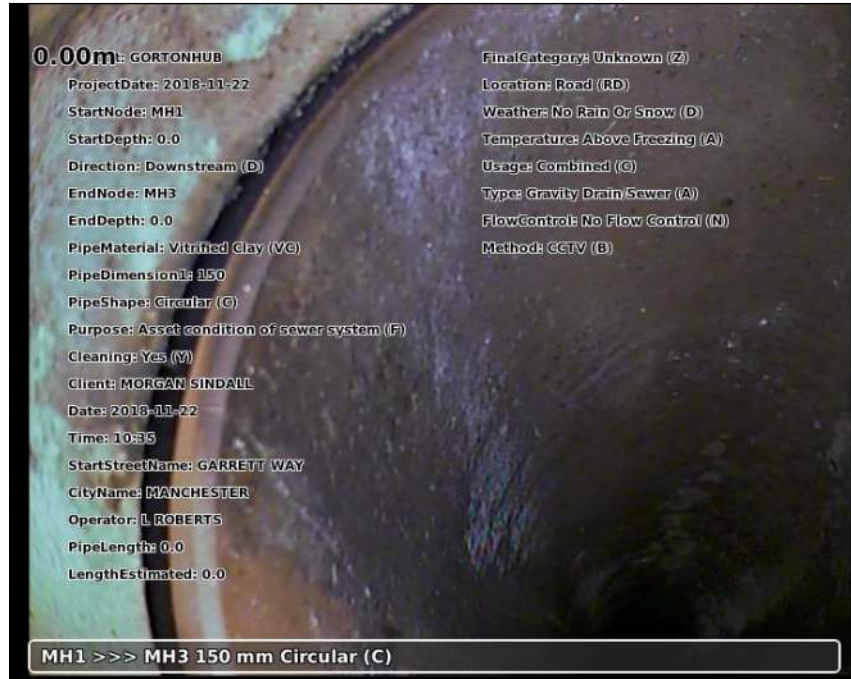
Photo: 20181122-103541-snap0000.jpg  
 0m, Start node type manhole reference number: MH1

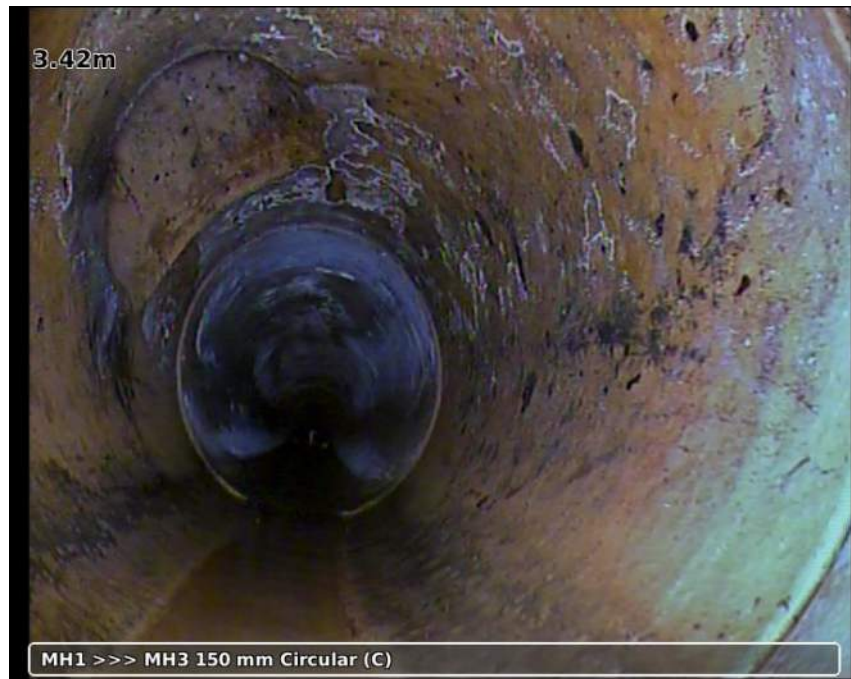
Photo: 20181122-103541-snap0001.jpg  
 3.42m, Junction from/at 10 o'clock diameter: 100 mm
