# Gorton Community Hub

## Flood Risk Assessment and Detailed Drainage Strategy

Curtins Ref: GCH-CUR-XX-XX-RP-C-0002

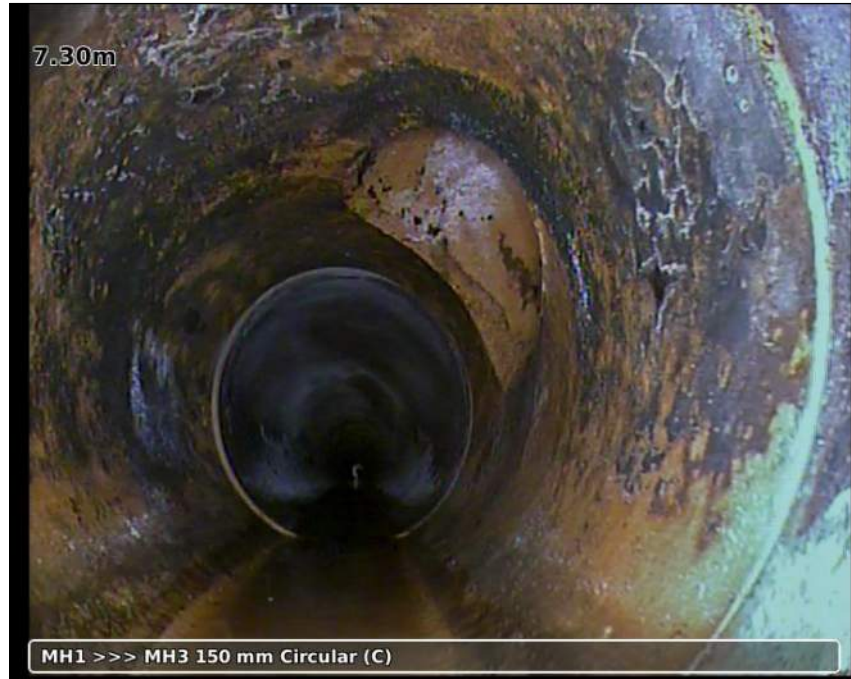
Photo: 20181122-103541-snap0002.jpg  
 7.3m, Junction from/at 02 o'clock diameter: 100 mm

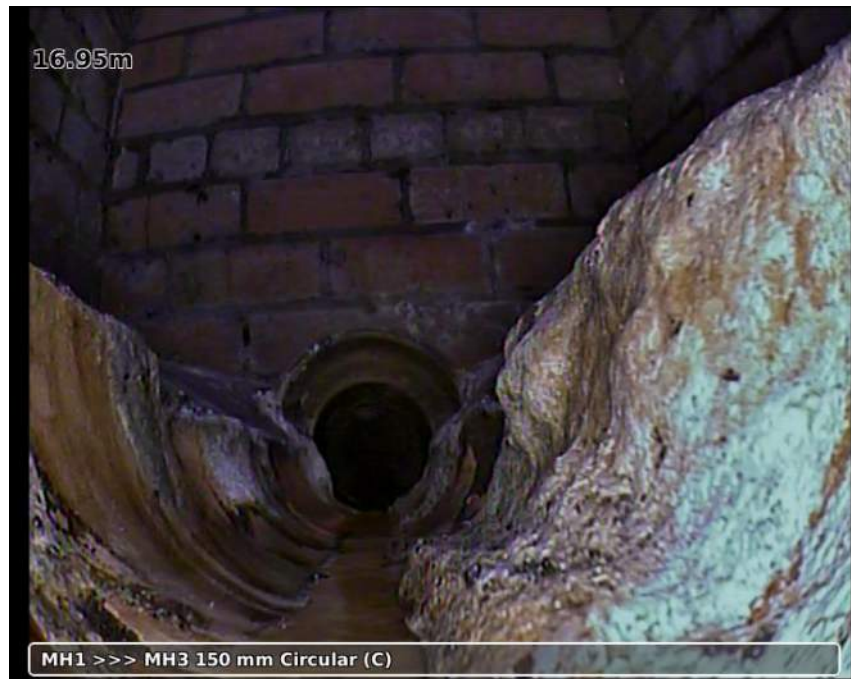
Photo: 20181122-103541-snap0003.jpg  
 16.95m, Finish node type manhole reference number: MH3

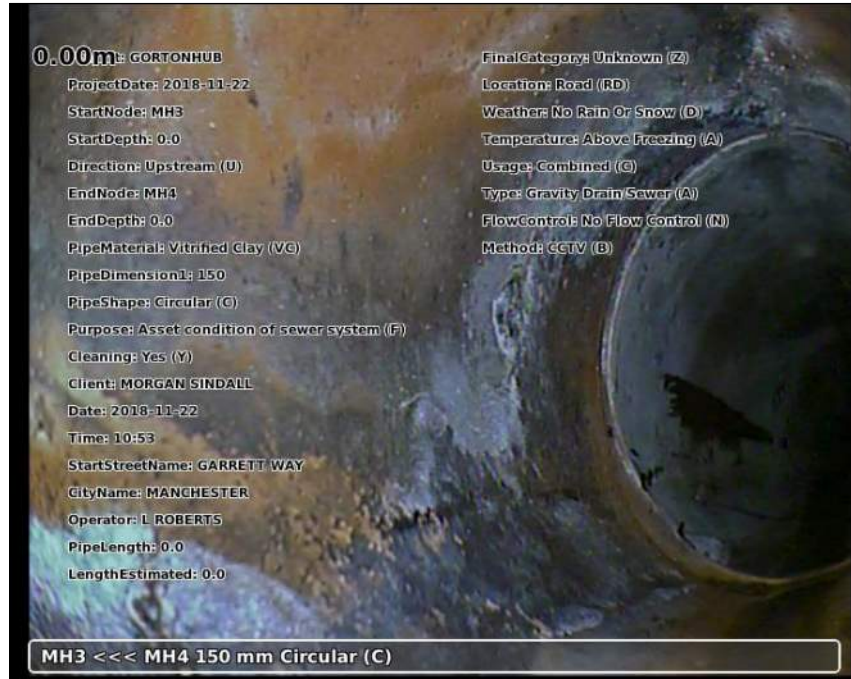
Photo: 20181122-105400-snap0000.jpg  
 0m, Start node type manhole reference number: MH3

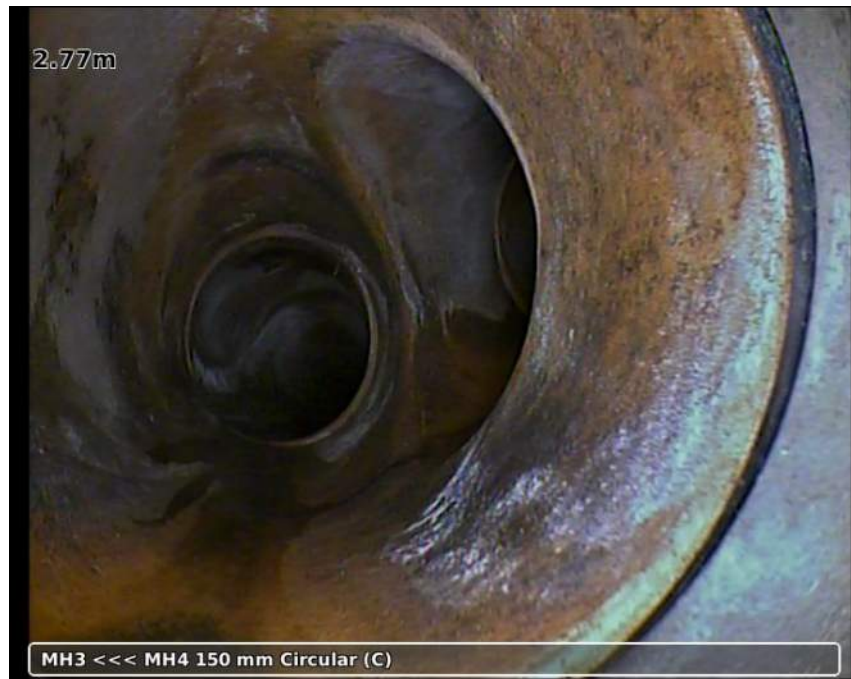
Photo: 20181122-105400-snap0001.jpg  
 2.77m, Junction from/at 03 o'clock diameter: 150 mm

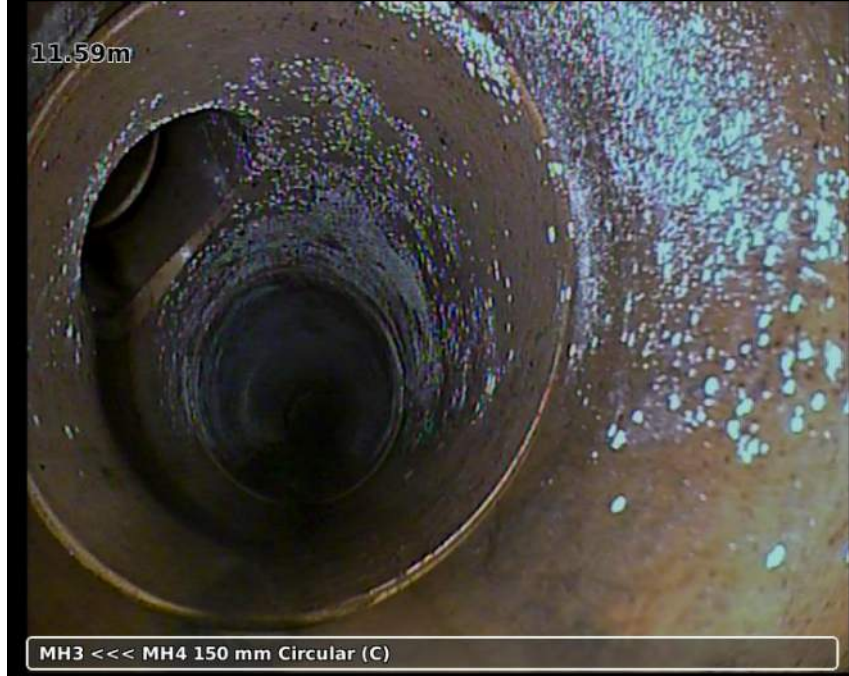
Photo: 20181122-105400-snap0002.jpg  
 11.59m, Junction from/at 10 o'clock diameter: 100 mm

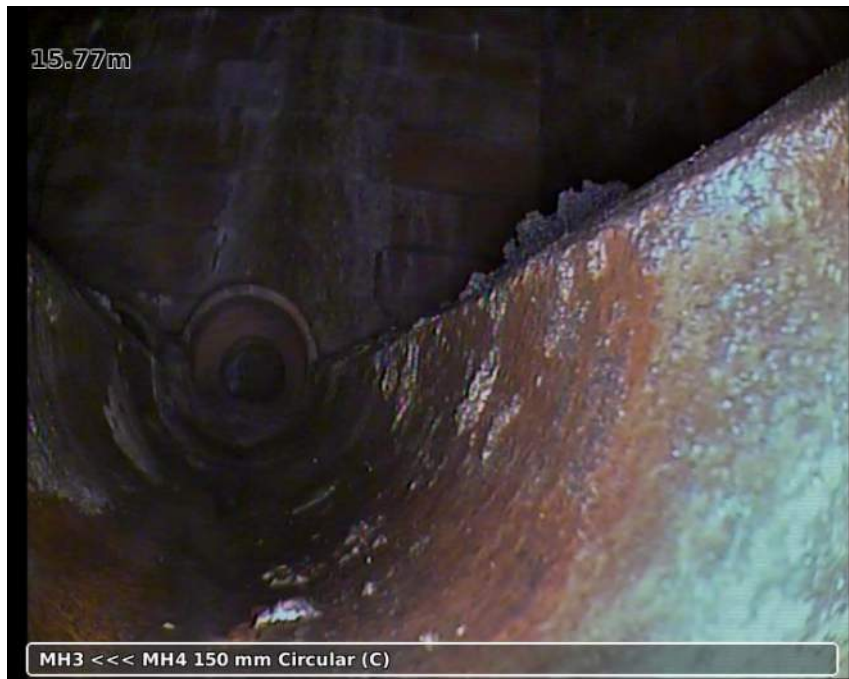
Photo: 20181122-105400-snap0003.jpg  
 15.77m, Finish node type manhole reference number: MH4

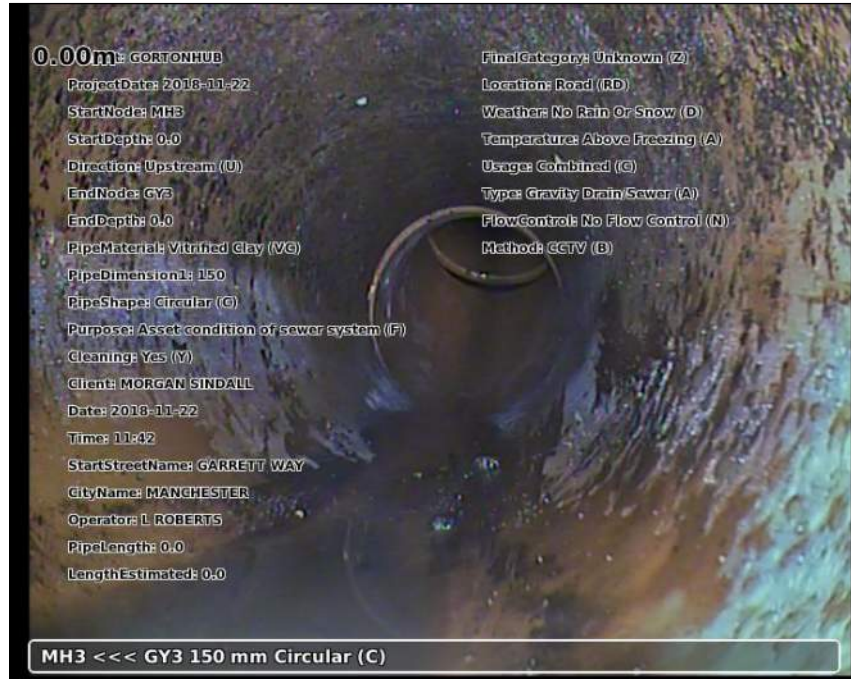
Photo: 20181122-114351-snap0000.jpg  
 0m, Start node type manhole reference number: MH3

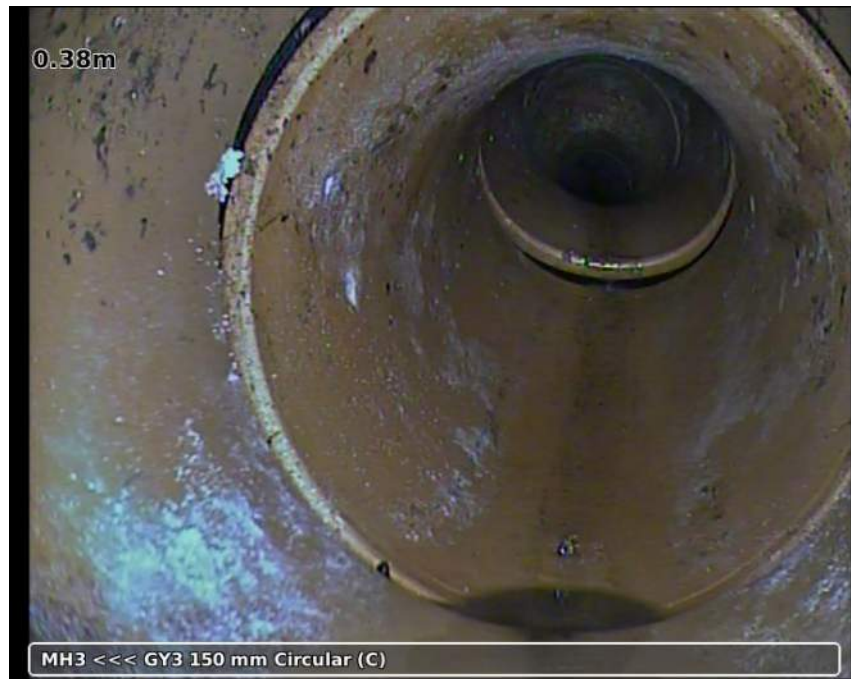
Photo: 20181122-114351-snap0001.jpg  
 0.38m, Line deviates up

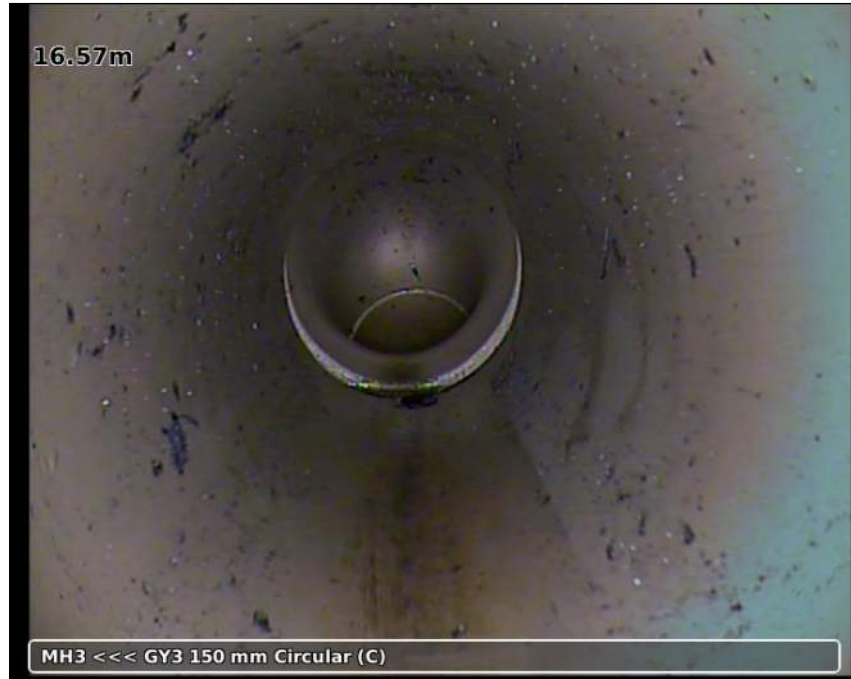
Photo: 20181122-114351-snap0002.jpg  
 16.57m, Line deviates up

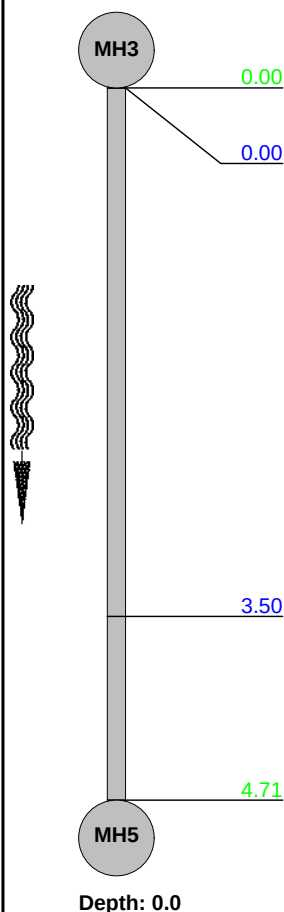
Start node type manhole reference number: MH3

Water level 05 % of the vertical dimension

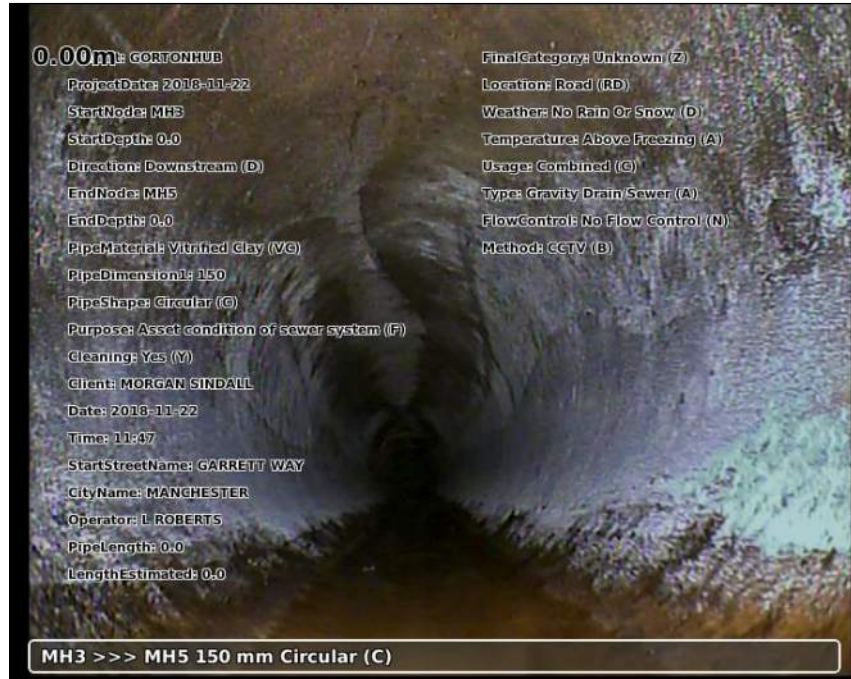
Photo: 20181122-114728-snap0000.jpg  
 0m, Start node type manhole reference number: MH3

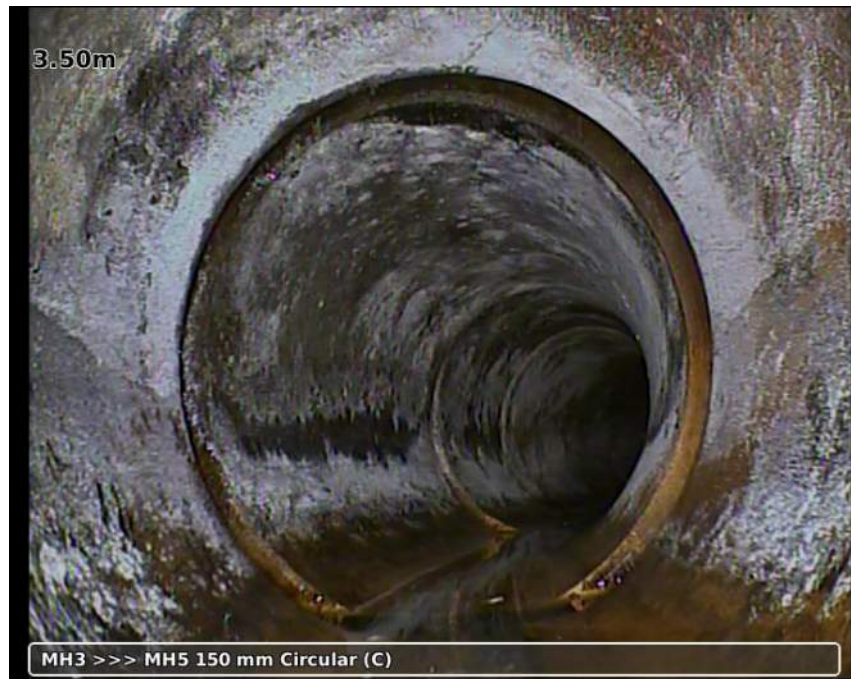
Photo: 20181122-114728-snap0001.jpg  
 3.5m, Line deviates right

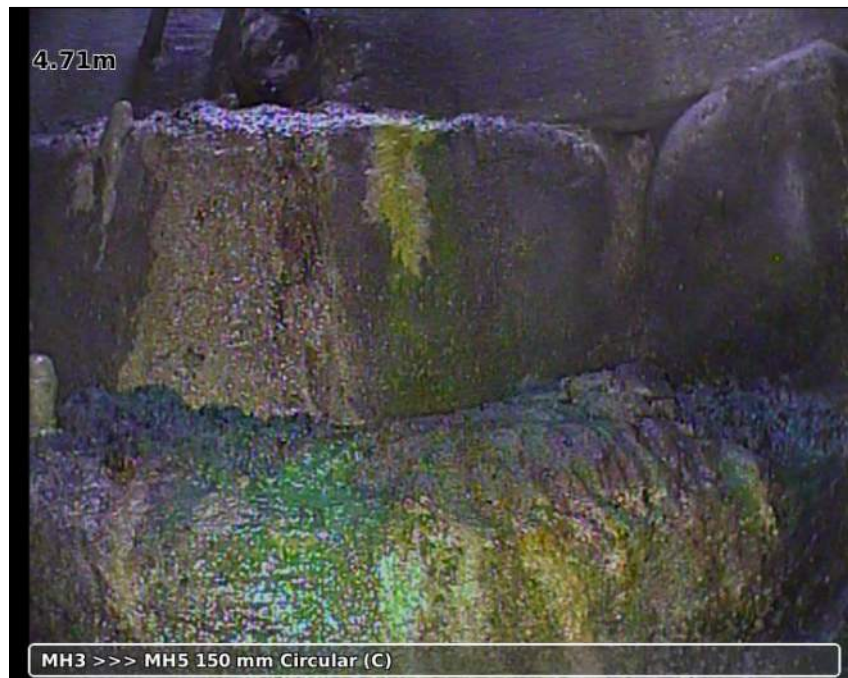
Photo: 20181122-114728-snap0002.jpg  
 4.71m, Finish node type manhole reference number: MH5

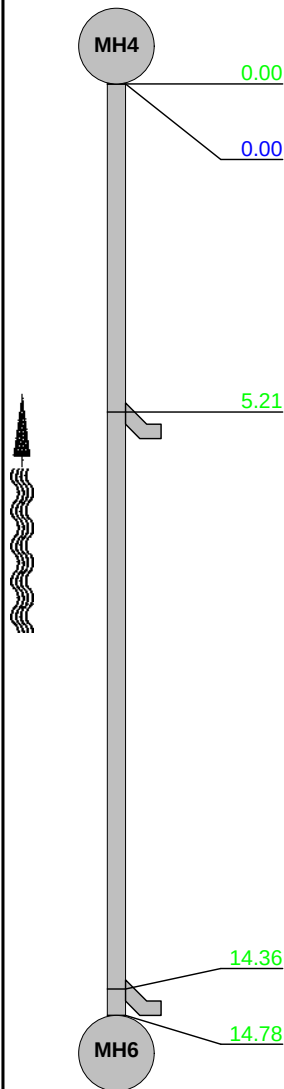
Start node type manhole reference number: MH4

Water level 05 % of the vertical dimension

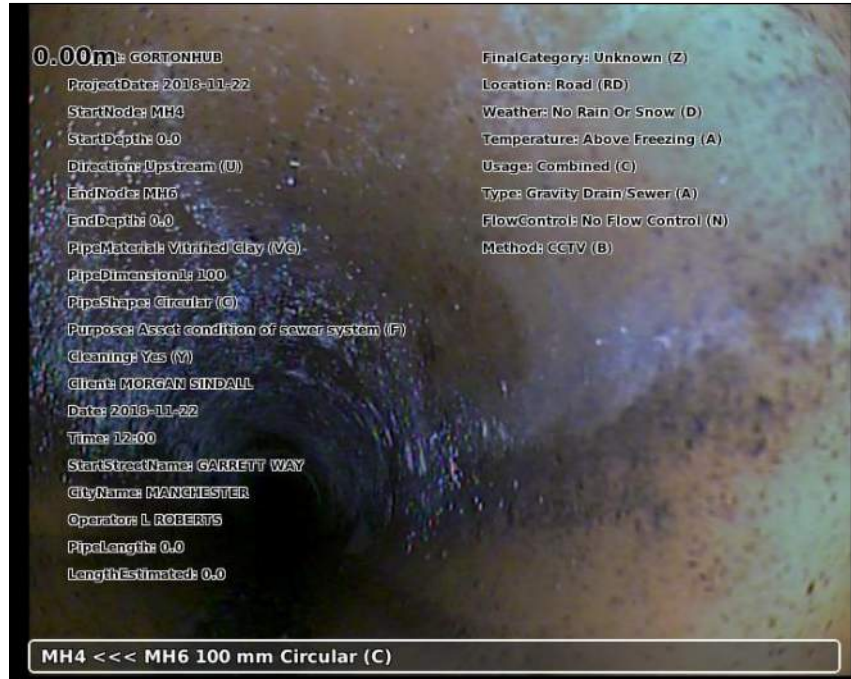
Photo: 20181122-120037-snap0000.jpg  
 0m, Start node type manhole reference number: MH4

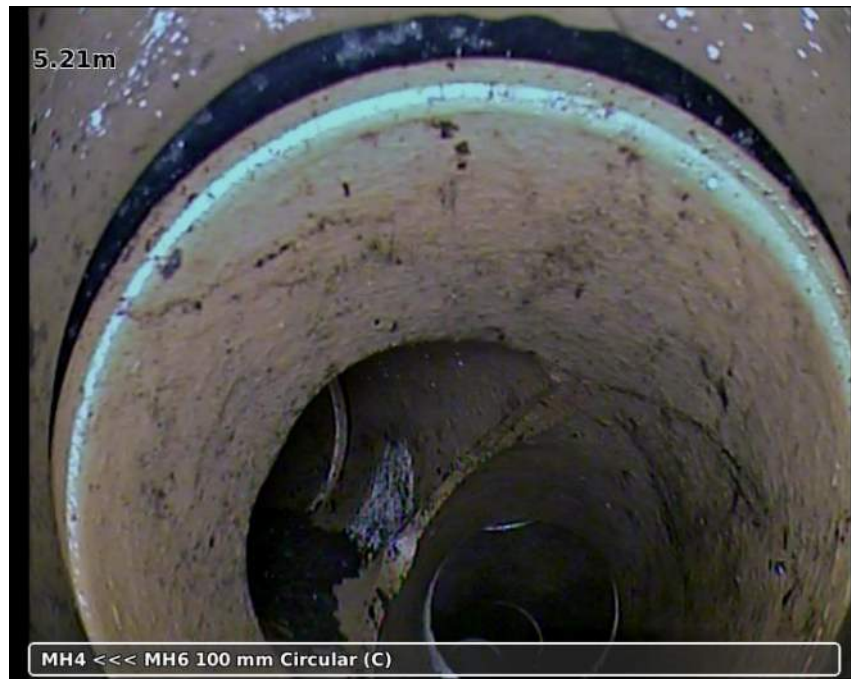
Photo: 20181122-120037-snap0001.jpg  
 5.21m, Junction from/at 09 o'clock diameter: 100 mm

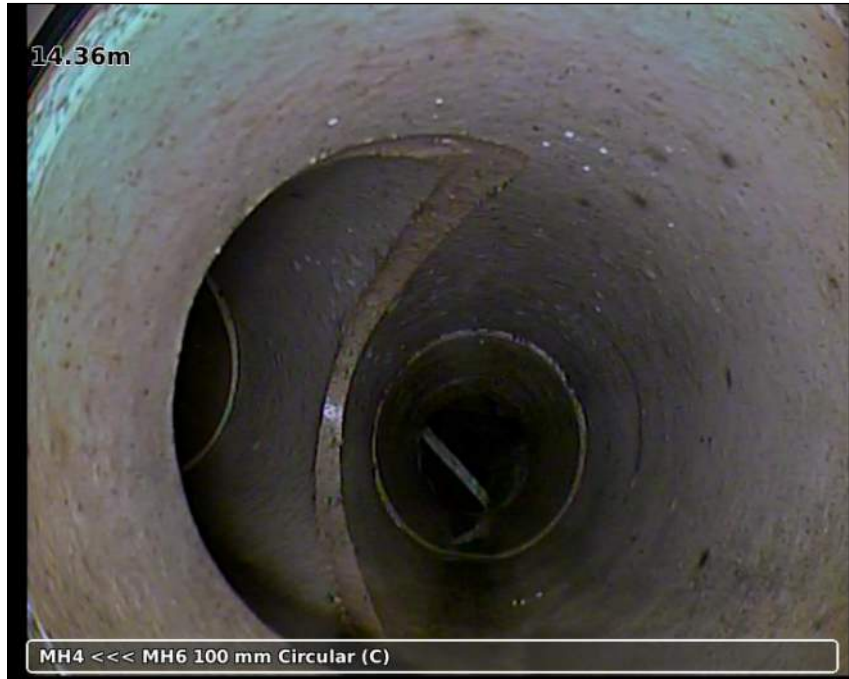
Photo: 20181122-120037-snap0002.jpg  
 14.36m, Junction from/at 09 o'clock diameter: 100 mm

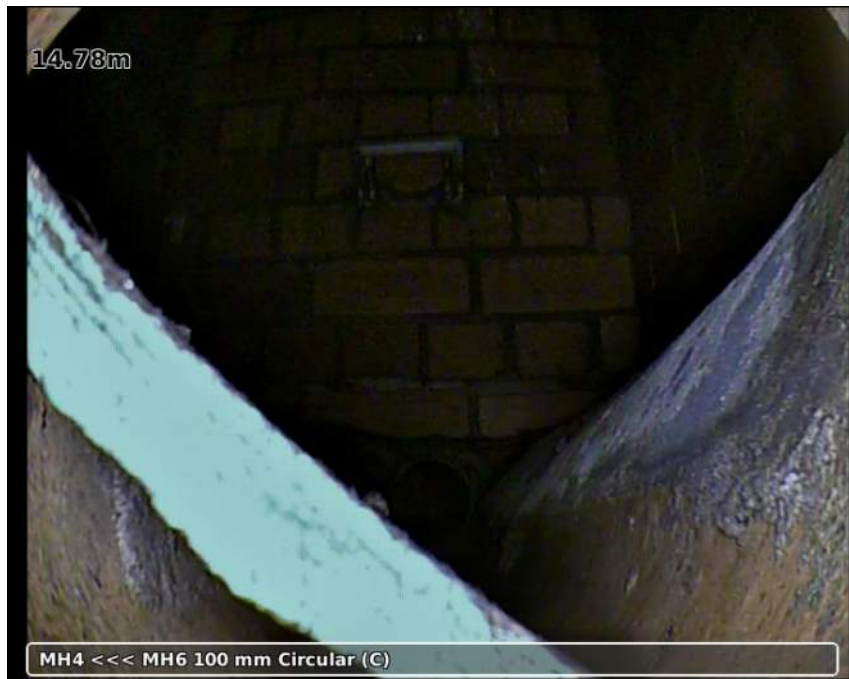
Photo: 20181122-120037-snap0003.jpg  
 14.78m, Finish node type manhole reference number: MH6

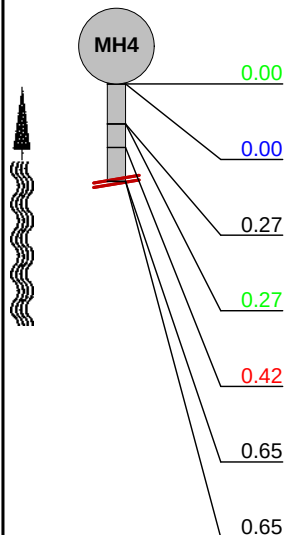
Start node type manhole reference number: MH4

Water level 05 % of the vertical dimension

Crack circumferential from/at 12 o'clock to 12 o'clock

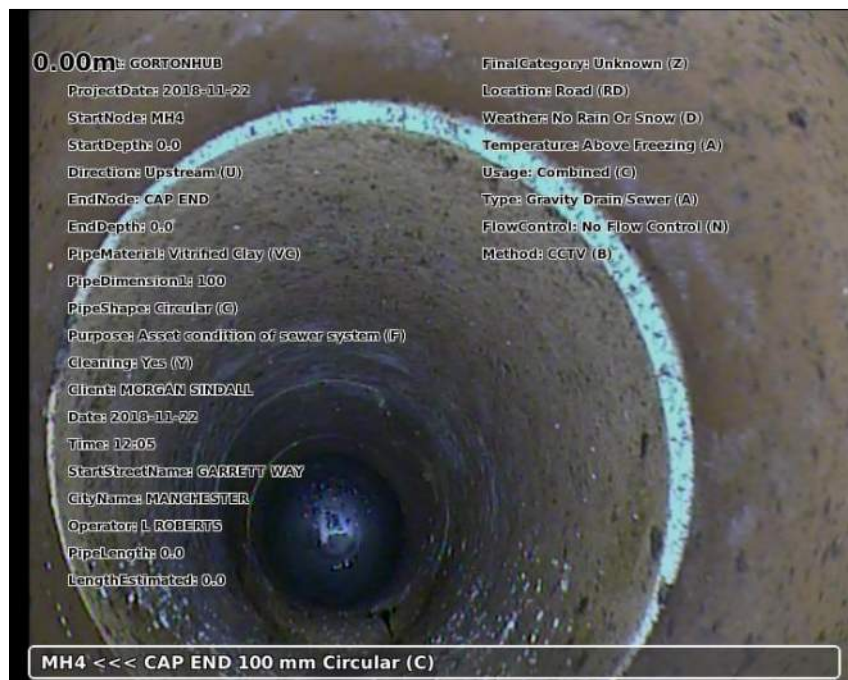
Photo: 20181122-120552-snap0000.jpg  
 0m, Start node type manhole reference number: MH4

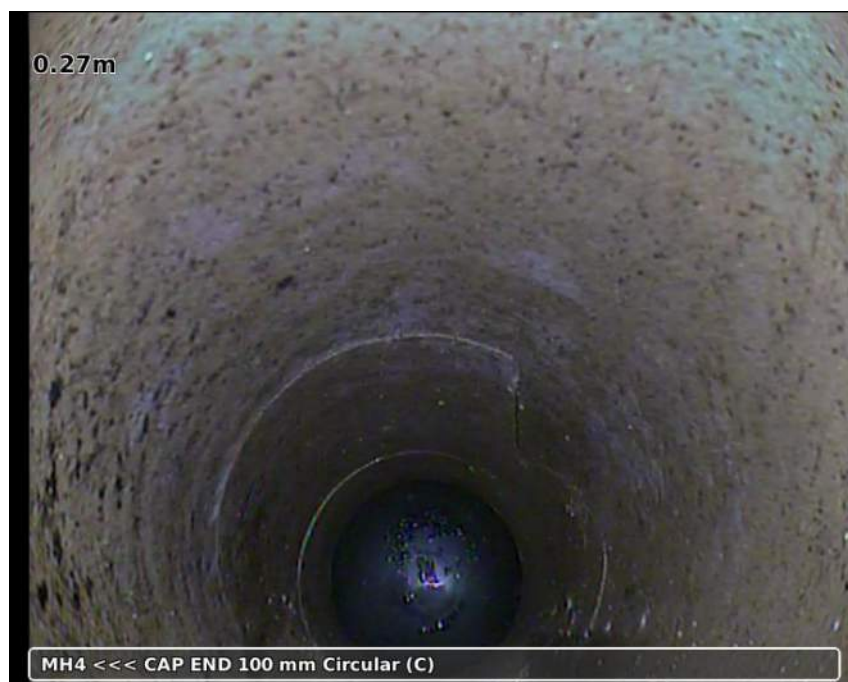
Photo: 20181122-120552-snap0001.jpg  
 0.27m, General photograph taken at this point

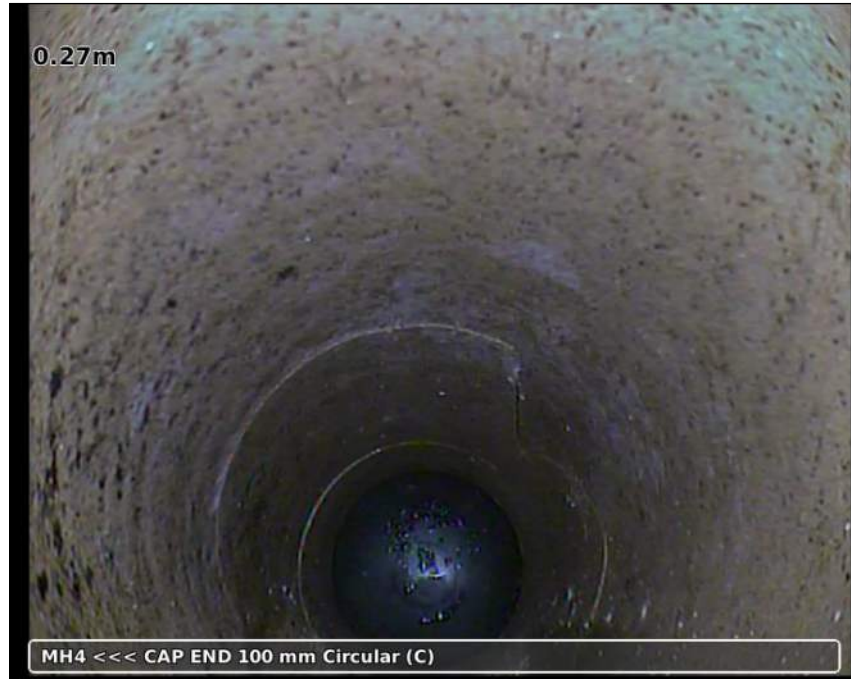
Photo: 20181122-120552-snap0002.jpg  
 0.27m, Junction from/at 06 o'clock diameter: 100 mm

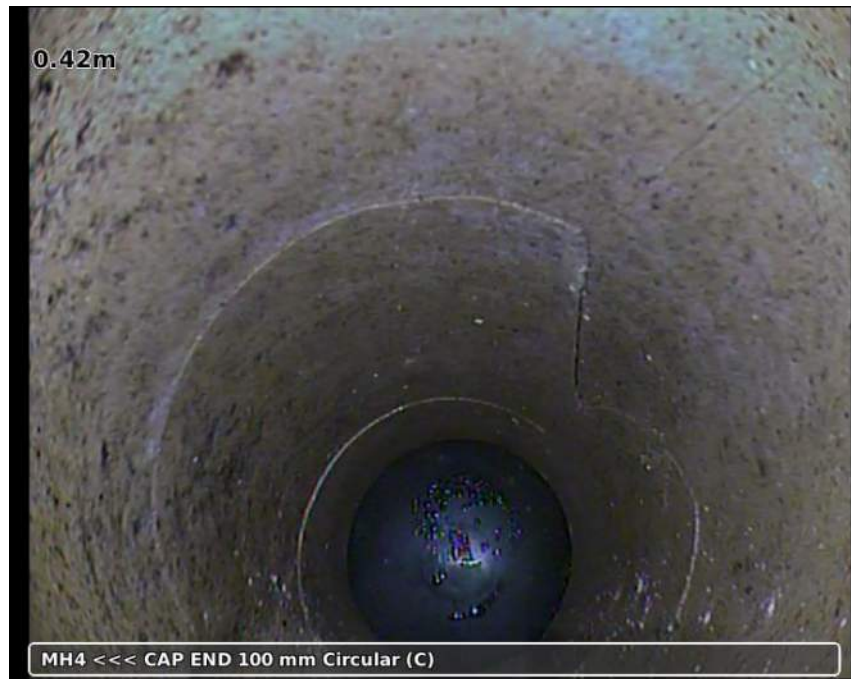
Photo: 20181122-120552-snap0003.jpg  
 0.42m, Crack circumferential from/at 12 o'clock to 12 o'clock

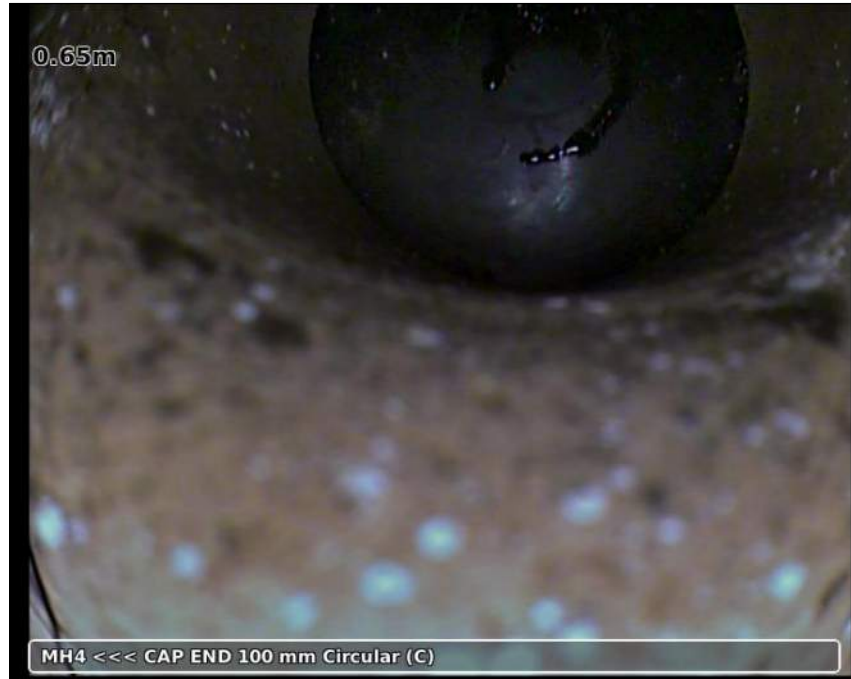
Photo: 20181122-120552-snap0004.jpg  
 0.65m, General photograph taken at this point

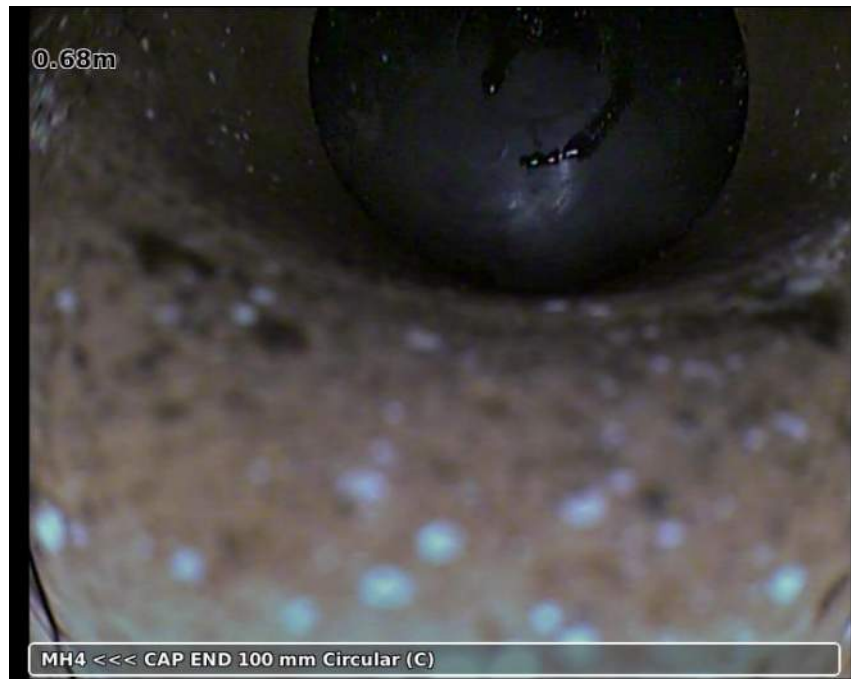
Photo: 20181122-120552-snap0005.jpg  
 0.65m, Survey abandoned

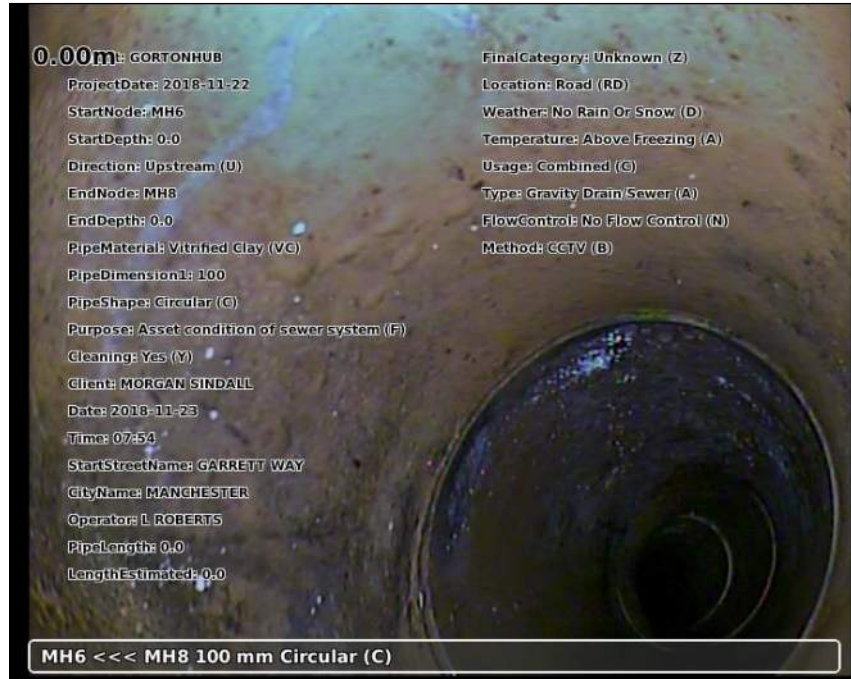
Photo: 20181123-082335-snap0000.jpg  
 0m, Start node type manhole reference number: MH6

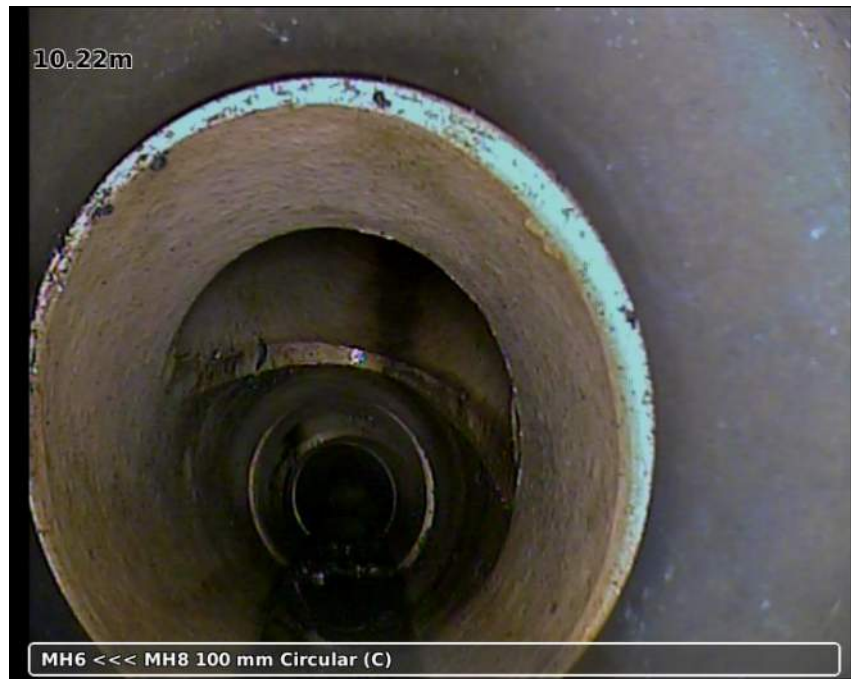
Photo: 20181123-082335-snap0001.jpg  
 10.22m, Junction from/at 01 o'clock diameter: 100 mm

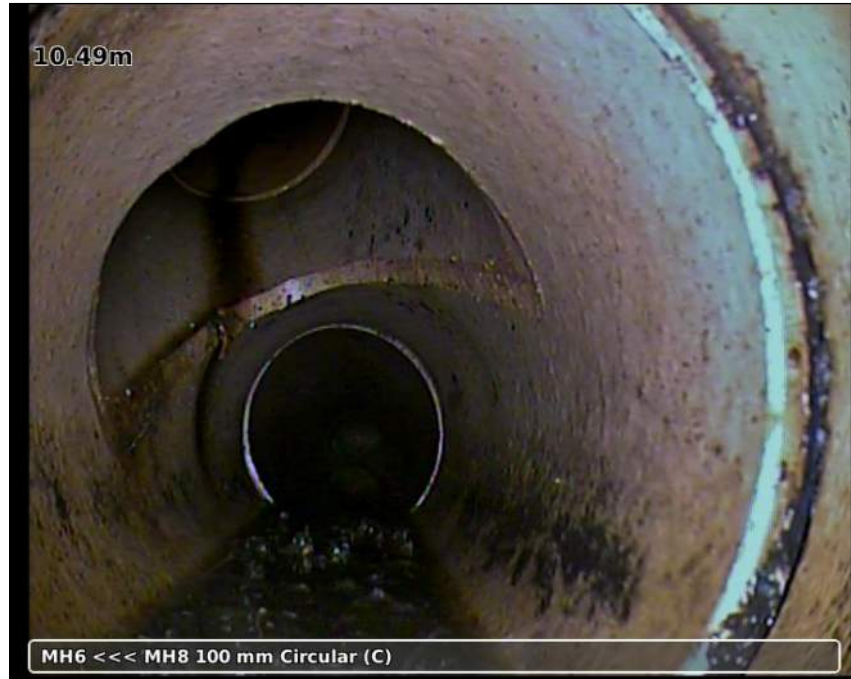
Photo: 20181123-082335-snap0002.jpg  
 10.49m, Junction from/at 11 o'clock diameter: 100 mm

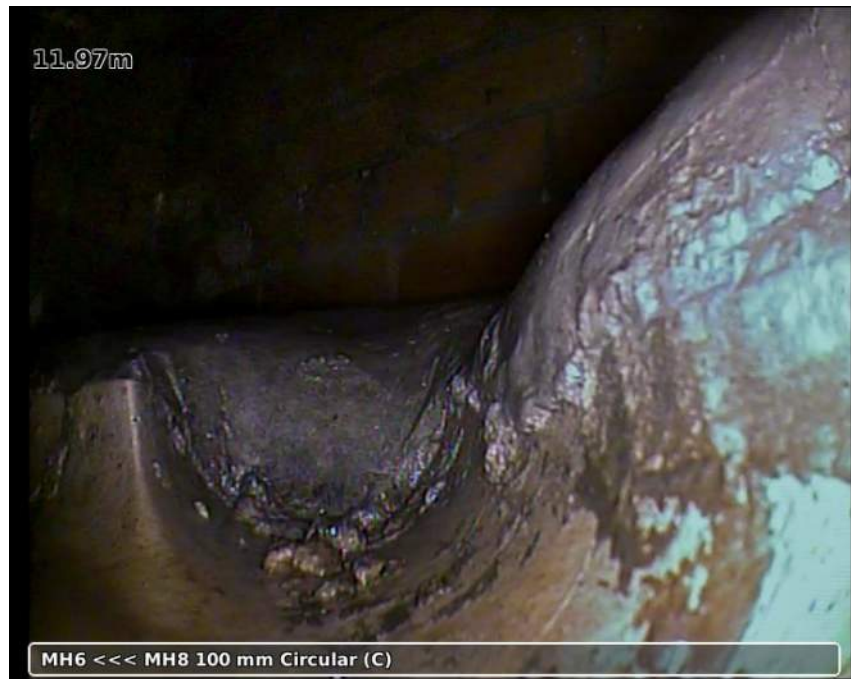
Photo: 20181123-082335-snap0003.jpg  
 11.93m, Finish node type manhole reference number: MH8

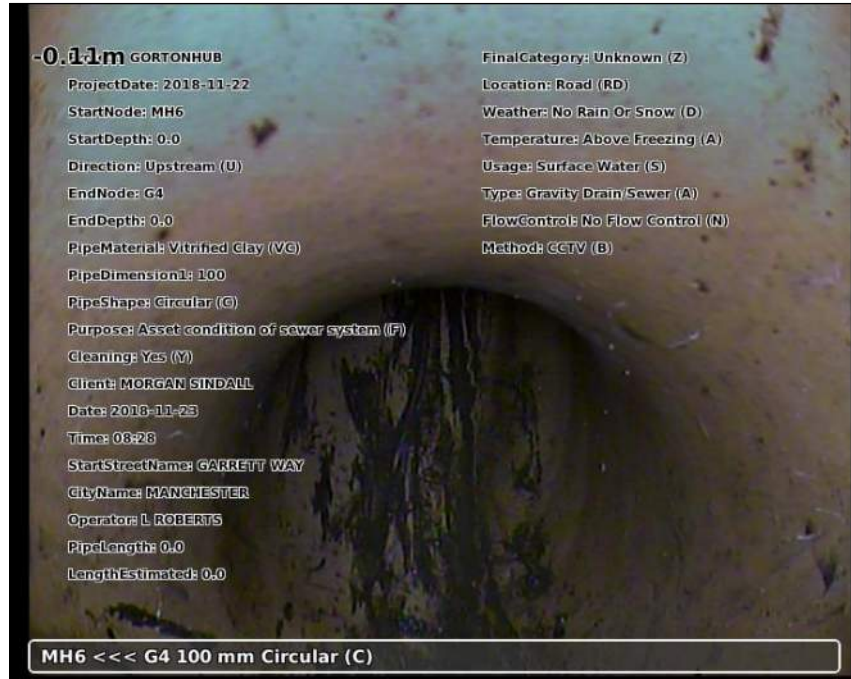
Photo: 20181123-082900-snap0000.jpg  
 -0.11m, Start node type manhole reference number: MH6

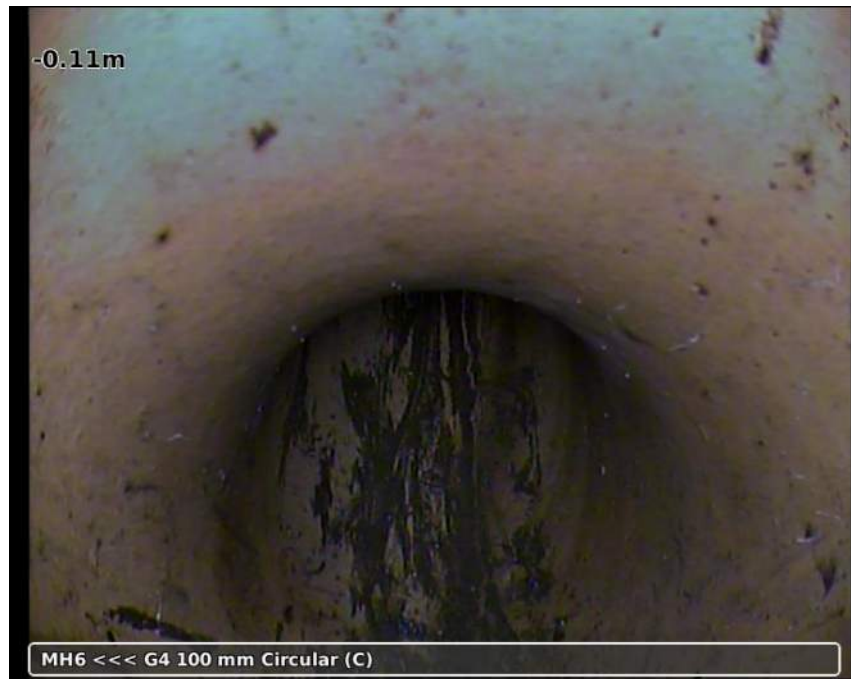
Photo: 20181123-082900-snap0001.jpg  
 -0.11m, Line deviates up

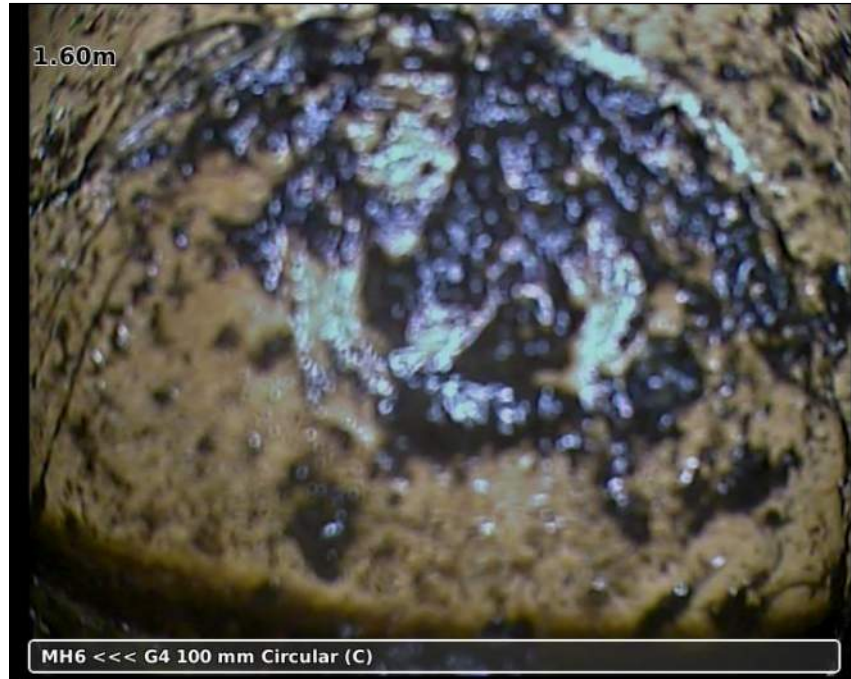
Photo: 20181123-082900-snap0002.jpg  
1.6m, Finish node type gully reference number: G4

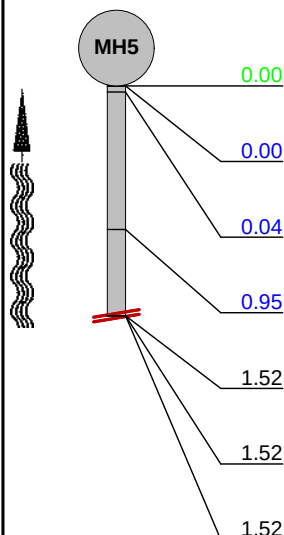
Start node type manhole reference number: MH5

Water level 05 % of the vertical dimension

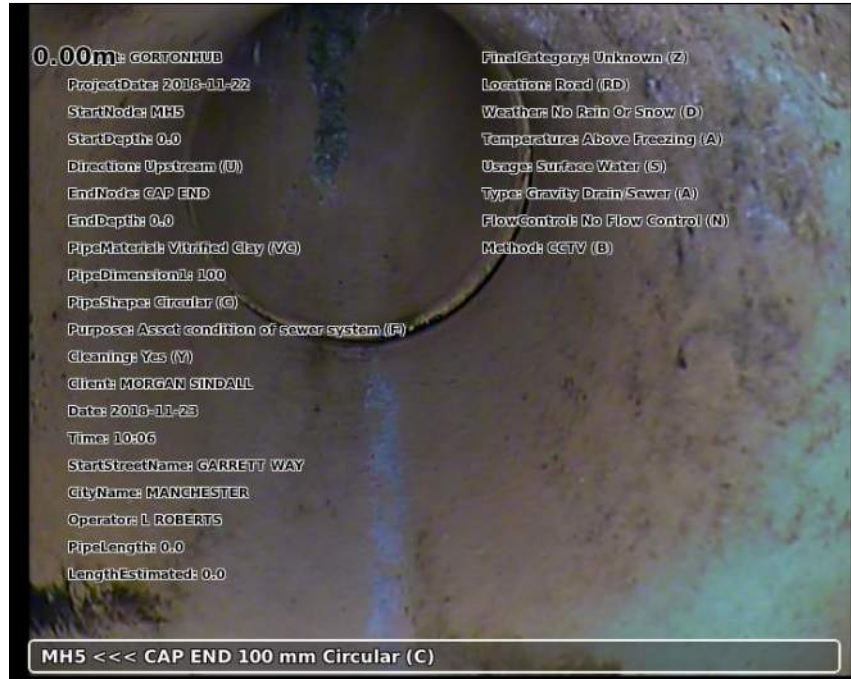
Photo: 20181123-100650-snap0000.jpg  
 0m, Start node type manhole reference number: MH5

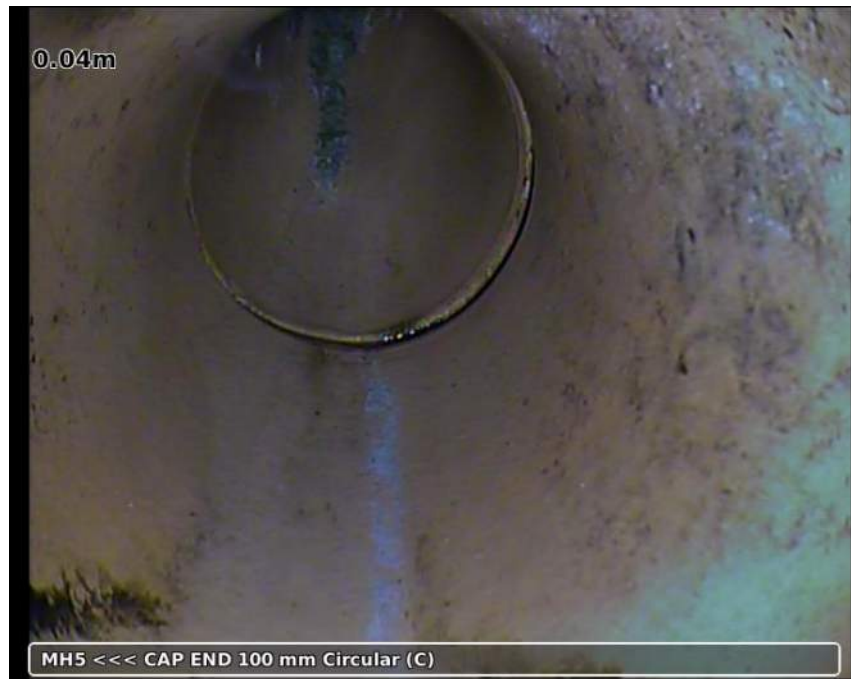
Photo: 20181123-100650-snap0001.jpg  
 0.04m, Line deviates up

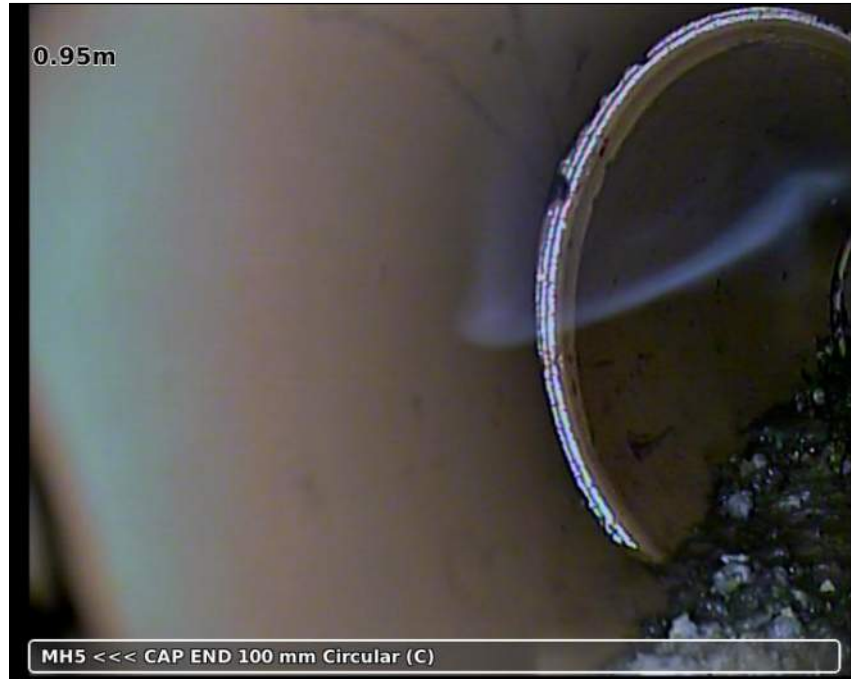
Photo: 20181123-100650-snap0002.jpg  
 0.95m, Attached deposits encrustation from/at 05 o'clock to 07 o'clock 10 % cross-sectional area loss

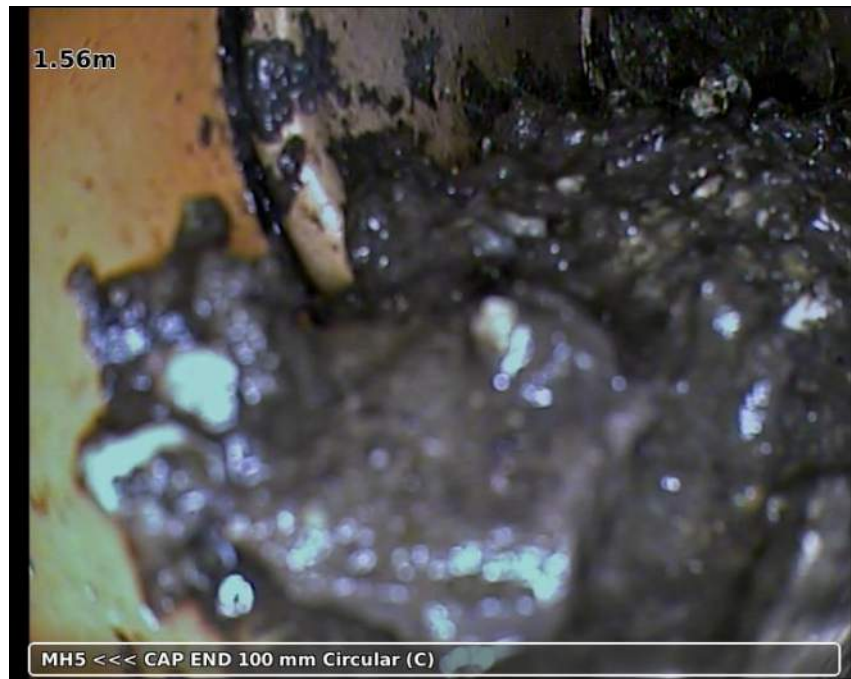
Photo: 20181123-100650-snap0005.jpg  
 1.52m, Survey abandoned

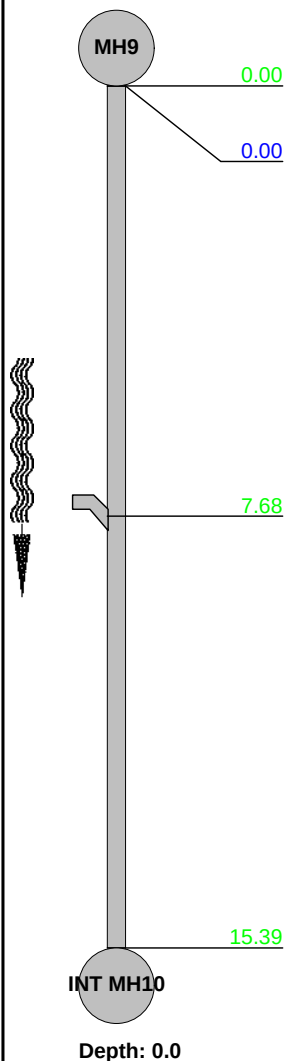
Start node type manhole reference number: MH9

Water level 05 % of the vertical dimension

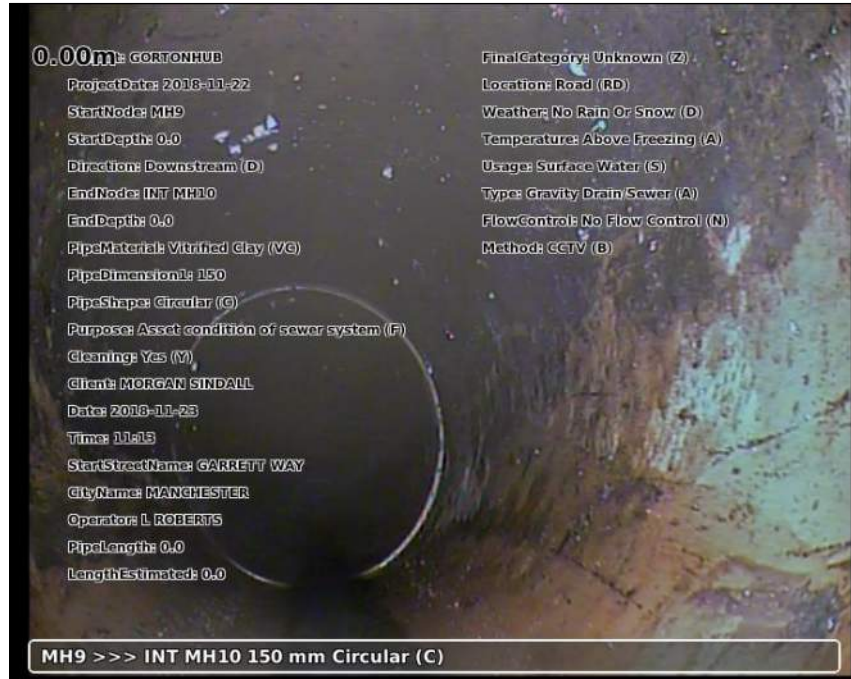
Photo: 20181123-111344-snap0000.jpg  
 0m, Start node type manhole reference number: MH9

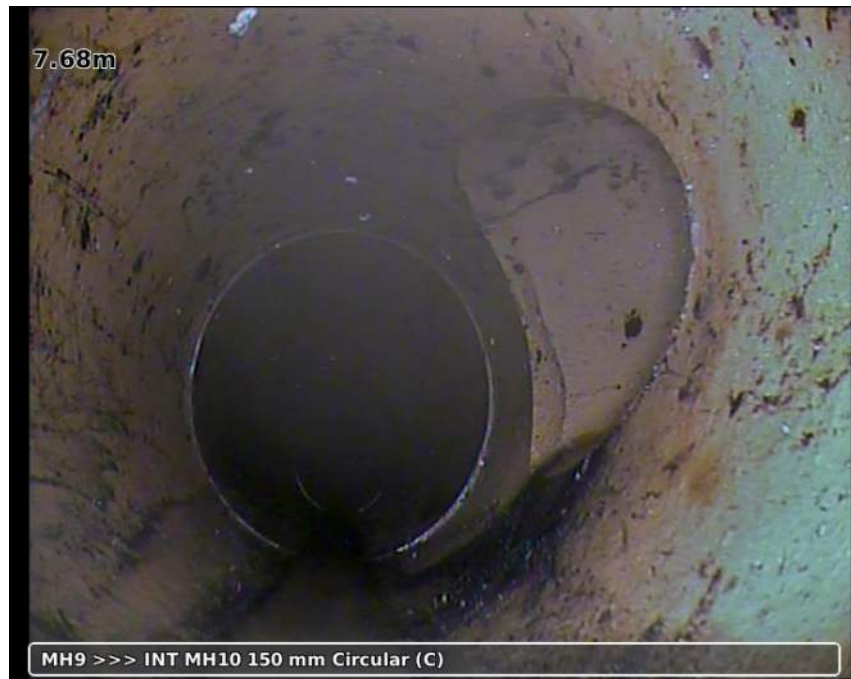
Photo: 20181123-111344-snap0001.jpg  
 7.68m, Junction from/at 03 o'clock diameter: 100 mm

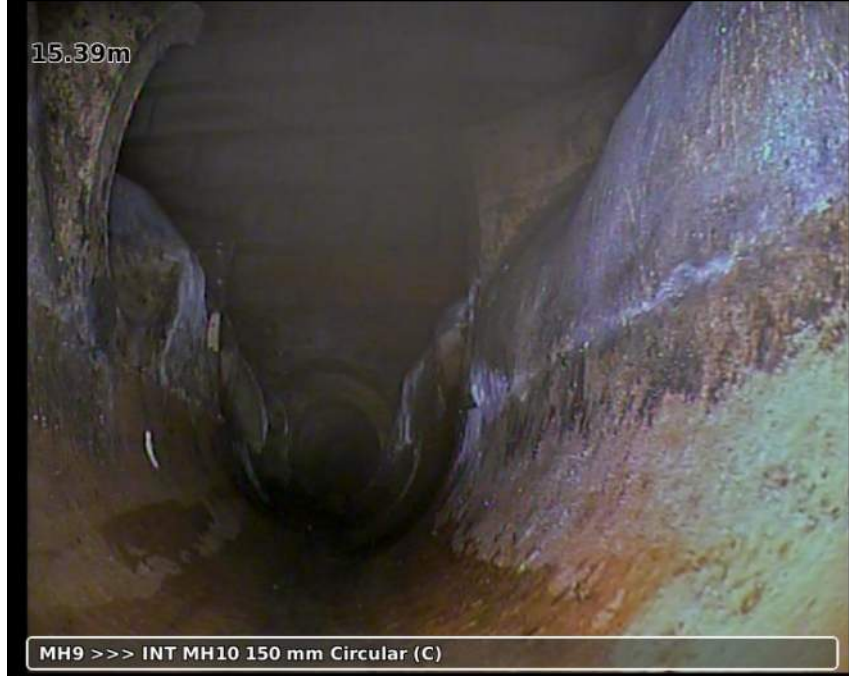
Photo: 20181123-111344-snap0002.jpg  
15.39m, Finish node type manhole reference number: INT MH10
