# Gorton Community Hub

## Flood Risk Assessment and Detailed Drainage Strategy

Curtins Ref: GCH-CUR-XX-XX-RP-C-0002

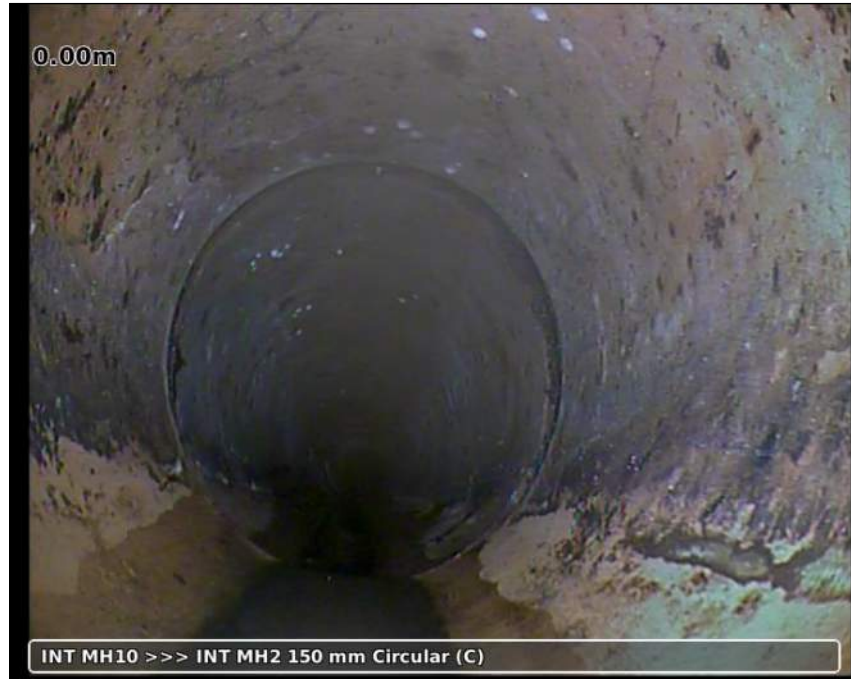
Photo: 20181123-111622-snap0000.jpg  
 0m, Start node type manhole reference number: INT MH10

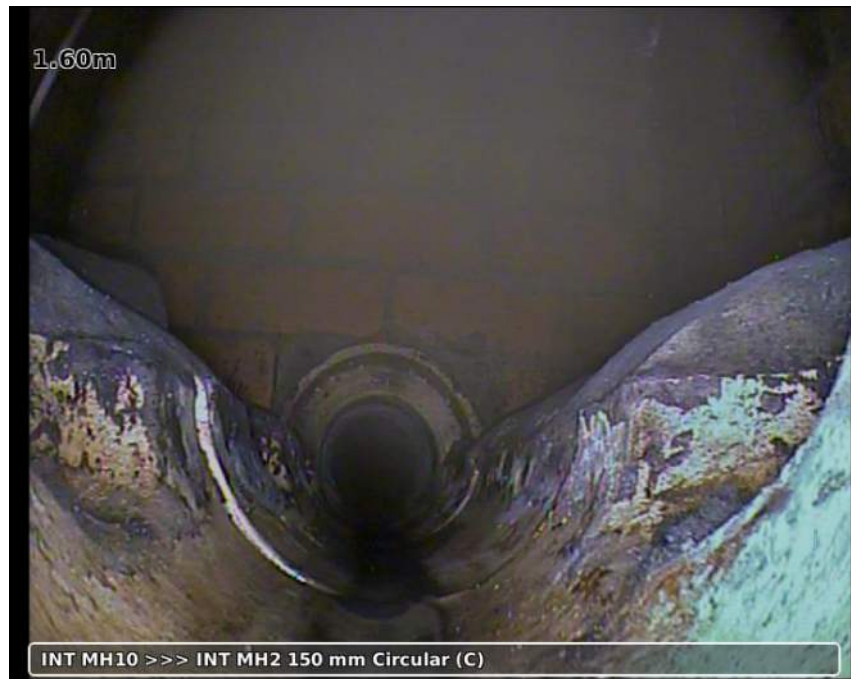
Photo: 20181123-111622-snap0001.jpg  
 1.6m, Finish node type manhole reference number: INT MH2

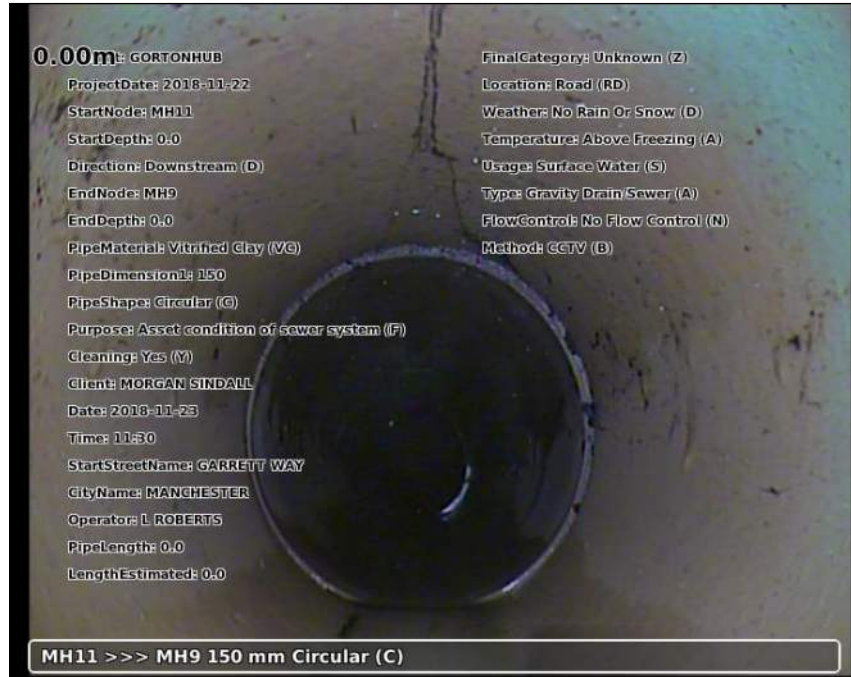
Photo: 20181123-113047-snap0000.jpg  
 0m, Start node type manhole reference number: MH11

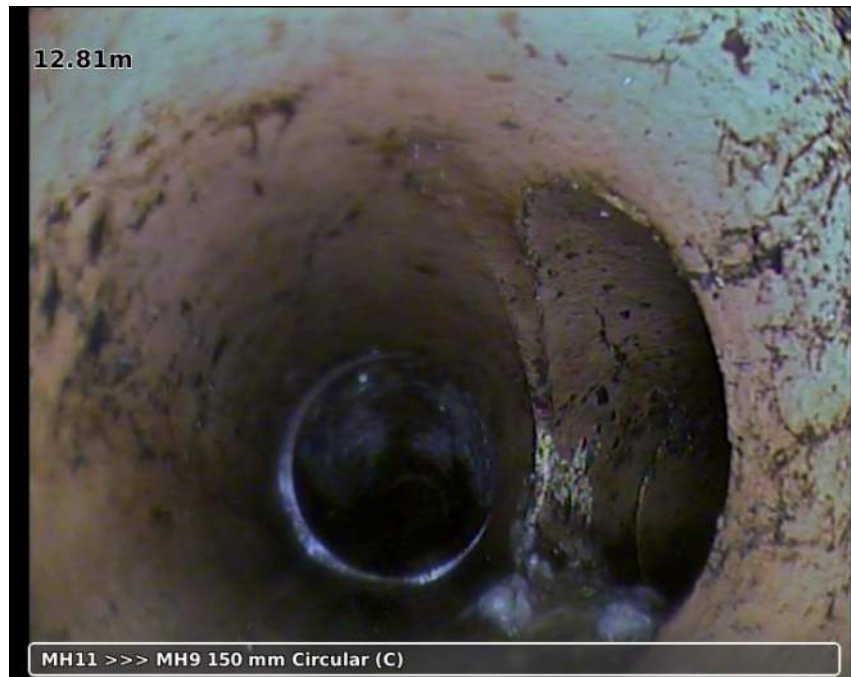
Photo: 20181123-113047-snap0001.jpg  
 12.81m, Junction from/at 03 o'clock diameter: 100 mm

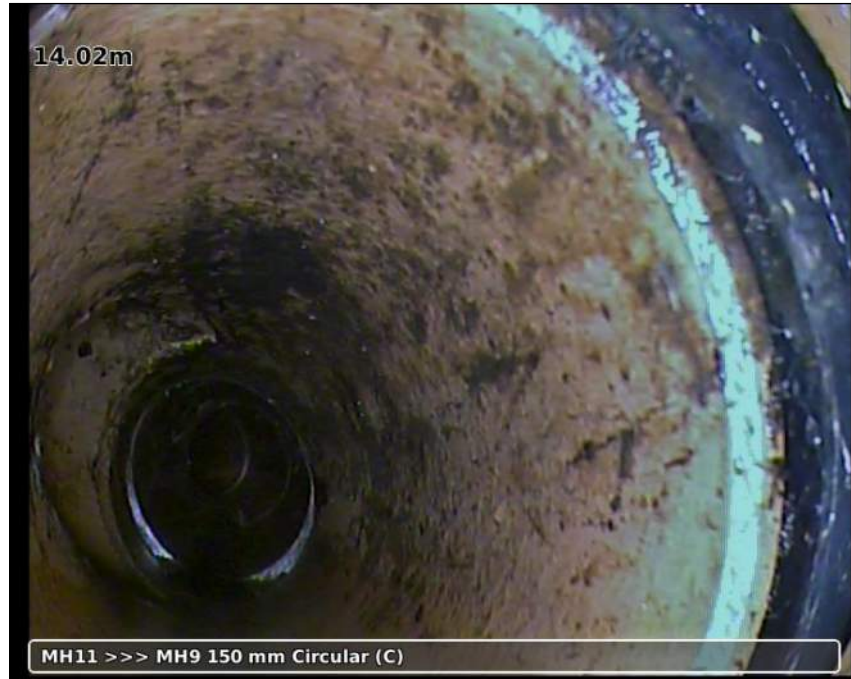
Photo: 20181123-113047-snap0002.jpg  
 14.02m, Junction from/at 09 o'clock diameter: 100 mm

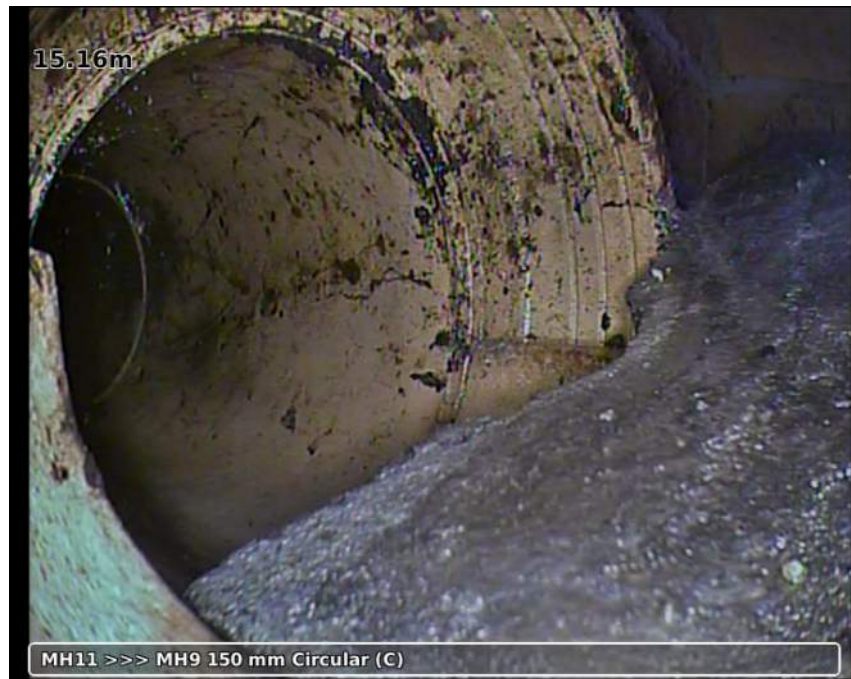
Photo: 20181123-113047-snap0003.jpg  
 15.16m, Finish node type manhole reference number: MH9

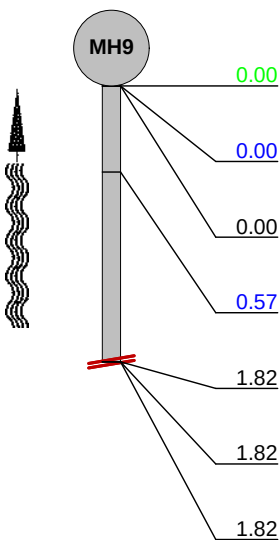
| 1:50 Position<br>Depth: 0.0 | Observation | |
|---|---|---|
| | <p>Start node type manhole reference number: MH9</p> <p>Water level 05 % of the vertical dimension</p> <p>Size changes new size(s) 100 mm high 100 mm wide</p> <p>Line deviates up</p> <p>General photograph taken at this point</p> <p>General photograph taken at this point</p> <p>Survey abandoned Remarks: CAPPED OFF</p> | <p>0 m</p> <p>0 m</p> <p>0.57 m</p> <p>1.82 m</p> <p>1.82 m</p> |

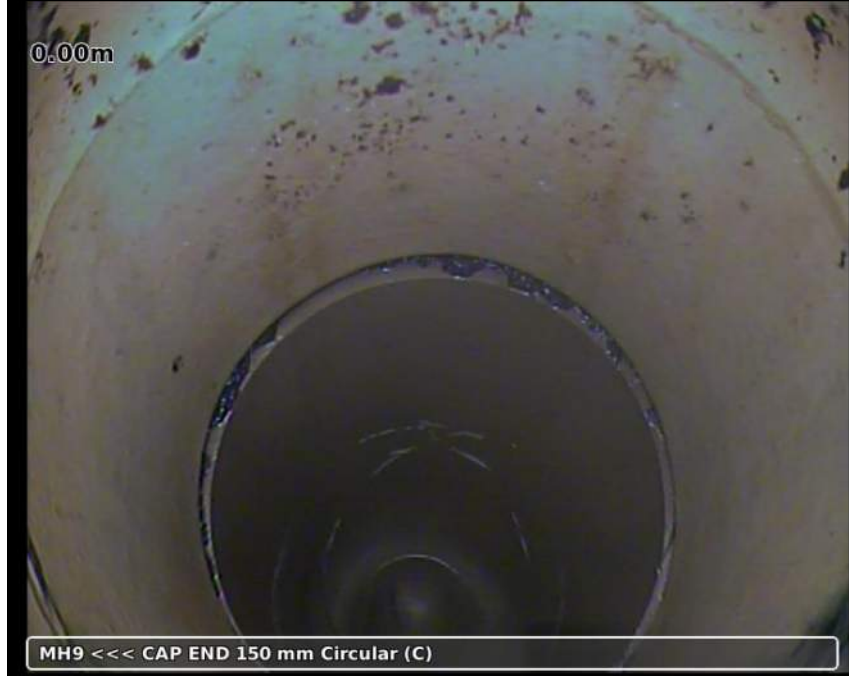
Photo: 20181123-115736-snap0000.jpg  
 0m, Start node type manhole reference number: MH9

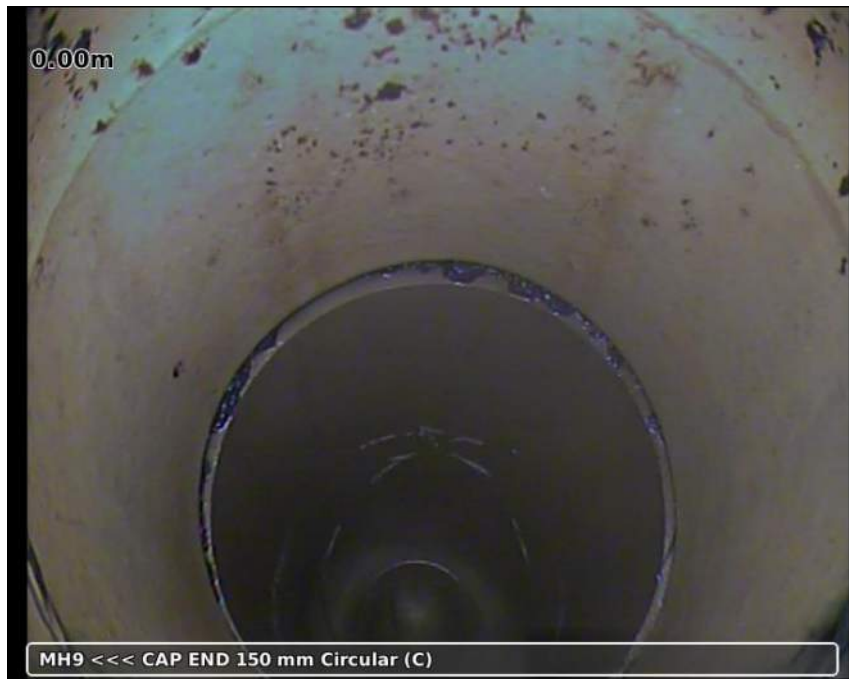
Photo: 20181123-115736-snap0001.jpg  
 0m, Size changes new size(s) 100 mm high 100 mm wide

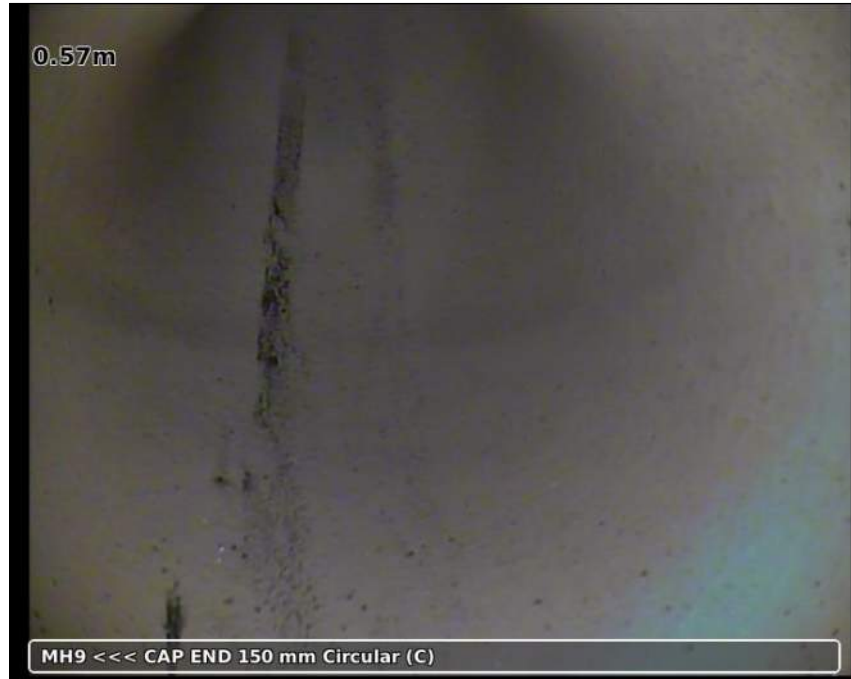
Photo: 20181123-115736-snap0002.jpg  
 0.57m, Line deviates up

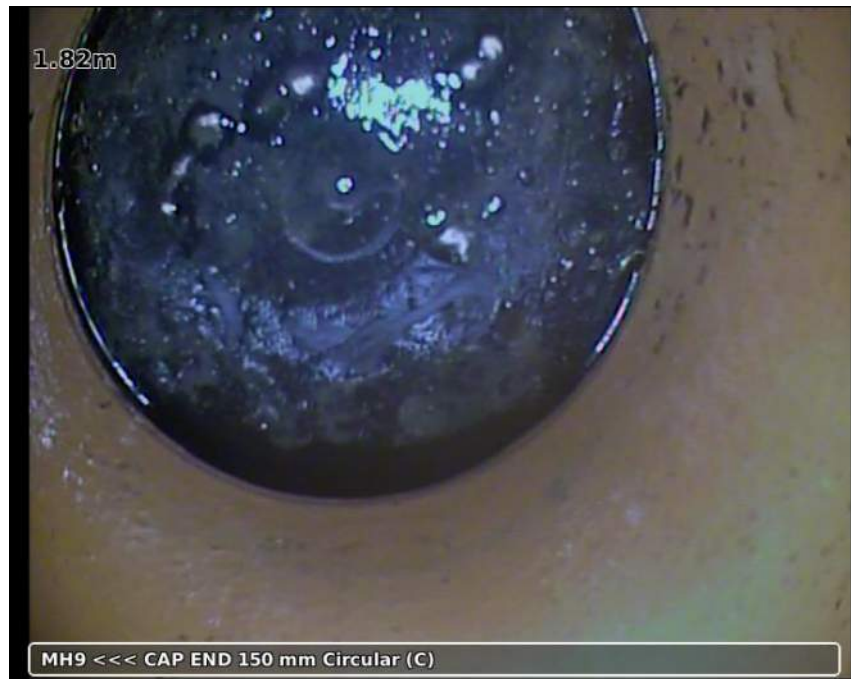
Photo: 20181123-115736-snap0005.jpg  
 1.82m, Survey abandoned

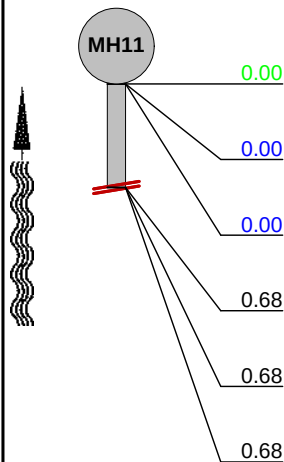
Start node type manhole reference number: MH11

Water level 05 % of the vertical dimension

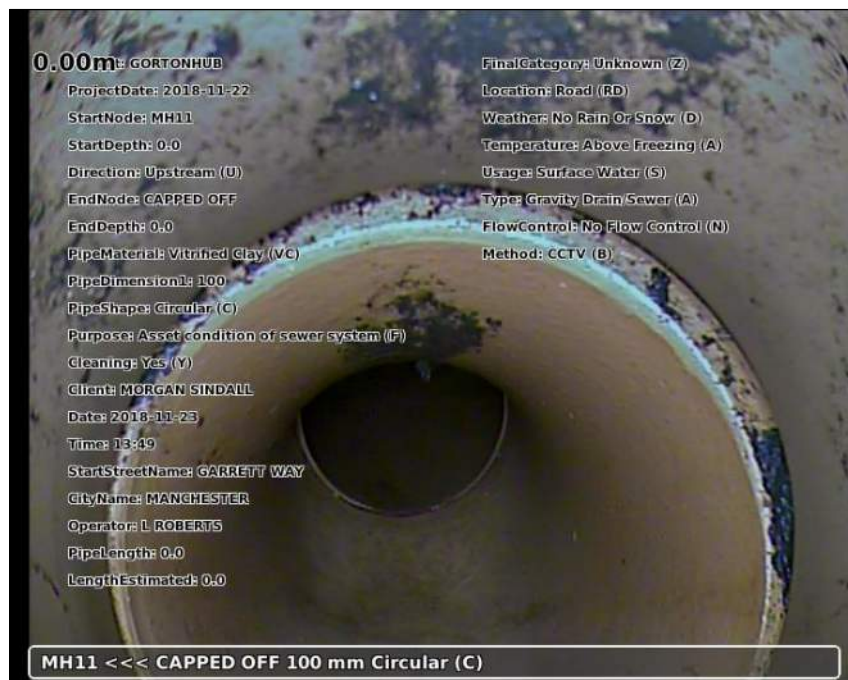
Photo: 20181123-135029-snap0000.jpg  
 0m, Start node type manhole reference number: MH11

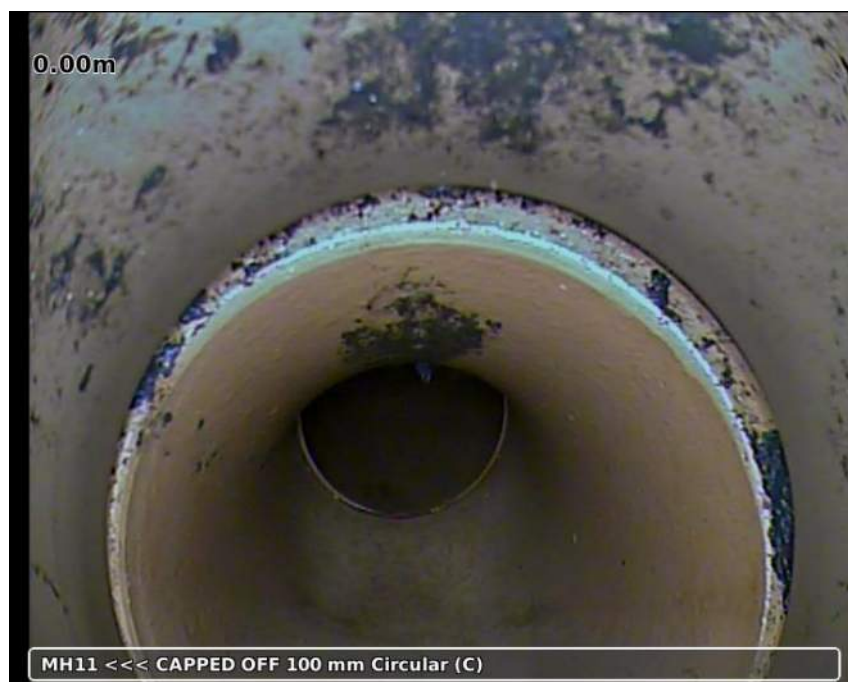
Photo: 20181123-135029-snap0001.jpg  
 0m, Line deviates up

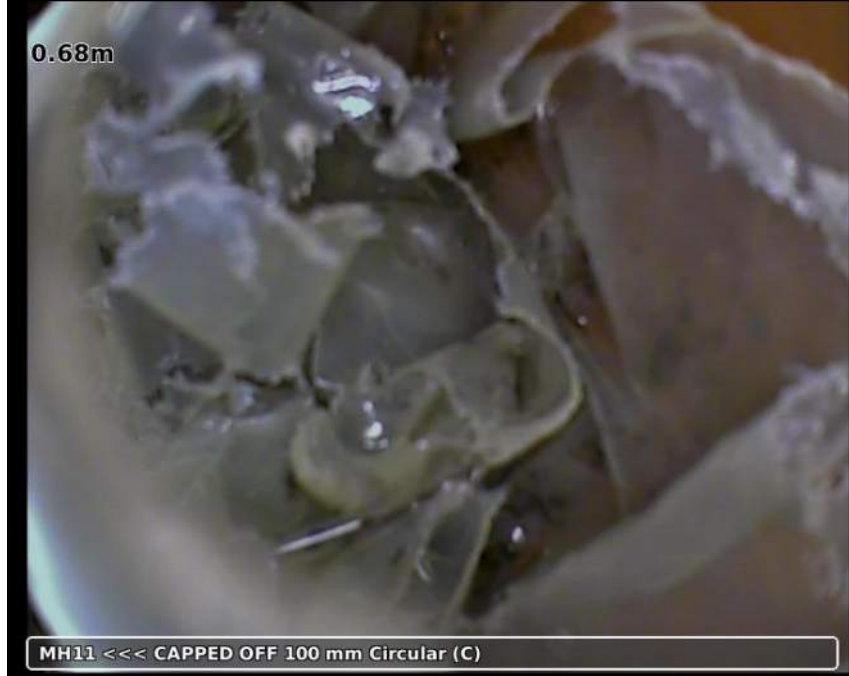
Photo: 20181123-135029-snap0004.jpg  
 0.68m, Survey abandoned

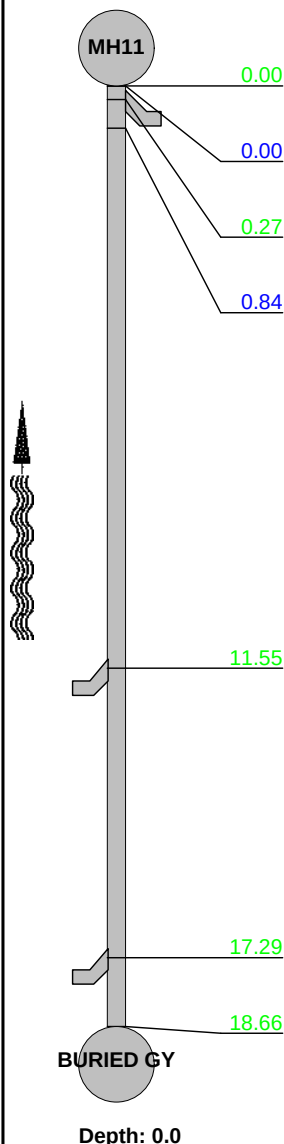
Start node type manhole reference number: MH11

Water level 05 % of the vertical dimension

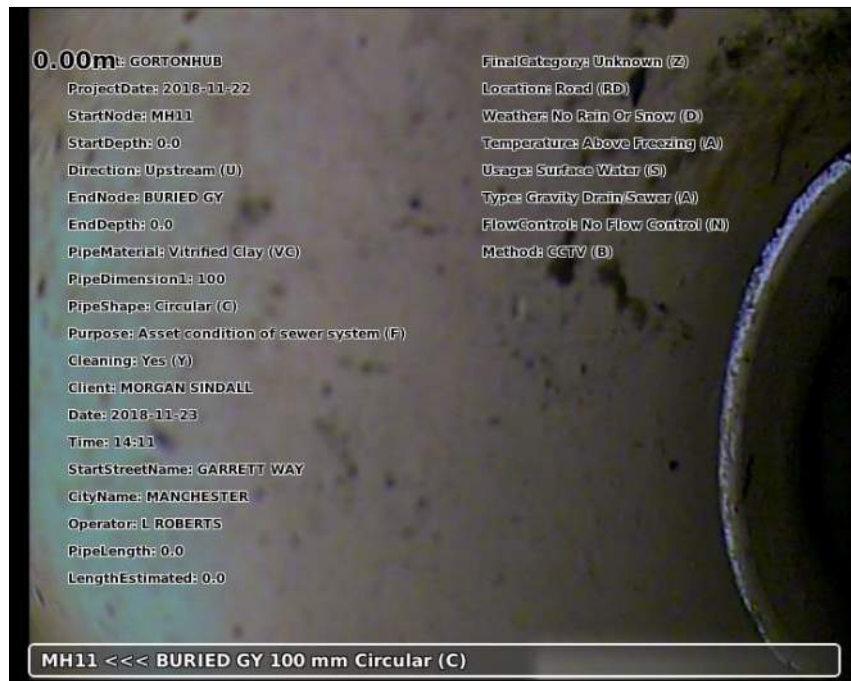
Photo: 20181123-141150-snap0000.jpg  
 0m, Start node type manhole reference number: MH11

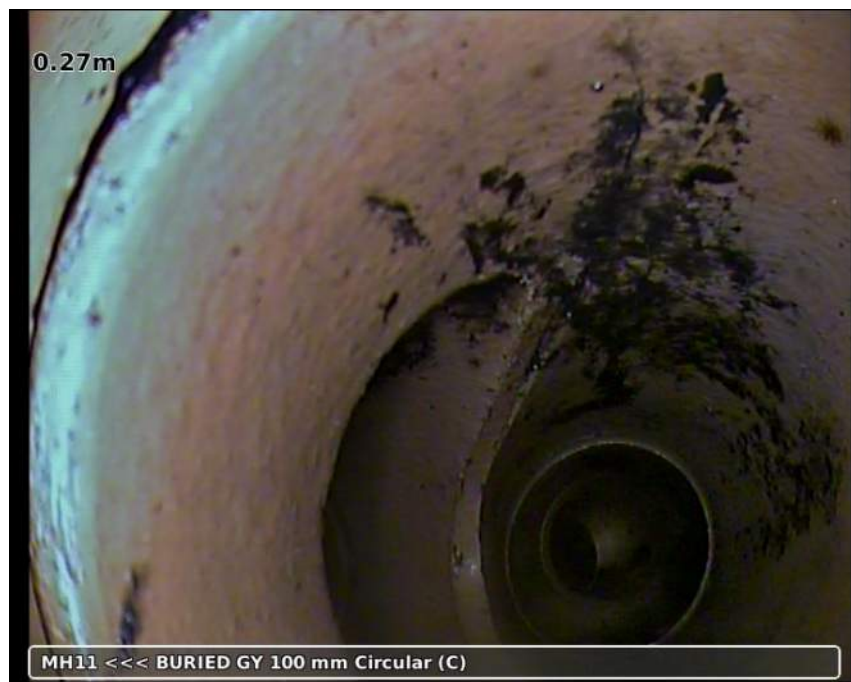
Photo: 20181123-141150-snap0001.jpg  
 0.27m, Junction from/at 09 o'clock diameter: 100 mm

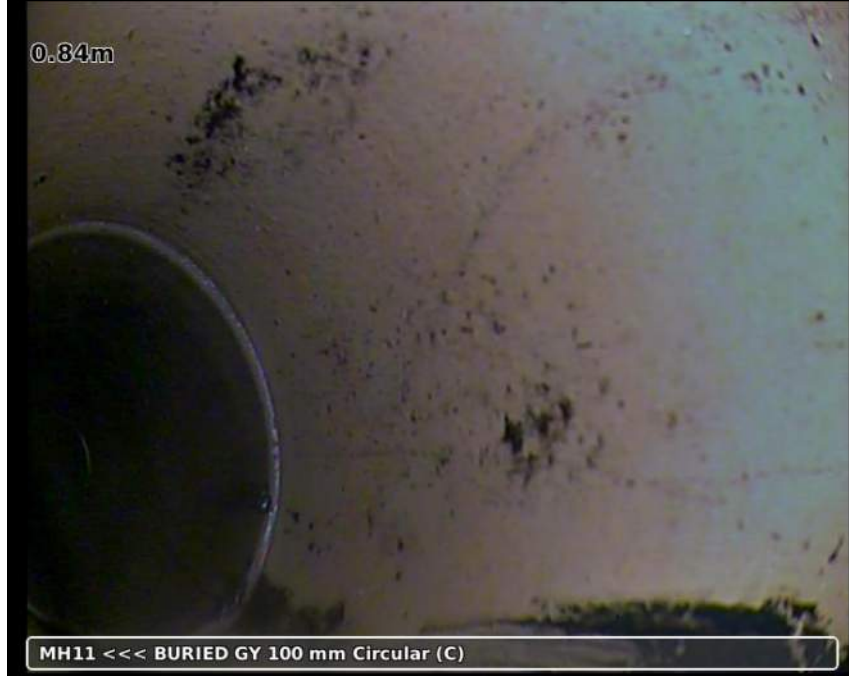
Photo: 20181123-141150-snap0002.jpg  
 0.84m, Line deviates left

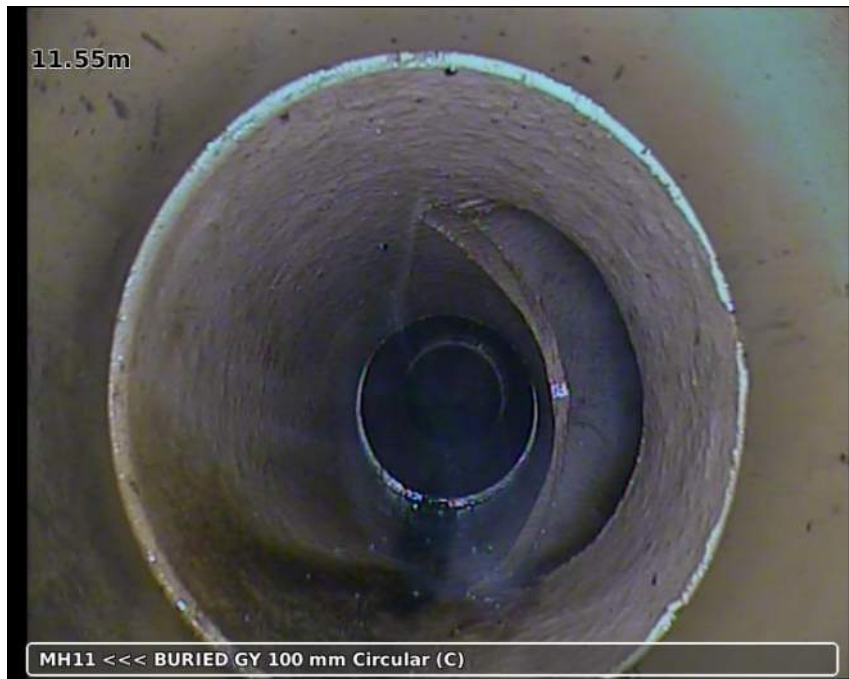
Photo: 20181123-141150-snap0003.jpg  
 11.55m, Junction from/at 03 o'clock diameter: 100 mm

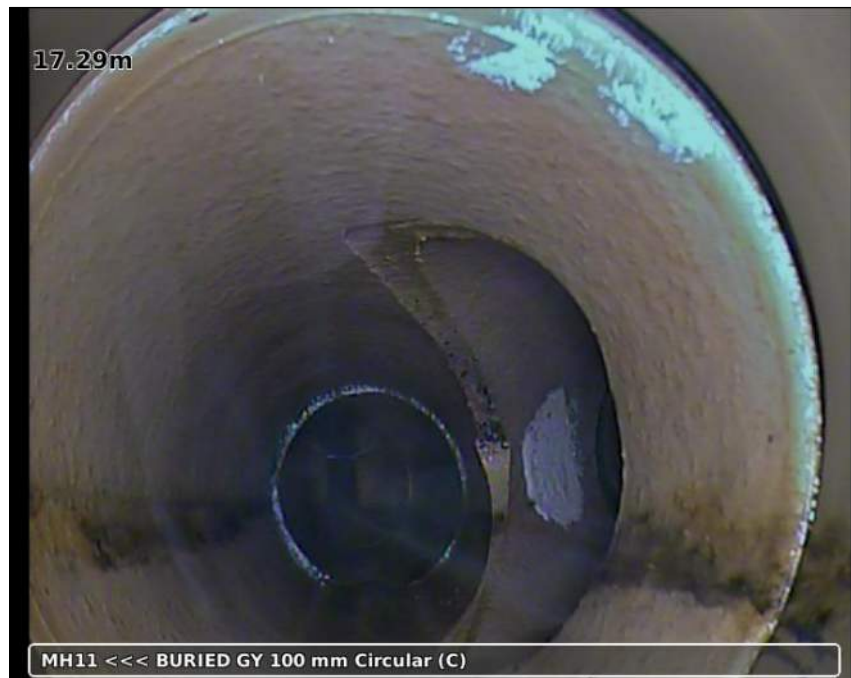
Photo: 20181123-141150-snap0004.jpg  
 17.29m, Junction from/at 03 o'clock diameter: 100 mm

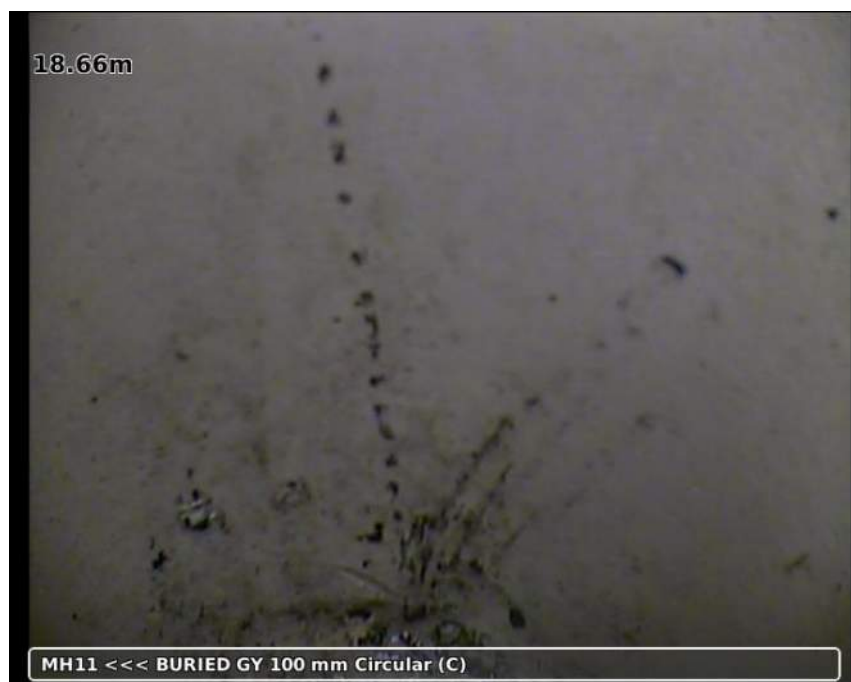
Photo: 20181123-141150-snap0005.jpg  
 18.66m, Finish node type gully reference number: BURIED GY

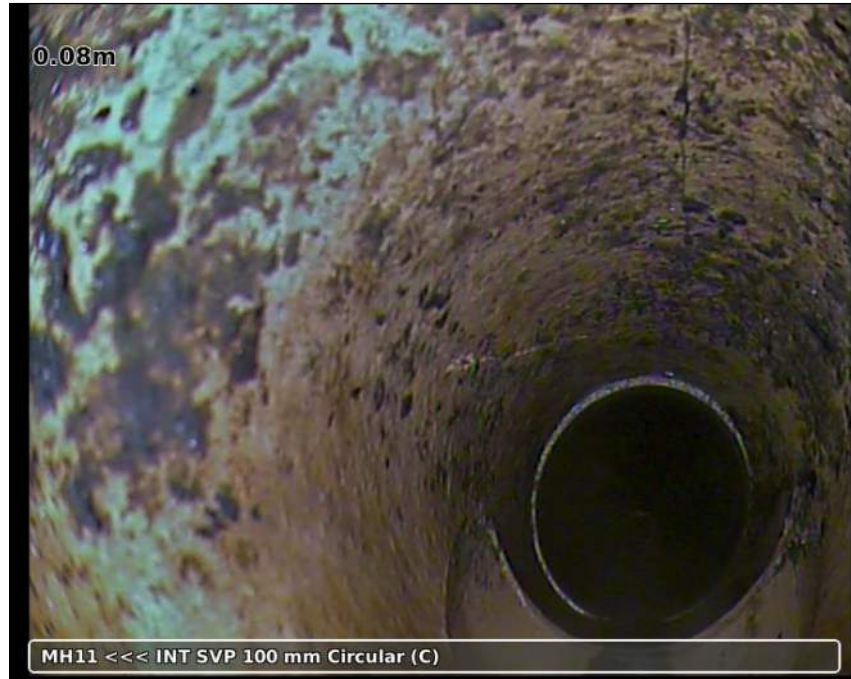
Photo: 20181123-142115-snap0002.jpg  
 0.08m, Junction from/at 06 o'clock diameter: 100 mm

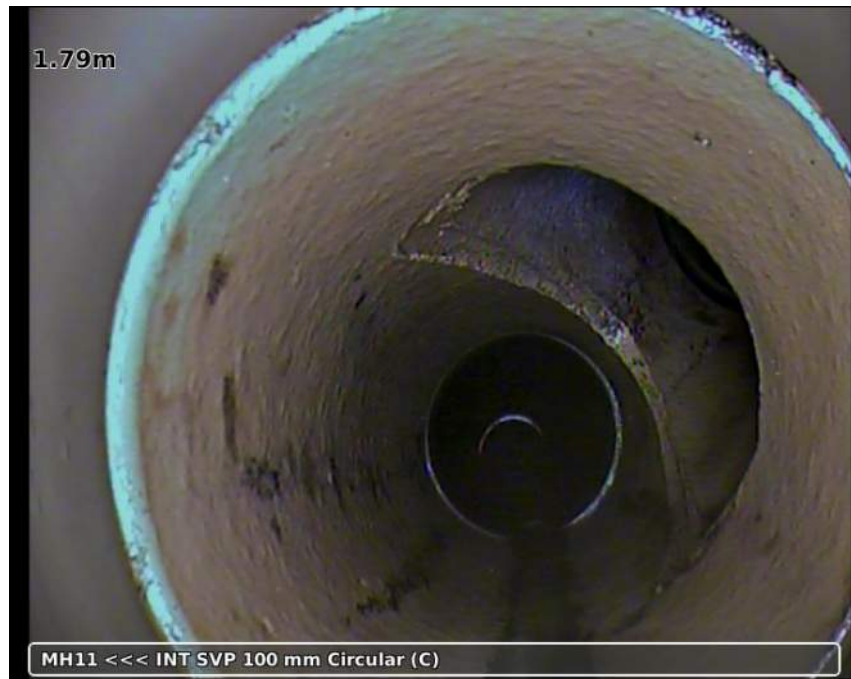
Photo: 20181123-142115-snap0003.jpg  
 1.79m, Junction from/at 03 o'clock diameter: 100 mm

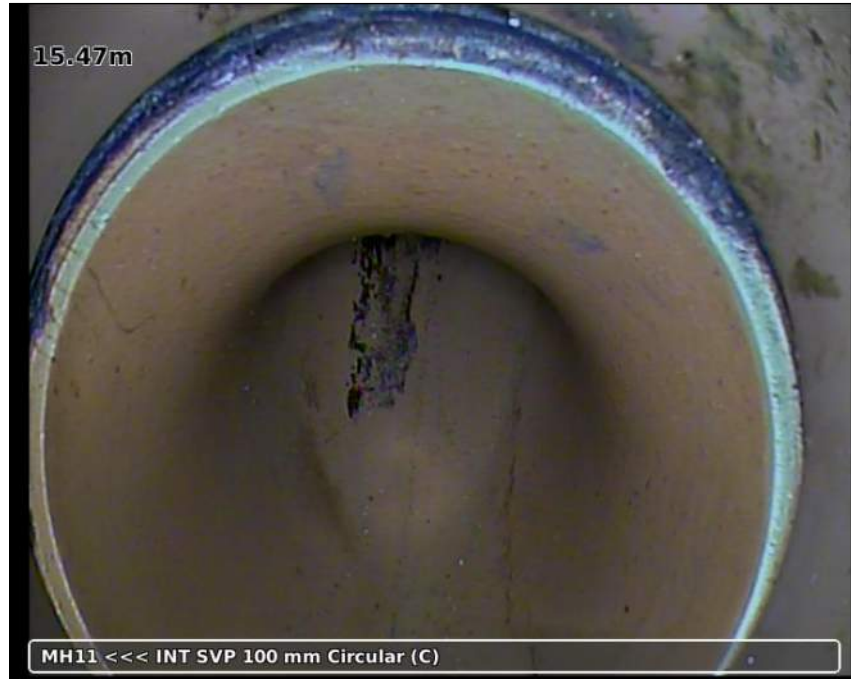
Photo: 20181123-142115-snap0004.jpg  
 15.47m, Line deviates up

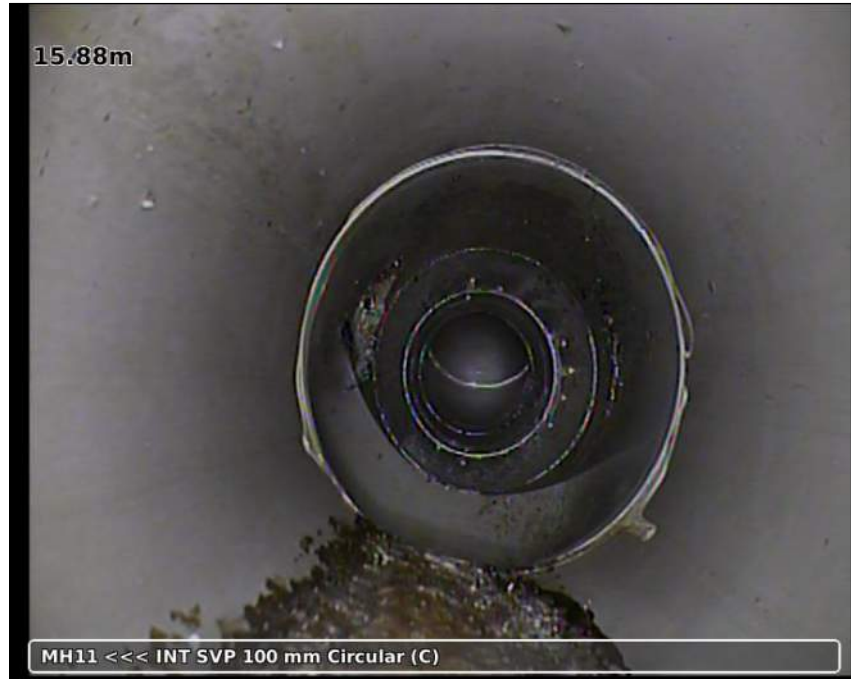
Photo: 20181123-142115-snap0006.jpg

15.88m, Finish node type other special chamber reference number: INT SVP

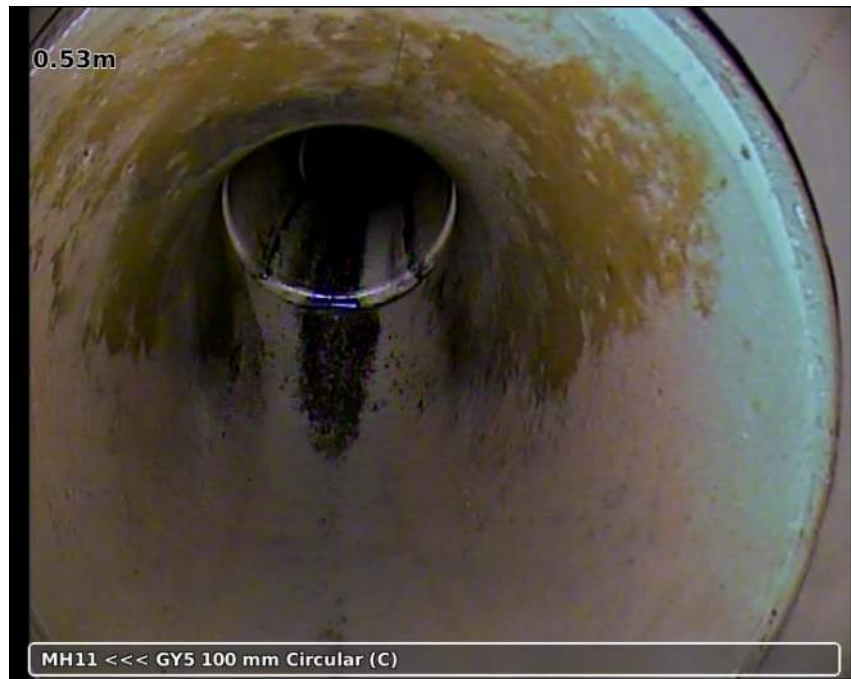
Photo: 20181123-144743-snap0001.jpg  
 0.53m, Line deviates up

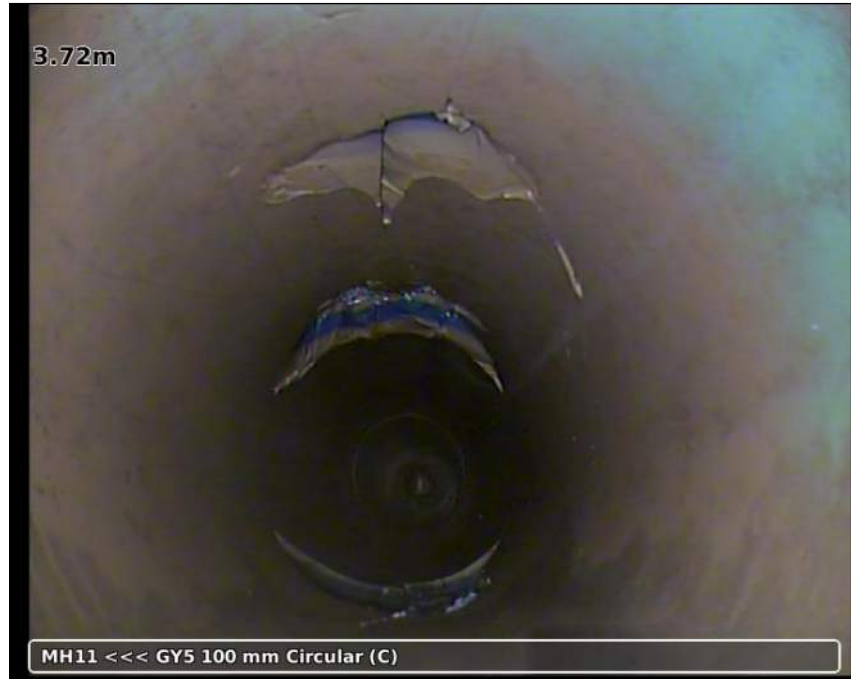
Photo: 20181123-144743-snap0002.jpg  
 3.72m, Hole in drain or sewer from/at 11 o'clock to 01 o'clock

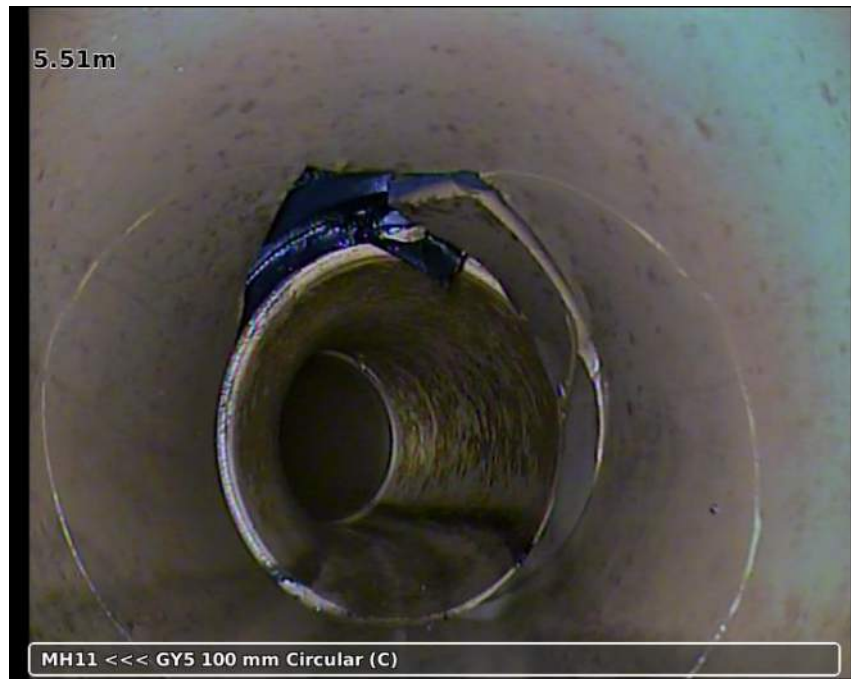
Photo: 20181123-144743-snap0003.jpg  
 5.51m, Broken pipe at joint from/at 10 o'clock to 02 o'clock

| 1:60 | Position | Observation | | | | | | | |
|---|---|---|---|---|---|---|---|---|---|
| | | 5.51 | Broken pipe at joint from/at 10 o'clock to 02 o'clock | | | | | | |

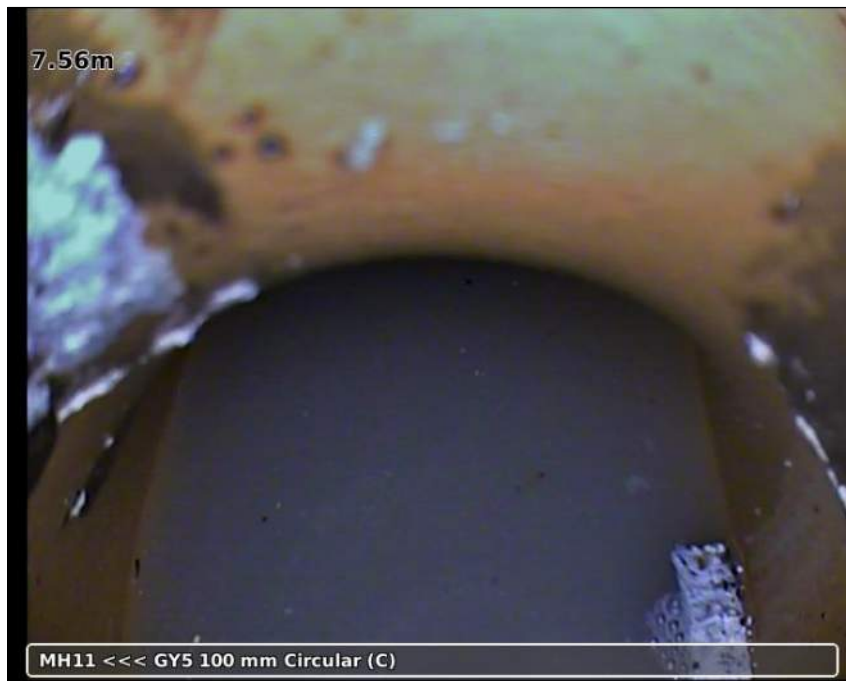
Photo: 20181123-144743-snap0004.jpg  
7.56m, Finish node type gully reference number: GY5

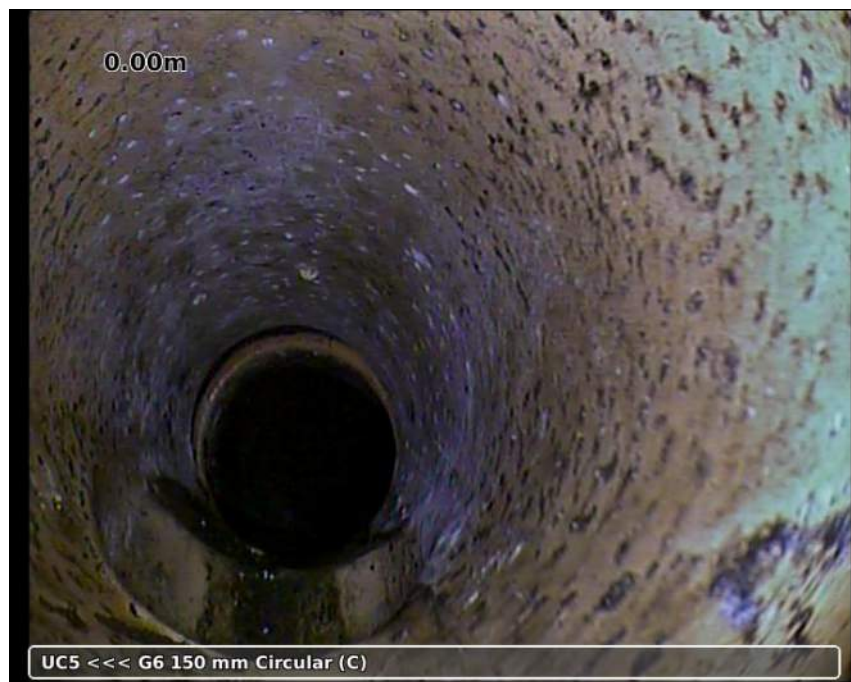
Photo: 20181204-144214-snap0001.jpg  
 0m, Junction from/at 05 o'clock to 07 o'clock diameter: 150 mm

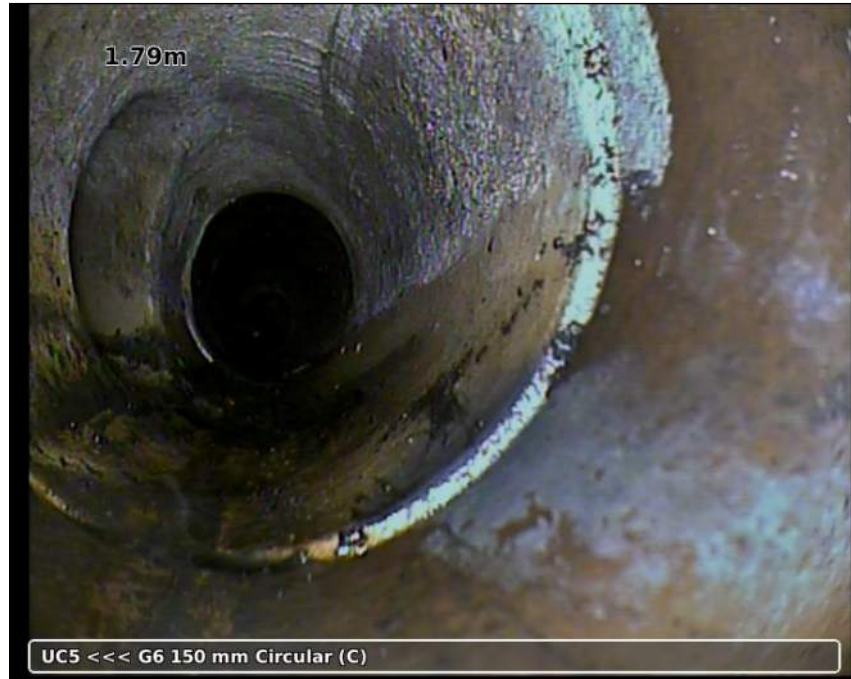
Photo: 20181204-144214-snap0002.jpg  
 1.79m, Junction from/at 07 o'clock to 10 o'clock diameter: 150 mm

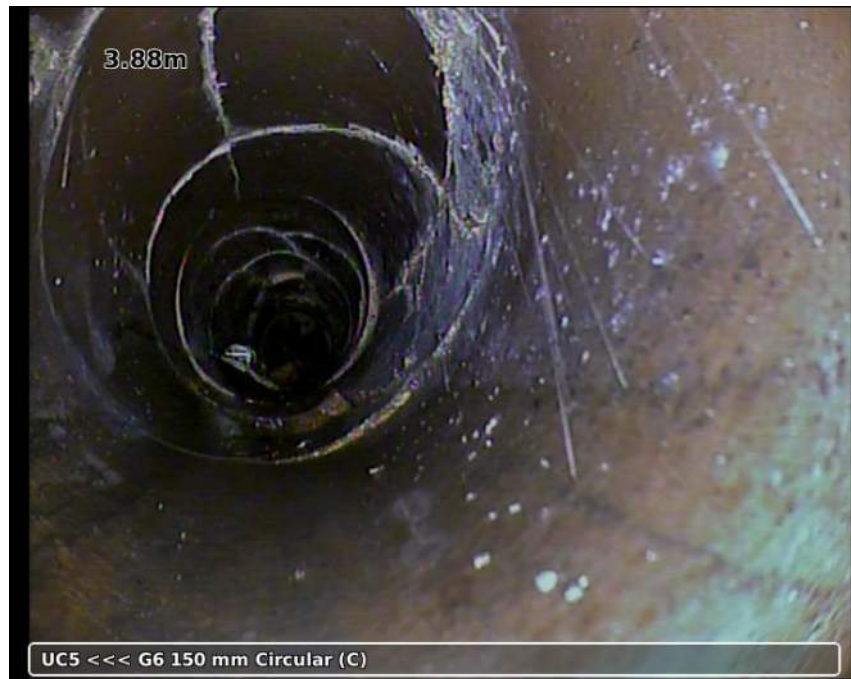
Photo: 20181204-144214-snap0003.jpg  
 3.88m, Fracture multiple from/at 12 o'clock to 12 o'clock

| 1:60 | Position | Observation | | | | | | | |
|---|---|---|---|---|---|---|---|---|---|
| | 3.88 | Fracture multiple from/at 12 o'clock to 12 o'clock | | | | | | | |

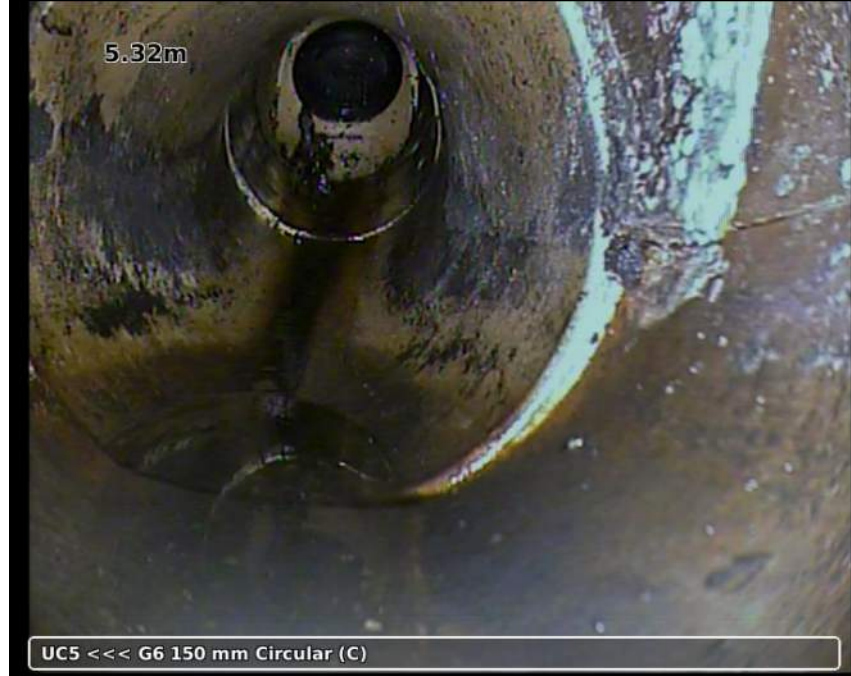
Photo: 20181204-144214-snap0004.jpg  
 5.32m, Line deviates up M

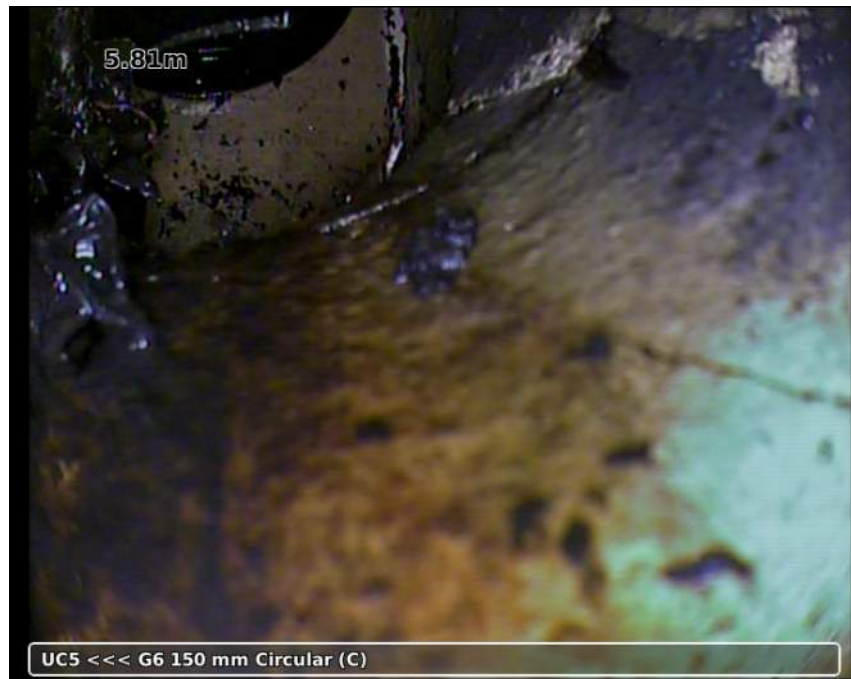
Photo: 20181204-144214-snap0005.jpg  
 5.81m, Finish node type gully reference number: G6

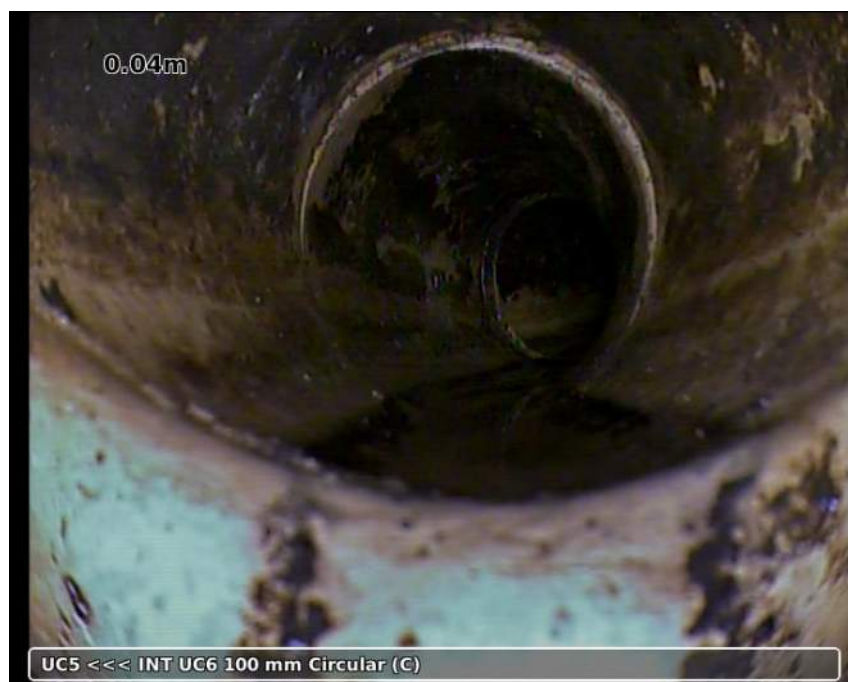
Photo: 20181204-144708-snap0001.jpg  
 0.04m, Junction from/at 05 o'clock to 07 o'clock diameter: 100 mm

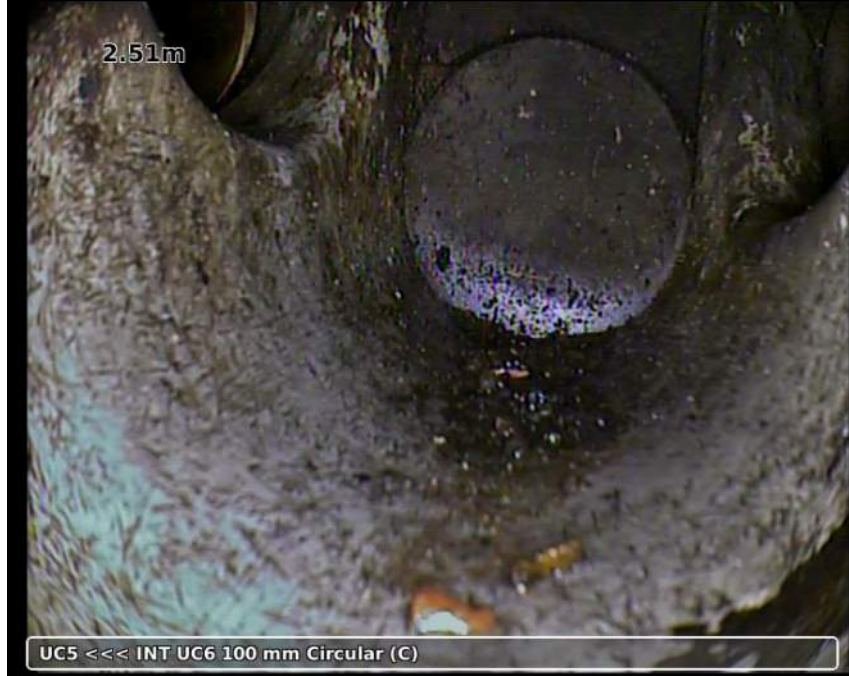
Photo: 20181204-144708-snap0002.jpg  
 2.51m, Finish node type manhole reference number: INT UC6

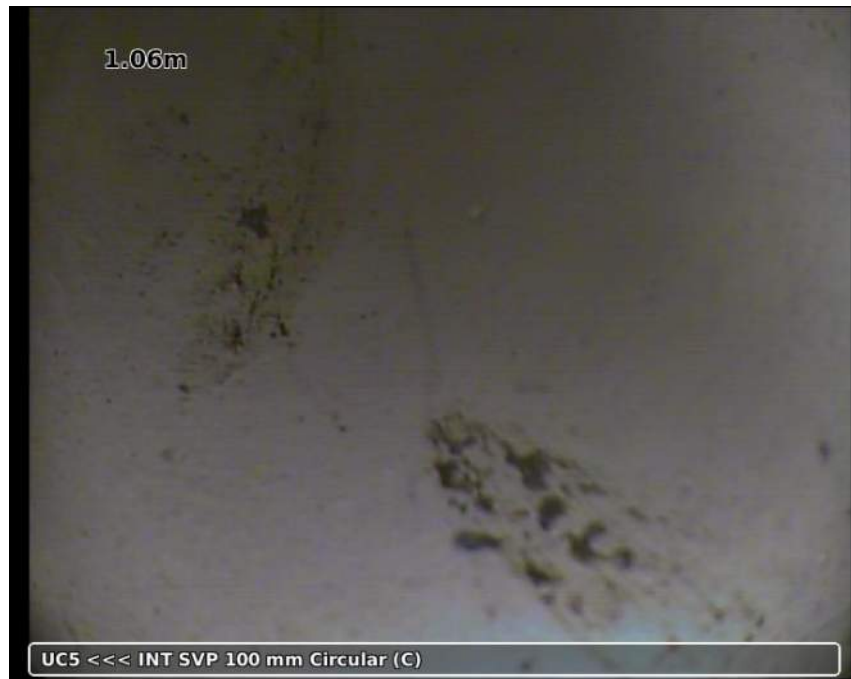
Photo: 20181204-145231-snap0001.jpg  
 1.06m, Line deviates up M

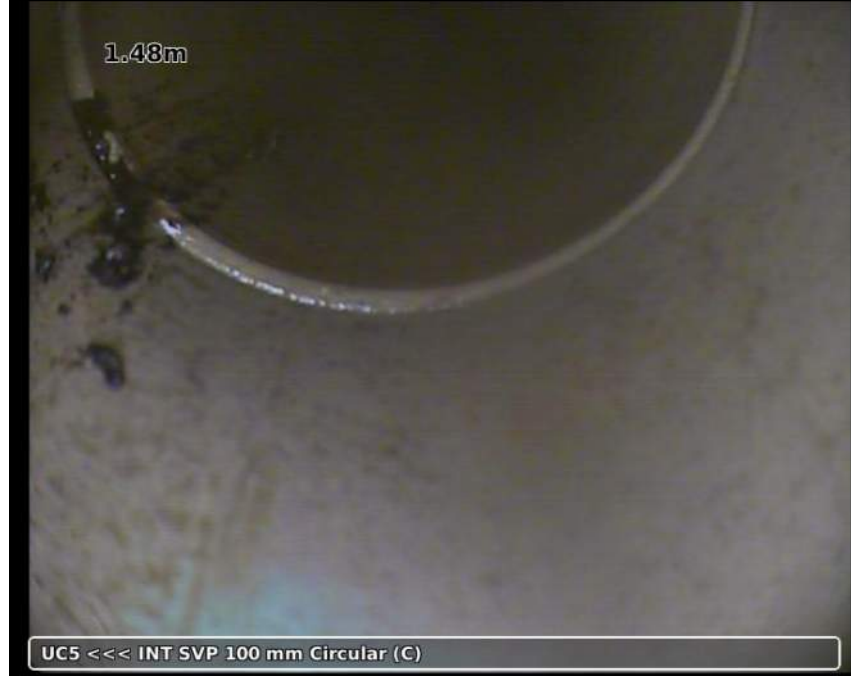
Photo: 20181204-145231-snap0002.jpg

1.48m, Finish node type other special chamber reference number: INT SVP

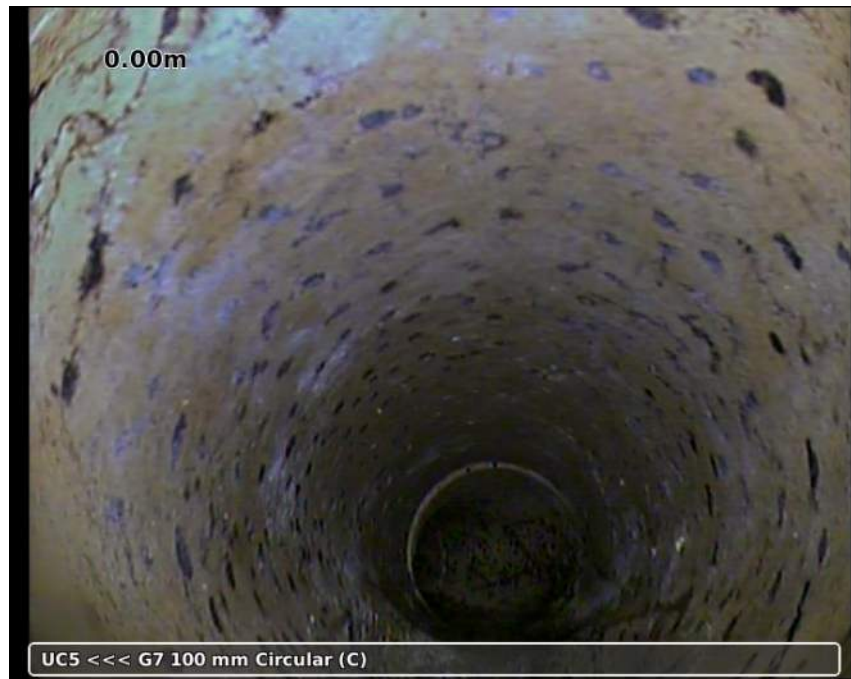
Photo: 20181204-145924-snap0001.jpg  
 0m, Junction from/at 05 o'clock to 07 o'clock diameter: 100 mm
