# Gorton Community Hub

## Flood Risk Assessment and Detailed Drainage Strategy

Curtins Ref: GCH-CUR-XX-XX-RP-C-0002

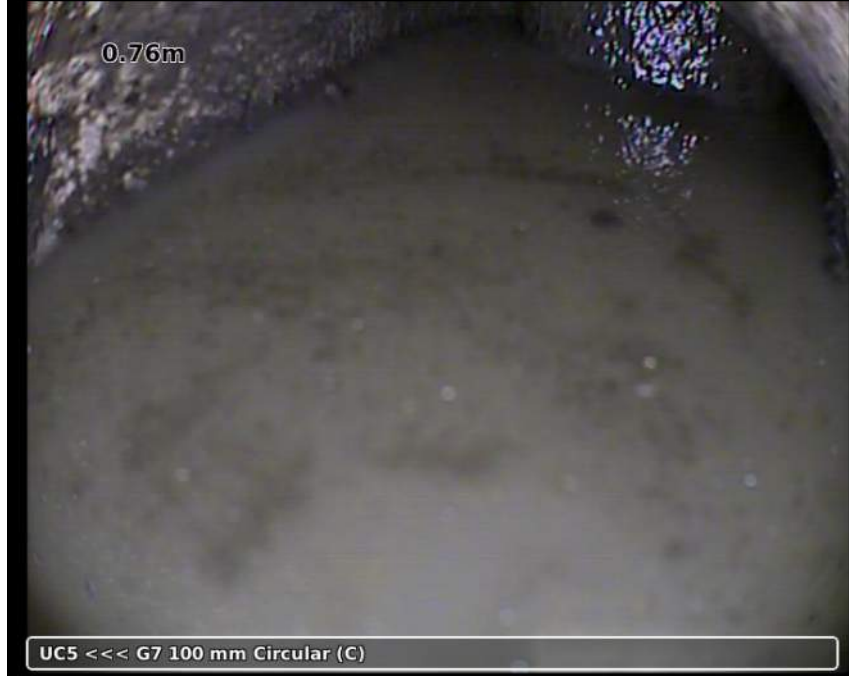
Photo: 20181204-145924-snap0002.jpg  
0.76m, Finish node type gully reference number: G7

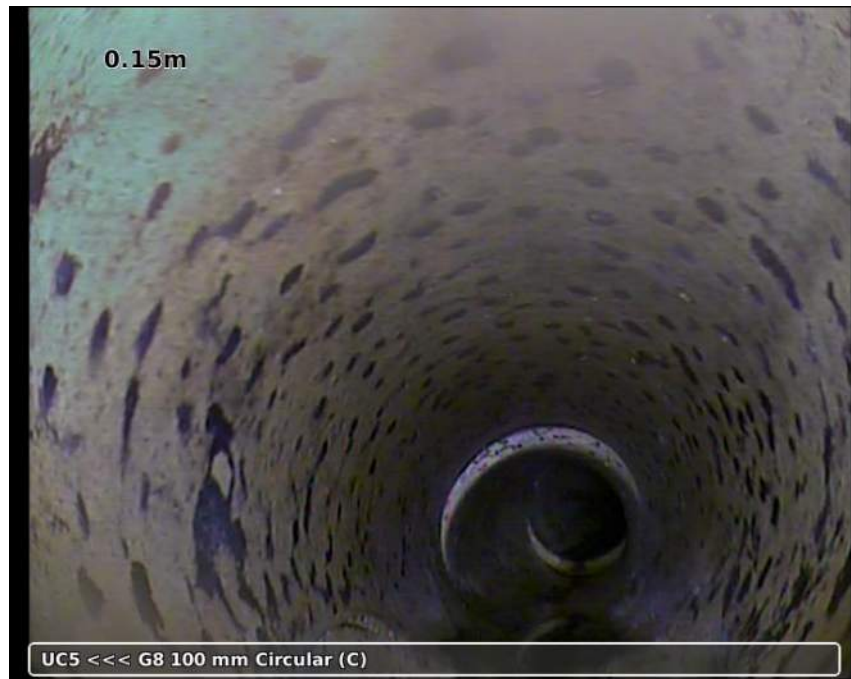
Photo: 20181204-150307-snap0001.jpg  
 0.15m, Junction from/at 05 o'clock to 07 o'clock diameter: 100 mm

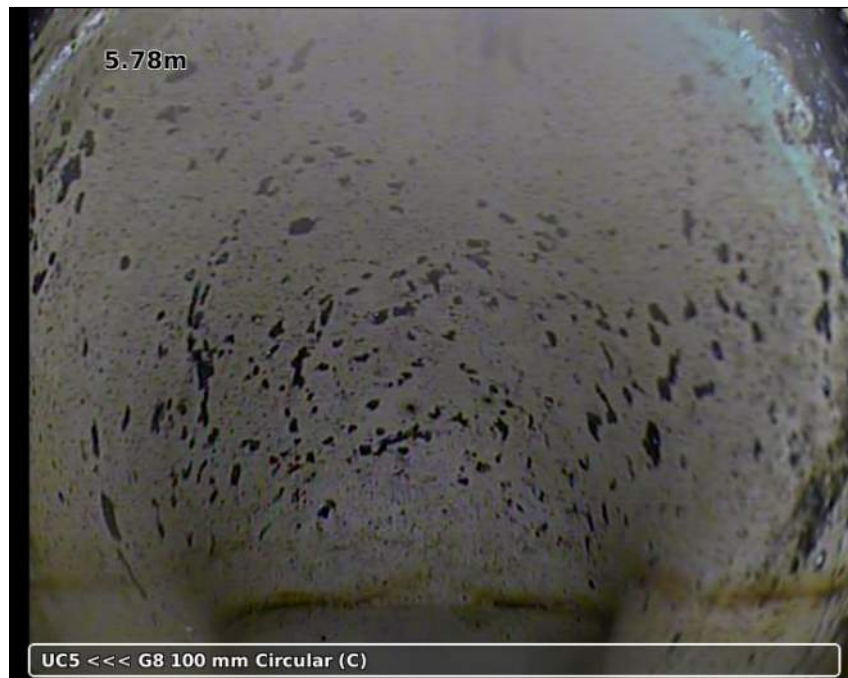
Photo: 20181204-150307-snap0002.jpg  
 5.78m, Finish node type gully reference number: G8

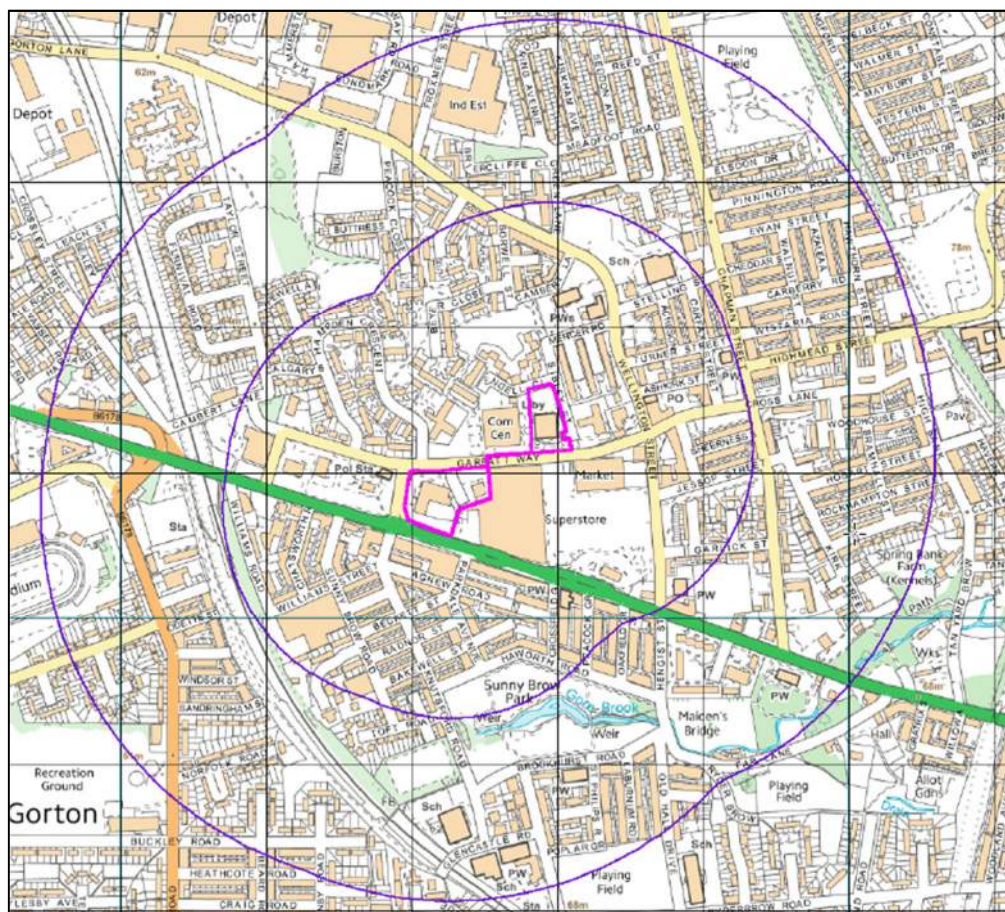
**Fig 2.1** – Site Location Plan. Site boundaries shown in pink, 250m and 500m buffers in purple.  
Crown Copyright. License Number 100022432

The site is located off Garrett Way, Gorton, Manchester as illustrated in *Figure 2.1* below. The site is currently occupied by the former Eastland Homes Hub with an adjacent car park to the west, disused pub and area of hardstanding to the east, areas of soft landscaping and a gated carpark to marginally to the south. The site is relatively level and is situated at approximately 68m AOD.

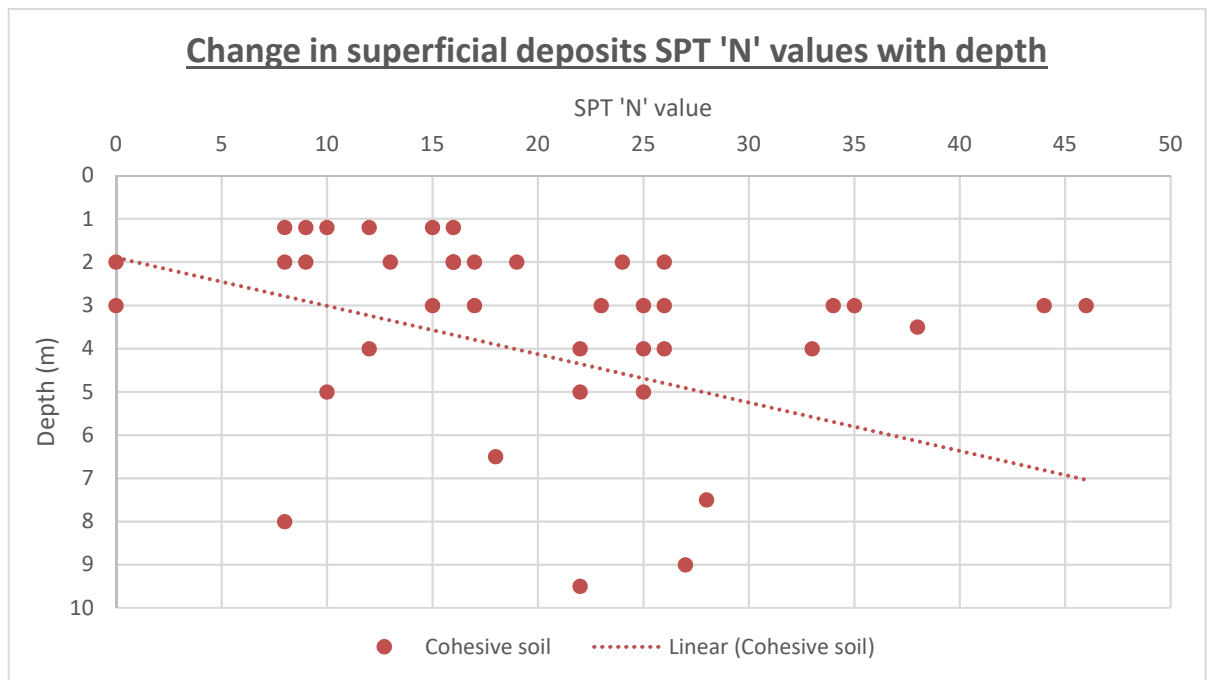
**Figure 5.3** – SPT 'N' value versus depth for Glacial Till deposits (Cohesive).

Figure 5.3 below shows the correlation between SPT 'N' values with depth for Cohesive material and Figure 5.4 for the correlation for Granular, which shows a general increase in 'N' value with depth for both cohesive and granular.

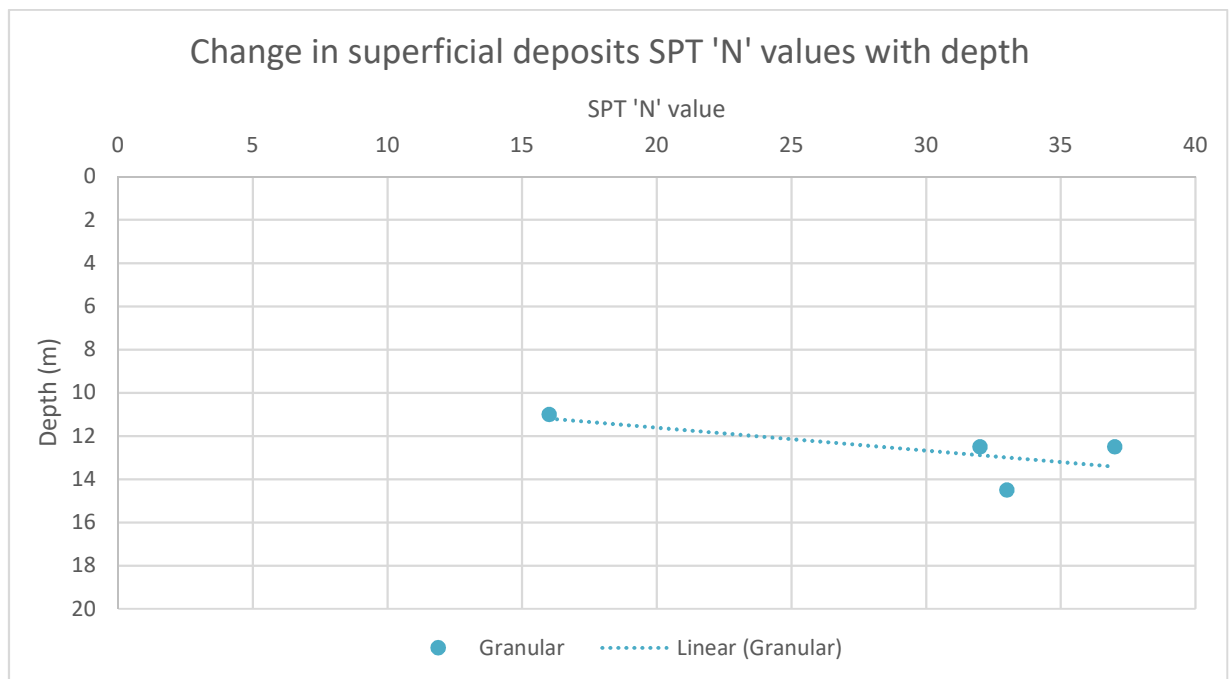
**Figure 5.4** – SPT 'N' value versus depth for Glacial Till deposits (Granular).

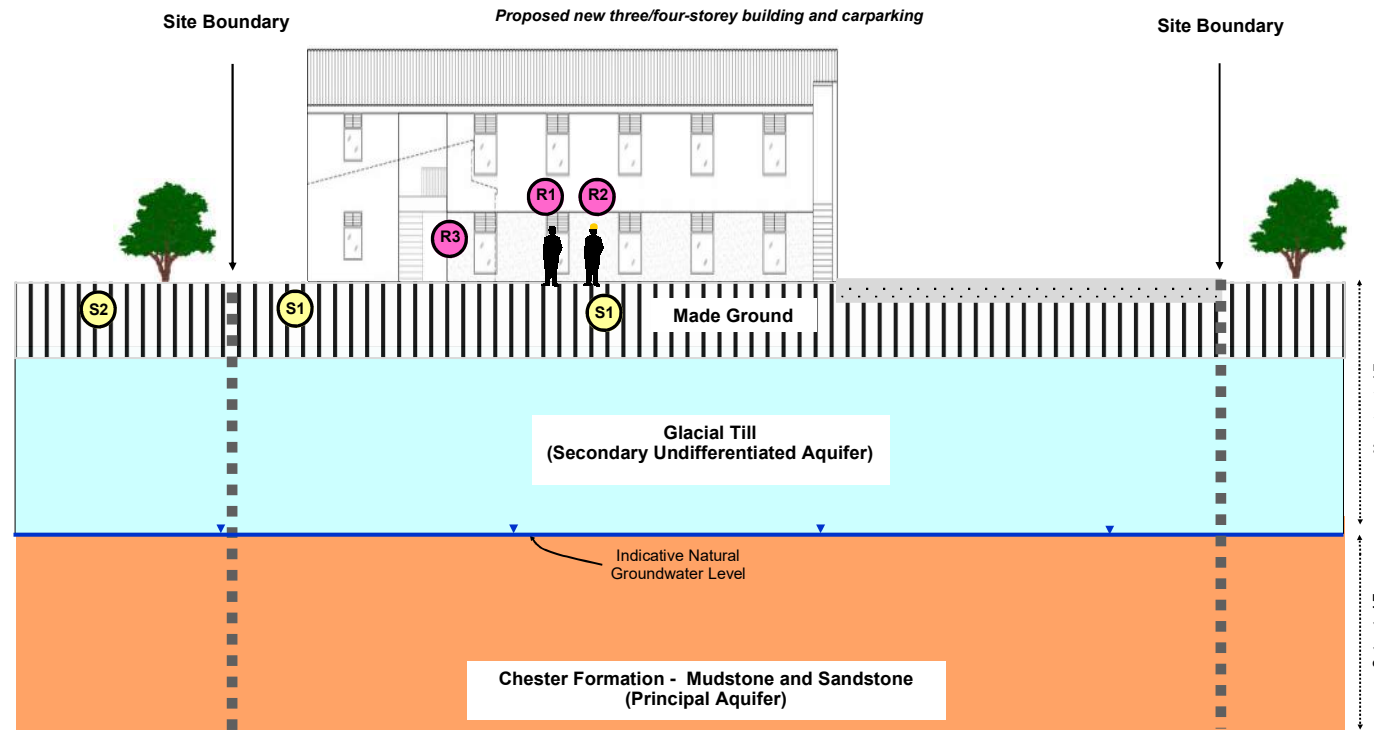
### Sources

- S1 Made Ground (onsite)
- S2 Made Ground (offsite)
- S3 Historic infilled ponds
- S4 Ground gas sources

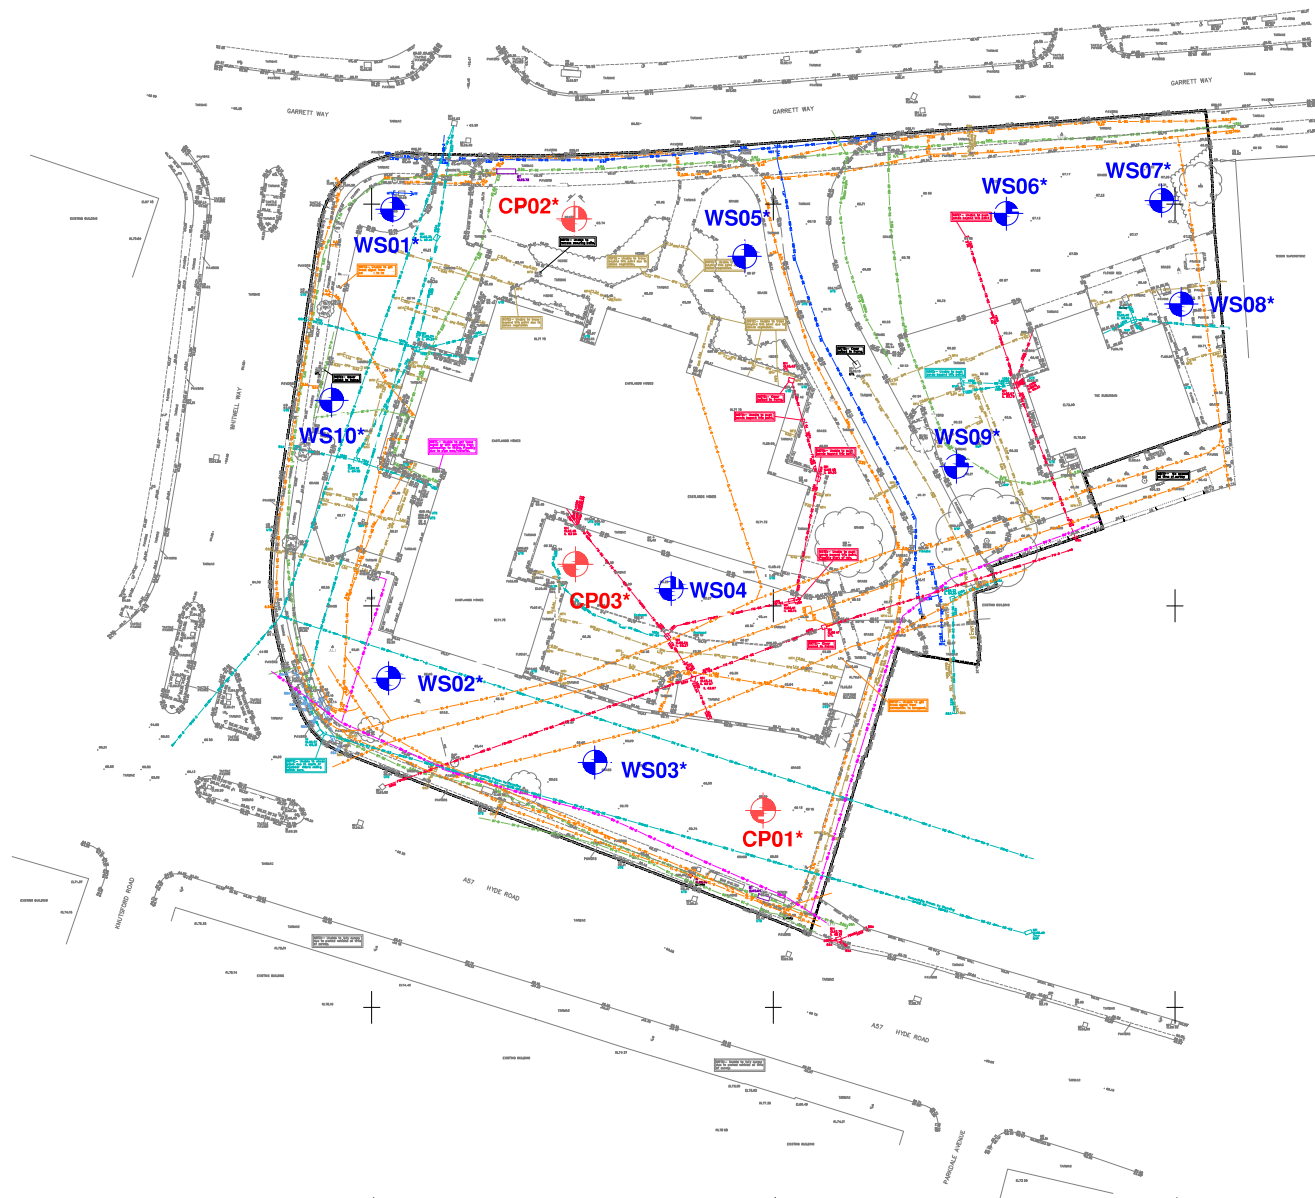
CABLE PERCUSSIVE  
BOREHOLE LOCATION  
(INSTALLATION\*)

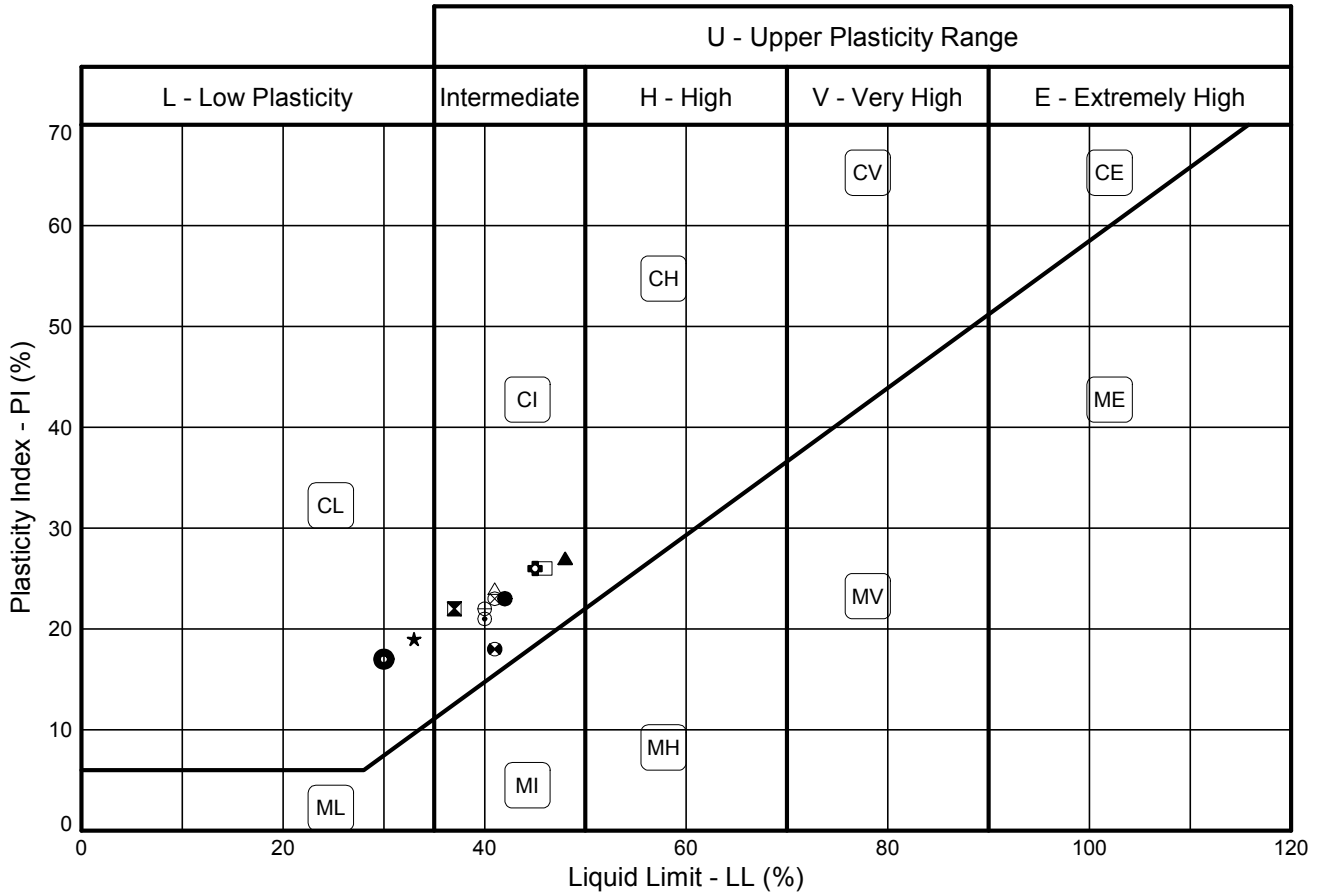
# PLASTICITY CHART - PI Vs LL

In accordance with BS5930:2015  
Testing in accordance with BS1377-2:1990

Plasticity testing undertaken in the Glacial Till recorded the clay to be of low to intermediate plasticity. In accordance with NHBC Standards Part 4 Chapter 4.2 building near trees, the clay can be described as having a low volume change potential.

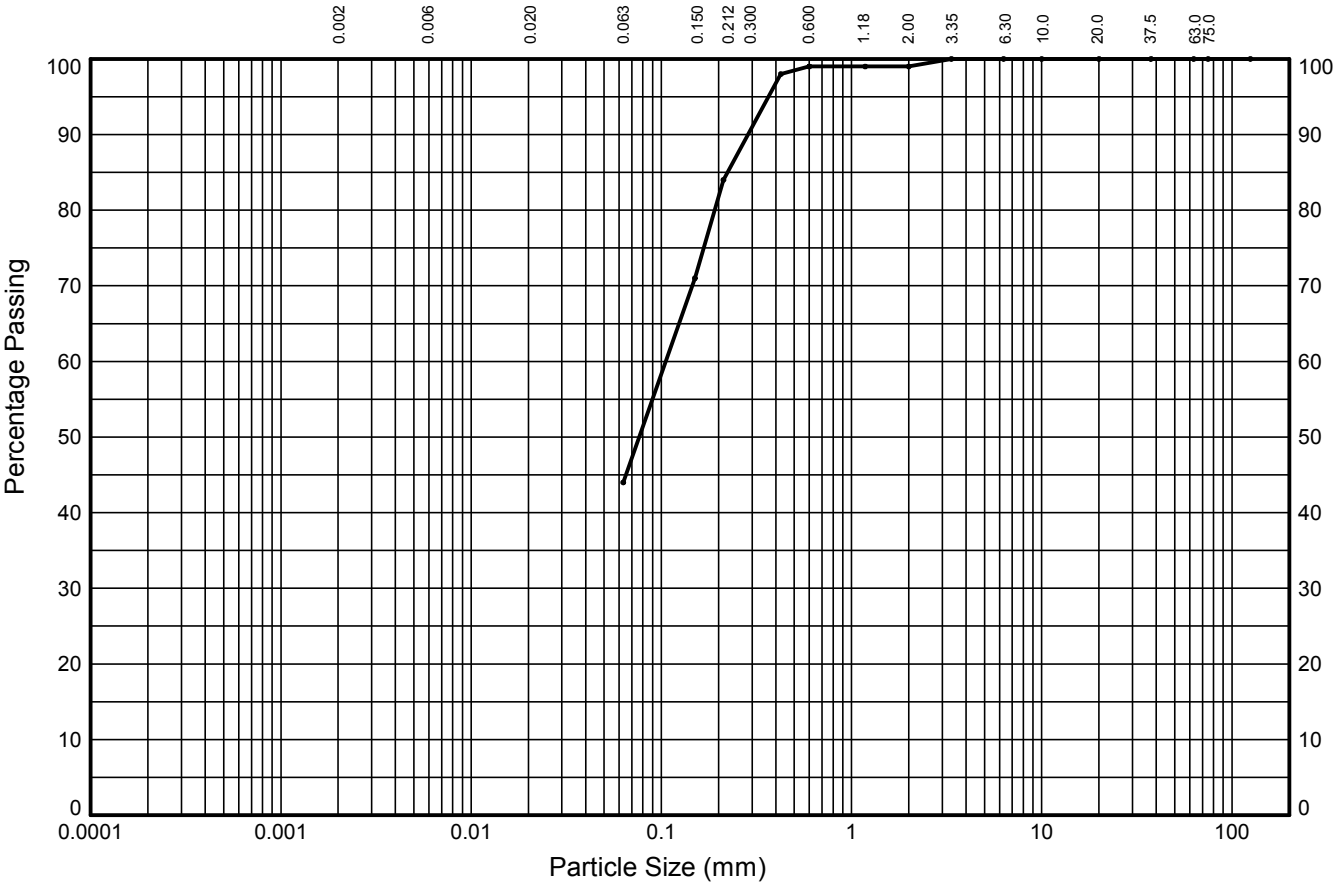
| CLAY | fine | medium | coarse | fine | medium | coarse | fine | medium | coarse | COBBLES |
| | - | - | - | 37% | 18% | 0% | 1% | 0% | 0% | |

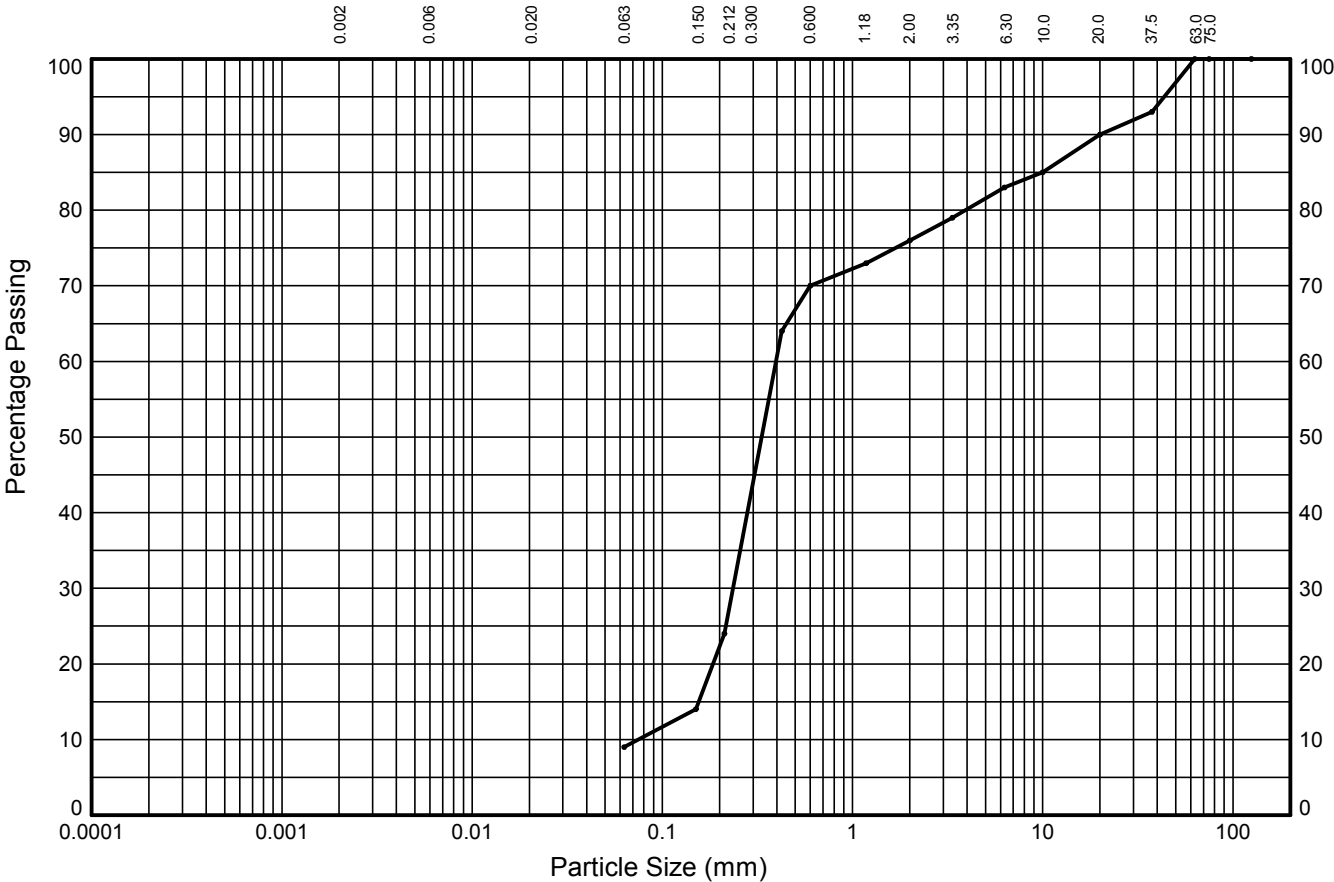
| CLAY | fine | medium | coarse | fine | medium | coarse | fine | medium | coarse | COBBLES |
| | - | - | - | 13% | 48% | 6% | 7% | 7% | 10% | |

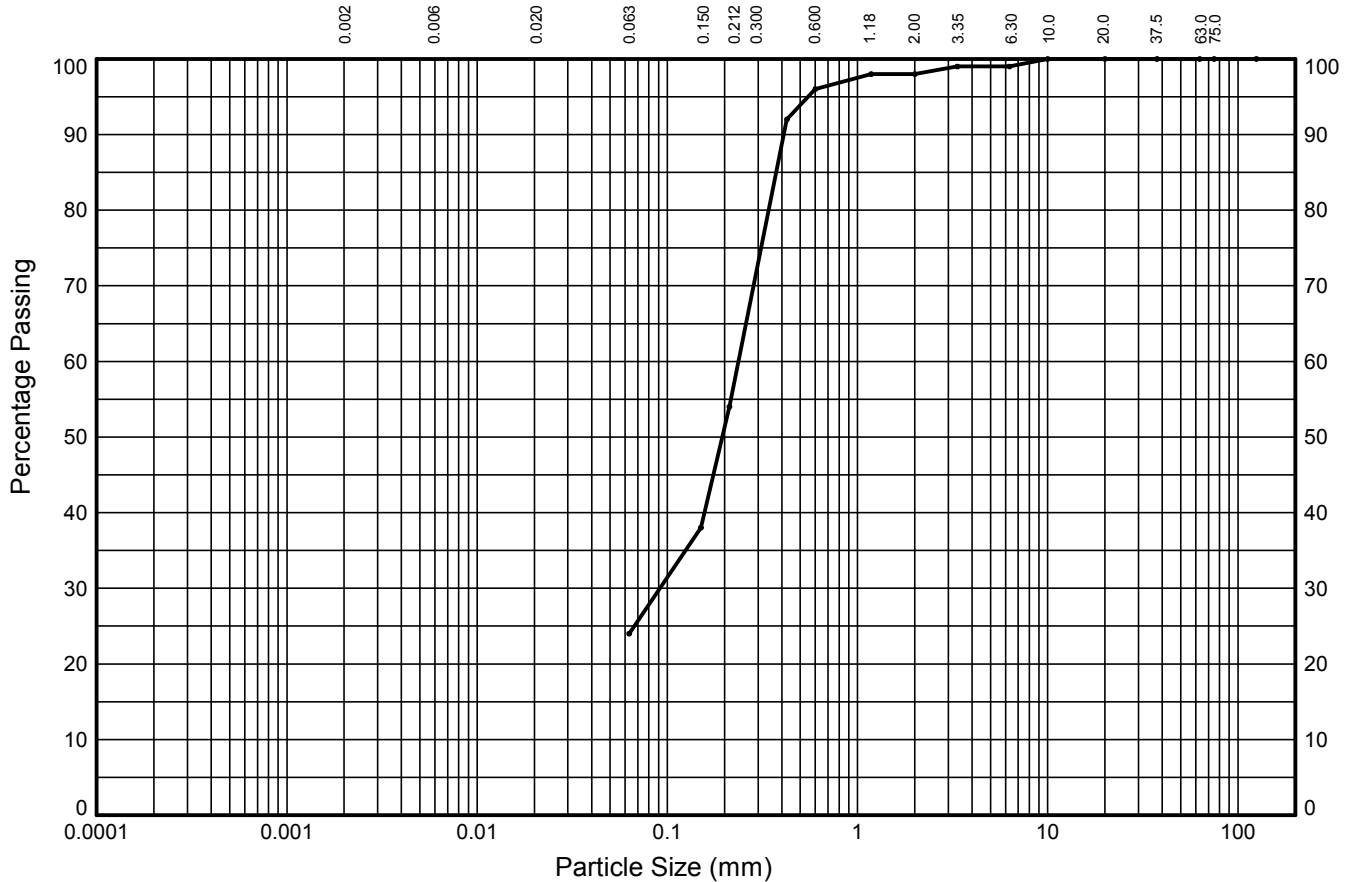
| CLAY | fine | medium | coarse | fine | medium | coarse | fine | medium | coarse | COBBLES |
| | - | - | - | 27% | 45% | 2% | 1% | 1% | 0% | |

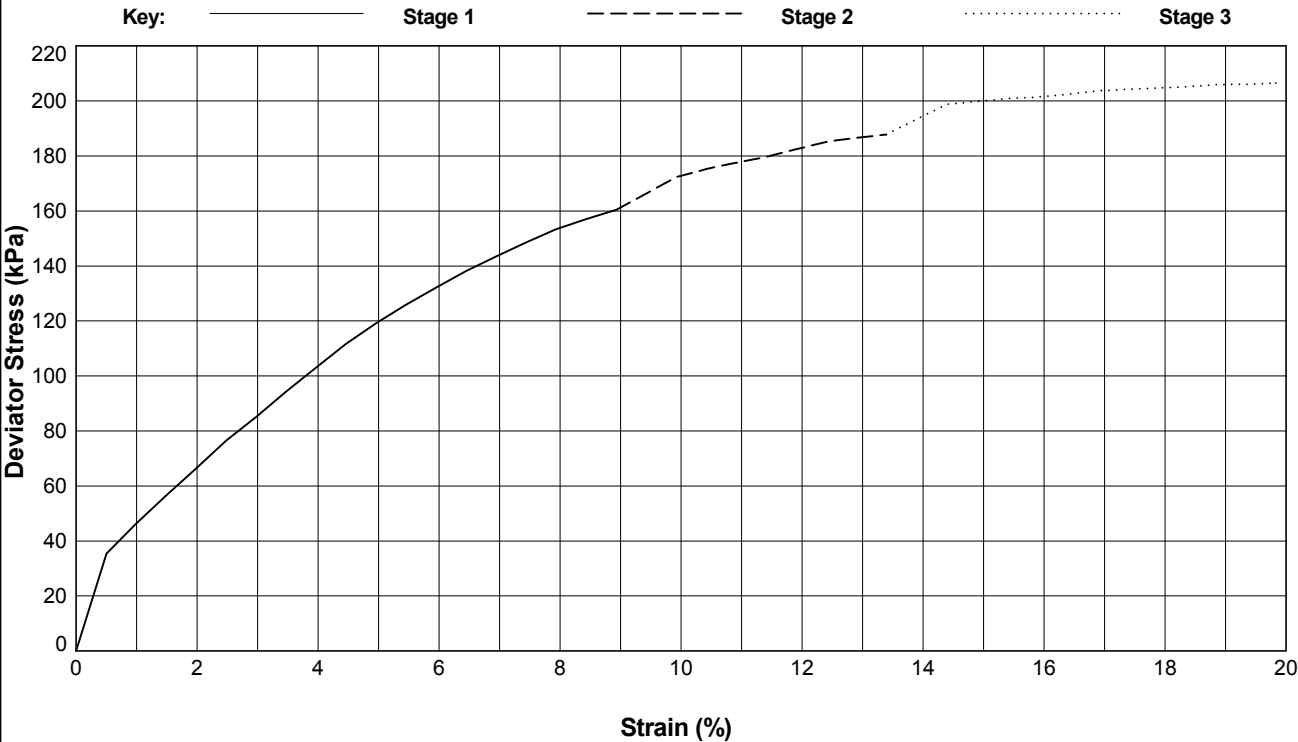
| STAGE NUMBER | | 1 | 2 | 3 |
|---|---|---|---|---|
| | Strain at Failure (%) | 8.9 | 13.4 | 19.8 |
| | Mode of Failure | | | Plastic |
