## HSG264 Asbestos Refurbishment Survey

**Rylands Building (Former Debenhams)**  
**Market Street**  
**Manchester**  
**M60 1TA**

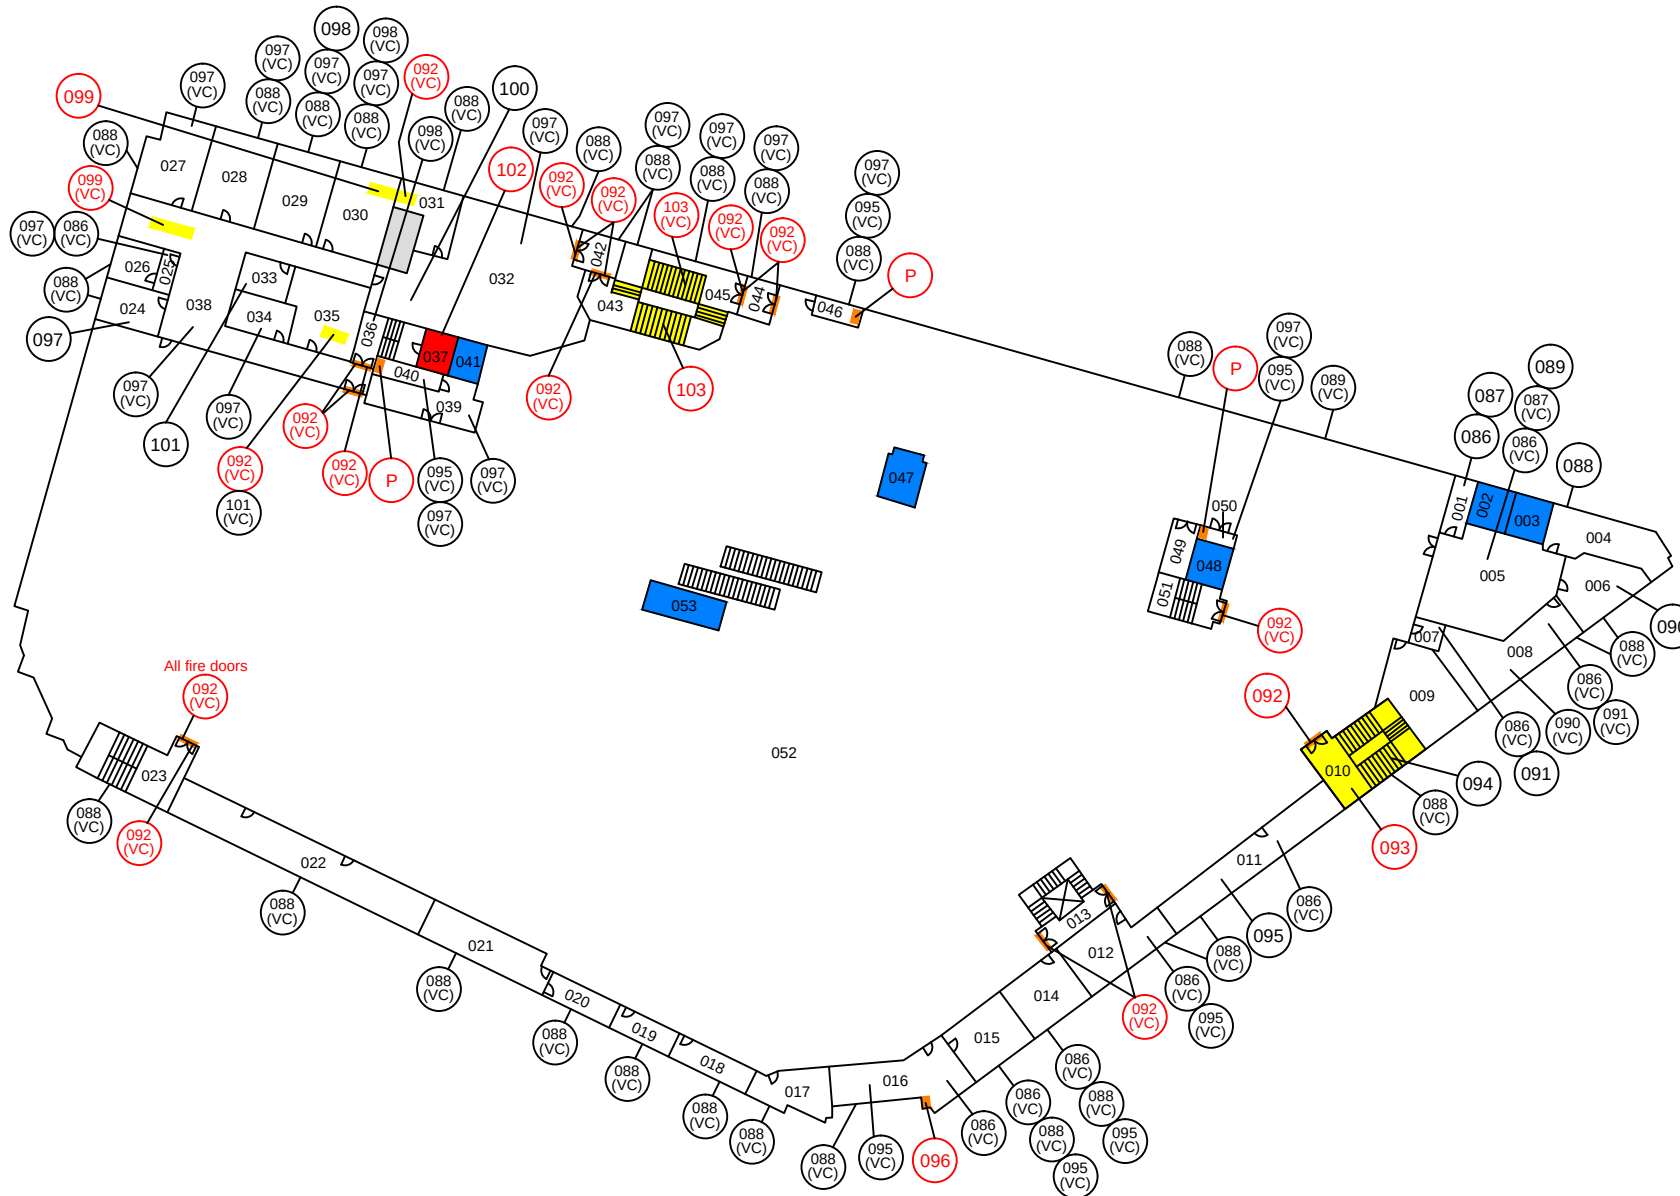
Negative Sample Location

This Drawing is for illustration purposes only and should not be used for detailed construction works as the drawing is not to scale and represents layout only. The hatching on the drawing denotes positive asbestos items found during the course of the survey and potential areas where asbestos could be found as those areas were inaccessible at the time the survey was undertaken.
