## HSG264 Asbestos Refurbishment Survey

**Rylands Building (Former Debenhams)**  
**Market Street**  
**Manchester**  
**M60 1TA**

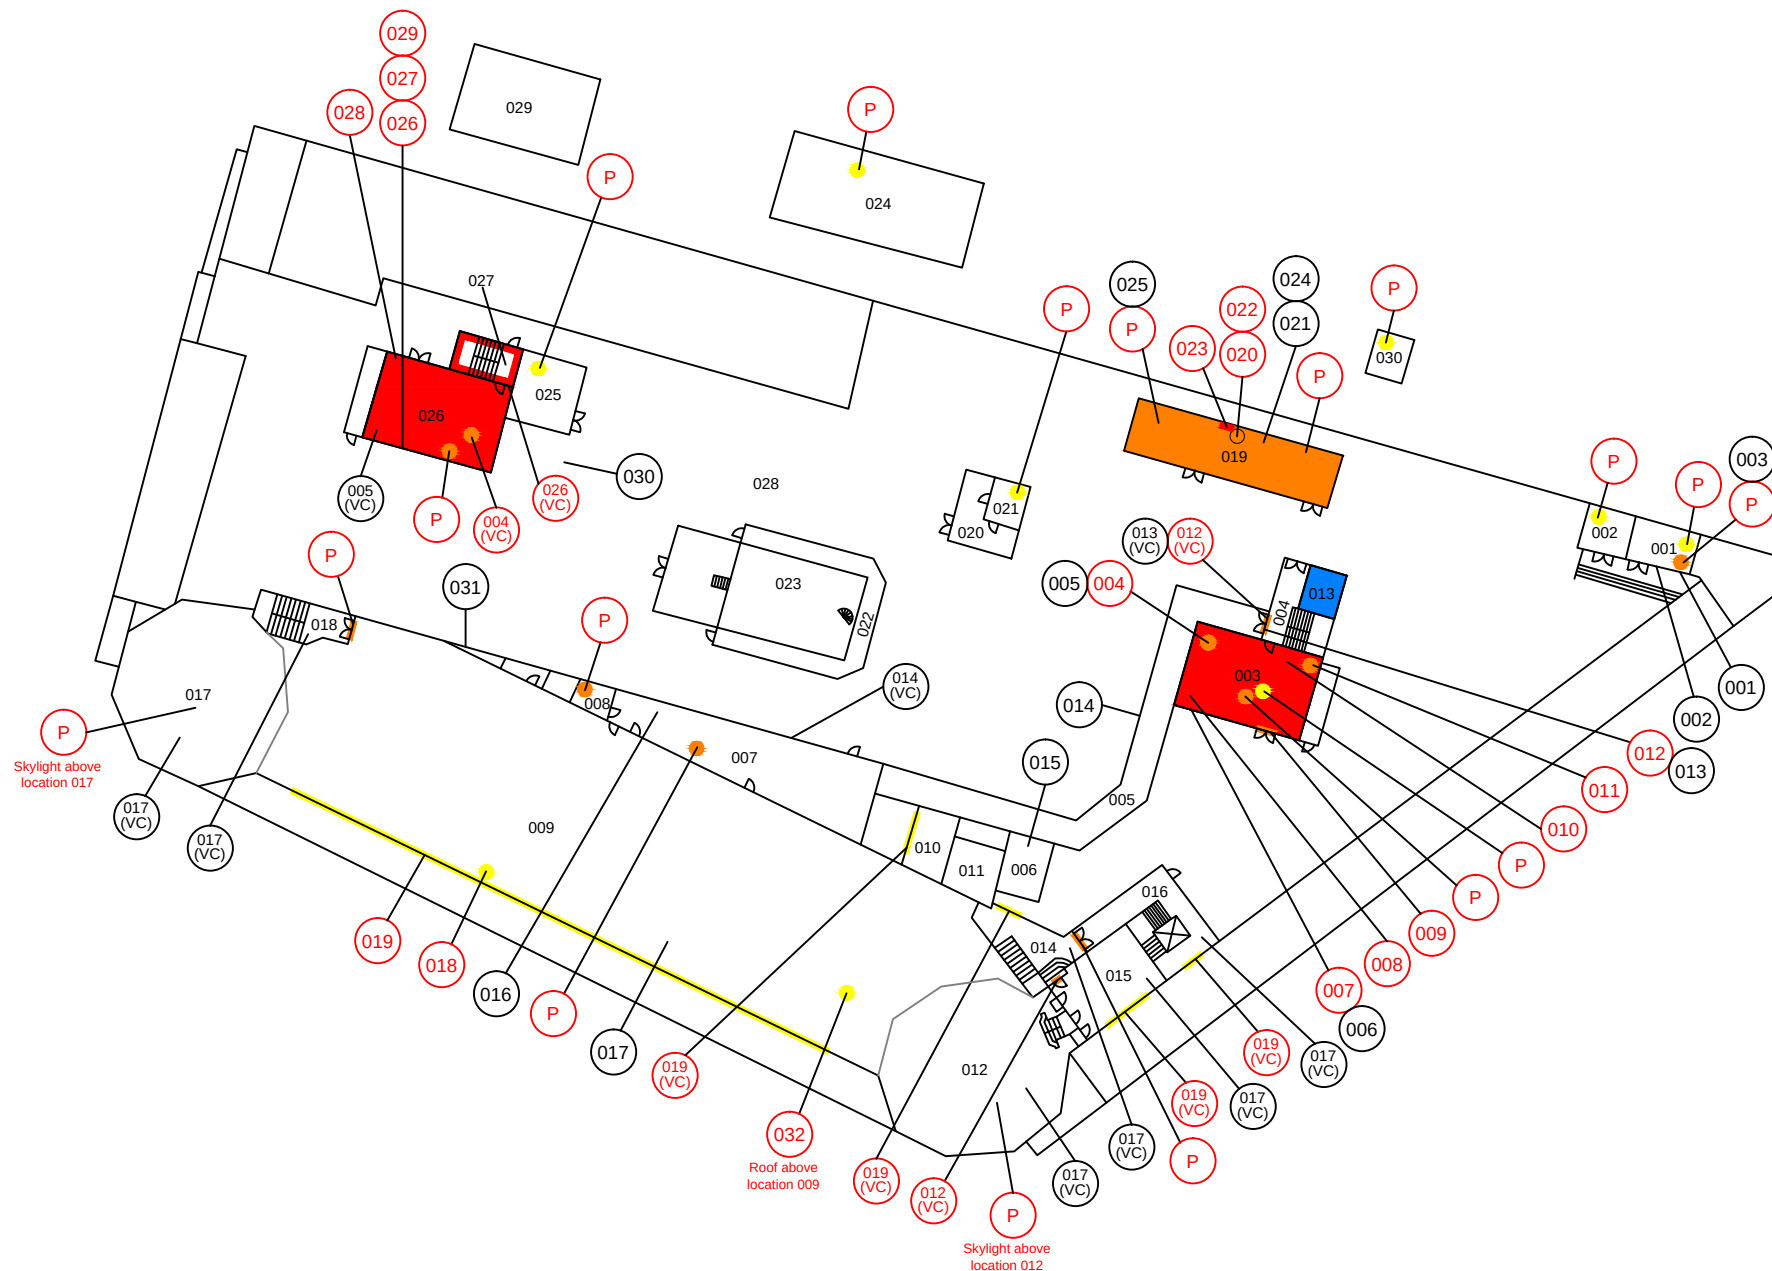
| | Negative Sample Location |

This Drawing is for illustration purposes only and should not be used for detailed construction works as the drawing is not to scale and represents layout only. The hatching on the drawing denotes positive asbestos items found during the course of the survey and potential areas where asbestos could be found as those areas were inaccessible at the time the survey was undertaken.
