**PHASE 3 REMEDIATION STATEMENT**

Report 1406A: Rev 0

**PROPOSED DEVELOPMENT:**

**NEW MOSTON PRIMARY SCHOOL, MOSTON LANE EAST  
MANCHESTER M40 3QJ**

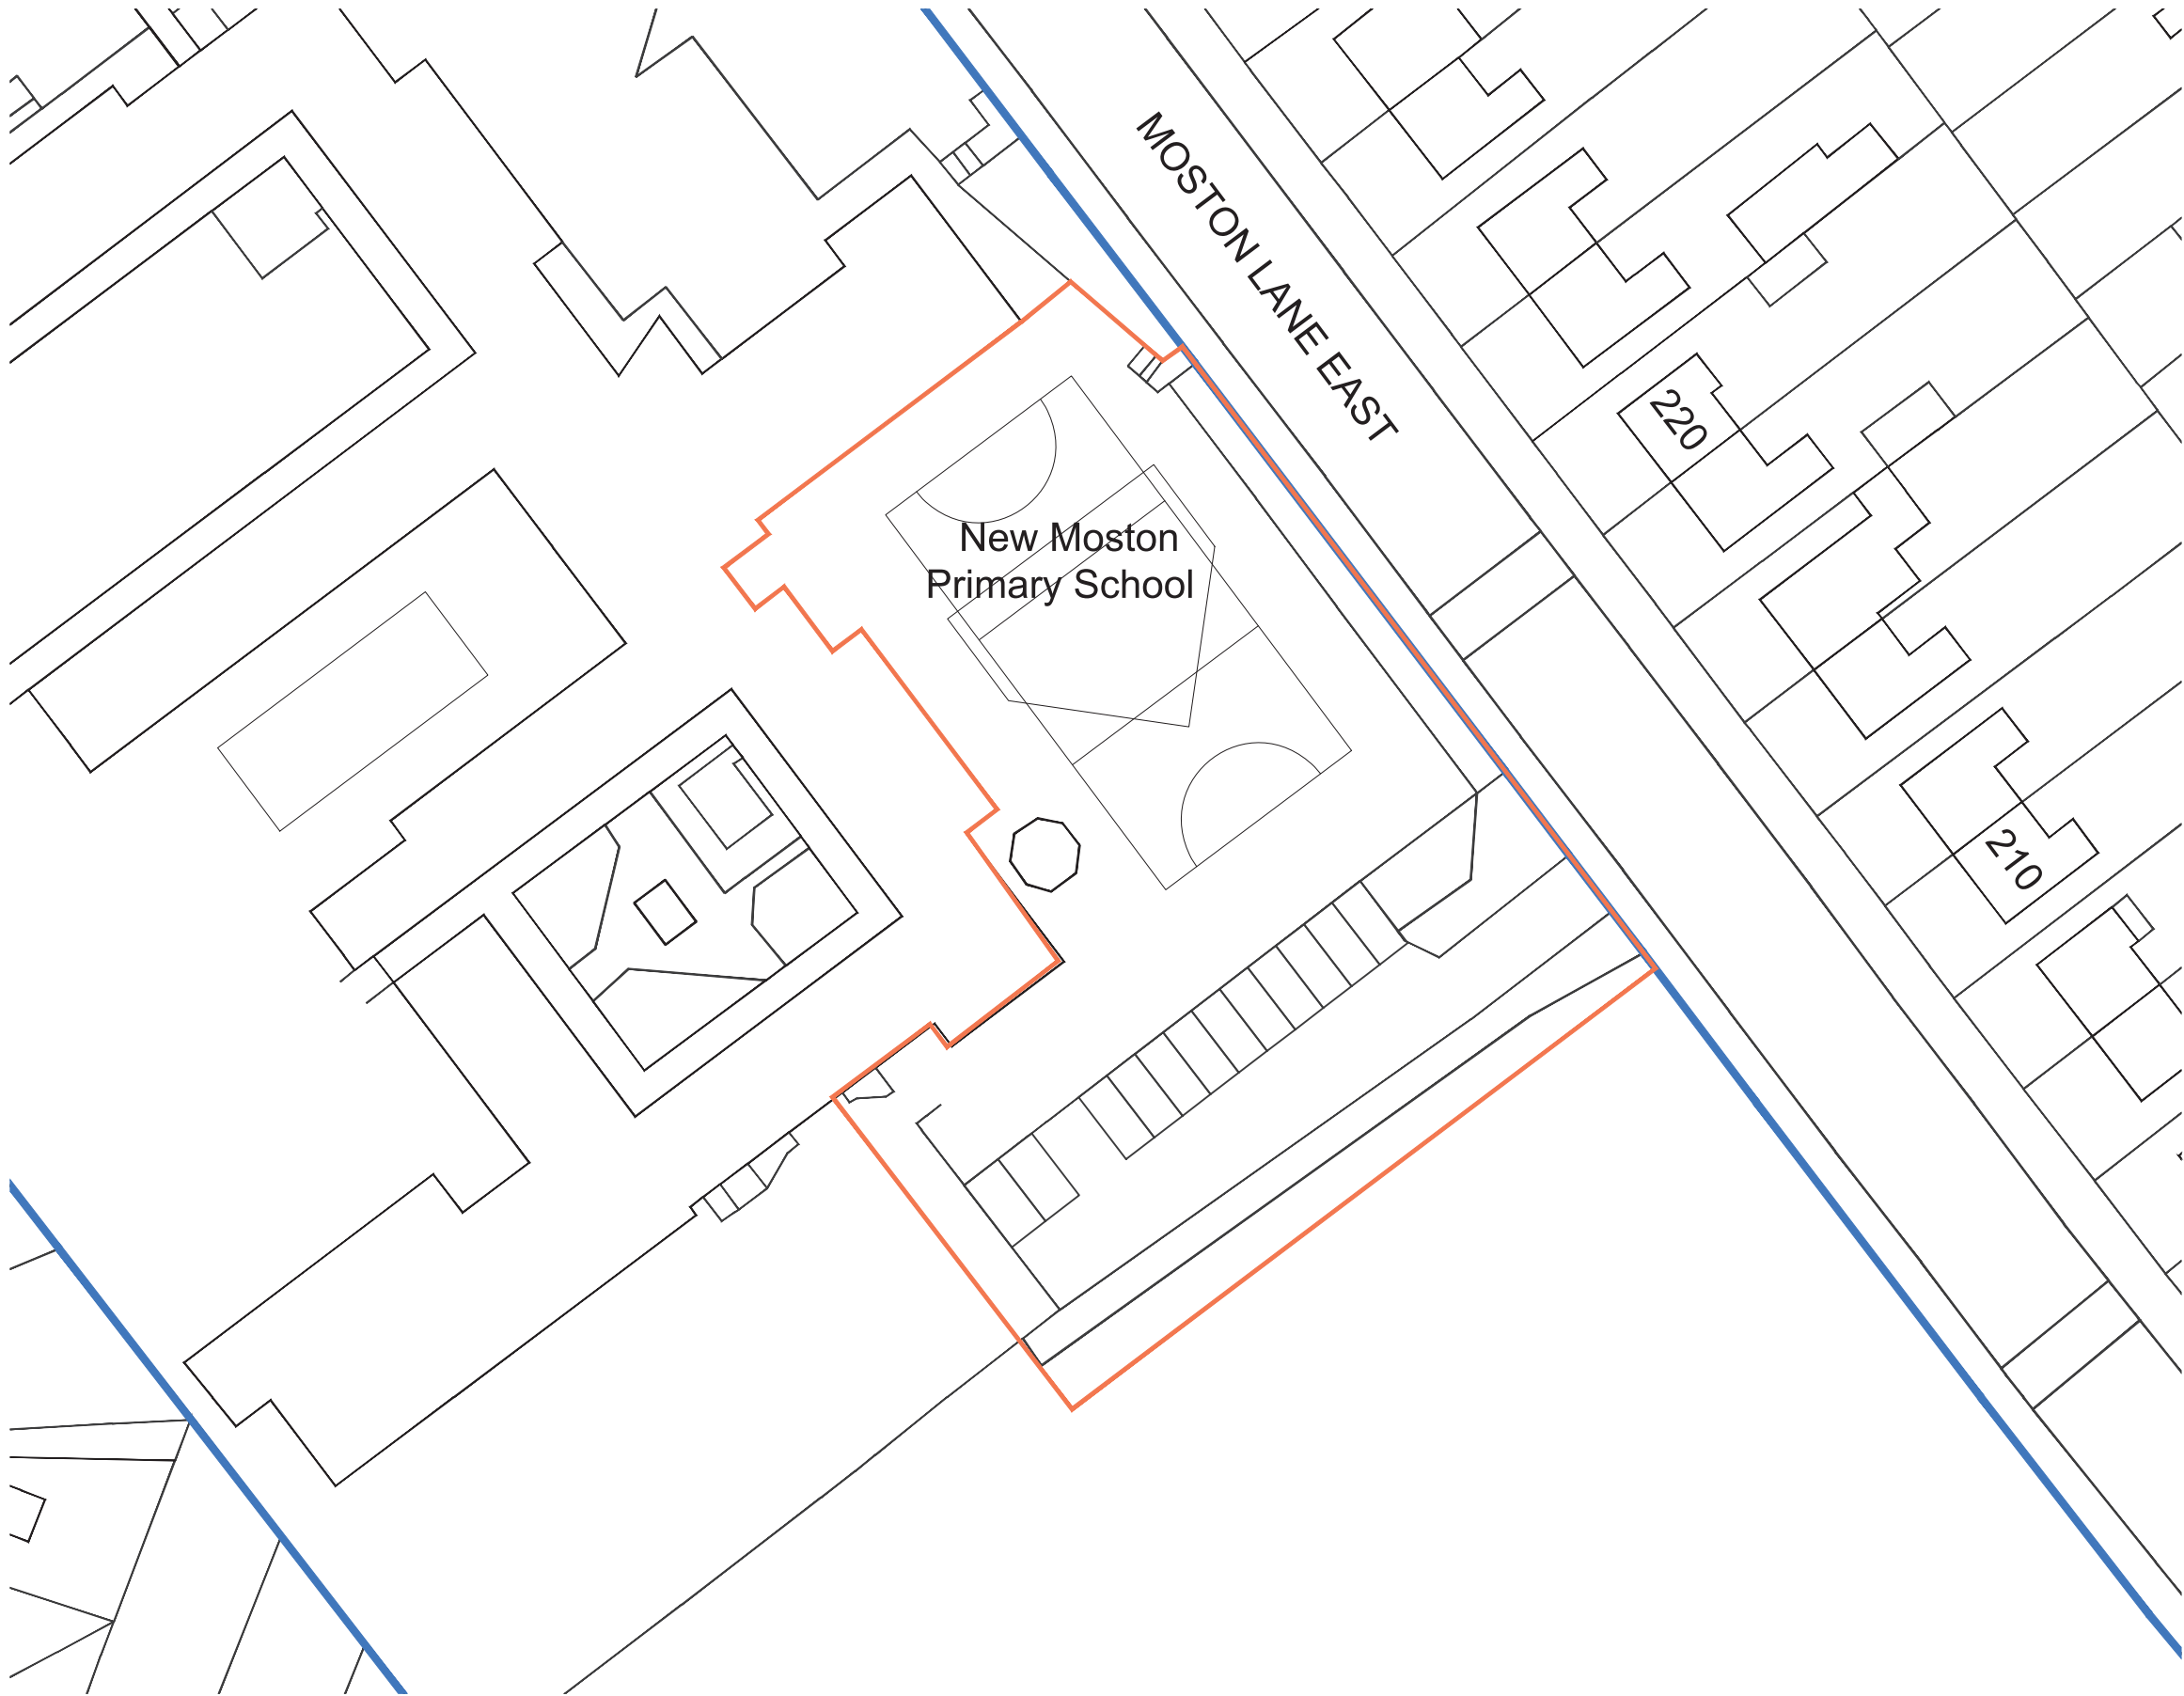
| Job no.<br>11343 | Dwg.no.<br>CAA-B01-XX-DR-A-1002 | Rev.<br>P1 | |

PROPOSED DEVELOPMENT PLAN
