## REMEDIATION AND ENABLING WORKS VALIDATION REPORT

Former Stagecoach Bus Depot  
Land off Bowes Street  
Manchester

Report Ref: 11-813-R2- Rev C  
Date Issued: August 2019

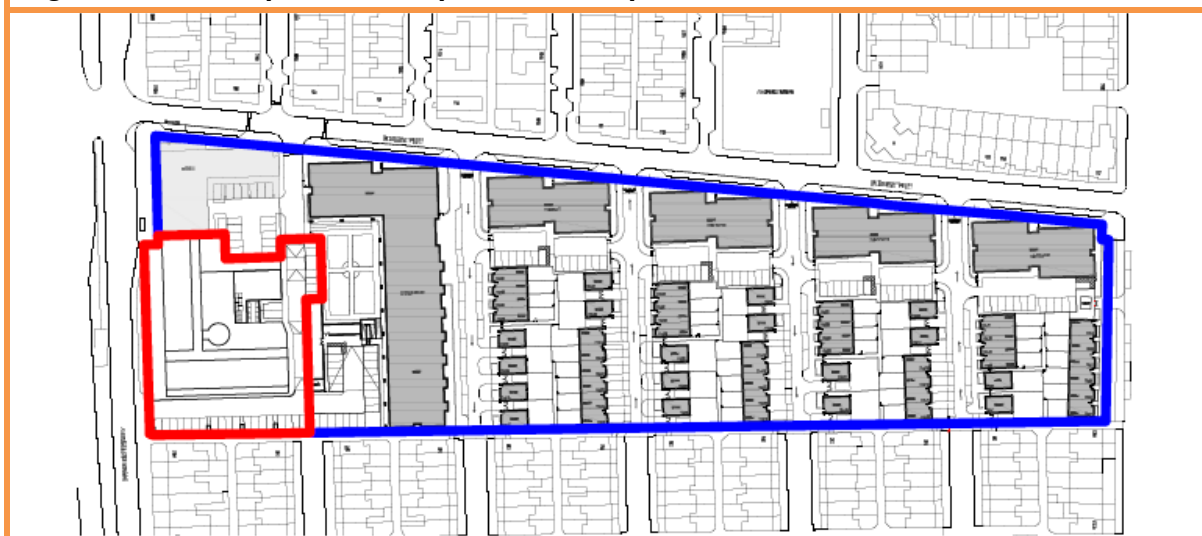
**Figure 1.2** *Snapshot of Proposed Development*

Rowlinson Construction propose to redevelop the site for low rise residential end use comprising a series of apartment dwellings with gardens, access roads, driveways and adopted drainage infrastructure under planning permission reference 127796/JO/2020. For the avoidance of doubt this report covered both the blue and red boundaries illustrated within figure 1.1 below.

The detailed development layout for the site is presented within Drawing No. 11-813-002 (Rev B) included within Appendix III.

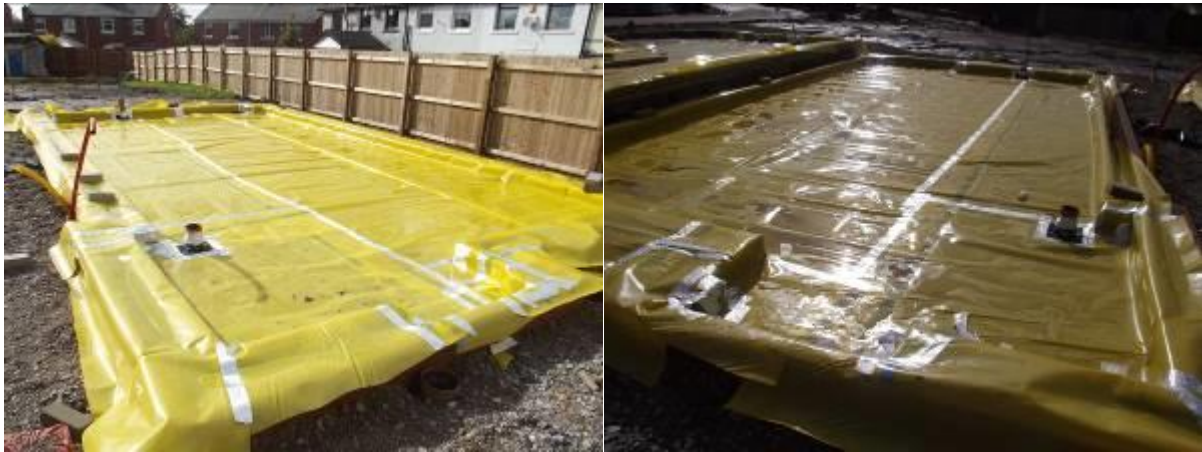
Examples of gas membrane verification (photographs include different membrane types for demonstrative purposes only – gas membranes are site specific):

*Photographs 1 and 2: Check general condition of membrane for punctures / tears etc*

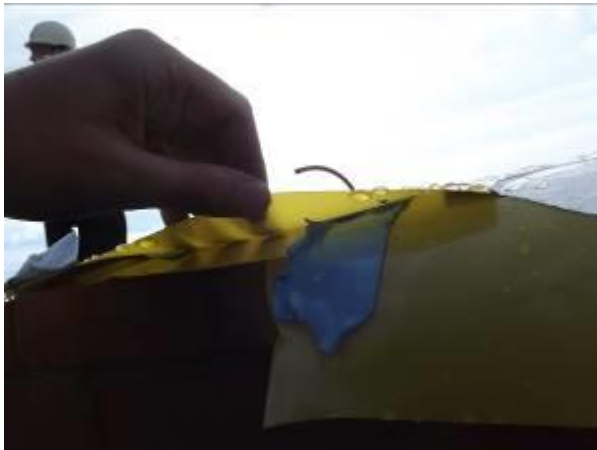
*Photograph 3: Confirm membrane product type and check joints between rolls of membrane to ensure 150mm overlap and presence of double sided butyl tape (by touch – may not be visible) and girth jointing tape.*

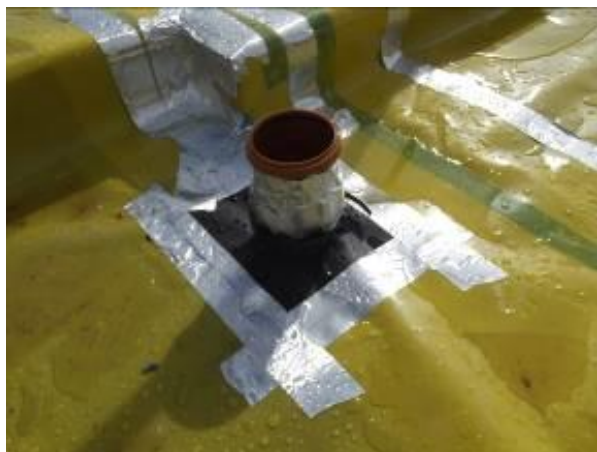
*Photograph 4: Check top hat is sealed to membrane and pipework. If the formed top hat is not tight to the pipework then also confirm presence of jubilee clip beneath butyl tape.*

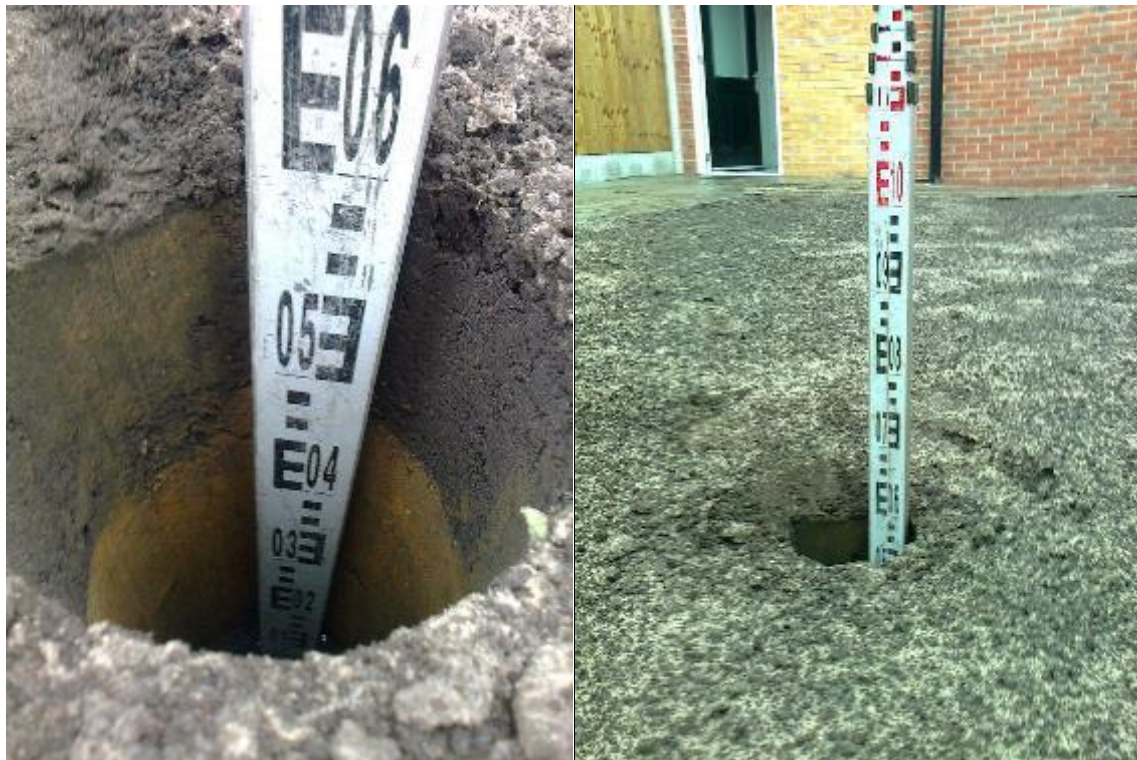
*Photographs 1 and 2: Examples of validation photographs demonstrating clean cover.*
