## 7.0 Asbestos Register

## HSG264 Asbestos Refurbishment Survey

**Rylands Building (Former Debenhams)**  
**Market Street**  
**Manchester**  
**M60 1TA**

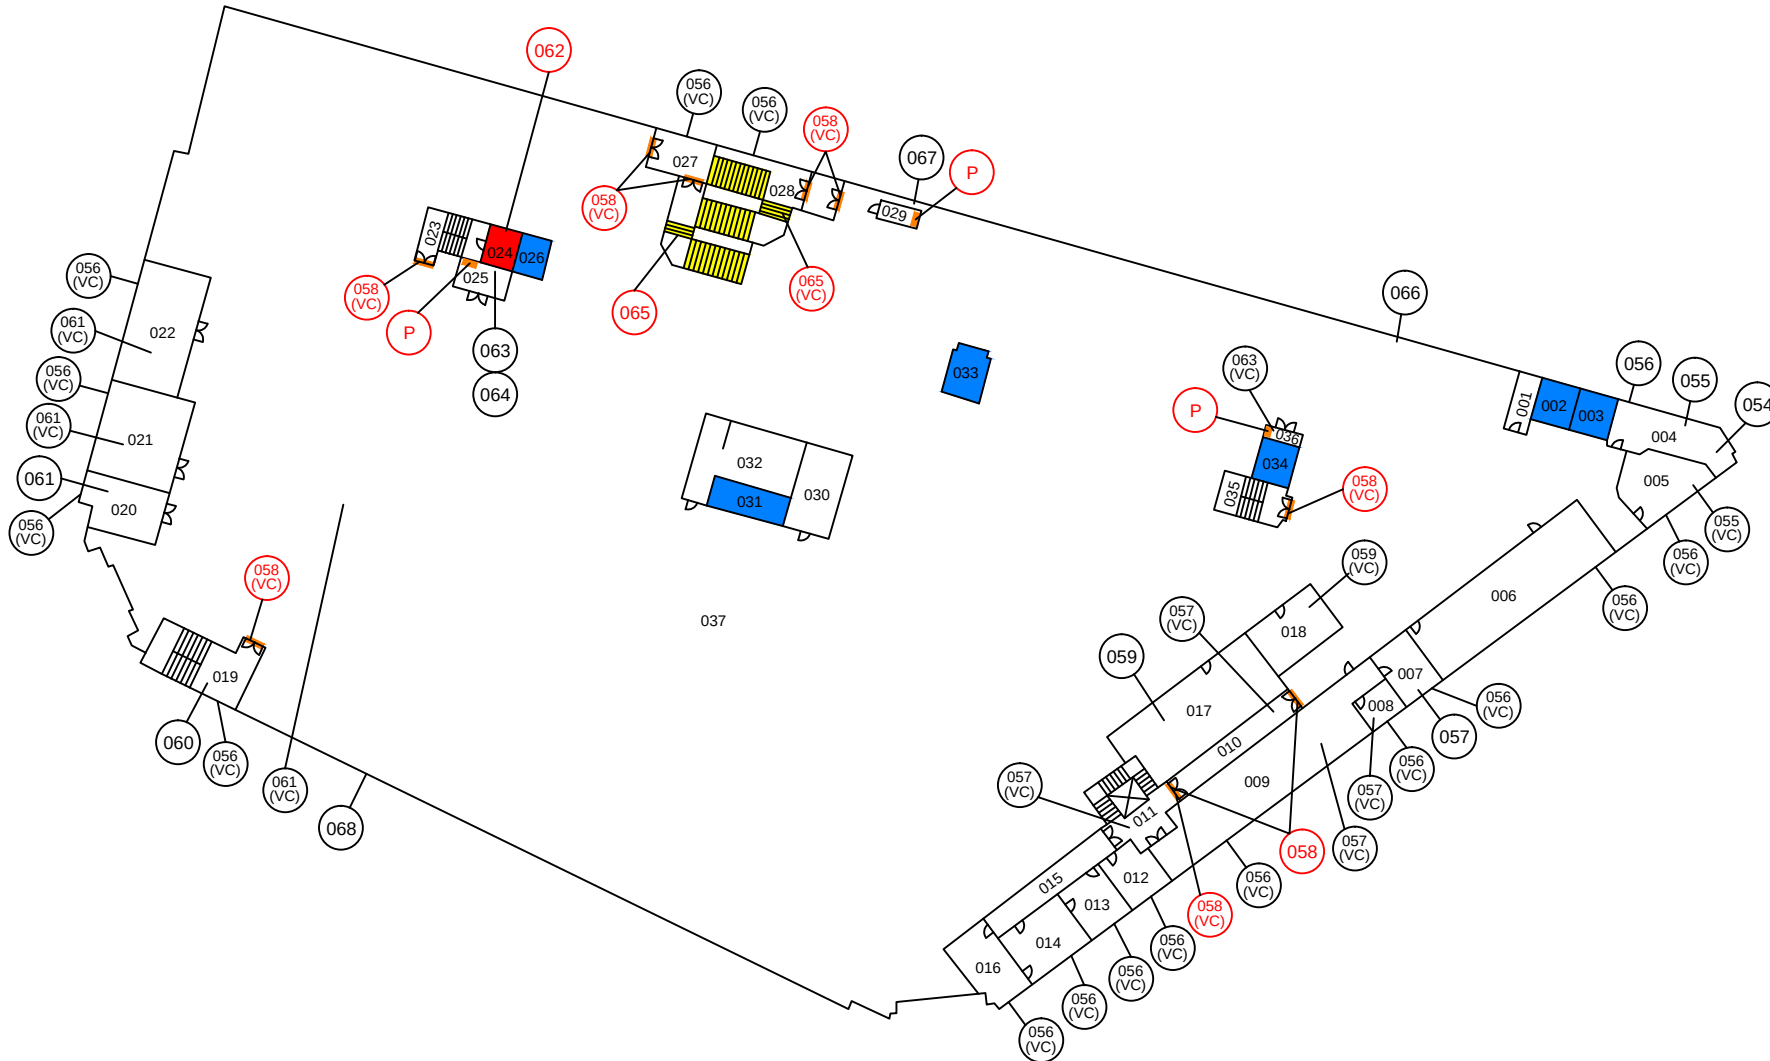
This Drawing is for illustration purposes only and should not be used for detailed construction works as the drawing is not to scale and represents layout only. The hatching on the drawing denotes positive asbestos items found during the course of the survey and potential areas where asbestos could be found as those areas were inaccessible at the time the survey was undertaken.
