## HSG264 Asbestos Refurbishment Survey

**Rylands Building (Former Debenhams)**  
**Market Street**  
**Manchester**  
**M60 1TA**

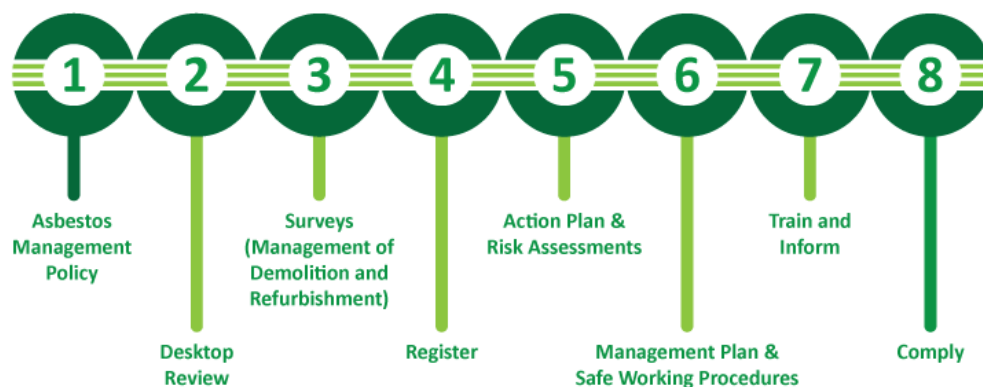
### Asbestos Knowledge Chain

OHA have prepared the following Asbestos Knowledge Chain to provide transparency of the process of achieving and maintaining compliance with the CAR2012:

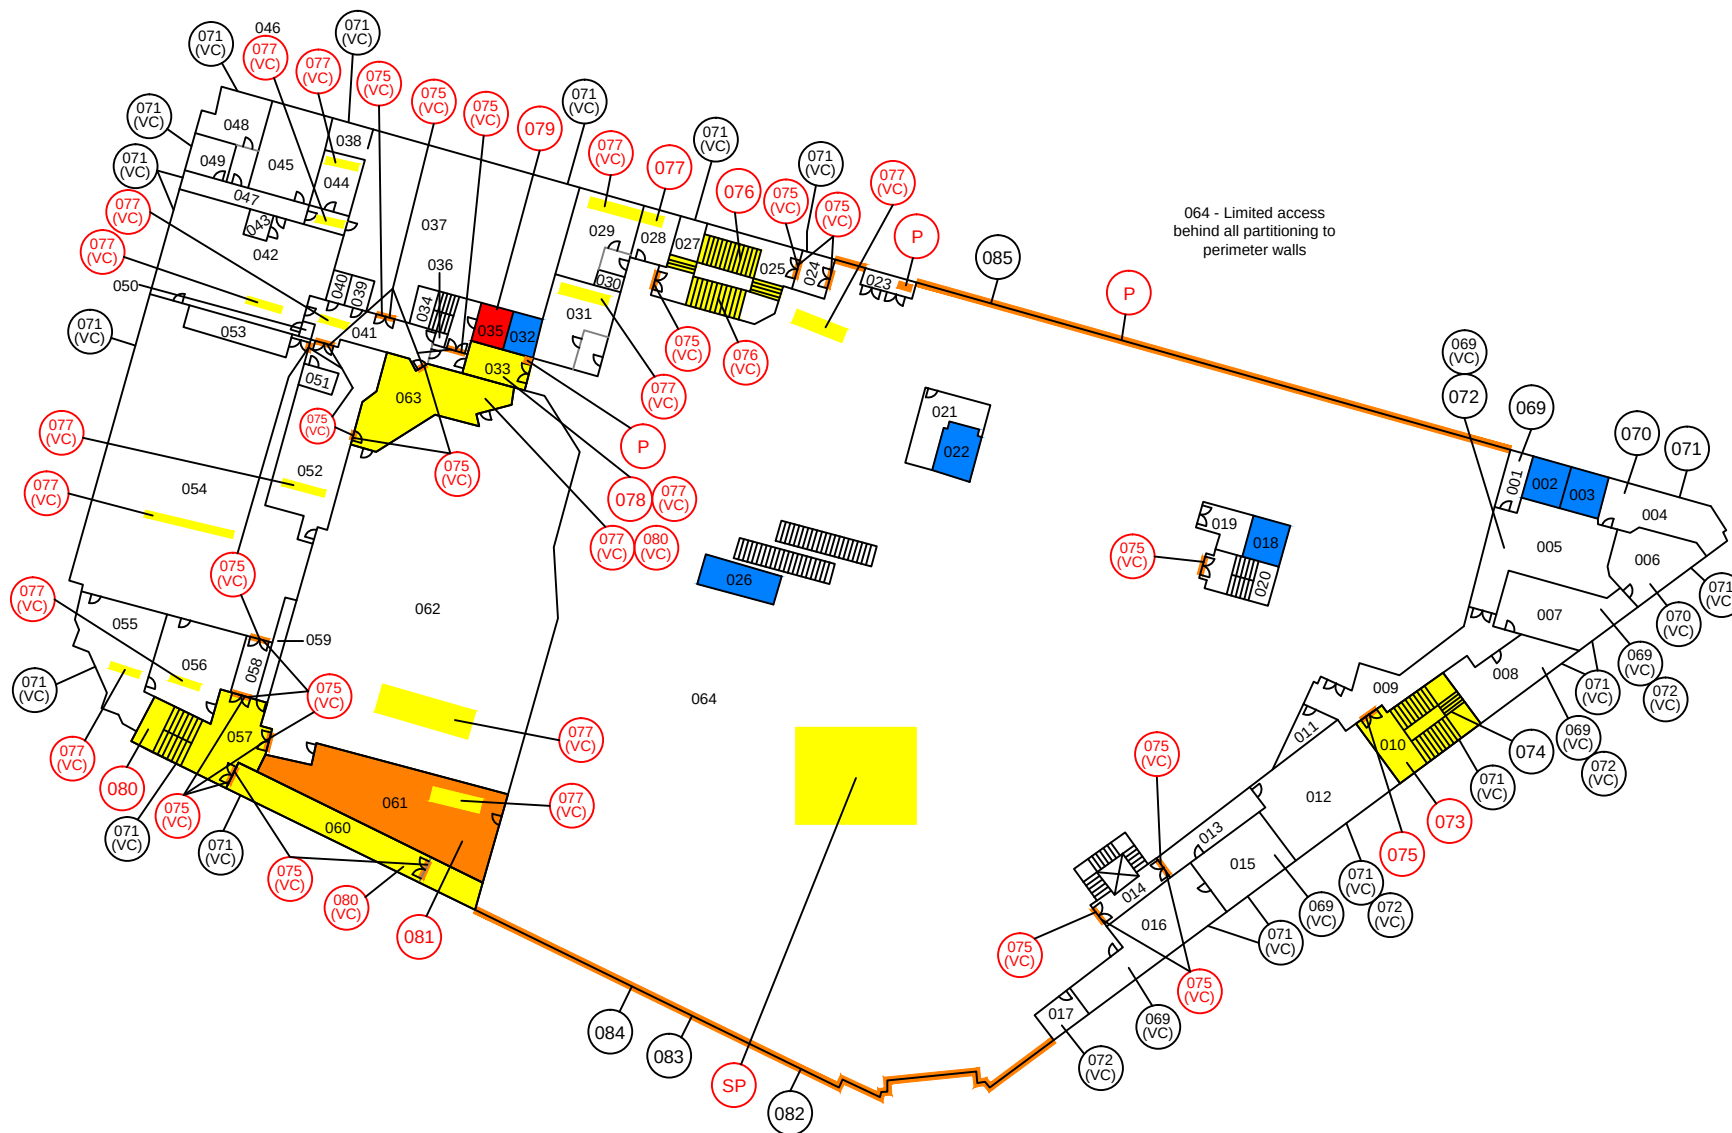
- Thermal Insulation (e.g. Pipe & Boiler Lagging) Sprayed Asbestos, Loose Asbestos, Asbestos Mattresses & Packing
- Asbestos Insulating Board (AIB), Millboards, Insulation Boards, Asbestos Textiles, Gaskets, Ropes, & Asbestos Paper or Felt
- Asbestos Reinforced Composites (Plastics, Resins, Mastics, Roofing Felts, Vinyl Floor Tiles, Semi-Rigid Paints, Decorative Finishes, Bitumen) & Cement
- No Access / Limited Access Areas
- Outside Scope of Survey
- Scope of Survey
- 001 Positive Sample Location
- 001(VC) Positive Visually Consistent Sample Location
- SP Strongly Presumed Sample Location
- P Presumed Sample Location
- 001 Negative Sample Location

This Drawing is for illustration purposes only and should not be used for detailed construction works as the drawing is not to scale and represents layout only. The hatching on the drawing denotes positive asbestos items found during the course of the survey and potential areas where asbestos could be found as those areas were inaccessible at the time the survey was undertaken.
