## HSG264 Asbestos Refurbishment Survey

**Rylands Building (Former Debenhams)**  
**Market Street**  
**Manchester**  
**M60 1TA**

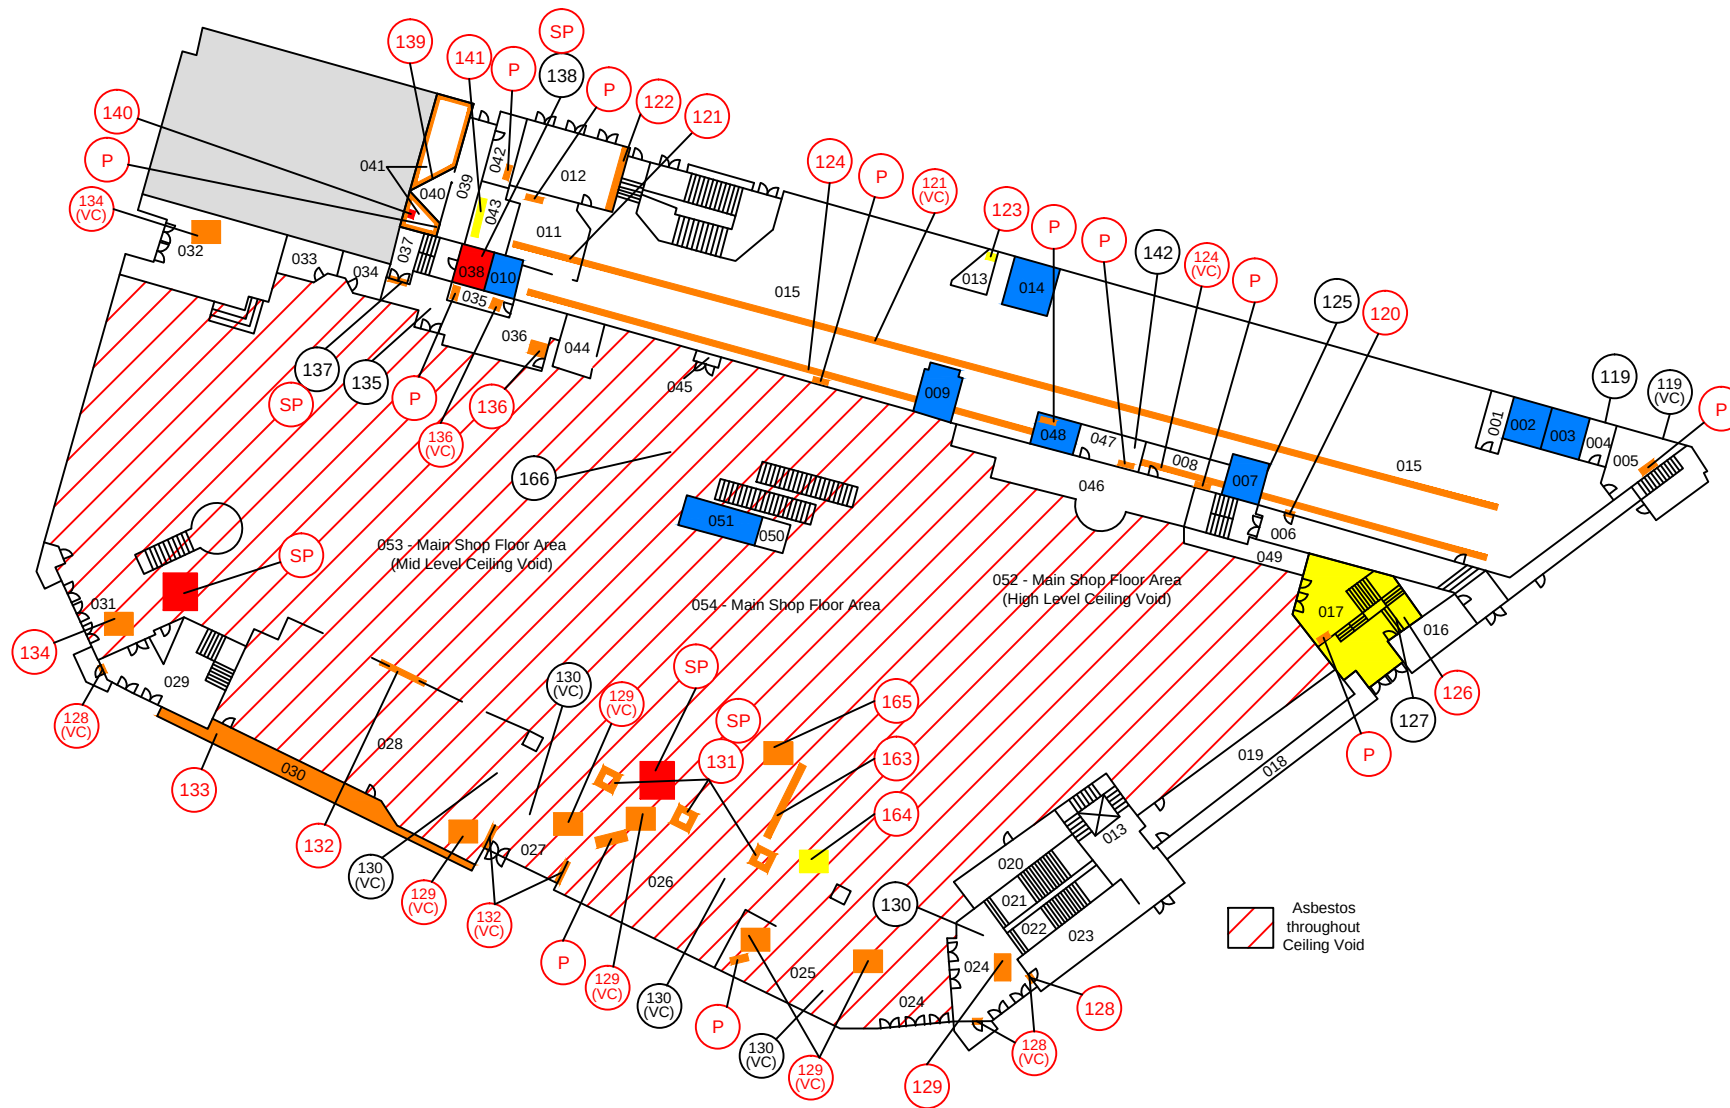
- Thermal Insulation (e.g. Pipe & Boiler Lagging) Sprayed Asbestos, Loose Asbestos, Asbestos Mattresses & Packing
- Asbestos Insulating Board (AIB), Millboards, Insulation Boards, Asbestos Textiles, Gaskets, Ropes, & Asbestos Paper or Felt
- Asbestos Reinforced Composites (Plastics, Resins, Mastics, Roofing Felts, Vinyl Floor Tiles, Semi-Rigid Paints, Decorative Finishes, Bitumen) & Cement
- No Access / Limited Access Areas
- Outside Scope of Survey
- Scope of Survey
- Positive Sample Location
- Positive Visually Consistent Sample Location
- Strongly Presumed Sample Location
- Presumed Sample Location
- Negative Sample Location

This Drawing is for illustration purposes only and should not be used for detailed construction works as the drawing is not to scale and represents layout only. The hatching on the drawing denotes positive asbestos items found during the course of the survey and potential areas where asbestos could be found as those areas were inaccessible at the time the survey was undertaken.

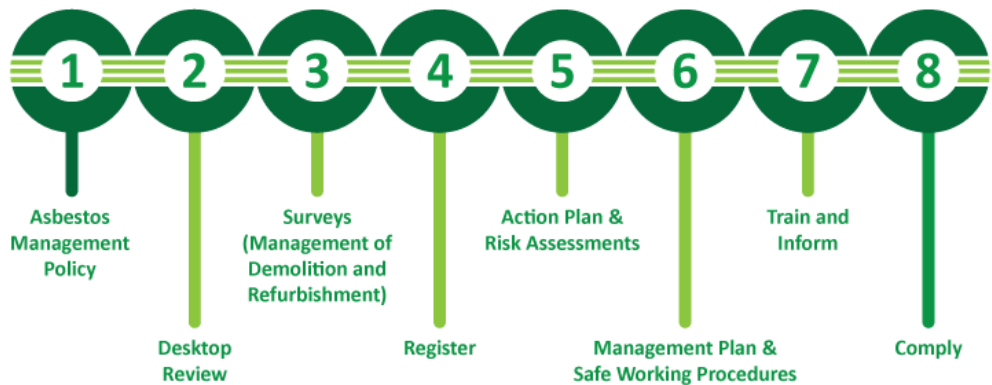
### Asbestos Knowledge Chain

OHA have prepared the following Asbestos Knowledge Chain to provide transparency of the process of achieving and maintaining compliance with the CAR2012:

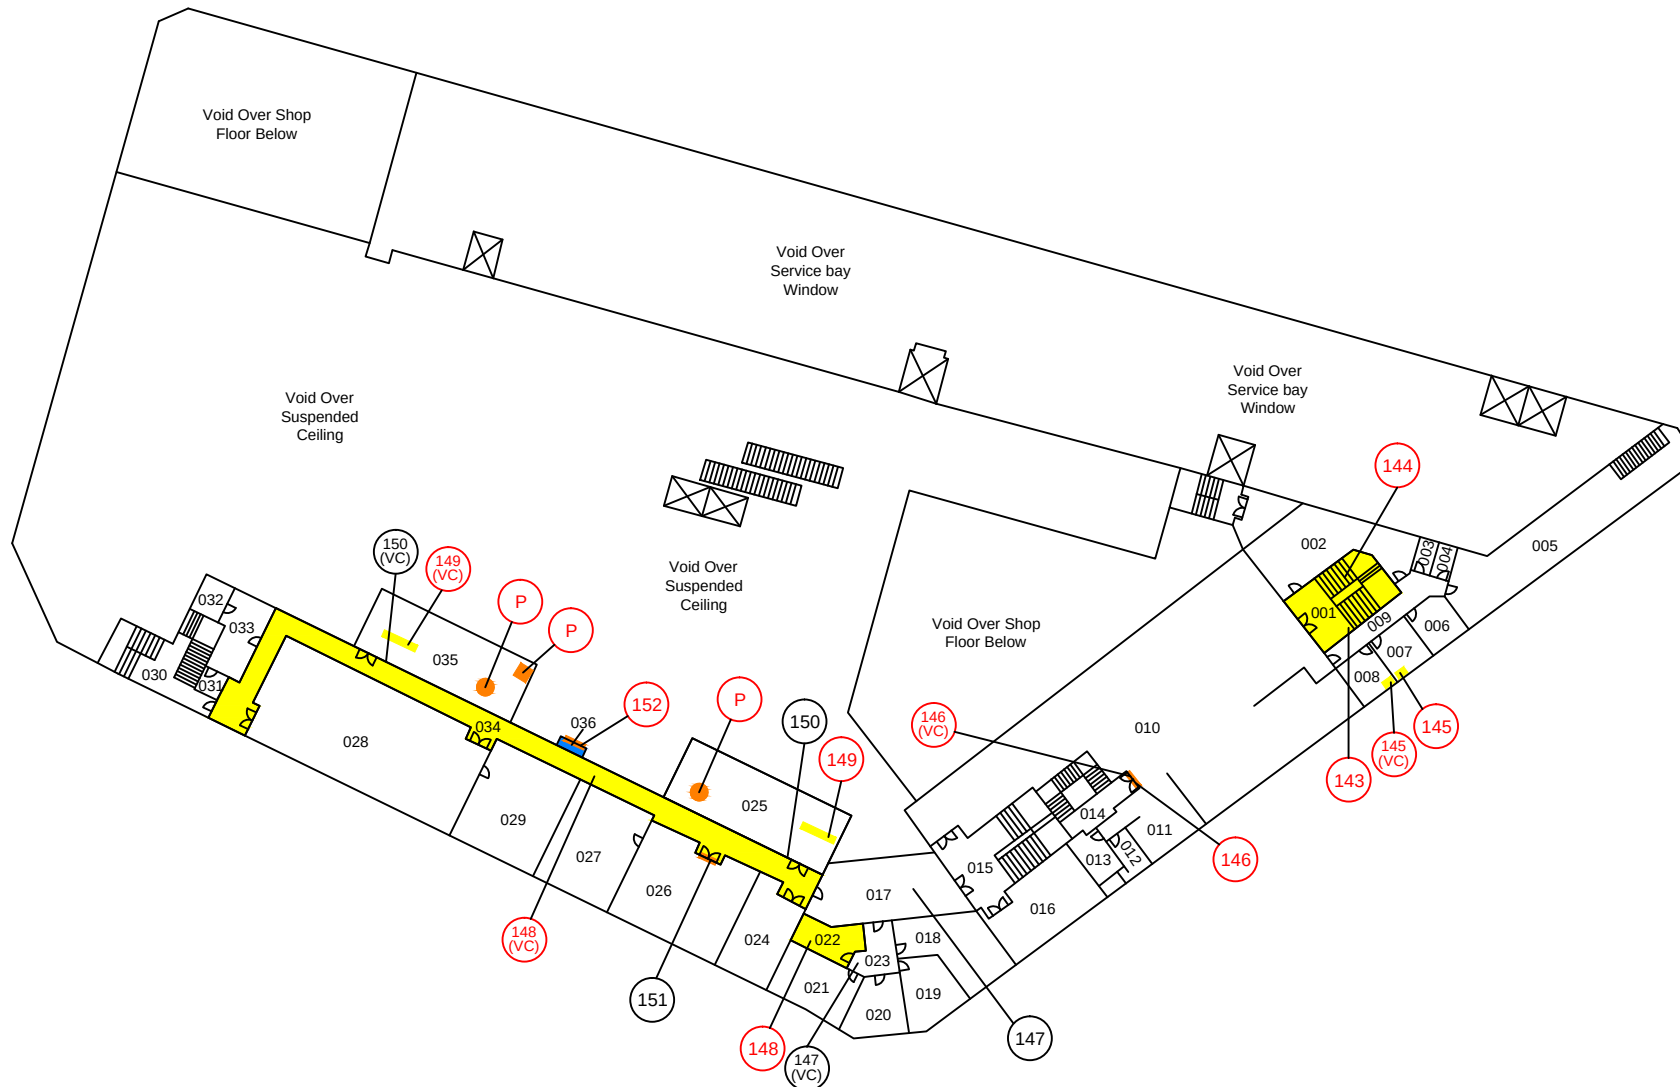
Negative Sample Location

This Drawing is for illustration purposes only and should not be used for detailed construction works as the drawing is not to scale and represents layout only. The hatching on the drawing denotes positive asbestos items found during the course of the survey and potential areas where asbestos could be found as those areas were inaccessible at the time the survey was undertaken.
