## HSG264 Asbestos Refurbishment Survey

**Rylands Building (Former Debenhams)**  
**Market Street**  
**Manchester**  
**M60 1TA**

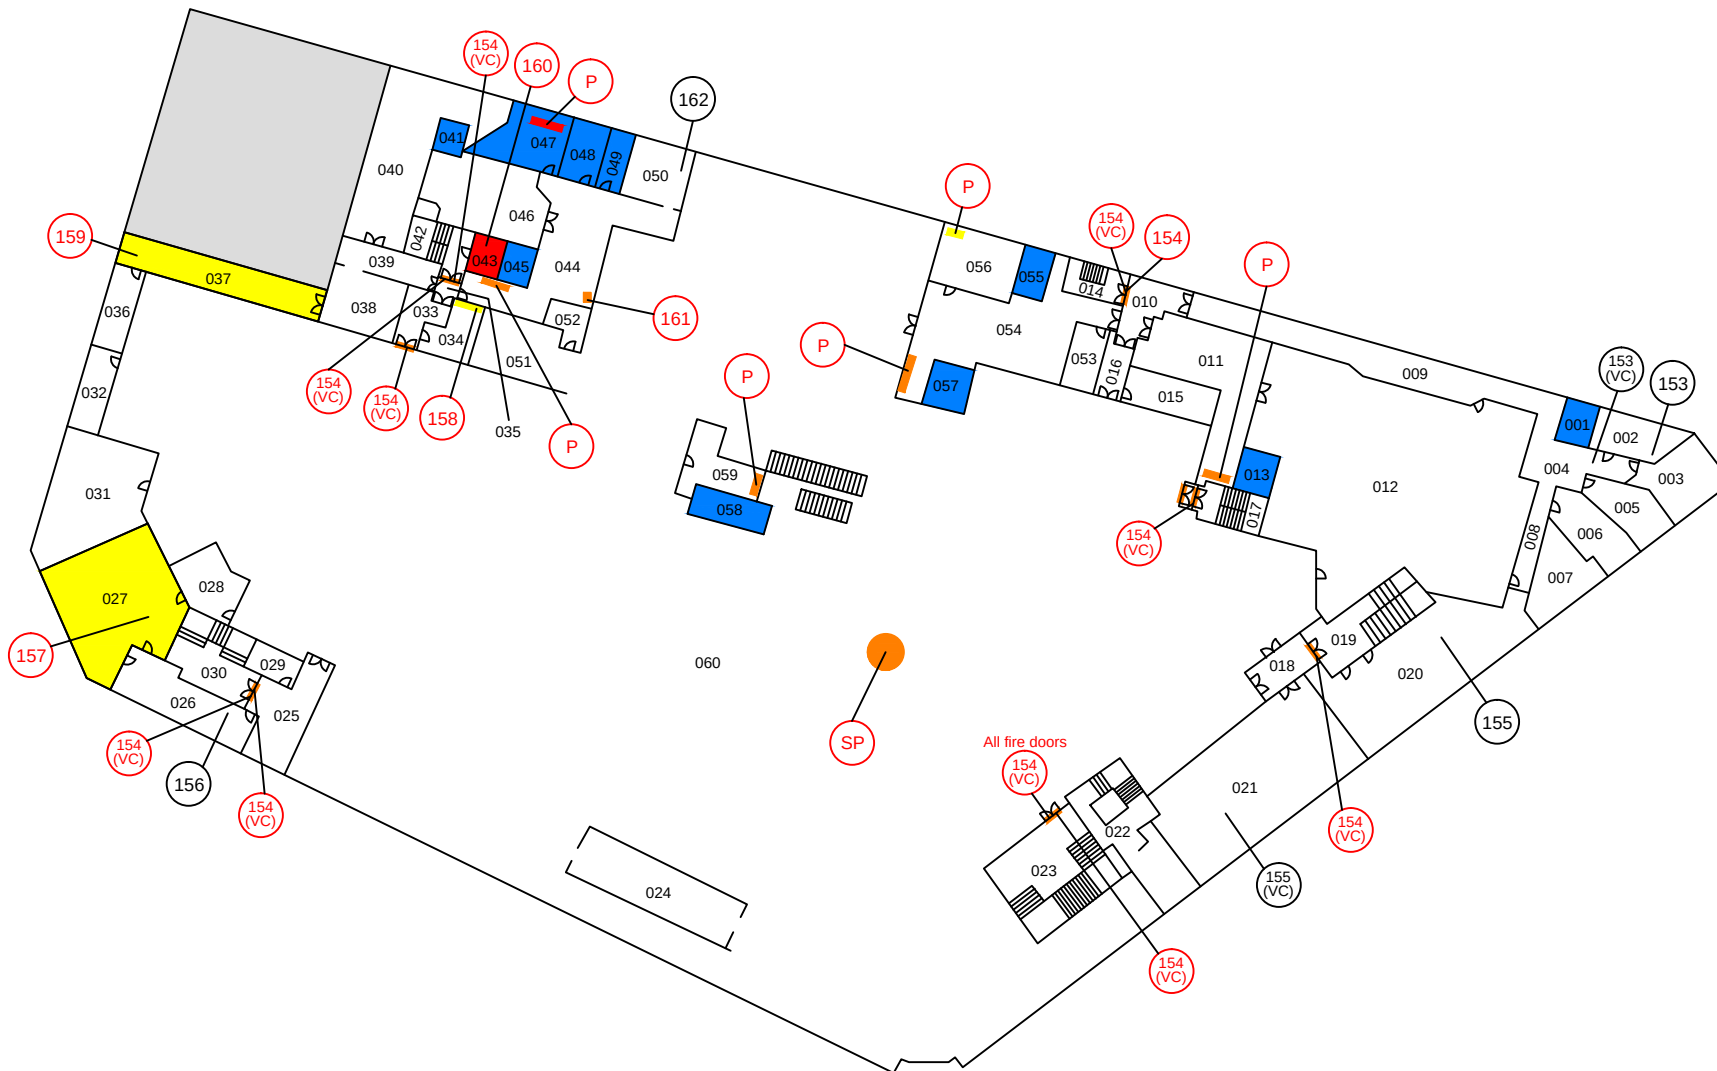
This Drawing is for illustration purposes only and should not be used for detailed construction works as the drawing is not to scale and represents layout only. The hatching on the drawing denotes positive asbestos items found during the course of the survey and potential areas where asbestos could be found as those areas were inaccessible at the time the survey was undertaken.
