Phase II Geoenvironmental Site Assessment  
Renaissance, Manchester

Reference: 14-261-R2-1  
Date: 21<sup>st</sup> May 2021

## PHASE II GEOENVIRONMENTAL SITE ASSESSMENT

Renaissance  
Deansgate  
Manchester  
M3 2FE

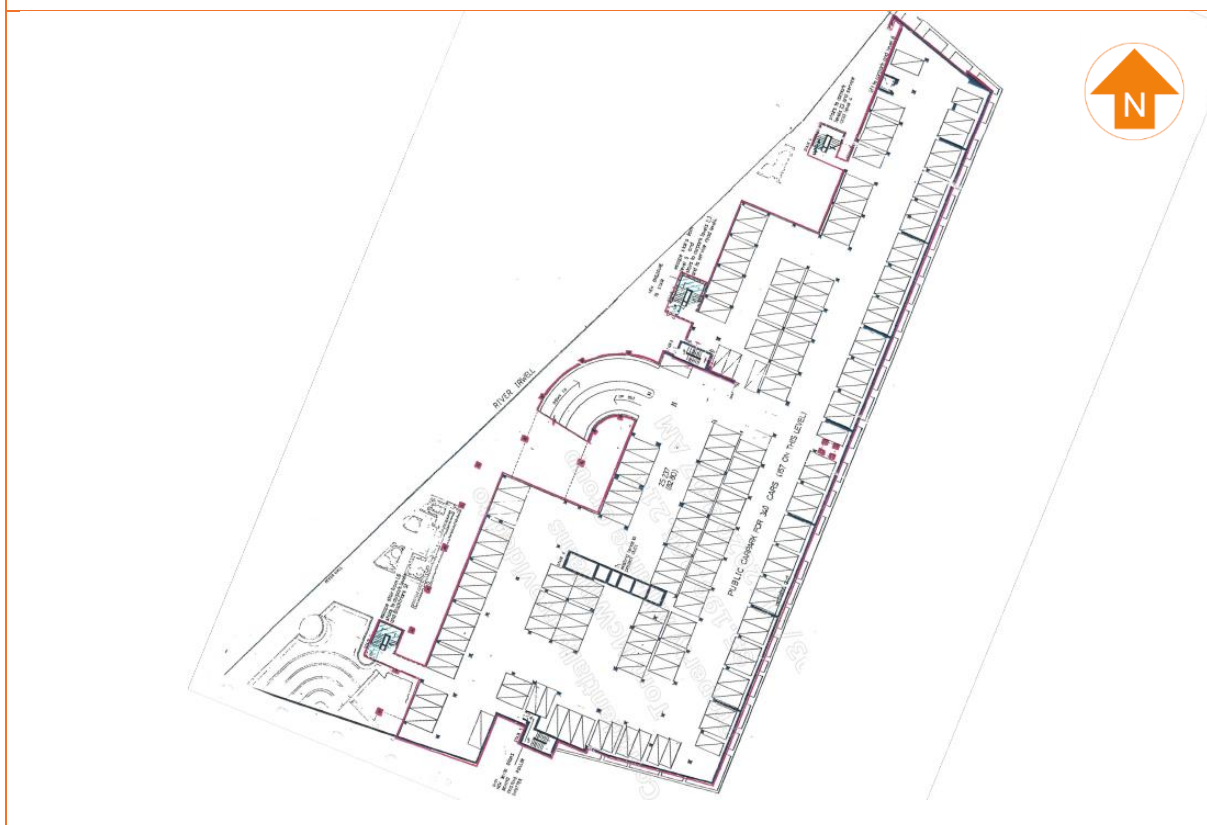
FIGURE 1.1      SNAPSHOT OF PROPOSED DEVELOPMENT

A snapshot of the proposed development layout is indicated in Figure 1.1.

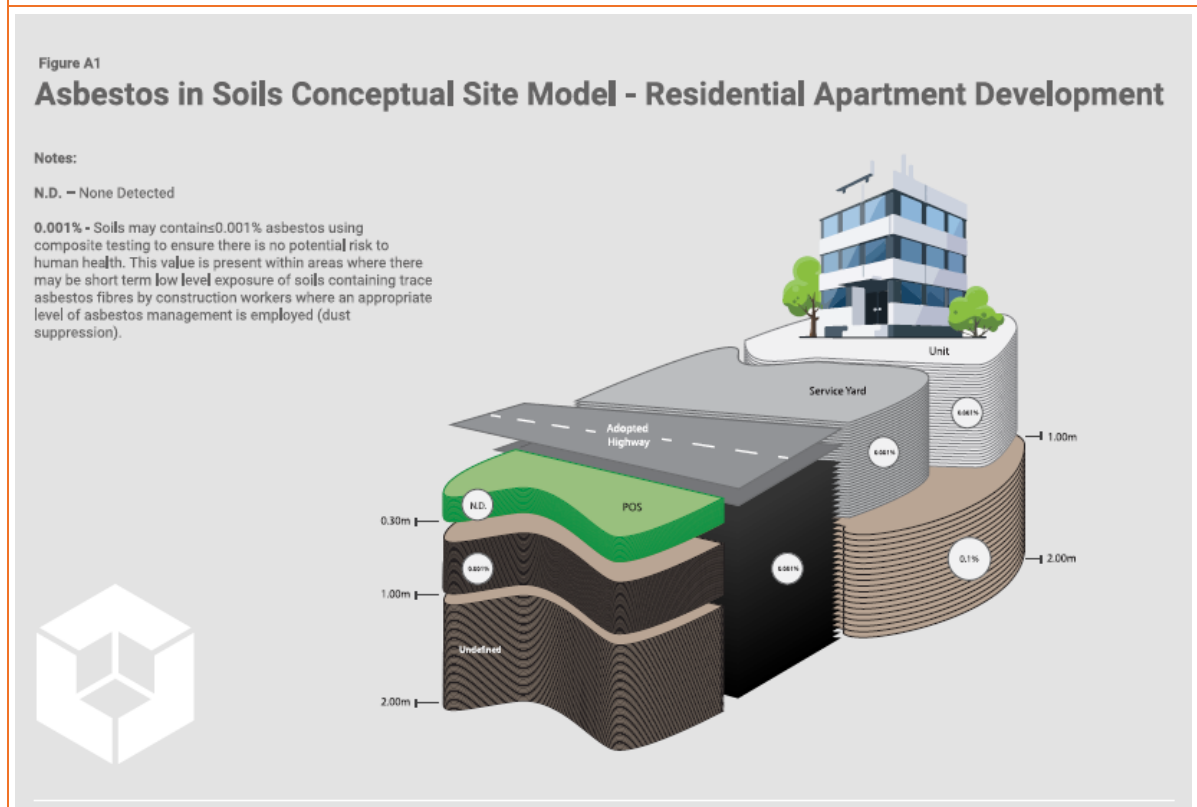
FIGURE 4.1 ASBESTOS RISK MITIGATION CONCEPTUAL SITE MODEL

No visual signs of ACM were encountered during the ground investigation; it is therefore likely that only trace fibres are present. Impacted soils should be managed according to the asbestos risk mitigation conceptual site model shown in Figure 4.1.

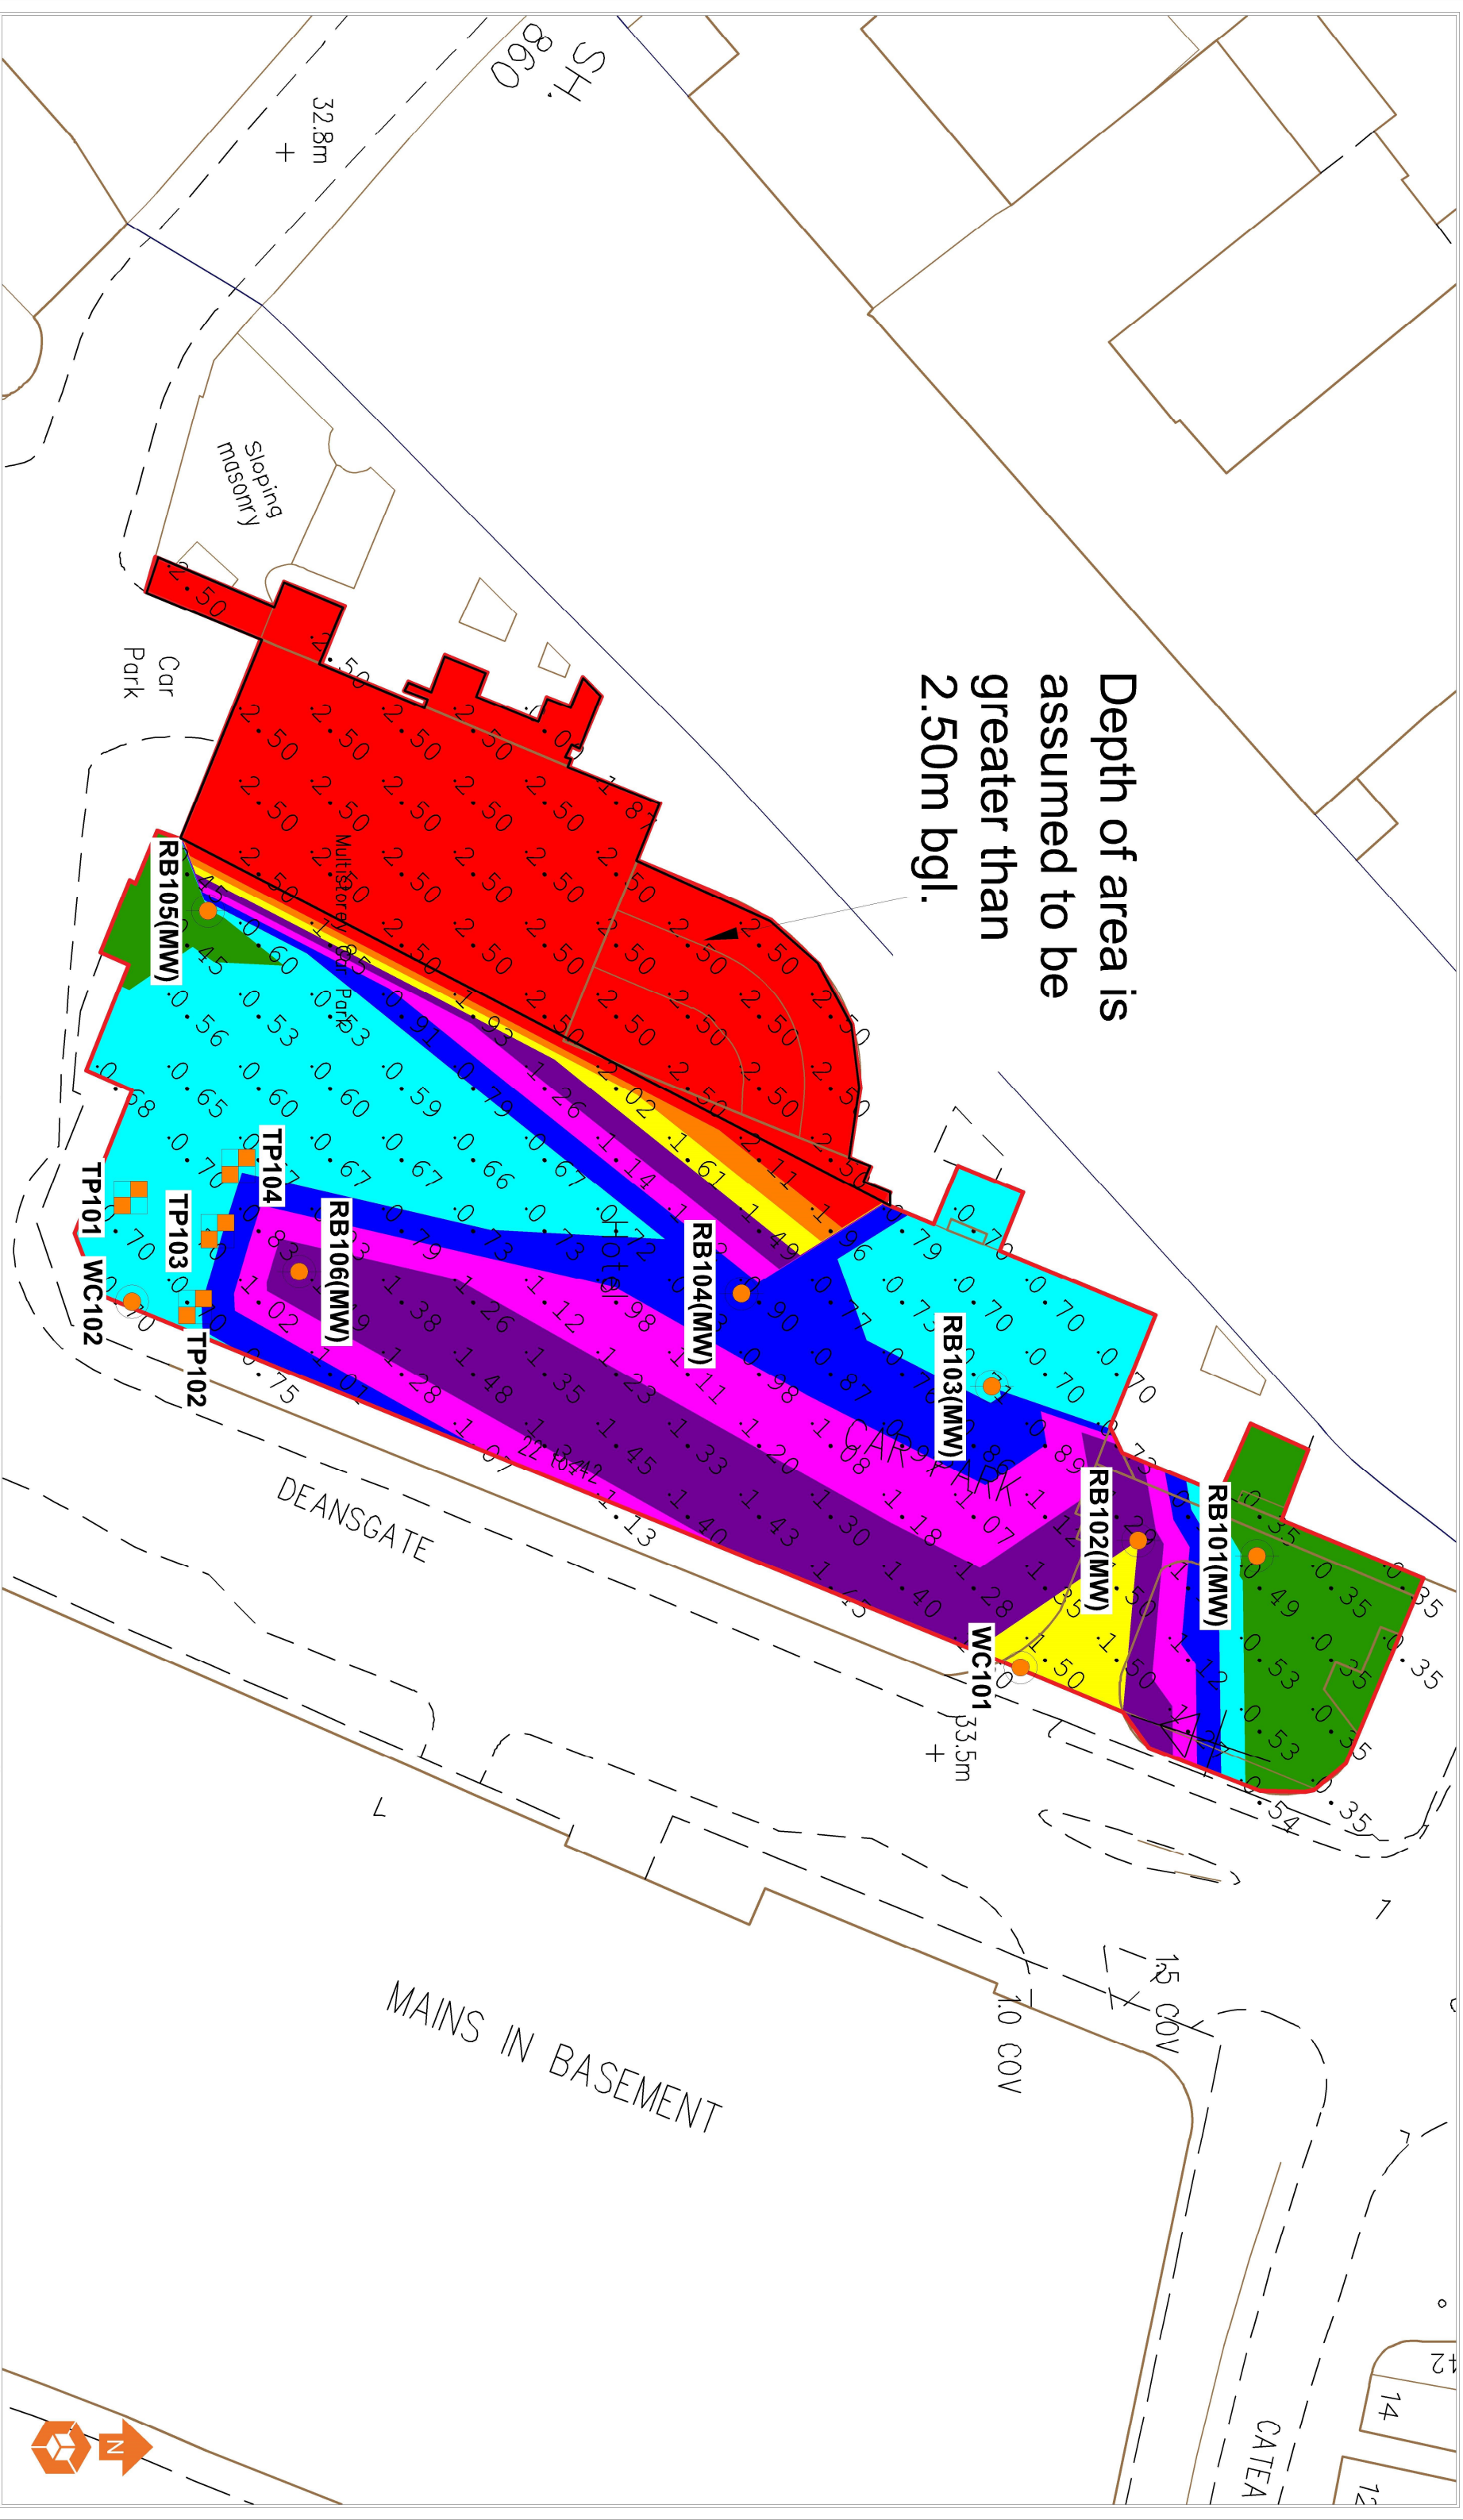
Depth of area is assumed to be greater than 2.50m bgl.
